FLORIDA DEPARTMENT OF TRANSPORTATION  
AVIATION AND SPACEPORT OFFICE

AIRGLADES  
AIRPARK (2IS)

DECEMBER 2013

# STATEWIDE Airfield Pavement Management PROGRAM

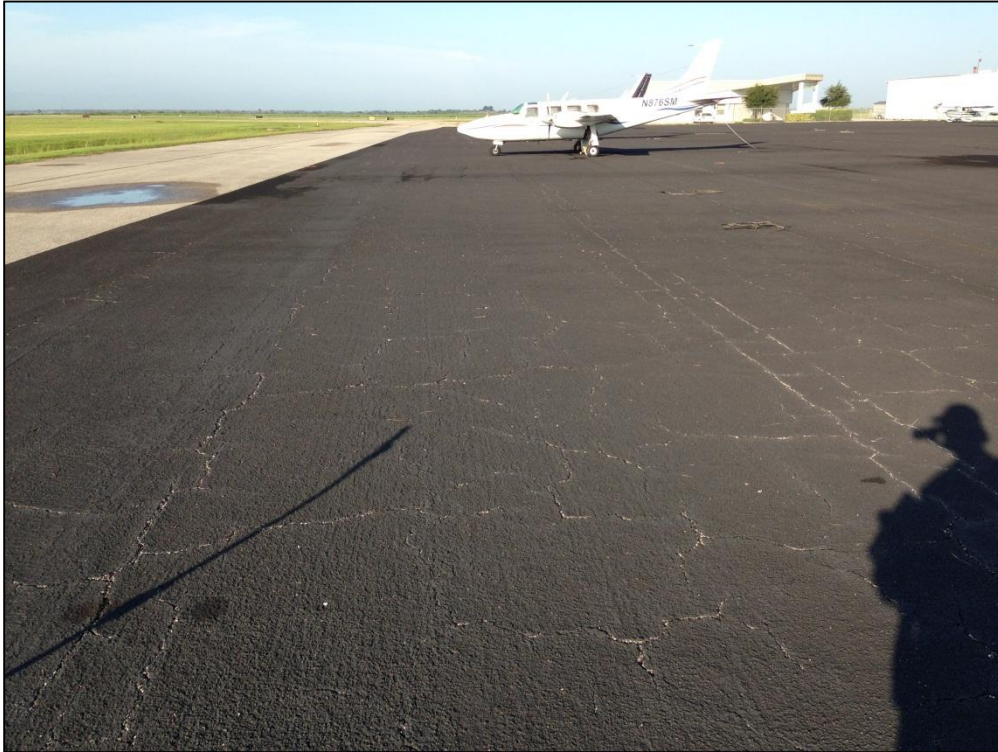
Apron East, Section 4505, Sample Unit 503 – Low Severity (52) Raveling, Low and Medium Severity (43) Block Cracking

- East Apron – Sections 4505
  - Reconstruction attributed to distresses related to subgrade quality, climate, and age of pavement.
- Northwest Apron – Sections 4405
  - Reconstruction attributed to distresses related to subgrade quality, climate, and age of pavement.
- South Apron – Sections 4305
  - Reconstruction attributed to distresses related to subgrade quality, climate, and age of pavement.
- Apron Hangar – Sections 4205
  - Reconstruction attributed to distresses related to load repetition, overloading, and construction quality.
- West Apron – Sections 4115
  - Mill and Overlay attributed to distresses related to climate and age of pavement.
- West Apron – Sections 4105
  - Reconstruction attributed to distresses related to subgrade quality, climate, and age of pavement.

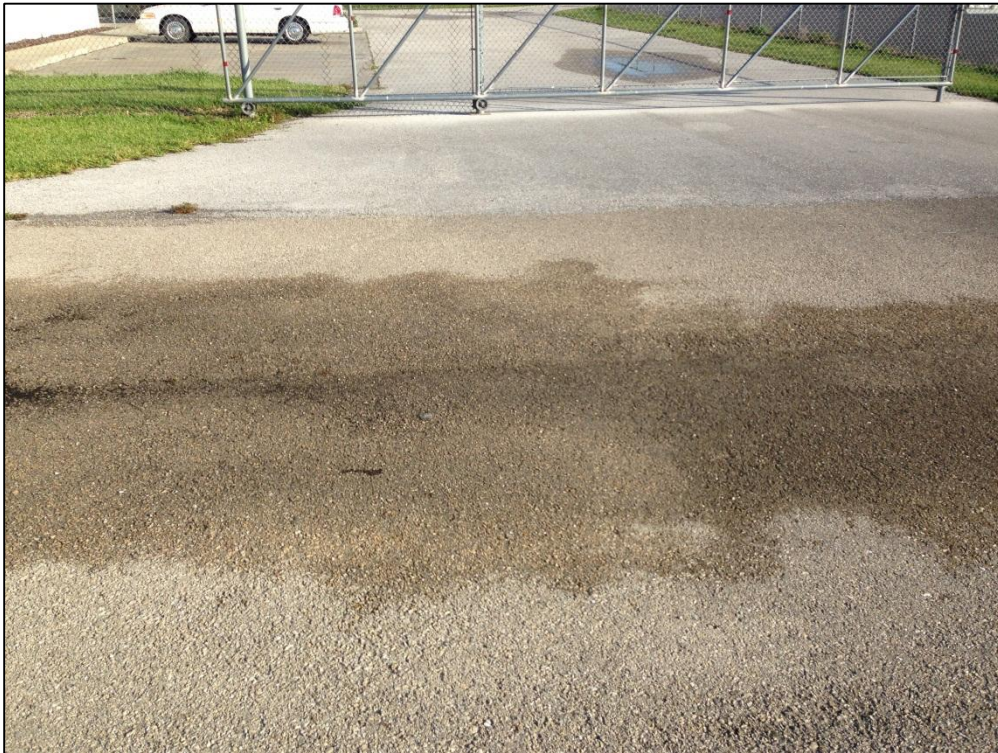
Apron South, Section 4305, Sample Unit 203 – Low Severity (48) Longitudinal and Transverse Cracking, Low and Medium Severity (52) Raveling, Low Severity (45) Depression

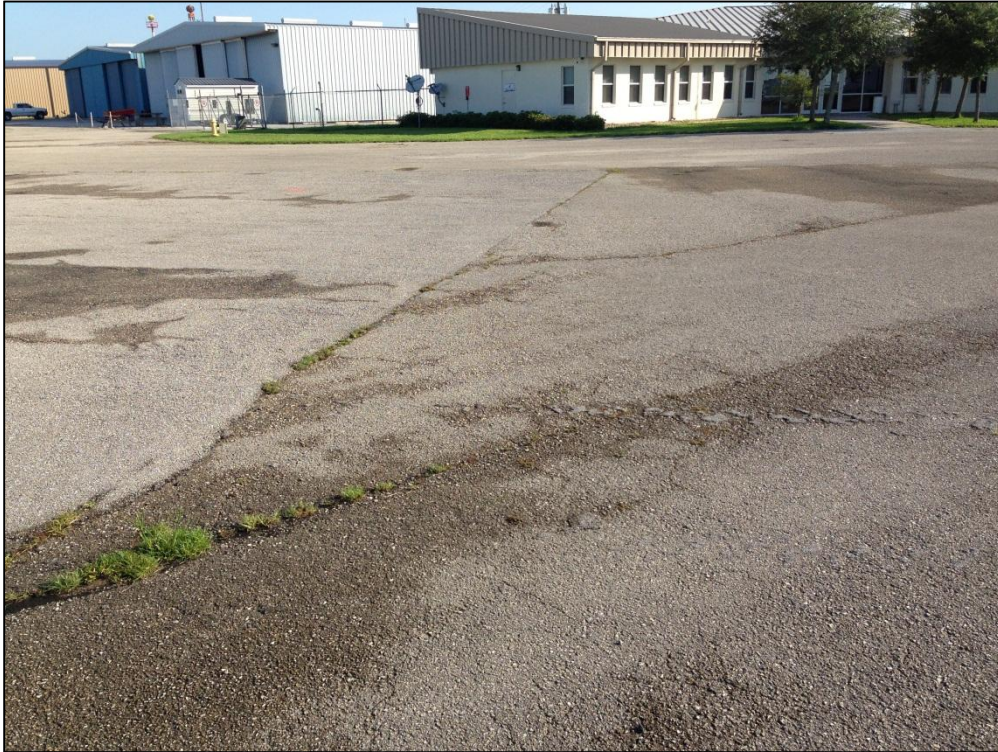
Apron South, Section 4305, Sample Unit 201 – Low and Medium Severity (48) Longitudinal and Transverse Cracking, Low and Medium Severity (52) Raveling, Low Severity (45) Depression

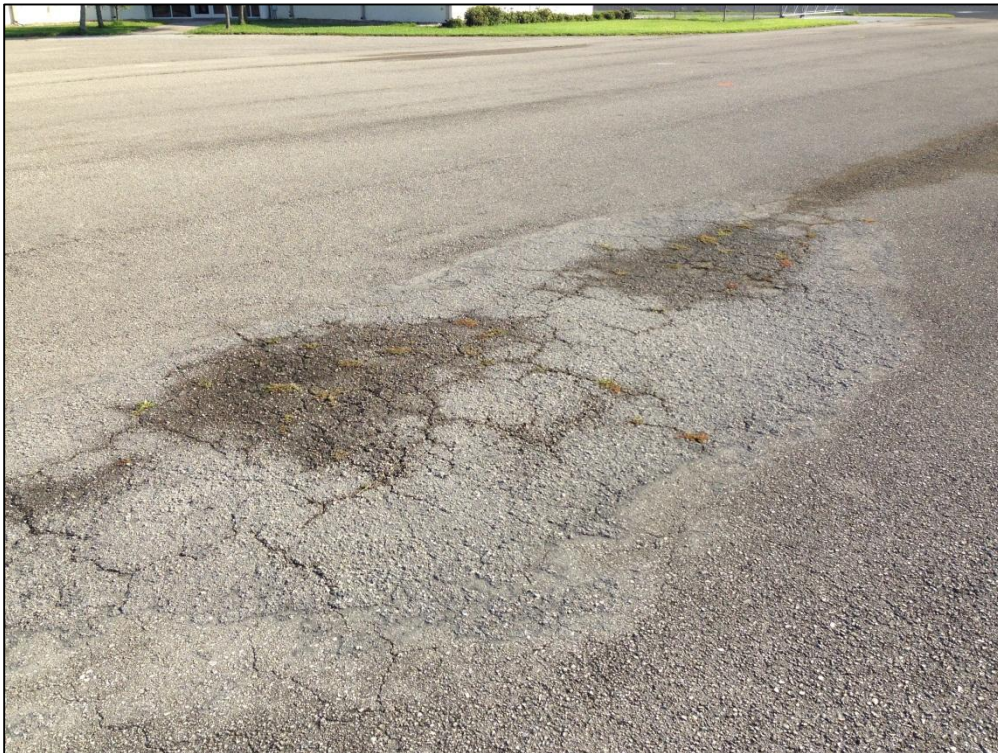
Apron South, Section 4305, Sample Unit 201 – Low and Medium Severity (48) Longitudinal and Transverse Cracking, Low and Medium Severity (52) Raveling, High Severity (50) Patching

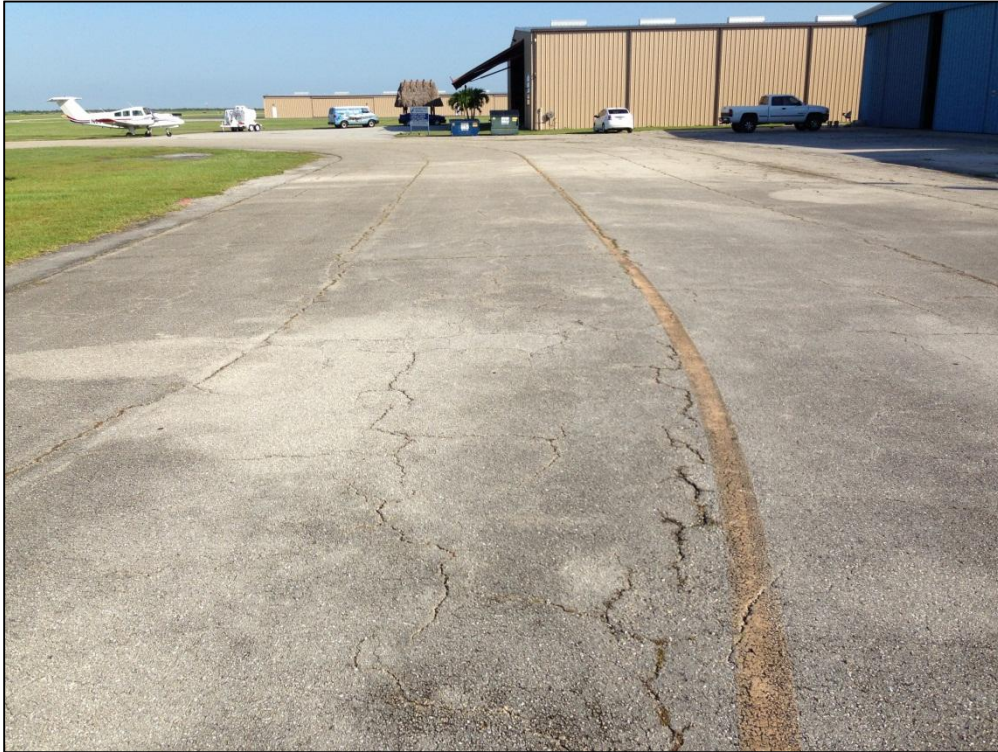
Taxiway Hangar, Section 405, Sample Unit 104 – Low Severity (48) Longitudinal and Transverse Cracking, Medium Severity (52) Raveling, Low and Medium Severity (43) Block Cracking

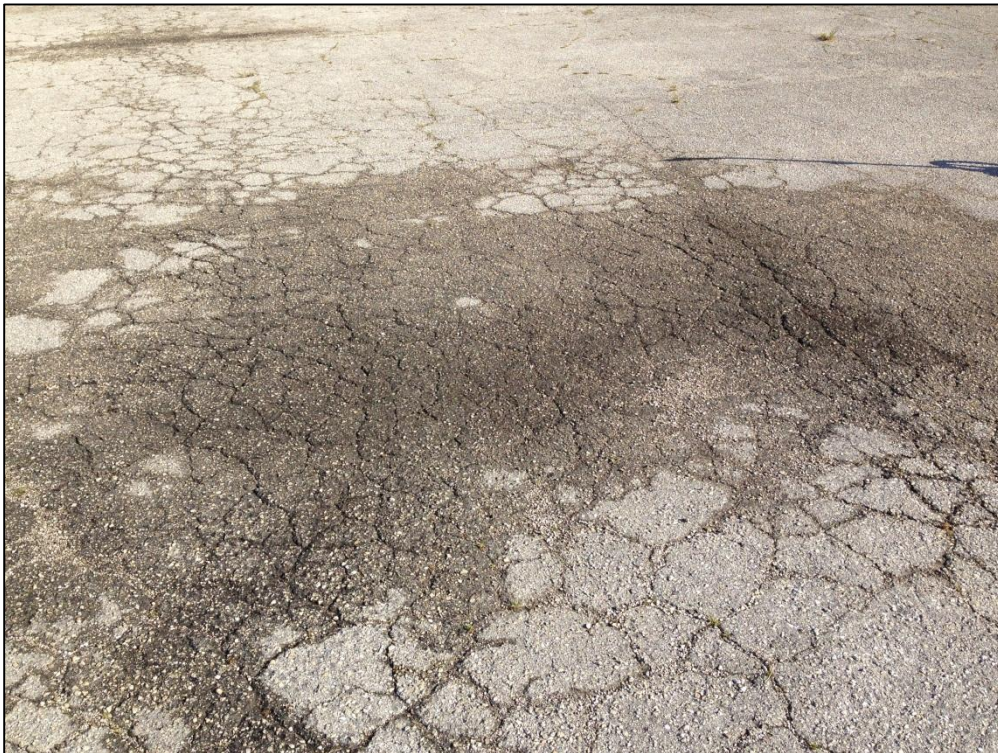
Taxiway Hangar, Section 405, Sample Unit 103 – Medium Severity (52) Raveling, Medium Severity (41) Alligator Cracking, Low and Medium Severity (43) Block Cracking, Low Severity (45) Depression

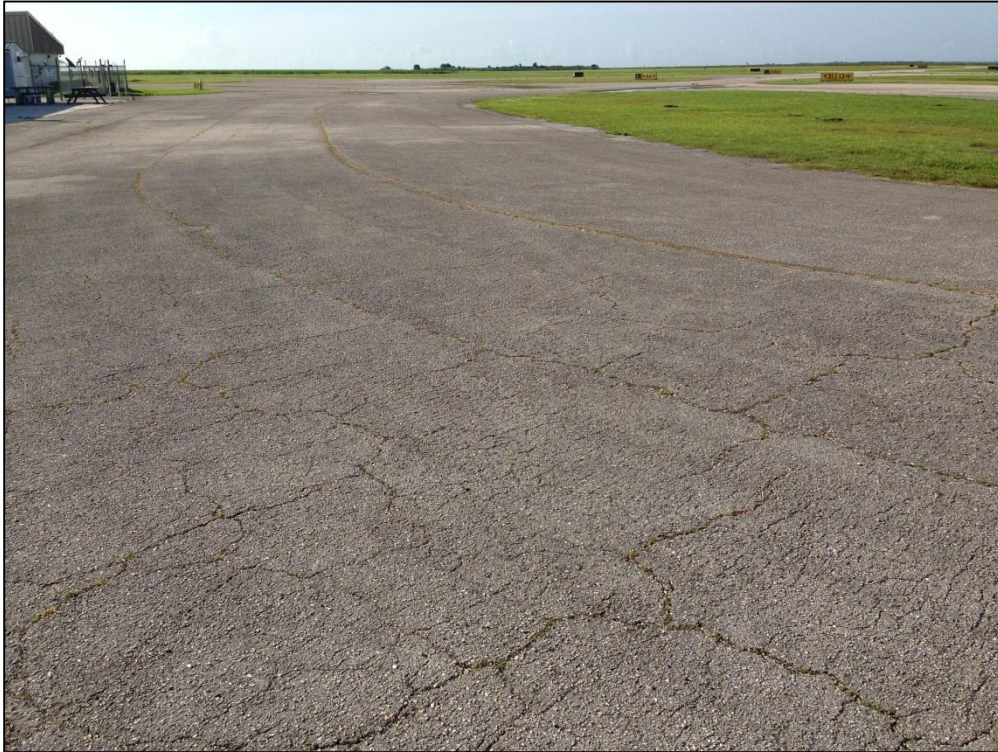
Taxiway Hangar, Section 405, Sample Unit 103 – Medium Severity (52) Raveling, Low and Medium Severity (43) Block Cracking

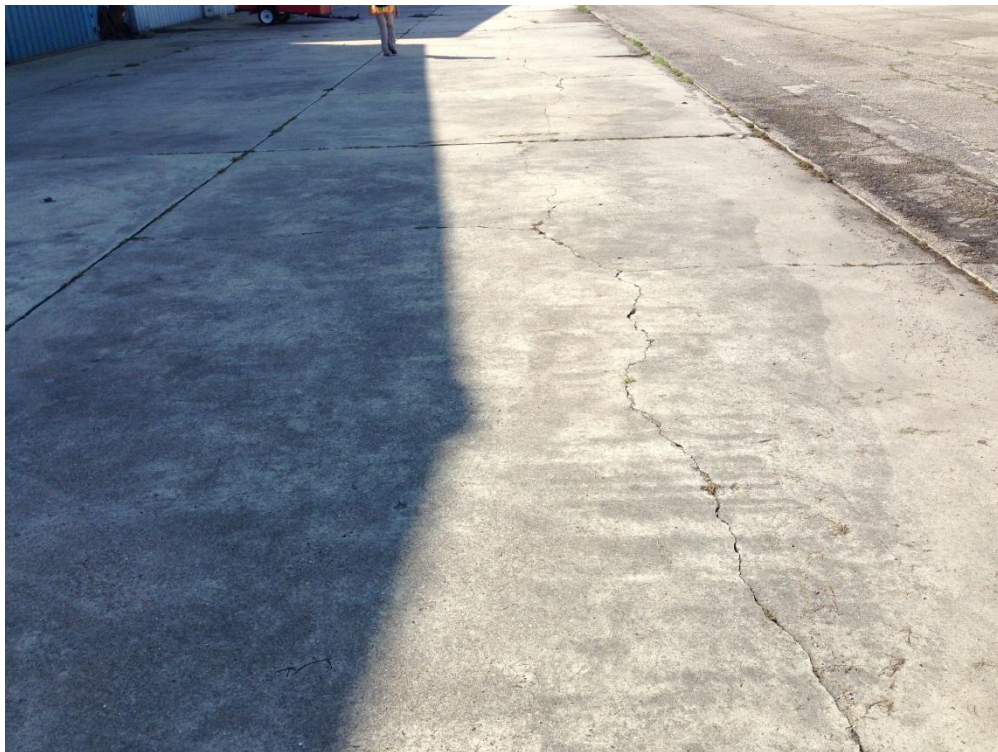
Apron Hangar, Section 4205, Sample Unit 100 – Low Severity (65) Joint Seal Damage, Low Severity (72) Shattered Slab

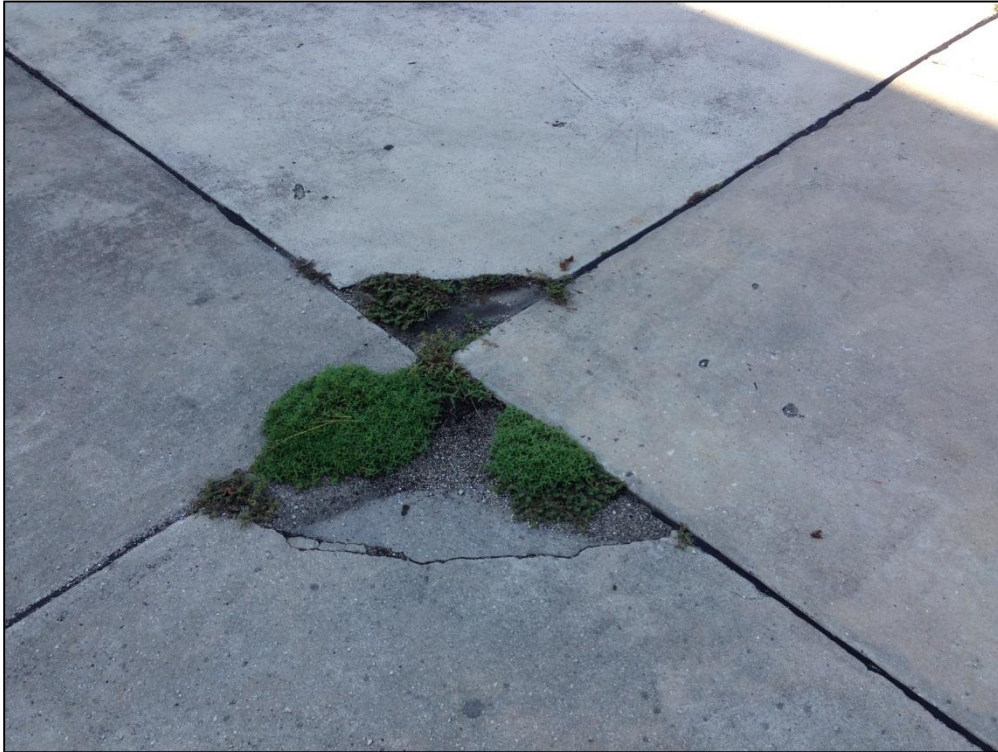
Apron Hangar, Section 4205, Sample Unit 100 – Low Severity (65) Joint Seal Damage, Medium Severity (62) Corner Break

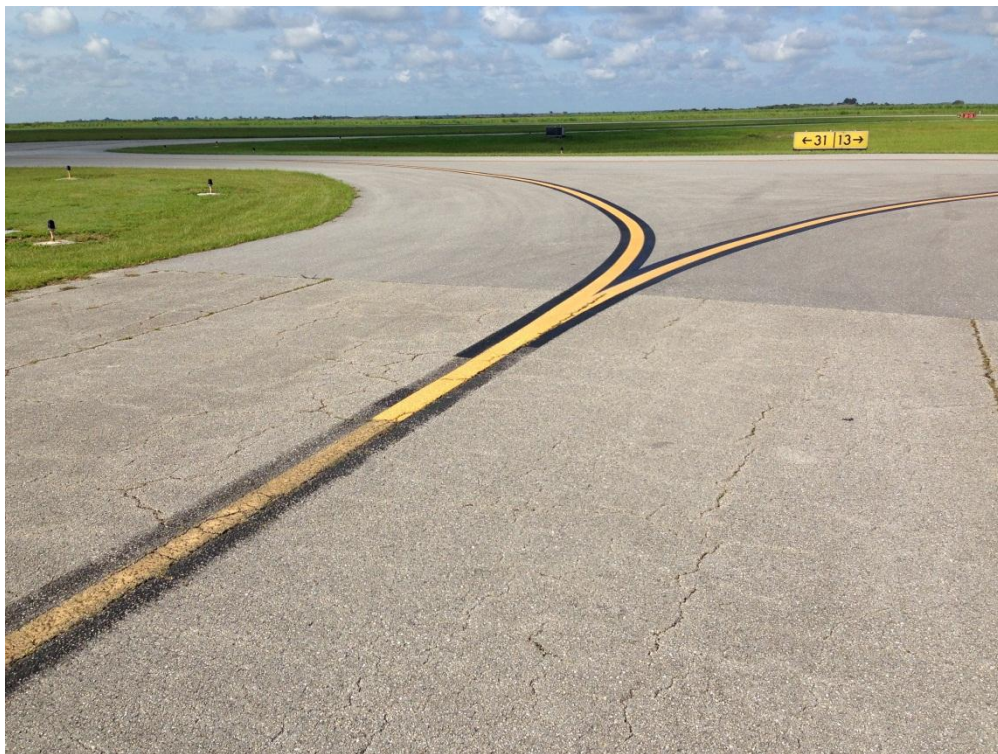
Taxiway Hangar, Section 407, Sample Unit 100 – Medium Severity (52) Raveling, Low Severity (43) Block Cracking

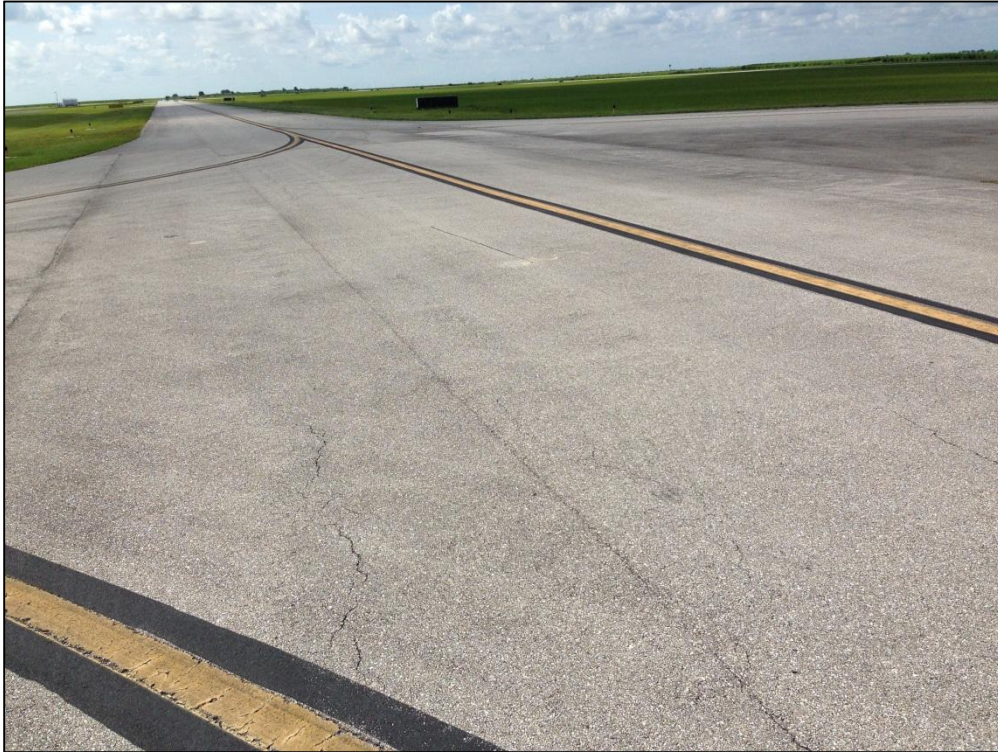
Taxiway Alpha, Section 103, Sample Unit 121 – Low Severity (48) Longitudinal and Transverse Cracking, Low Severity (57) Weathering, Low Severity (56) Swelling

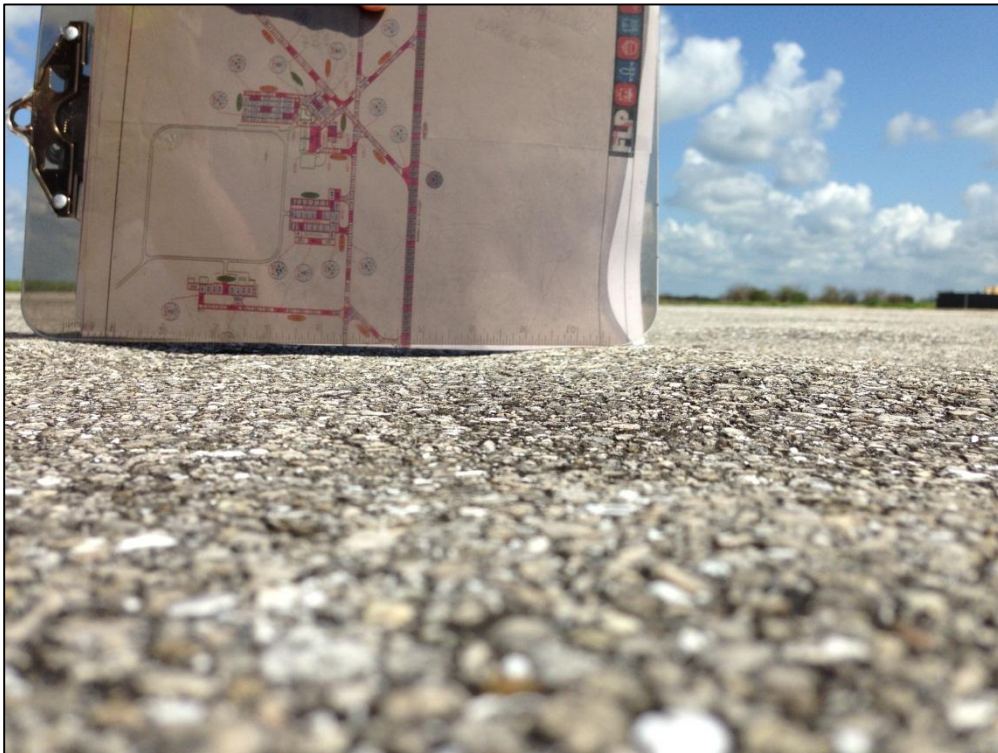
Taxiway Alpha, Section 103, Sample Unit 121 – Low Severity (57) Weathering, Low Severity (56) Swelling

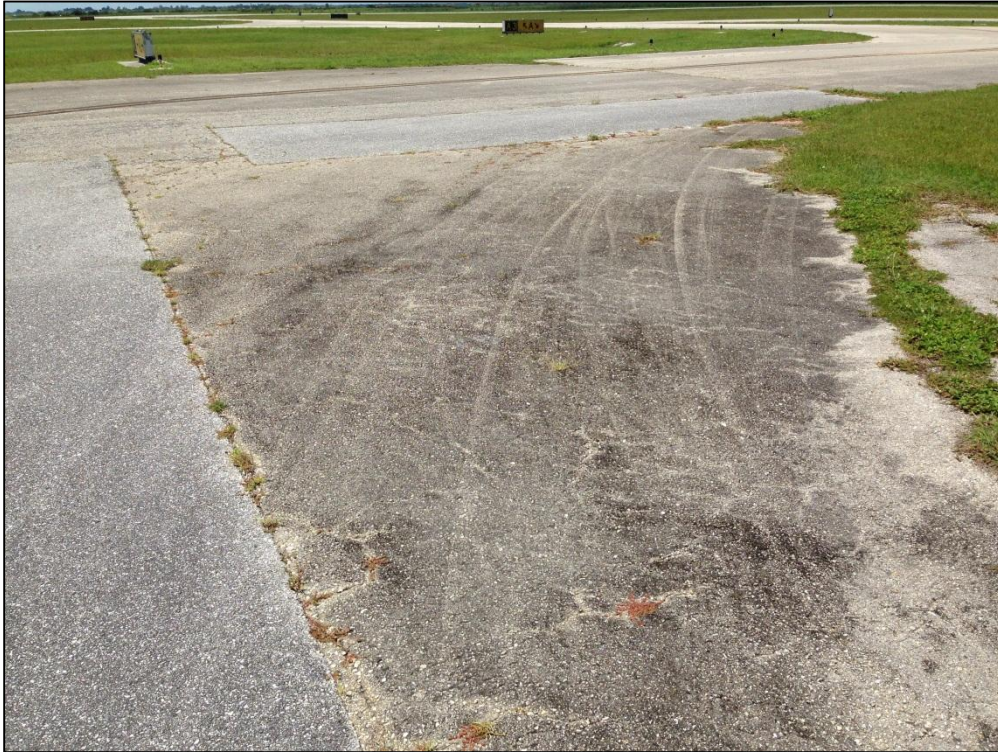
Taxiway South Apron, Section 505, Sample Unit 100 – Low Severity (48) Longitudinal and Transverse Cracking, Medium Severity (52) Raveling, Low Severity (43) Block Cracking

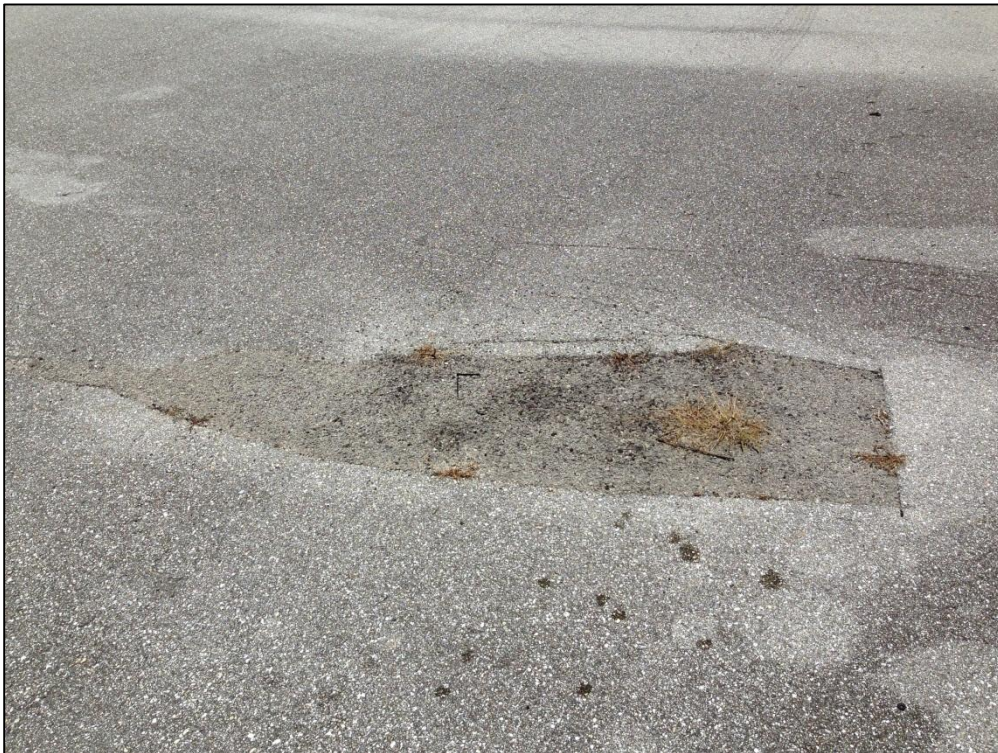
Apron West, Section 4115, Sample Unit 102 – Low Severity (48) Longitudinal and Transverse Cracking, Low Severity (57) Weathering, Low Severity (52) Raveling, High Severity (50) Patching

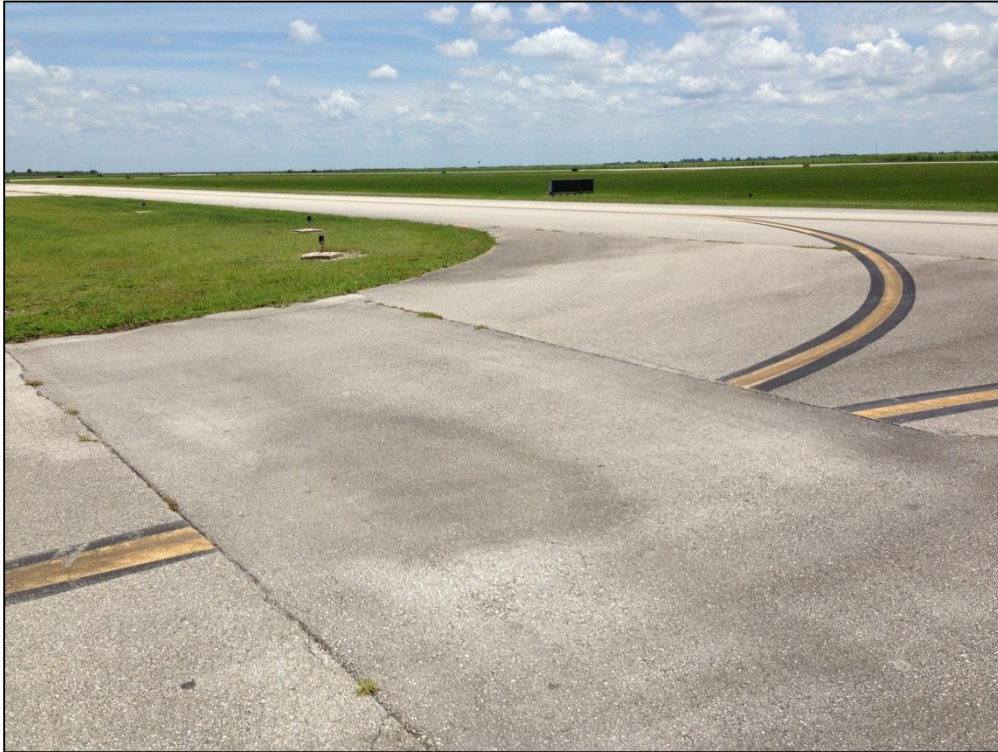
Taxiway West Apron, Section 305, Sample Unit 100 – Medium Severity (48) Longitudinal and Transverse Cracking, Medium Severity (50) Patching, Low and Medium Severity (52) Raveling

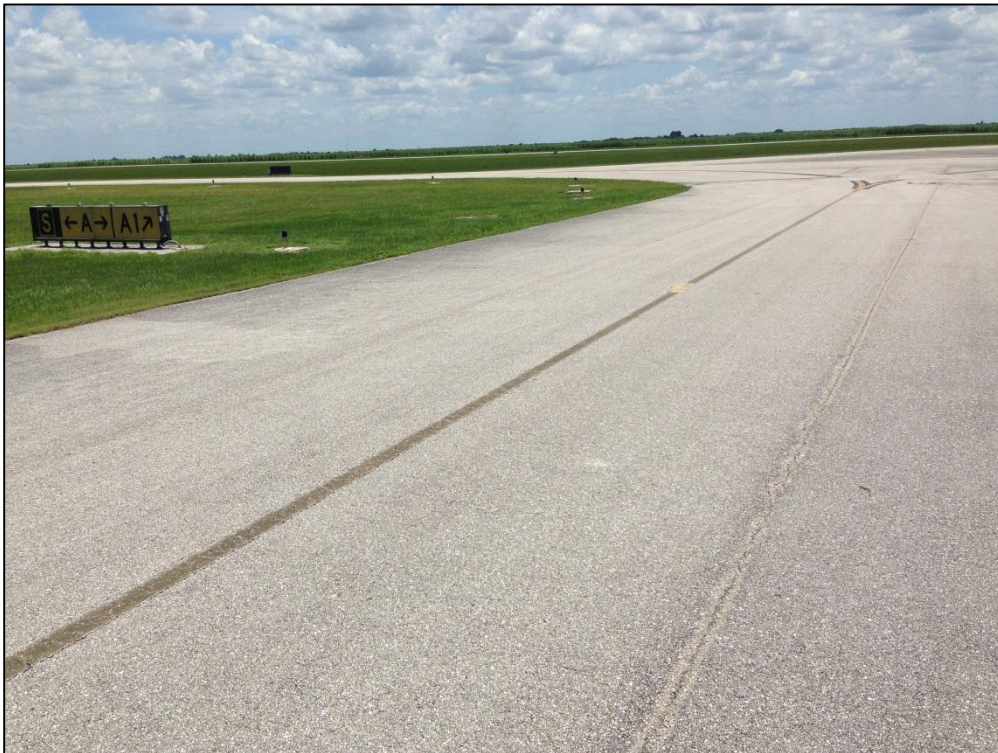
Taxiway South, Section 605, Sample Unit 101 – Low Severity (48) Longitudinal and Transverse Cracking, Low Severity (57) Weathering

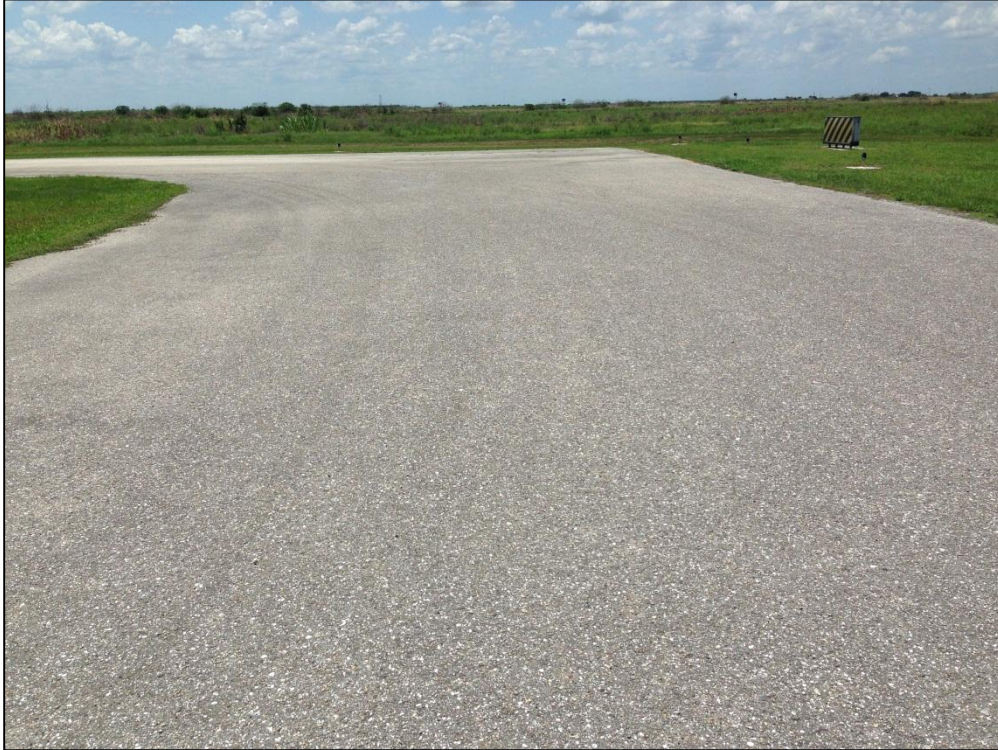
Apron North West, Section 4405, Sample Unit 201 – Medium Severity (52) Raveling
