FLORIDA DEPARTMENT OF TRANSPORTATION
AVIATION AND SPACEPORT OFFICE

TRI-COUNTY
AIRPORT (1J0)

DECEMBER 2013

STATEWIDE
**Airfield
Pavement
Management**
PROGRAM

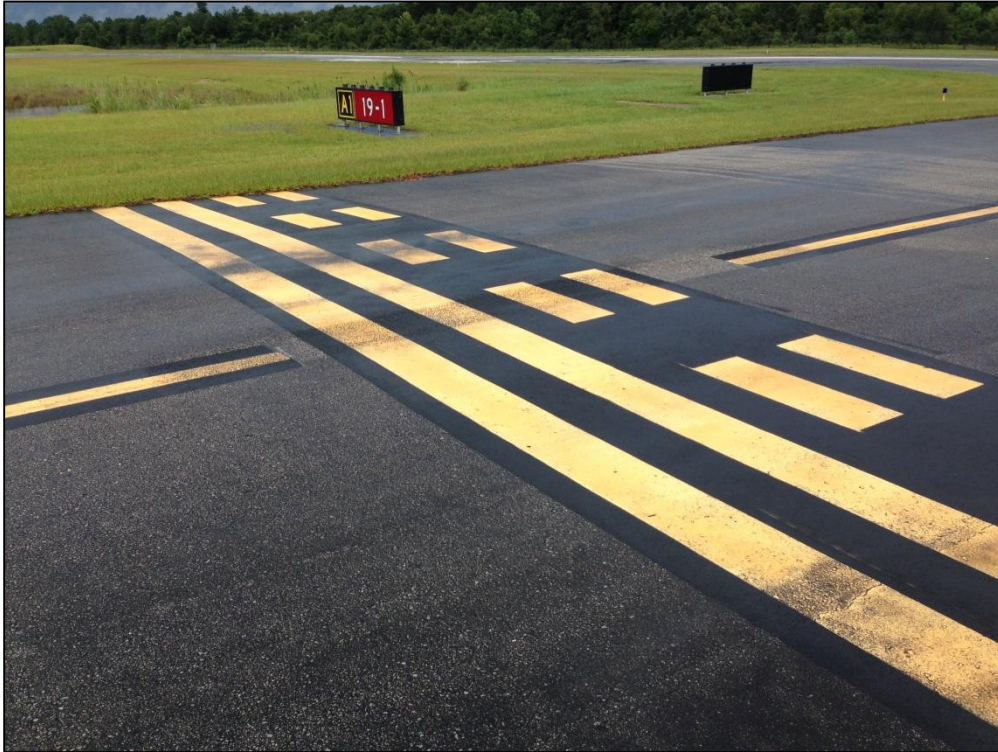
Taxiway A1, Section 105, Sample Unit 101 – Low Severity (48) Longitudinal and Transverse Cracking, Low Severity (57) Weathering, Low Severity (52) Raveling

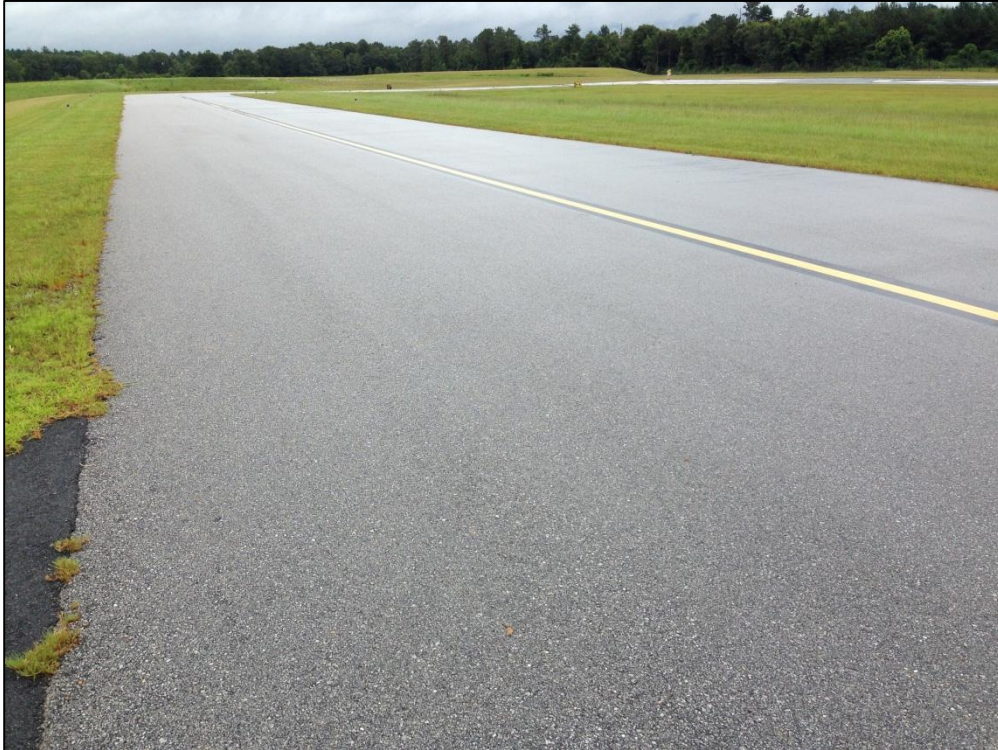
Taxiway A, Section 110, Sample Unit 101 – Low Severity (57) Weathering, Low Severity (48) Longitudinal and Transverse Cracking

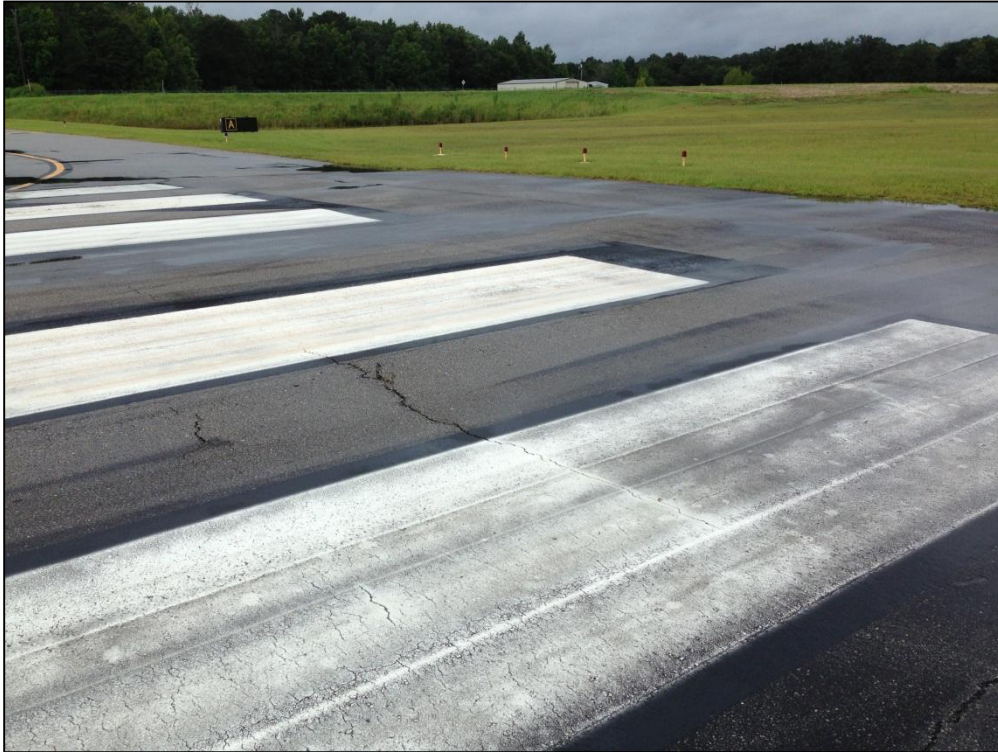
Runway 1-19 exhibited pavement condition indices ranging from 70 - 73. Generally, the pavements are in Fair condition. Pavements on Runway 1-19 exhibited low severity longitudinal/transverse cracking; low severity raveling; low severity weathering; and low severity swelling. These are climate, age, and subgrade quality based distresses. Swelling in particular was found along the entire length of the runway in substantial quantities. Swelling should be monitored due to its ability to affect ride quality and propagate other distresses such as longitudinal/transverse cracking and raveling.

Runway 1-19, Section 6105, Sample Unit 179 – Low Severity (48) Longitudinal and Transverse Cracking, Low Severity (57) Weathering, Low Severity (52) Raveling

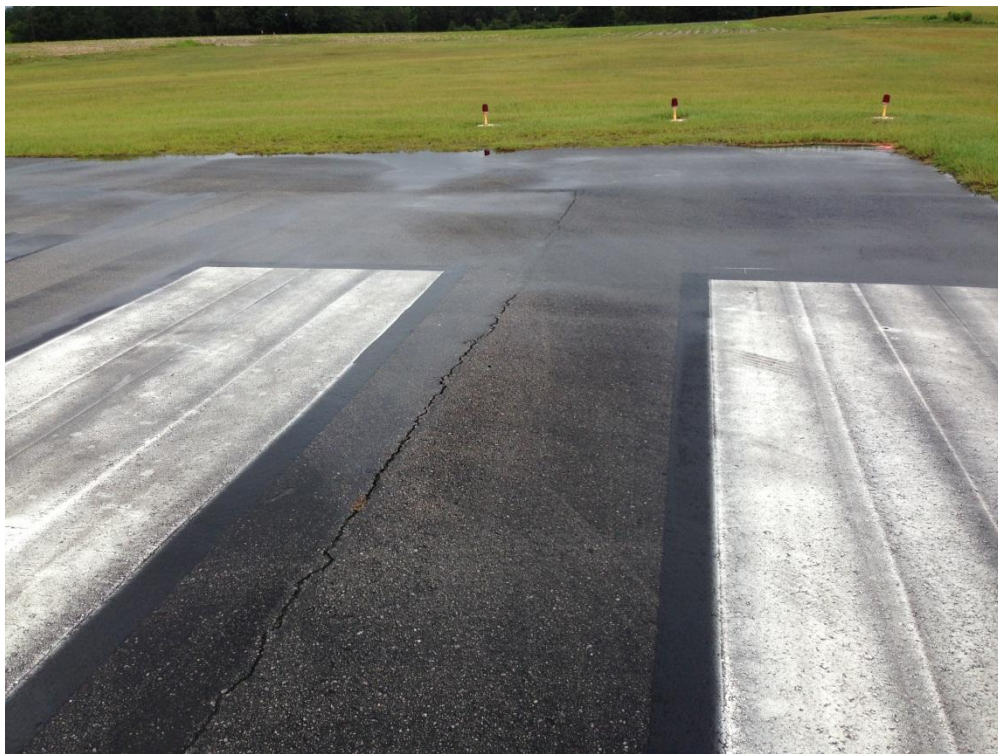
Runway 1-19, Section 6105, Sample Unit 179 – Low Severity (48) Longitudinal and Transverse Cracking, Low Severity (57) Weathering, Low Severity (52) Raveling

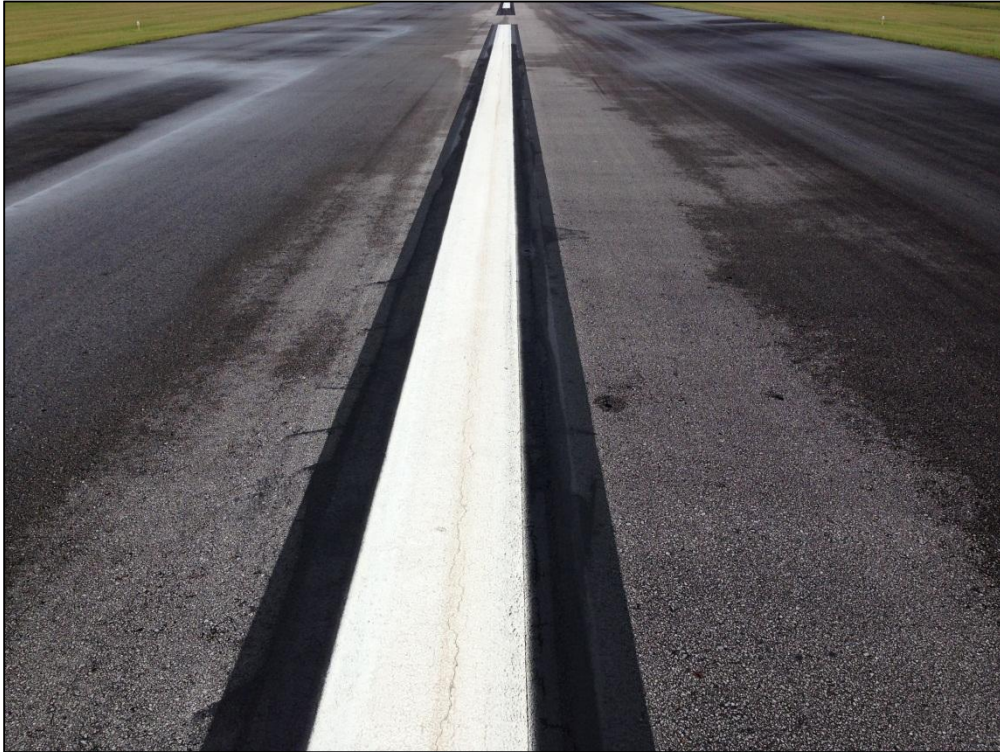
Runway 1-19, Section 6105, Sample Unit 143 – Low Severity (48) Longitudinal and Transverse Cracking, Low Severity (57) Weathering, Low Severity (52) Raveling

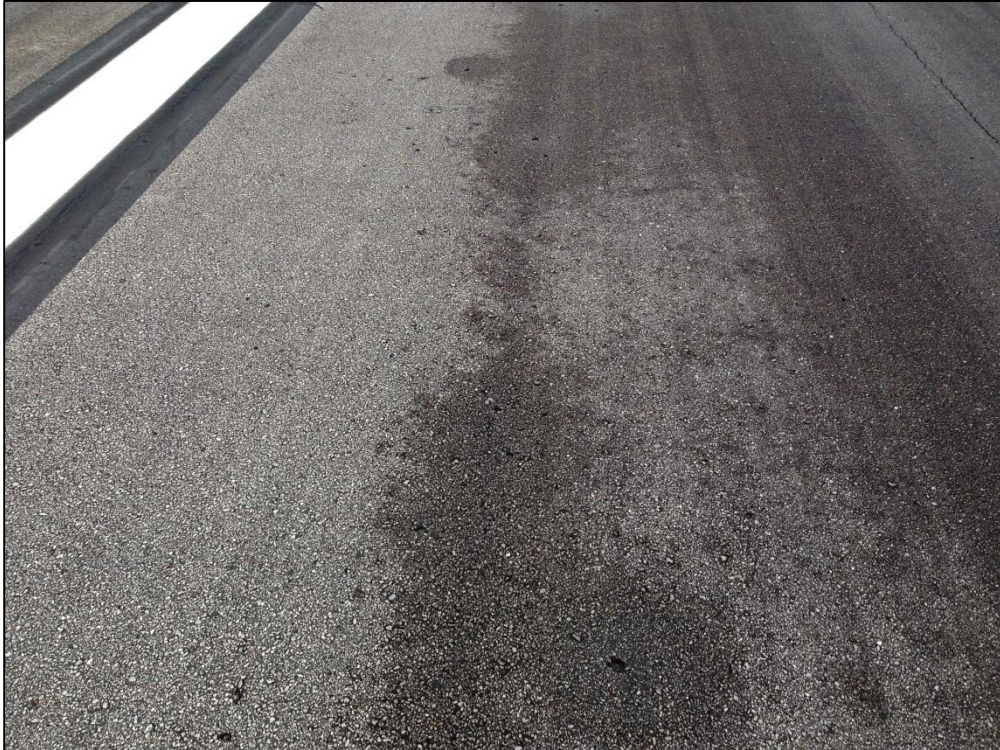
Runway 1-19, Section 6105, Sample Unit 143 – Low Severity (48) Longitudinal and Transverse Cracking, Low Severity (57) Weathering, Low Severity (52) Raveling, Low Severity (56) Swelling
