FLORIDA DEPARTMENT OF TRANSPORTATION
AVIATION AND SPACEPORT OFFICE

QUINCY
MUNICIPAL
AIRPORT (2J9)

DECEMBER 2013

STATEWIDE
**Airfield
Pavement
Management**
PROGRAM

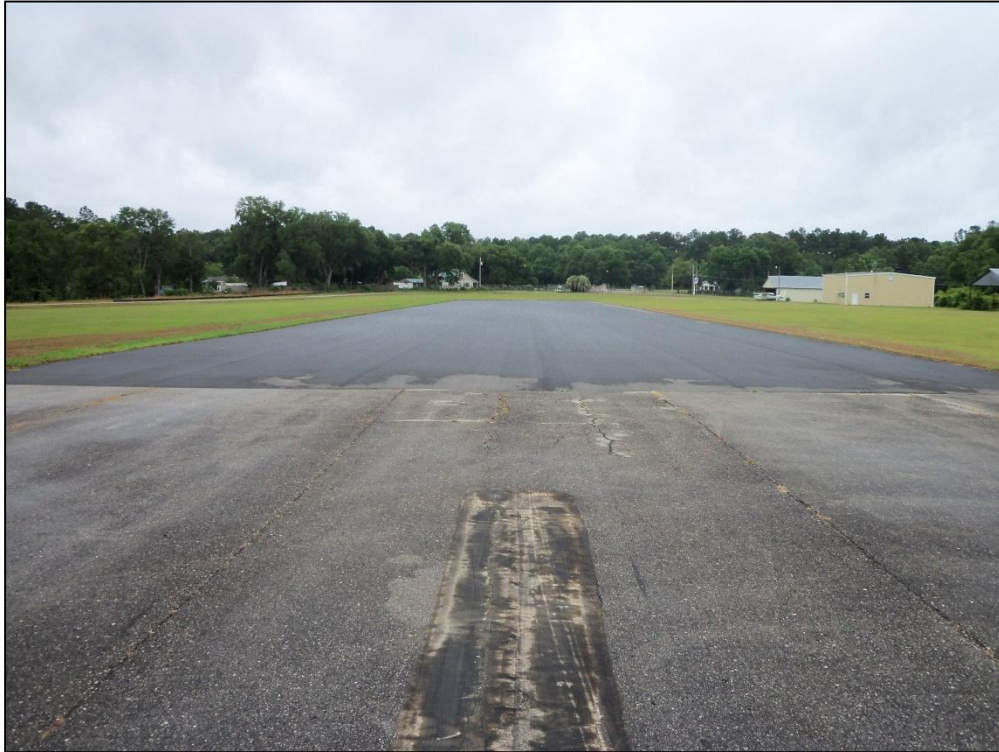
Runway 14-32 exhibited low and medium severity longitudinal/transverse cracking which occurred primarily along the pavement joints. The surface of the runway showed signs of low severity weathering and raveling. Approximately 500' of new AC pavement was placed at the 32 end of Runway 14-32 as a

Runway 14-32, Section 6105, Sample Unit 109 – Low and Medium Severity (48) Longitudinal and Transverse Cracking, Low Severity (57) Weathering, Low Severity (52) Raveling

- Runway 14-32 – Sections 6105 and 6110
 - Mill and Overlay attributed to climate and age of pavement.
- Taxiway to Hangars – Sections 105, 110, 125 and 130
 - Mill and Overlay attributed to climate and age of pavement.

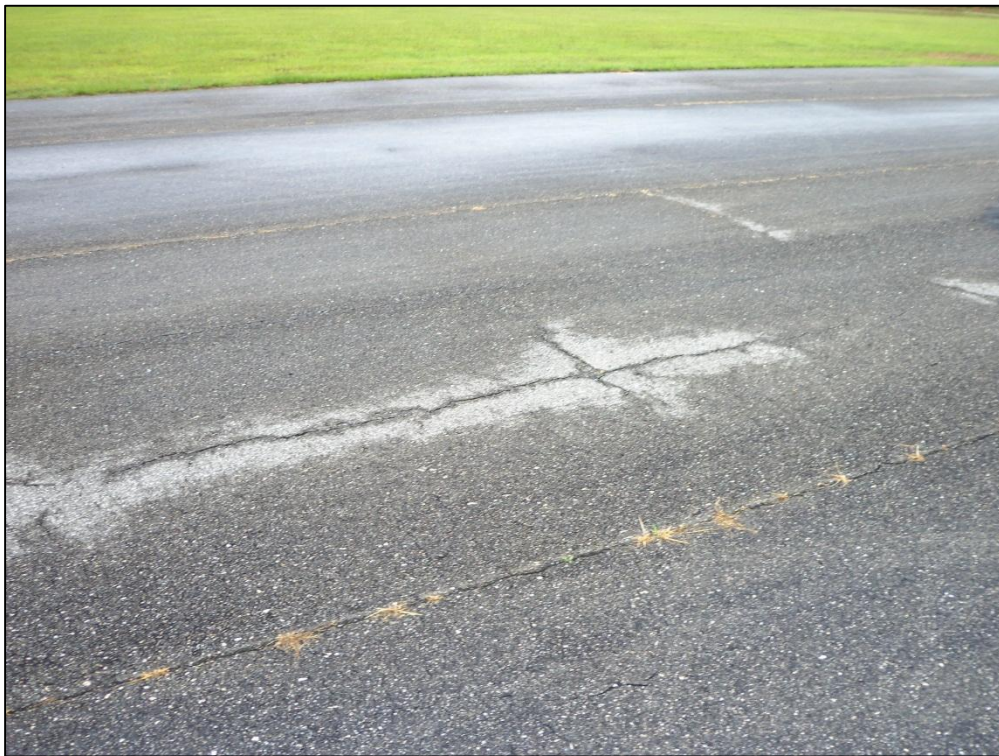
Runway 14-32, Section 6105, Sample Unit 154 – Low and Medium Severity (48) Longitudinal and Transverse Cracking, Low Severity (57) Weathering, Low Severity (52) Raveling

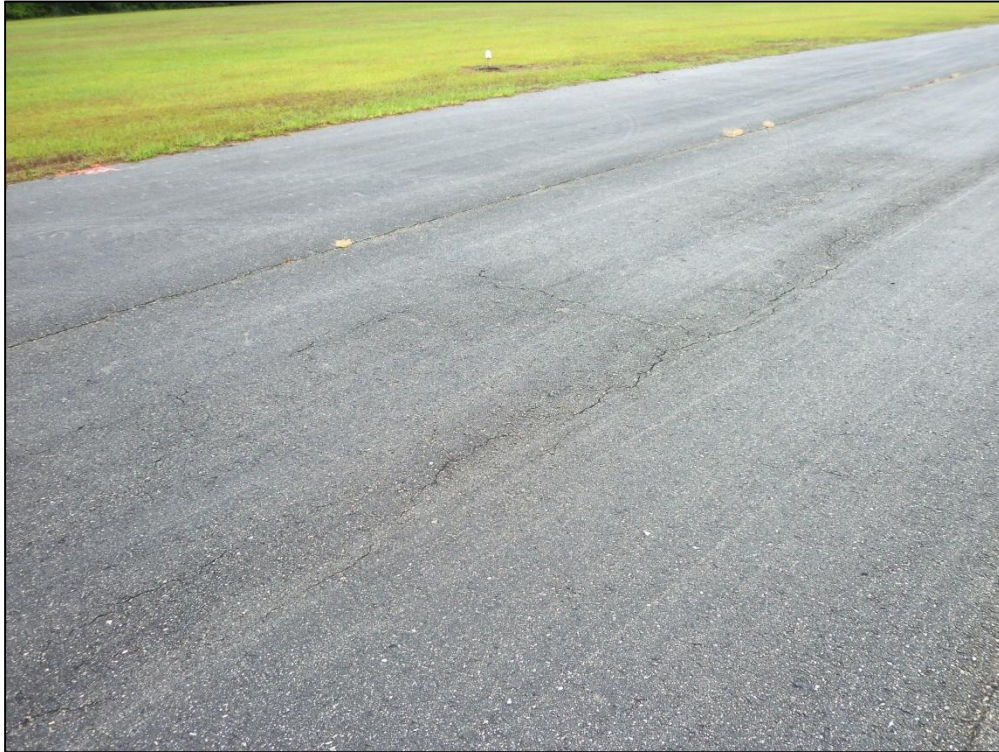
Runway 14-32, Section 6105, Sample Unit 124 – Low and Medium Severity (48) Longitudinal and Transverse Cracking, Low Severity (57) Weathering, Low Severity (52) Raveling

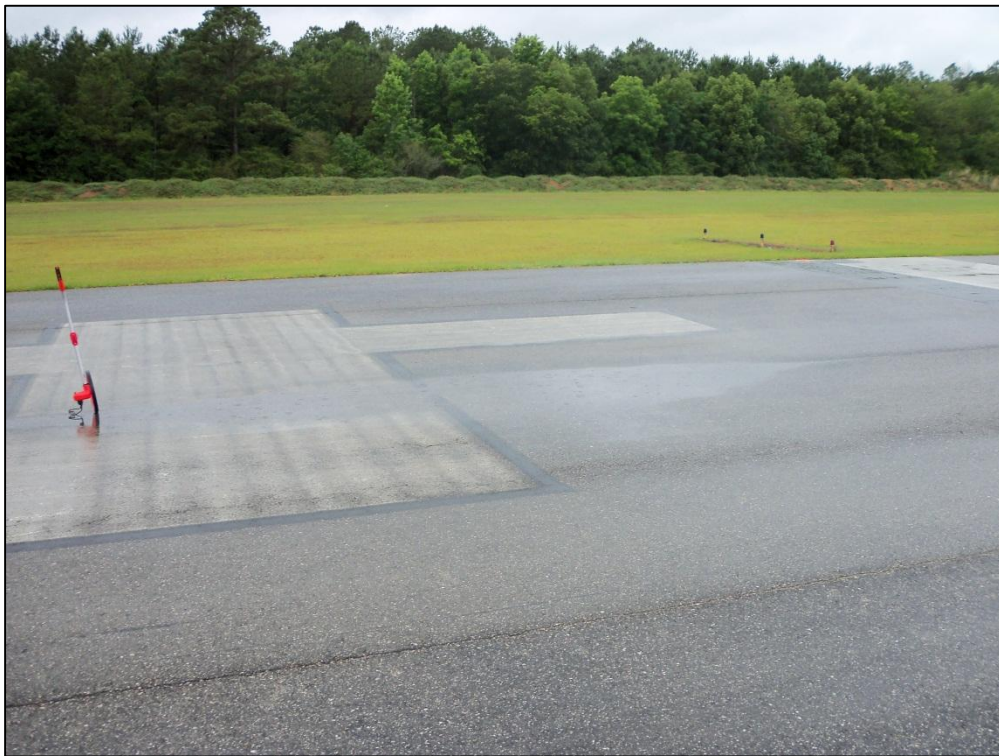
Runway 14-32, Section 6110, Sample Unit 105 – Low Severity (48) Longitudinal and Transverse Cracking, Low Severity (57) Weathering, Low Severity (52) Raveling, Low Severity (45) Depression

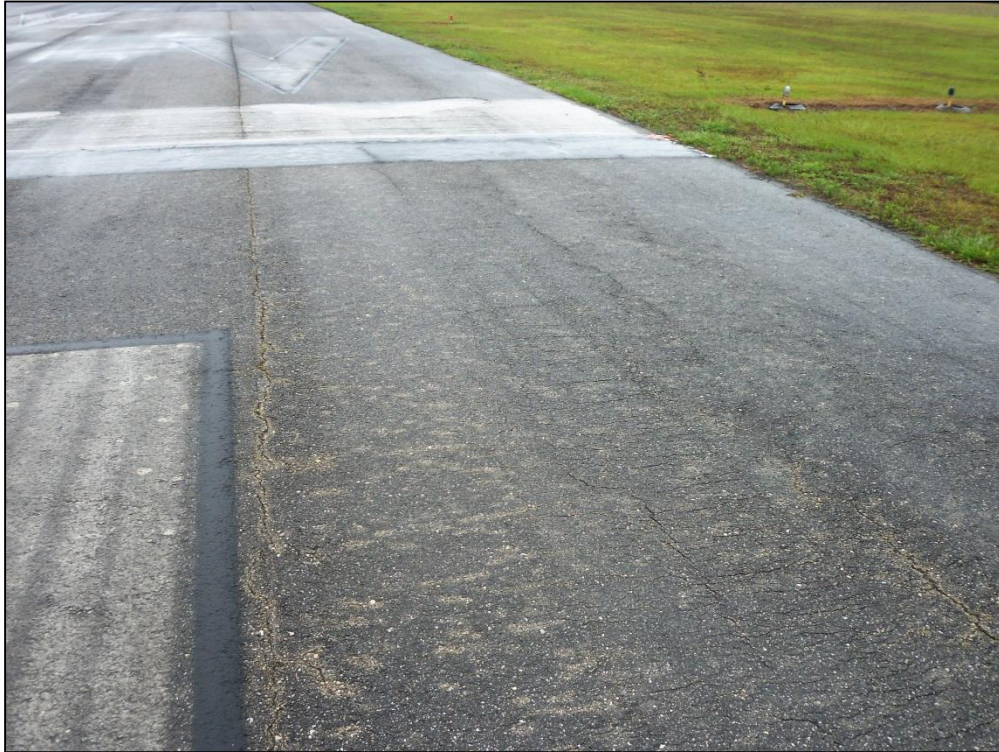
Runway 14-32, Section 6110, Sample Unit 105 – Low Severity (48) Longitudinal and Transverse Cracking, Low Severity (57) Weathering, Low Severity (52) Raveling

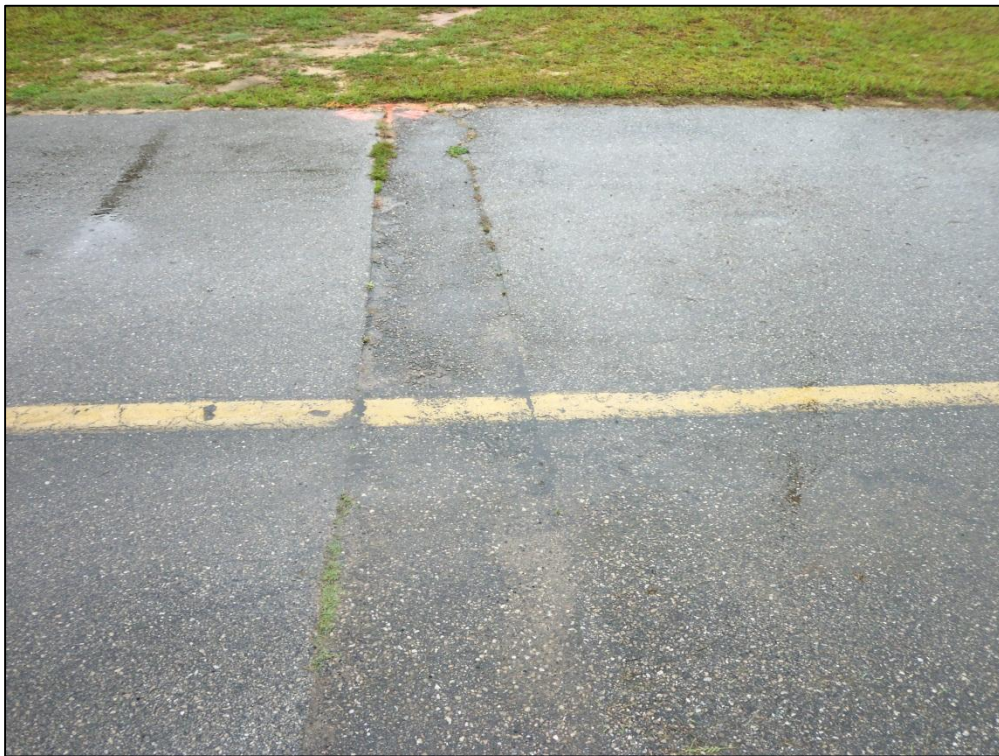
The pavement throughout the hangar facilities exhibited low and medium severity longitudinal/transverse cracking along with low and medium severity weathering and raveling. Low and medium severity depressions along with low severity patches were also observed in the hangar taxilanes.

Taxiway Hangar, Section 120, Sample Unit 101 – Low Severity (57) Weathering, Low Severity (52) Raveling, Low Severity (50) Patching

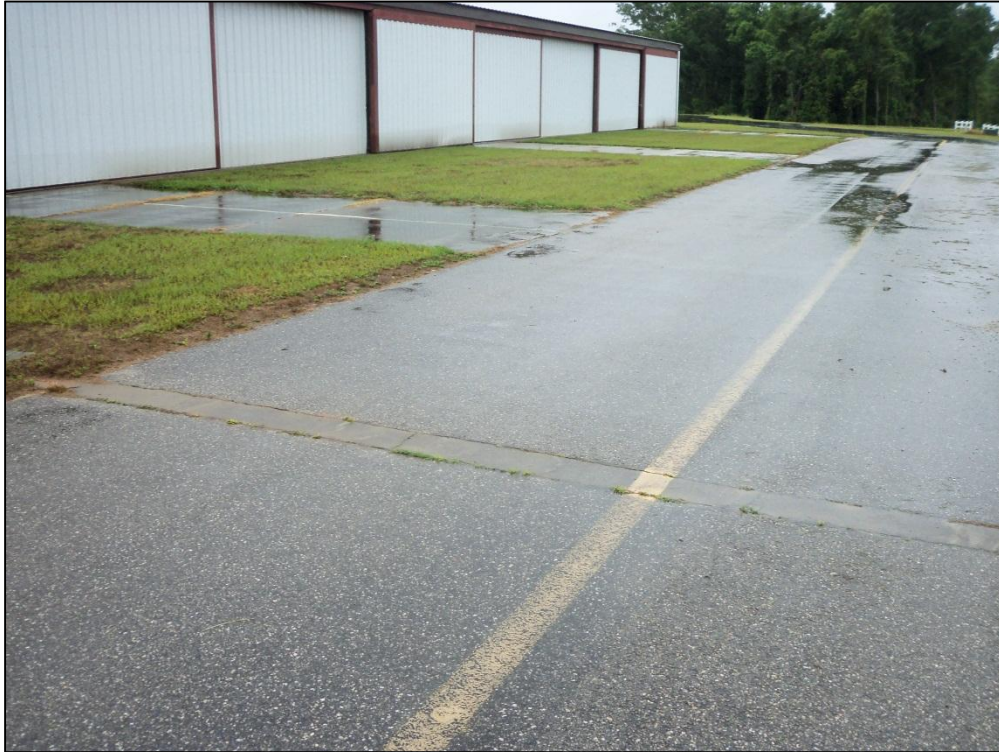
Taxiway Hangar, Section 120, Sample Unit 101 –Low Severity (57) Weathering, Low Severity (52) Raveling, Low Severity (50) Patching

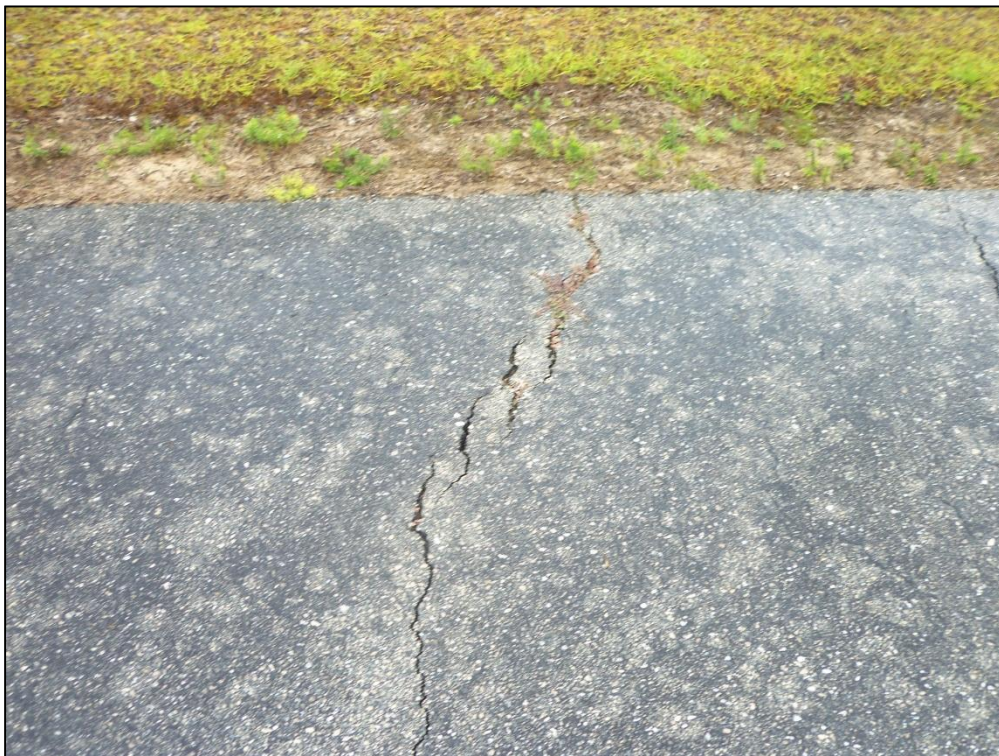
Taxiway Hangar, Section 110, Sample Unit 100 – Low and Medium Severity (48) Longitudinal and Transverse Cracking, Low Severity (57) Weathering

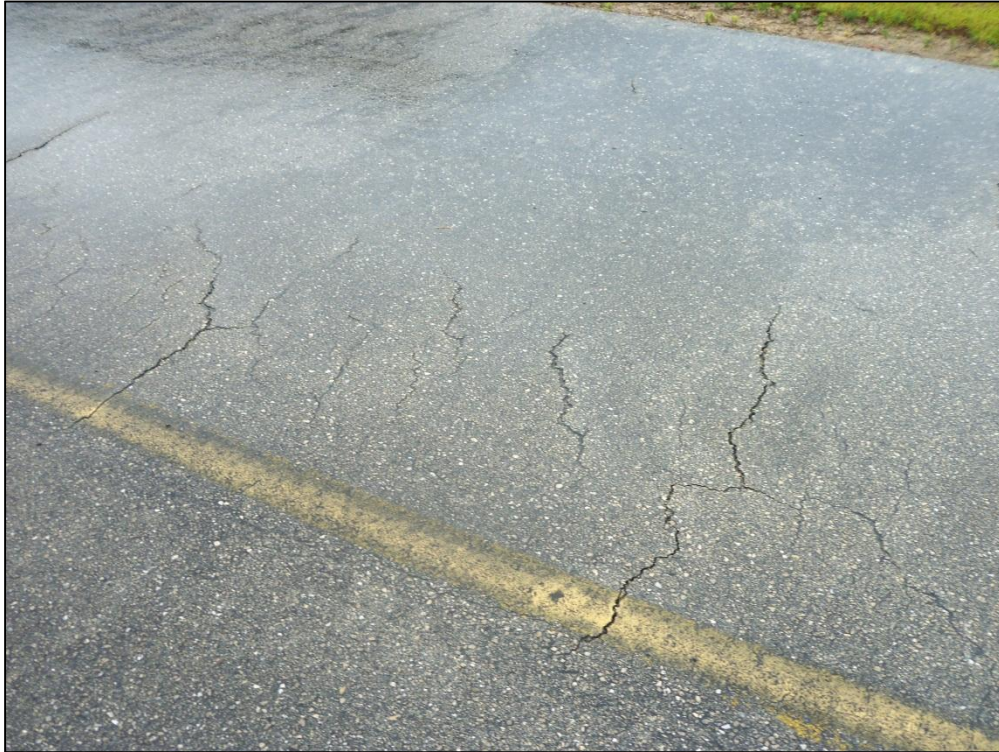
Taxiway Hangar, Section 110, Sample Unit 100 – Low and Medium Severity (48) Longitudinal and Transverse Cracking, Low Severity (57) Weathering

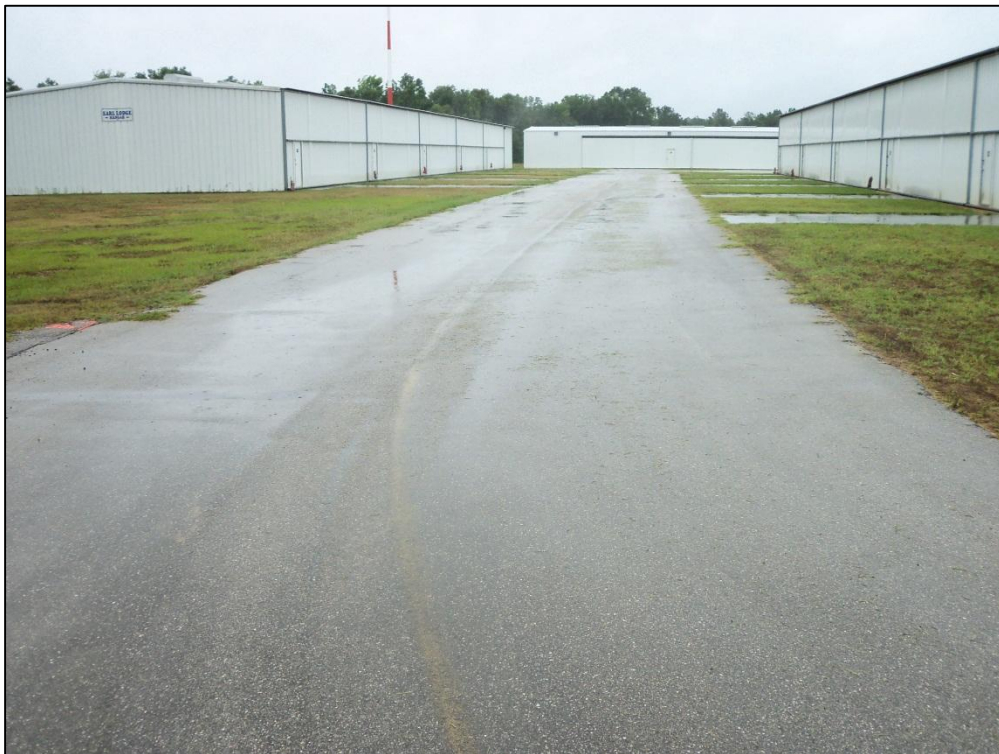
Taxiway Hangar, Section 125, Sample Unit 202 –Low Severity (57) Weathering, Low Severity (52) Raveling

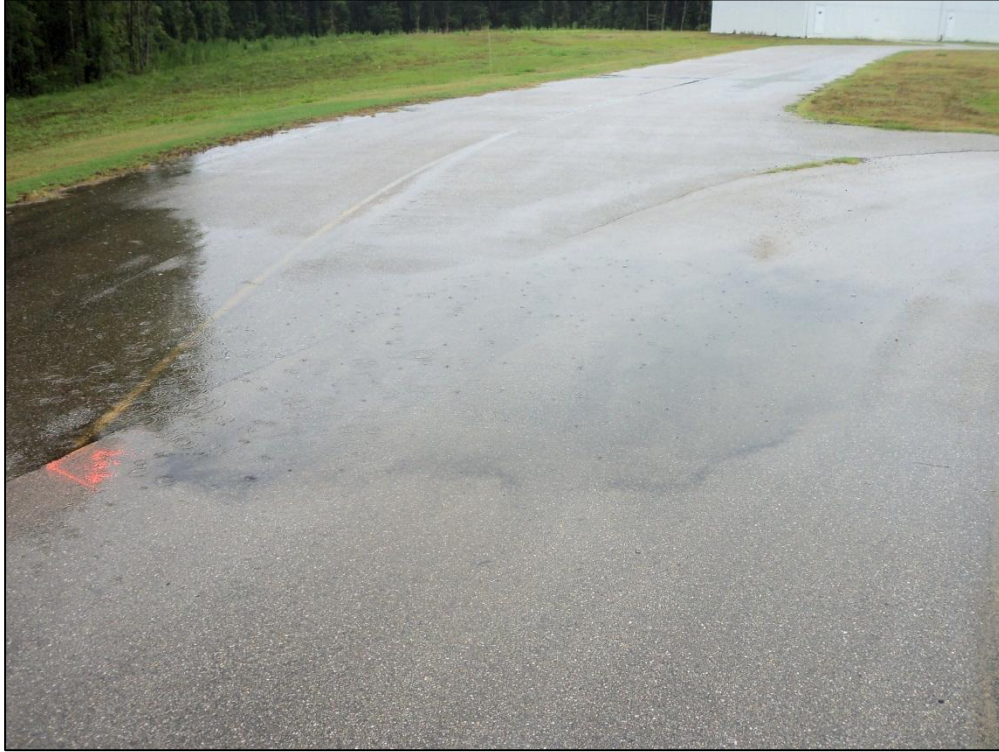
Taxiway Hangar, Section 125, Sample Unit 202 –Low Severity (57) Weathering, Low Severity (52) Raveling, Medium Severity (45) Depression
