FLORIDA DEPARTMENT OF TRANSPORTATION
AVIATION AND SPACEPORT OFFICE

PETER PRINCE
FIELD AIRPORT (2R4)

DECEMBER 2013

STATEWIDE
**Airfield
Pavement
Management**
PROGRAM

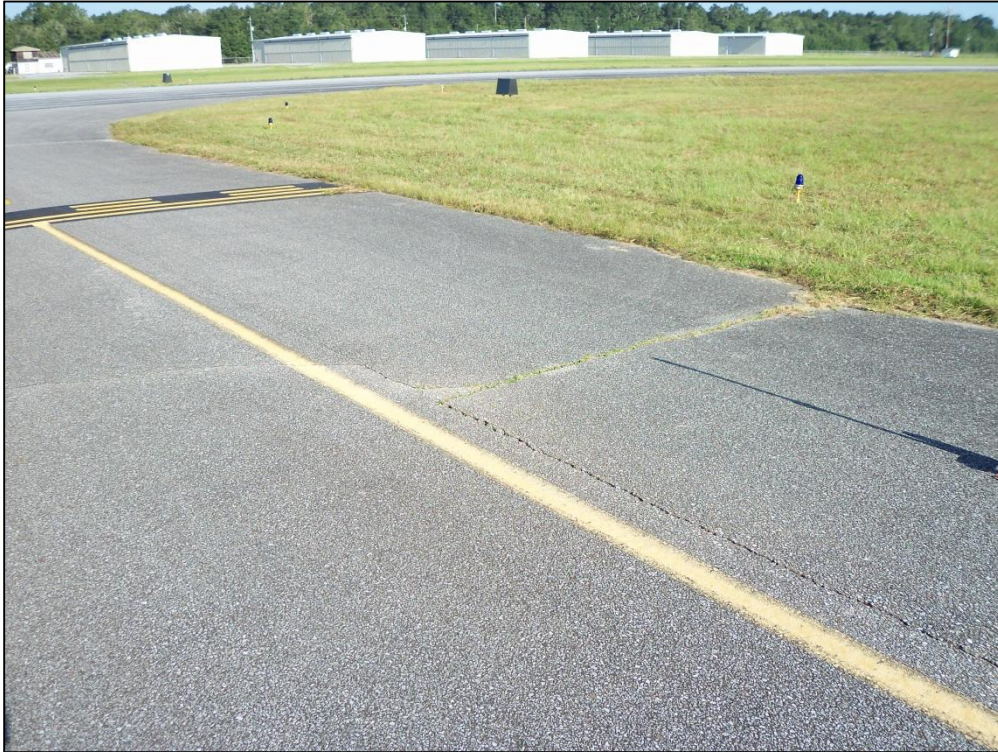
Taxiway B, Section 205, Sample Unit 120 – Low, Medium, and High Severity (48) Longitudinal and Transverse Cracking, Low Severity (57) Weathering

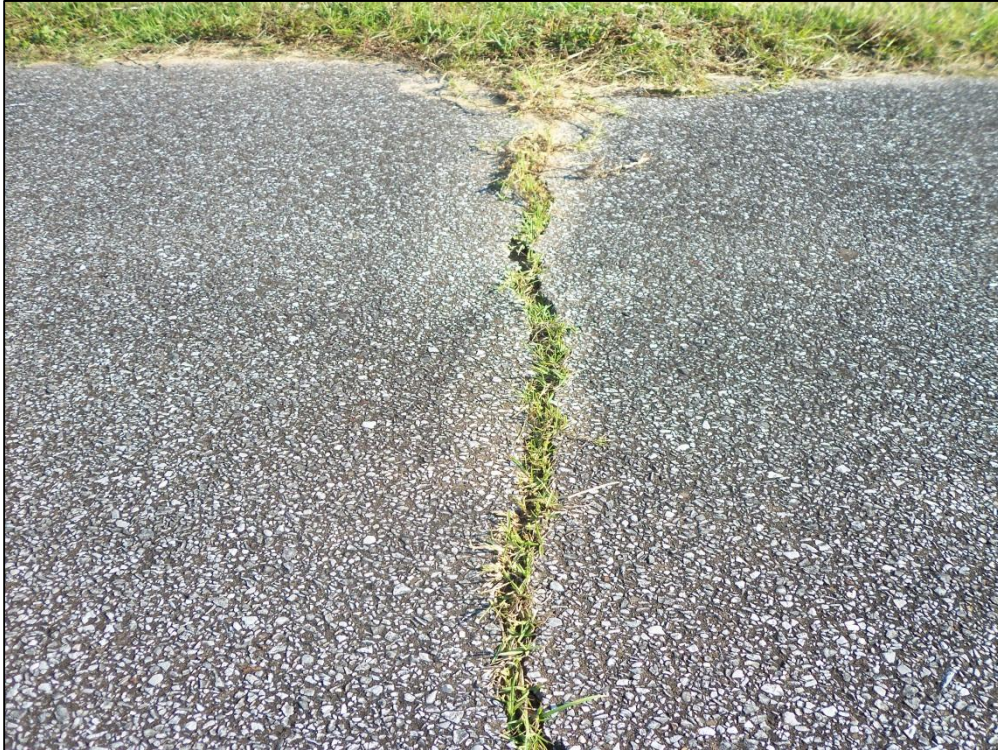
Taxiway B, Section 205, Sample Unit 120 – High Severity (48) Longitudinal and Transverse Cracking, Low Severity (57) Weathering

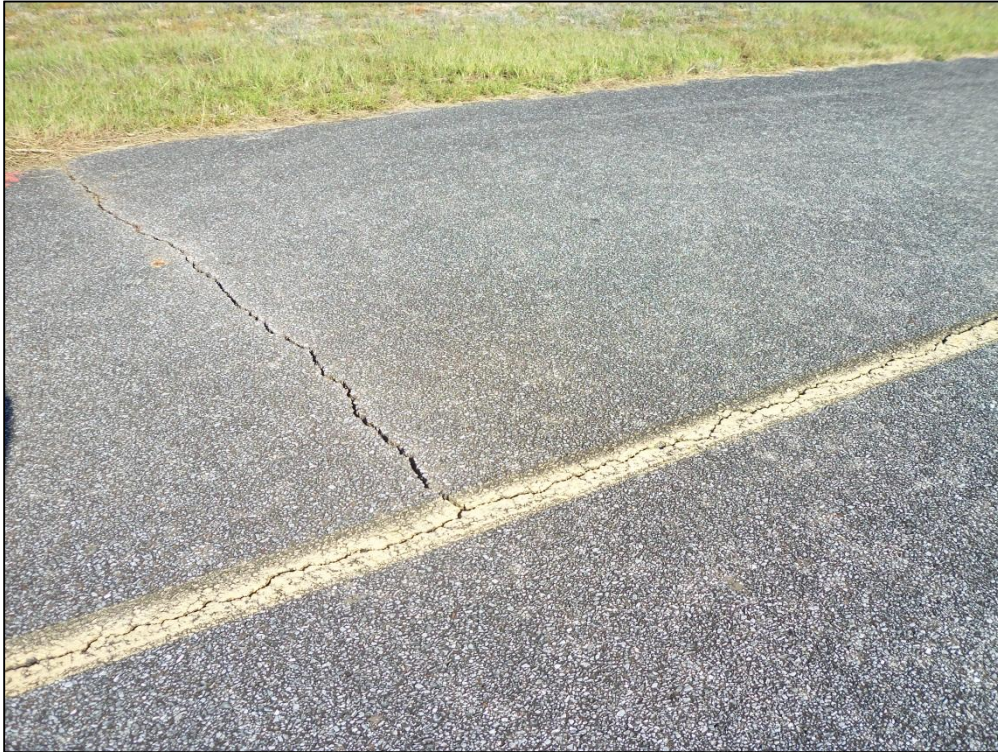
Taxiway B, Section 205, Sample Unit 117 – Low and Medium Severity (48) Longitudinal and Transverse Cracking, Medium Severity (57) Weathering

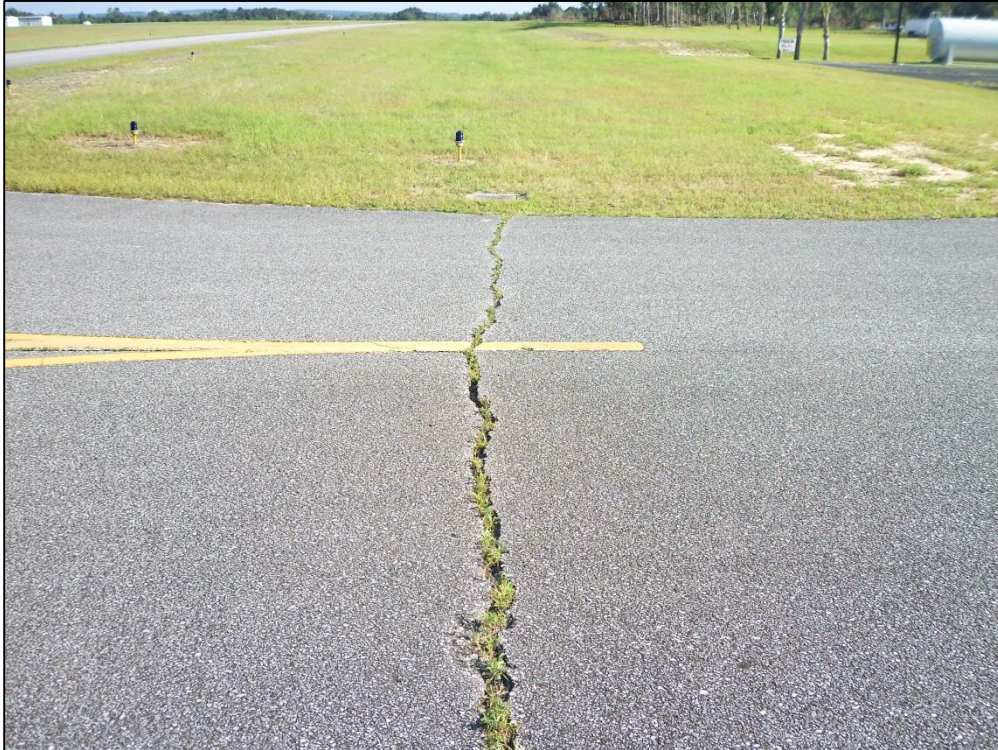
Taxiway B, Section 250, Sample Unit 200 – High Severity (48) Longitudinal and Transverse Cracking, Medium Severity (57) Weathering

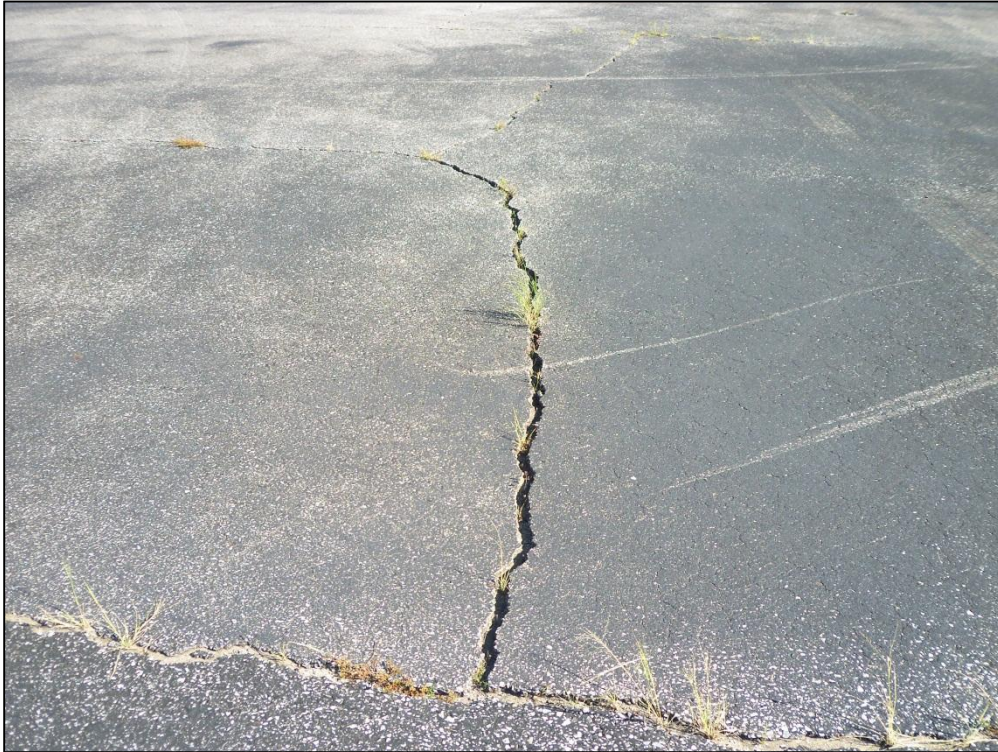
Apron, Section 4205, Sample Unit 251 – Medium and High Severity (48) Longitudinal and Transverse Cracking, Low Severity (57) Weathering

- ⦿ Runway 18-36 – Section 6105
 - Mill and Overlay attributed to climate and age of pavement.
- ⦿ Apron West – Section 4205
 - Mill and Overlay attributed to climate and age of pavement.
- ⦿ Apron East – Sections 4125, 4120, 4115, 4110 and 4105
 - Mill and Overlay attributed to subgrade quality, climate and age of pavement.
- ⦿ Taxiway A – Sections 510, 120, 115 and 105
 - Mill and Overlay attributed to climate and age of pavement.
- ⦿ Taxiway D – Sections 410 and 405
 - Mill and Overlay attributed to climate and age of pavement.
- ⦿ Taxiway C – Section 305
 - Mill and Overlay attributed to climate and age of pavement.
- ⦿ Taxiway B – Sections 250, 215 and 210
 - Mill and Overlay attributed to subgrade quality, climate and age of pavement.

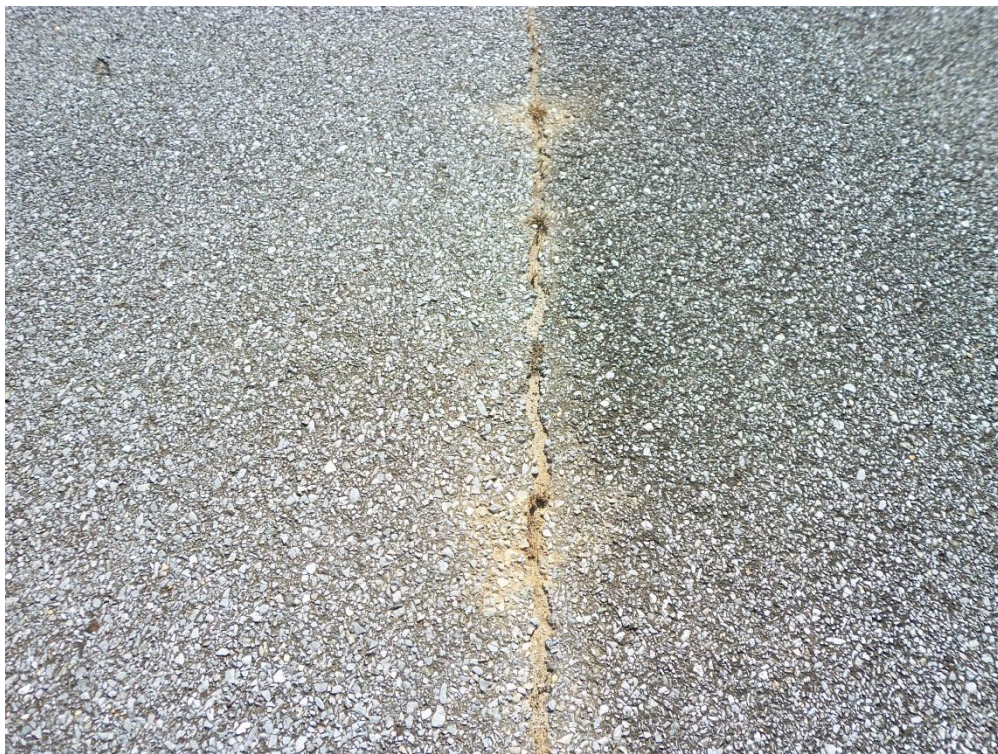
Apron, Section 4105, Sample Unit 500 – Medium Severity (48) Longitudinal and Transverse Cracking, Low Severity (52) Raveling, Low Severity (57) Weathering

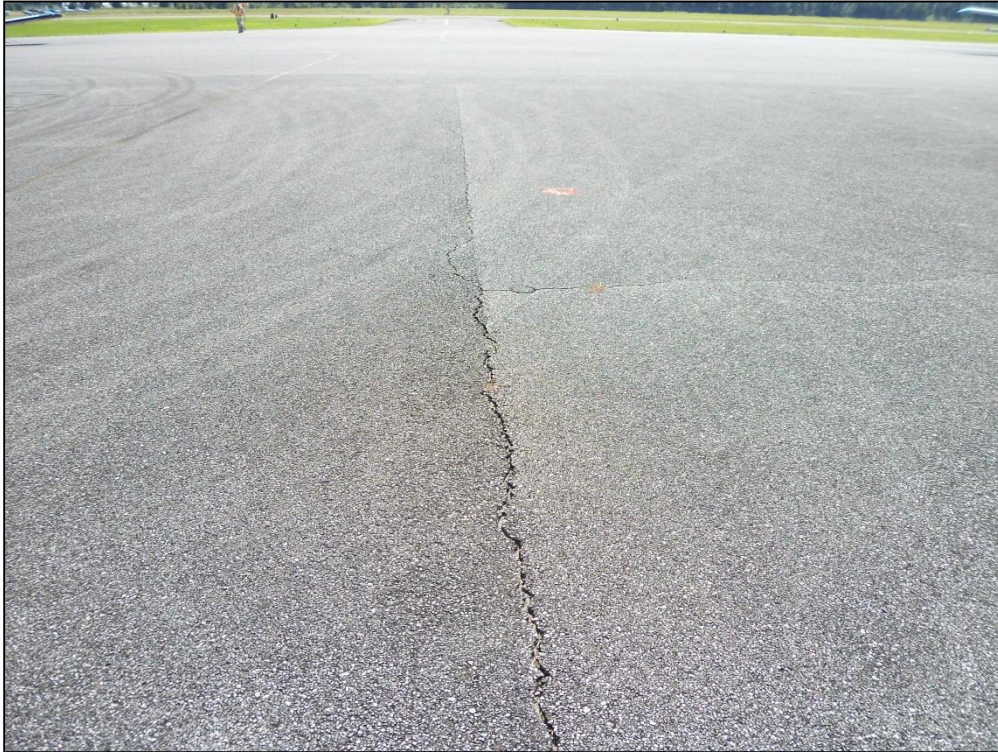
Apron, Section 4115, Sample Unit 502 – Low and Medium Severity (48) Longitudinal and Transverse Cracking, Low Severity (52) Raveling, Low Severity (57) Weathering

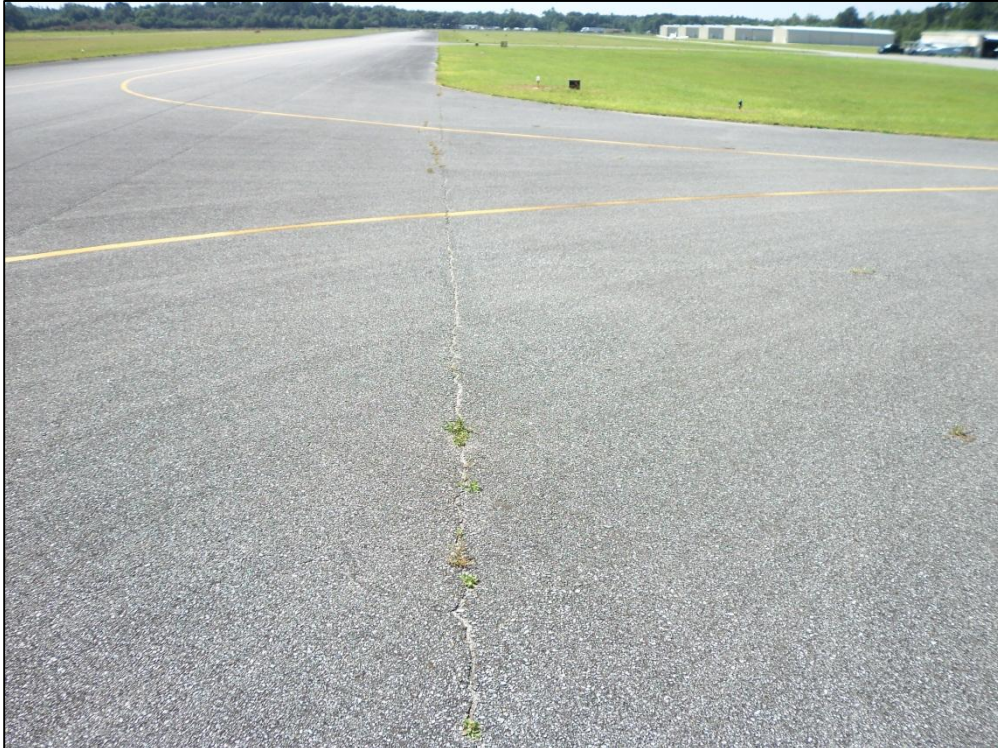
Taxiway D, Section 410, Sample Unit 400 – Medium Severity (48) Longitudinal and Transverse Cracking, Low Severity (52) Raveling, Low Severity (57) Weathering

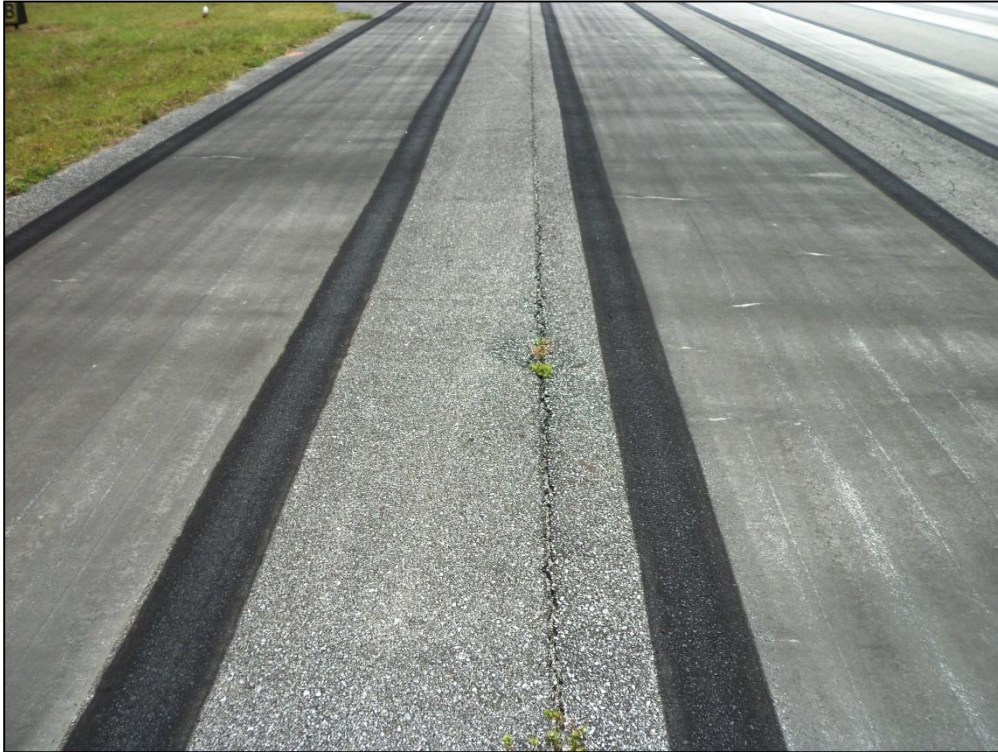
Runway 18-36 exhibited low and medium severity longitudinal/transverse cracking along with low severity weathering and raveling. One instance of high severity longitudinal/transverse cracking was also observed.

Runway 18-36, Section 6105, Sample Unit 171 – Medium Severity (48) Longitudinal and Transverse Cracking, Low Severity (57) Weathering

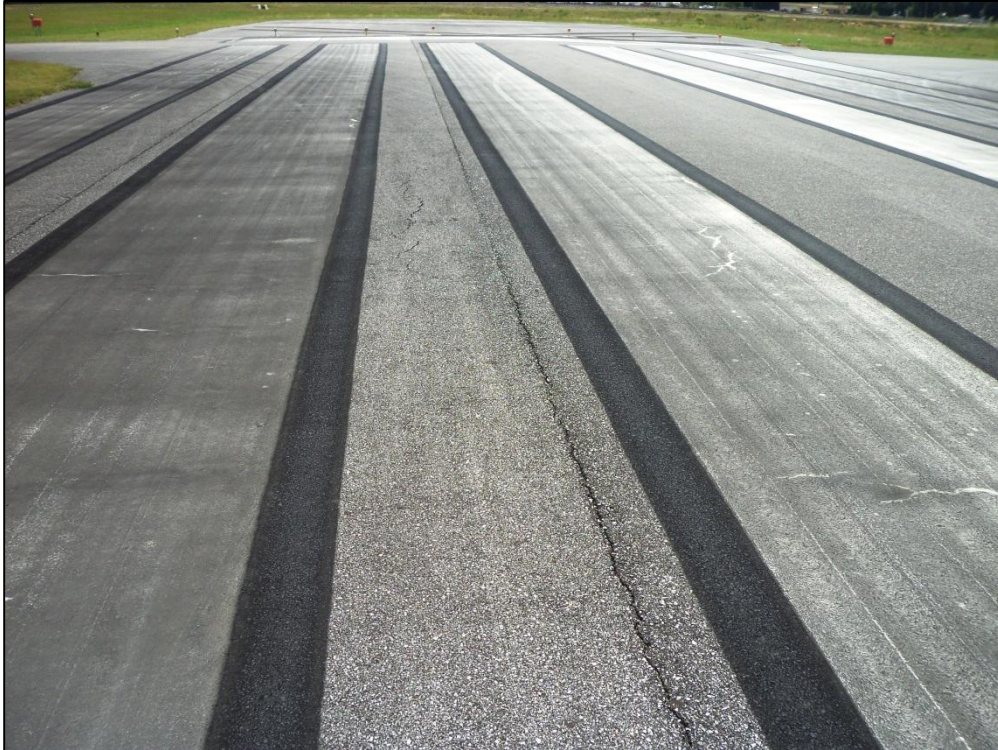
Runway 18-36, Section 6105, Sample Unit 171 – Low Severity (48) Longitudinal and Transverse Cracking, Low Severity (52) Raveling, Low Severity (57) Weathering

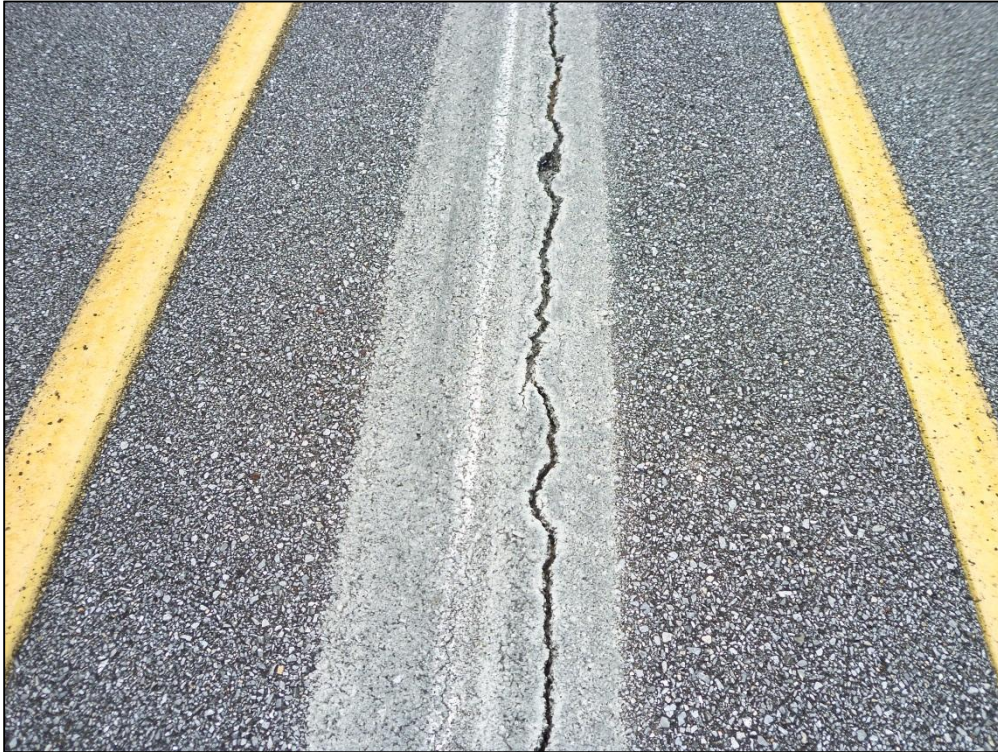
Runway 18-36, Section 6105, Sample Unit 141 – Medium Severity (48) Longitudinal and Transverse Cracking, Low Severity (52) Raveling, Low Severity (57) Weathering

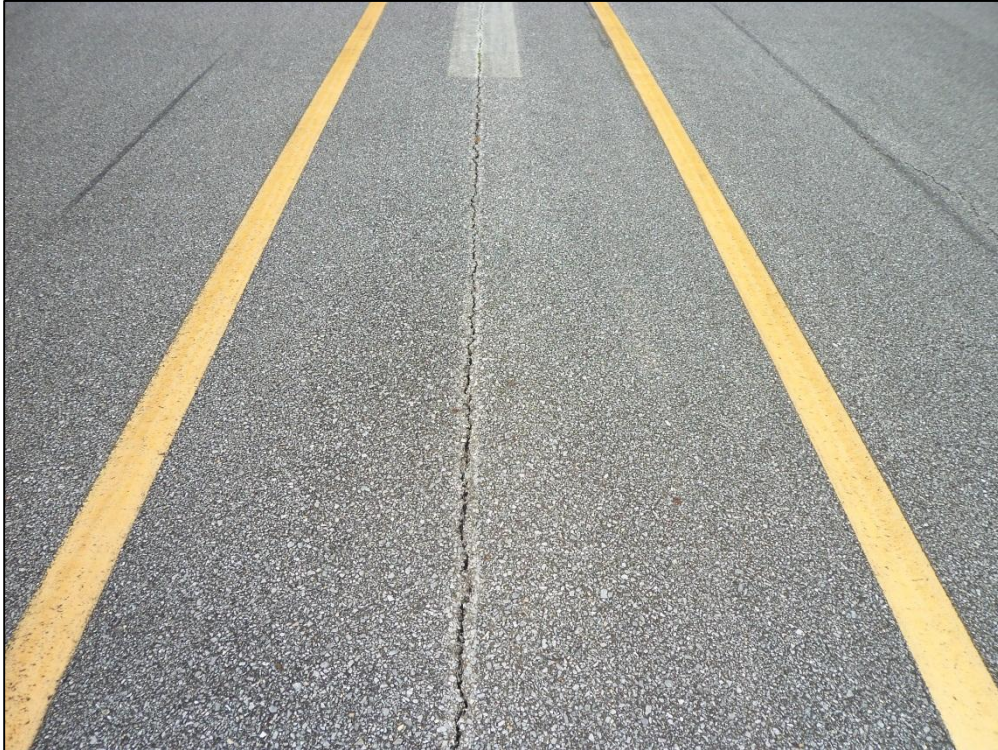
Runway 18-36, Section 6105, Sample Unit 120 – Medium Severity (48) Longitudinal and Transverse Cracking, Low Severity (57) Weathering
