FLORIDA DEPARTMENT OF TRANSPORTATION
AVIATION AND SPACEPORT OFFICE

SUWANEE COUNTY
AIRPORT (24J)

DECEMBER 2013

STATEWIDE Airfield Pavement Management PROGRAM

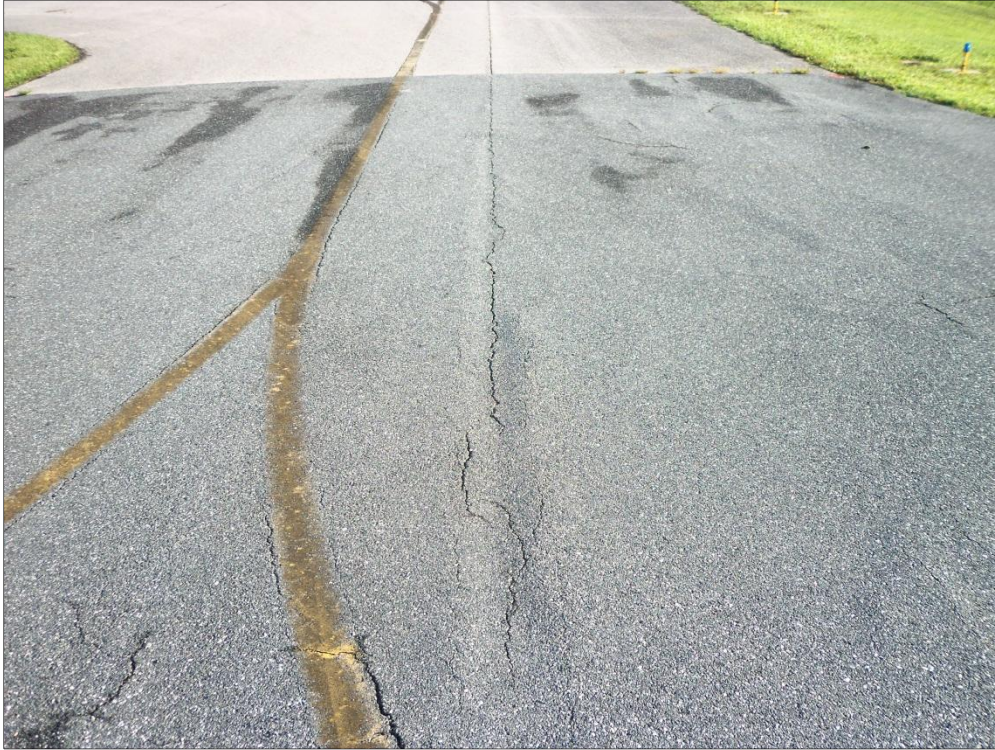
Apron Connector, Section 120, Sample Unit 100 – Low and Medium Severity (48) Longitudinal and Transverse Cracking, Low Severity (57) Weathering, Low Severity (52) Raveling, Low Severity (56) Swelling

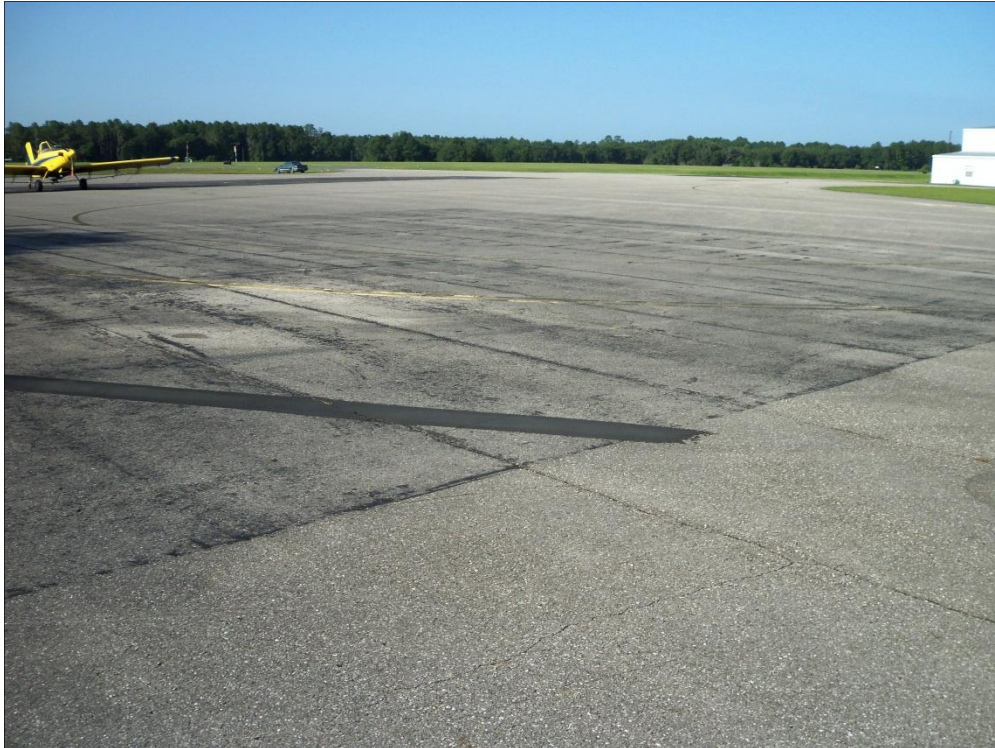
Apron, Section 4105, Sample Unit 454 – Low and Medium Severity (48) Longitudinal and Transverse Cracking, High Severity (50) Patching, Low Severity (52) Raveling, Low Severity (57) Weathering

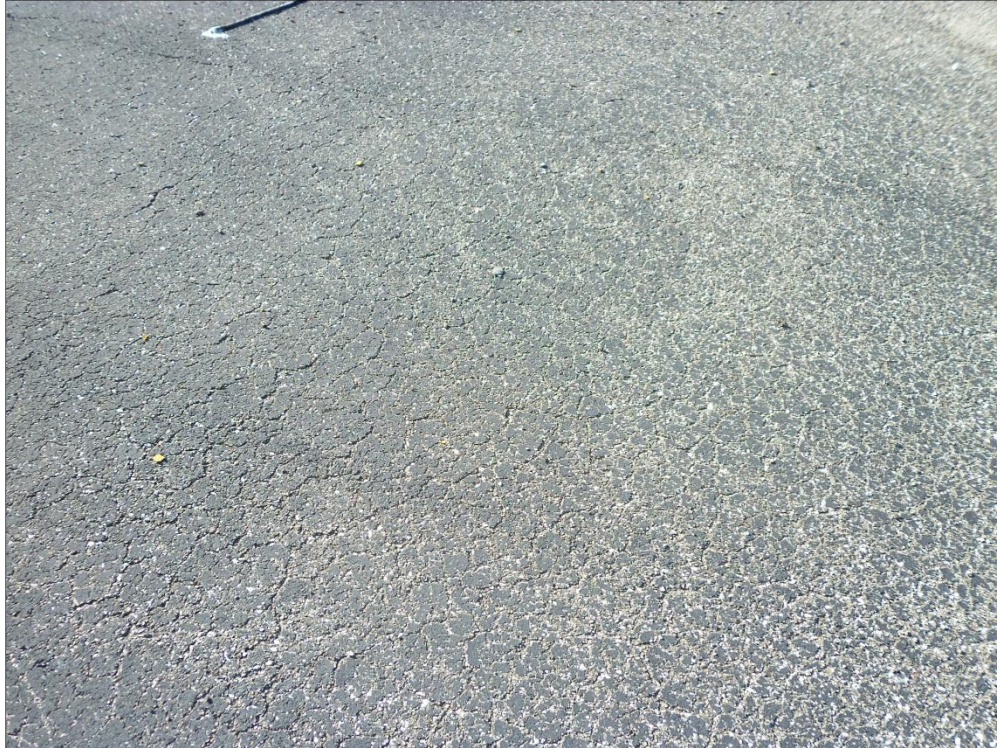
Apron, Section 4105, Sample Unit 454 – High Severity (57) Weathering

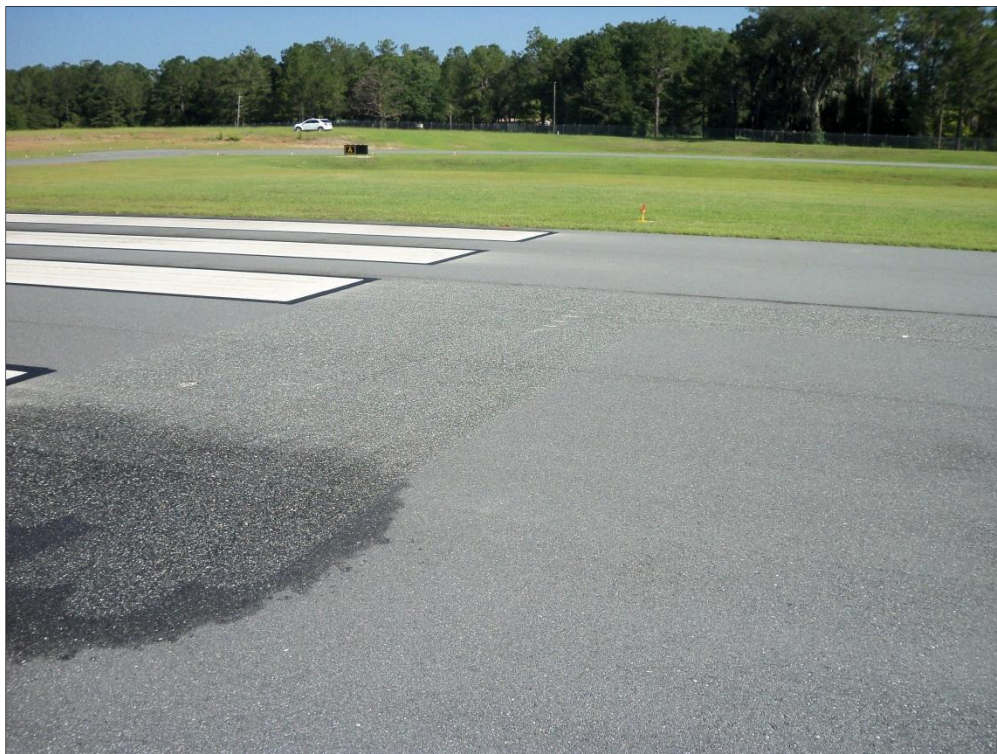
Runway 7-25 only exhibited low severity longitudinal/transverse cracking, weathering and raveling, with the longitudinal cracking primarily being located along the pavement joints.

Runway 7-25, Section 6105, Sample Unit 103 – Low Severity (52) Raveling, Low Severity (57) Weathering

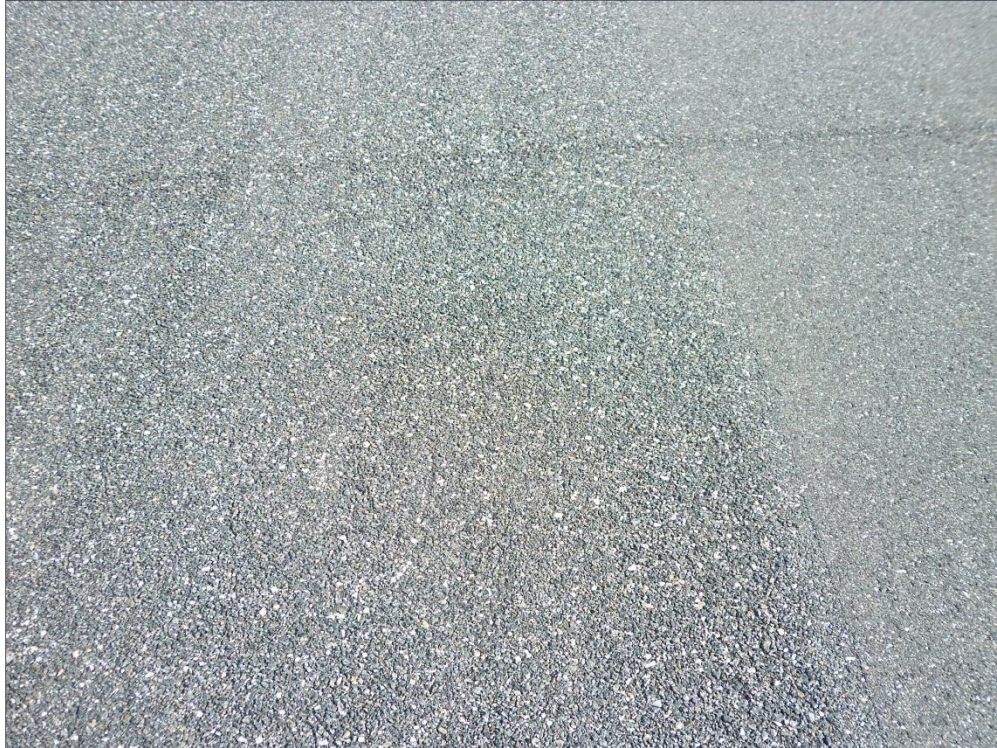
Runway 7-25, Section 6105, Sample Unit 103 – Low Severity (52) Raveling, Low Severity (57) Weathering

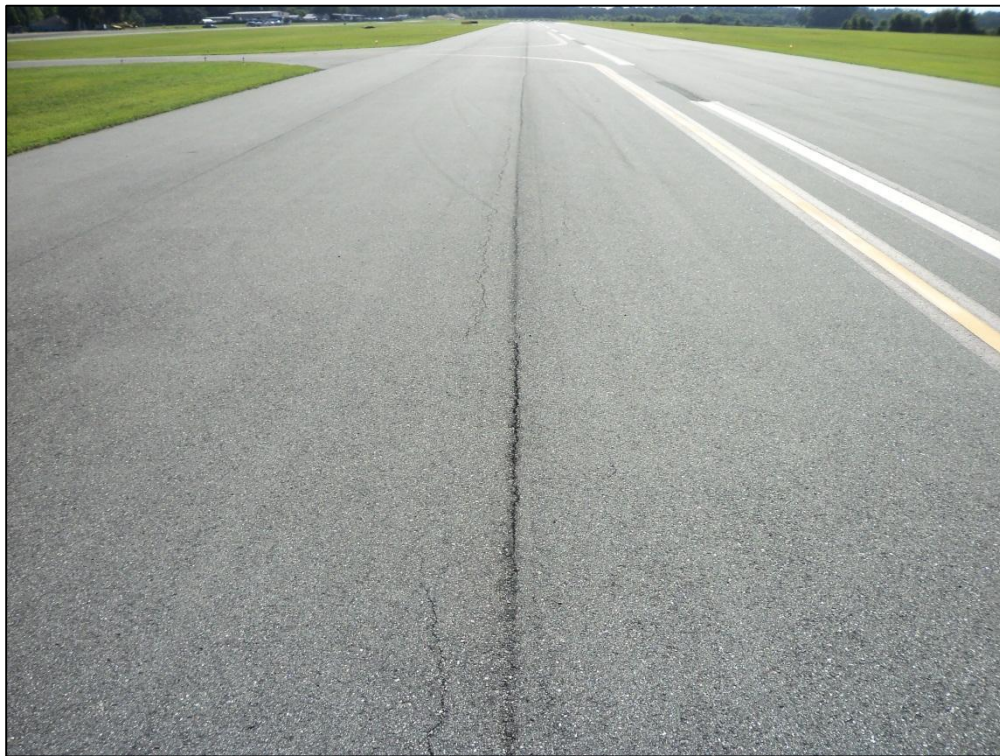
Runway 7-25, Section 6110, Sample Unit 134 – Low Severity (48) Longitudinal and Transverse Cracking

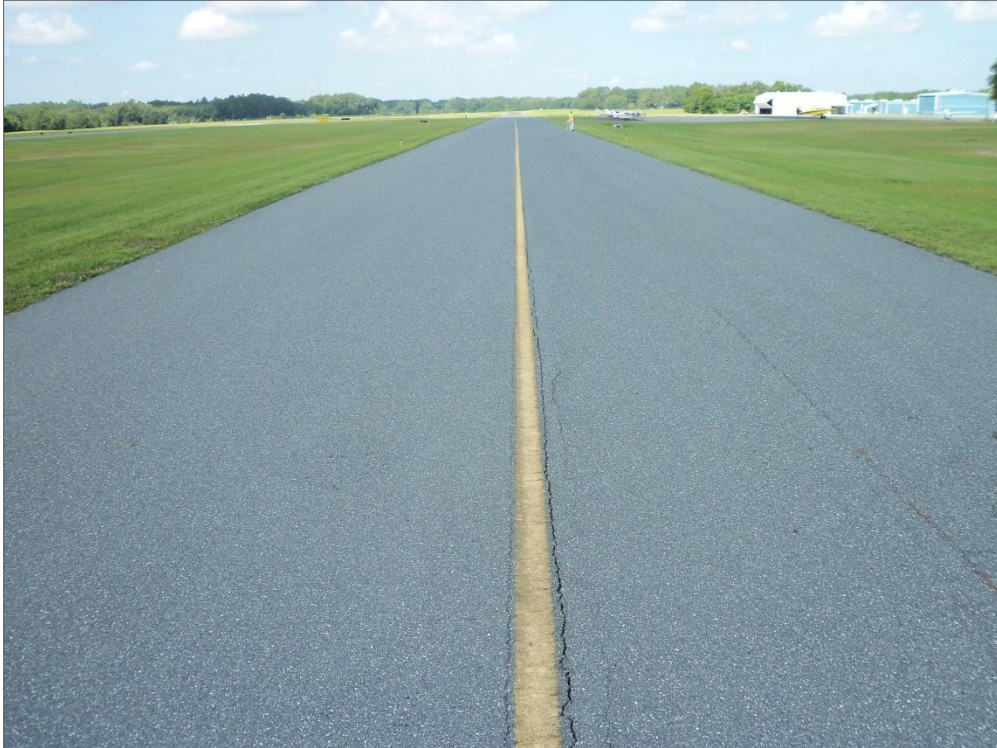
Taxiway Alpha exhibited very similar distresses to the runway, with the addition of isolated instances of low severity swelling and medium severity longitudinal/transverse cracking.

Taxiway A, Section 105, Sample Unit 104 – Low Severity (48) Longitudinal and Transverse Cracking, Low Severity (57) Weathering

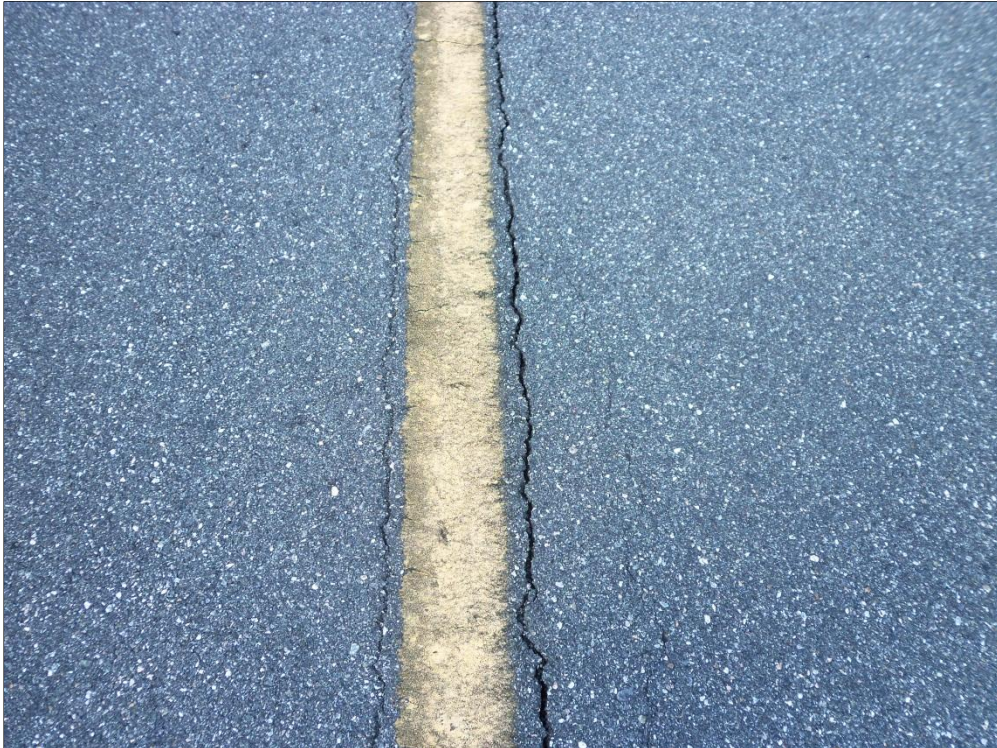
Taxiway A, Section 105, Sample Unit 104 – Low Severity (48) Longitudinal and Transverse Cracking, Low Severity (57) Weathering

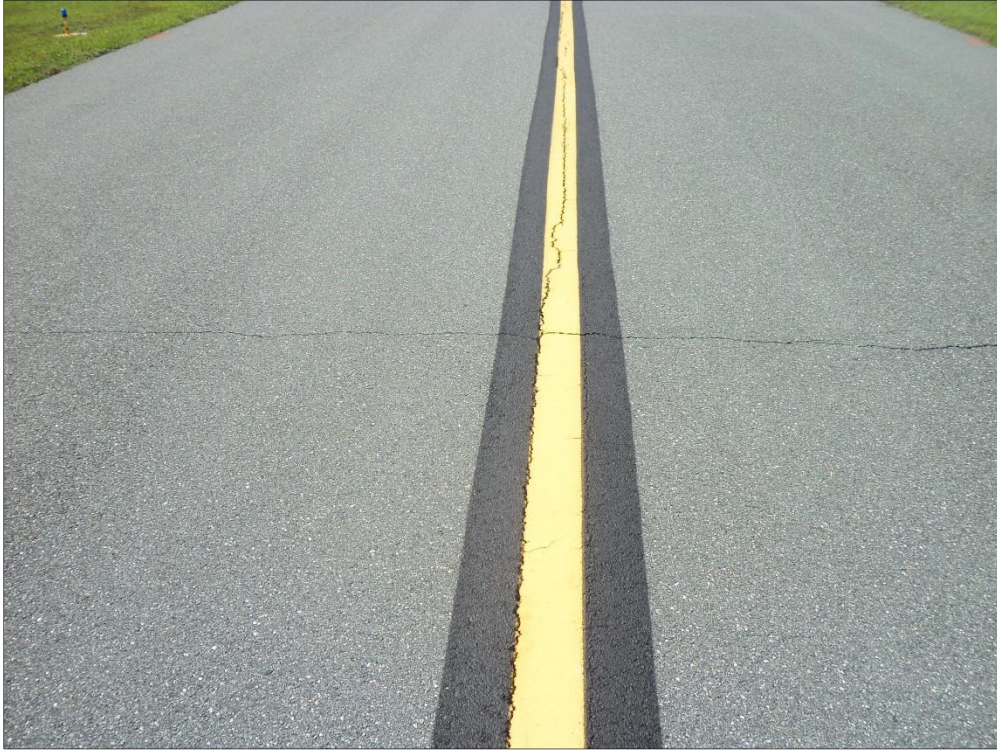
Taxiway A1, Section 115, Sample Unit 101 – Low Severity (48) Longitudinal and Transverse Cracking, Low Severity (57) Weathering

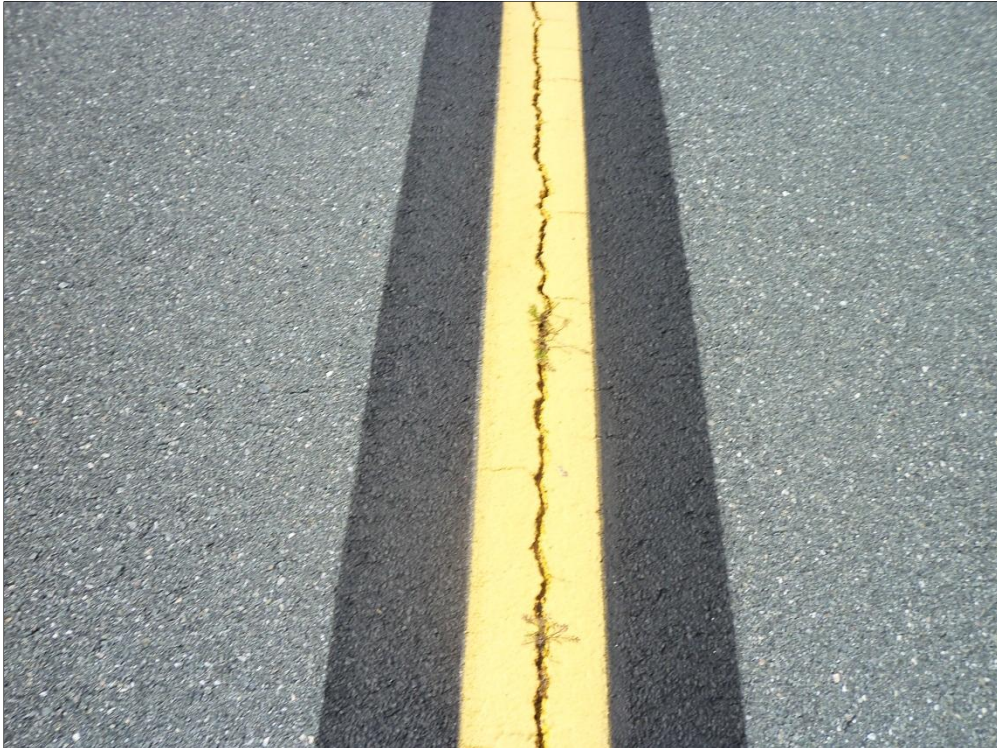
Taxiway A1, Section 115, Sample Unit 101 – Low Severity (48) Longitudinal and Transverse Cracking, Low Severity (57) Weathering

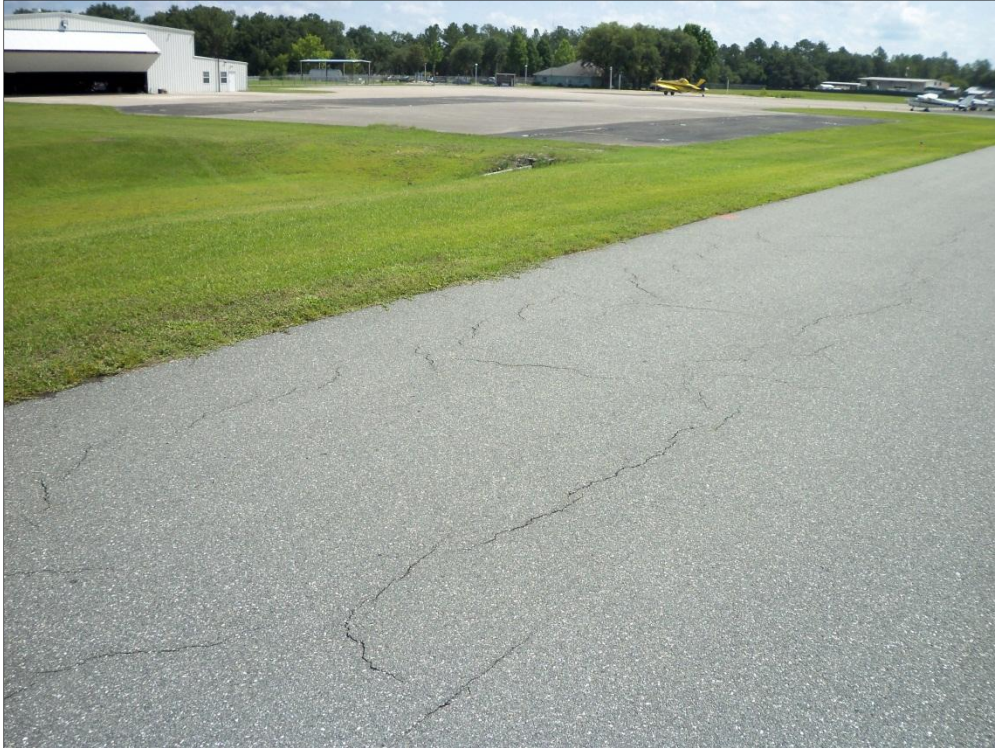
Taxiway A, Section 110, Sample Unit 117 – Low Severity (48) Longitudinal and Transverse Cracking, Low Severity (57) Weathering
