FLORIDA DEPARTMENT OF TRANSPORTATION
AVIATION AND SPACEPORT OFFICE

PALATKA
MUNICIPAL
AIRPORT – KAY
LARKIN FIELD (28J)

DECEMBER 2013

STATEWIDE
**Airfield
Pavement
Management**
PROGRAM

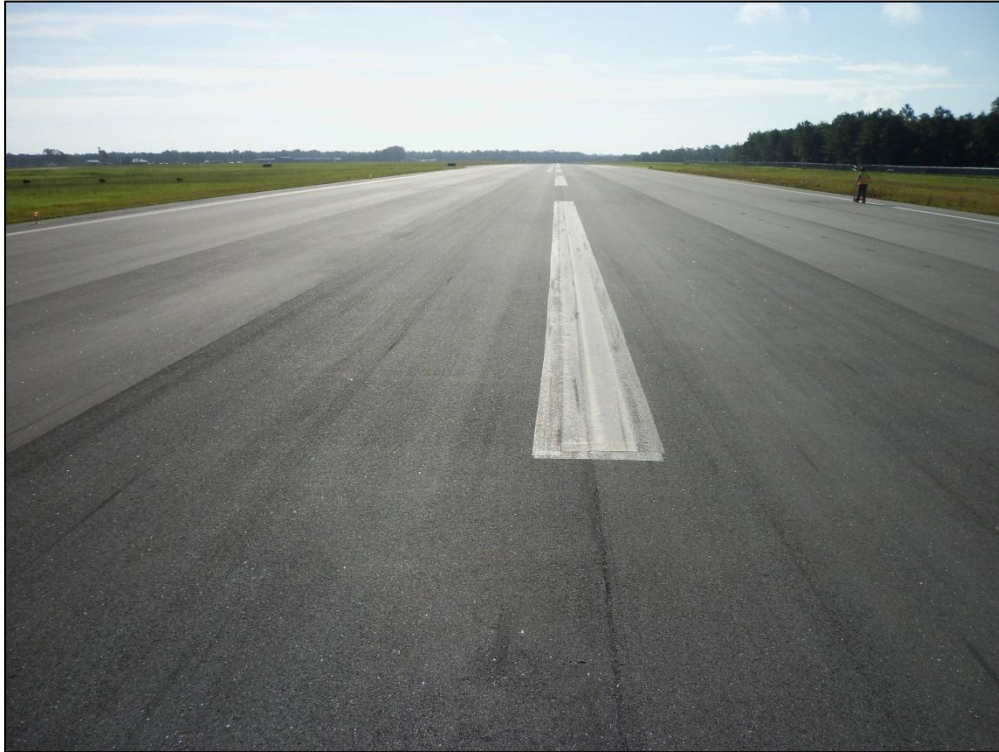
Runway 9-27, Section 6115, Sample Unit 86 – No Distresses

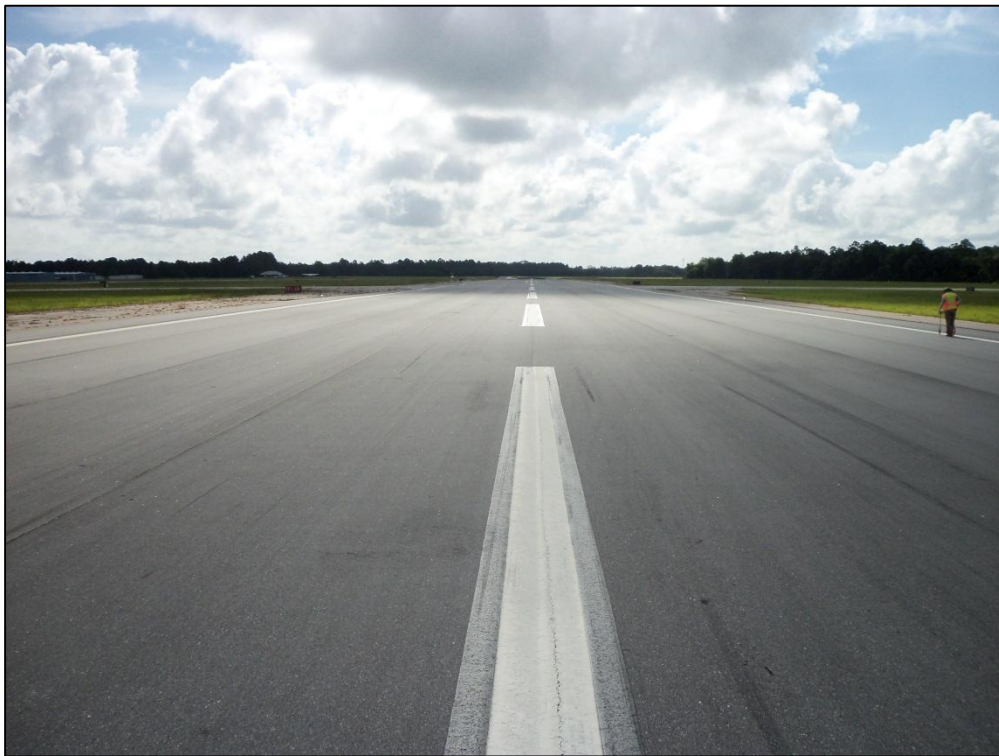
Runway 9-27, Section 6105, Sample Unit 134 – Low Severity (48) Longitudinal and Transverse Cracking

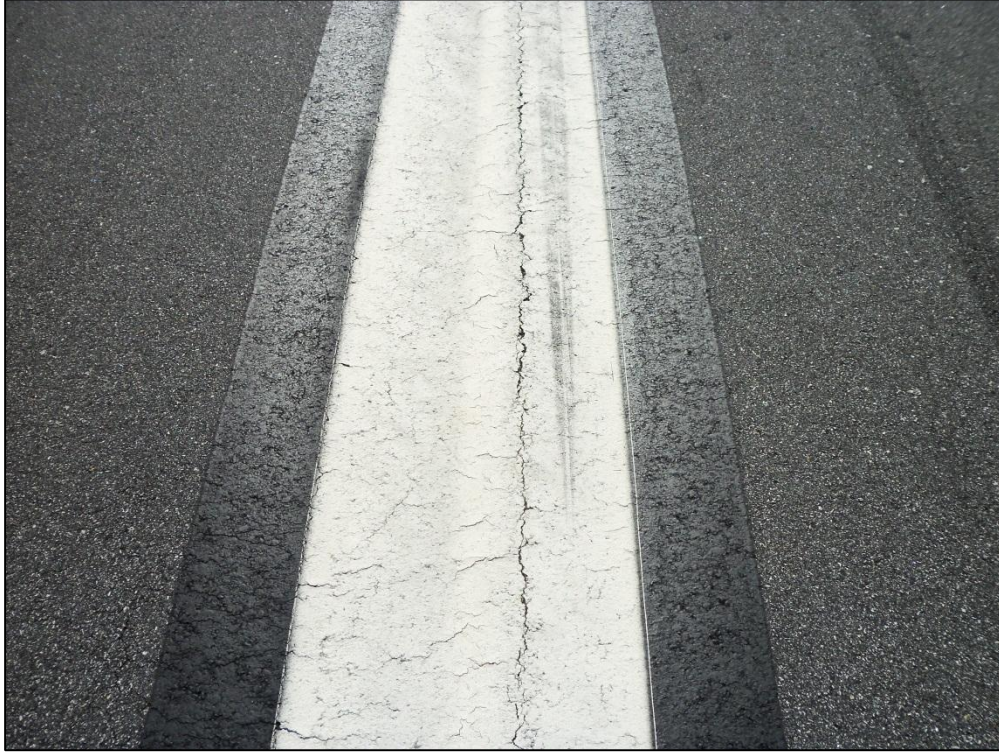
Runway 9-27, Section 6105, Sample Unit 134 – Low Severity (48) Longitudinal and Transverse Cracking

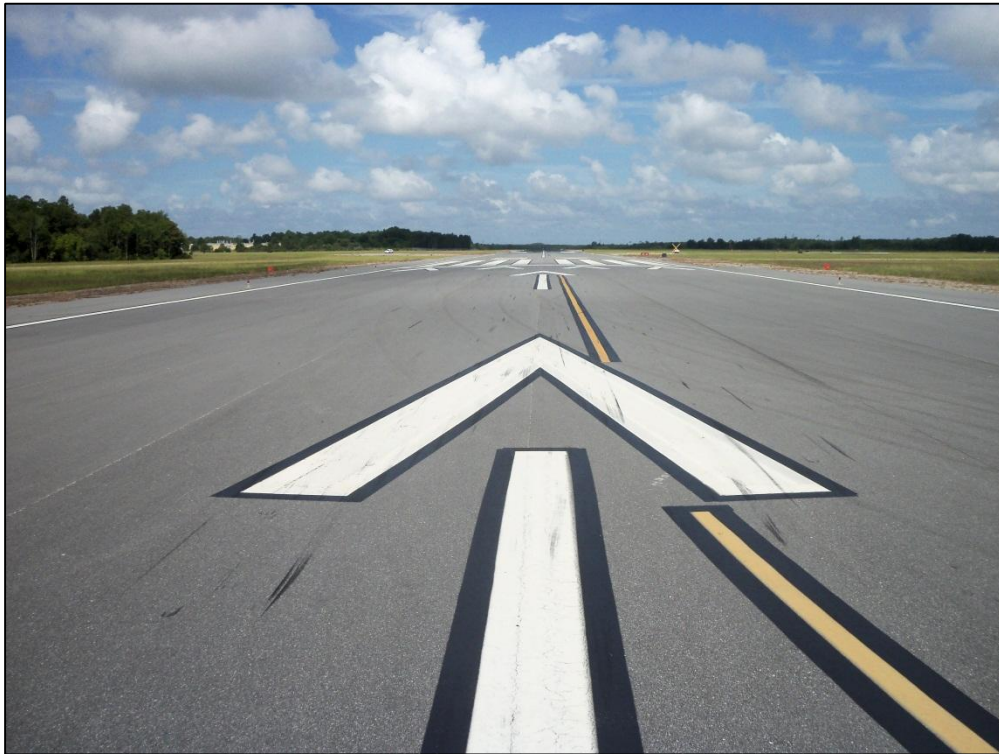
Runway 9-27, Section 6110, Sample Unit 198 – No Distresses

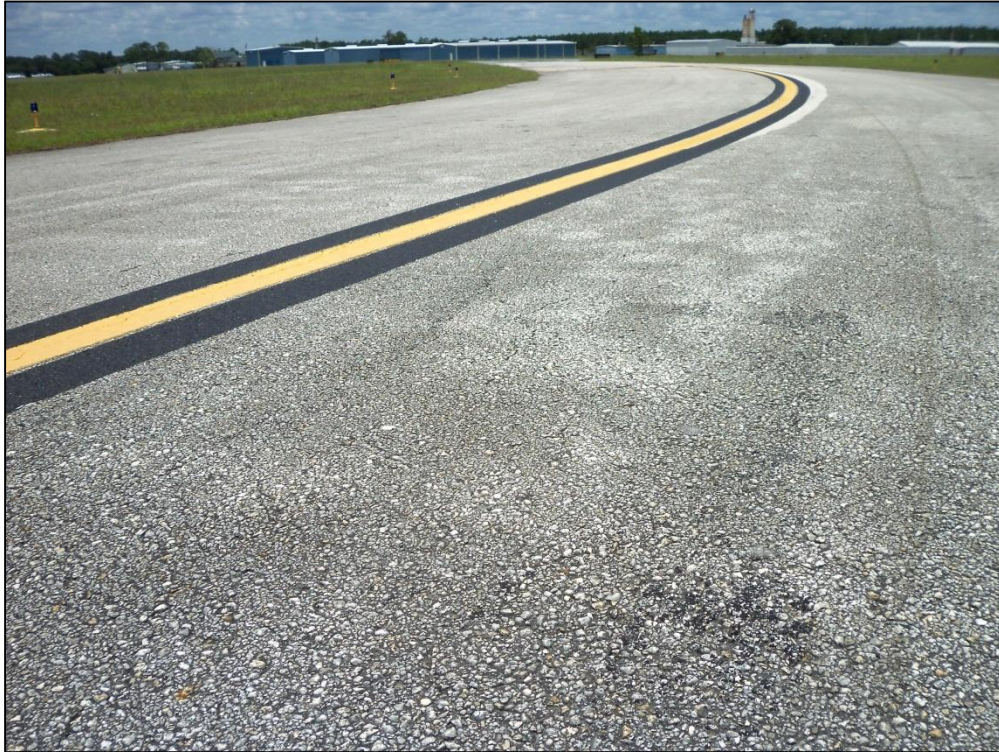
Taxiway Bravo, Section 2005, Sample Unit 101 – Low Severity (48) Longitudinal and Transverse Cracking, Low Severity (57) Weathering, Low and Medium Severity (52) Raveling, Low Severity (56) Swelling

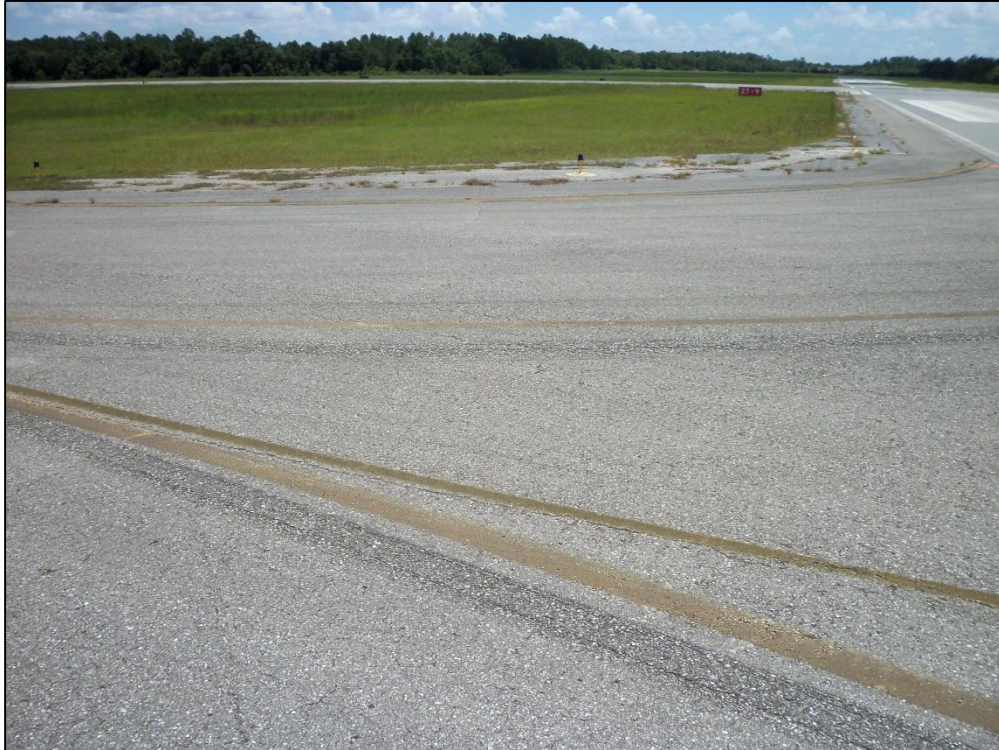
Taxiway Alpha, Section 107, Sample Unit 125 – Low Severity (48) Longitudinal and Transverse Cracking, Low Severity (57) Weathering, Low and Medium Severity (52) Raveling

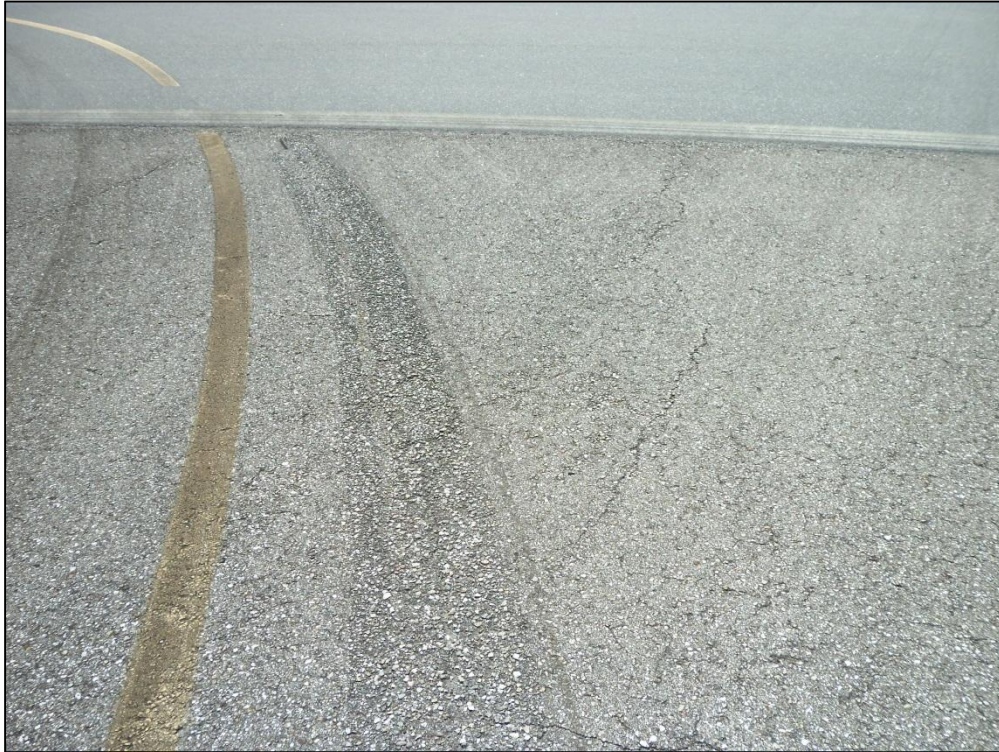
Taxiway Alpha, Section 107, Sample Unit 125 – Low Severity (48) Longitudinal and Transverse Cracking, Low Severity (57) Weathering, Low and Medium Severity (52) Raveling

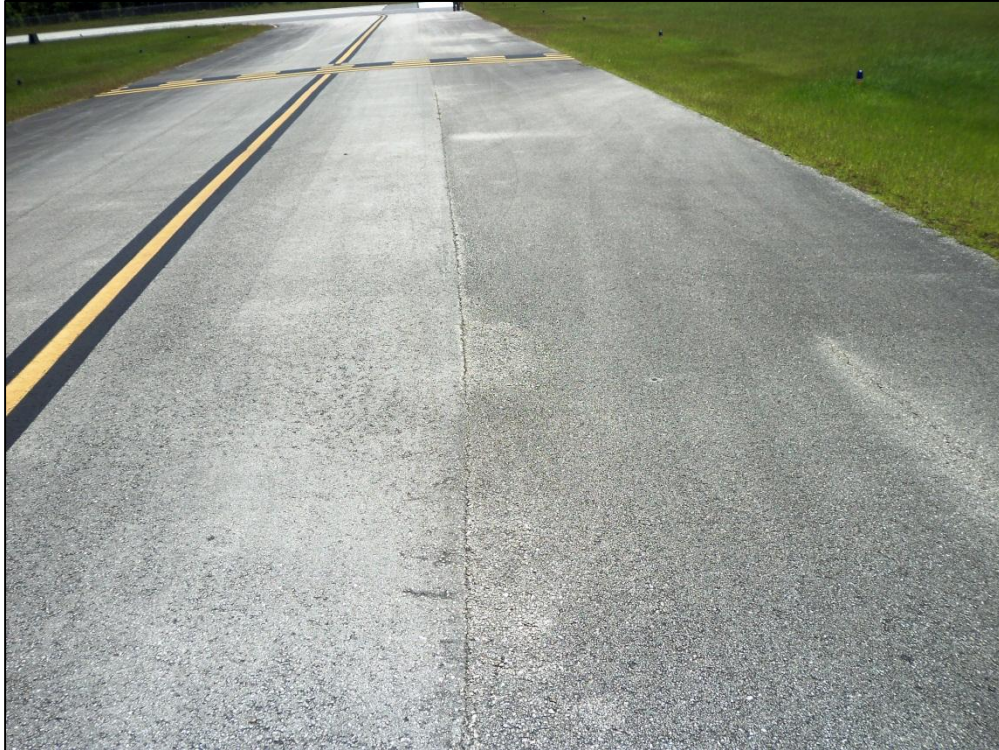
Taxiway Alpha, Section 100, Sample Unit 102 – Low Severity (48) Longitudinal and Transverse Cracking, Low Severity (57) Weathering, Low Severity (52) Raveling

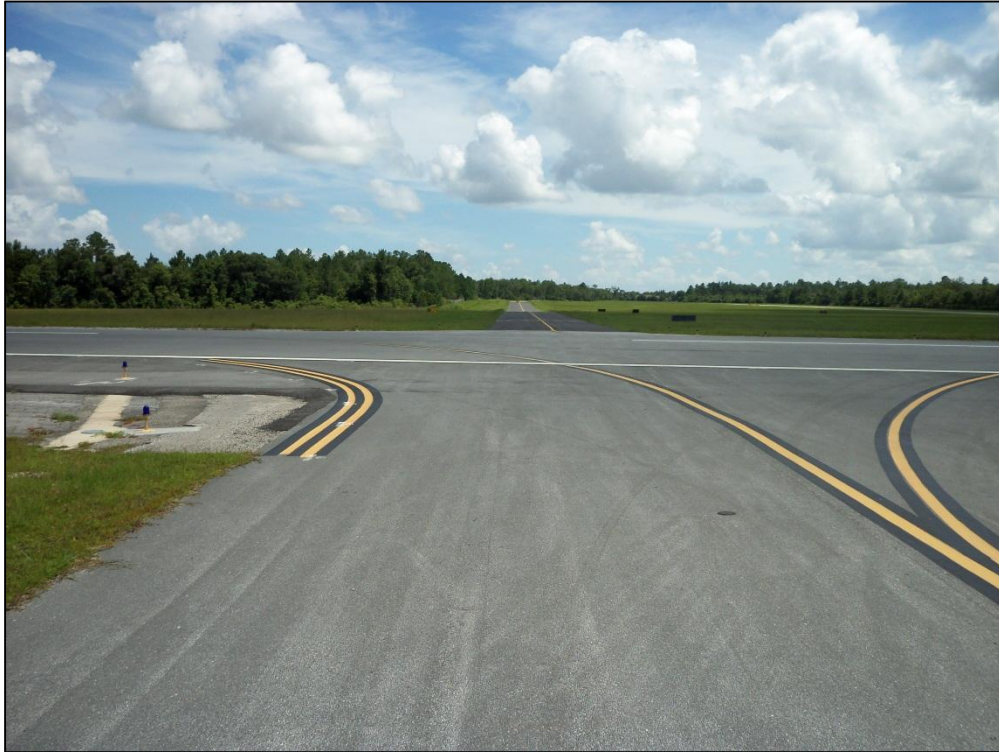
Taxiway Charlie, Section 315, Sample Unit 100 – Low Severity (57) Weathering

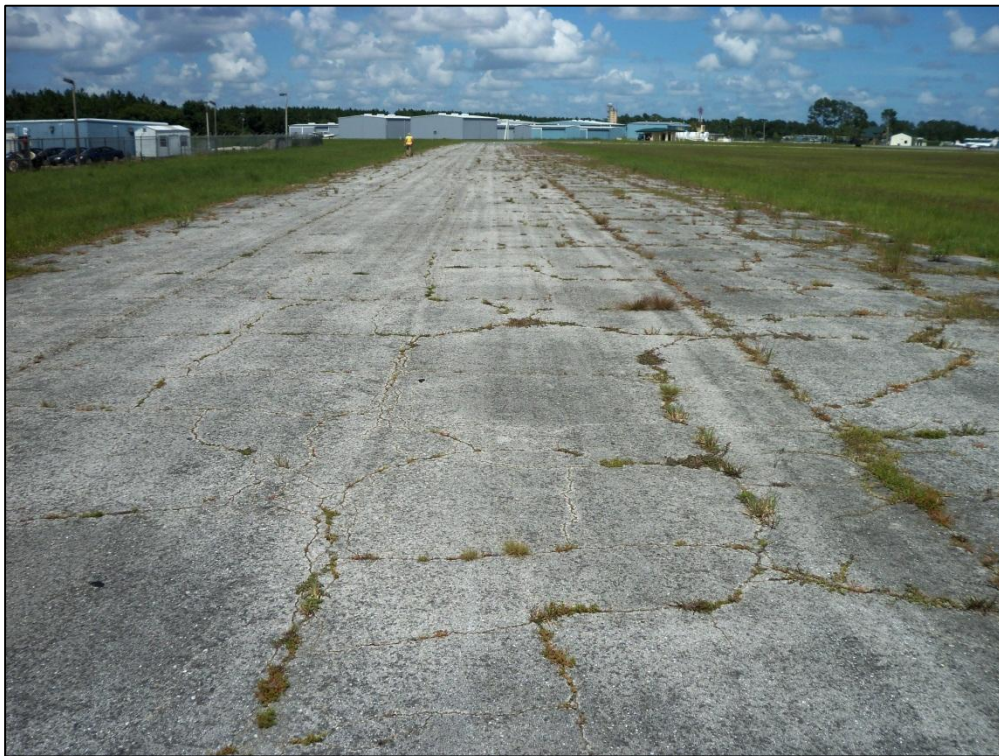
Taxiway Bravo, Section 705, Sample Unit 105 – Medium Severity (52) Raveling, Medium Severity (43) Block Cracking

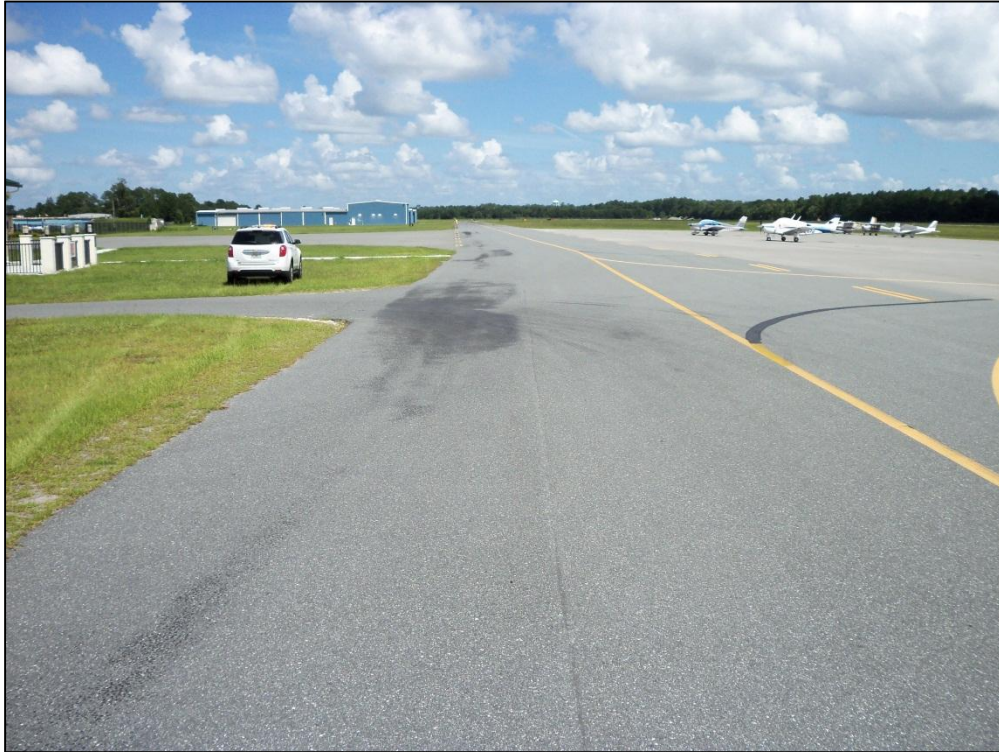
Taxiway Bravo, Section 215, Sample Unit 108 – Low Severity (57) Weathering, Bleeding (42)

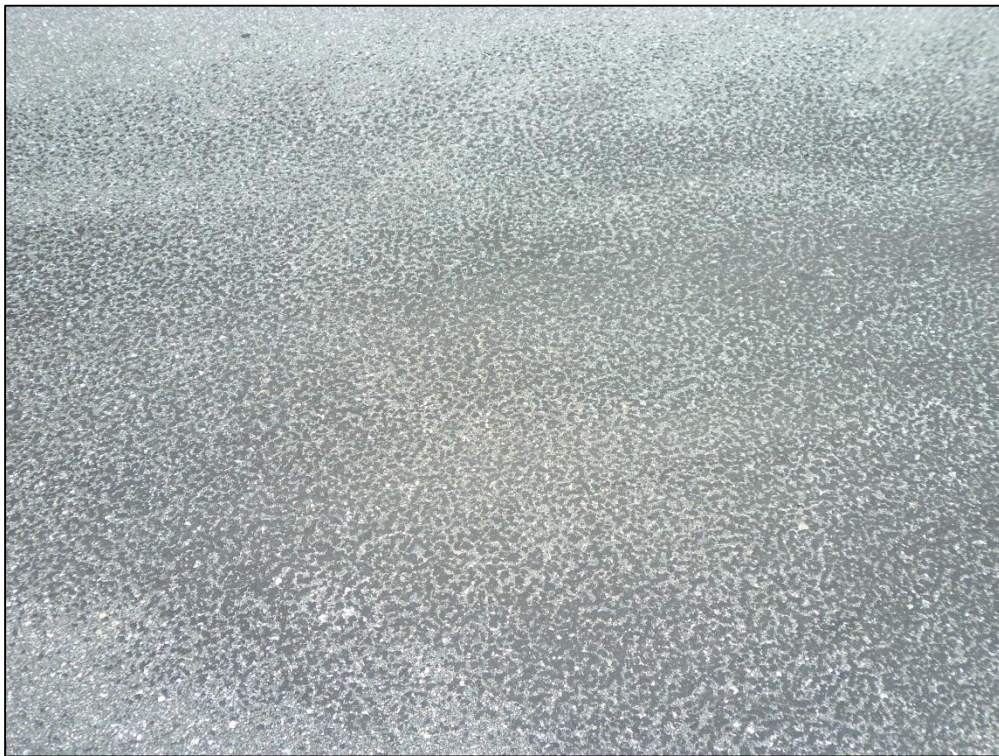
Taxiway B, Section 215, Sample Unit 108 – Bleeding (42)

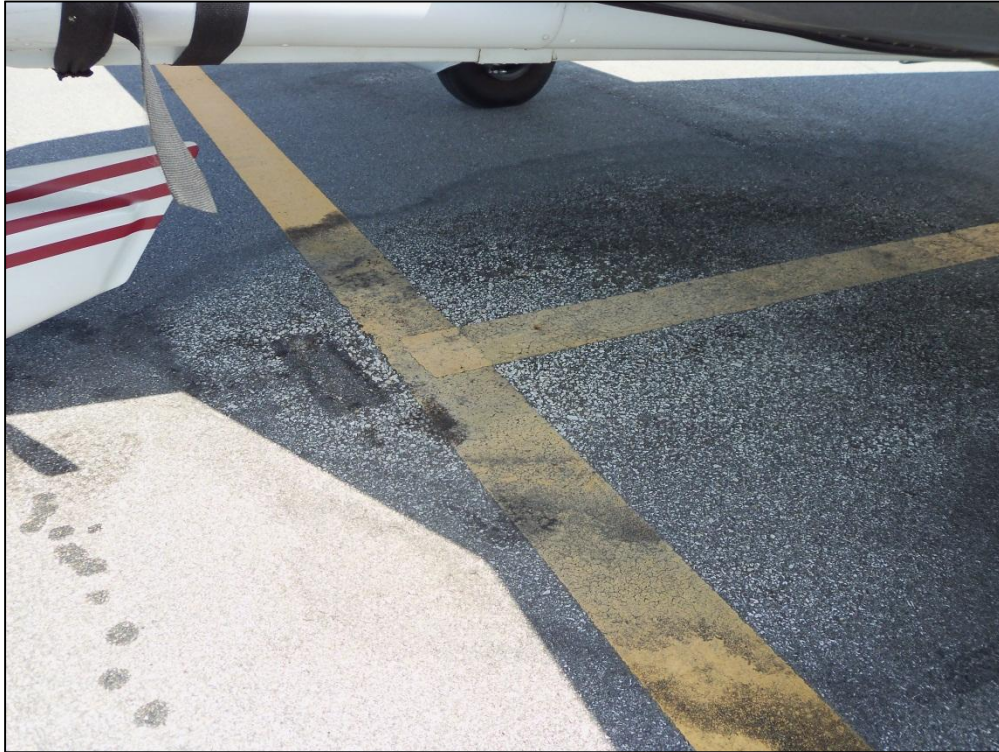
Apron, Section 4115, Sample Unit 301 – Oil Spillage (49), Low Severity (57) Weathering

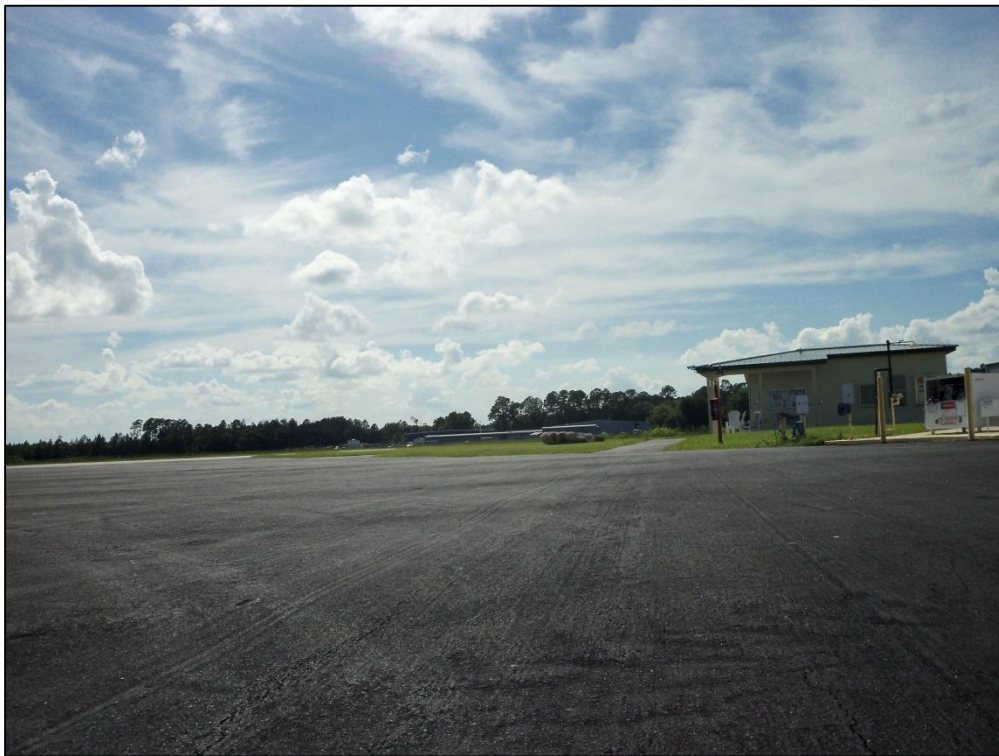
Apron North T-Hangar, Section 4215, Sample Unit 100 – Low Severity (48) Longitudinal and Transverse Cracking, Low Severity (57) Weathering, Low Severity (45) Depression

- East Apron to T-Hangar – Sections 4305
 - Mill and Overlay attributed to distresses related to climate and age of pavement.
- Apron – Section 4215
 - Mill and Overlay attributed to distresses related to loading, subgrade quality, climate, and age of pavement.
- North Apron to T-Hangar – Sections 4210 and 4205
 - Mill and Overlay attributed to distresses related to climate and age of pavement.
- Taxiway B – Section 2005 and 215
 - Mill and Overlay attributed to distresses related to climate and age of pavement.
- Taxiway B – Section 705
 - Reconstruction attributed to distresses related to subgrade quality, climate, and age of pavement.
- Taxiway A – Section 125 and 107
 - Reconstruction attributed to distresses related to climate and age of pavement.

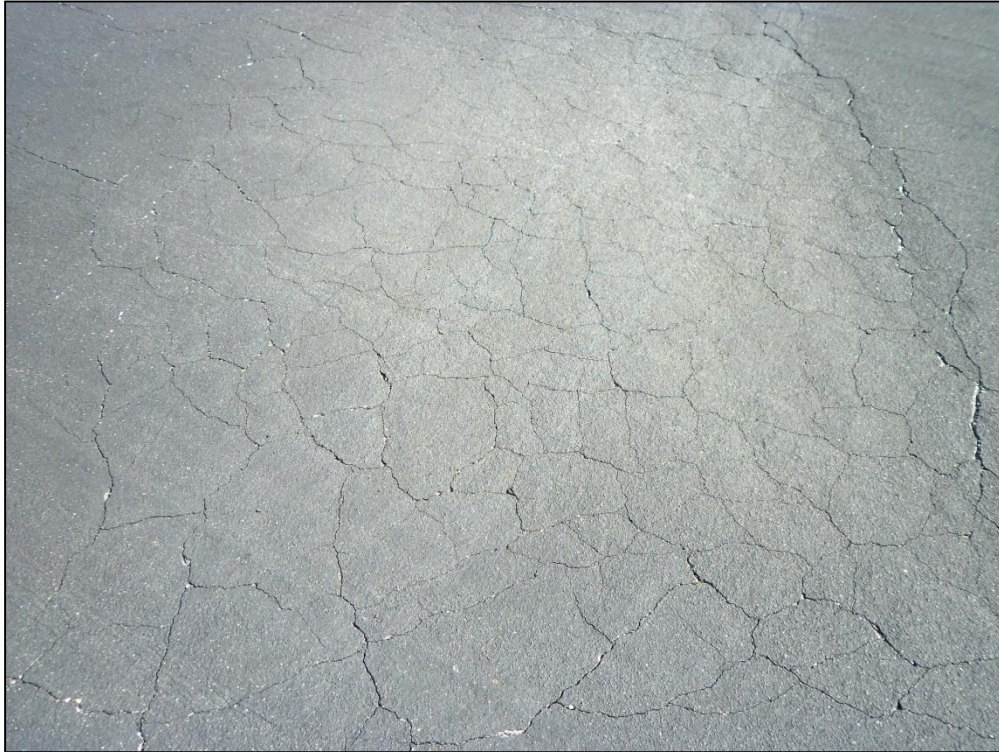
Apron North T-Hangar, Section 4215, Sample Unit 100 – Low Severity (57) Weathering, Low Severity (41) Alligator Cracking

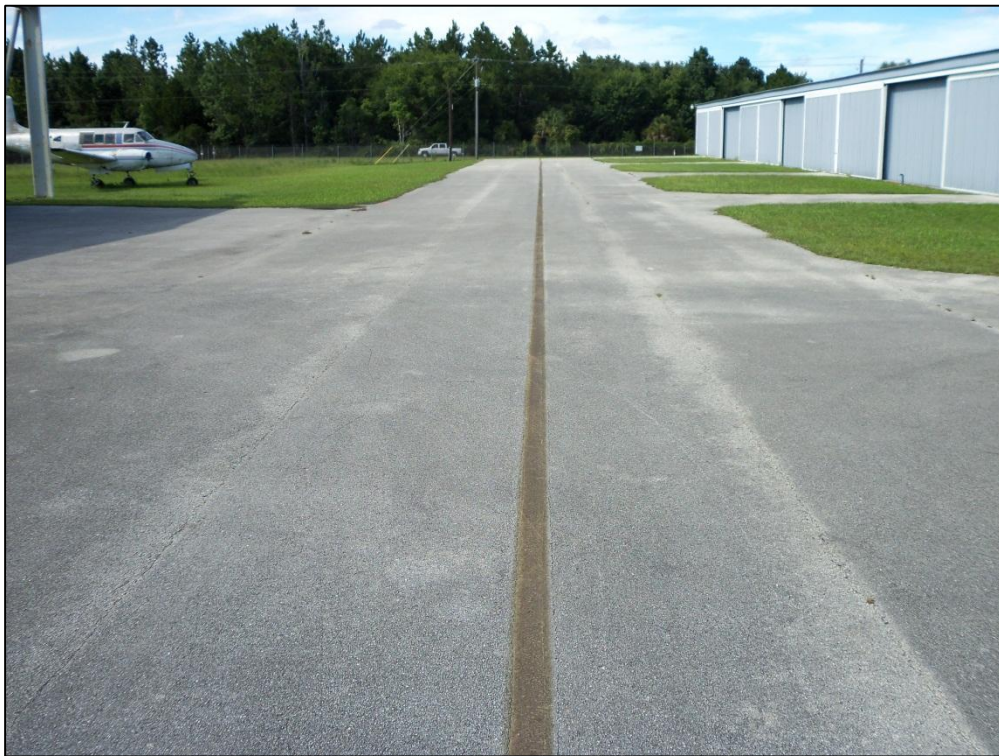
Apron North T-Hangar, Section 4205, Sample Unit 503 – Low Severity (48) Longitudinal and Transverse Cracking, Low Severity (57) Weathering, Low and Medium Severity (52) Raveling

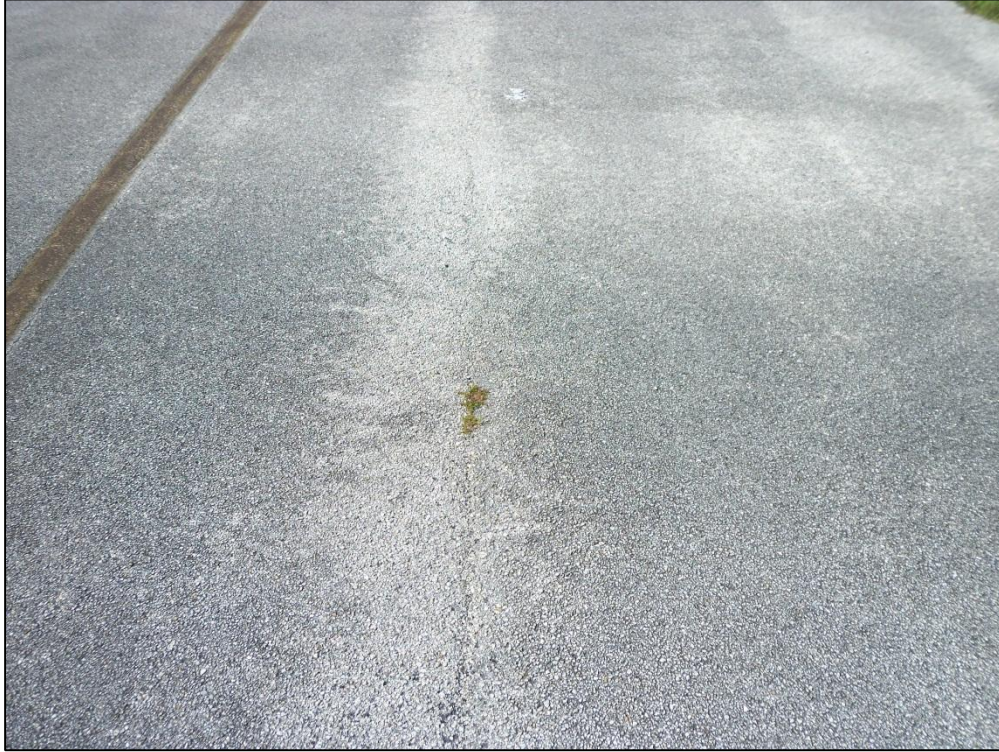
Apron North T-Hangar, Section 4205, Sample Unit 503 – Low Severity (48) Longitudinal and Transverse Cracking, Low Severity (57) Weathering, Low and Medium Severity (52) Raveling
