FLORIDA DEPARTMENT OF TRANSPORTATION
AVIATION AND SPACEPORT OFFICE

PERRY-FOLEY
AIRPORT (40J)

DECEMBER 2013

STATEWIDE Airfield Pavement Management PROGRAM

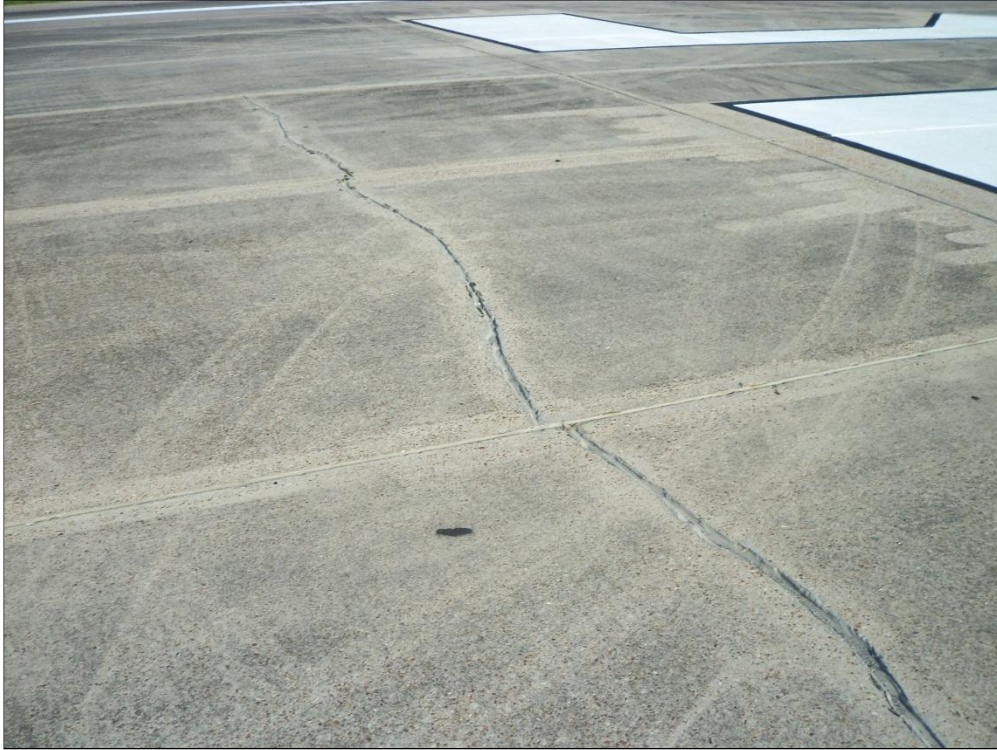
Runway 18-36, Section 6310, Sample Unit 300 – Low Severity (63) Longitudinal, Transverse, and Diagonal Cracking

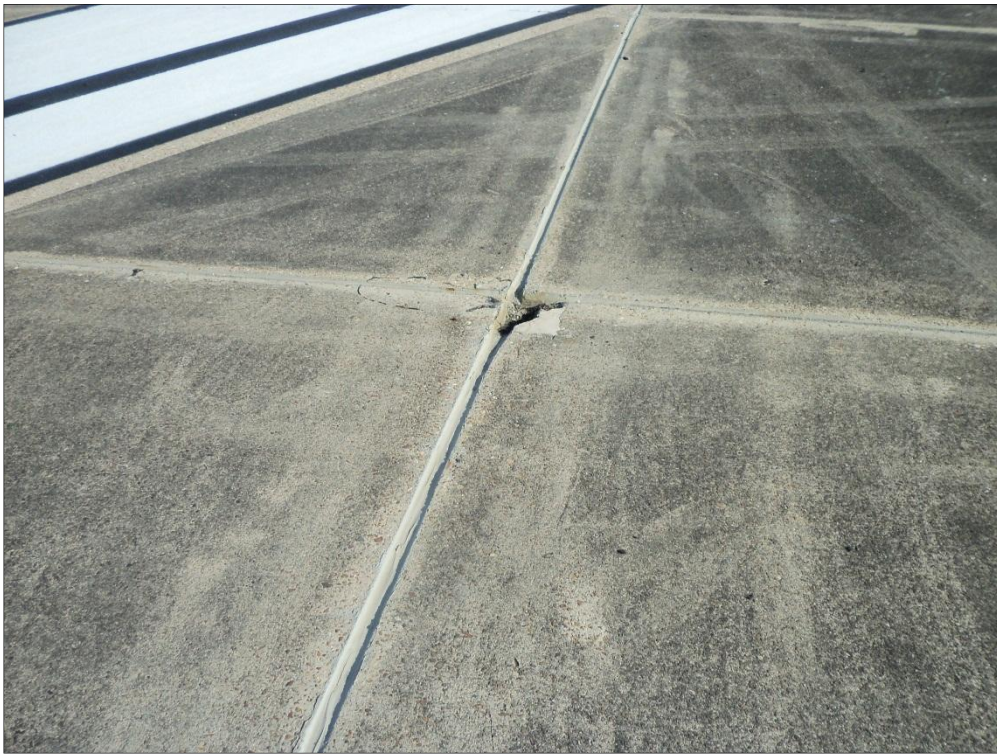
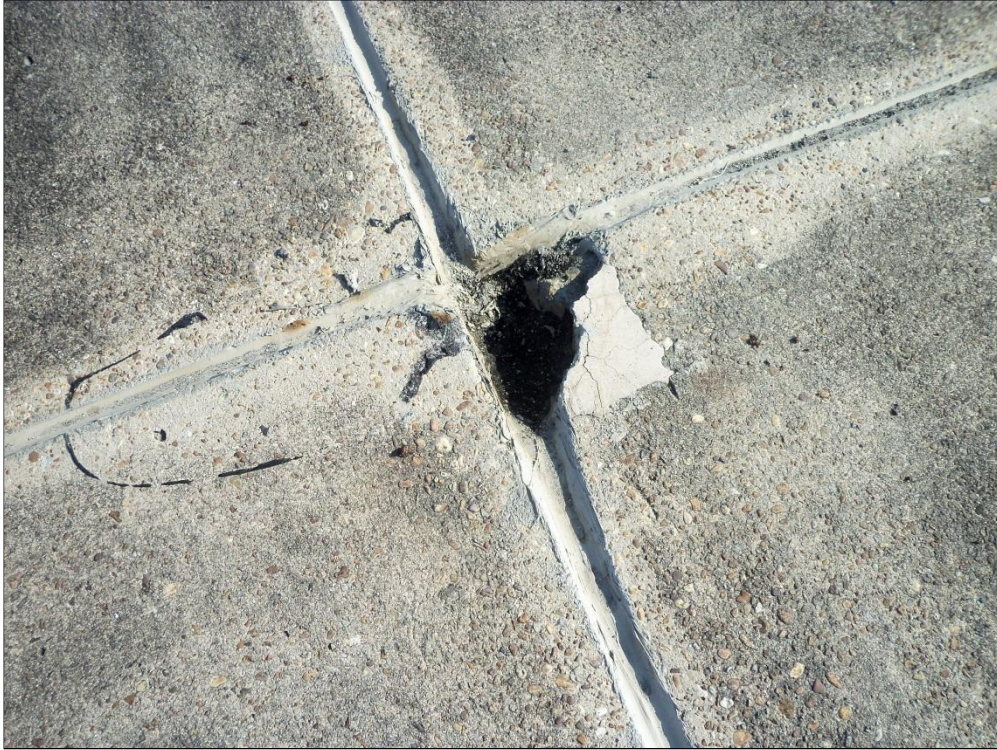
Runway 6-24, Section 6210, Sample Unit 500 – High Severity (75) Corner Spalling

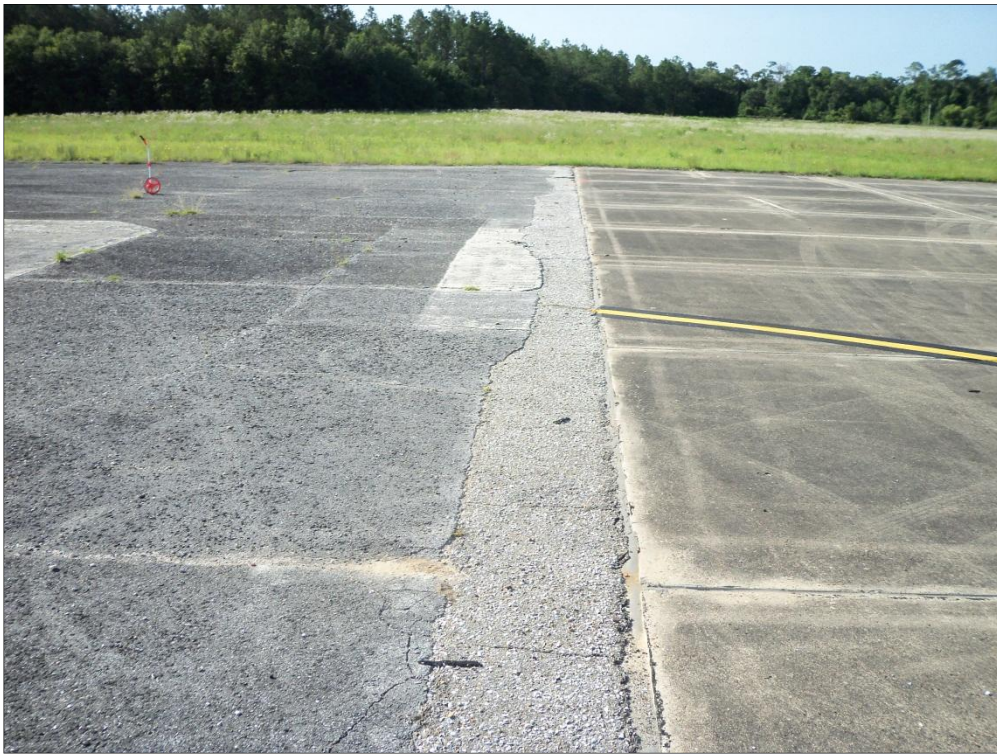
Runway 6-24, Section 6215, Sample Unit 307 – High Severity (50) Patching, Medium Severity (52) Raveling, Low and Medium Severity (43) Block Cracking

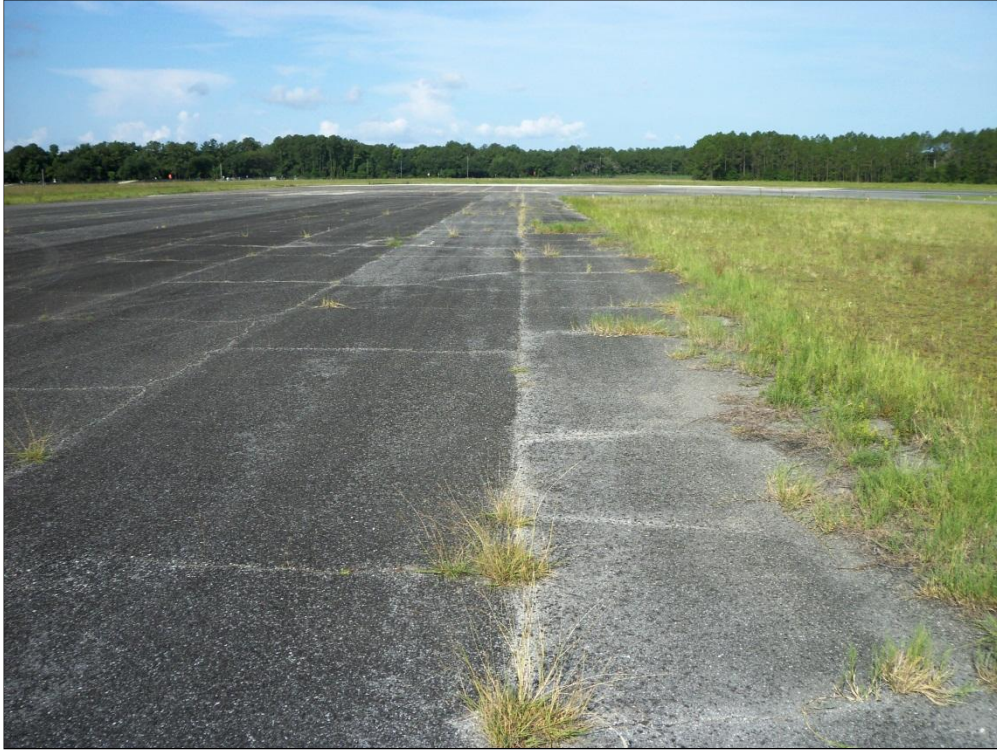
Runway 6-24, Section 6220, Sample Unit 111 – Medium Severity (52) Raveling, High and Medium Severity (43) Block Cracking

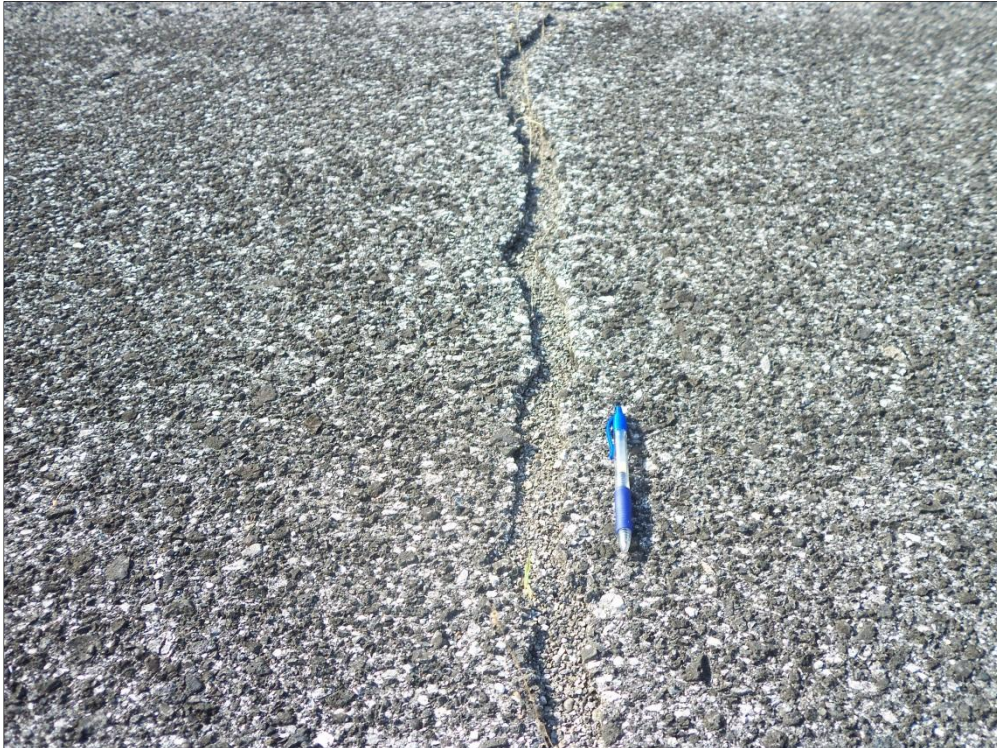
Runway 6-24, Section 6220, Sample Unit 111 – Medium Severity (52) Raveling, High Severity (43) Block Cracking

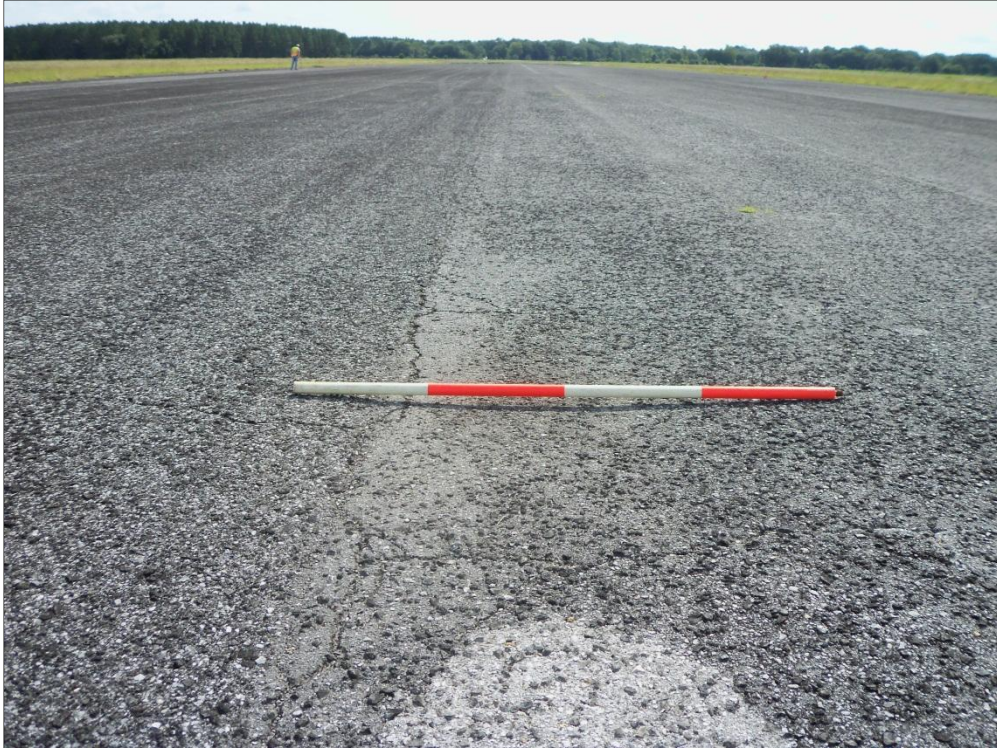
Runway 6-24, Section 6215, Sample Unit 374 – Medium Severity (52) Raveling, Low and Medium Severity (43) Block Cracking, Low Severity (45) Depression

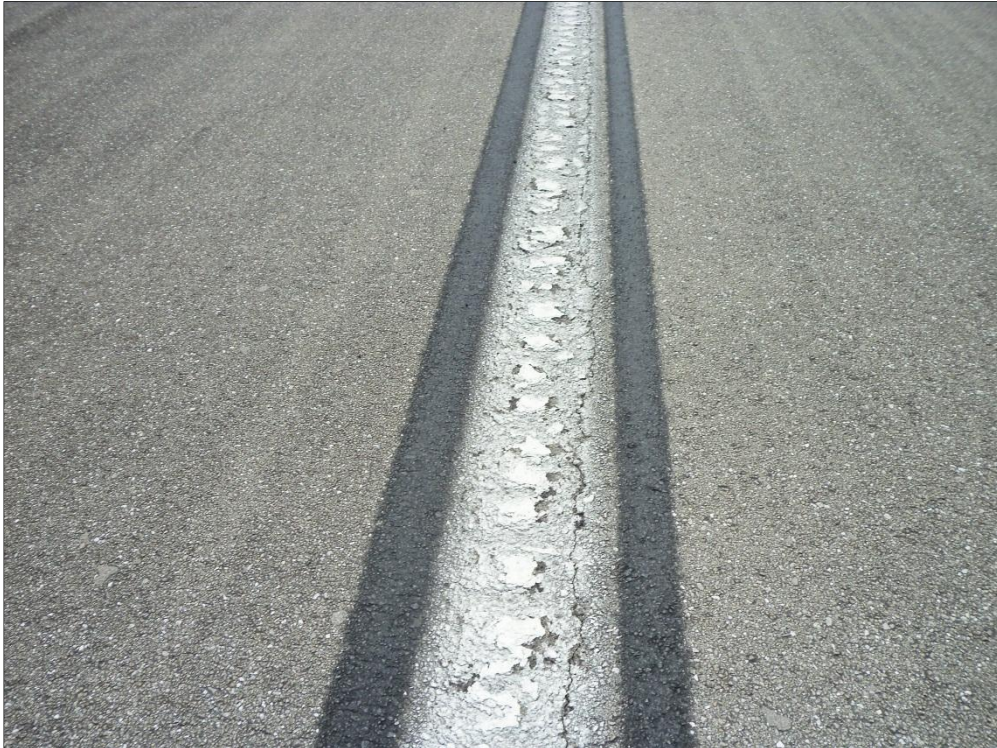
Runway 12-30 exhibited low severity longitudinal/transverse cracking along with low and medium severity weathering. High severity raveling was observed along the paint sections of the centerline and touchdown markers.

Runway 12-30, Section 6115, Sample Unit 339 – Low and Medium Severity (57) Weathering, Low Severity (48) Longitudinal and Transverse Cracking, High Severity (52) Raveling

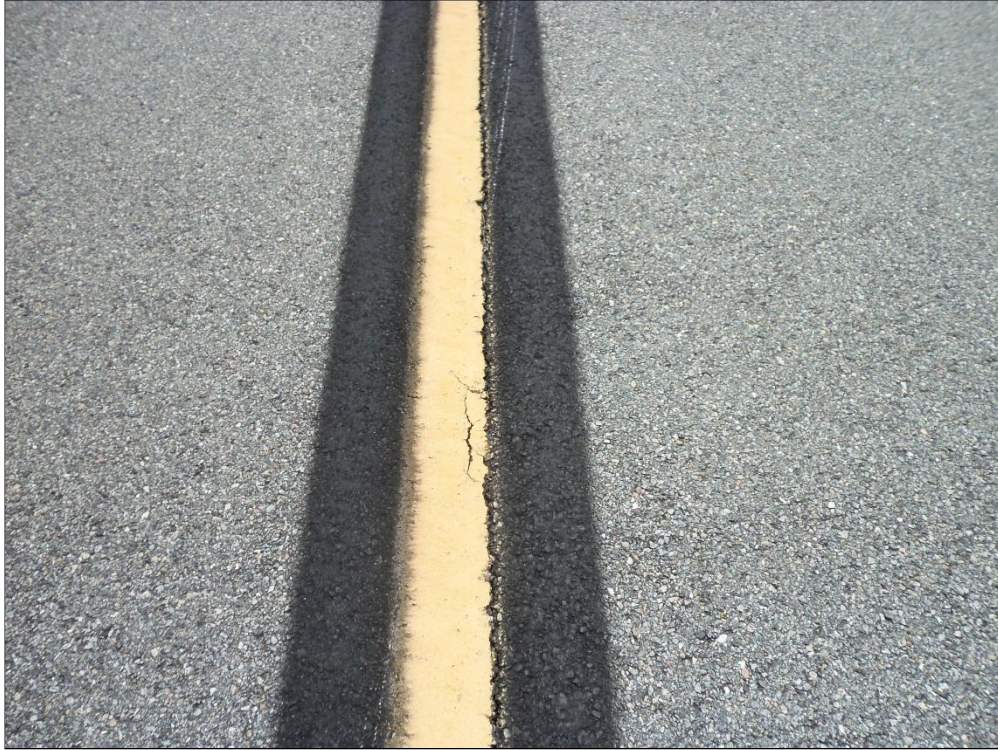
Taxiway C, Section 205, Sample Unit 119 – Low Severity (52) Raveling, Medium Severity (48) Longitudinal and Transverse Cracking, Low Severity (57) Weathering

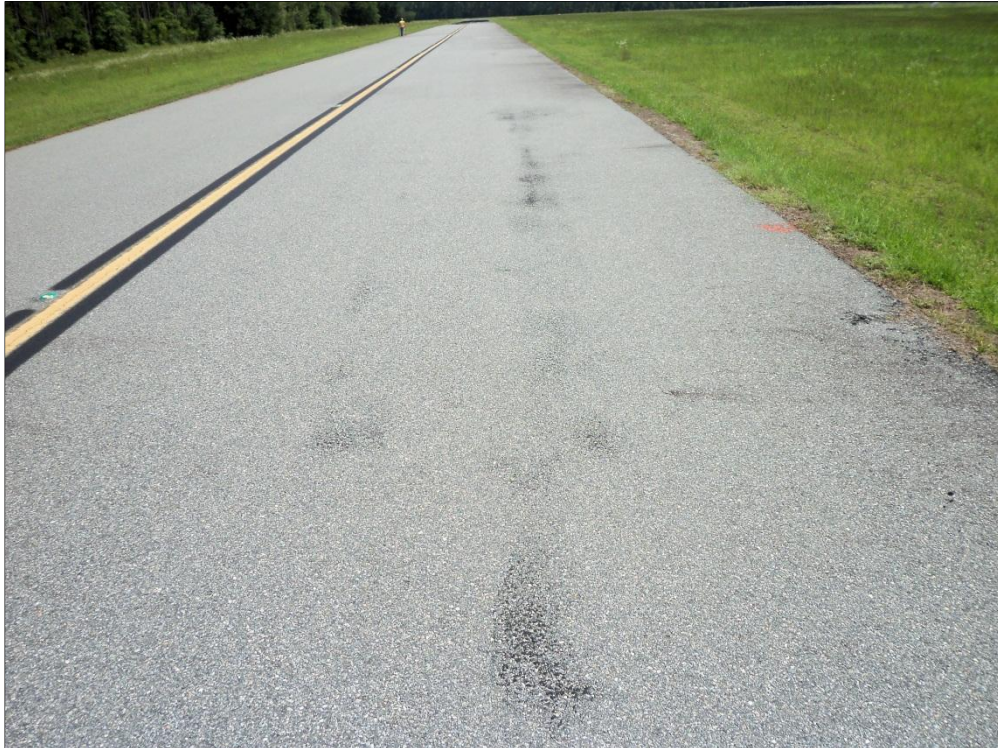
Taxiway B, Section 105, Sample Unit 120 – Low Severity (52) Raveling, (42) Bleeding, Low Severity (57) Weathering

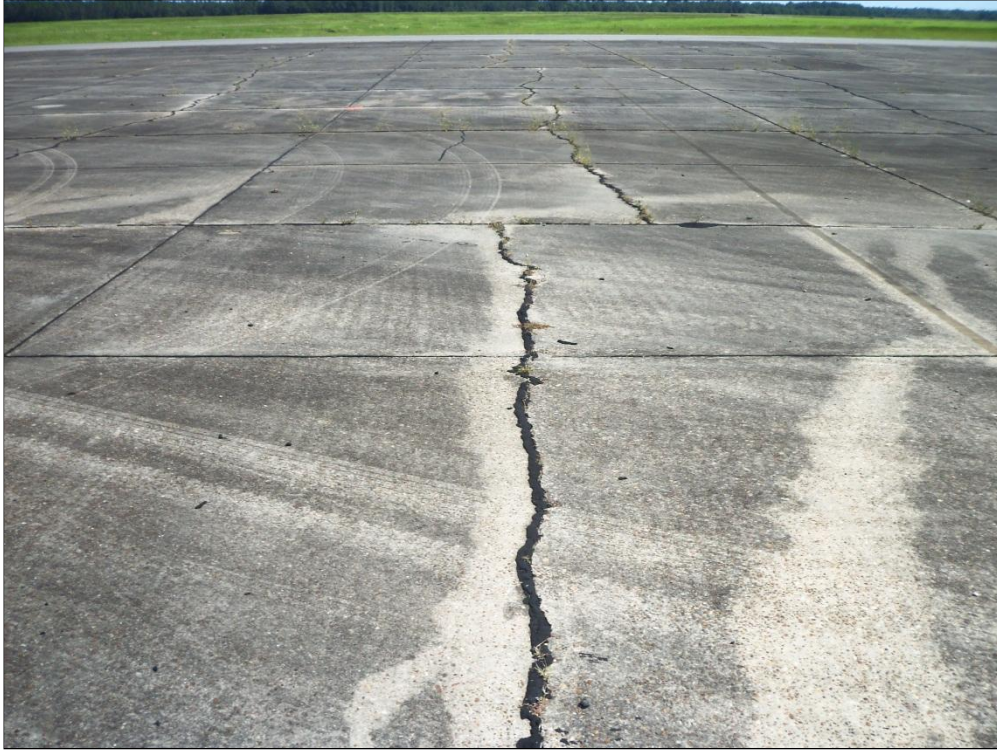
Apron, Section 4105, Sample Unit 301 - Low and Medium Severity (63) Longitudinal, Transverse and Diagonal Cracking, Medium Severity (65) Joint Seal Damage

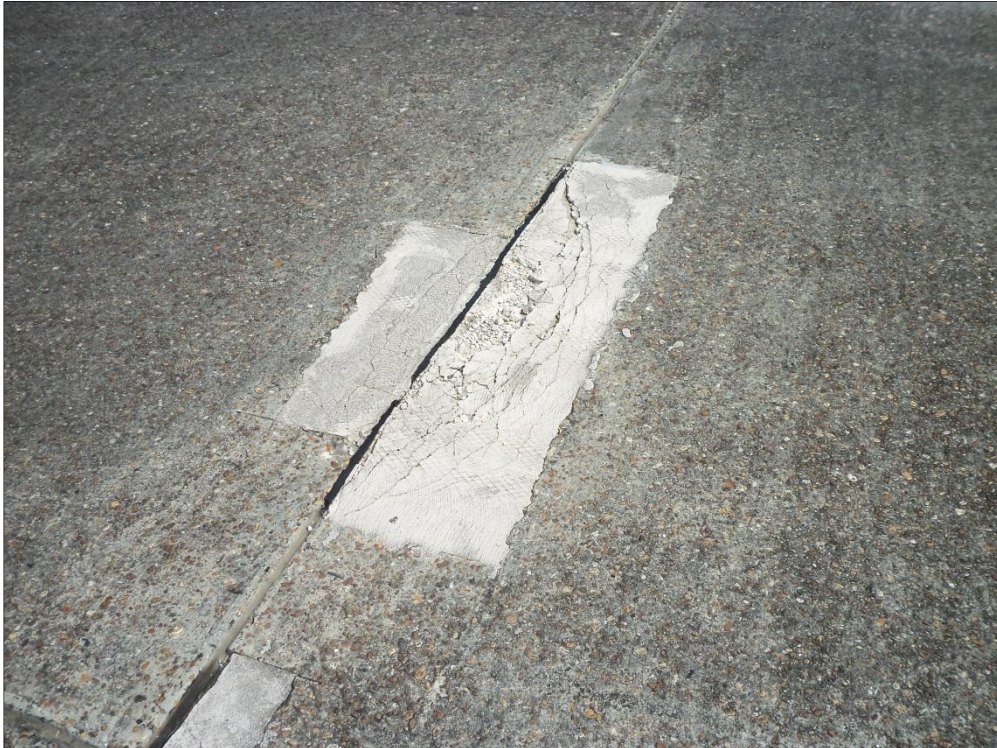
Apron, Section 4105, Sample Unit 205 - High Severity (50) Patching
