FLORIDA DEPARTMENT OF TRANSPORTATION
AVIATION AND SPACEPORT OFFICE

KEYSTONE
AIRPARK (42J)

DECEMBER 2013

STATEWIDE Airfield Pavement Management PROGRAM

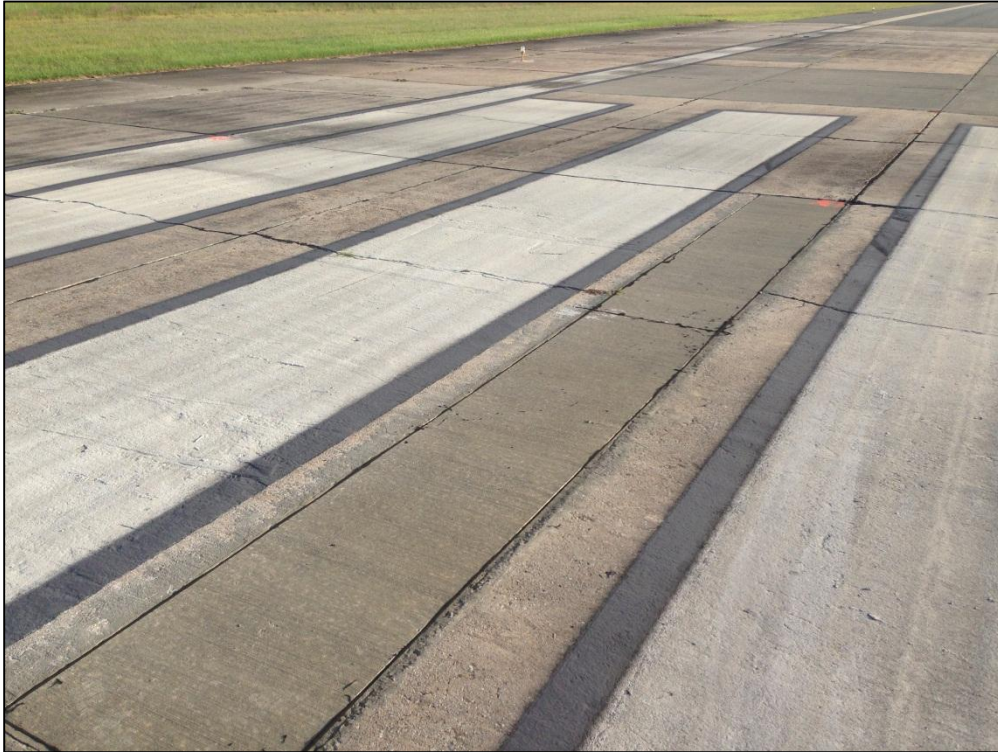
Runway 5-23, Section 6110, Sample Unit 96 – Medium Severity (65) Joint Seal Damage, Low Severity (63) Longitudinal, Transverse, and Diagonal Cracking, Low Severity (67) Large Patching

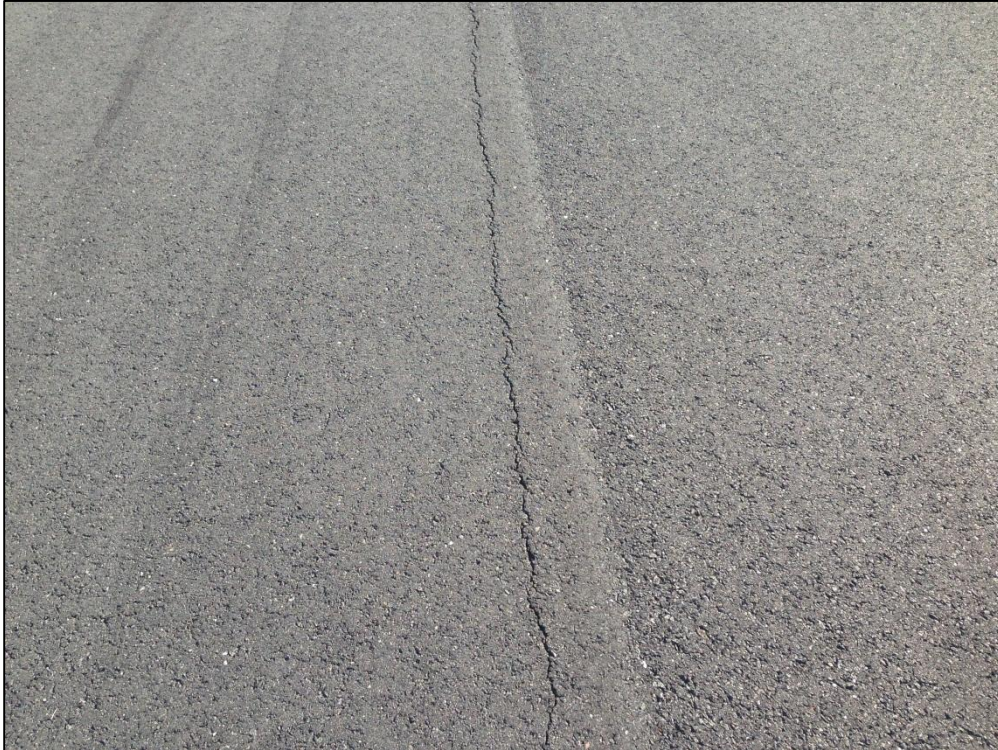
Runway 5-23, Section 6115, Sample Unit 307 – Low Severity (48) Longitudinal and Transverse Cracking

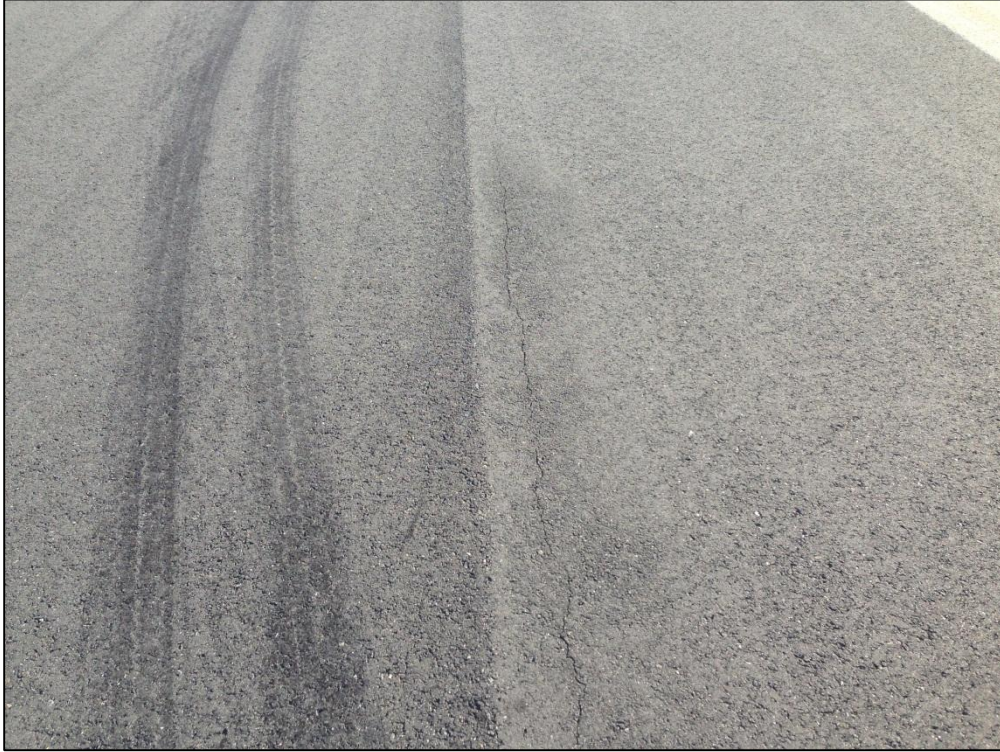
Runway 5-23, Section 6120, Sample Unit 504 – Low Severity (48) Longitudinal and Transverse Cracking

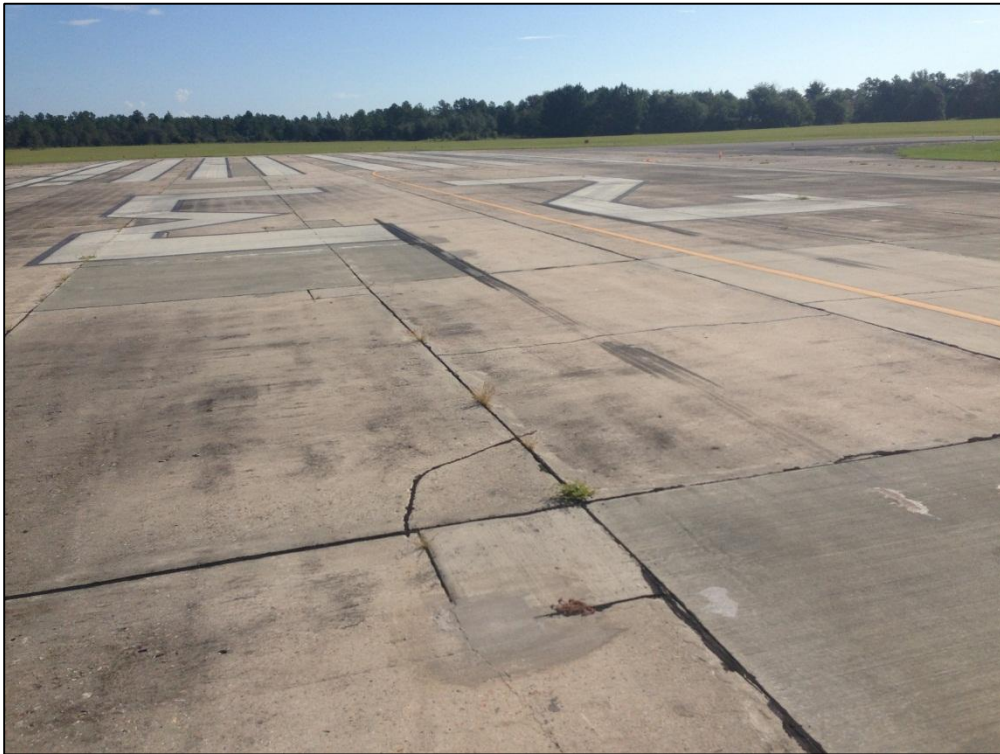
Runway 5-23, Section 6130, Sample Unit 344 – Medium Severity (65) Joint Seal Damage, Low Severity (63) Longitudinal, Transverse, and Diagonal Cracking, Low Severity (66) Small Patching, Low Severity (67) Large Patching, Low Severity (62) Corner Break, (73) Shrinkage Cracking

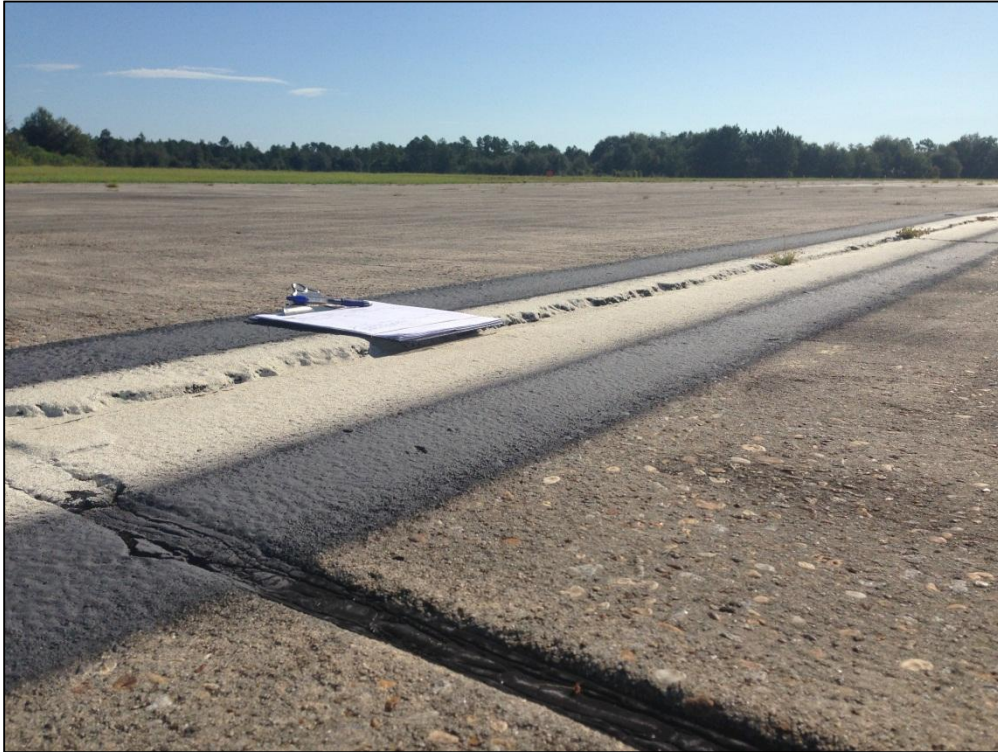
Runway 11-29, Section 6205, Sample Unit 195 – Medium Severity (65) Joint Seal Damage, Medium Severity (71) Faulting

- ⦿ Runway 11-29 – Sections 6220 and 6205
 - PCC Restoration attributed to distresses related to loading and construction quality.
- ⦿ Runway 11-29 – Section 6215
 - Mill and Overlay attributed to distresses related to climate and age of pavement.
- ⦿ Runway 5-23 – Sections 6135, 6130, 6110, and 6105
 - Mill and Overlay attributed to distresses related to loading and construction quality.
- ⦿ Apron T-Hangars – Section 4520
 - Reconstruction attributed to distresses related to subgrade quality, climate, and age of pavement.
- ⦿ Apron T-Hangars – Section 4515
 - Mill and Overlay attributed to distresses related to climate and age of pavement.
- ⦿ Apron T-Hangars – Section 4505
 - Reconstruction attributed to distresses related to overloading.

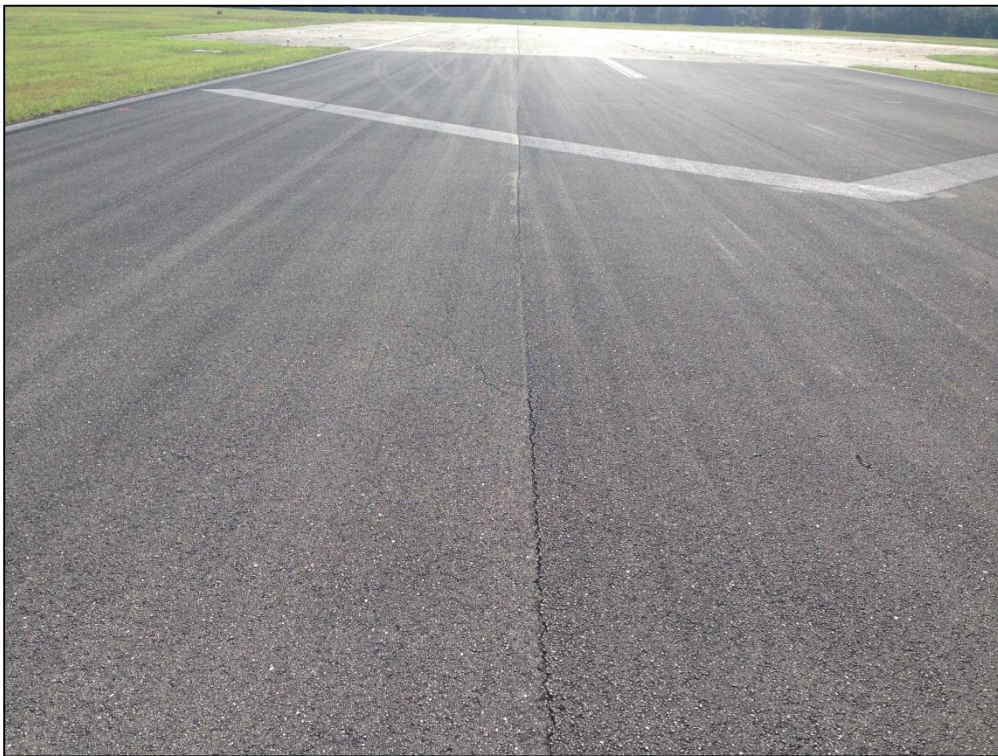
Runway 11-29, Section 6215, Sample Unit 192 – Low Severity (48) Longitudinal and Transverse Cracking, Low Severity (52) Raveling, Low Severity (57) Weathering

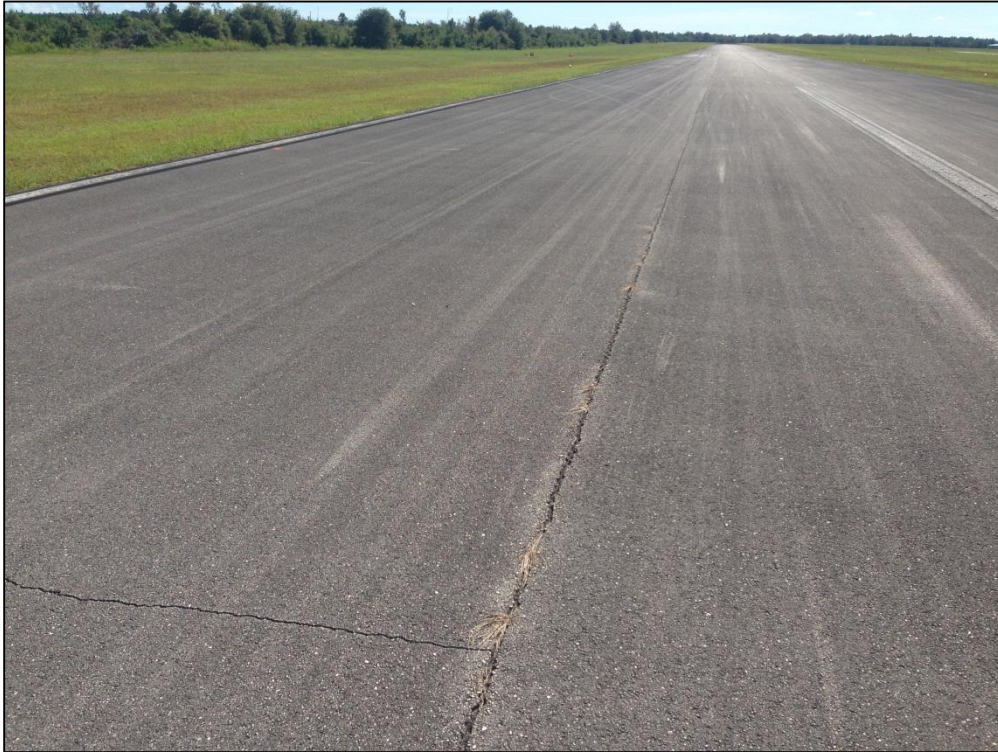
Runway 11-29, Section 6215, Sample Unit 111 – Low and Medium Severity (48) Longitudinal and Transverse Cracking, Low Severity (52) Raveling, Low Severity (57) Weathering

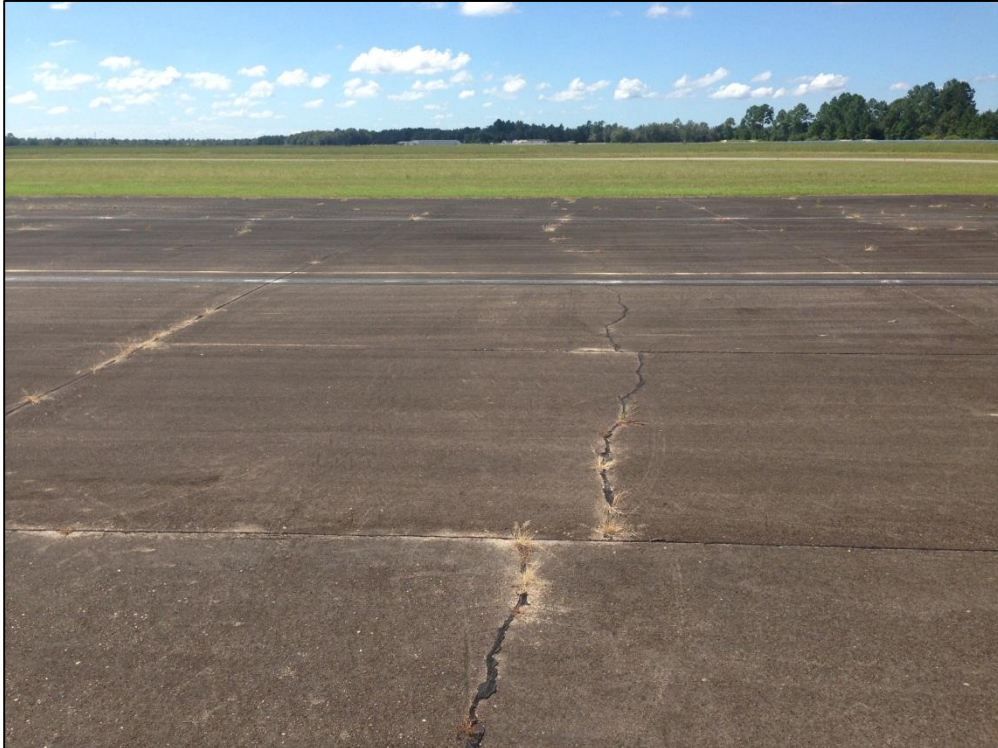
Runway 11-29, Section 6220, Sample Unit 103 – Medium Severity (65) Joint Seal Damage, Low Severity (63) Longitudinal, Transverse, and Diagonal Cracking

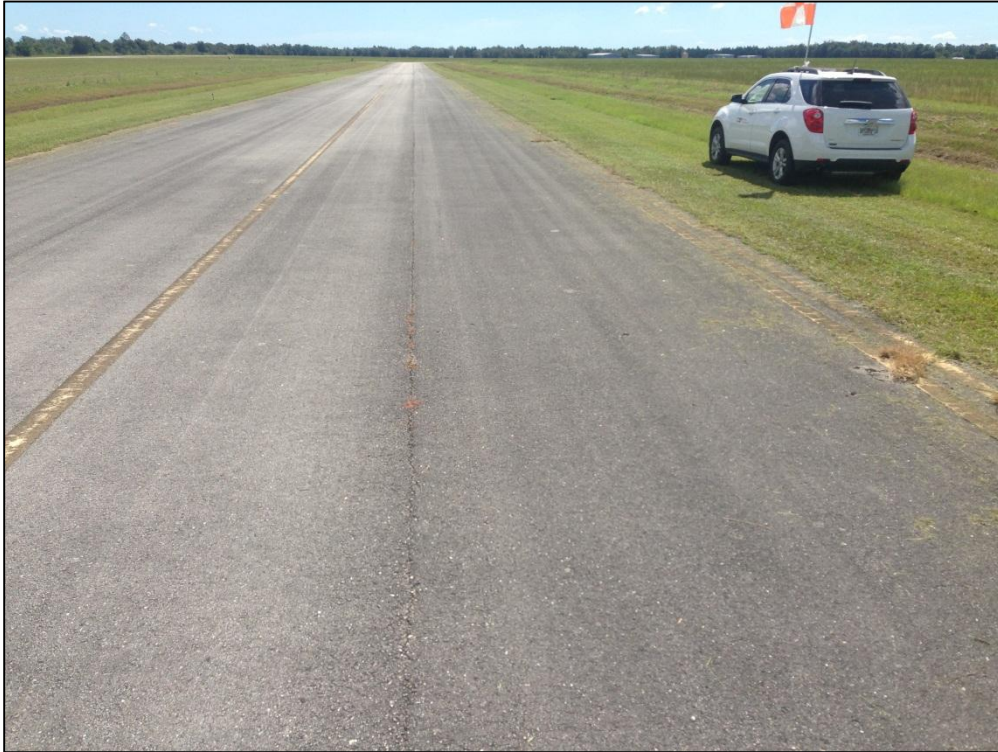
Taxiway C, Section 305, Sample Unit 132 – Low Severity (48) Longitudinal and Transverse Cracking, Low Severity (52) Raveling, Low Severity (57) Weathering

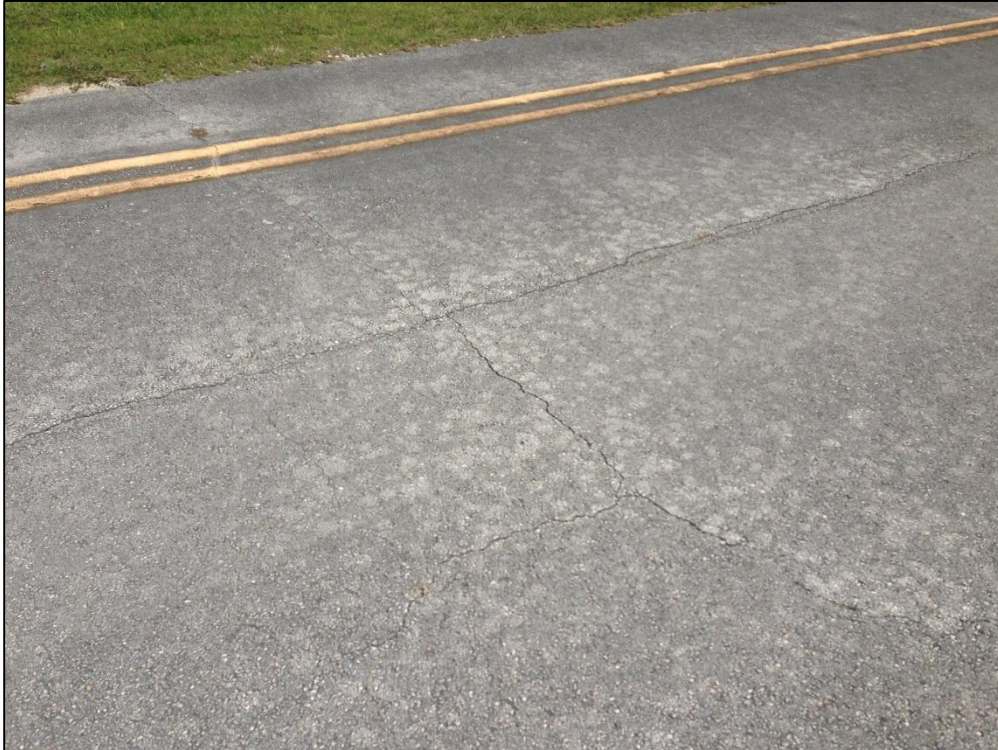
Taxiway B, Section 205, Sample Unit 101 – Low Severity (48) Longitudinal and Transverse Cracking, Low Severity (52) Raveling, Low Severity (57) Weathering

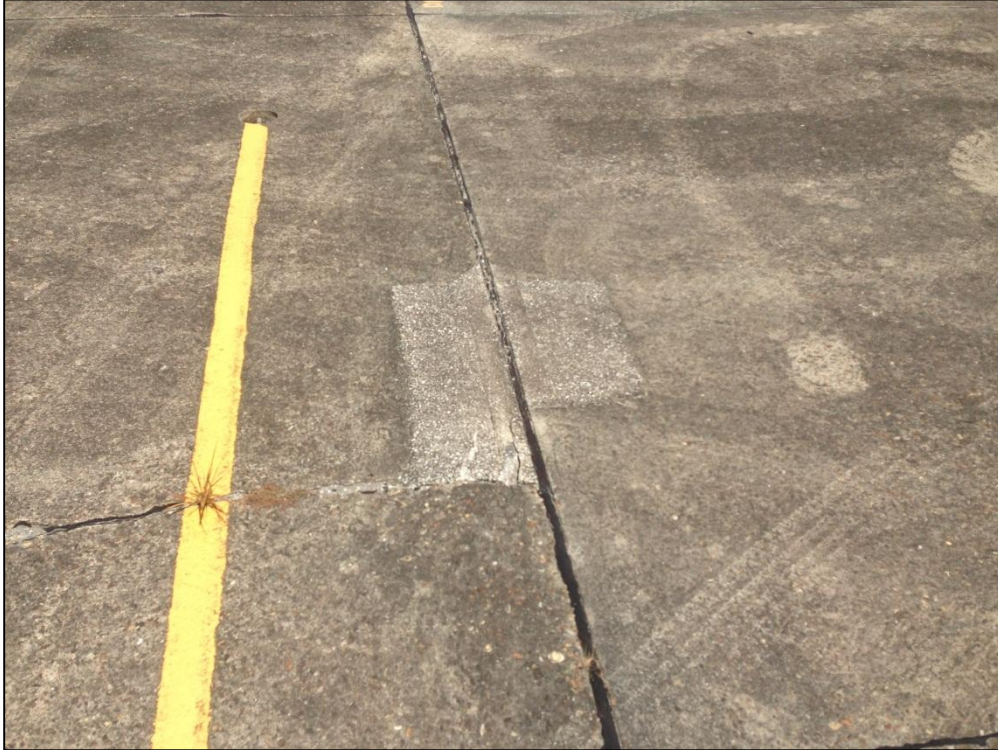
Apron, Section 4105, Sample Unit 500 – Medium Severity (65) Joint Seal Damage, Low Severity (63) Longitudinal, Transverse, and Diagonal Cracking, Low and Medium Severity (66) Small Patching

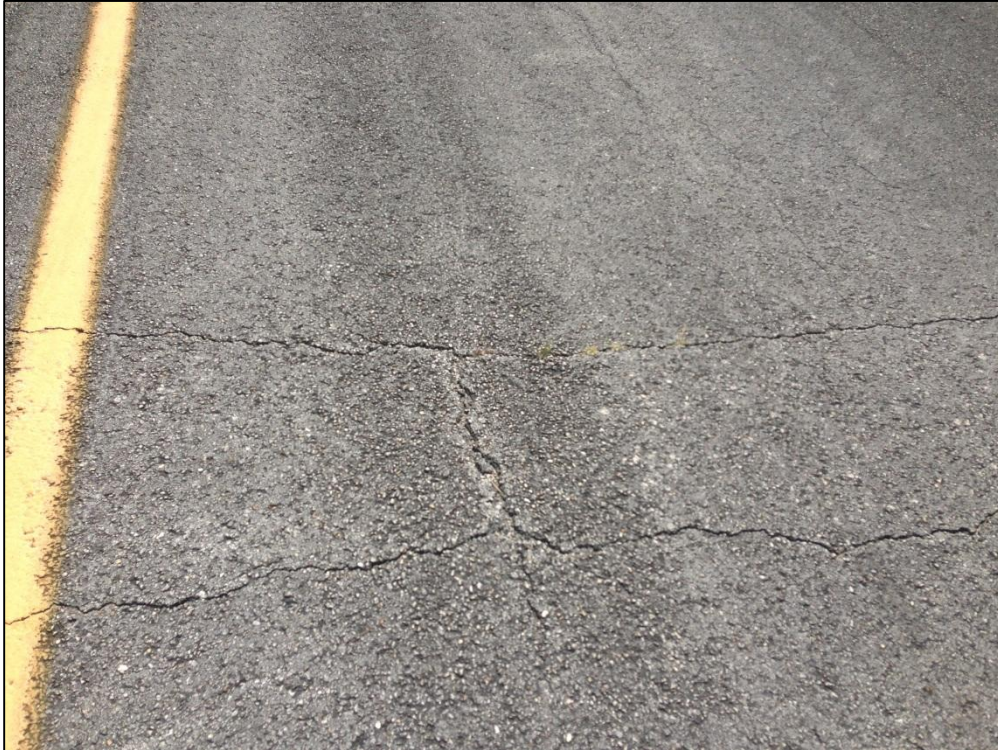
Taxiway A, Section 105, Sample Unit 153 – Low and Medium Severity (48) Longitudinal and Transverse Cracking, Low Severity (52) Raveling, Low Severity (57) Weathering

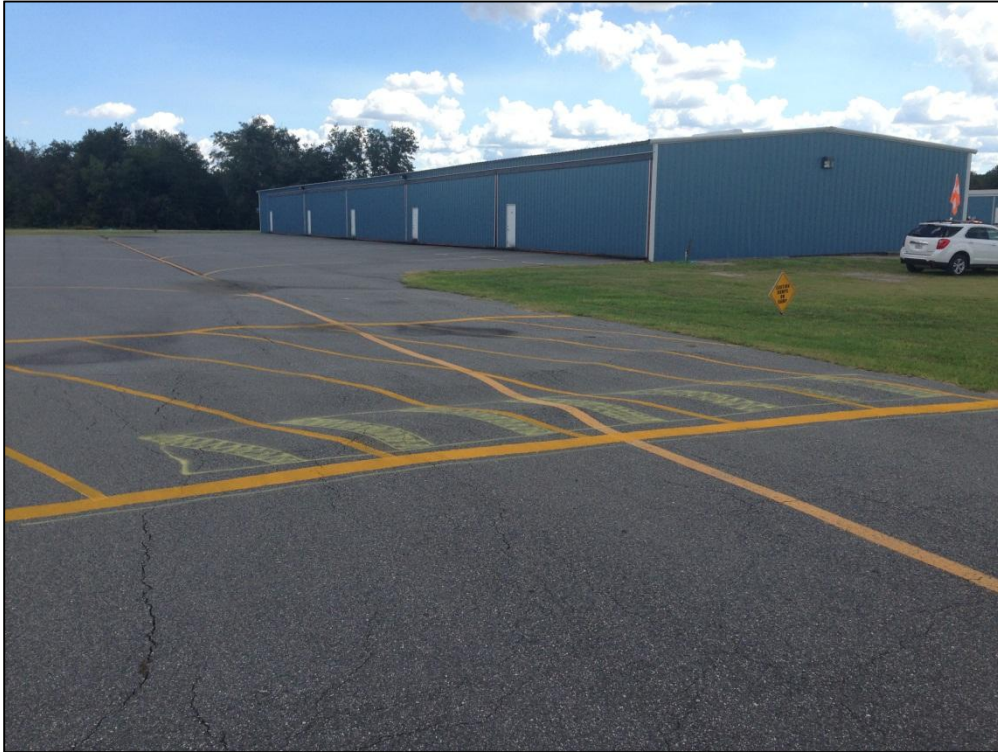
Apron T-Hang, Section 4520, Sample Unit 100 – Low Severity (48) Longitudinal and Transverse Cracking, Low Severity (57) Weathering, High Severity (56) Swelling

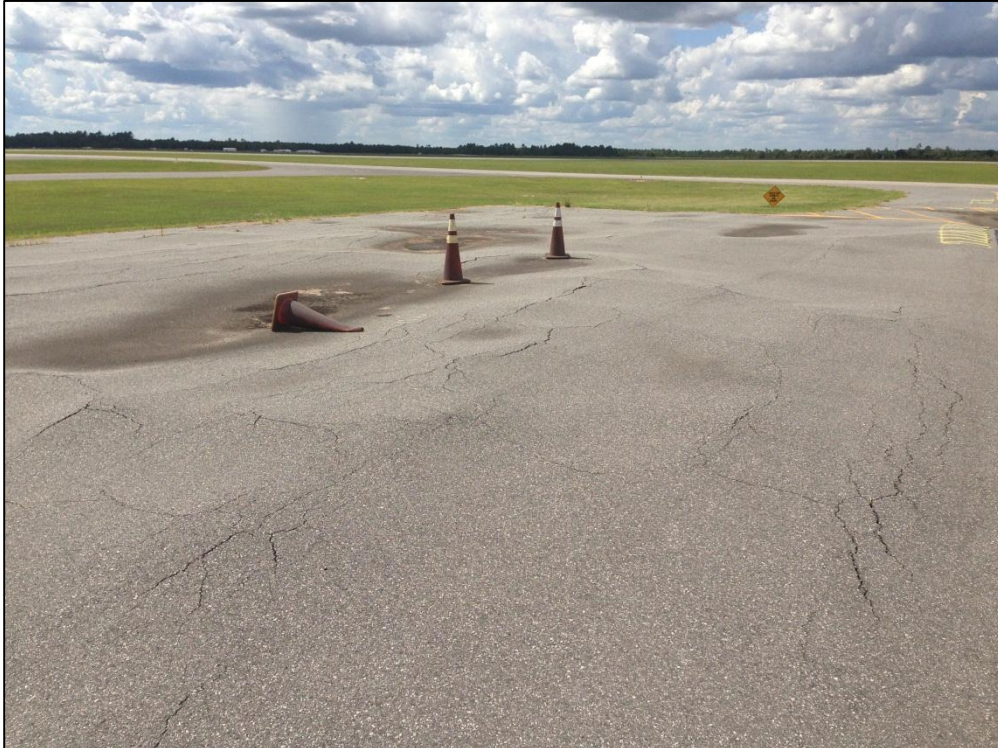
Apron T-Hang, Section 4520, Sample Unit 402 – Low Severity (48) Longitudinal and Transverse Cracking, Low Severity (57) Weathering, High Severity (56) Swelling

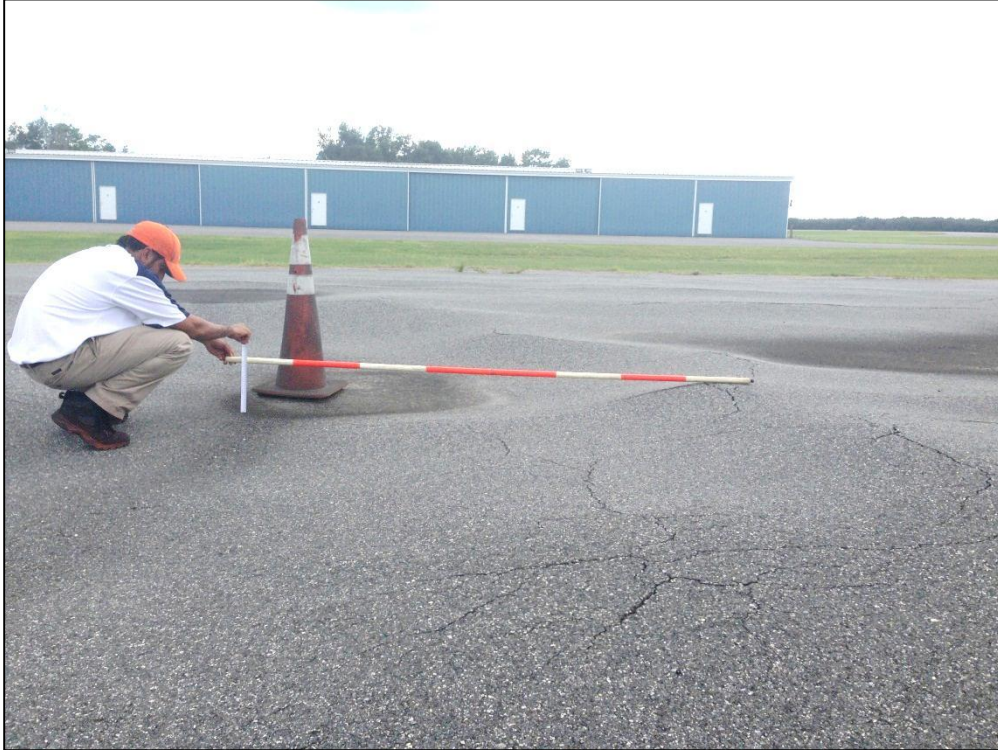
Apron T-Hang, Section 4520, Sample Unit 402 – Low Severity (48) Longitudinal and Transverse Cracking, Low Severity (57) Weathering, High Severity (56) Swelling

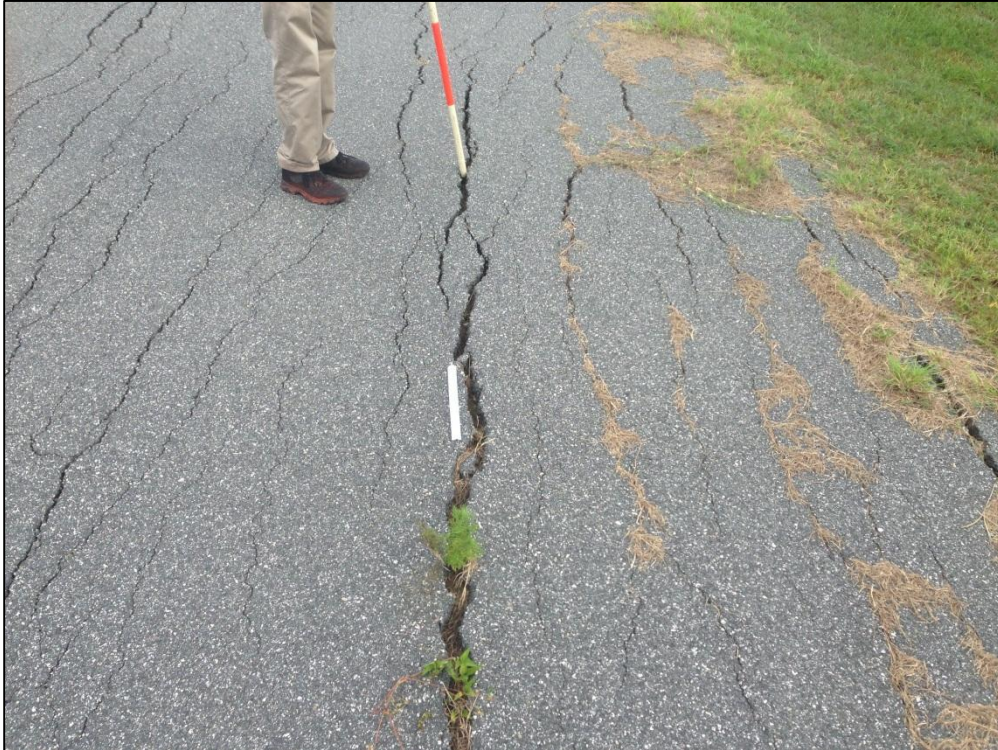
Apron T-Hang, Section 4520, Sample Unit 402 – Low and High Severity (48) Longitudinal and Transverse Cracking, Low Severity (57) Weathering, High Severity (56) Swelling
