APALACHICOLA
REGIONAL
AIRPORT (AAF)

DECEMBER 2013

STATEWIDE Airfield Pavement Management PROGRAM

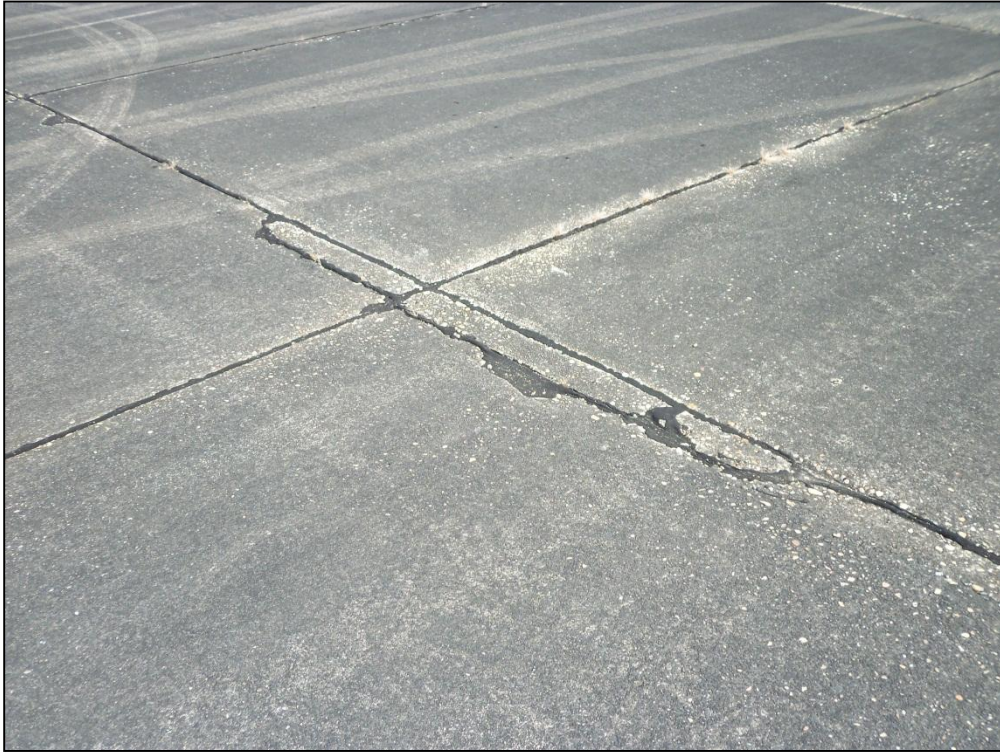
Runway 18-36, Section 6305, Sample Unit 374 – Low and Medium Severity (74) Joint Spalling, Medium Severity (65) Joint Seal Damage

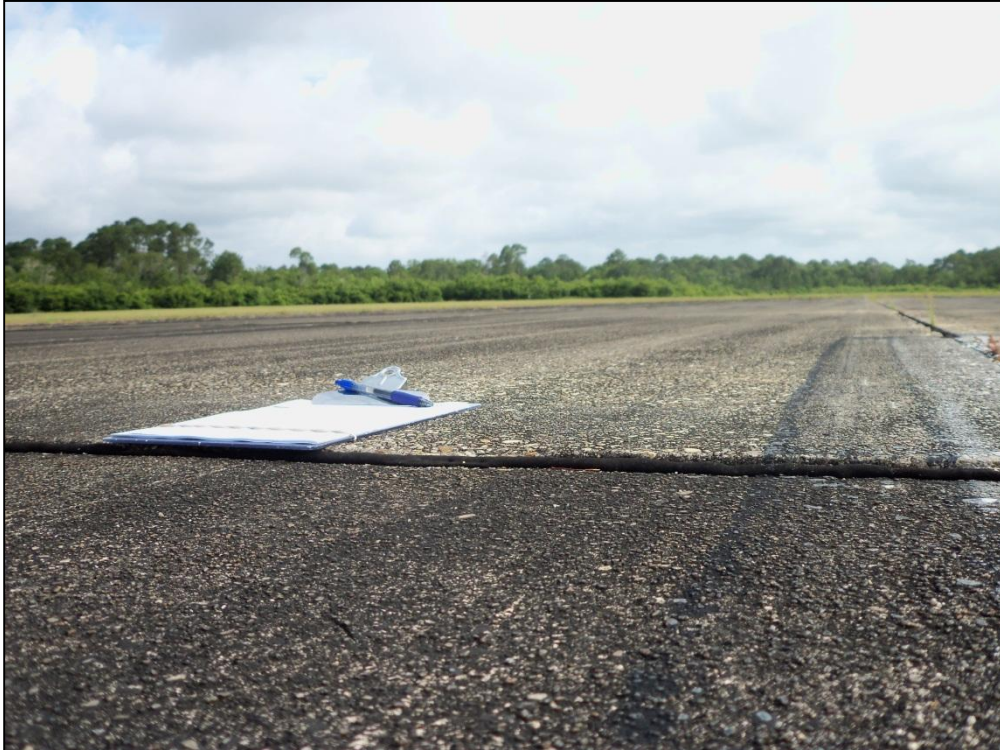
Runway 18-36, Section 6305, Sample Unit 374 –Low Severity (71) Settlement or Faulting

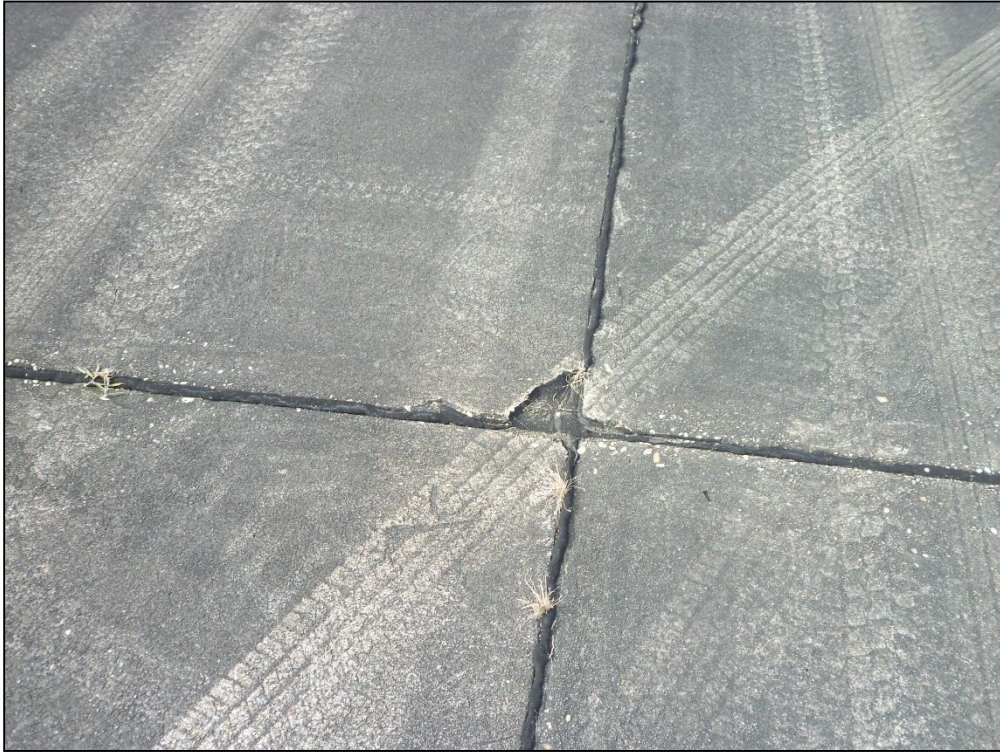
Runway 18-36, Section 6305, Sample Unit 374 –Low Severity (75) Corner Spalling, Medium Severity (65) Joint Seal Damage

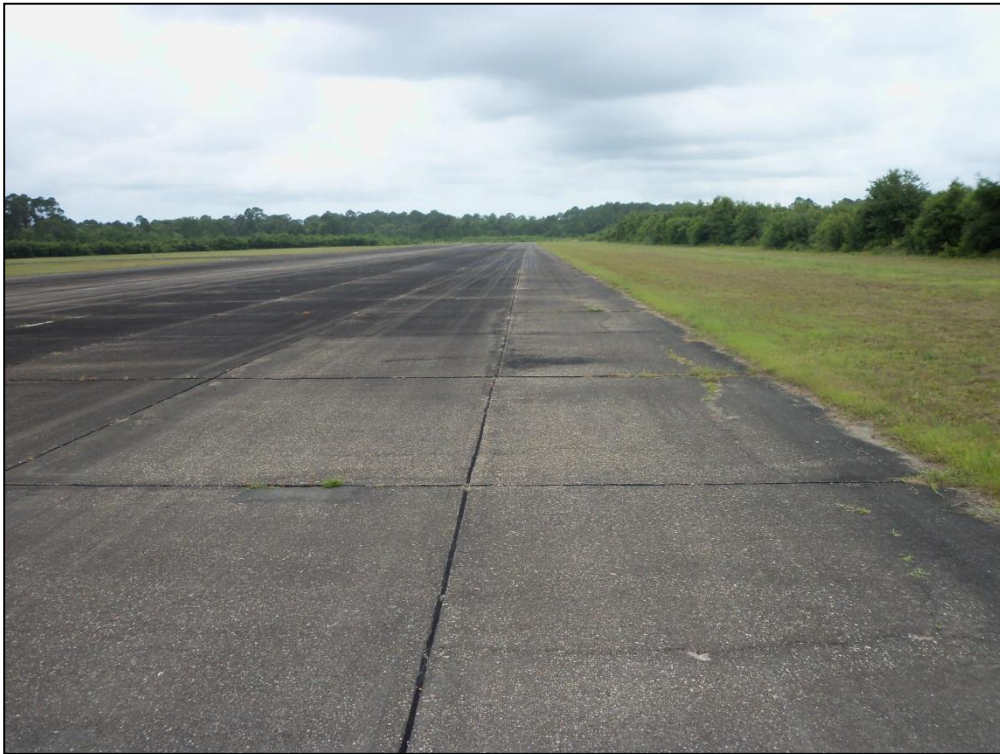
Runway 18-36, Section 6310, Sample Unit 564 –Low Severity (66) Small Patching, Medium Severity (65) Joint Seal Damage, Low Severity (63) Longitudinal, Transverse and Diagonal Cracking, Shrinkage Cracks (73)

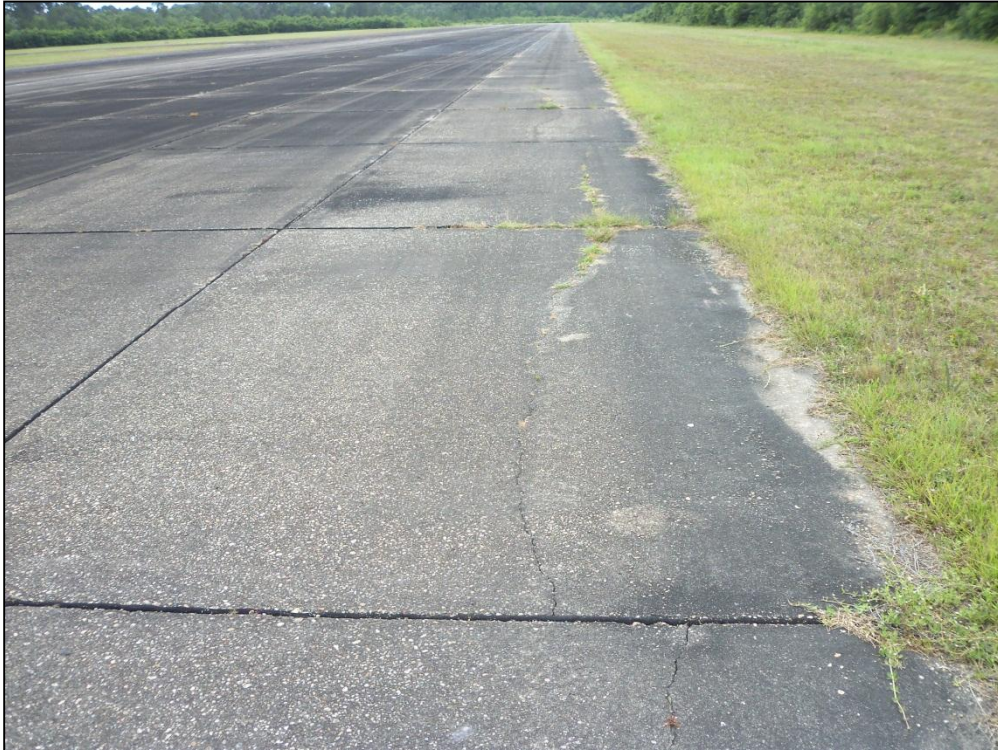
Runway 18-36, Section 6310, Sample Unit 564 – Medium Severity (65) Joint Seal Damage, Low Severity (63) Longitudinal, Transverse and Diagonal Cracking

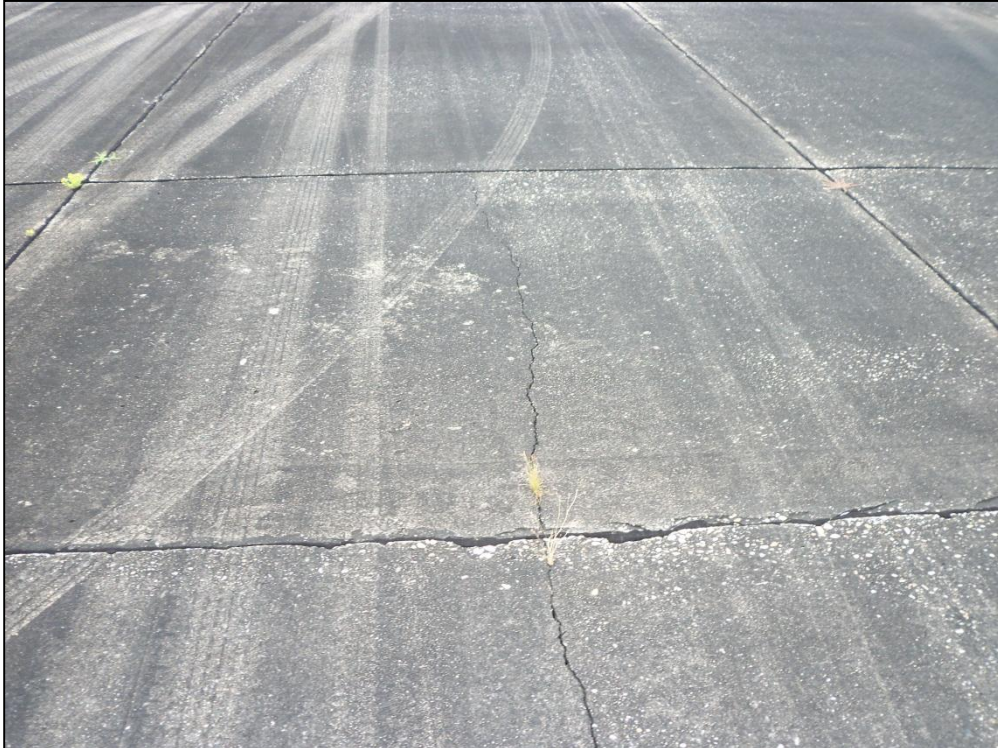
Runway 18-36, Section 6305, Sample Unit 350 – Medium Severity (74) Joint Spalling, Medium Severity (65) Joint Seal Damage, Low Severity (63) Longitudinal, Transverse and Diagonal Cracking

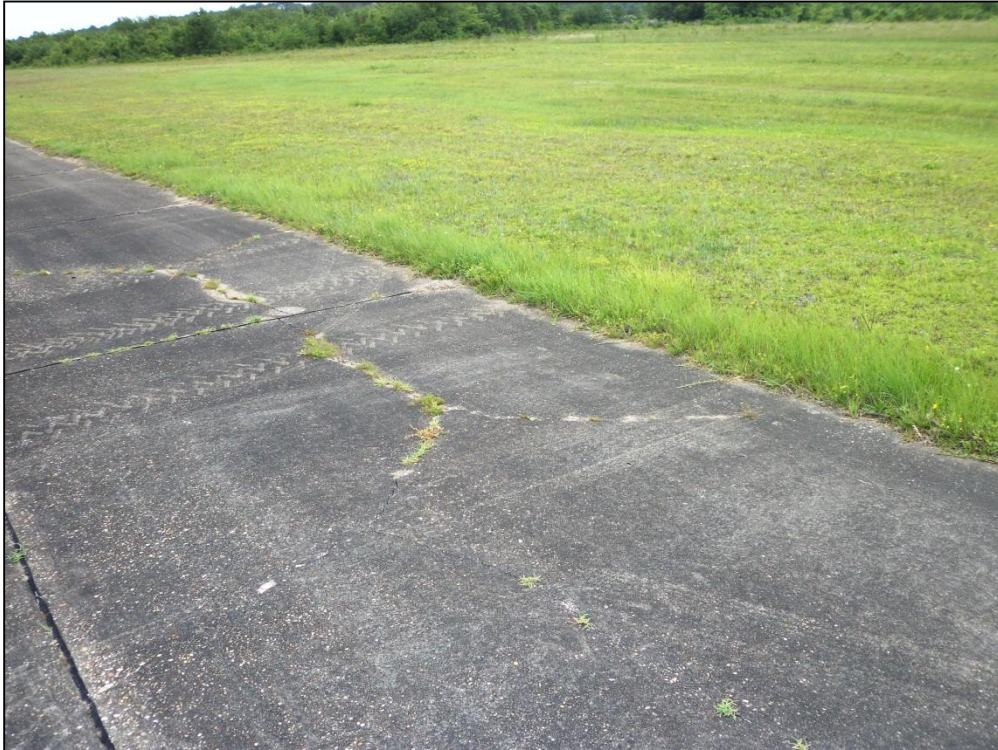
Runway 16-36, Section 6310, Sample Unit 544 – Medium Severity (65) Joint Seal Damage, Low Severity (72) Shattered Slab

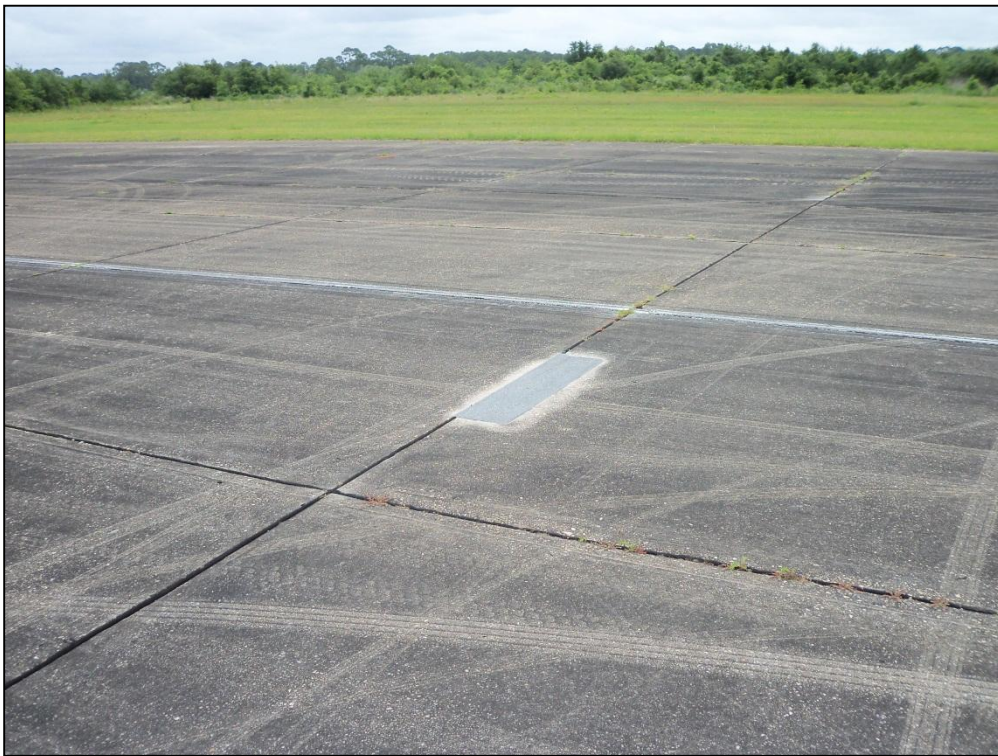
Runway 18-36, Section 6305, Sample Unit 344 – Medium Severity (65) Joint Seal Damage, Low Severity (66) Small Patching

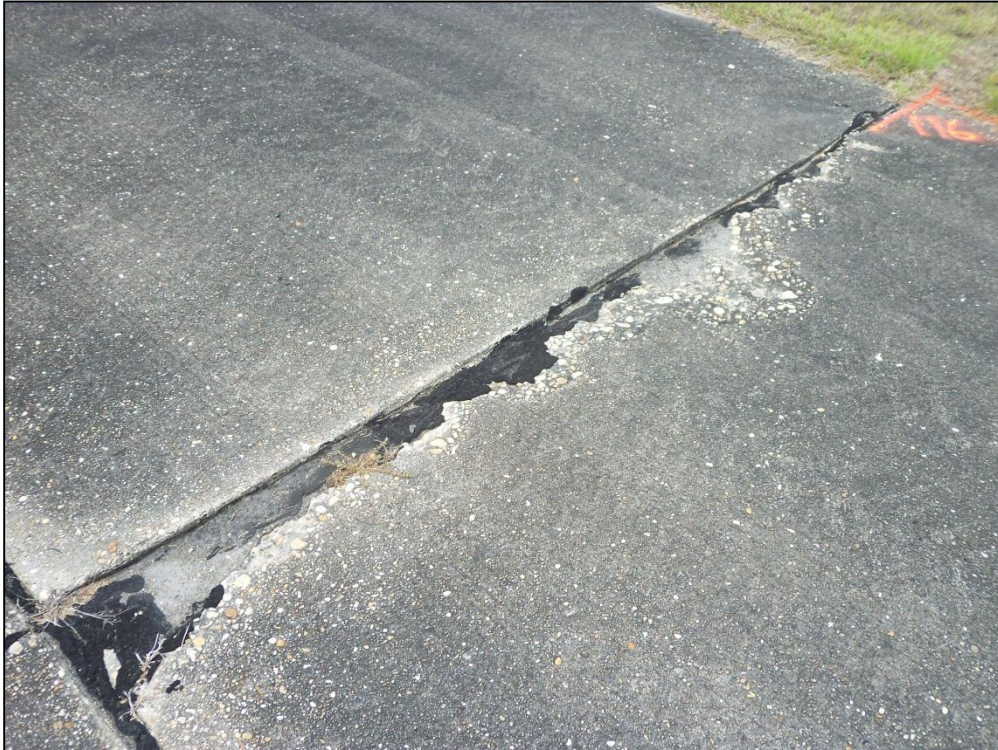
Runway 16-36, Section 6310, Sample Unit 116 – High Severity (74) Joint Spalling, Medium Severity (65) Joint Seal Damage

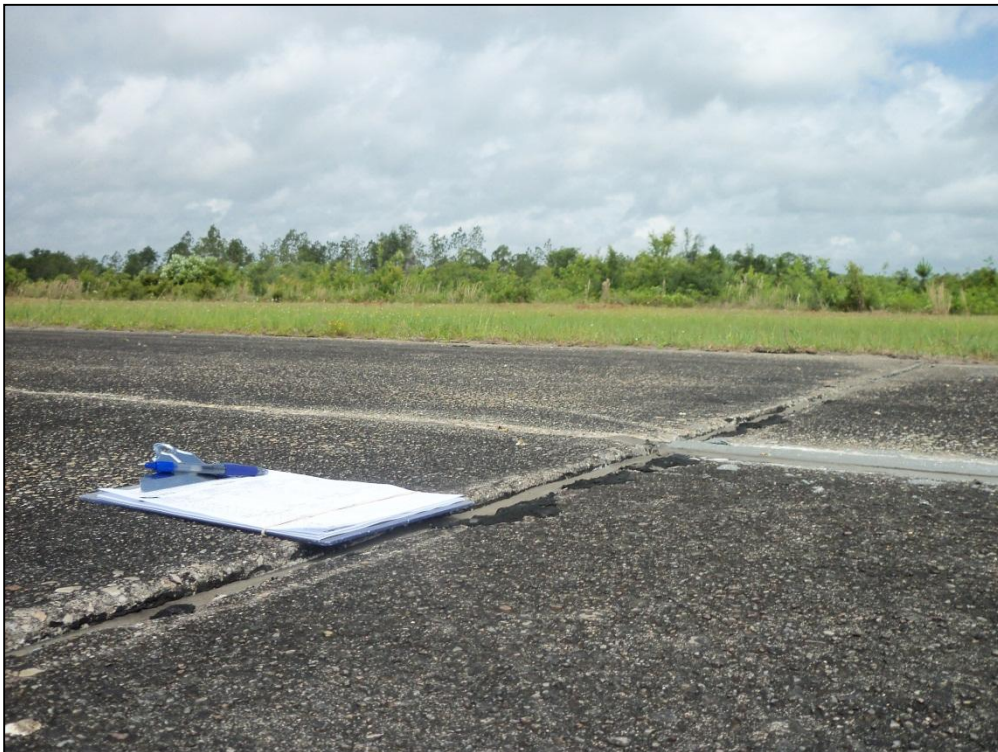
Runway 6-24, Section 6210, Sample Unit 108 – Low Severity (71) Settlement of Faulting, Low Severity (74) Joint Spalling

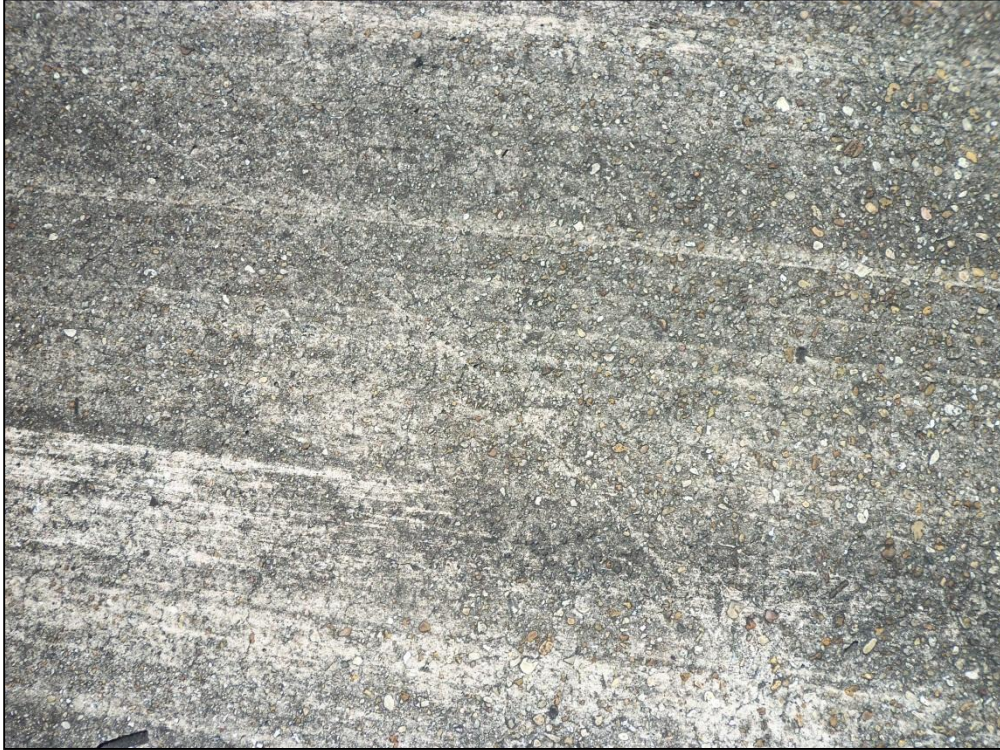
Runway 6-24, Section 6205, Sample Unit 312 – Low Severity (70) Scaling, Map Cracking, Crazing

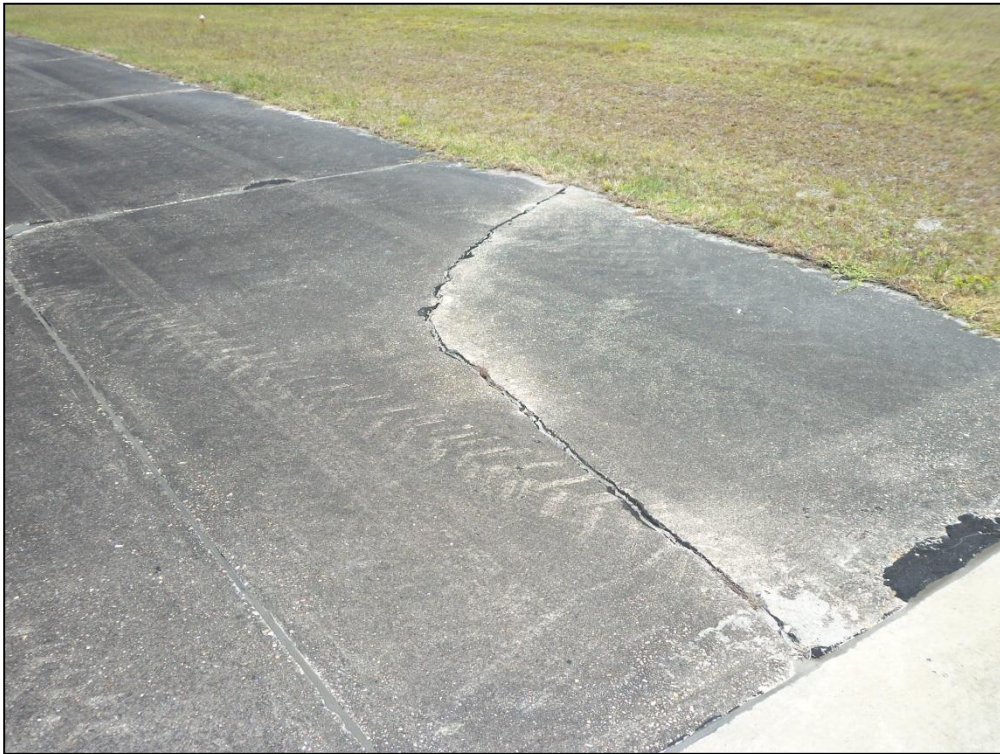
Runway 6-24, Section 6210, Sample Unit 540 – Low Severity (74) Joint Spalling, Medium Severity (63) Longitudinal, Transverse, and Diagonal Cracking

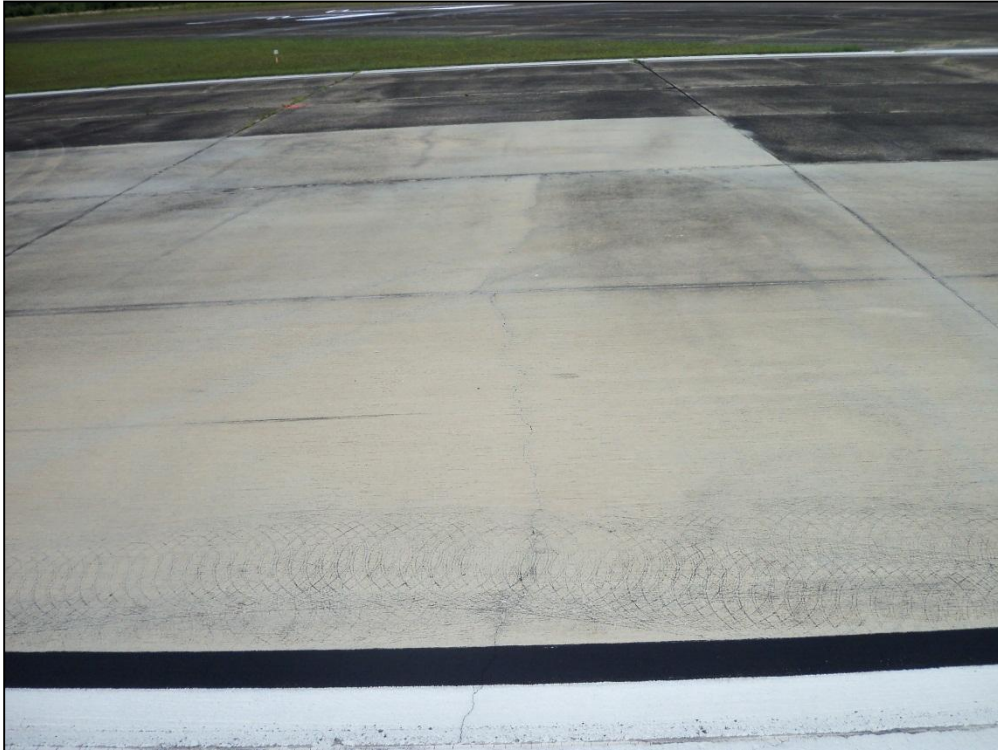
Runway 14-32, Section 6105, Sample Unit 301 – Low Severity (63) Longitudinal, Transverse, and Diagonal Cracking

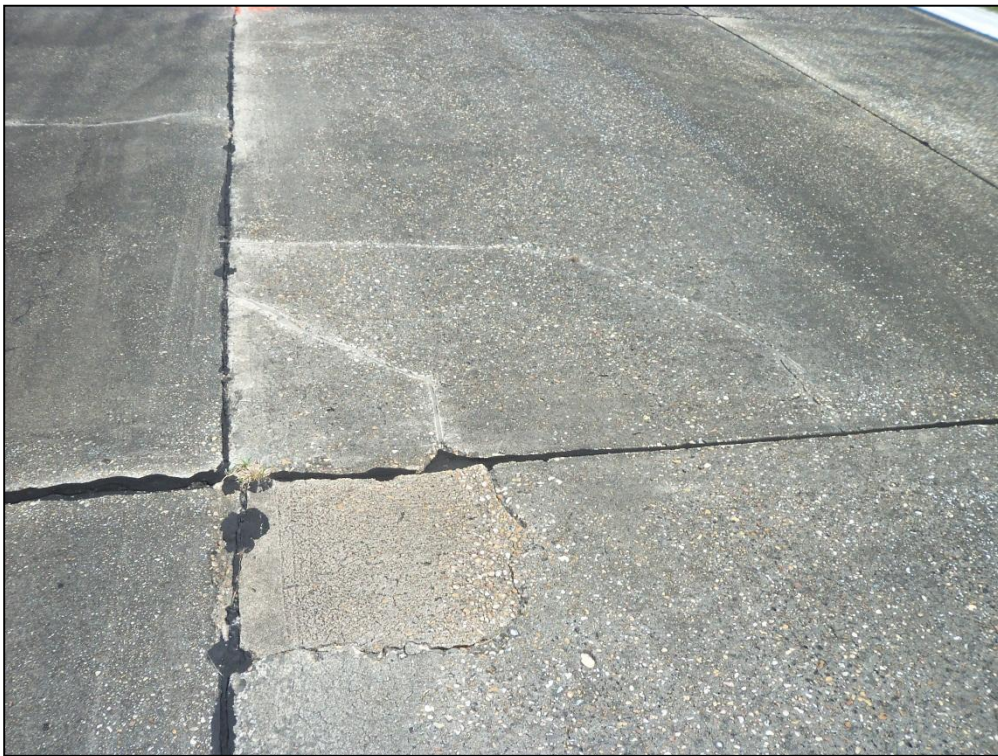
Runway 14-32, Section 6110, Sample Unit 504 –Low Severity (63) Longitudinal, Transverse, and Diagonal Cracking, Low Severity (62) Corner Break, Low Severity (70) Scaling, Map Cracking, and Cracking, Medium Severity (66) Small Patching, Medium Severity (65) Joint Seal Damage

- Runway 18-36 – Section 6310
 - PCC Restoration attributed to distresses related to structural, climate and age of pavement.
- Runway 14-32 – Section 6110
 - PCC Restoration attributed to distresses related to structural, climate and age of pavement.
- Apron – Section 4105
 - PCC Restoration attributed to distresses related to structural, climate and age of pavement.
- Taxiway B4 – Section 345
 - PCC Restoration attributed to distresses related to structural, climate and age of pavement.
- Taxiway D – Section 335
 - PCC Restoration attributed to distresses related to structural, climate and age of pavement.
- Taxiway B3 – Section 325
 - PCC Restoration attributed to distresses related to structural, climate and age of pavement.

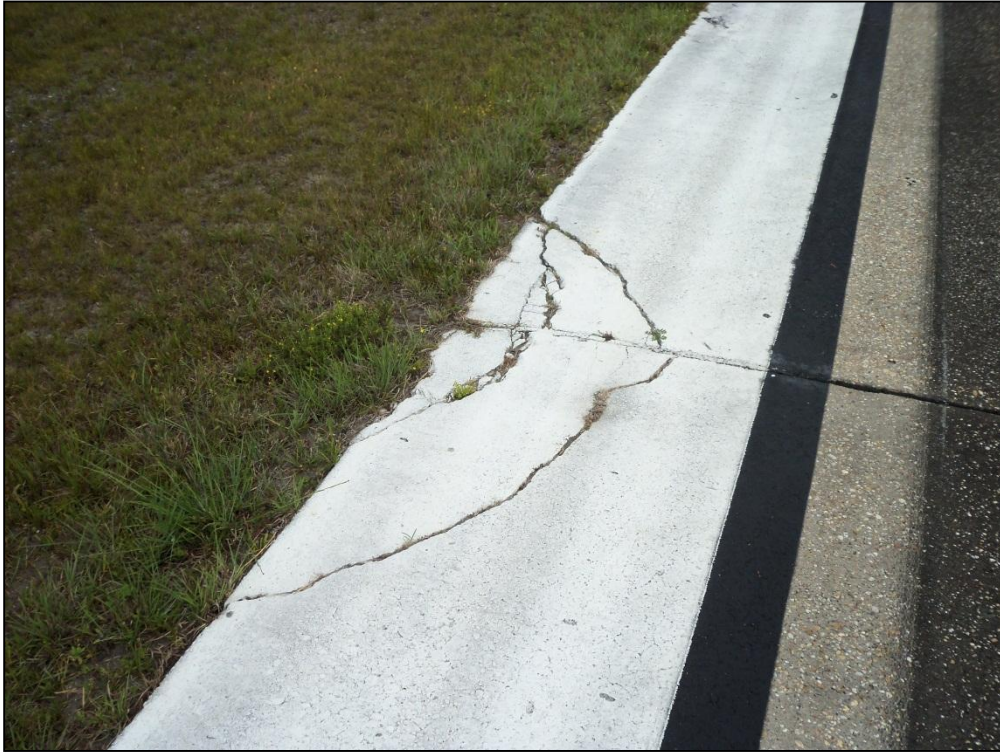
Runway 14-32, Section 6110, Sample Unit 104 -Medium Severity (62) Corner Break

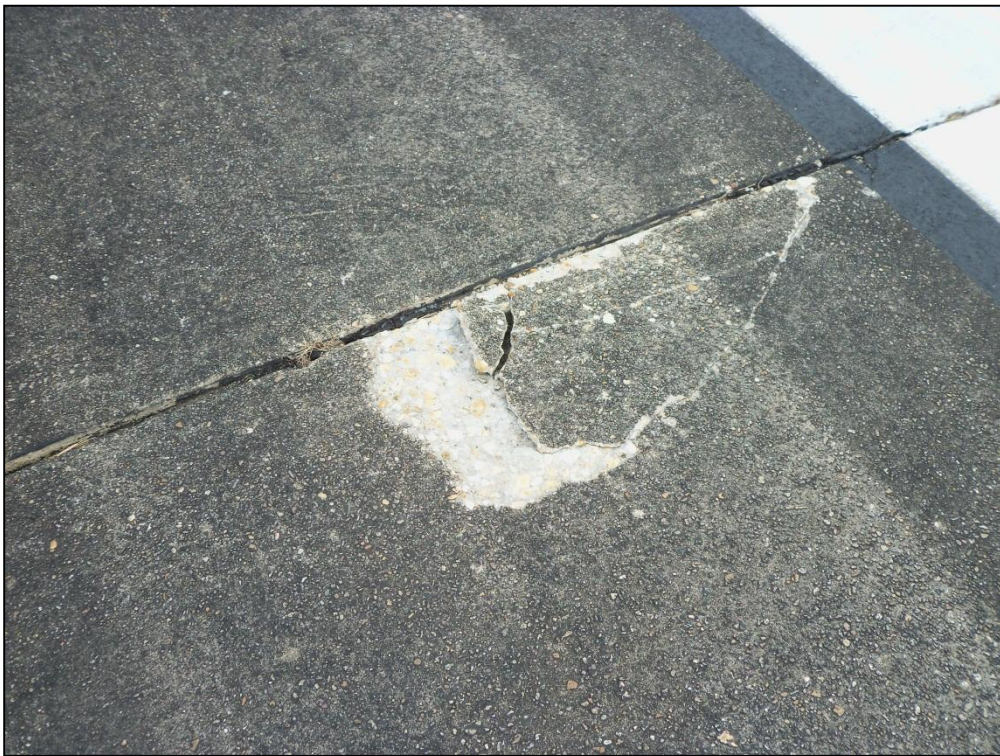
Runway 14-32, Section 6110, Sample Unit 548 -High Severity (74) Joint Spalling, Medium Severity (65) Joint Seal Damage

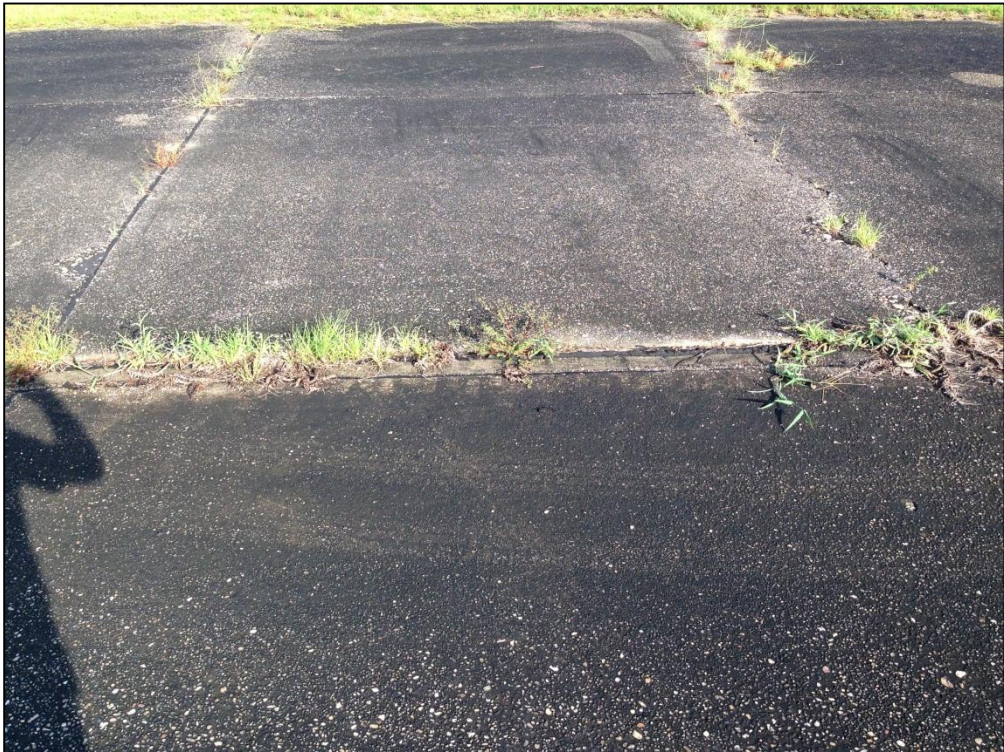
Taxiway C, Section 110, Sample Unit 206 – Medium Severity (65) Joint Seal Damage, Medium Severity (63) Longitudinal, Transverse, and Diagonal Cracking, Medium Severity (71) Faulting

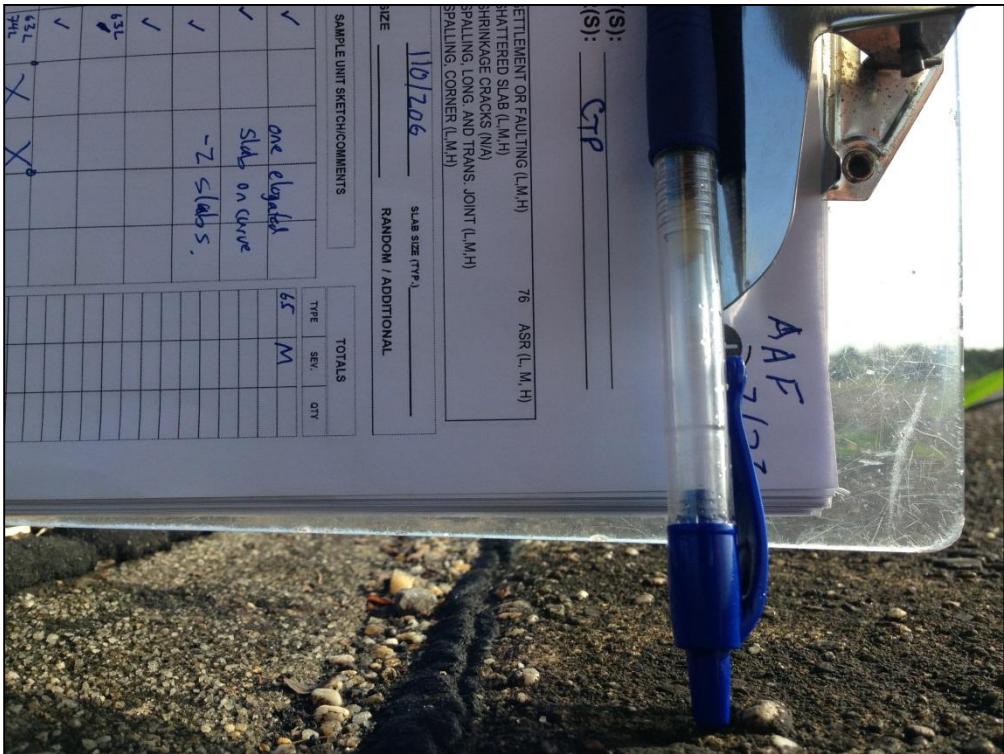
Taxiway C, Section 110, Sample Unit 206 – Medium Severity (71) Faulting

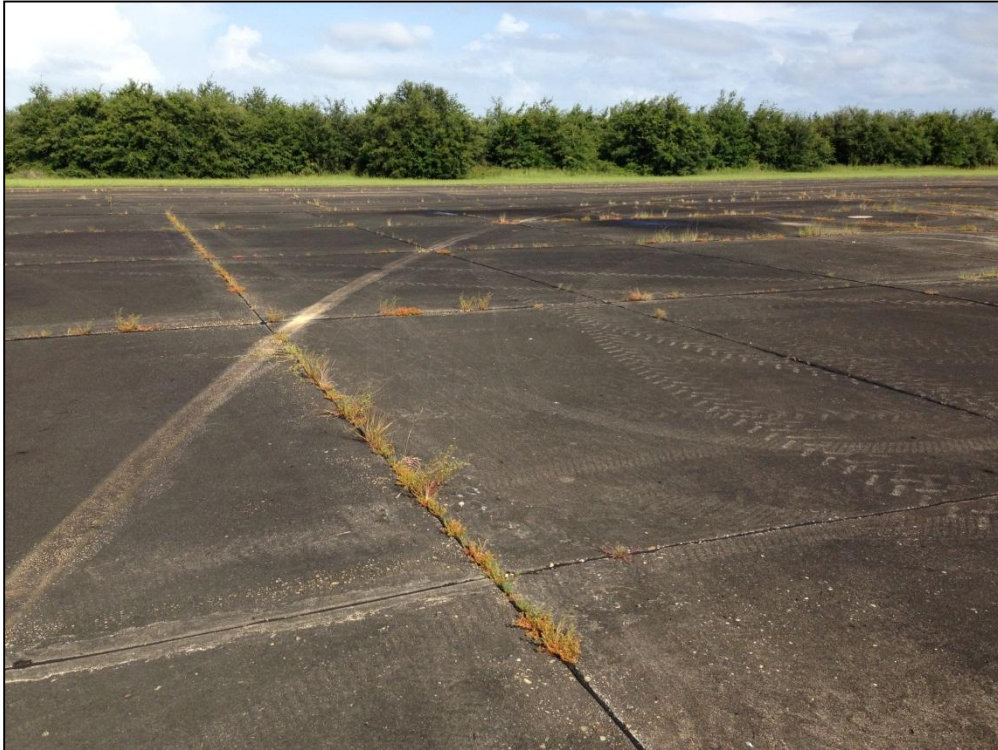
Taxiway C1, Section 160, Sample Unit 103 – Medium Severity (65) Joint Seal Damage

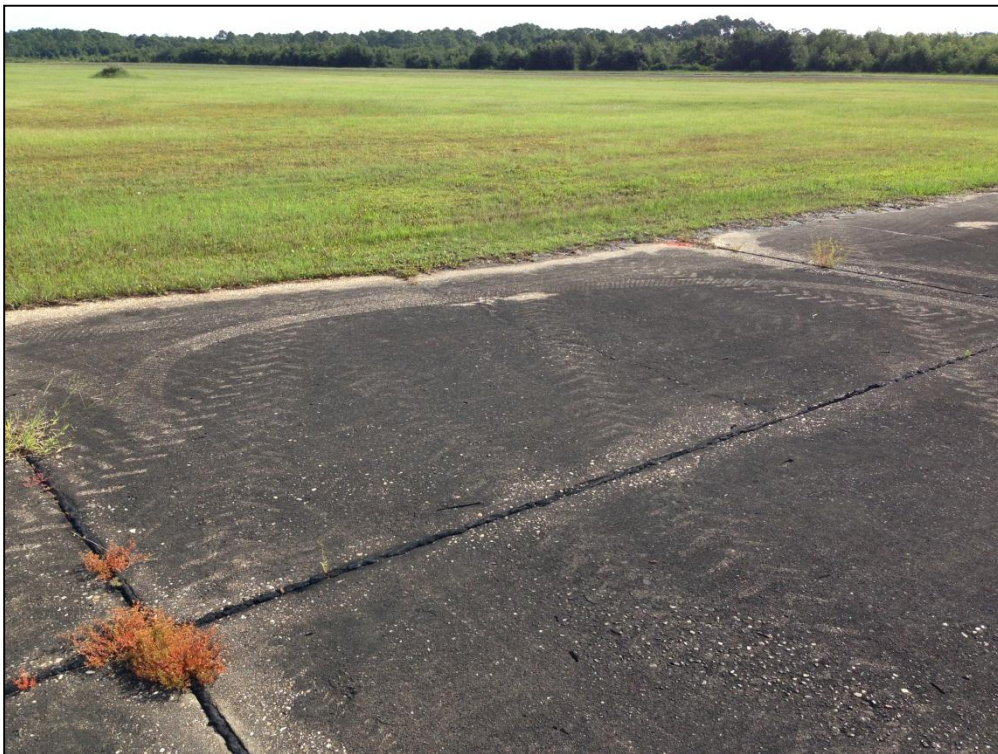
Taxiway C1, Section 160, Sample Unit 103 – Medium Severity (65) Joint Seal Damage, Low Severity (63) Longitudinal, Transverse, and Diagonal Cracking

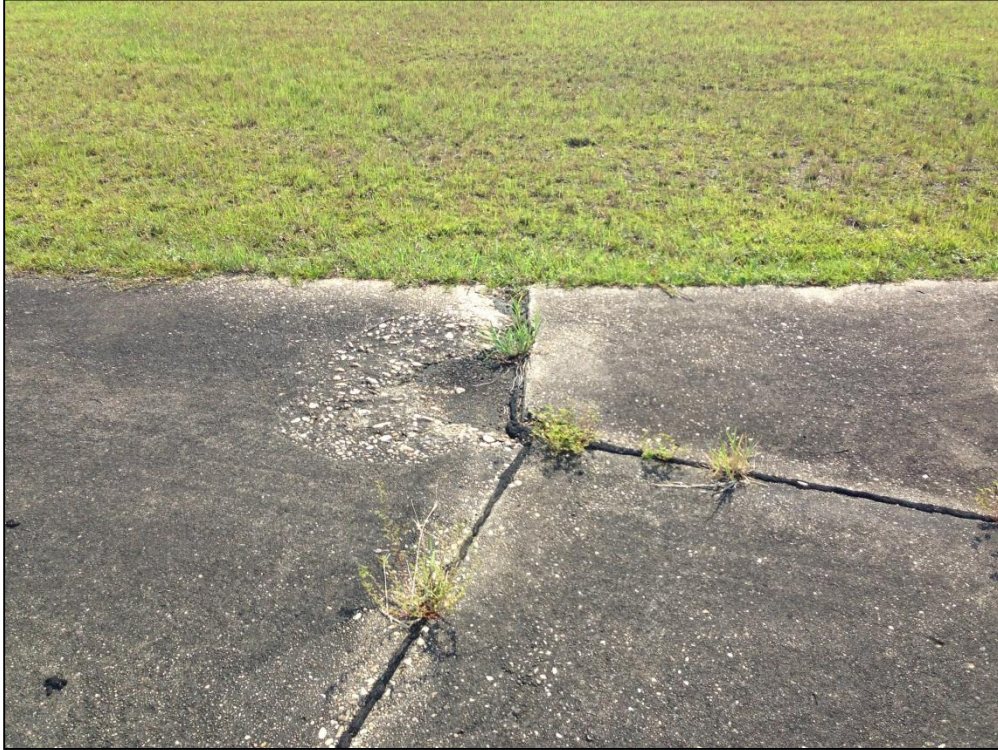
Taxiway C, Section 105, Sample Unit 129 – Medium Severity (65) Joint Seal Damage, High Severity (75) Corner Spalling

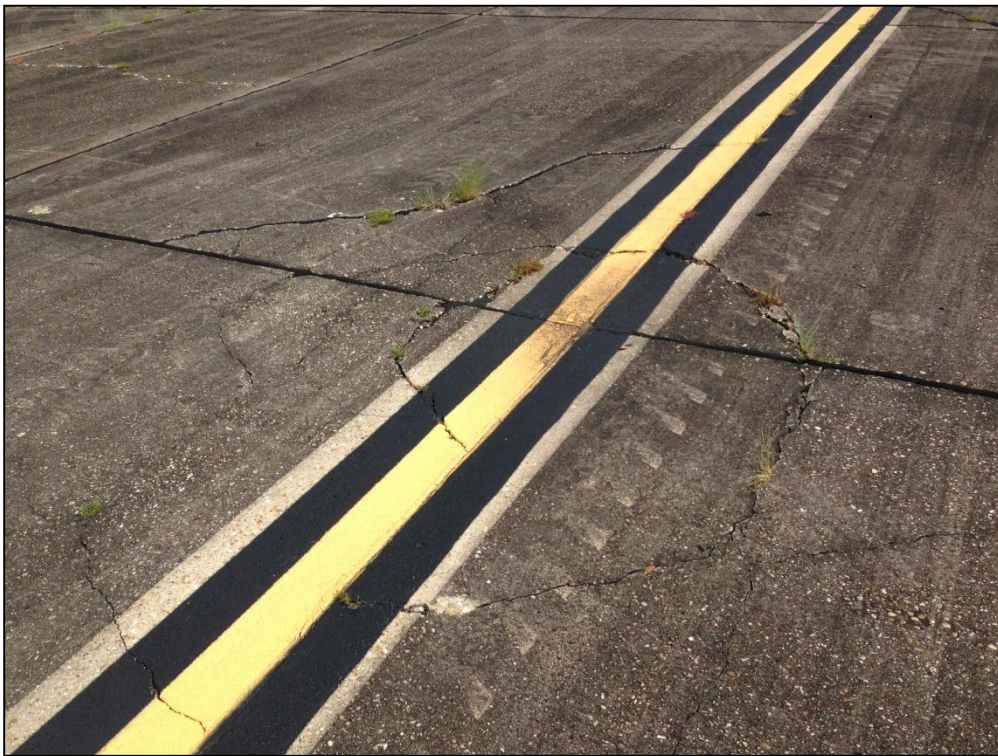
Taxiway D, Section 335, Sample Unit 103 – Low Severity (65) Joint Seal Damage, Medium Severity (63) Longitudinal, Transverse, and Diagonal Cracking, Low and Medium Severity (62) Corner Break, (73) Shrinkage Cracking

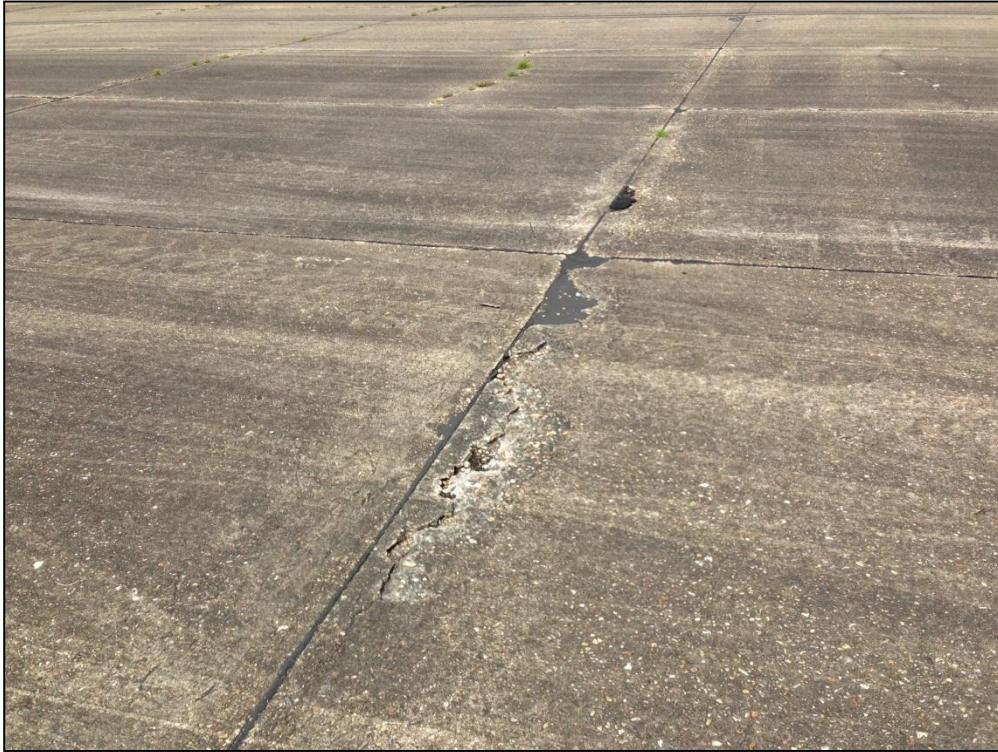
Apron, Section 4105, Sample Unit 210 – Low Severity (63) Longitudinal, Transverse, and Diagonal Cracking, Low and Medium Severity (74) Joint Spalling, Low Severity (75) Corner Spalling

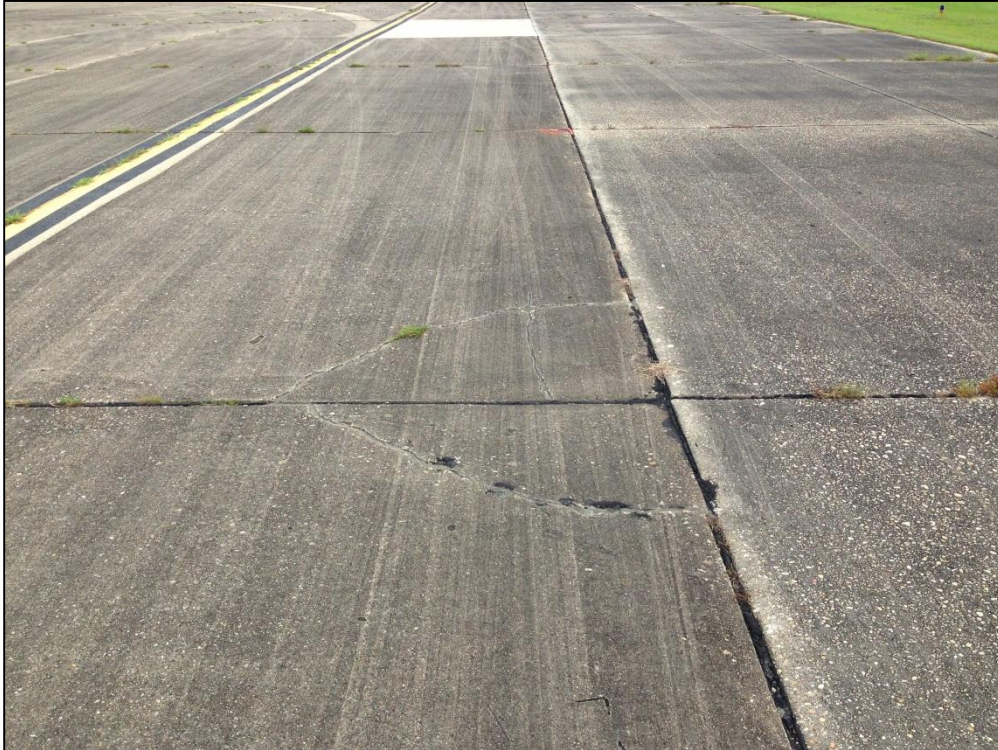
Taxiway A5, Section 205, Sample Unit 101 – Medium Severity (65) Joint Seal Damage, Low Severity (62) Corner Break, Low Severity (70) Scaling, Map Cracking, Crazing
