FLORIDA DEPARTMENT OF TRANSPORTATION  
AVIATION AND SPACEPORT OFFICE

AVON PARK  
EXECUTIVE  
AIRPORT (AVO)

DECEMBER 2013

# STATEWIDE Airfield Pavement Management PROGRAM

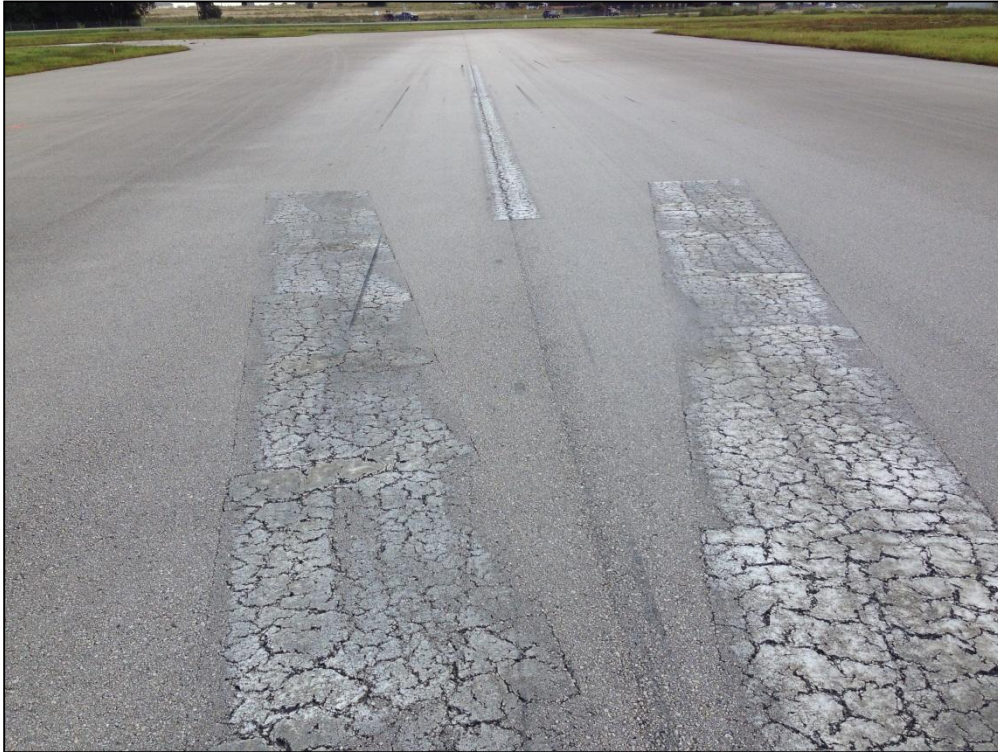
Runway 5-23, Section 6110, Sample Unit 171 – Low Severity (57) Weathering, Low Severity (52) Raveling

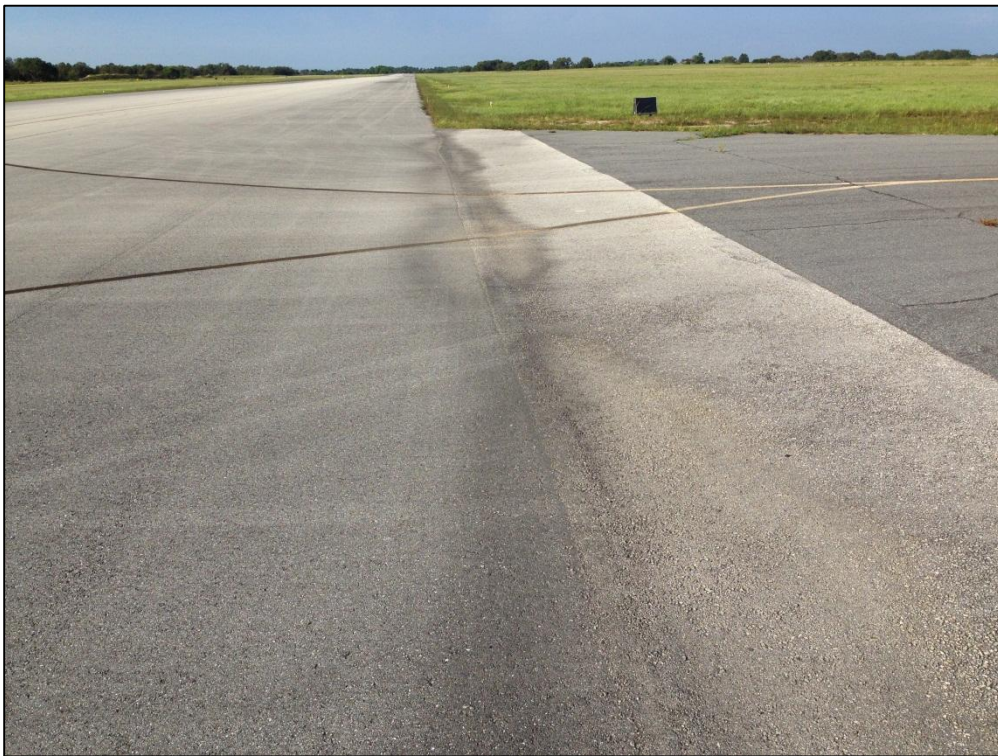
Runway 5-23, Section 6104, Sample Unit 348 –Low Severity (45) Depression, Low Severity (57) Weathering

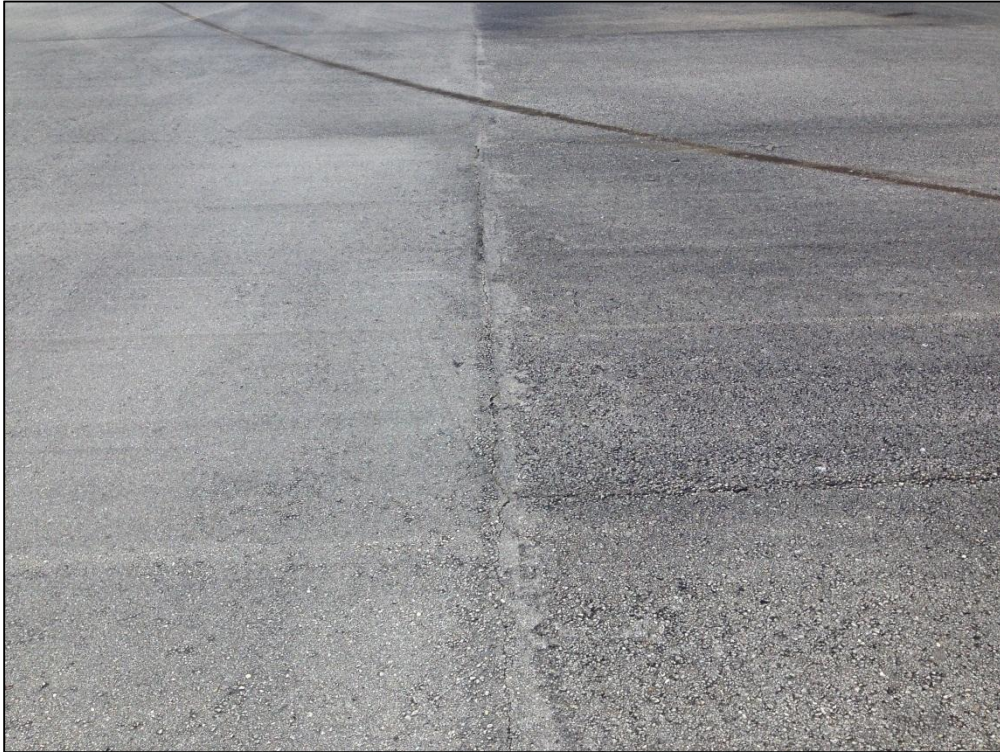
Runway 5-23, Section 6102, Sample Unit 99 – Low and Medium Severity (48) Longitudinal and Transverse Cracking, Low Severity (57) Weathering

- Runway 5-23 – Section 6102
  - Mill and overlay attributed to distresses related to climate, age, and subgrade quality of pavement.
- East Apron – Section 4505
  - Mill and overlay attributed to distresses related to climate, age, and subgrade quality of pavement.
- Southeast Apron – Section 4405
  - Mill and overlay attributed to distresses related to climate, age, and subgrade quality of pavement.
- South Apron – Section 4305
  - Reconstruction attributed to distresses related to climate, age, and subgrade quality of pavement.
- Northeast Apron – Sections 4205, 4210
  - Reconstruction or mill and overlay attributed to distresses related to climate, age, and subgrade quality of pavement.
- Northwest Apron – Section 4105
  - Mill and overlay attributed to distresses related to climate and age of pavement.

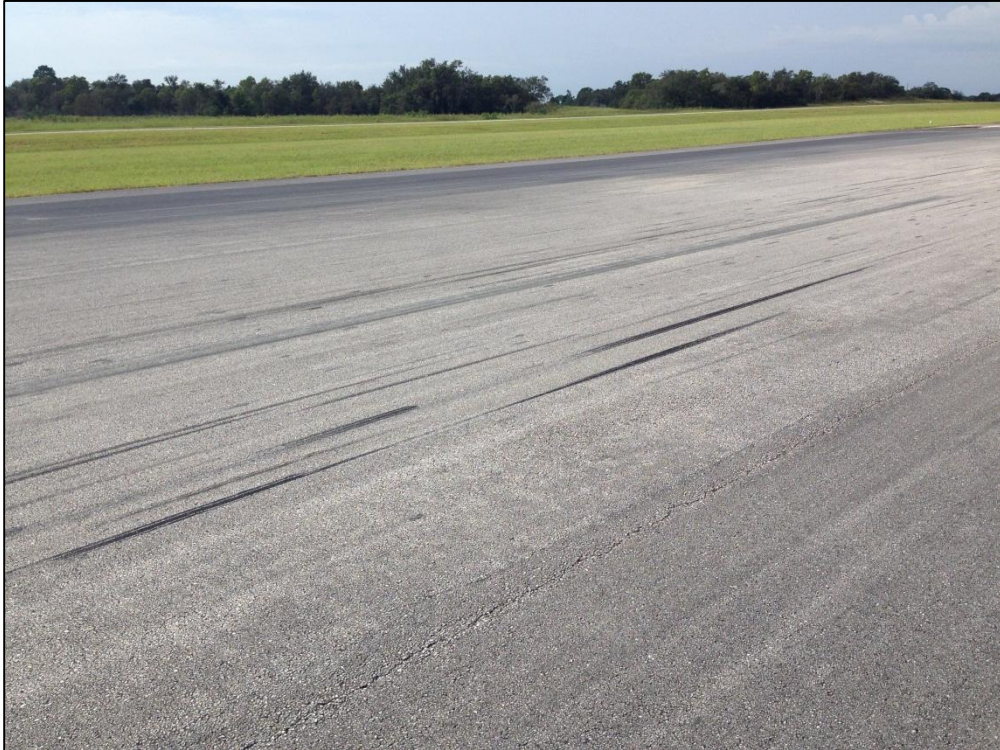
Runway 5-23, Section 6102, Sample Unit 94 – Low Severity (48) Longitudinal and Transverse Cracking, Low Severity (57) Weathering

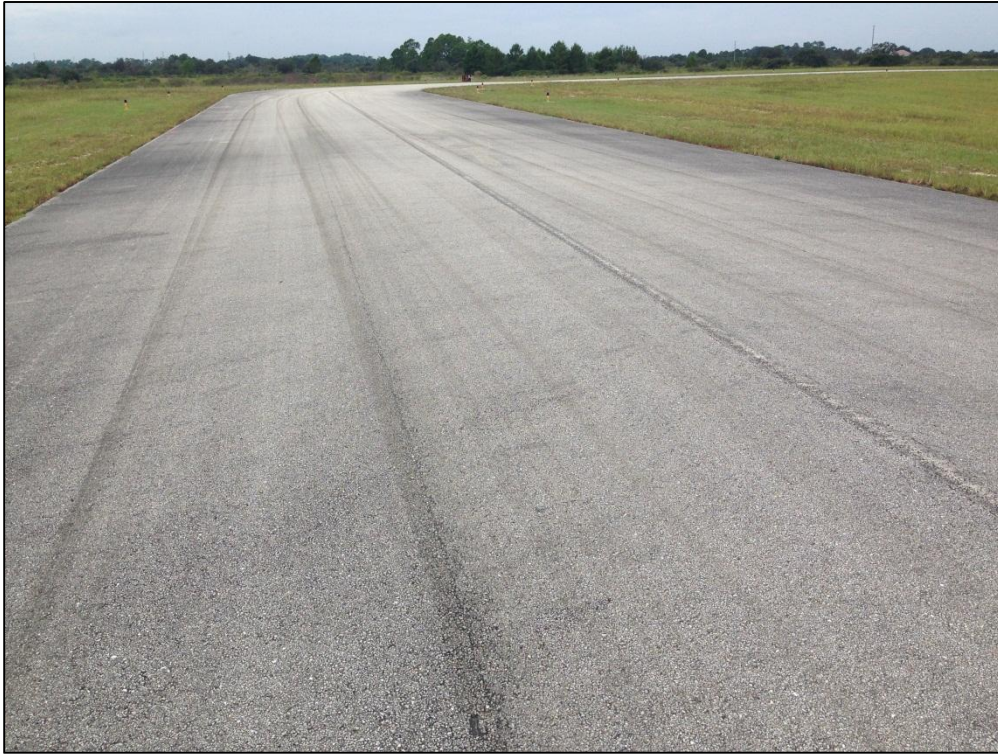
Taxiway E, Section 502, Sample Unit 104 – Low Severity (48) Longitudinal and Transverse Cracking, Low and Medium Severity (57) Weathering

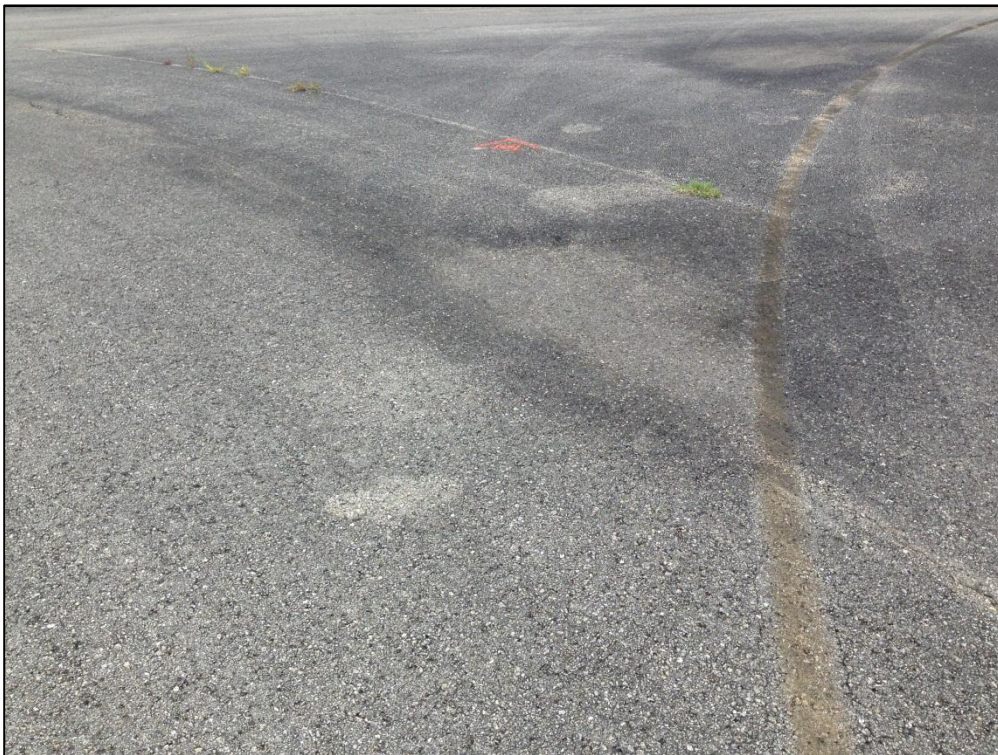
Taxiway D, Section 415, Sample Unit 101 – Low Severity (45) Depression, Medium Severity (57) Weathering

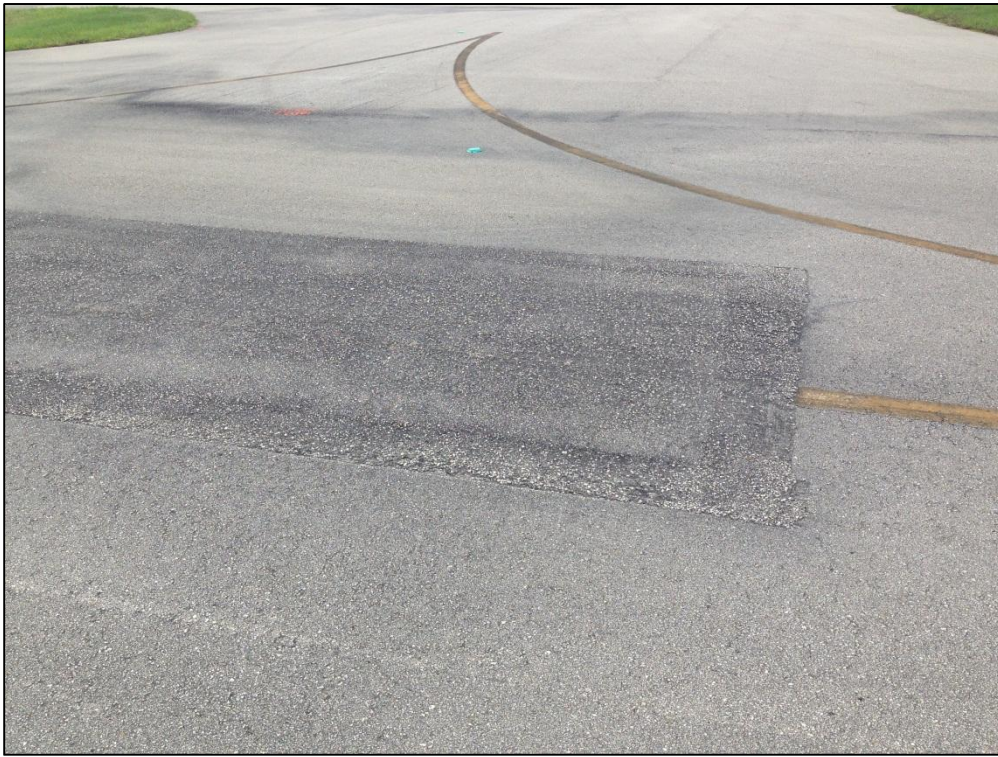
Taxiway H, Section 605, Sample Unit 102 – Medium Severity (50) Patching, Low Severity (57) Weathering

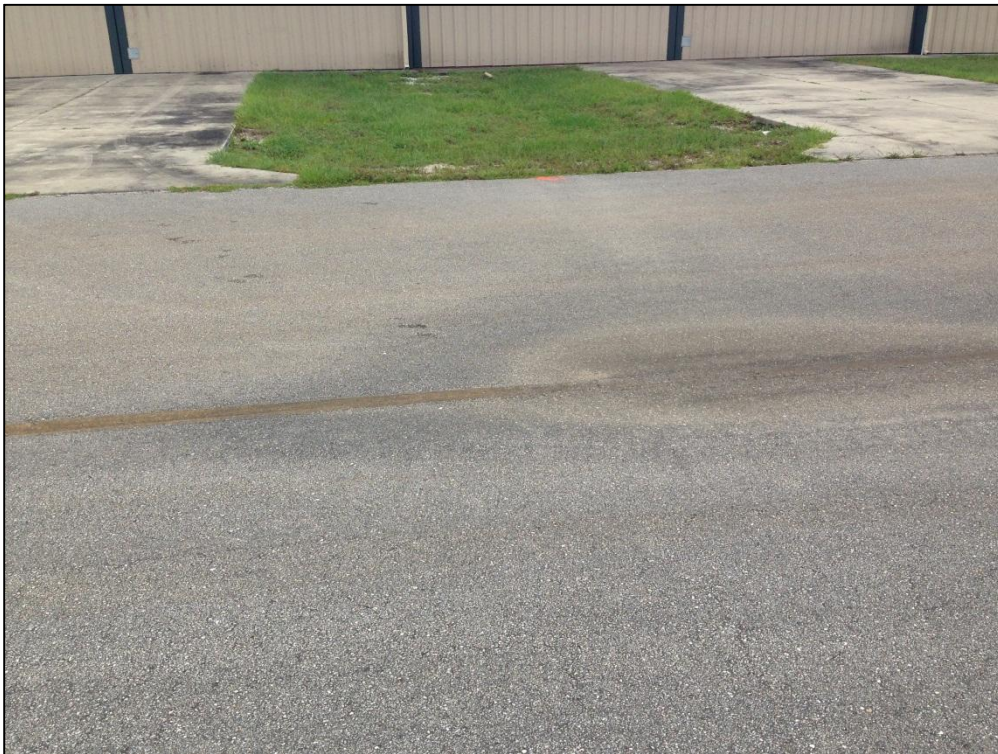
Apron T-Hang, Section 4605, Sample Unit 402 – Low Severity (45) Depression, Low Severity (57) Weathering

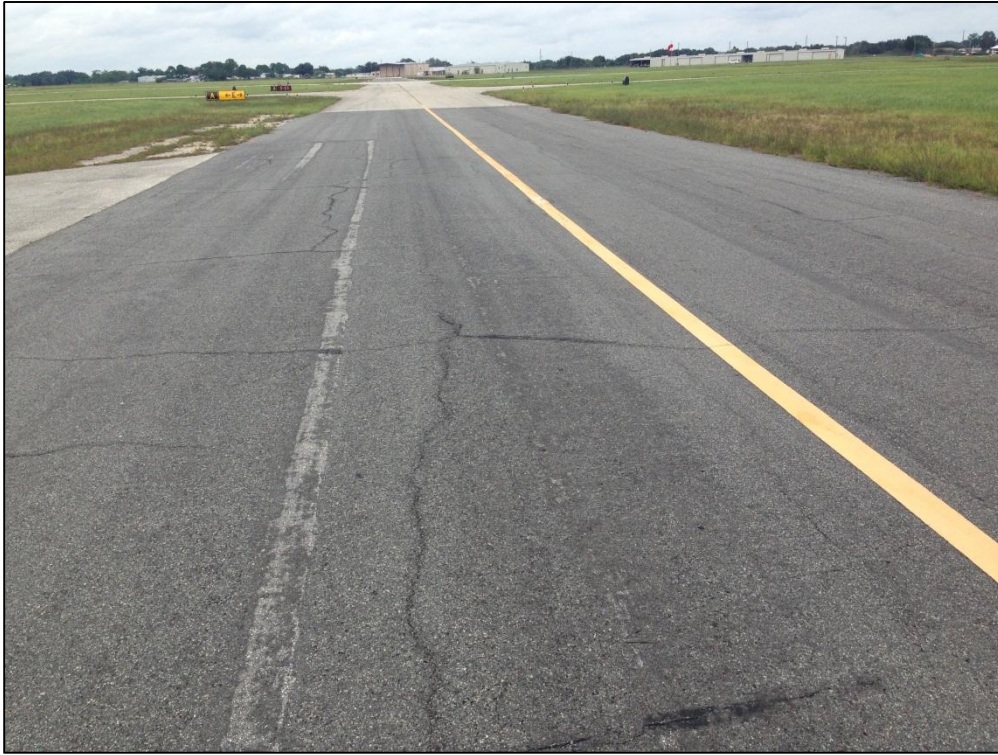
Taxiway A, Section 115, Sample Unit 105 – Low Severity (43) Block Cracking, Medium Severity (57) Weathering

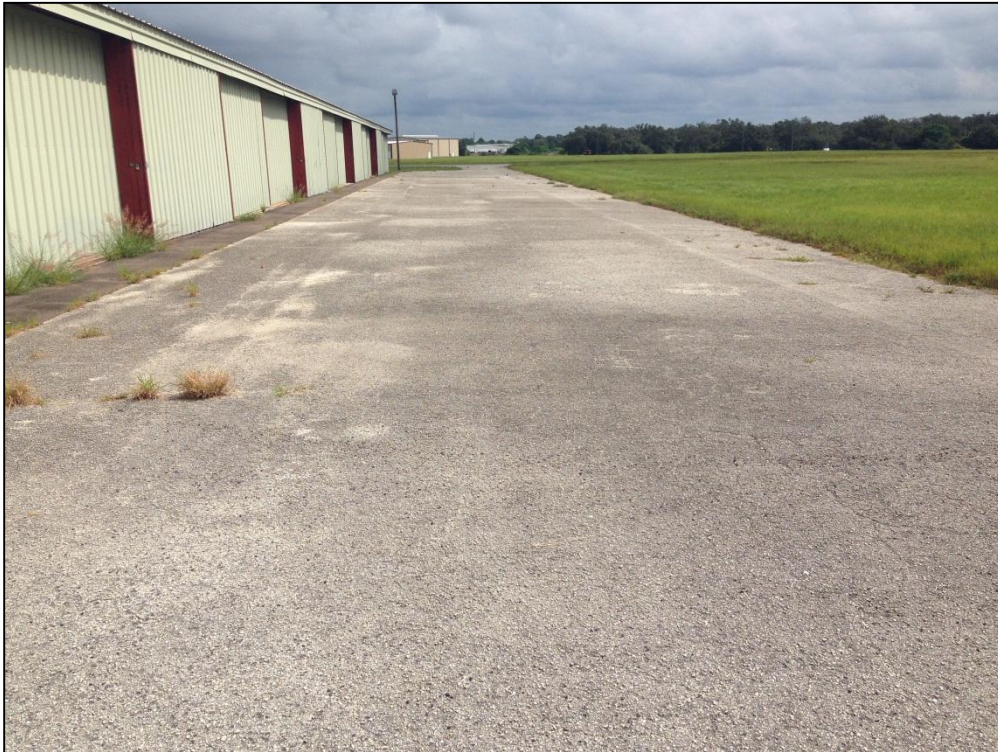
Apron S, Section 4305, Sample Unit 400 – Low Severity (43) Block Cracking, Medium Severity (52) Raveling

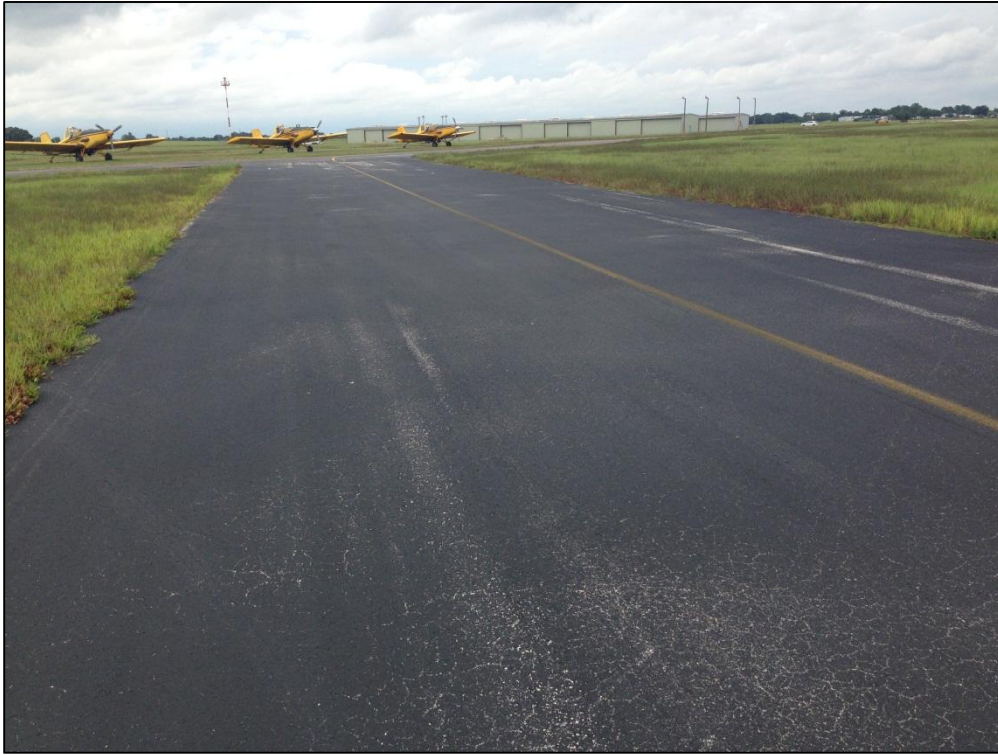
Taxiway A, Section 130, Sample Unit 121 – Low Severity (57) Weathering

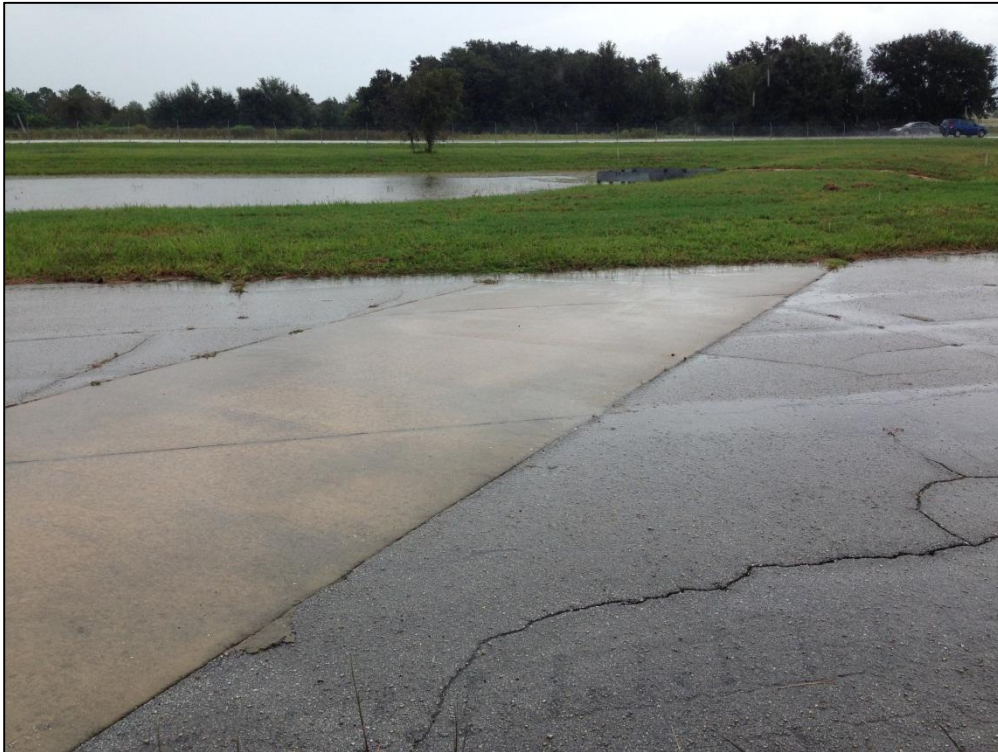
Taxiway F, Section 405, Sample Unit 101 – Low Severity (43) Block Cracking, Low Severity (50) Patching, Low Severity (52) Raveling, Low (57) Weathering

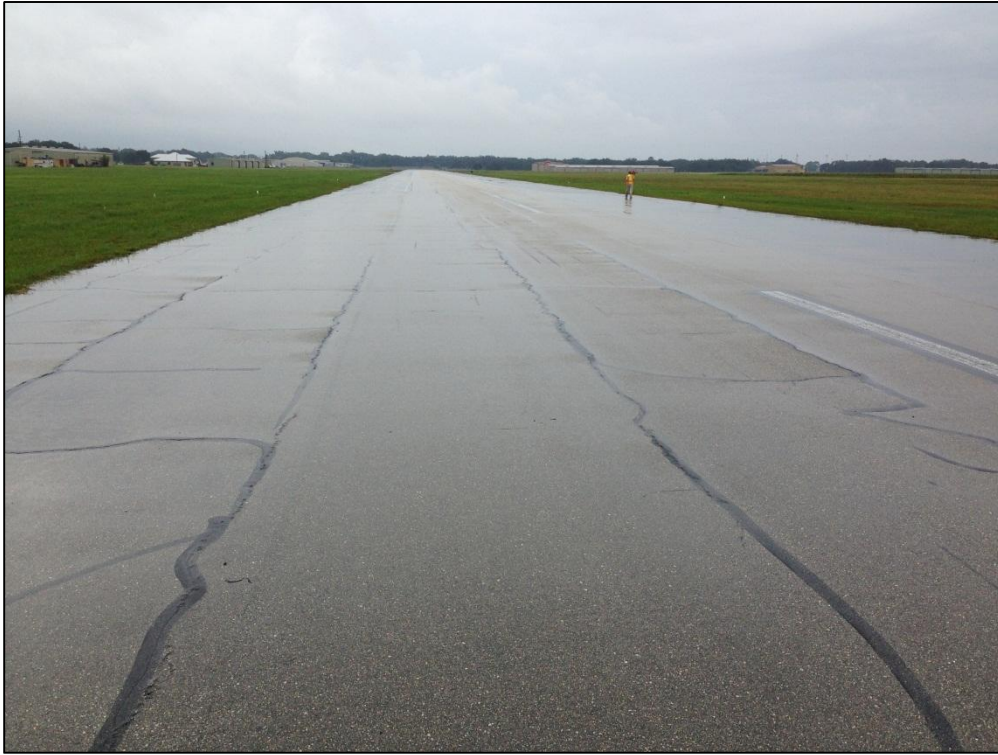
Runway 10-28, Section 6205, Sample Unit 115 – Low Severity (48) Longitudinal and Transverse Cracking, Low Severity (57) Weathering
