FLORIDA DEPARTMENT OF TRANSPORTATION  
AVIATION AND SPACEPORT OFFICE

BROOKSVILLE/  
TAMPA BAY  
REGIONAL  
AIRPORT (BKV)

DECEMBER 2013

# STATEWIDE Airfield Pavement Management PROGRAM

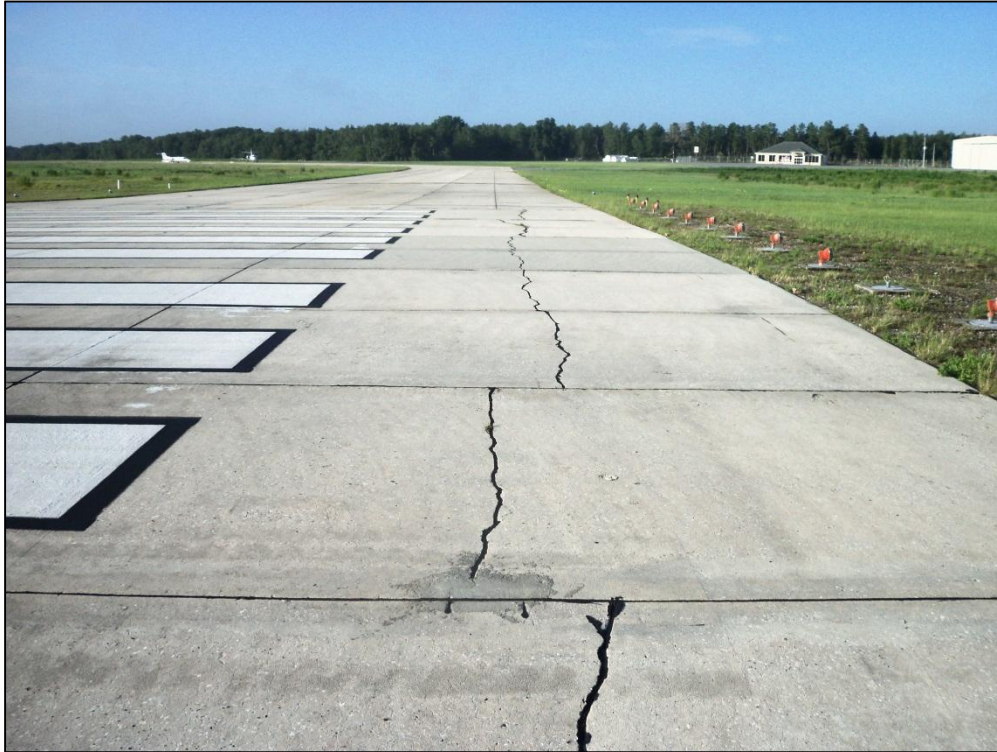
Runway 9-27, Section 6110, Sample Unit 300 – Low Severity (66) Small Patching, Low Severity (63) Longitudinal, Transverse and Diagonal Cracking

- Runway 3-21 – Sections 6205 and 6210
  - PCC Restoration attributed to climate and age of pavement.
- Runway 9-27 – Sections 6105 and 6110
  - PCC Restoration attributed to climate and age of pavement.
- Taxiway A3 – Sections 120 and 125
  - Reconstruction and PCC Restoration attributed to climate and age of pavement, load repetition and construction quality.
- Taxiway A – Section 105
  - PCC Restoration attributed to climate and age of pavement, subgrade quality, load repetition and construction quality.
- Taxiway A6 – Section 135
  - Reconstruction attributed to pavement repair along with the climate and age of pavement.
- Taxiway B – Section 205
  - Reconstruction attributed to climate and age of pavement.
- Taxiway A1 – Sections 110 and 112
  - Mill and Overlay along with PCC Restoration attributed to climate and age of pavement, load repetition and construction quality.

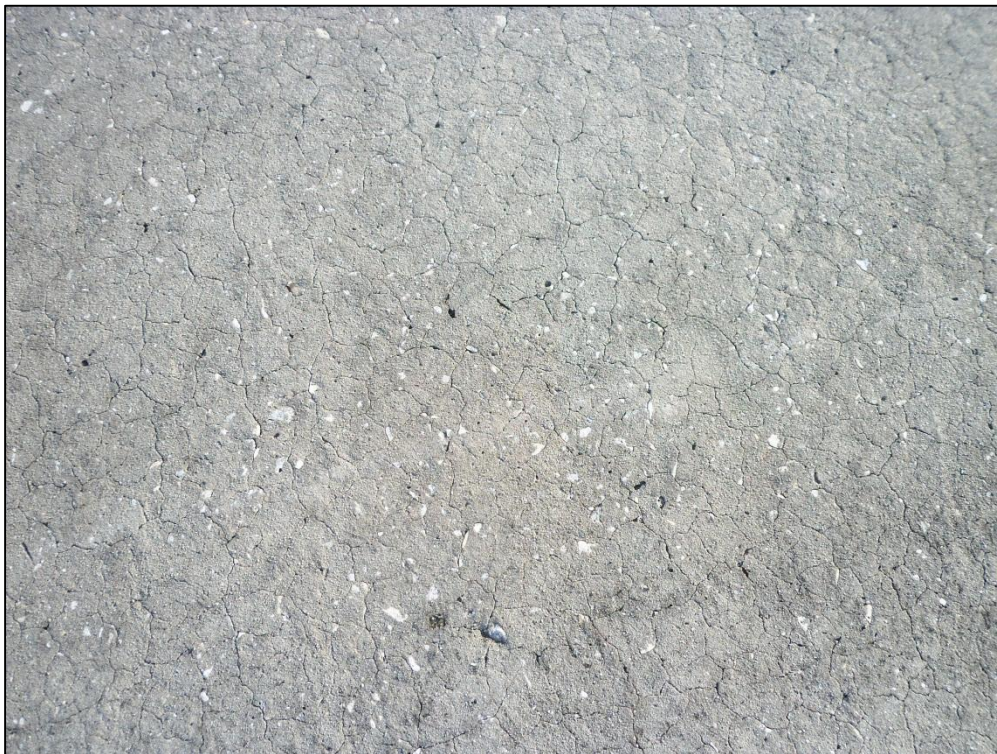
Runway 9-27, Section 6105, Sample Unit 104 – Medium Severity (70) Scaling, Map Cracking, Crazing

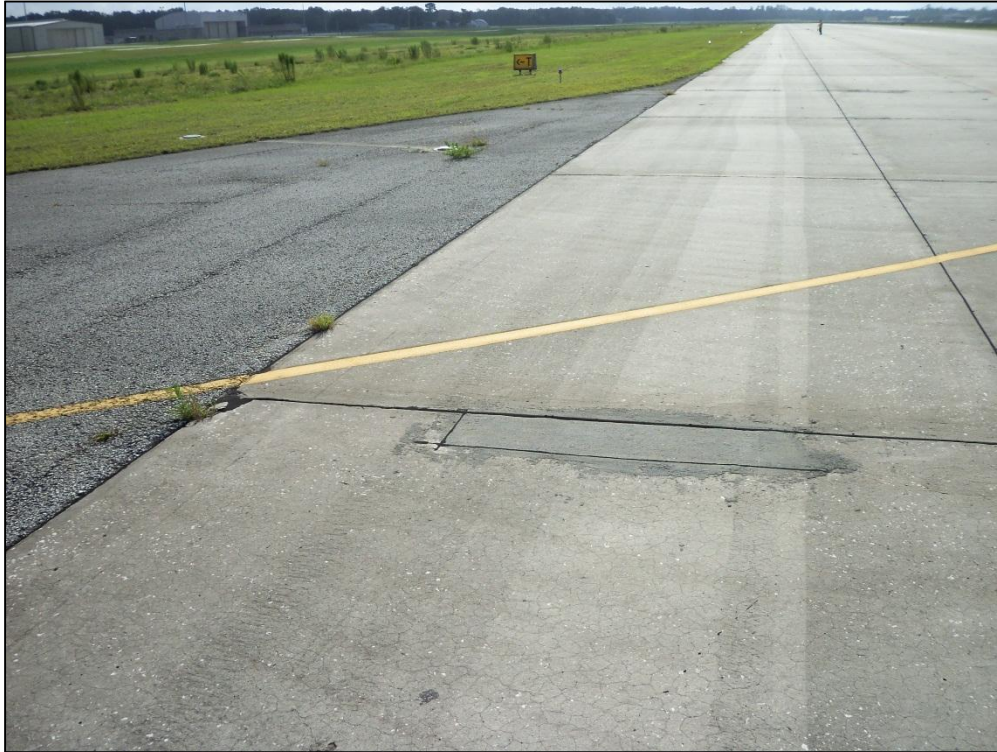
Runway 9-27, Section 6105, Sample Unit 168 –Medium Severity (70) Scaling, Map Cracking, Crazing, Low Severity (66) Small Patching, Low Severity (75) Corner Spalling

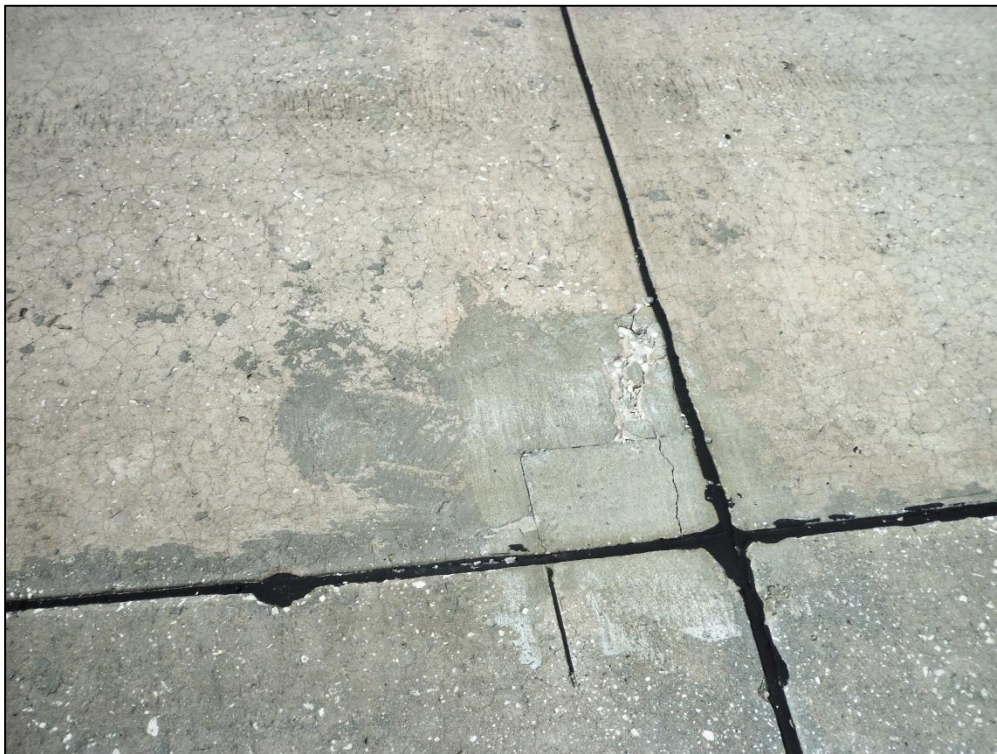
Taxiway Alpha, Section 105, Sample Unit 254 –Medium Severity (70) Scaling, Map Cracking, Crazing, Low Severity (66) Small Patching, Low Severity (74) Joint Spalling

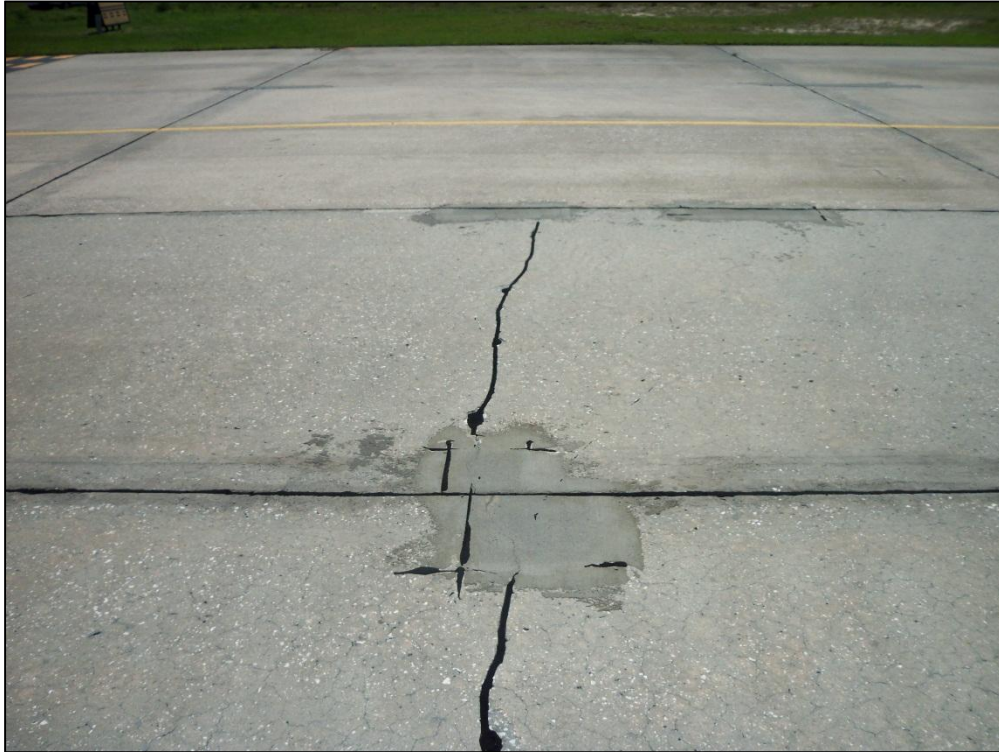
Taxiway A9, Section 140, Sample Unit 902 – Low and Medium Severity (70) Scaling, Map Cracking, Crazing, Low Severity (66) Small Patching, Low Severity (63) Longitudinal, Transverse and Diagonal Cracking

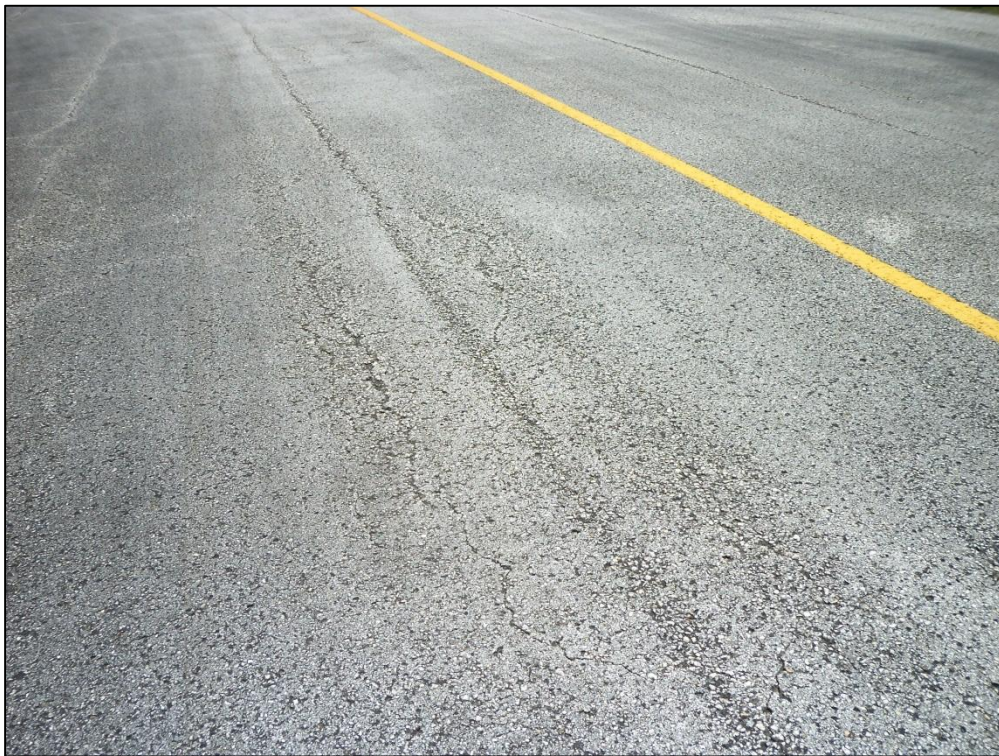
Taxiway A6, Section 135, Sample Unit 606 –Low and Medium Severity (48) Longitudinal and Transverse Cracking, Medium and High Severity (52) Raveling

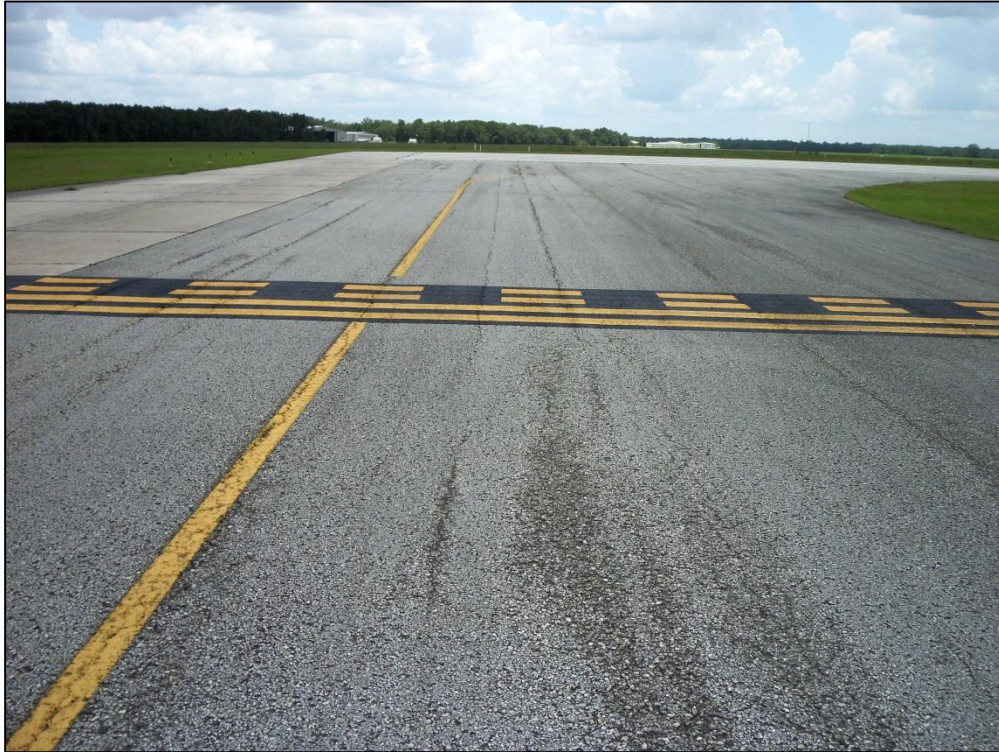
Taxiway A6, Section 125, Sample Unit 301 –Low and Medium Severity (48) Longitudinal and Transverse Cracking, Medium and High Severity (52) Raveling

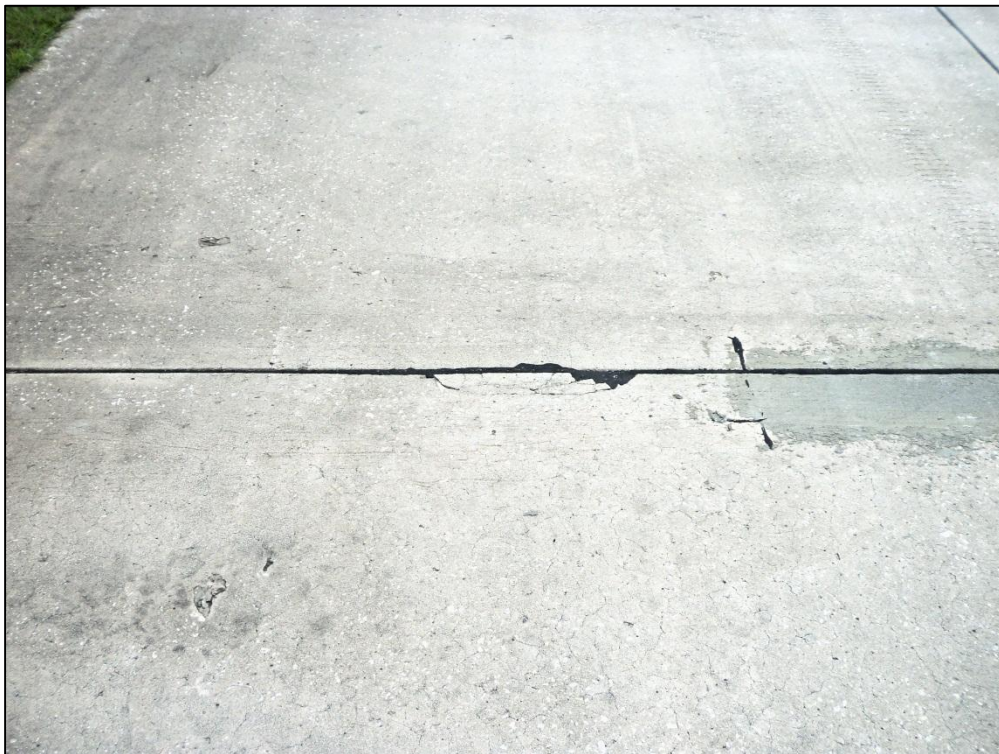
Runway 3-21, Section 6205, Sample Unit 592 –Low Severity (70) Scaling, Map Cracking, Crazing, Low Severity (66) Small Patching, Low Severity (74) Joint Spalling

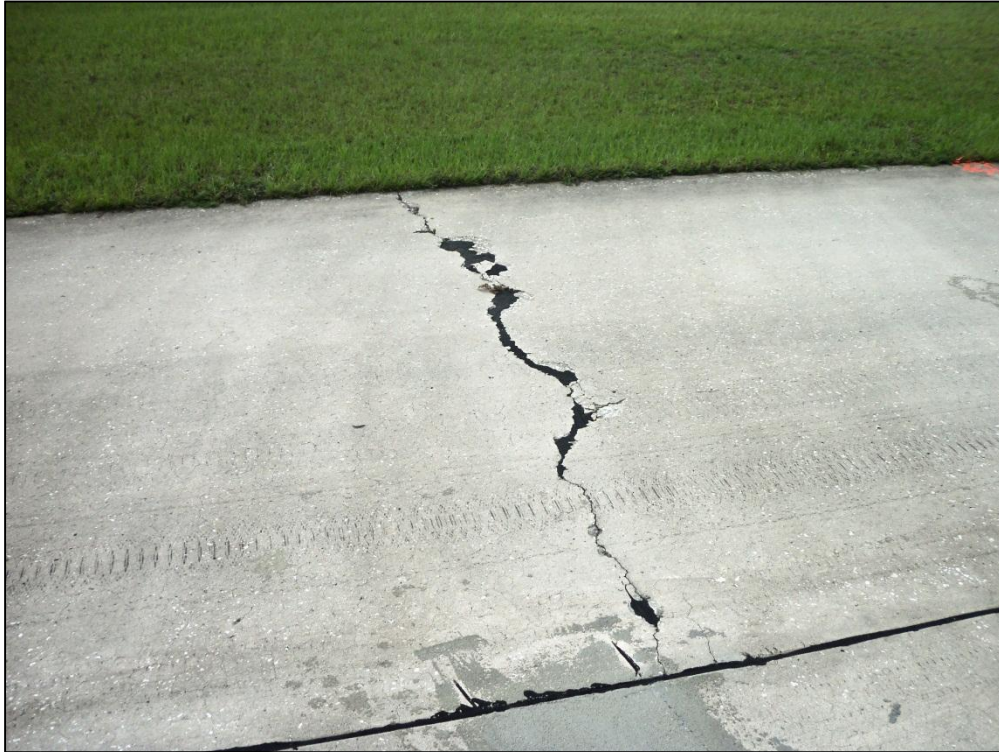
Runway 3-21, Section 6205, Sample Unit 164 – Low Severity (66) Small Patching, Medium Severity (63) Longitudinal, Transverse and Diagonal Cracking, (73) Shrinkage Cracking

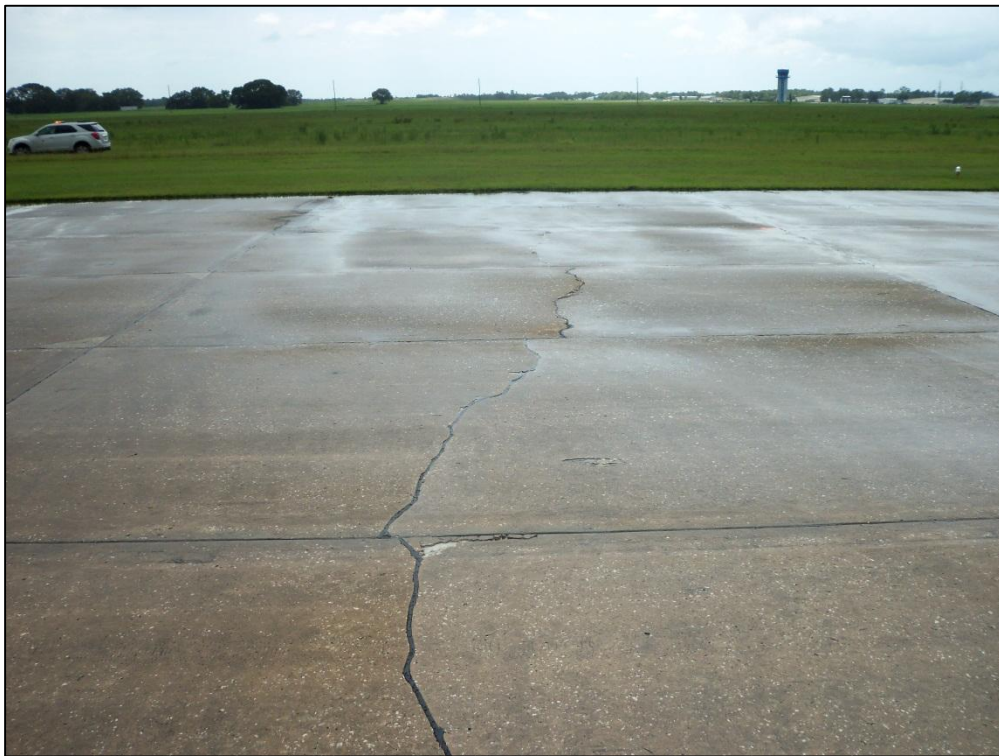
Runway 3-21, Section 6210, Sample Unit 337 – Low Severity (63) Longitudinal, Transverse and Diagonal Cracking, Medium Severity (74) Joint Spalling

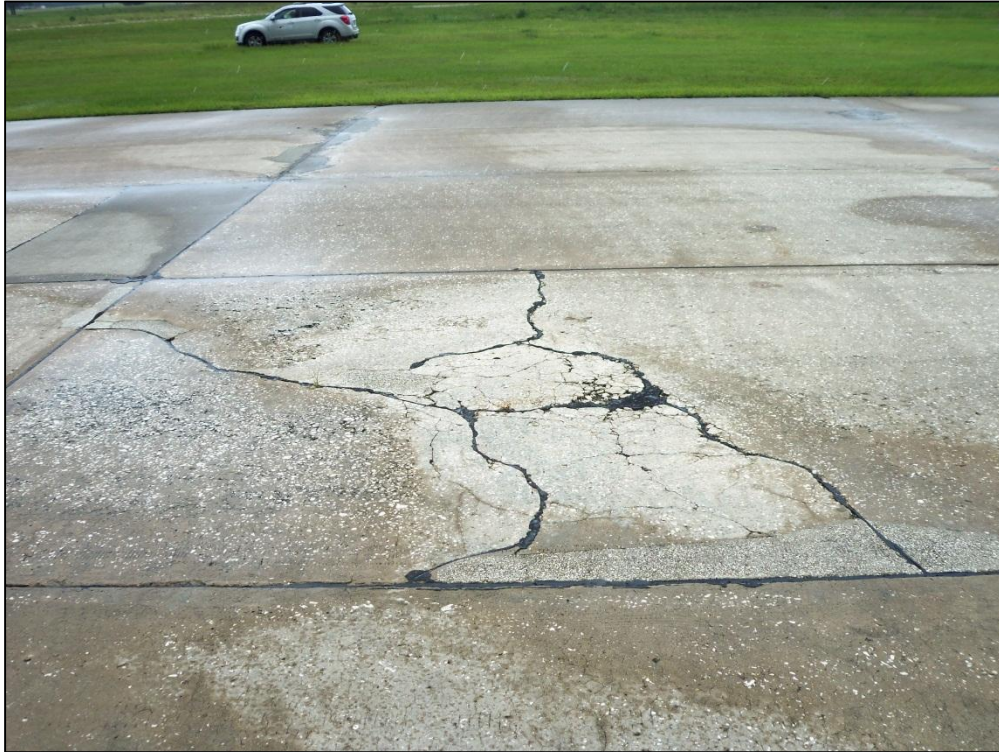
Runway 3-21 exhibited low and medium severity map cracking, longitudinal, transverse and diagonal cracking, joint spalling, corner spalling, patching, and shrinkage cracking. One instance of a high severity shattered slab was located

and identified to the airport for future repair due to its high risk of FOD. The majority of these distresses observed can be attributed to the age of the PCC pavement.

Runway 3-21, Section 6210, Sample Unit 313 – High Severity (72) Shattered Slab

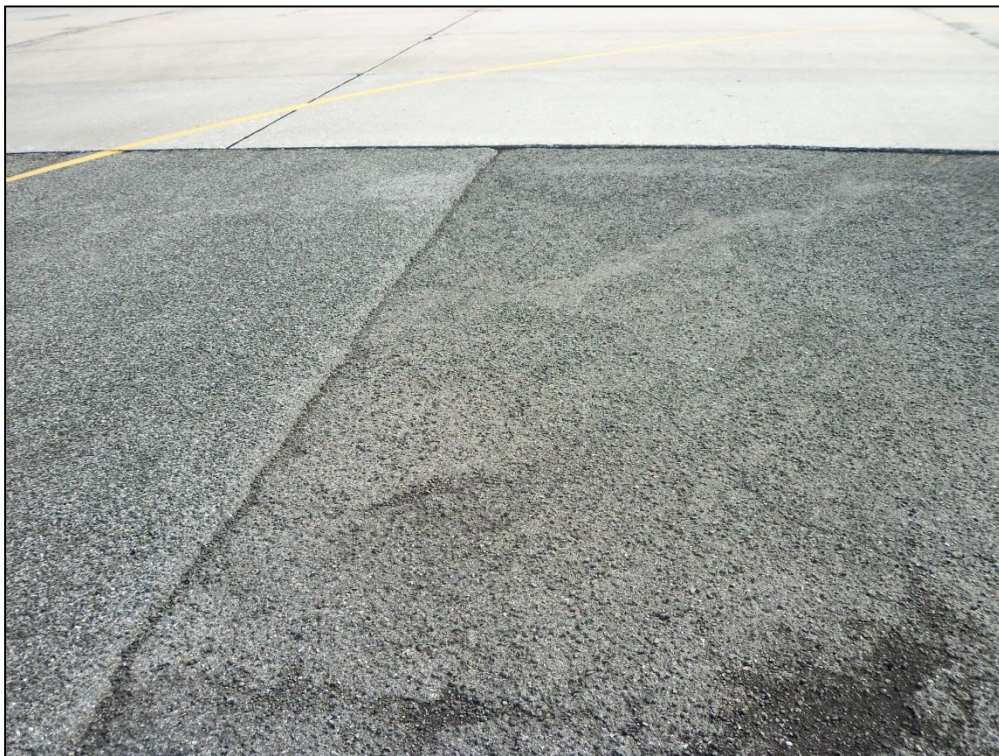
Taxiway Bravo, Section 205, Sample Unit 148 – Low and Medium Severity (48) Longitudinal and Transverse Cracking, Medium and High Severity (52) Raveling

- Reconstruction attributed to pavement repair along with the climate and age of pavement.
- ⦿ Taxiway B – Section 205
  - Reconstruction attributed to climate and age of pavement.

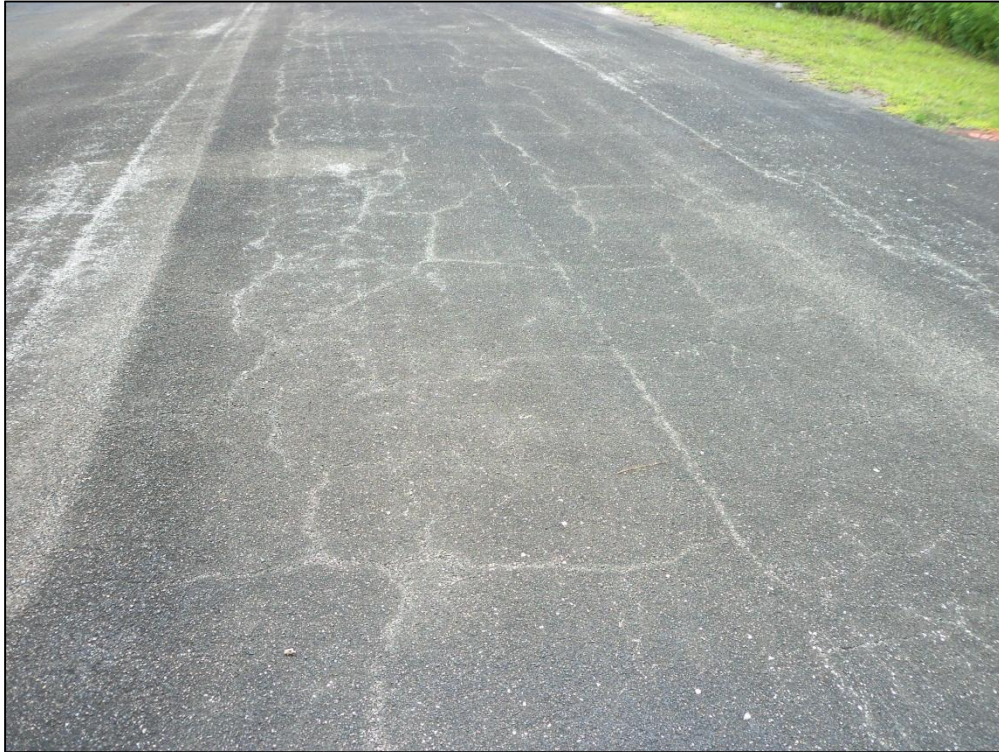
Apron North East, Section 4105, Sample Unit 852 – Low Severity (43) Block Cracking, Low Severity (48) Longitudinal and Transverse Cracking, Low Severity (57) Weathering, Low and High Severity (52) Raveling

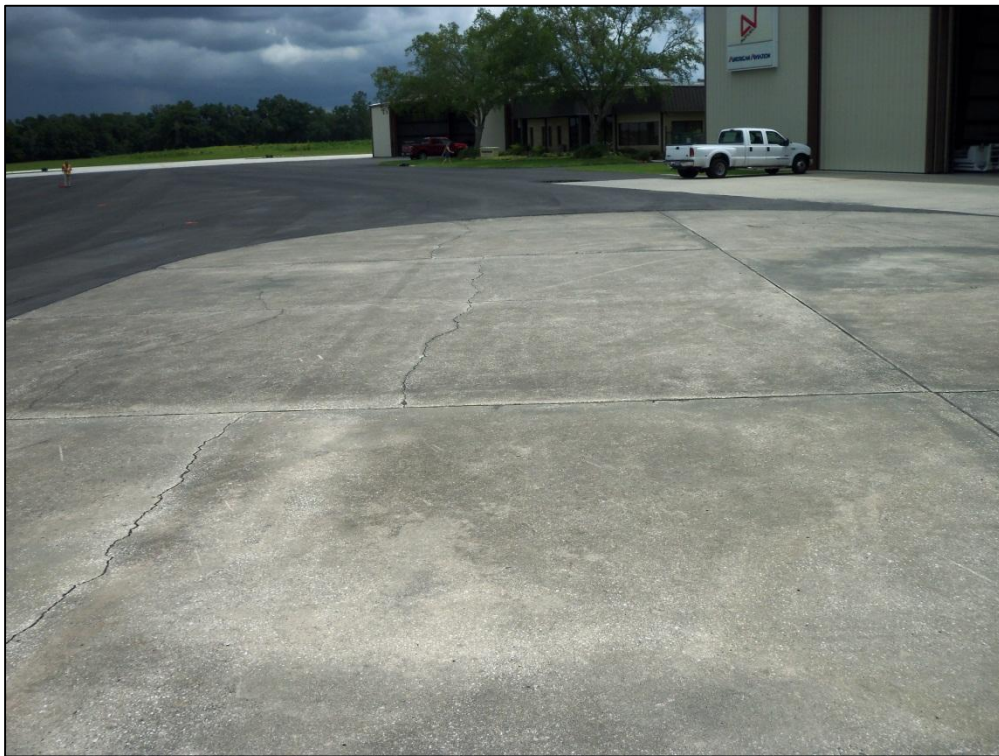
Apron North East, Section 4130, Sample Unit 100 – Low Severity (63) Longitudinal, Transverse and Diagonal Cracking

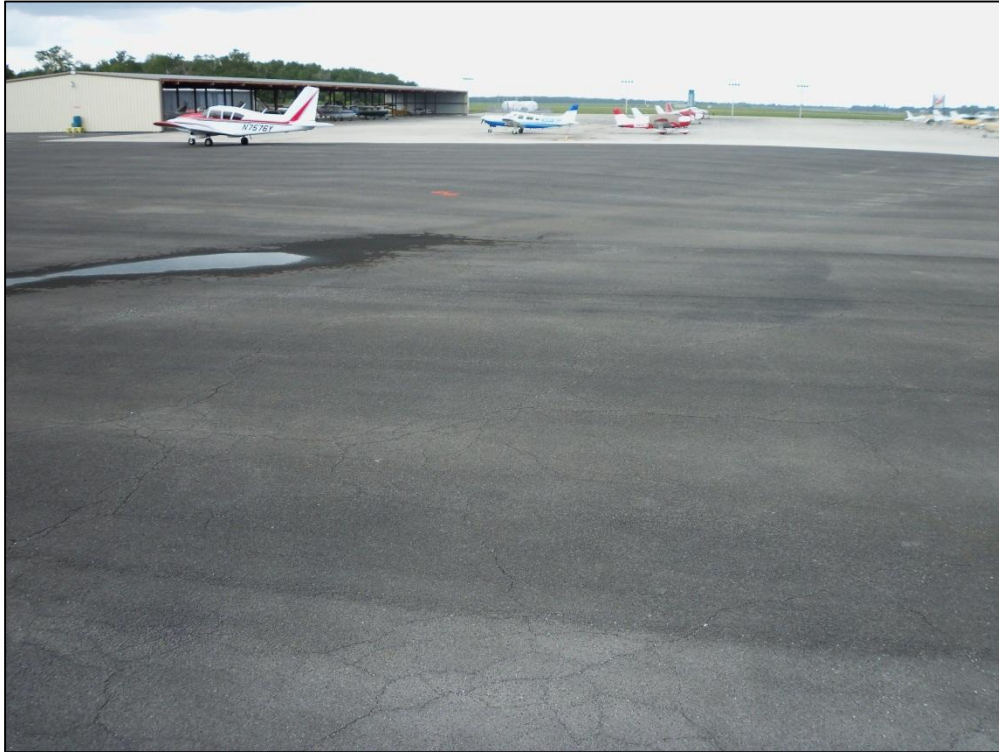
Apron North East, Section 4147, Sample Unit 155 – Low Severity (45) Depression, Low Severity (43) Block Cracking

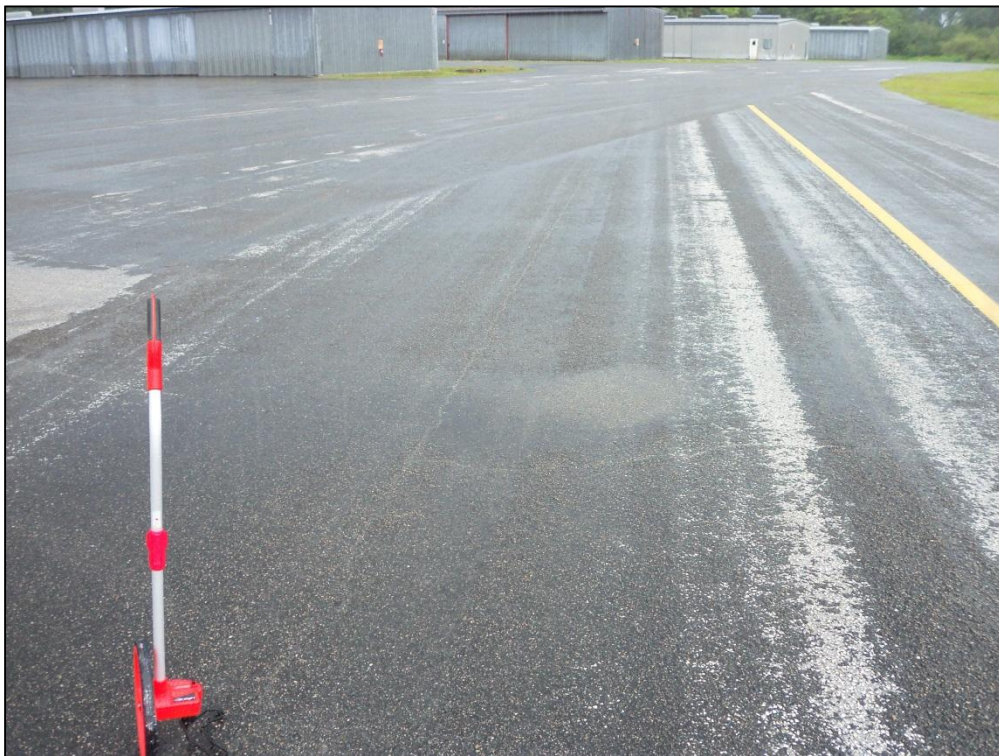
Taxiway A1, Section 112, Sample Unit 119 – Low Severity (45) Depression, Low Severity (57) Weathering, Low and Medium Severity (52) Raveling, Low Severity (48) Longitudinal and Transverse Cracking
