FLORIDA DEPARTMENT OF TRANSPORTATION
AVIATION AND SPACEPORT OFFICE

BARTOW MUNICIPAL
AIRPORT (BOW)

DECEMBER 2013

STATEWIDE Airfield Pavement Management PROGRAM

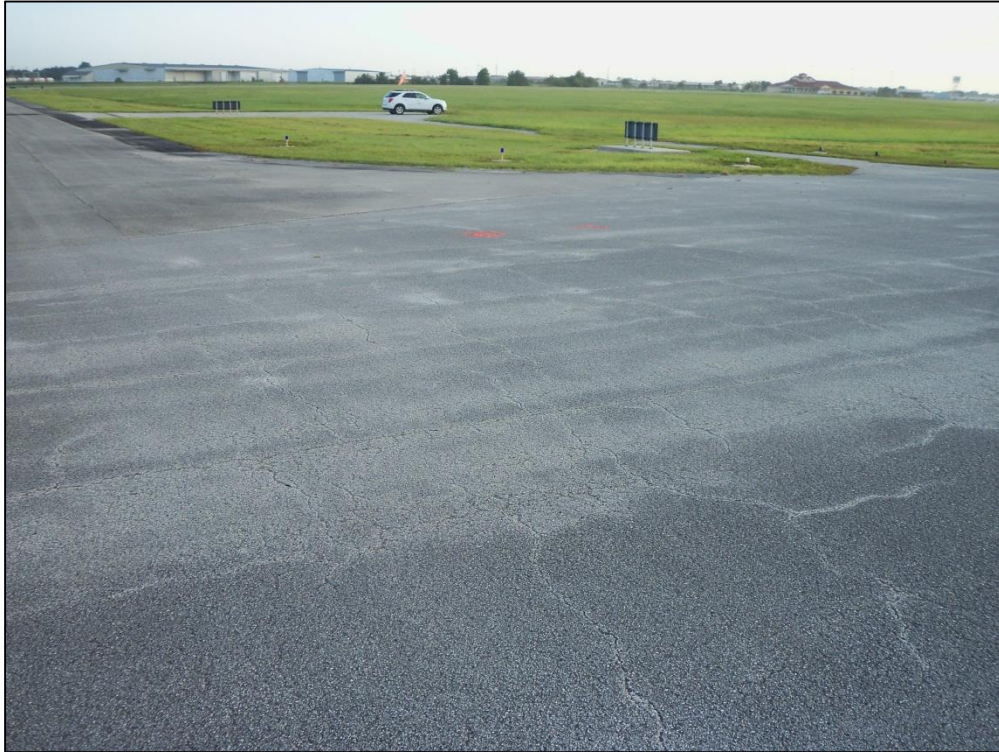
Runway 9R-27L, Section 6205, Sample Unit 300 – Medium Severity (52) Raveling, Low Severity (43) Block Cracking

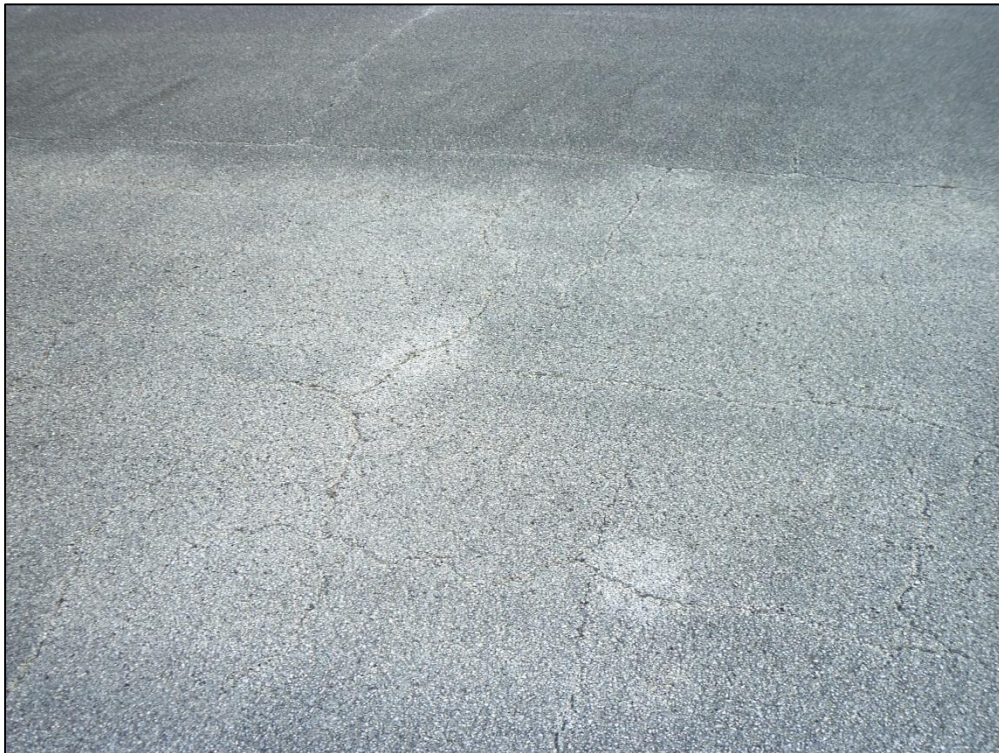
Runway 9R-27L, Section 6210, Sample Unit 512 – Medium (52) Raveling, Low Severity (43) Block Cracking

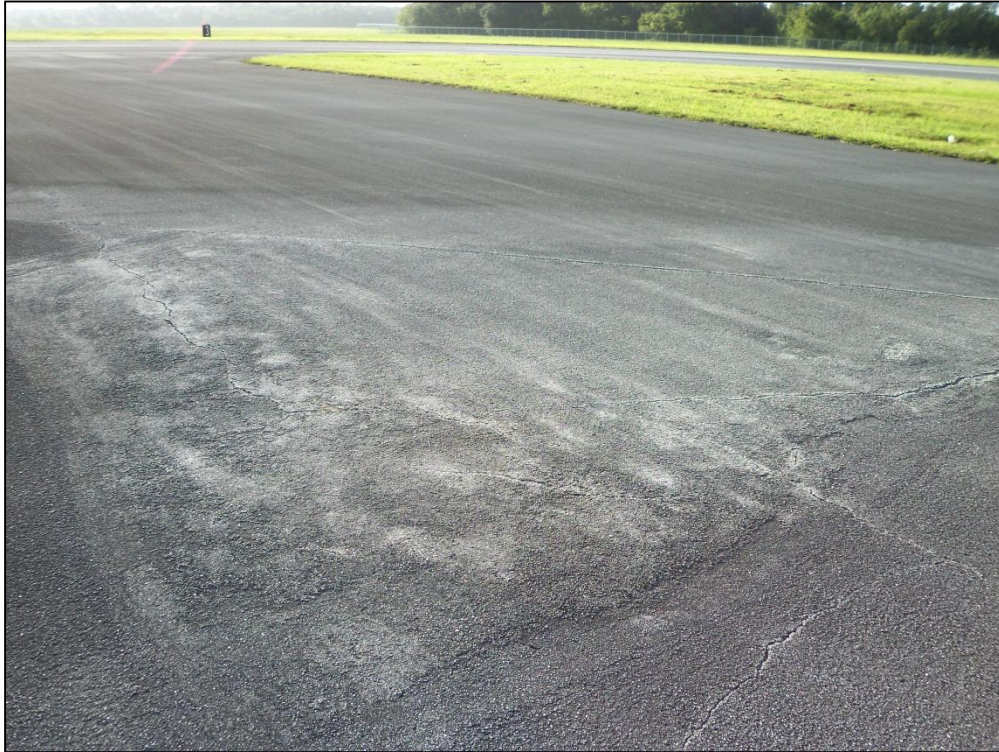
Runway 9R-27L, Section 6205, Sample Unit 329 – Medium Severity (50) Patching

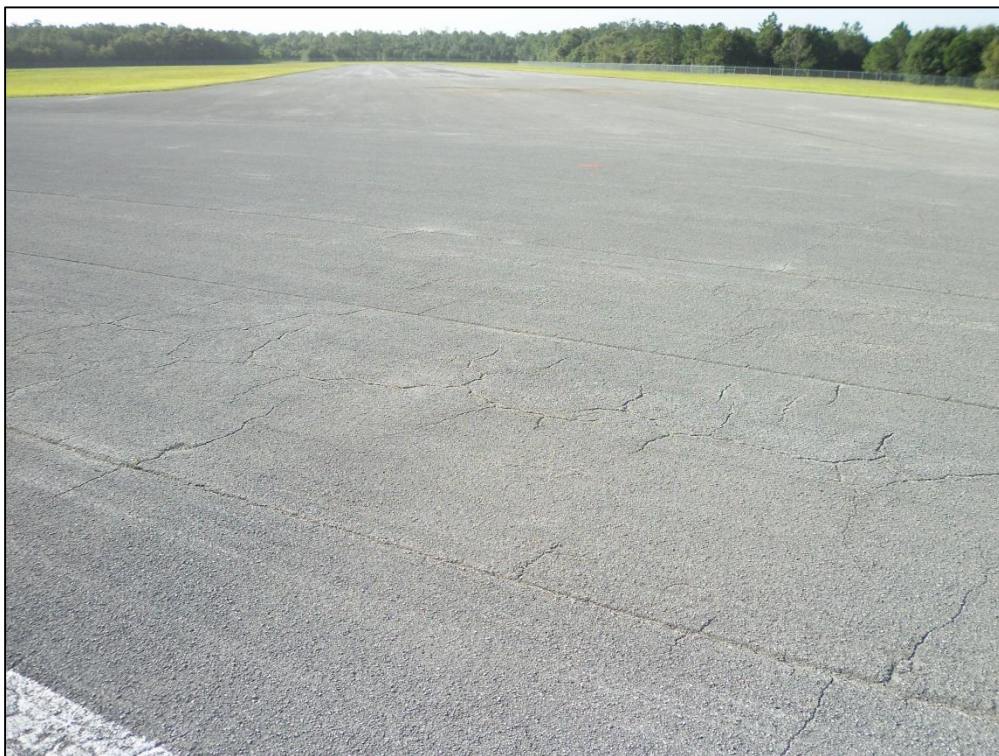
Runway 9R-27L, Section 6205, Sample Unit 354 – Medium Severity (52) Raveling, Medium Severity (43) Block Cracking

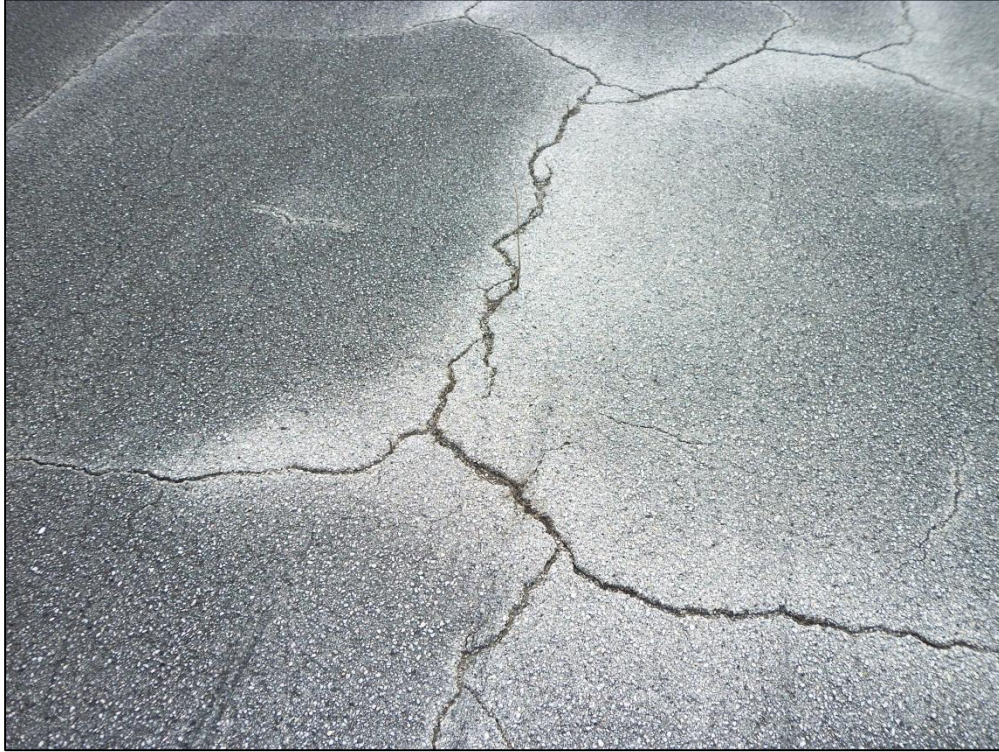
Runway 9R-27L, Section 6205, Sample Unit 378 – Medium Severity (52) Raveling, Medium Severity (43) Block Cracking

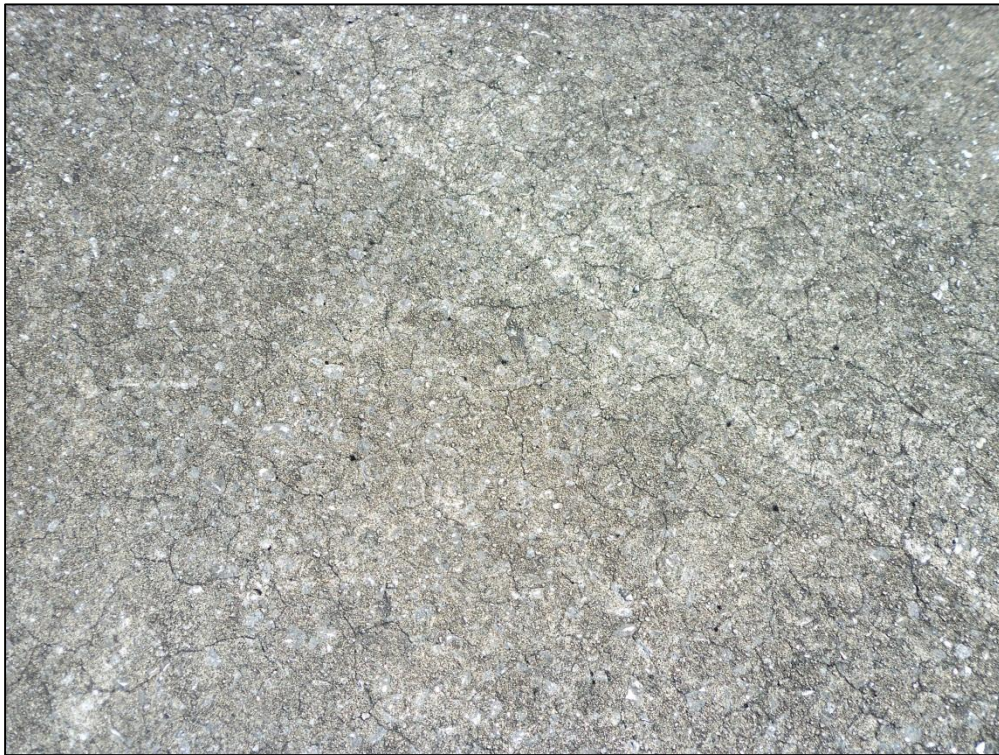
Runway 9R-27L, Section 6220, Sample Unit 184 – Low Severity (70) Scaling, Map Cracking, Crazing

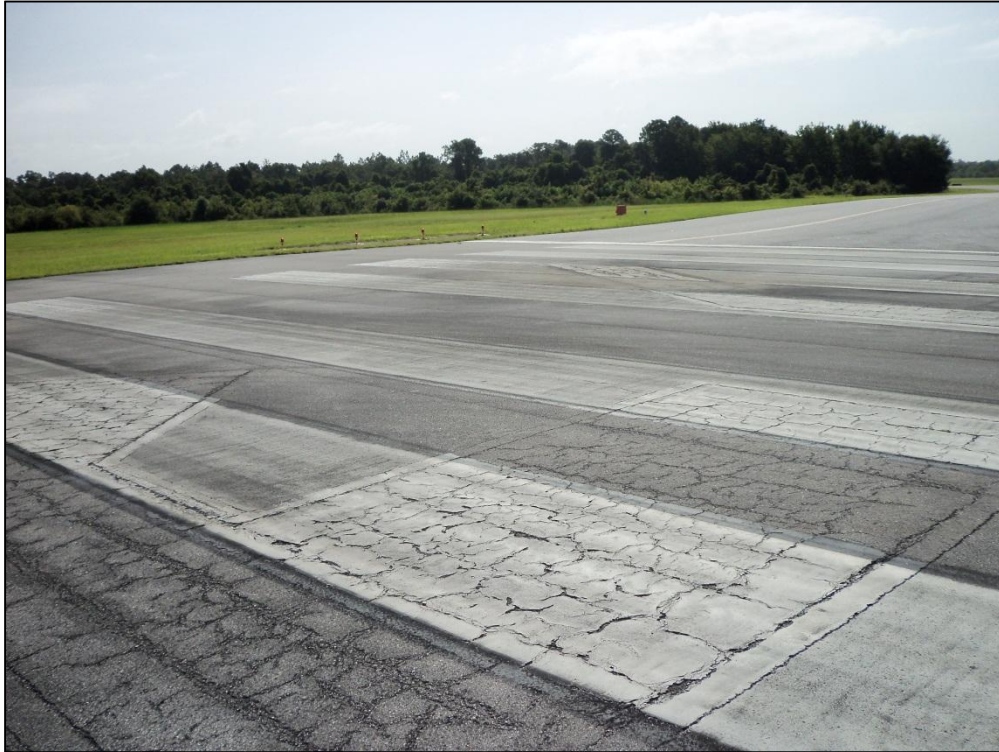
Runway 5-23, Section 6315, Sample Unit 198 – Medium Severity (52) Raveling, Low Severity (48) Longitudinal and Transverse Cracking

- ⦿ Runway 5-23 – Sections 6315, 6310, and 6305
 - Mill and Overlay attributed to distresses related to subgrade quality, climate, and age of pavement.
- ⦿ Runway 9R-27L – Sections 6210 and 6205
 - Reconstruction attributed to distresses related to loading, climate, and age of pavement.
- ⦿ Hold Apron Taxiway A – Section 5105
 - Reconstruction attributed to distresses related to climate and age of pavement.
- ⦿ T-Hangar Apron – Section 4205
 - Mill and Overlay attributed to distresses related to loading, climate, and age of pavement.
- ⦿ North Apron – Section 4105
 - Reconstruction attributed to distresses related to climate and age of pavement.
- ⦿ North Apron – Sections 4110 and 4132
 - Reconstruction attributed to distresses related to loading and construction quality.

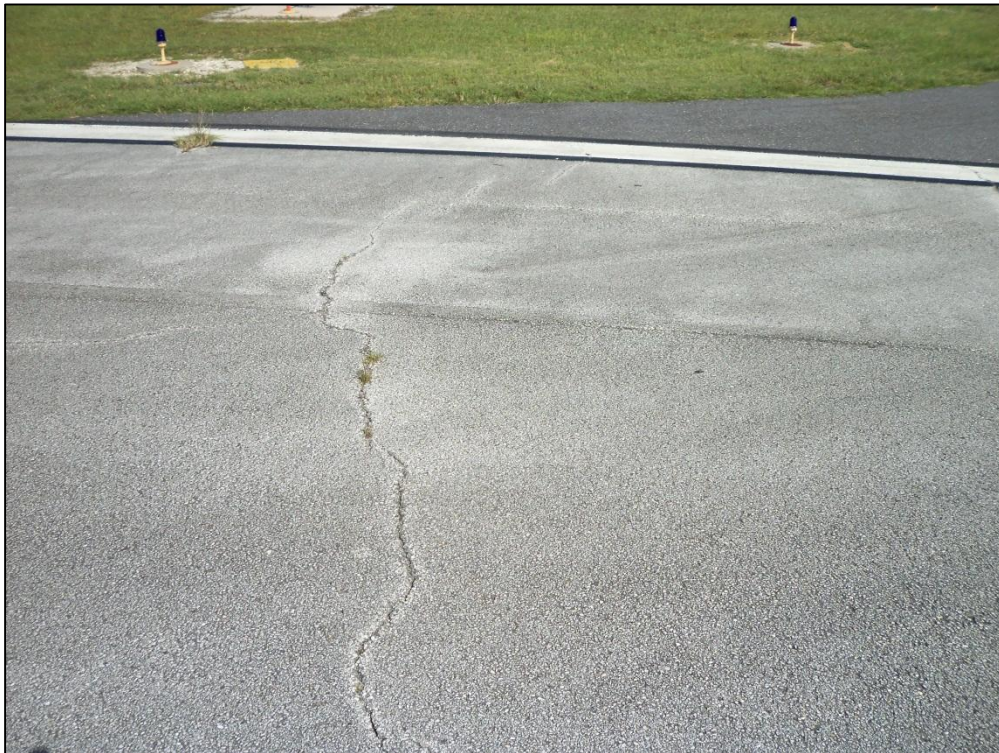
Runway 5-23, Section 6315, Sample Unit 187 – Low Severity (52) Raveling, Low Severity (57) Weathering, Medium Severity (48) Longitudinal and Transverse Cracking

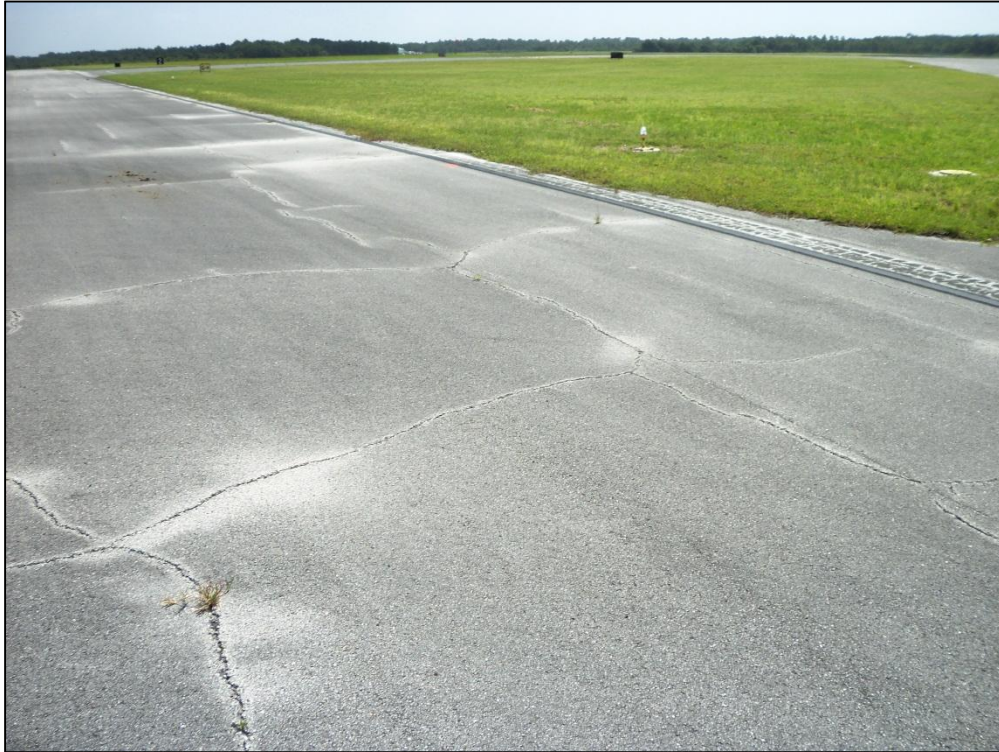
Runway 5-23, Section 6315, Sample Unit 145 – Low Severity (52) Raveling, Low Severity (57) Weathering, Medium Severity (43) Block Cracking

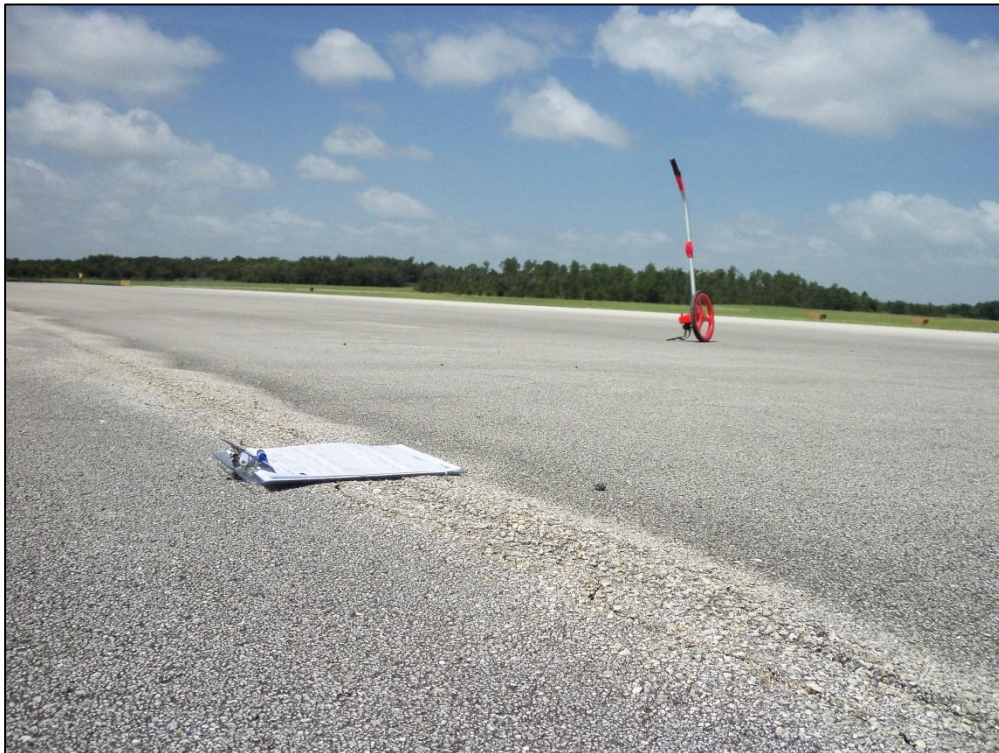
Runway 5-23, Section 6315, Sample Unit 117 – Low Severity (52) Raveling, Low Severity (57) Weathering, Medium Severity (56) Swelling

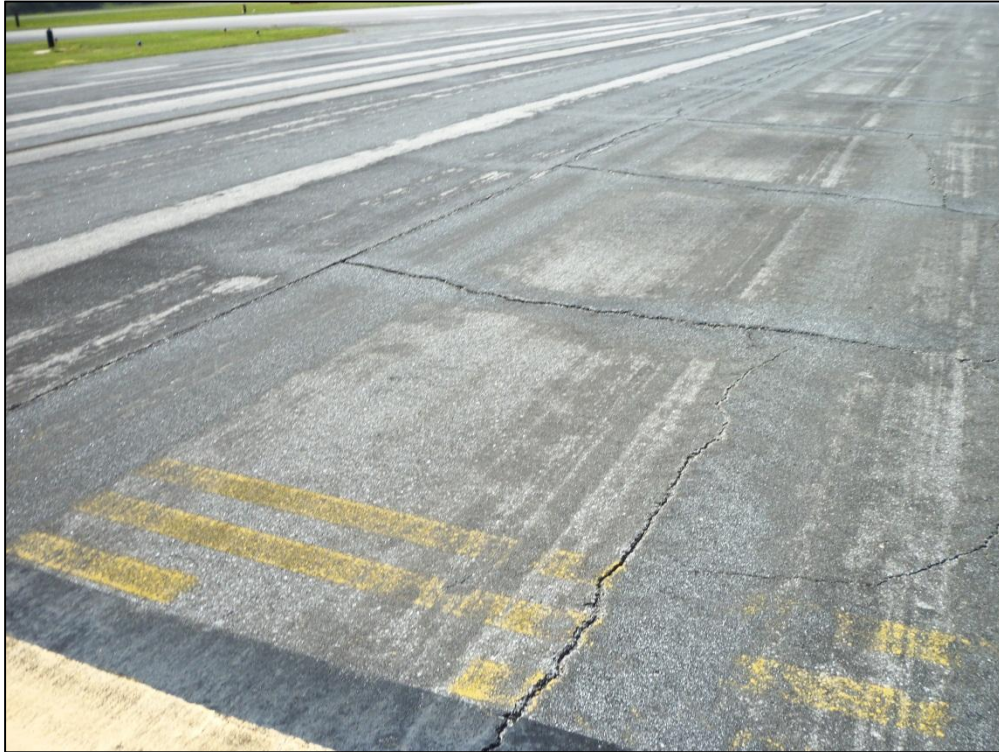
Taxiway F, Section 610, Sample Unit 103 – Medium Severity (57) Weathering, Medium Severity (43) Block Cracking

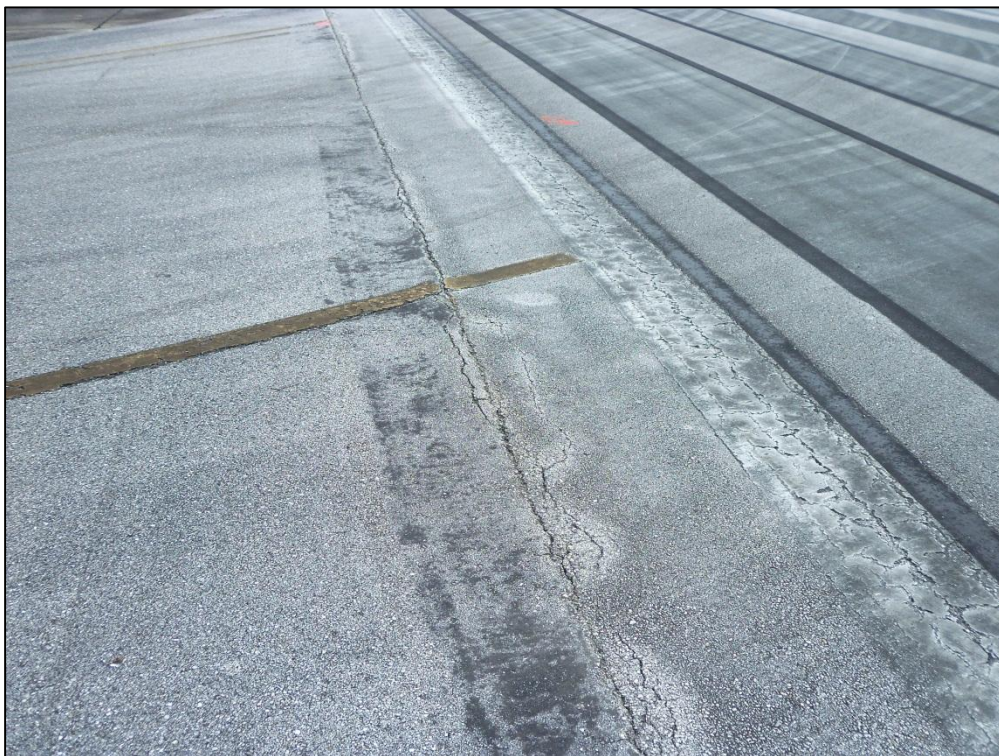
Taxiway C3, Section 320, Sample Unit 112 – Low Severity (52) Raveling, Low Severity (57) Weathering, Low Severity (48) Longitudinal and Transverse Cracking

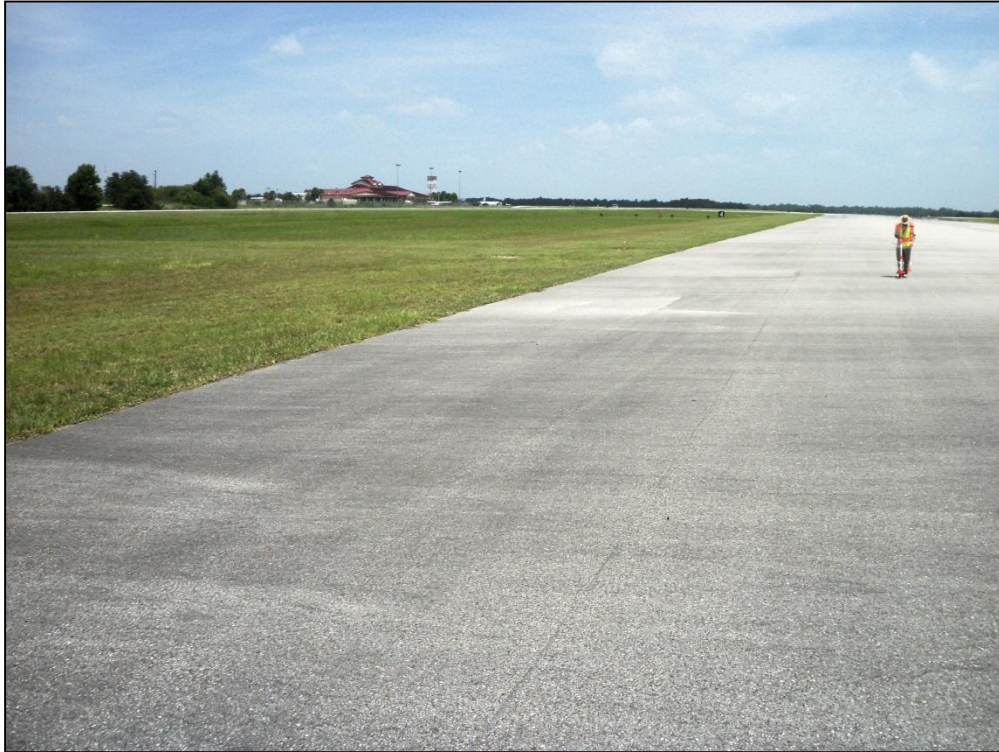
Runway 9L-27R, Section 6110, Sample Unit 104 – Low Severity (57) Weathering

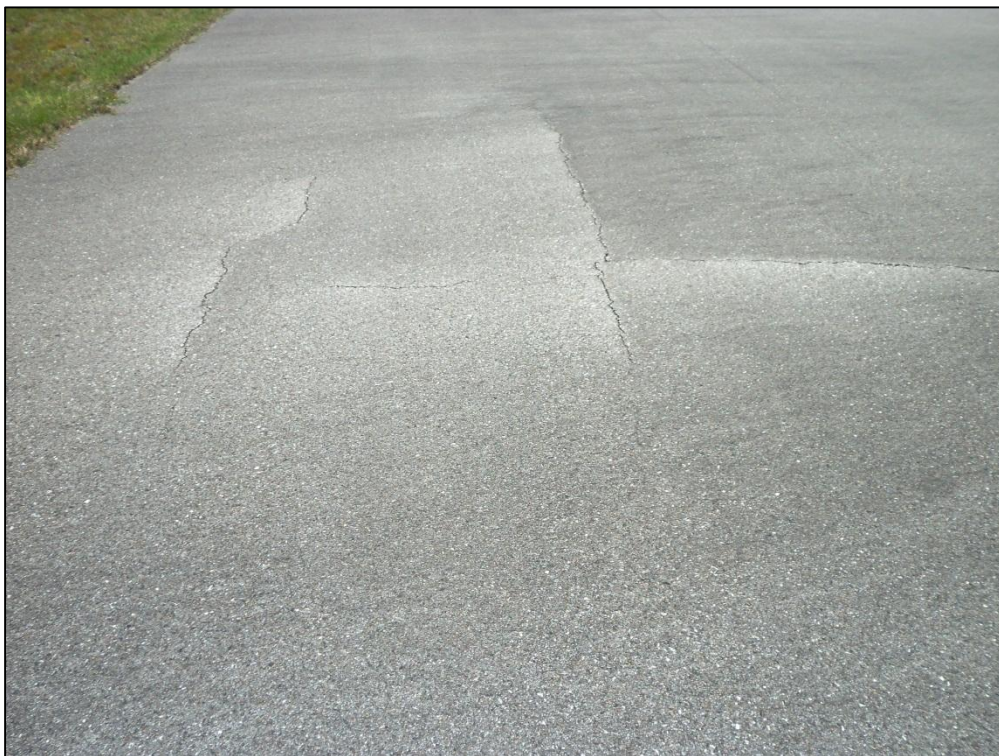
Runway 9L-27R, Section 6110, Sample Unit 104 –Low Severity (57) Weathering, Low Severity (48) Longitudinal and Transverse Cracking

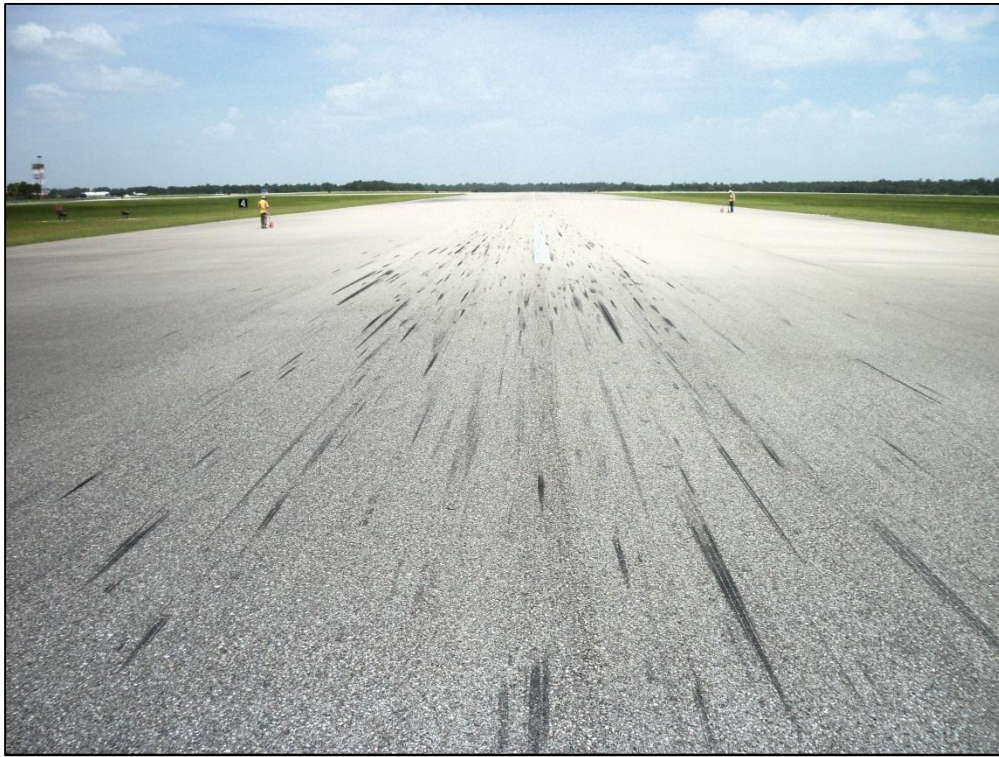
Runway 9L-27R, Section 6115, Sample Unit 310 –Medium Severity (57) Weathering

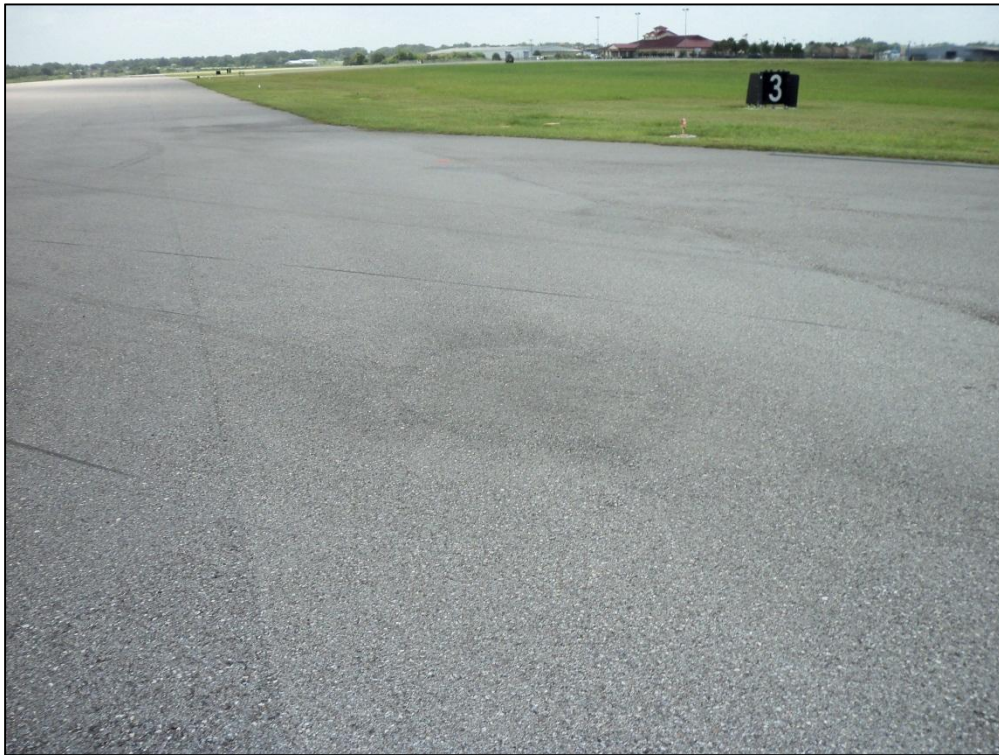
Runway 9L-27R, Section 6124, Sample Unit 160 –Low Severity (57) Weathering, Low Severity (45) Depression

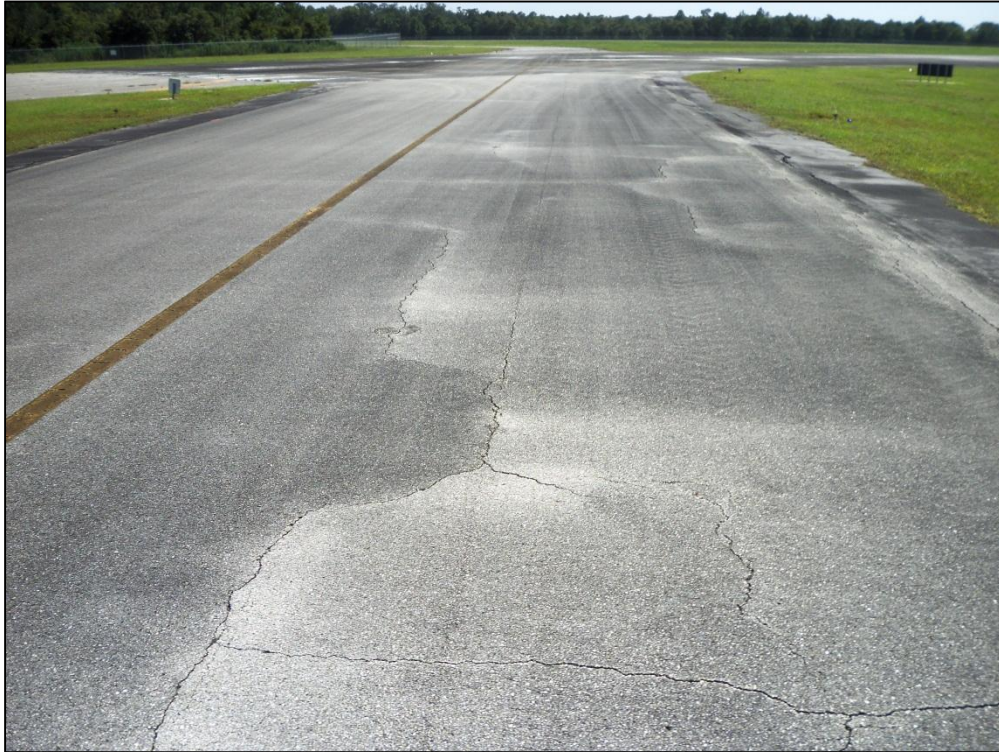
Taxiway A3, Section 115, Sample Unit 109 – Low Severity (52) Raveling, Low Severity (57) Weathering, Low and Medium Severity (48) Longitudinal and Transverse Cracking

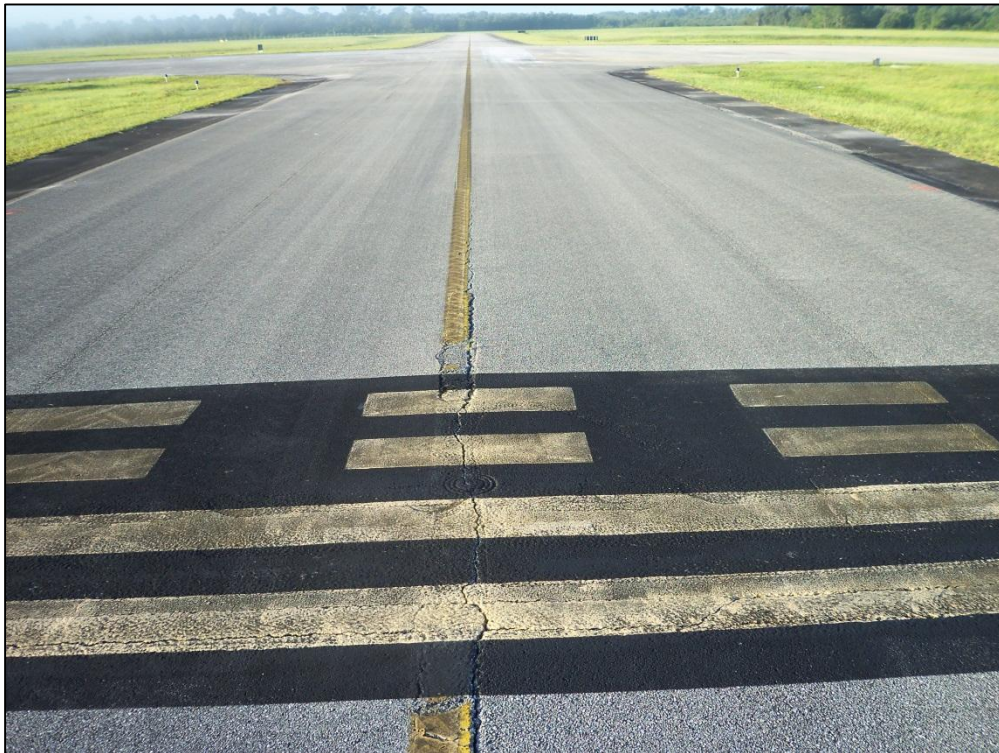
Taxiway C, Section 310, Sample Unit 106 – Low Severity (52) Raveling, Low Severity (57) Weathering, Low and Medium Severity (48) Longitudinal and Transverse Cracking

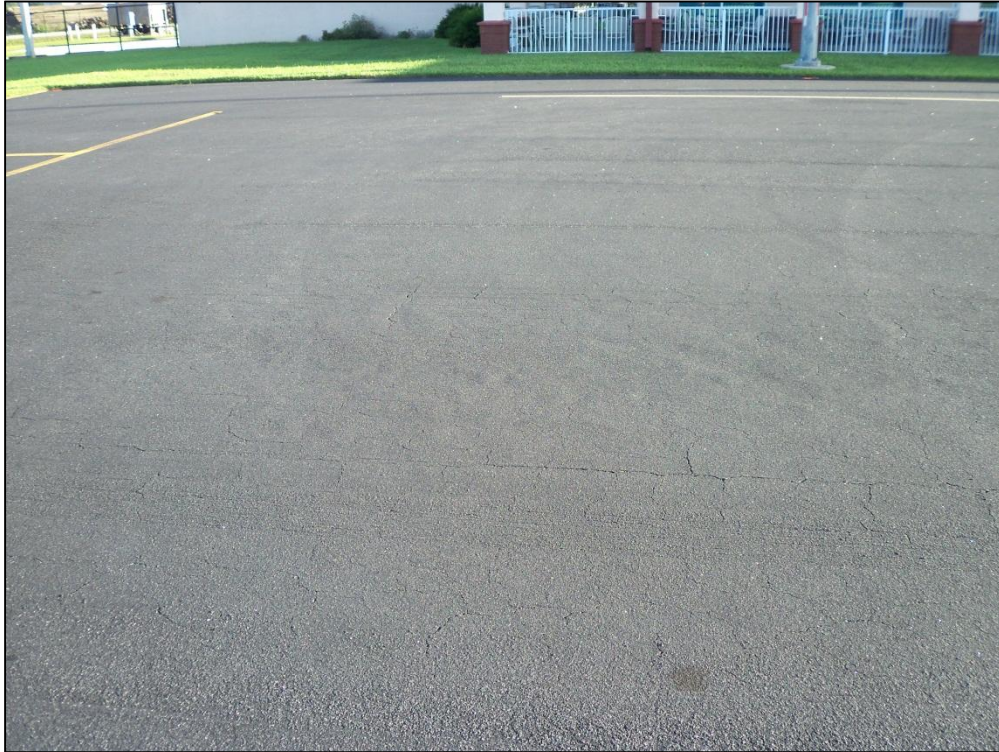
Apron FBO, Section 4405, Sample Unit 100 – Low Severity (57) Weathering

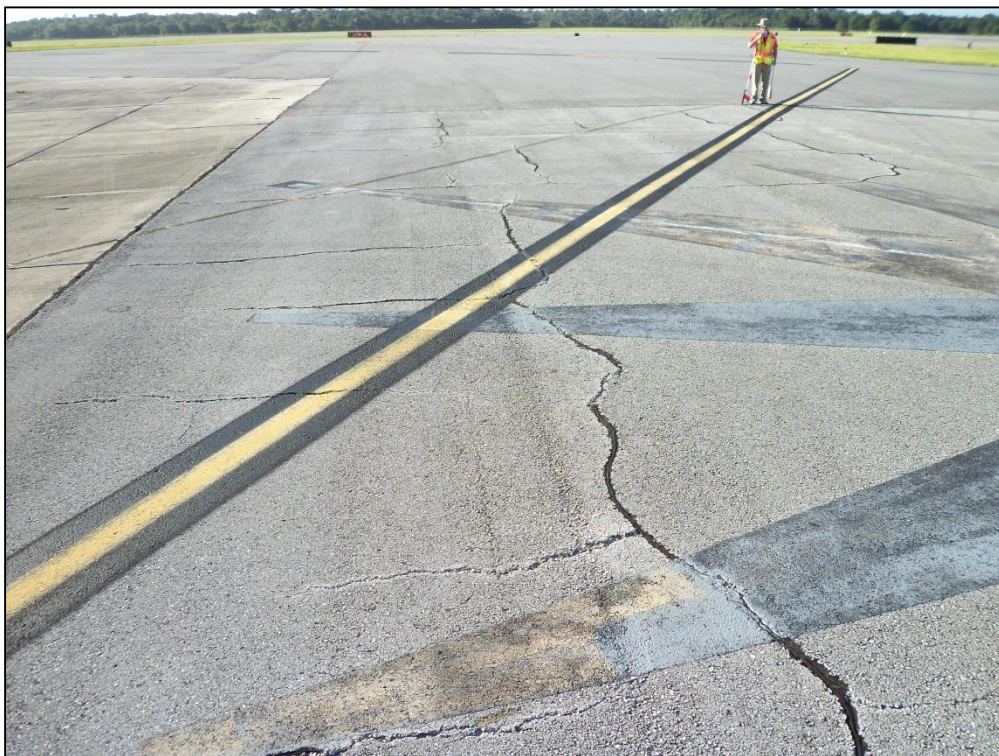
Apron North, Section 4105, Sample Unit 200 – Low and Medium Severity (52) Raveling, Medium Severity (43) Block Cracking

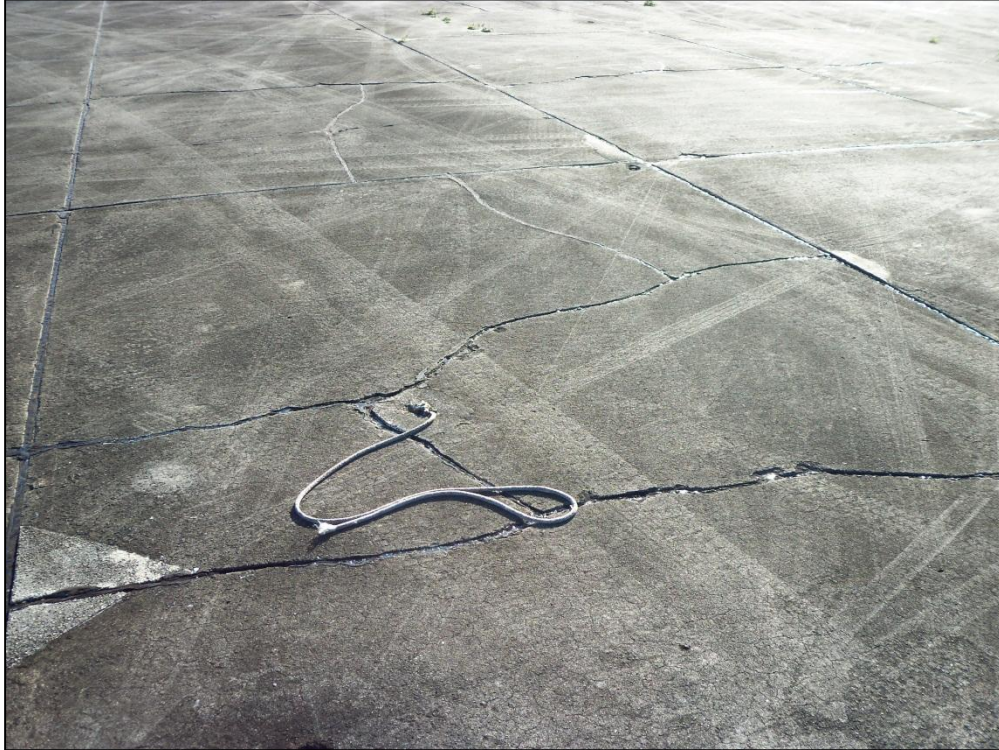
Apron North, Section 4110, Sample Unit 802 – Low Severity (72) Shattered Slab

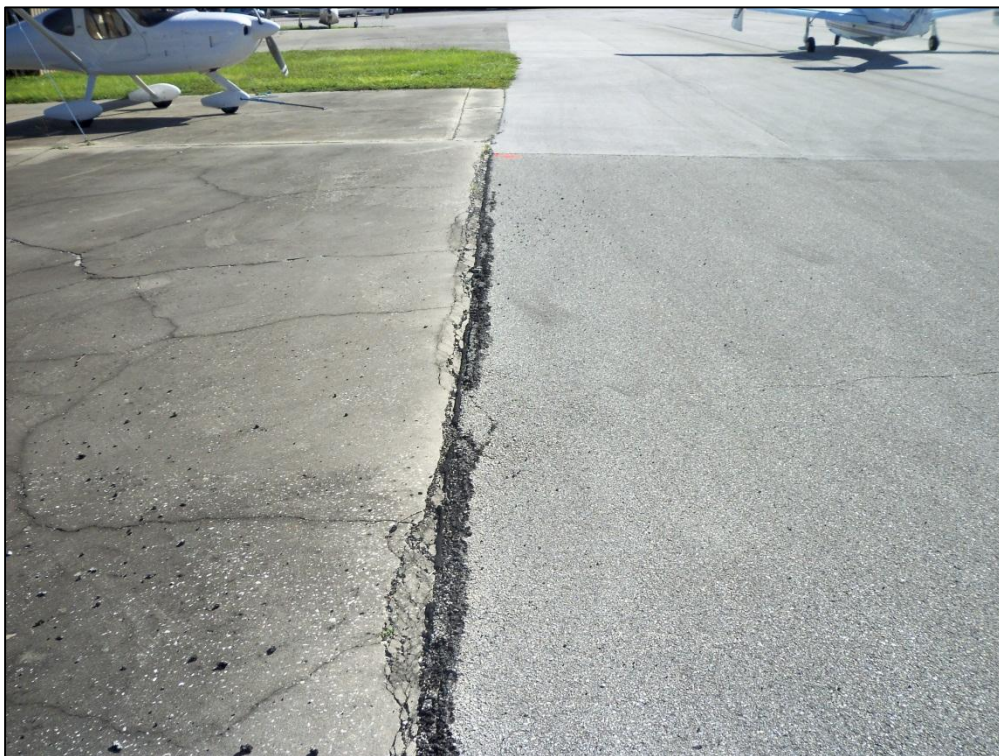
Apron North, Section 4120, Sample Unit 106 – Low Severity (52) Raveling, Low Severity (57) Weathering, Medium Severity (54) Shoving

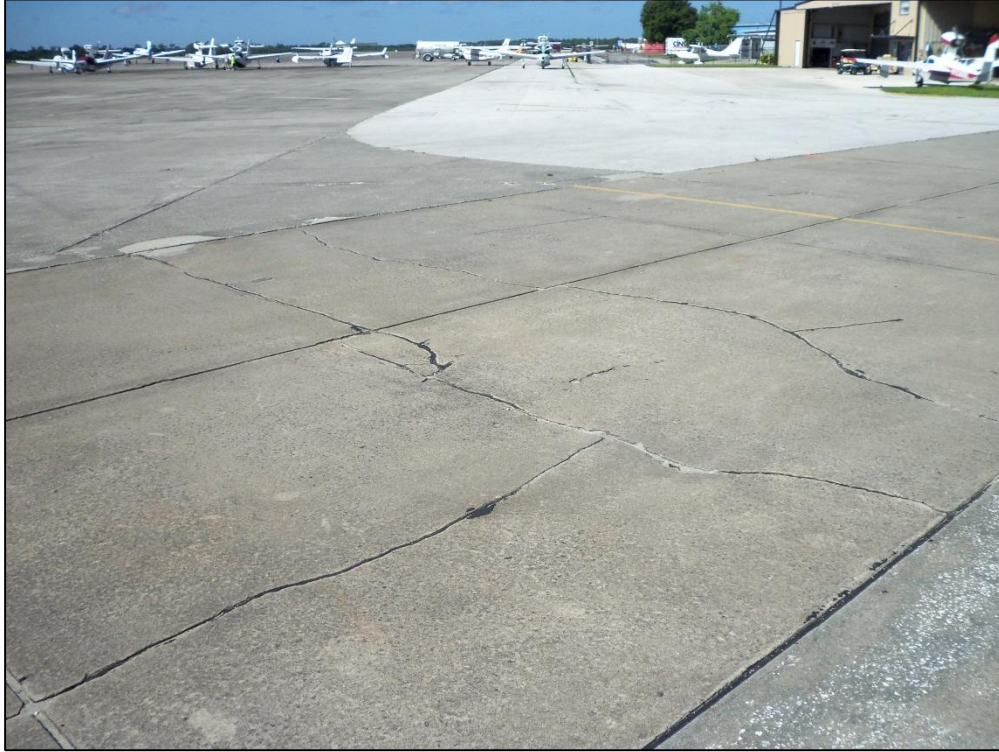
Apron North, Section 4132, Sample Unit 602 – Low Severity (72) Shattered Slab
