# FLORIDA DEPARTMENT OF TRANSPORTATION AVIATION AND SPACEPORT OFFICE

Pavement Evaluation Report - Bob Sikes Airport

In AUGUST 2013, a PCI survey inspection was performed at Bob Sikes Airport. The results of the inspection indicate that, based on ASTM D 5340-11, the airport's airfield pavement facilities had an overall area-weighted average PCI of 87, representing a GOOD overall network condition. Table I summarizes the overall condition summary by network level branch in comparison to the FDOT recommended minimum service level.

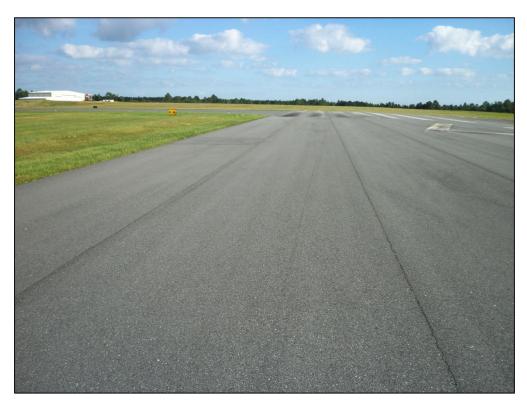
Runway 17-35 exhibited low severity weathering and longitudinal/transverse cracking with isolated locations of low severity raveling. The majority of the longitudinal/transverse cracking was within the first 2,000' of either end of the runway, where most of the cracking was occurring at the pavement joints.

Runway 17-35, Section 6130, Sample Unit 252 – Low Severity (48) Longitudinal and Transverse Cracking, Low Severity (57) Weathering

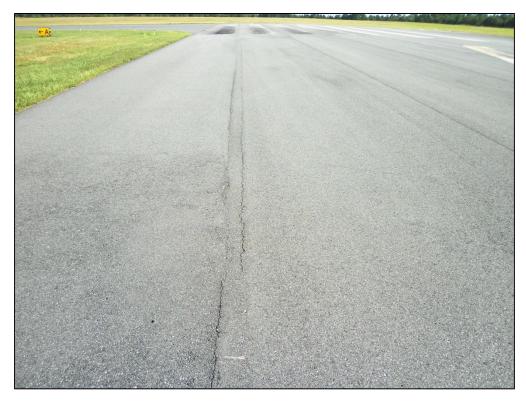
Runway 17-35, Section 6130, Sample Unit 252 – Low Severity (48) Longitudinal and Transverse Cracking, Low Severity (57) Weathering

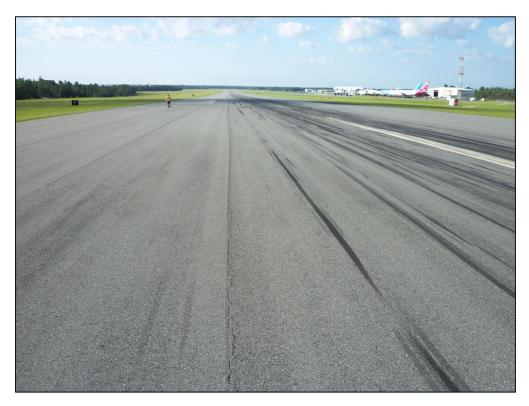
Runway 17-35, Section 6125, Sample Unit 445 – Low Severity (48) Longitudinal and Transverse Cracking, Low Severity (57) Weathering

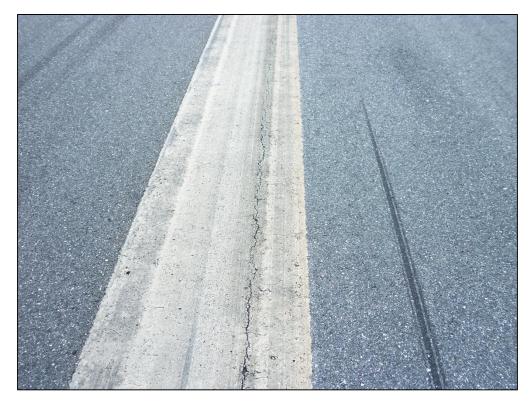
Runway 17-35, Section 6115, Sample Unit 346 – Low Severity (48) Longitudinal and Transverse Cracking, Low Severity (57) Weathering

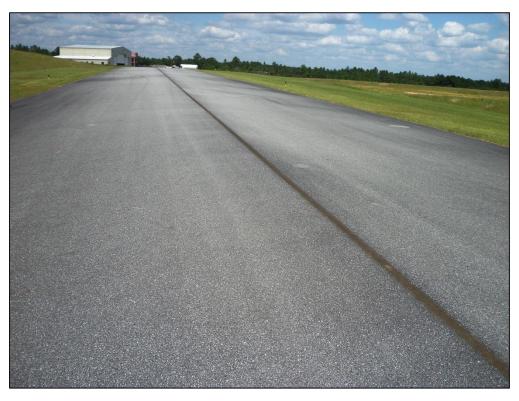
Taxiway PMV, Section 505, Sample Unit 109 - Low Severity (57) Weathering

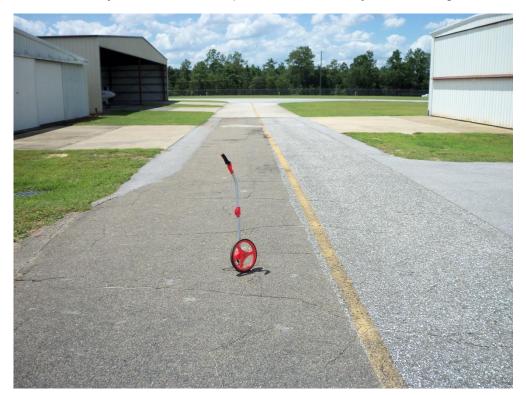
Apron Hang, Section 4210, Sample Unit 301 – Medium Severity (43) Block Cracking, Medium and High Severity (52) Raveling, Low, Medium, and High Severity (50) Patching

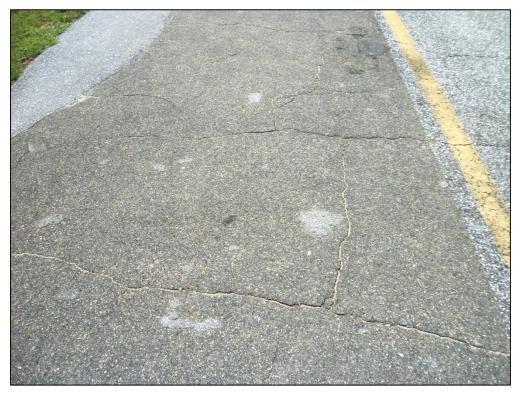
Apron Hang, Section 4210, Sample Unit 301 – Medium Severity (43) Block Cracking, Medium Severity (52) Raveling, Medium Severity (50) Patching

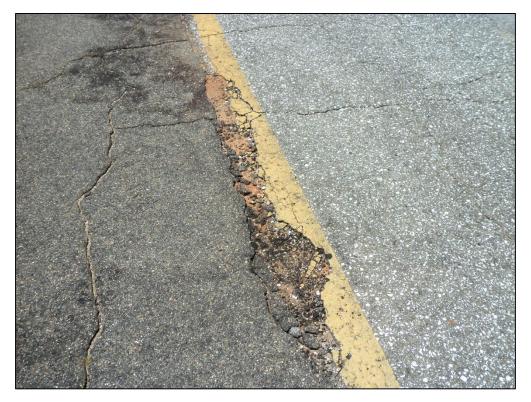
Apron Hang, Section 4210, Sample Unit 301 – Medium Severity (43) Block Cracking, Medium Severity (50) Patching, Medium and High Severity (52) Raveling

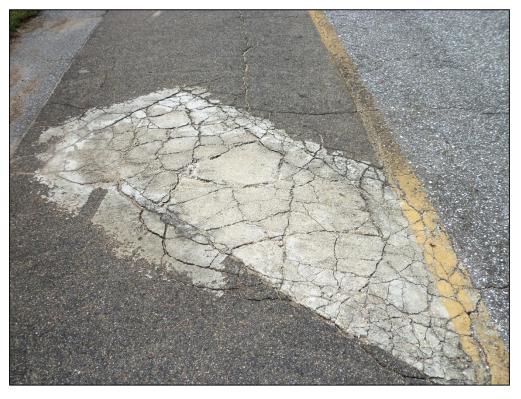
Apron Hang, Section 4210, Sample Unit 301 – High Severity (50) Patching

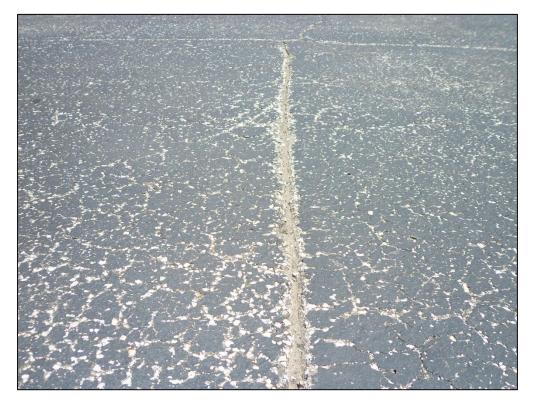
The portions of the apron that were inspected were located towards the southwest side of the airfield. These pavement sections were significantly aged which was reflected in the pavement distresses that were found. These pavement sections exhibited distresses such as low and medium severity block cracking, longitudinal/transverse cracking, swelling, raveling, and patching.

Apron, Section 4115, Sample Unit 207 – High Severity (48) Longitudinal and Transverse Cracking, Low Severity (52) Raveling, Low Severity (57) Weathering

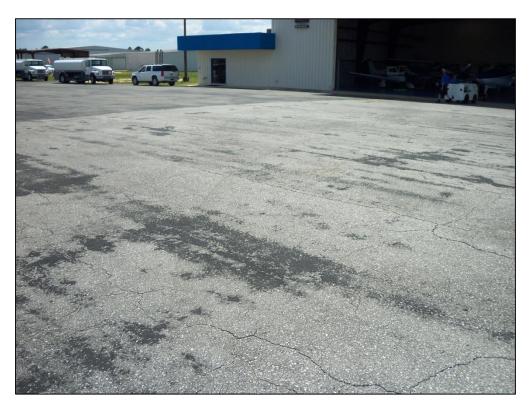
Apron, Section 4110, Sample Unit 306 – Low and Medium Severity (48) Longitudinal and Transverse Cracking, Low Severity (52) Raveling, Low Severity (57) Weathering, Low Severity (43) Block Cracking, Oil Spillage (49)

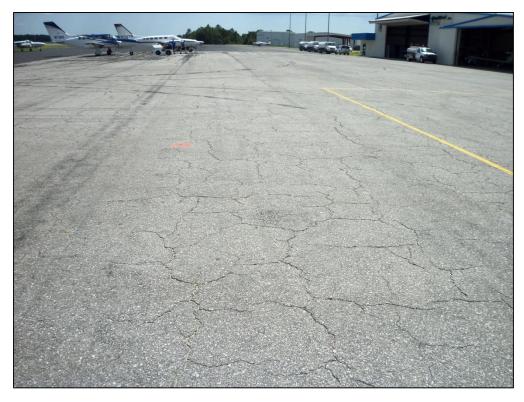
Apron, Section 4105, Sample Unit 410– Medium Severity (43) Block Cracking, Low Severity (52) Raveling, Medium Severity (57) Weathering
