FLORIDA DEPARTMENT OF TRANSPORTATION
AVIATION AND SPACEPORT OFFICE

WAUCHULA
MUNICIPAL
AIRPORT (CHN)

DECEMBER 2013

STATEWIDE Airfield Pavement Management PROGRAM

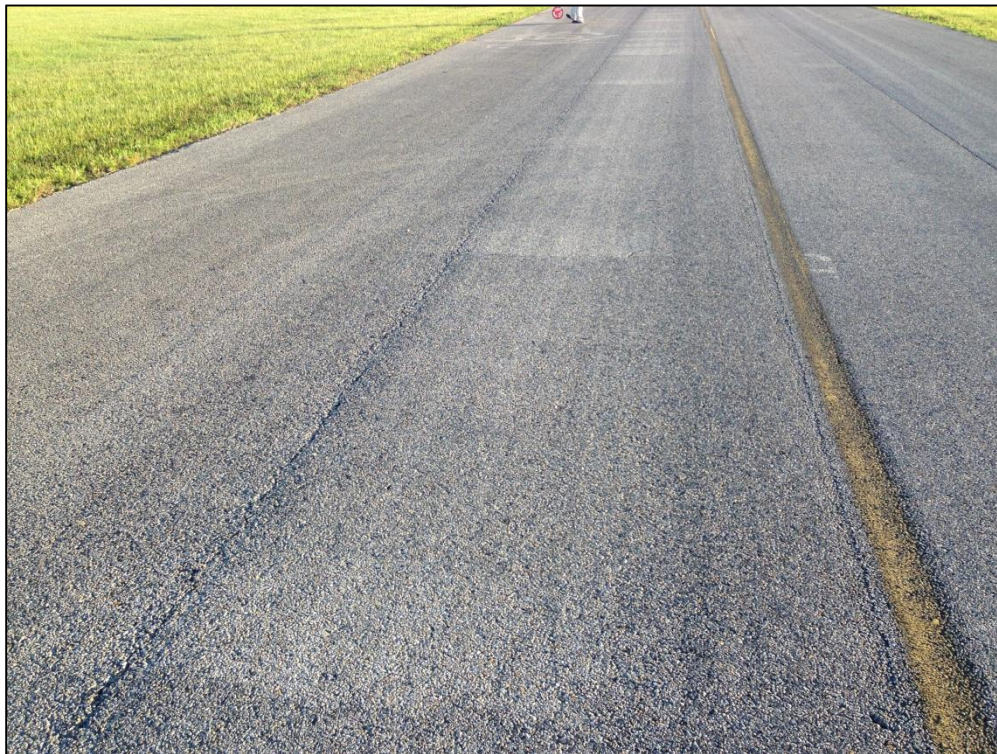
Taxiway Parallel, Section 125, Sample Unit 101 – Low Severity (48) Longitudinal and Transverse Cracking, Low Severity (52) Raveling, Low Severity (57) Weathering

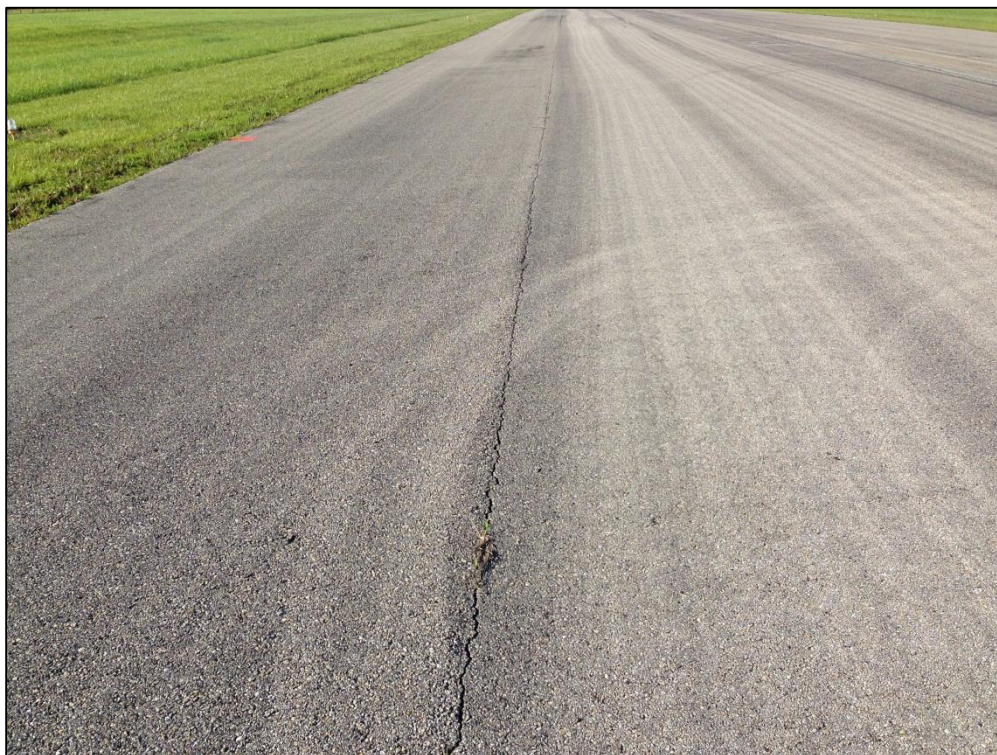
Runway 18-36, Section 6105, Sample Unit 136 – Low Severity (48) Longitudinal and Transverse Cracking, Low Severity (52) Raveling, Low Severity (57) Weathering

- Runway 18-36 – Section 6105
 - Mill and Overlay attributed to distresses related to climate and age of pavement.
- Taxiway to Hangars – Sections 235, 210, and 205
 - Mill and Overlay attributed to distresses related to subgrade quality, PCC pavement movement, climate, and age of pavement.
- Parallel Taxiway – Sections 160, 125, 120, 115, and 110
 - Mill and Overlay attributed to distresses related to climate and age of pavement.
- Parallel Taxiway – Section 105
 - Reconstruction attributed to distresses related to subgrade quality, climate, and age of pavement.

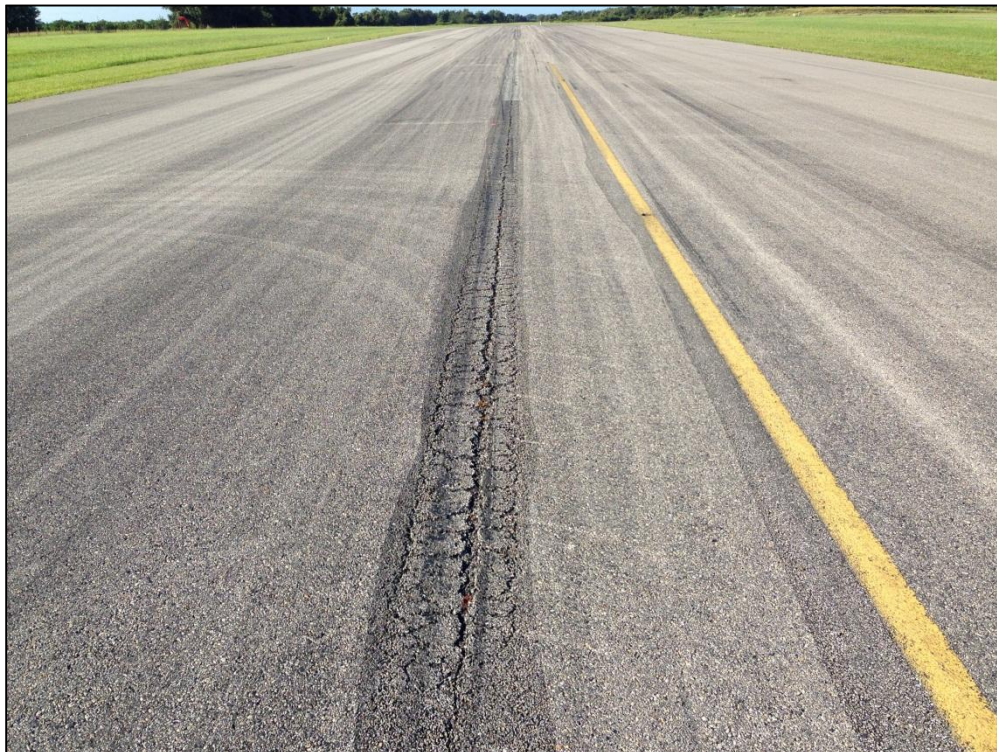
Runway 18-36, Section 6105, Sample Unit 136 – Low Severity (48) Longitudinal and Transverse Cracking, Low Severity (52) Raveling, Low Severity (57) Weathering

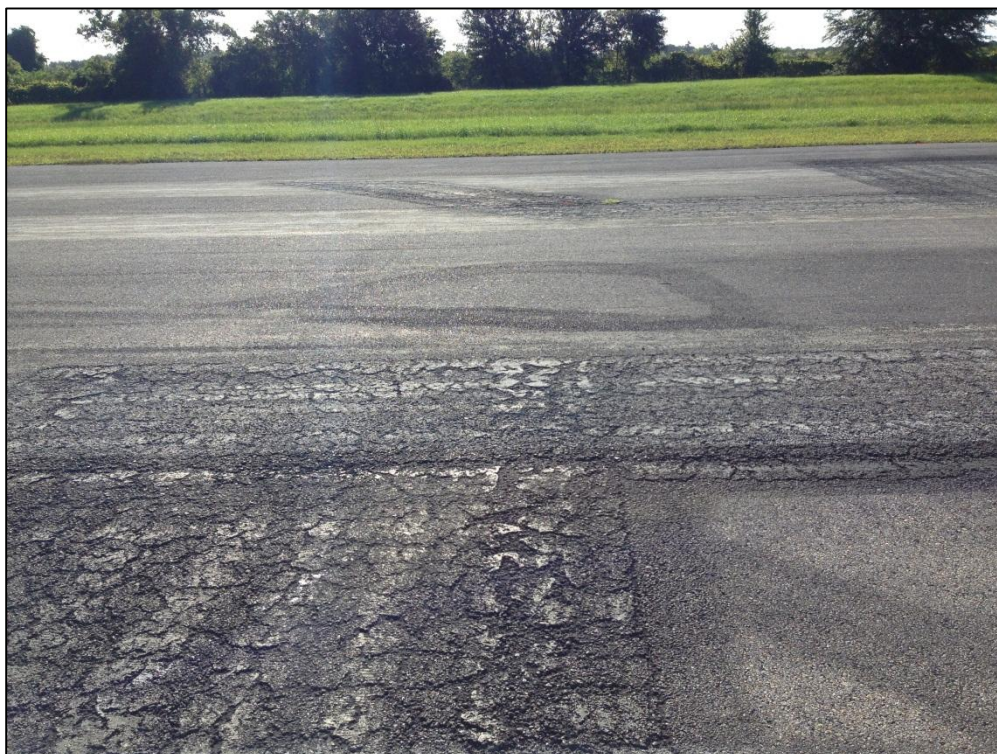
Runway 18-36, Section 6105, Sample Unit 101 – Low Severity (48) Longitudinal and Transverse Cracking, Low and Medium Severity (52) Raveling, Low Severity (57) Weathering

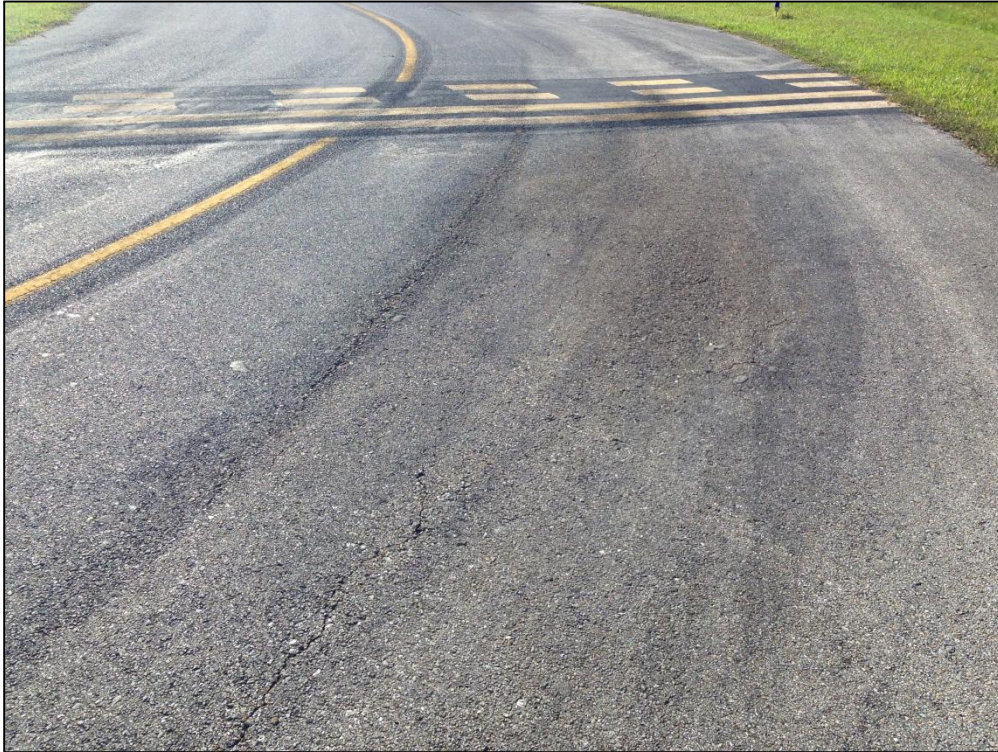
Taxiway Parallel, Section 105, Sample Unit 101 – Low Severity (48) Longitudinal and Transverse Cracking, Low Severity (52) Raveling, Low Severity (57) Weathering, Low Severity (45) Depression

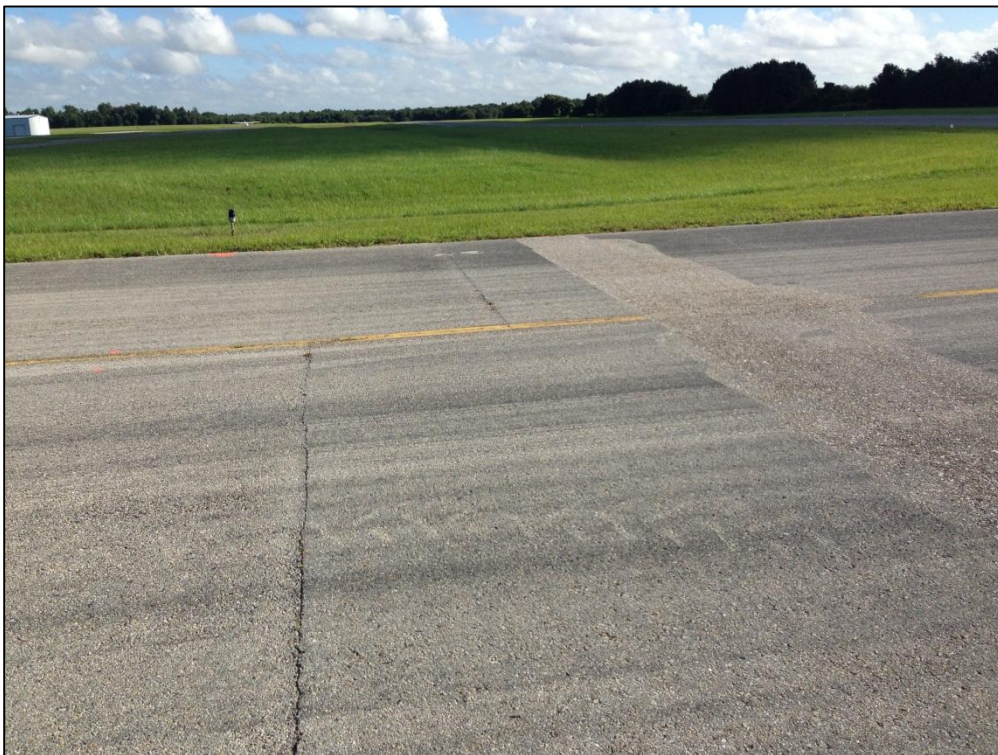
Taxiway T-Hangar, Section 205, Sample Unit 100 – Low Severity (48) Longitudinal and Transverse Cracking, Low Severity (52) Raveling, Low Severity (57) Weathering

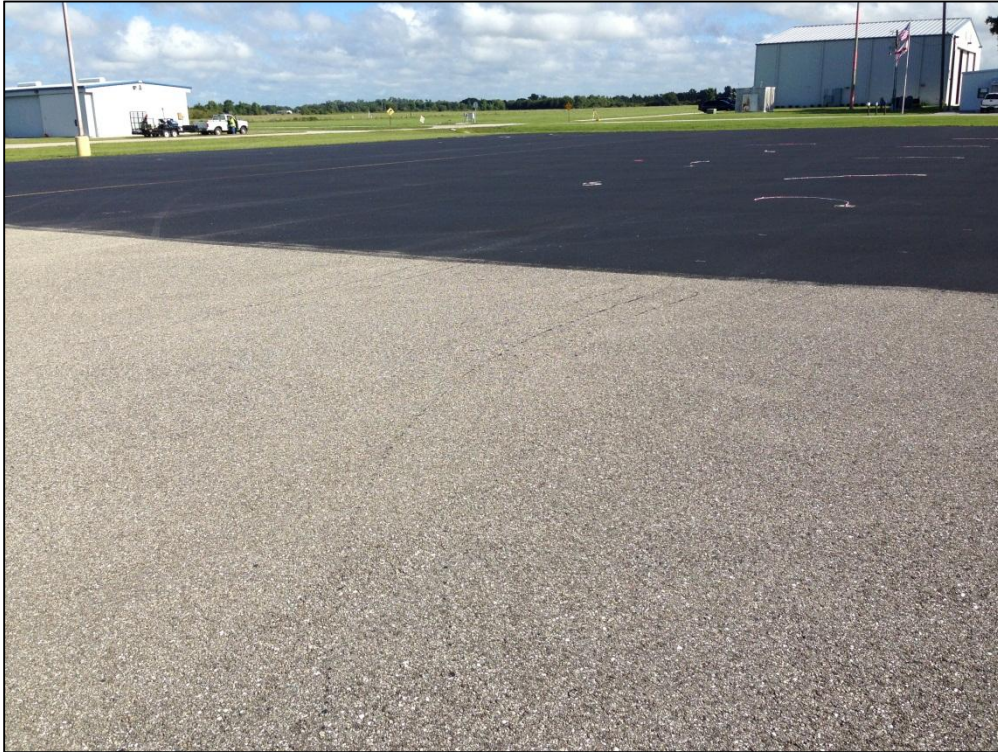
Apron, Section 4105, Sample Unit 102 – Low Severity (52) Raveling, Low Severity (57) Weathering

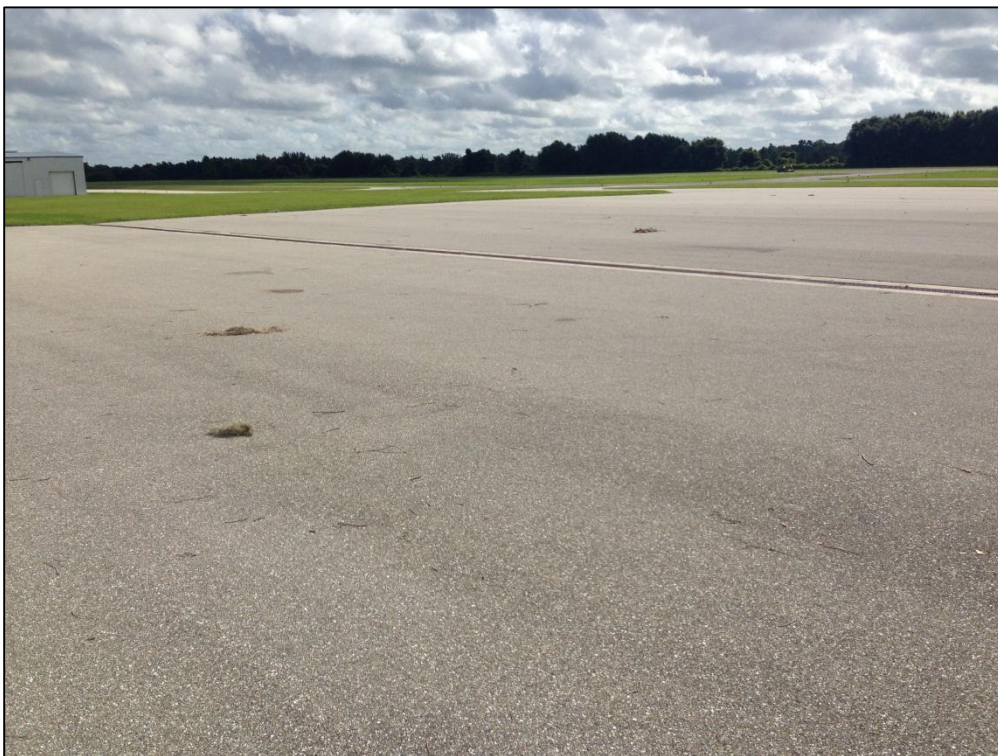
Apron, Section 4205, Sample Unit 101 – Low Severity (57) Weathering

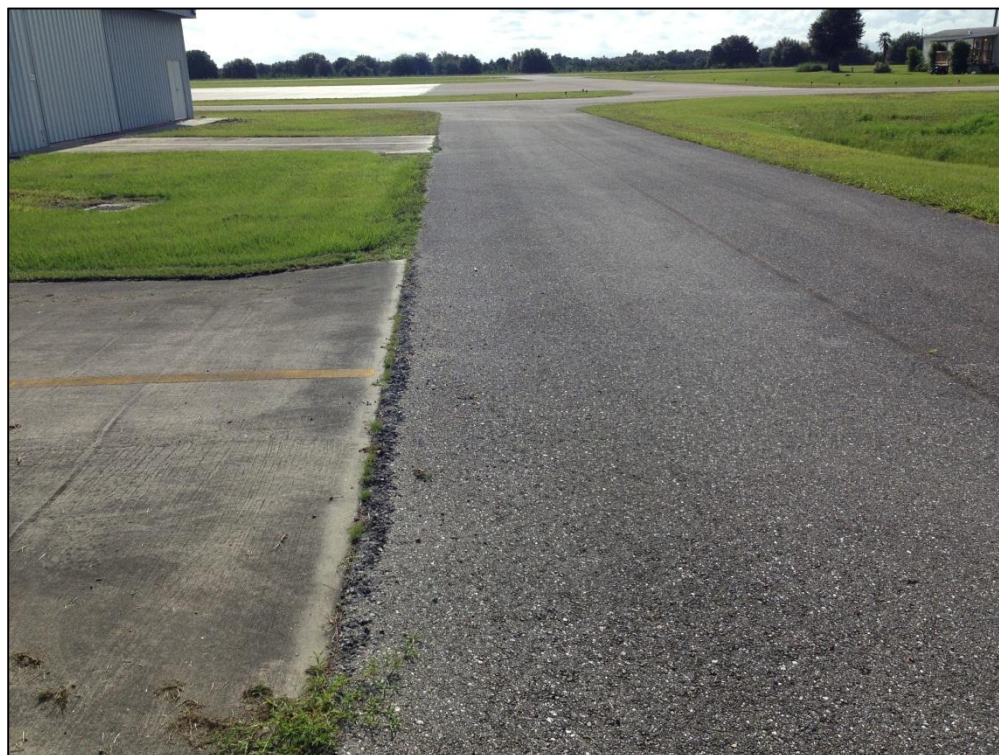
Taxiway T-Hangar, Section 210, Sample Unit 102 – Low Severity (52) Raveling, Low Severity (57) Weathering, Low Severity (54) Shoving

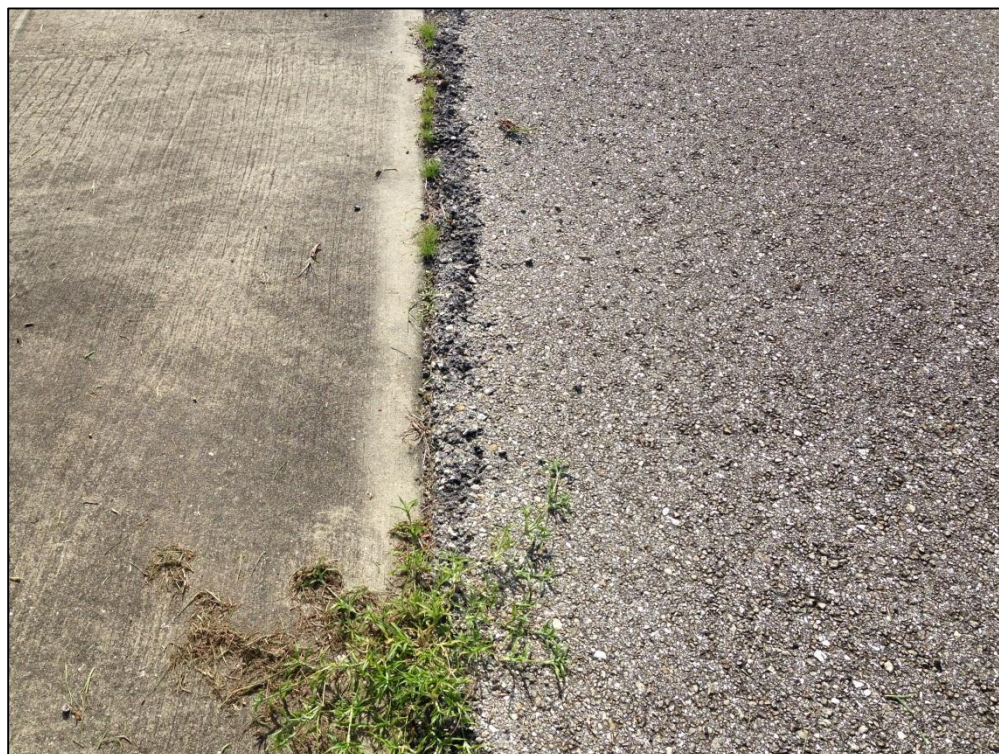
Taxiway T-Hangar, Section 210, Sample Unit 102 – Low Severity (52) Raveling, Low Severity (57) Weathering, Low Severity (54) Shoving

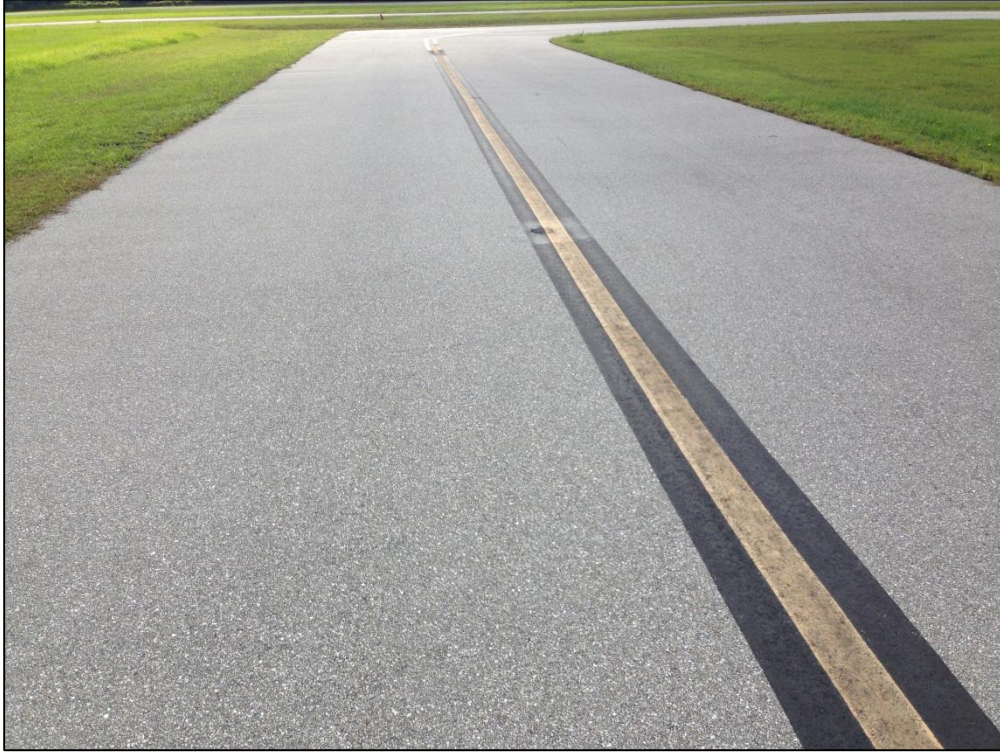
T-Hangar North, Section 240, Sample Unit 400 – Low Severity (57) Weathering
