FLORIDA DEPARTMENT OF TRANSPORTATION
AVIATION AND SPACEPORT OFFICE

MERRITT ISLAND
AIRPORT (COI)

DECEMBER 2013

STATEWIDE Airfield Pavement Management PROGRAM

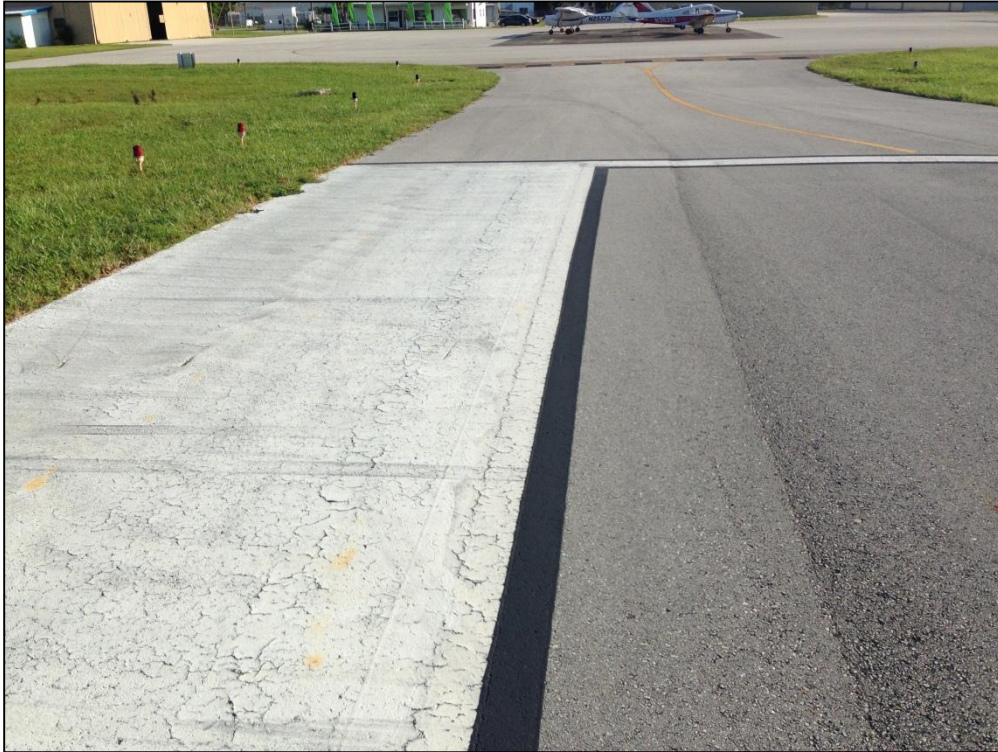
Runway 11-29, Section 6105, Sample Unit 100 – Low Severity (48) Longitudinal and Transverse Cracking, Low Severity (57) Weathering, Low Severity (52) Raveling

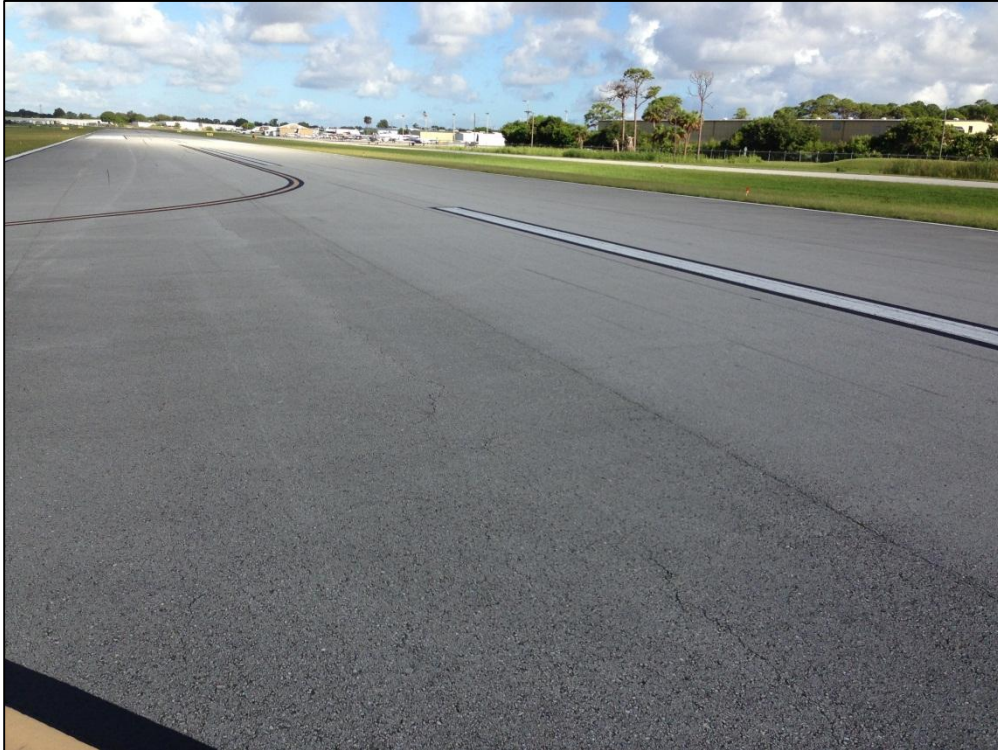
Runway 11-29, Section 6105, Sample Unit 103 – Low Severity (48) Longitudinal and Transverse Cracking, Low Severity (57) Weathering, Low Severity (52) Raveling

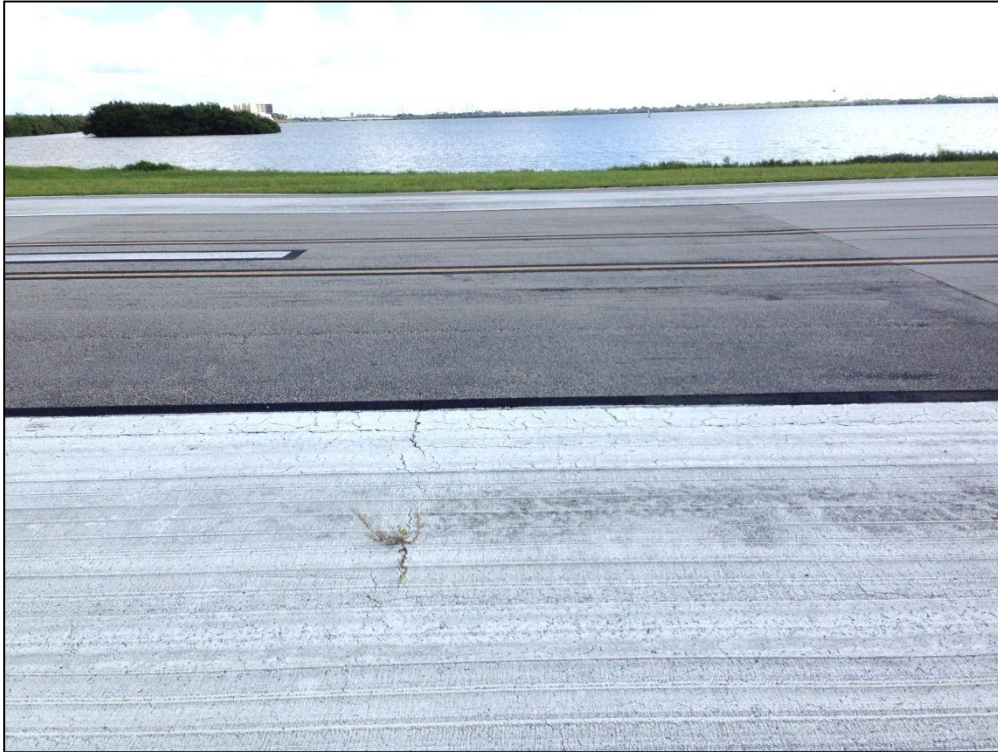
Runway 11-29, Section 6105, Sample Unit 149 – Low Severity (48) Longitudinal and Transverse Cracking, Low Severity (57) Weathering, Low Severity (52) Raveling

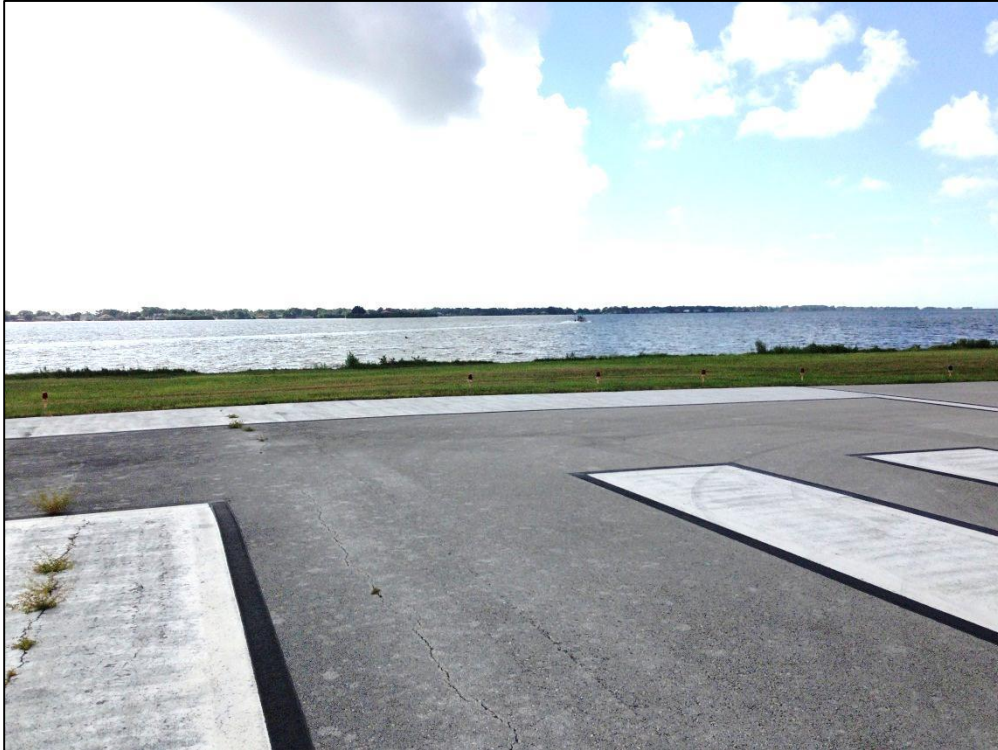
Runway 11-29, Section 6105, Sample Unit 167 – Low Severity (48) Longitudinal and Transverse Cracking, Low Severity (57) Weathering, Low Severity (52) Raveling

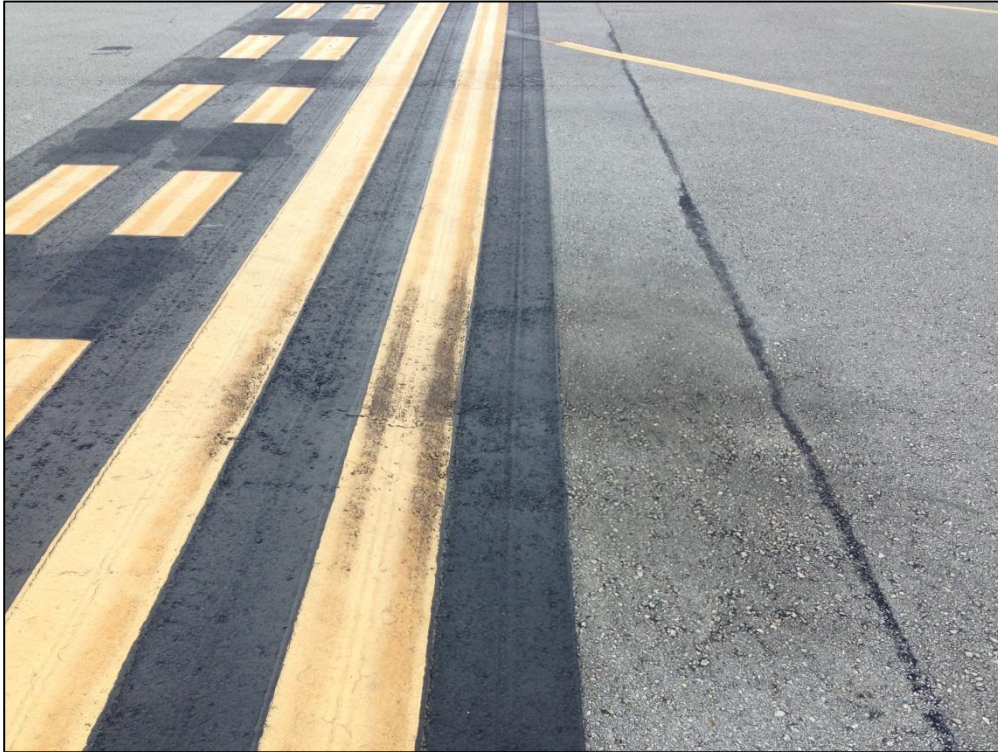
Taxiway A, Section 110, Sample Unit 101 – Low Severity (48) Longitudinal and Transverse Cracking, Low Severity (45) Depression, Low Severity (52) Raveling

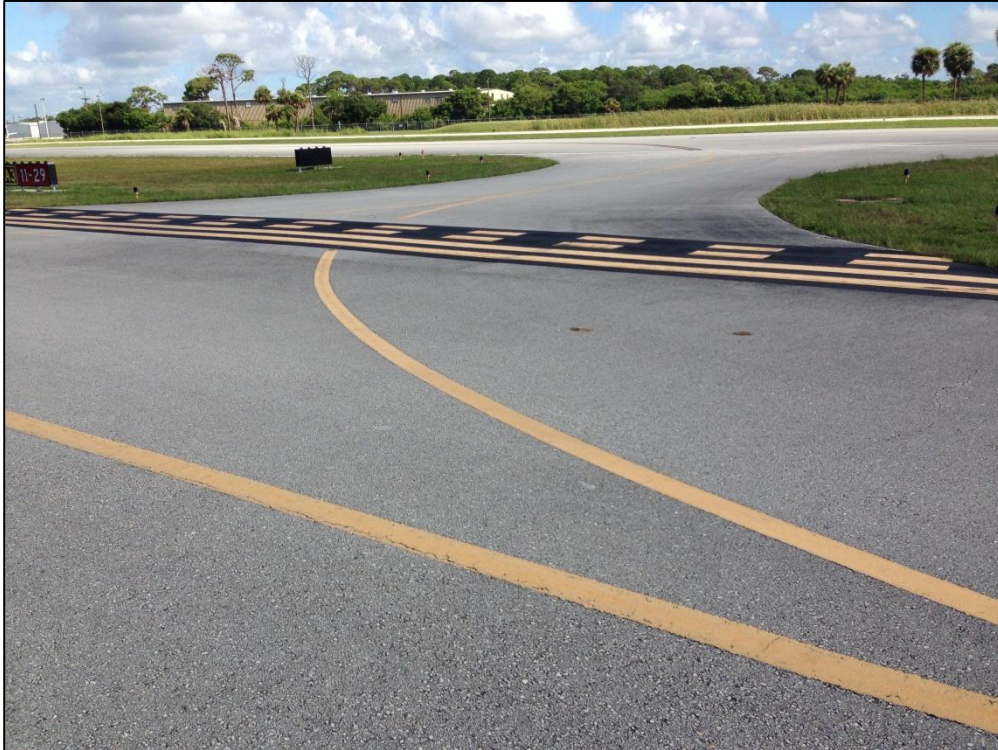
Taxiway A, Section 105, Sample Unit 115 – Low Severity (48) Longitudinal and Transverse Cracking, Low Severity (57) Weathering

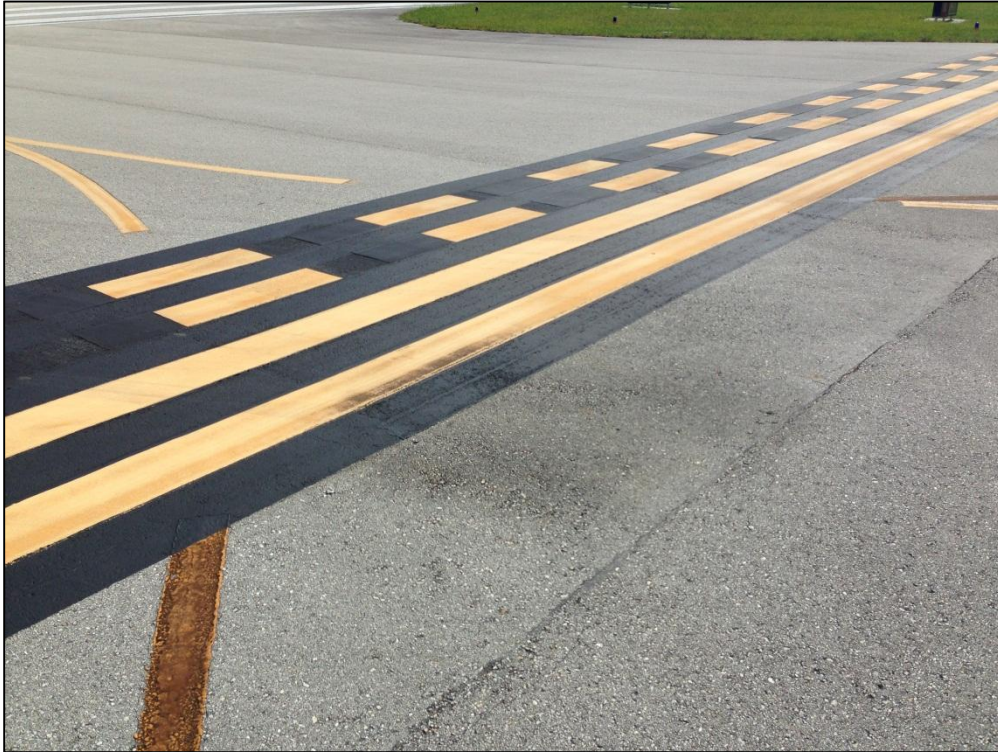
Taxiway A1, Section 305, Sample Unit 101 – Low Severity (48) Longitudinal and Transverse Cracking, Low Severity (45) Depression, Low Severity (57) Weathering

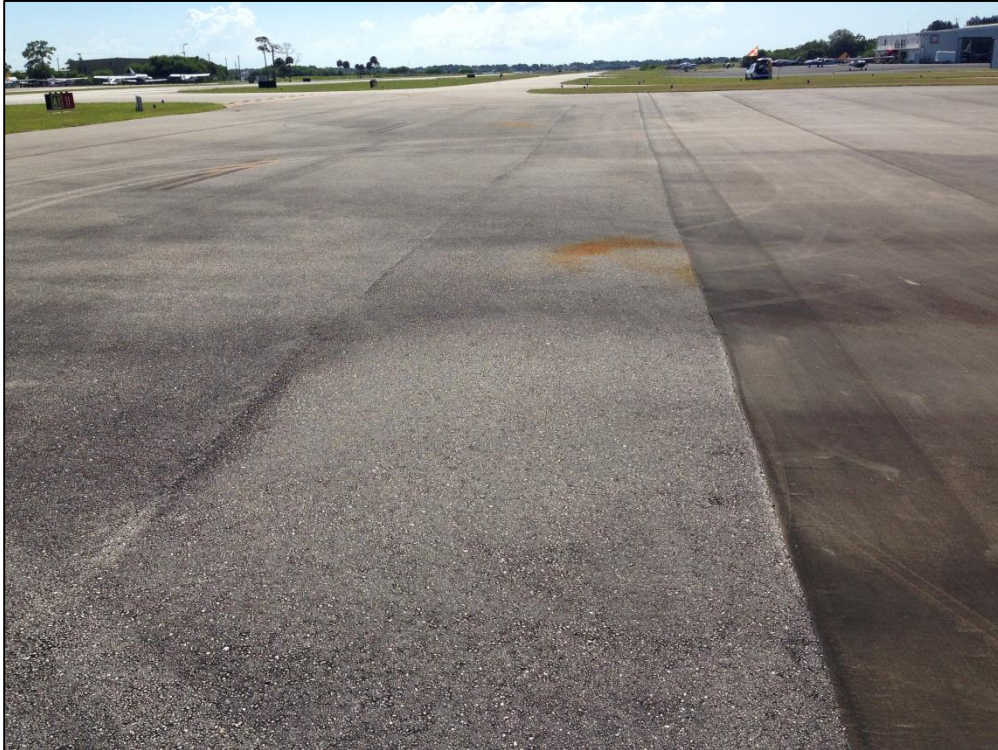
Apron SW, Section 4310, Sample Unit 101 – Low Severity (48) Longitudinal and Transverse Cracking, Low Severity (57) Weathering

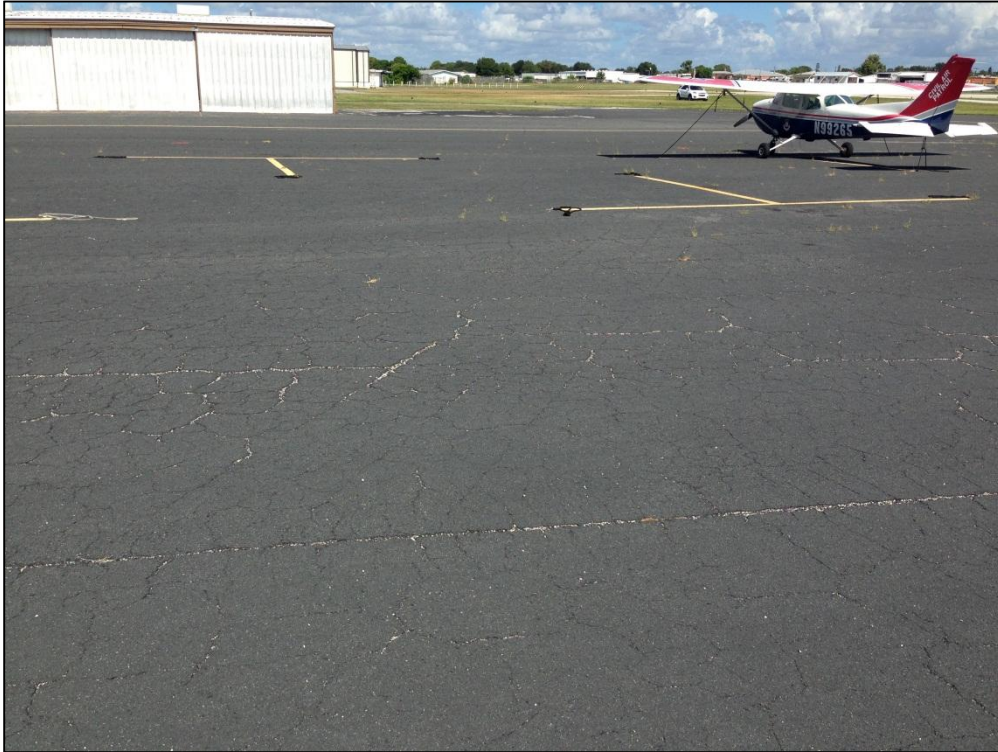
Apron S, Section 4115, Sample Unit 406 –Medium Severity (43) Block Cracking, Medium Severity (52) Raveling

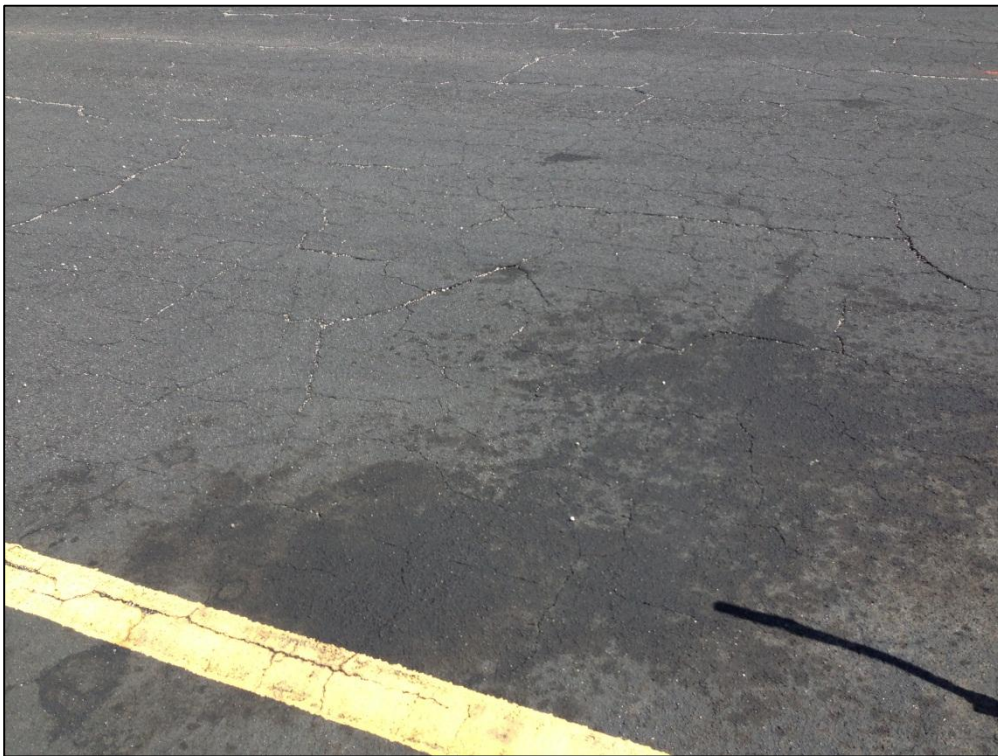
Apron S, Section 4105, Sample Unit 201 –Medium Severity (43) Block Cracking, Medium Severity (52) Raveling, Oil Spillage (49)

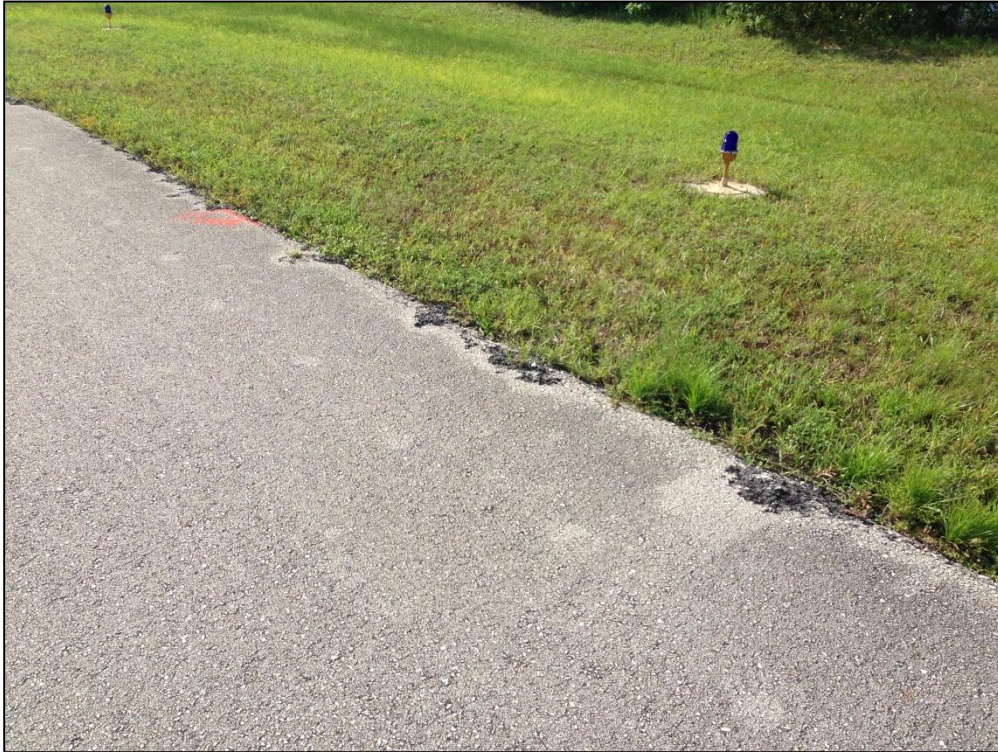
Apron Run-Up Runway 29, Section 5105, Sample Unit 102 – Low Severity (57) Weathering, Medium Severity (52) Raveling

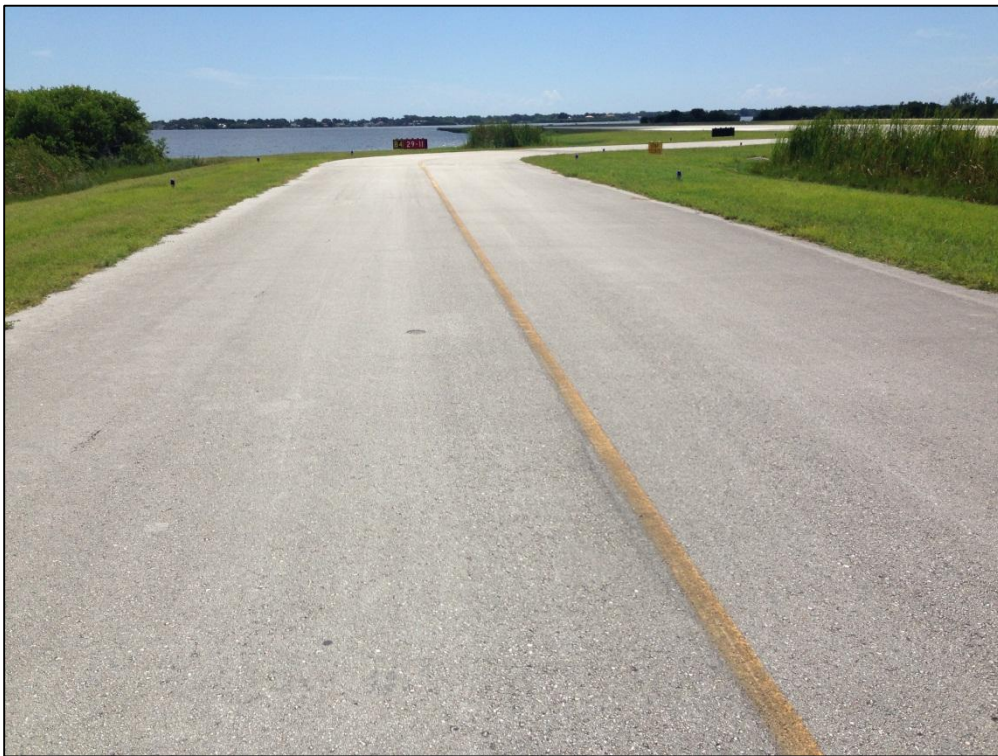
Taxiway B, Section 210, Sample Unit 123 – Low Severity (57) Weathering, Low Severity (52) Raveling

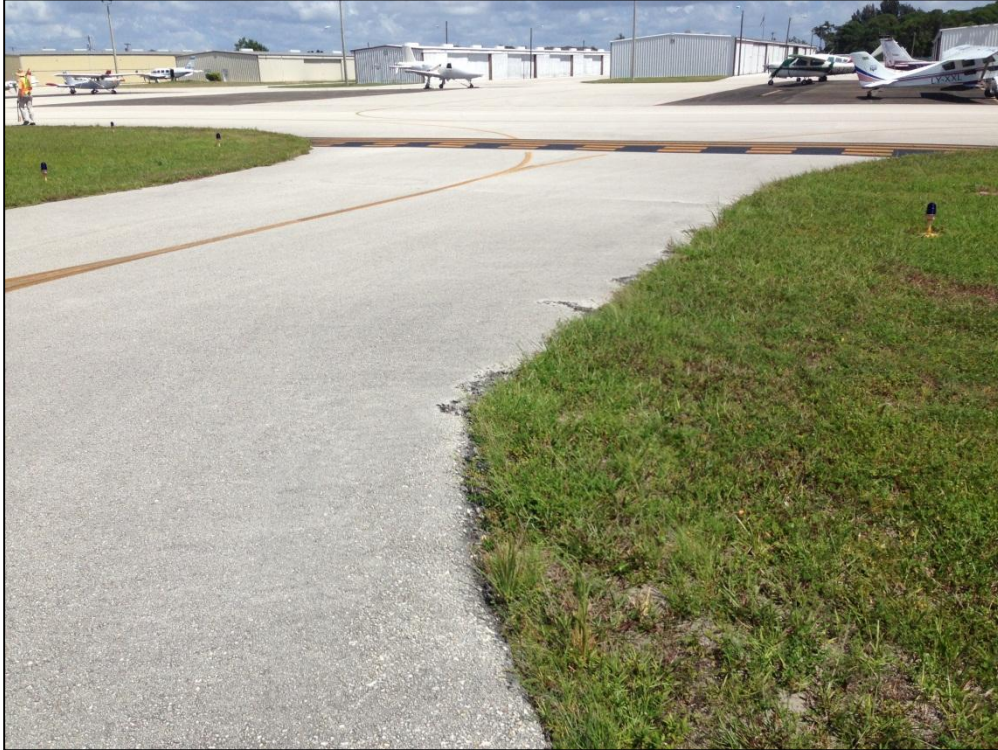
Taxiway B4, Section 410, Sample Unit 400 – Low Severity (48) Longitudinal and Transverse Cracking, Low Severity (57) Weathering, Low and Medium Severity (52) Raveling

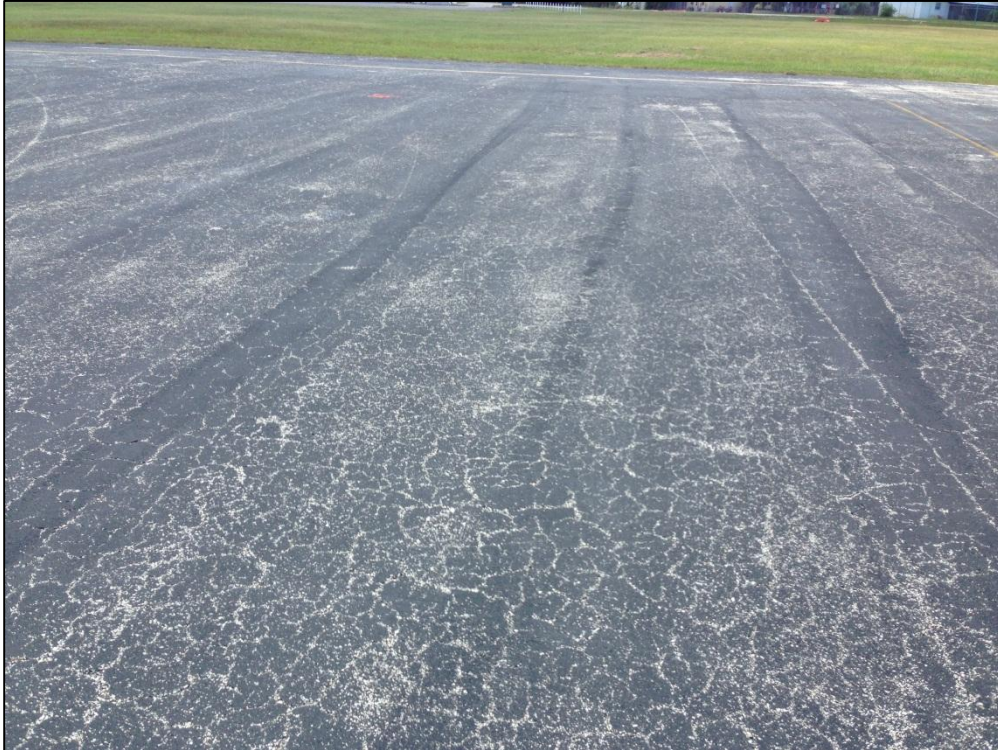
Apron N, Section 4205, Sample Unit 197 – Medium Severity (43) Block Cracking, Medium Severity (52) Raveling

- Apron North – Section 4205
 - Reconstruction attributed to distresses related to climate and age of pavement.
- Apron North – Section 4203
 - PCC Restoration attributed to distresses related to loading and construction quality.
- Apron South – Sections 4115, 4111, 4110, 4106, and 4105
 - Reconstruction attributed to distresses related to subgrade quality, climate, and age of pavement.
- Taxiway A1 – Sections 305
 - Mill and Overlay attributed to distresses related to subgrade quality, climate, and age of pavement.
- Taxiway B – Sections 205
 - Mill and Overlay attributed to distresses related to climate and age of pavement.

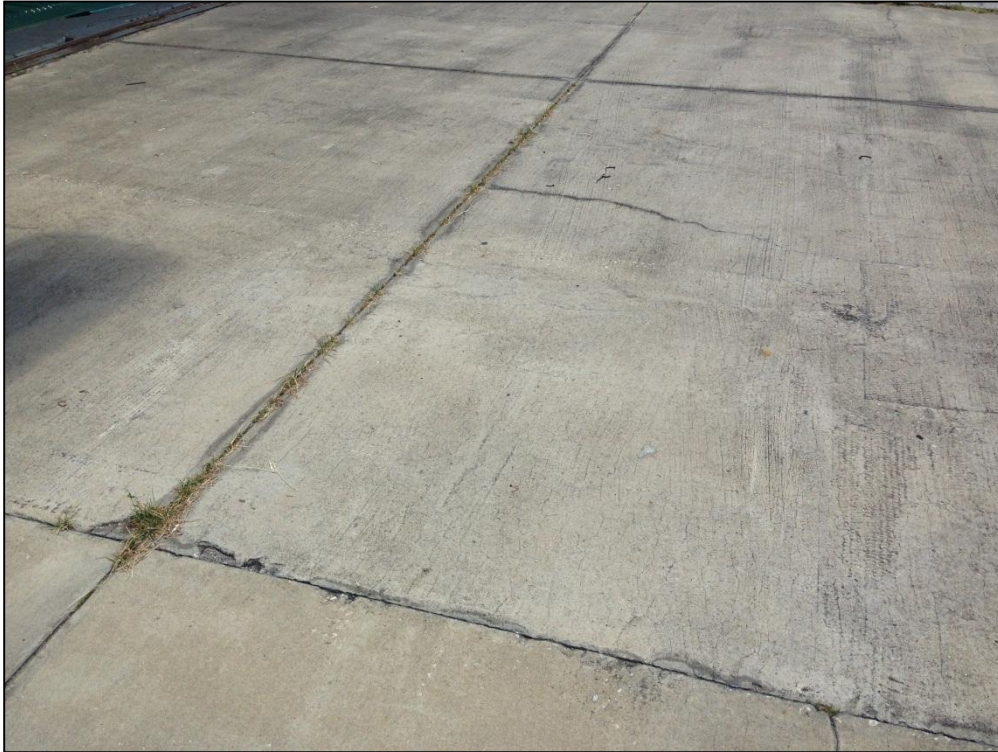
Apron N, Section 4203, Sample Unit 100 – Low Severity (70) Scaling, Map Cracking, Crazing, Low Severity (74) Joint Spalling, Shrinkage Cracking (73)

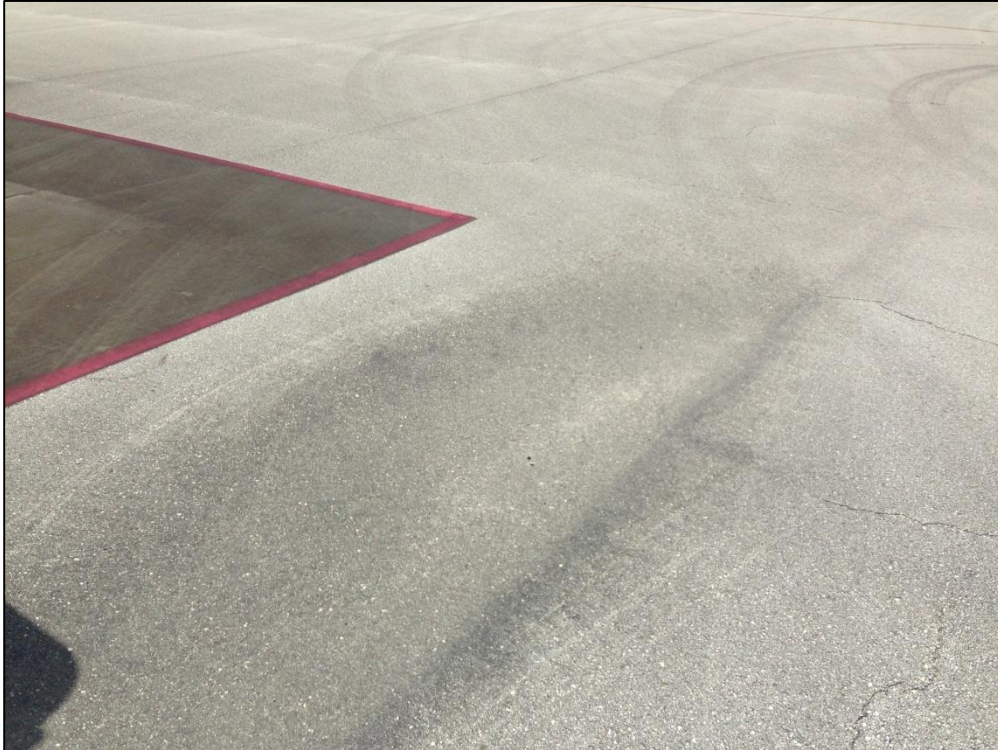
Apron N, Section 4215, Sample Unit 355 – Low Severity (48) Longitudinal and Transverse Cracking, Low Severity (57) Weathering, Low Severity (45) Depression
