FLORIDA DEPARTMENT OF TRANSPORTATION
AVIATION AND SPACEPORT OFFICE

CROSS CITY
AIRPORT (CTY)

DECEMBER 2013

STATEWIDE Airfield Pavement Management PROGRAM

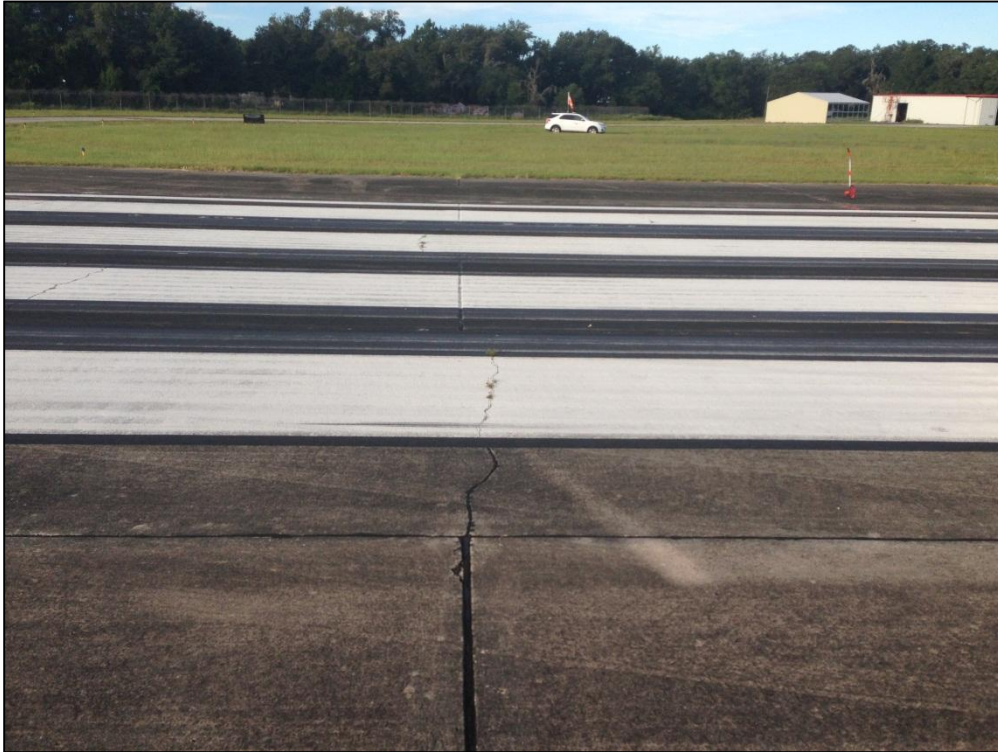
Runway 13-31, Section 6110, Sample Unit 196 – Medium Severity (65) Joint Seal Damage, Low Severity (63) Longitudinal, Transverse, and Diagonal Cracking

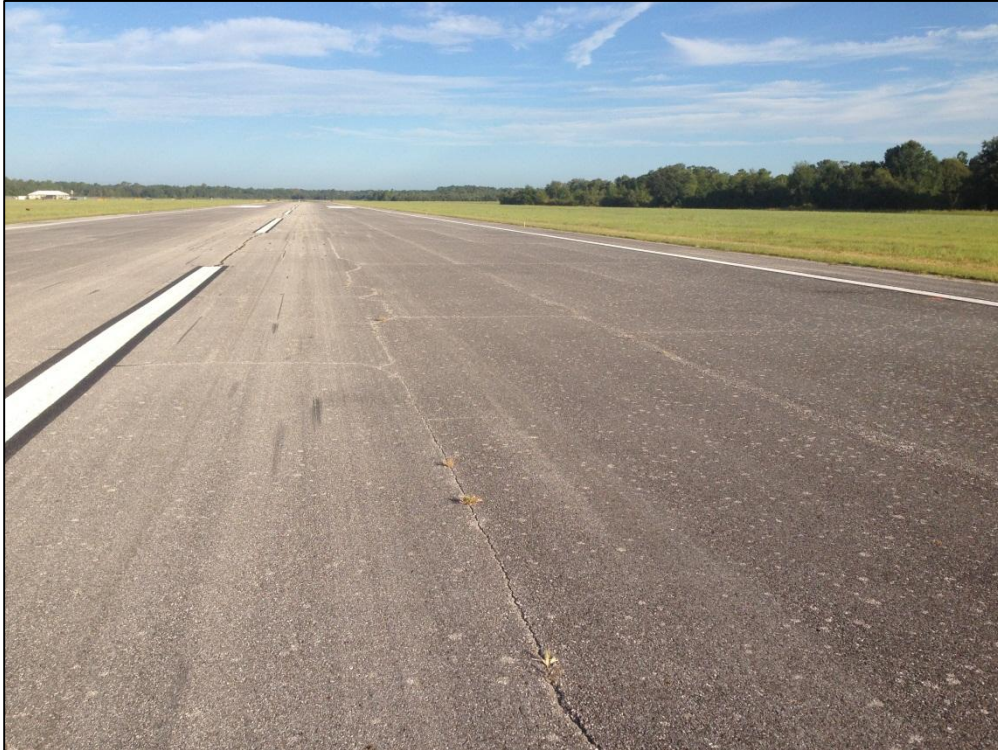
Runway 13-31, Section 6105, Sample Unit 192 – Low and Medium Severity (48) Longitudinal and Transverse Cracking, Low Severity (57) Weathering, Low Severity (52) Raveling

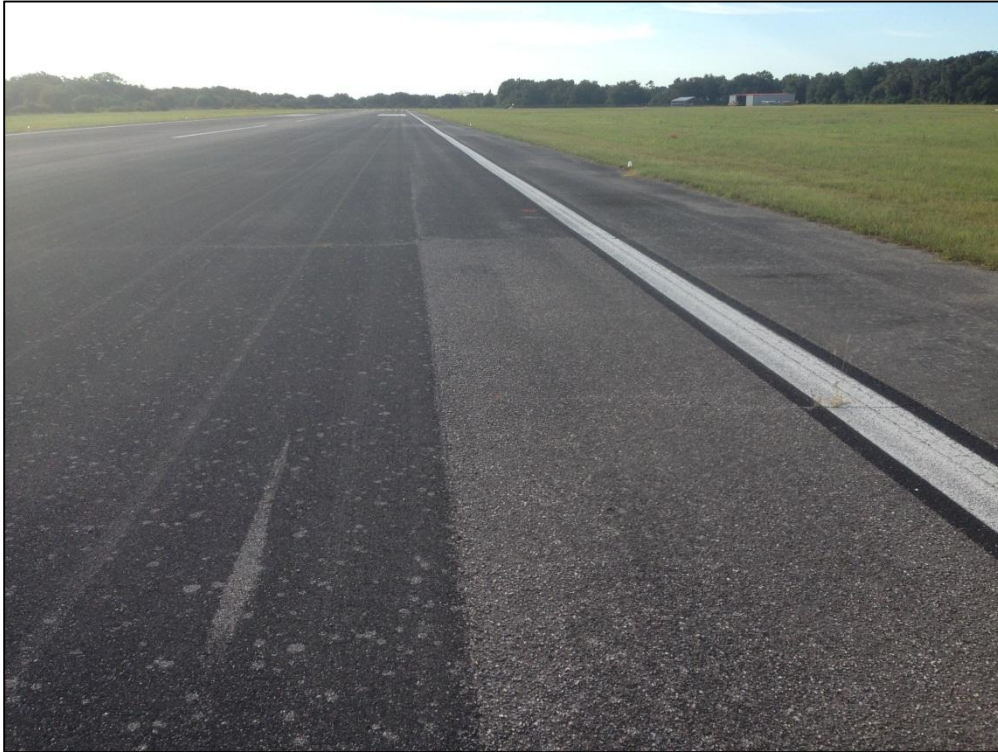
Runway 13-31, Section 6105, Sample Unit 164 – Low, Medium, and High Severity (52) Raveling

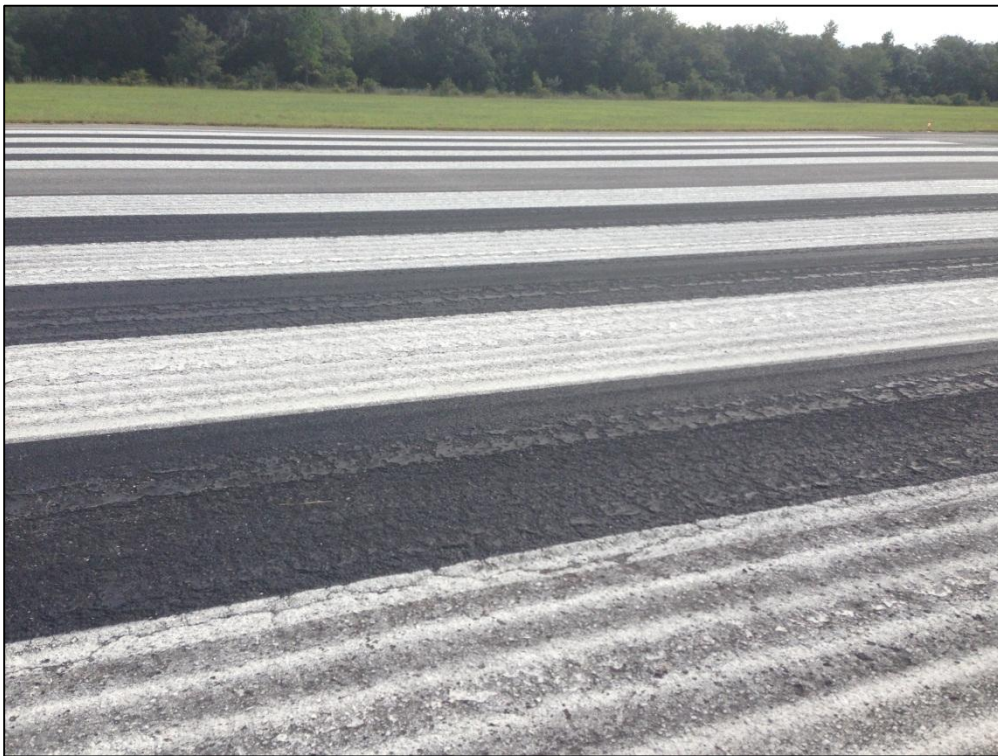
Runway 13-31, Section 6105, Sample Unit 101 – Medium and High Severity (52) Raveling

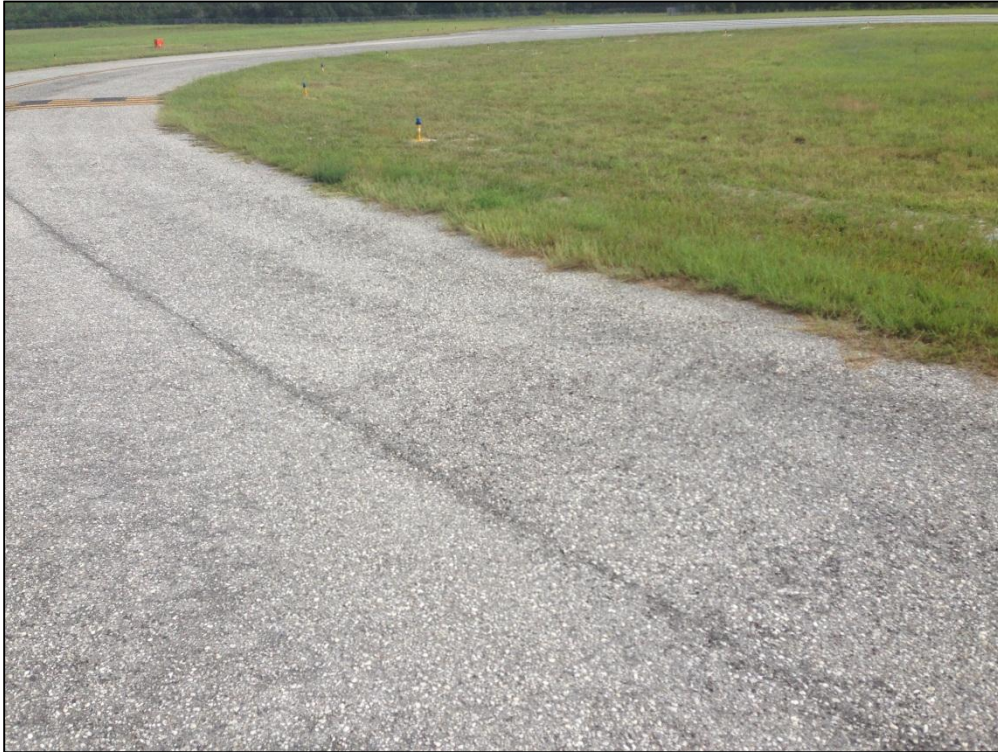
Taxiway A, Section 105, Sample Unit 102 – Low Severity (48) Longitudinal and Transverse Cracking, Medium Severity (52) Raveling

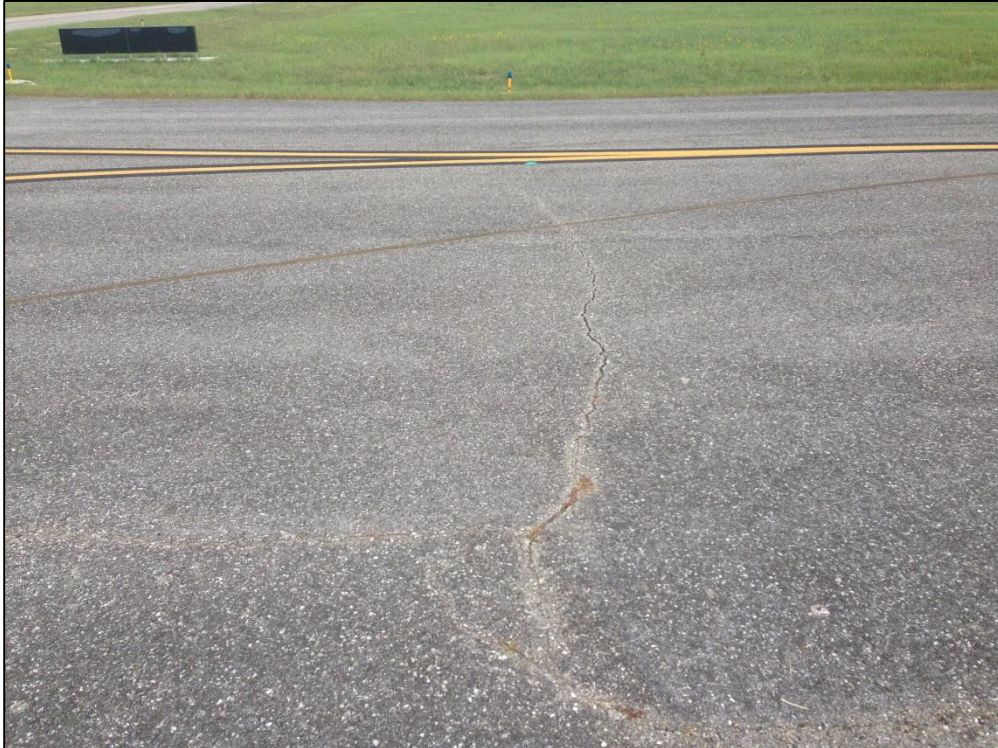
Taxiway A2, Section 160, Sample Unit 102 – Low and Medium Severity (48) Longitudinal and Transverse Cracking, Low and Medium Severity (52) Raveling

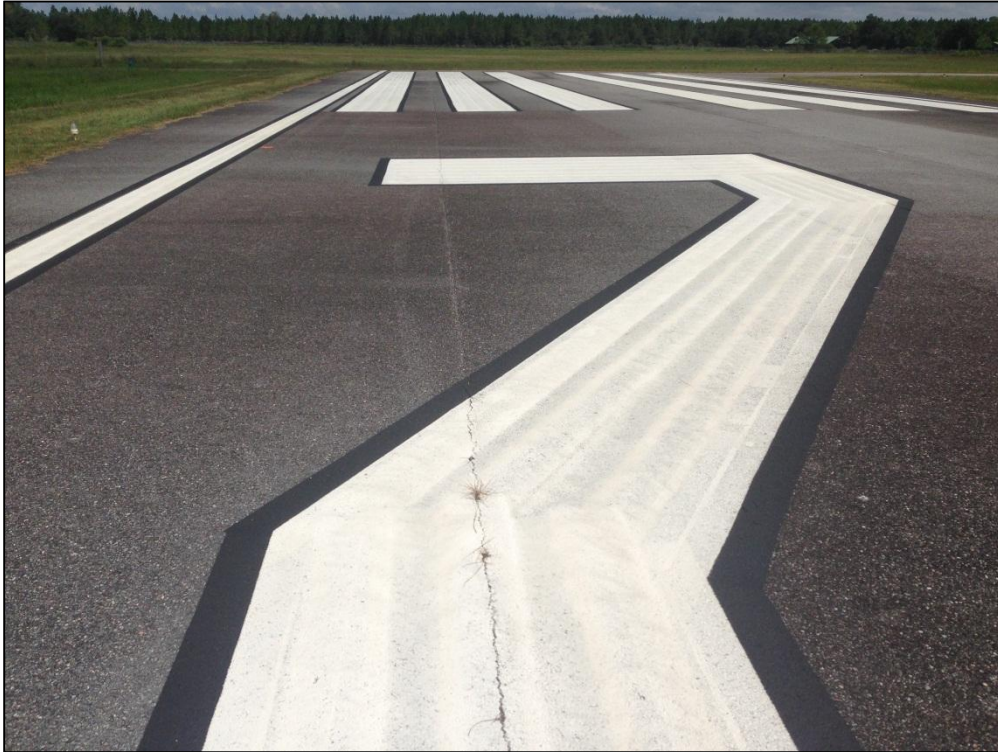
Runway 4-22, Section 6210, Sample Unit 201 – Low Severity (48) Longitudinal and Transverse Cracking, Low Severity (52) Raveling, Low Severity (57) Weathering

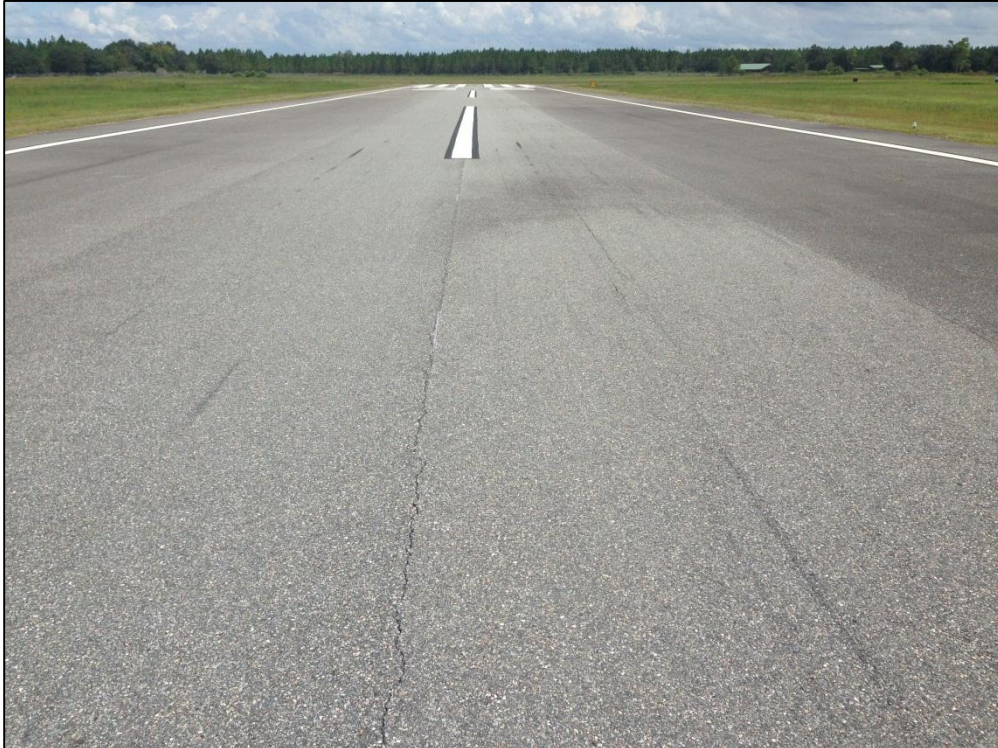
Runway 4-22, Section 6210, Sample Unit 192 – Low Severity (48) Longitudinal and Transverse Cracking, Low Severity (52) Raveling, Low Severity (57) Weathering

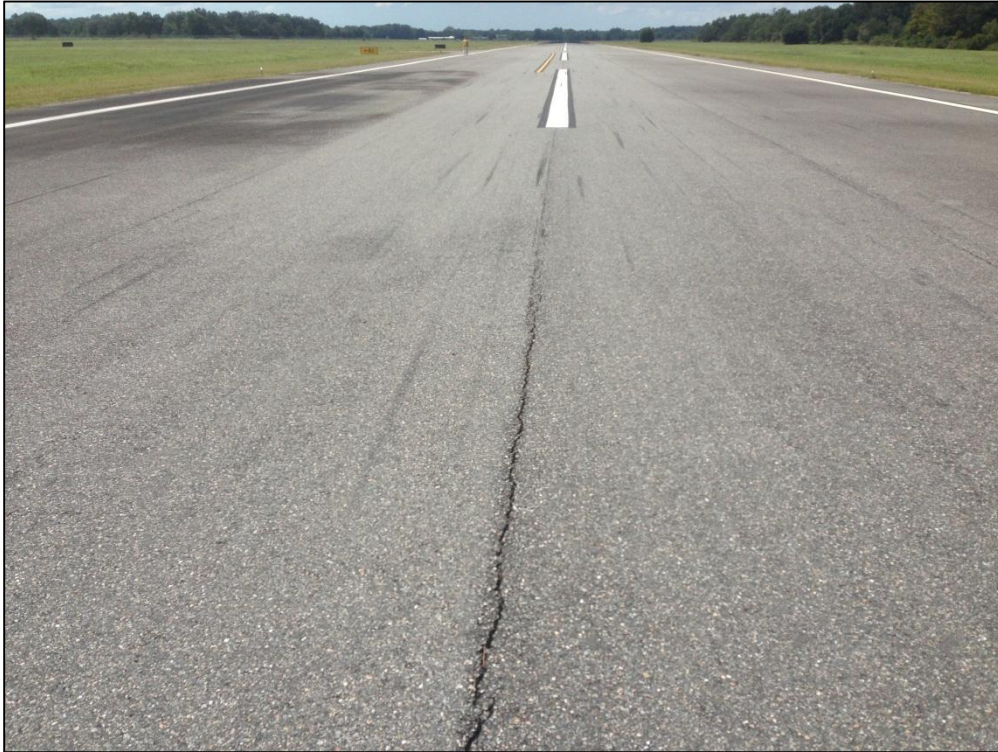
Runway 4-22, Section 6210, Sample Unit 180 – Medium Severity (48) Longitudinal and Transverse Cracking, Low Severity (52) Raveling, Low Severity (57) Weathering

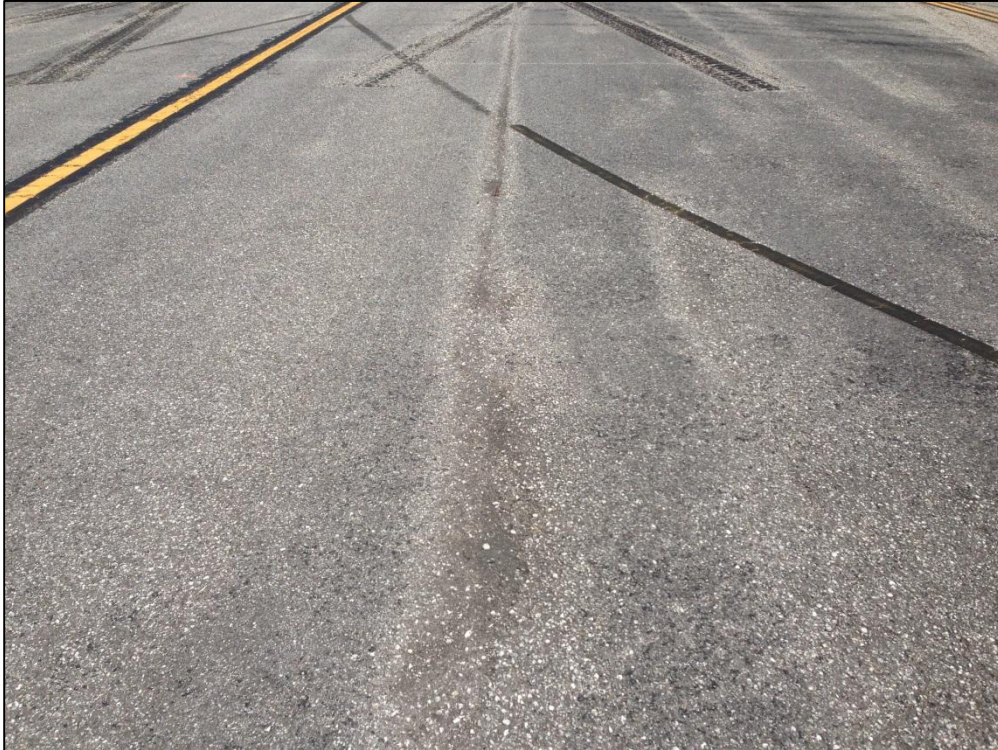
Runway 4-22, Section 6205, Sample Unit 100 – Low Severity (48) Longitudinal and Transverse Cracking, Low, Medium, and High Severity (52) Raveling

- ⦿ Runway 4-22 – Section 6205
 - Reconstruction attributed to distresses related to climate and age of pavement.
- ⦿ Runway 13-31 – Section 6110
 - PCC Restoration attributed to distresses related to loading and subgrade quality.
- ⦿ Runway 13-31 – Section 6105
 - Reconstruction attributed to distresses related to subgrade quality, climate, and age of pavement.
- ⦿ Apron – Sections 4105
 - PCC Restoration attributed to distresses related to loading and subgrade quality.
- ⦿ Taxiway B2 – Section 220
 - Mill and Overlay attributed to distresses related to subgrade quality, climate, and age of pavement.
- ⦿ Taxiway B – Sections 210, 207, and 205
 - Mill and Overlay attributed to distresses related to climate and age of pavement.

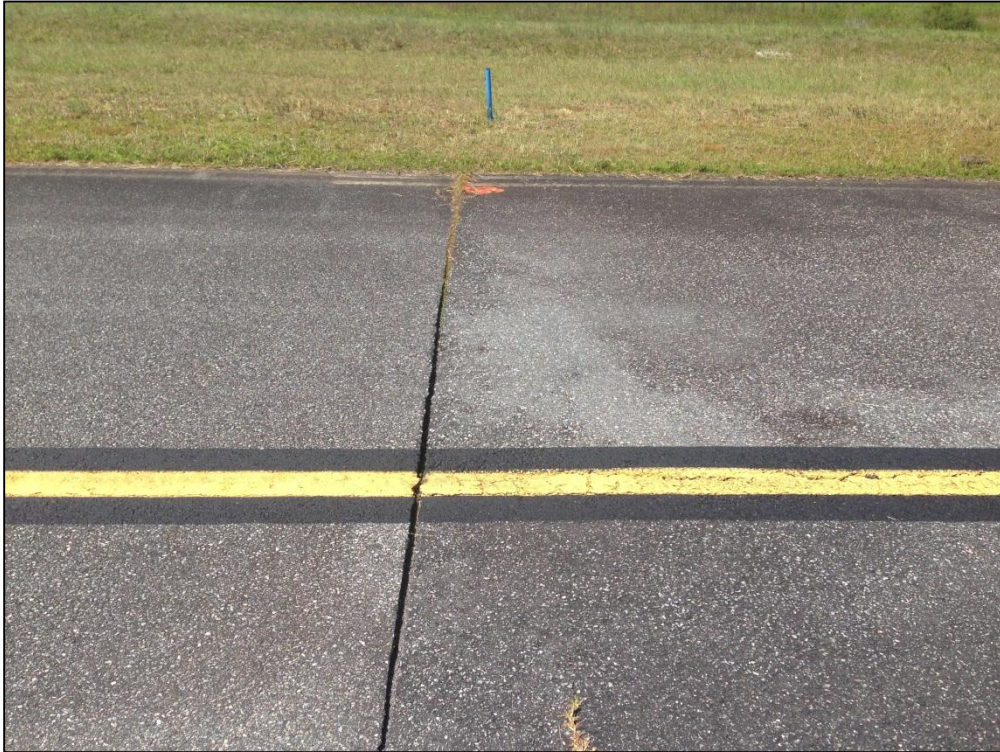
Taxiway B, Section 207, Sample Unit 103 – High Severity (48) Longitudinal and Transverse Cracking, Low Severity (52) Raveling, Low Severity (57) Weathering

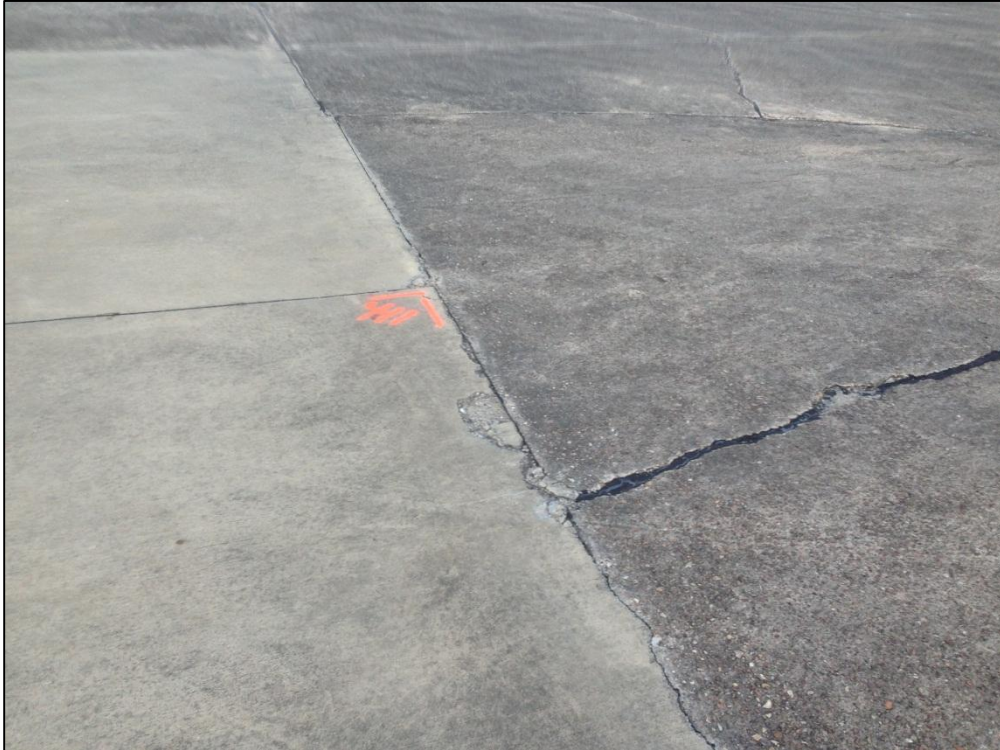
Apron, Section 4110, Sample Unit 411 – Low Severity (65) Joint Seal Damage, High Severity (74) Joint Spalling

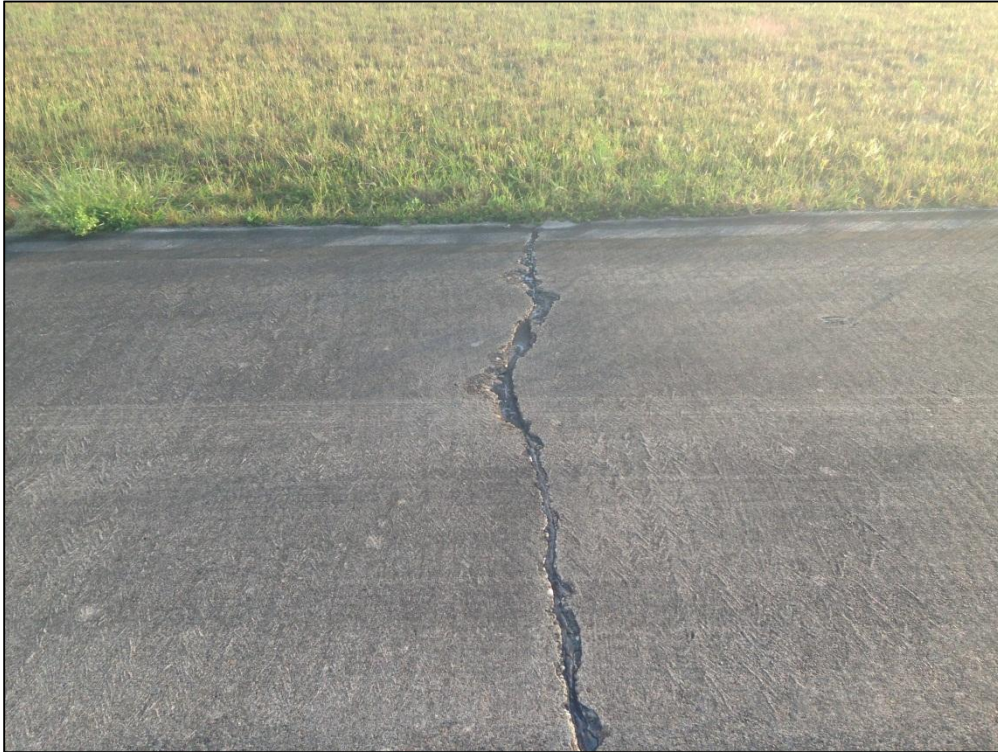
Apron, Section 4105, Sample Unit 407 – Low Severity (65) Joint Seal Damage, Medium Severity (63) Longitudinal, Transverse, and Diagonal Cracking

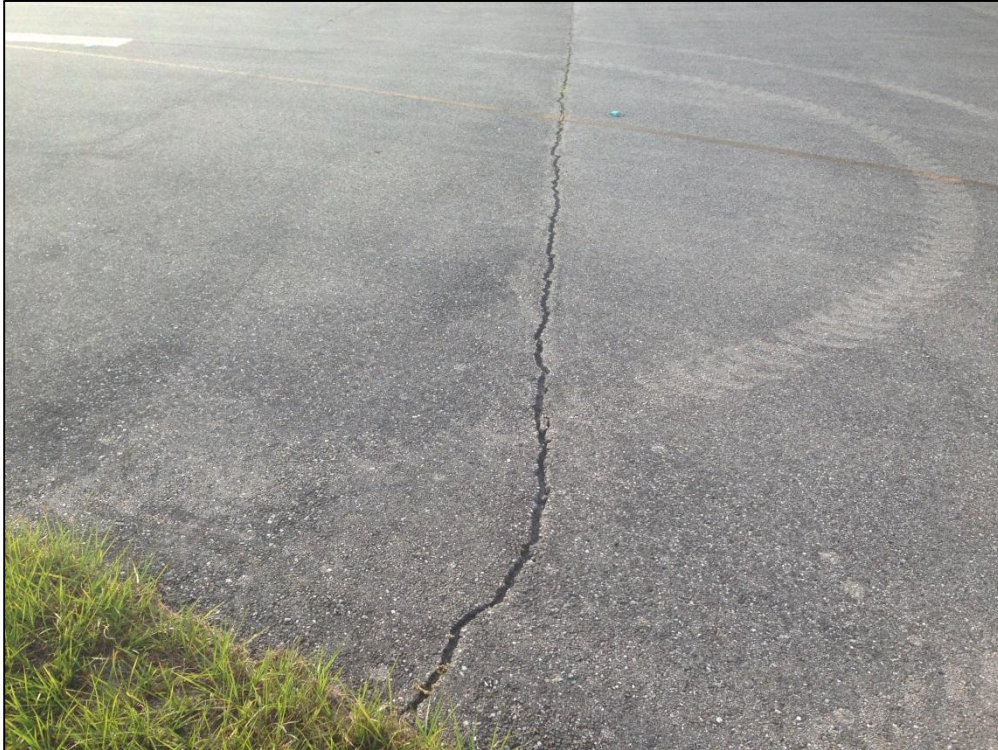
Taxiway A, Section 175, Sample Unit 101 – High Severity (48) Longitudinal and Transverse Cracking, Low Severity (52) Raveling, Low Severity (57) Weathering
