FLORIDA DEPARTMENT OF TRANSPORTATION
AVIATION AND SPACEPORT OFFICE

INVERNESS
AIRPORT (INF)

DECEMBER 2013

STATEWIDE Airfield Pavement Management PROGRAM

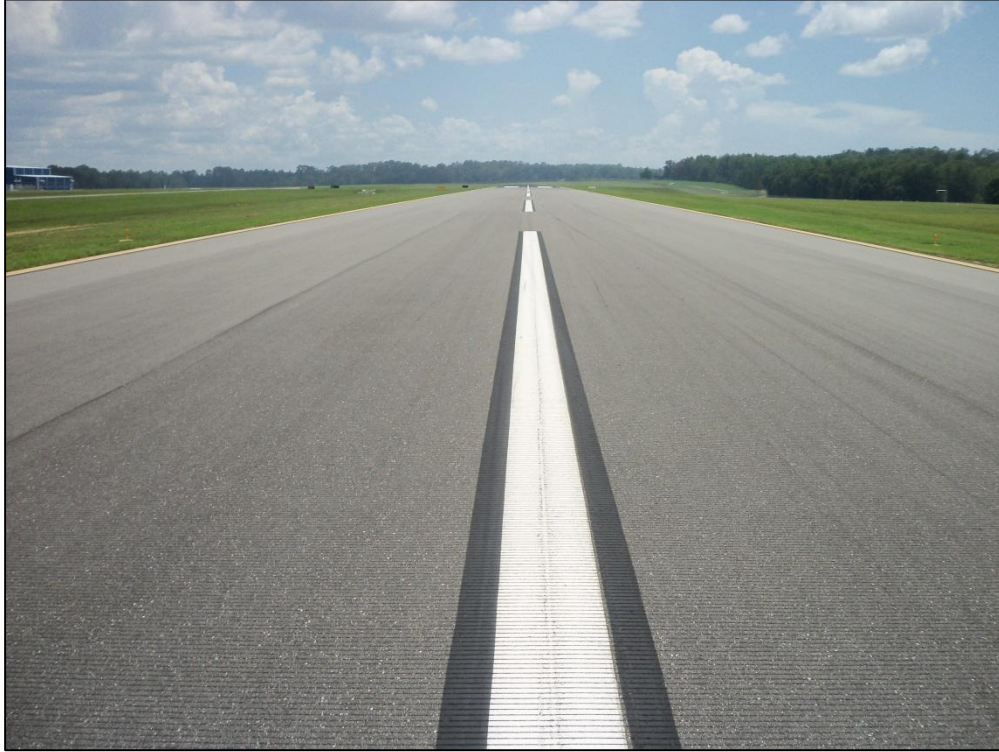
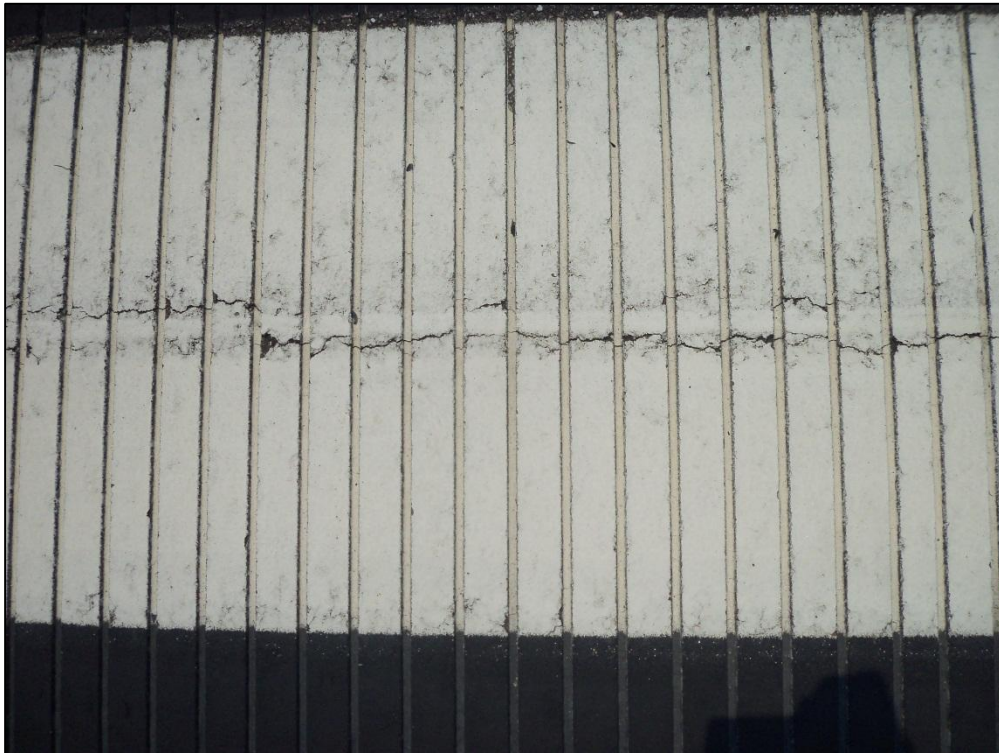
Runway 1-19 and its parallel Taxiway Alpha were recently fully reconstructed in 2010 and only exhibited small amounts of low severity longitudinal/transverse cracking which primarily was located along the runway centerline. These pavements were in good overall condition.

Runway 01-19, Section 6105, Sample Unit 144 – Low Severity (48) Longitudinal and Transverse Cracking

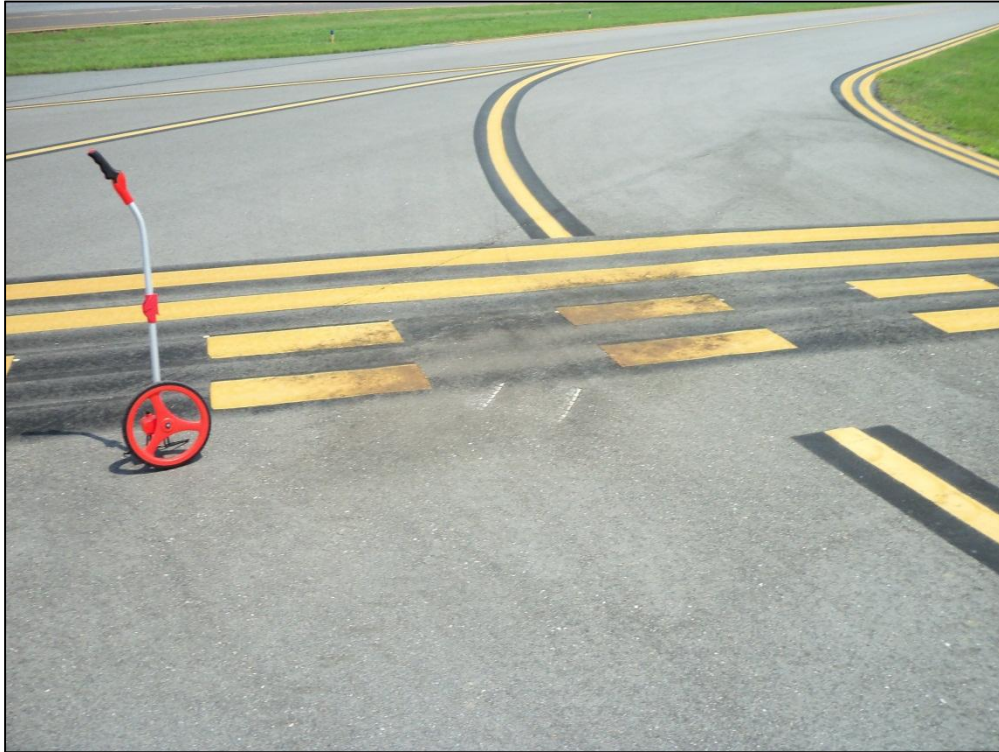
Taxiway A1, Section 115, Sample Unit 201 – Low Severity (45) Depression

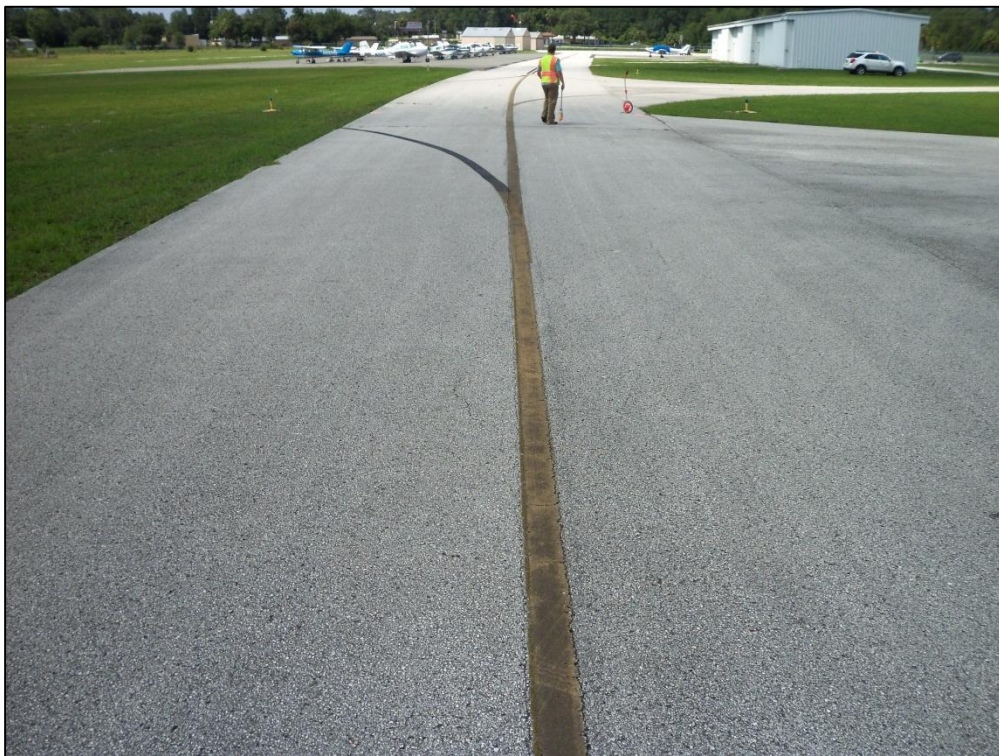
Taxiway GA AP, Section 205, Sample Unit 401 – Low Severity (48) Longitudinal and Transverse Cracking, Low Severity (52) Raveling, Low Severity (57) Weathering

- ⦿ Apron GA – Section 4005.
 - Mill and Overlay attributed to distresses related to climate and age of pavement.
- ⦿ Taxiway to GA Apron – Section 205
 - Mill and Overlay attributed to distresses related to subgrade quality, climate, and age of pavement.

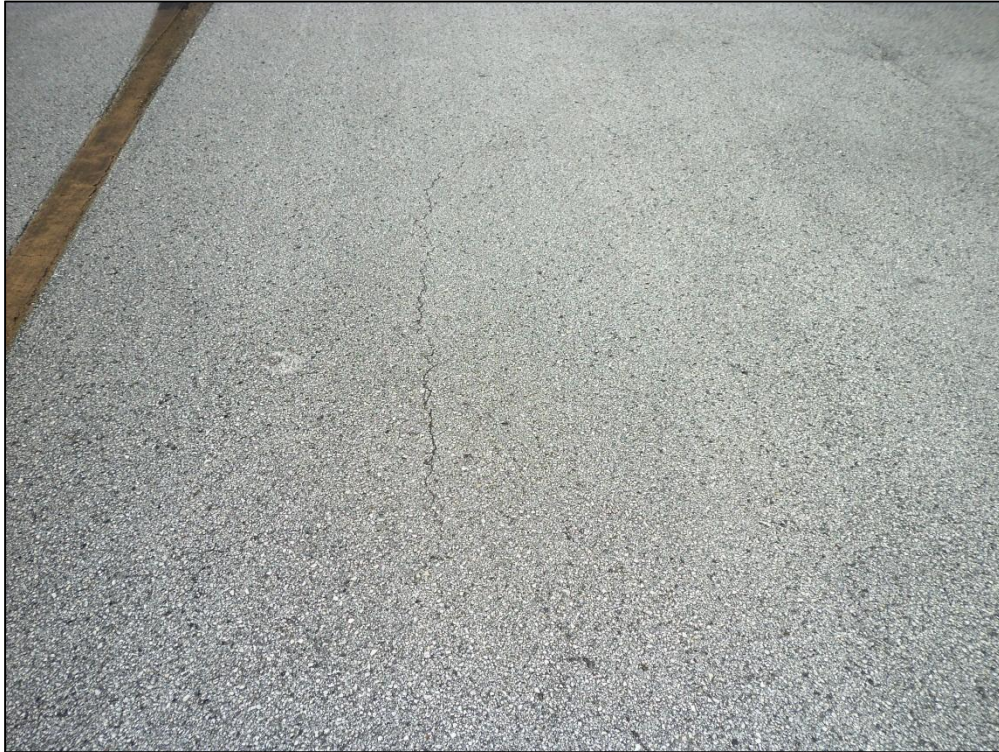
Taxiway GA AP, Section 205, Sample Unit 401 – Low Severity (48) Longitudinal and Transverse Cracking, Low Severity (52) Raveling, Low Severity (57) Weathering

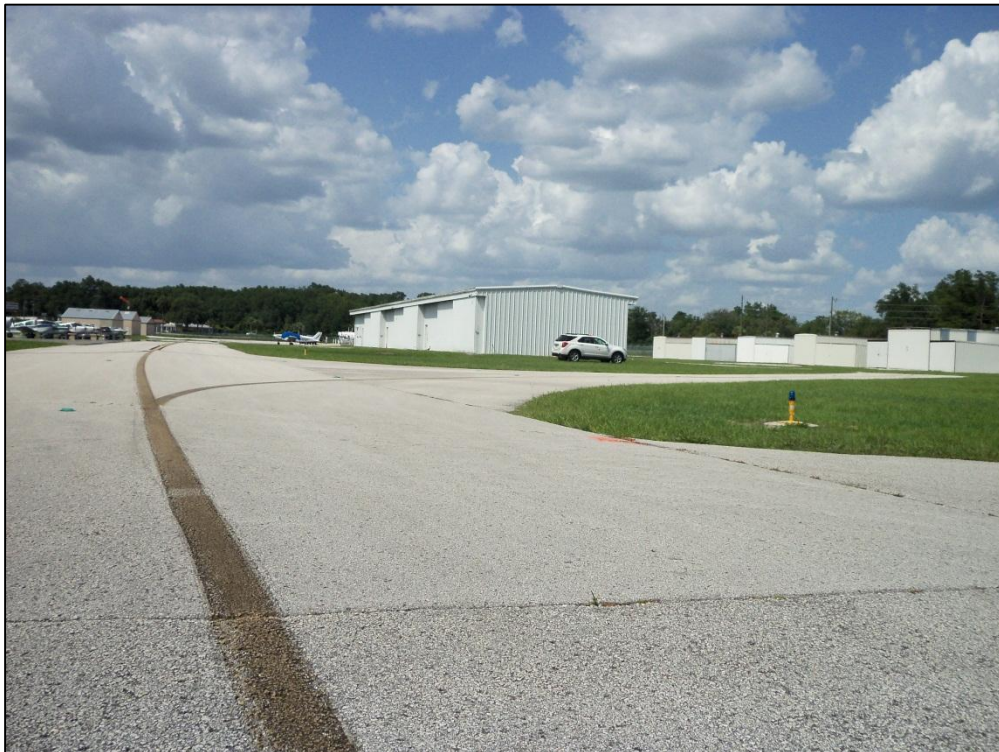
Taxiway GA AP, Section 205, Sample Unit 401 – Low Severity (48) Longitudinal and Transverse Cracking, Low Severity (52) Raveling, Low Severity (57) Weathering, Low Severity (56) Swelling

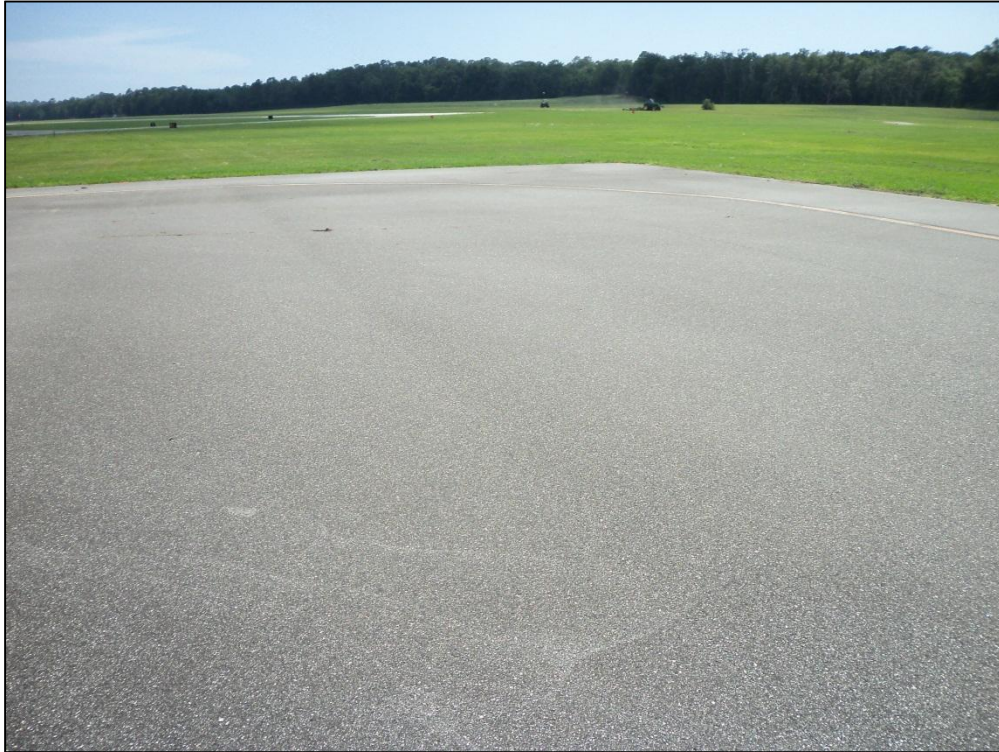
Apron GA, Section 4020, Sample Unit 100 –Low Severity (57) Weathering

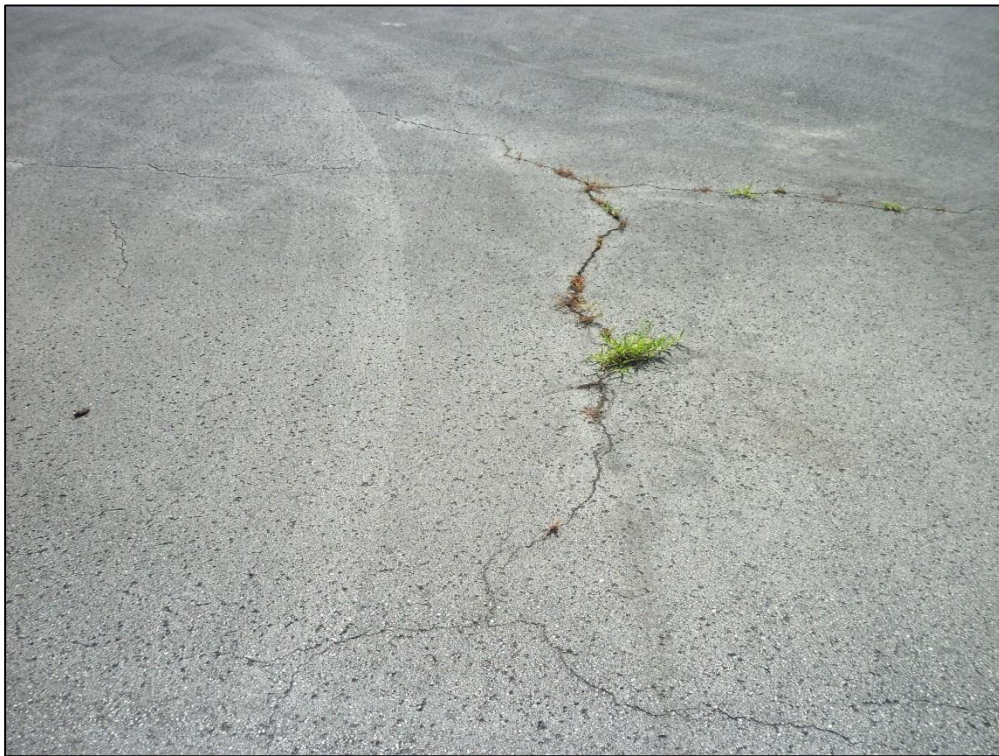
Apron GA, Section 4005, Sample Unit 604 – Low and Medium Severity (48) Longitudinal and Transverse Cracking, Low Severity (52) Raveling, Low Severity (57) Weathering

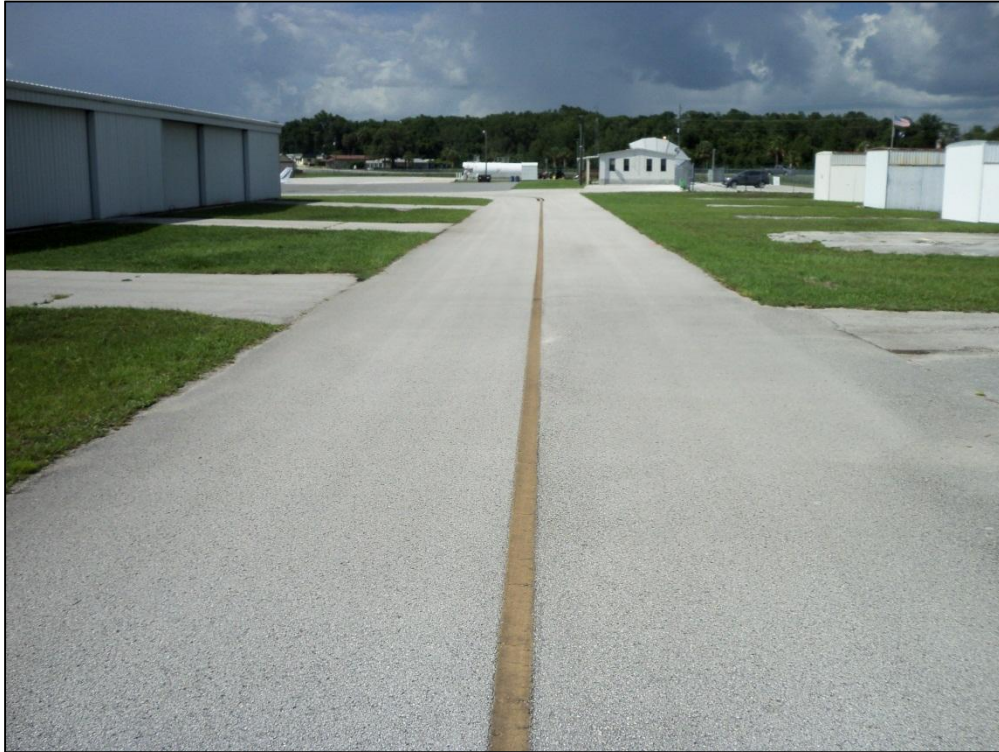
Taxiway GA AP, Section 205, Sample Unit 102 – Low Severity (48) Longitudinal and Transverse Cracking, Low Severity (52) Raveling, Low Severity (57) Weathering

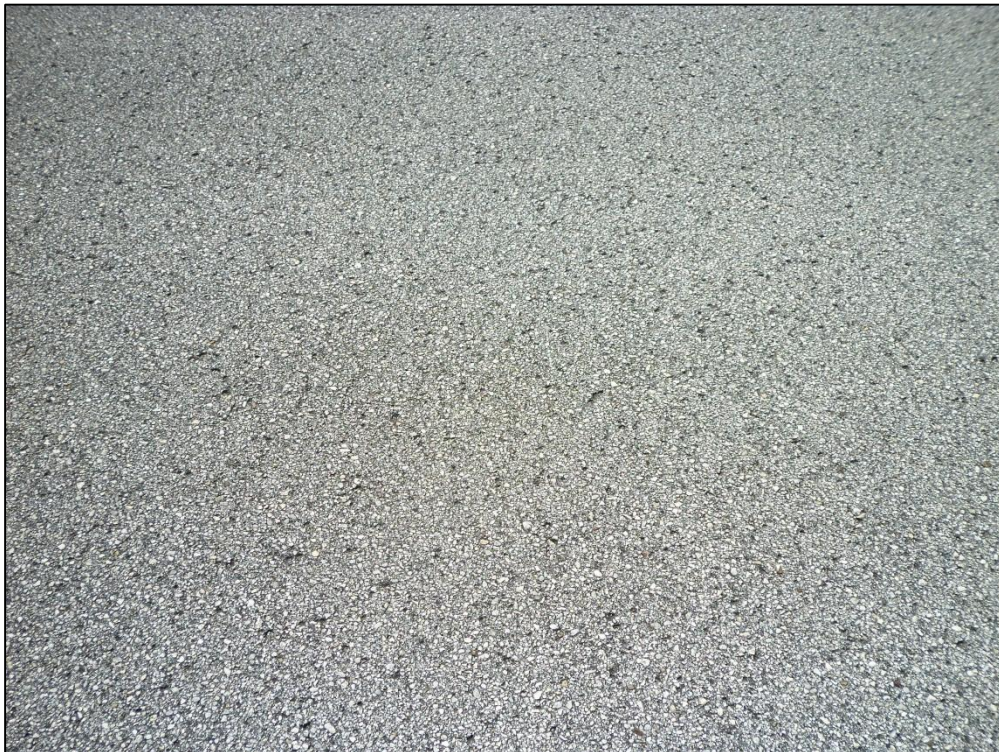
Taxiway GA AP, Section 205, Sample Unit 102 –Low Severity (52) Raveling, Low Severity (57) Weathering
