FLORIDA DEPARTMENT OF TRANSPORTATION  
AVIATION AND SPACEPORT OFFICE

LAKE CITY  
GATEWAY  
AIRPORT (LCQ)

DECEMBER 2013

# STATEWIDE Airfield Pavement Management PROGRAM

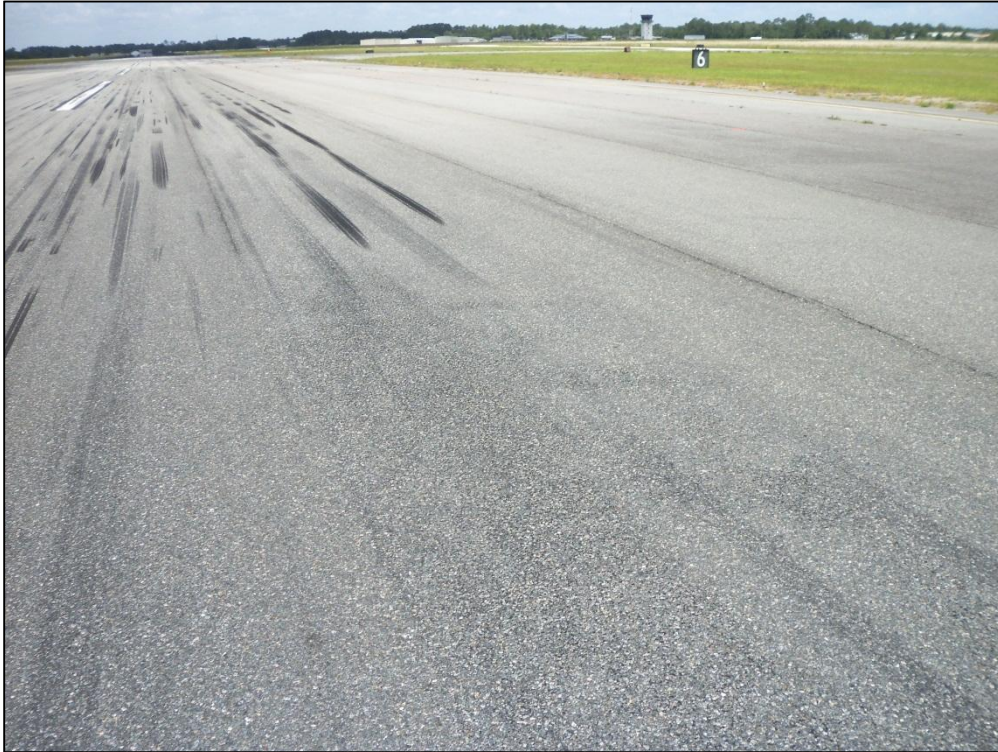
Runway 10-28, Section 6114, Sample Unit 423 – Low Severity (48) Longitudinal and Transverse Cracking, (42) Bleeding, Medium Severity (57) Weathering

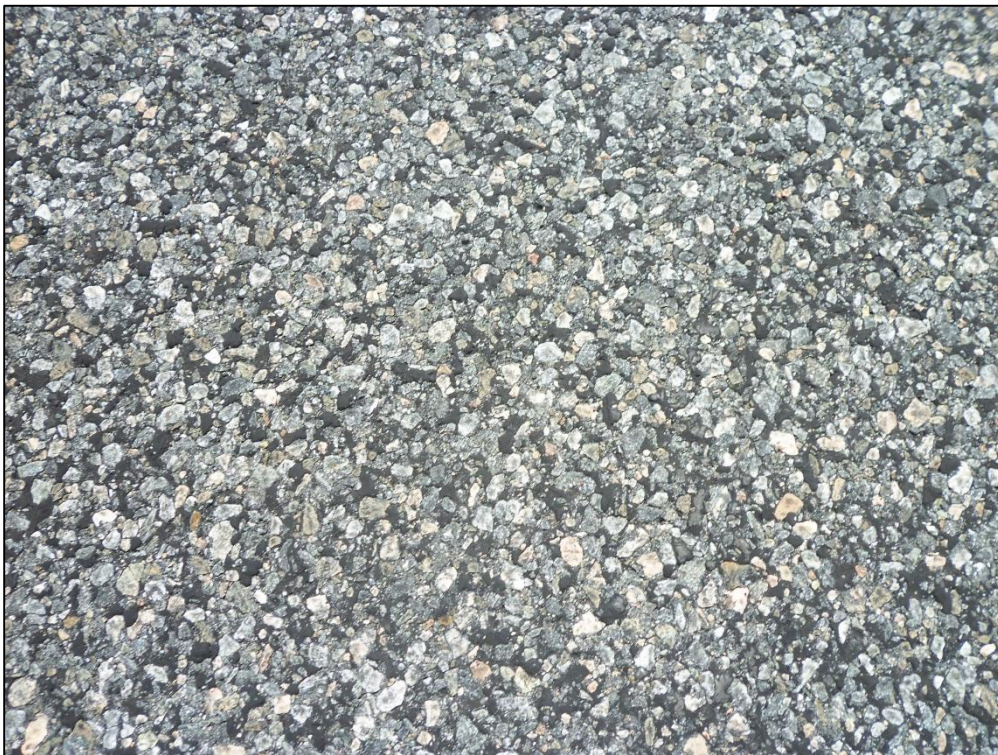
Runway 10-28, Section 6114, Sample Unit 423 – (42) Bleeding, Medium Severity (57) Weathering

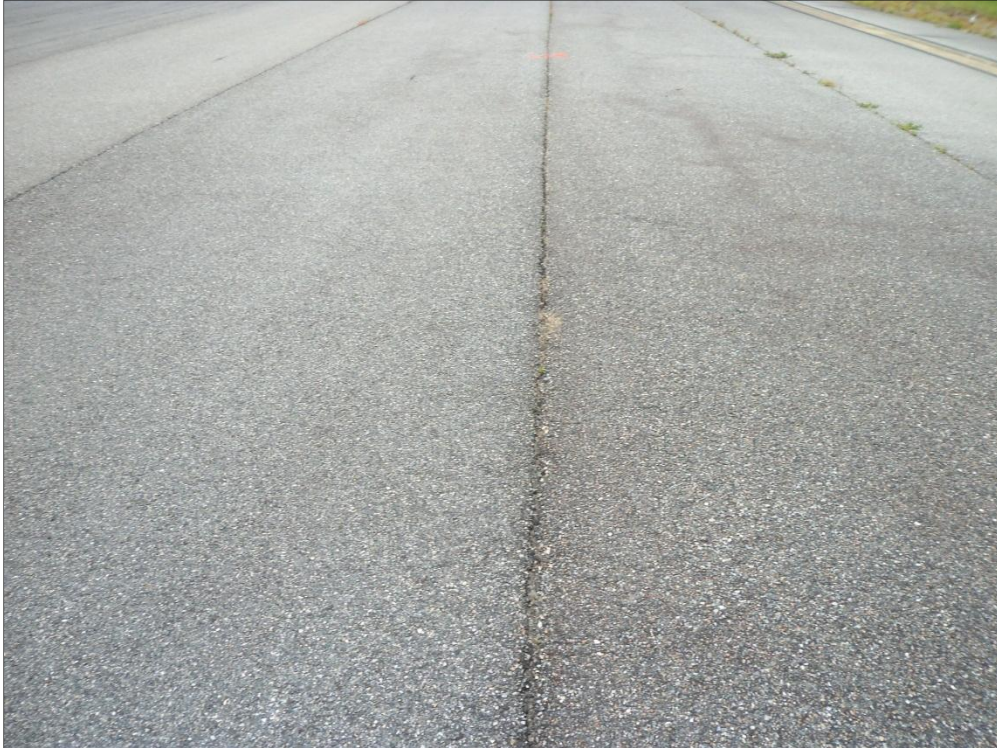
Runway 10-28, Section 6114, Sample Unit 419 – Medium Severity (48) Longitudinal and Transverse Cracking, Medium Severity (57) Weathering

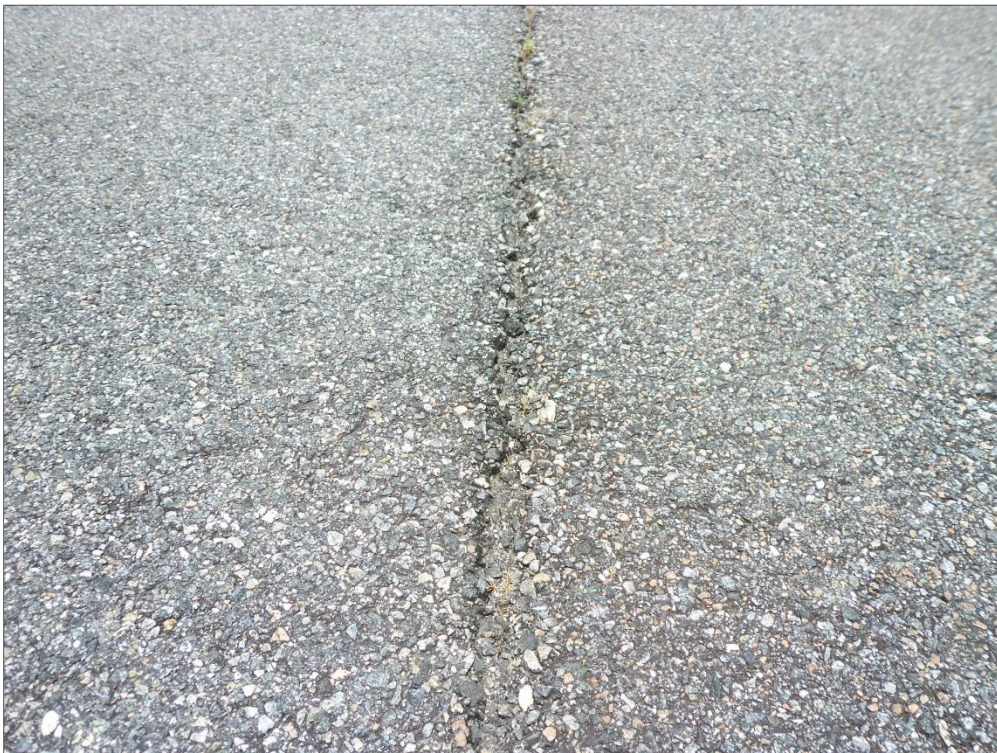
Runway 10-28, Section 6114, Sample Unit 419 – Medium Severity (48) Longitudinal and Transverse Cracking

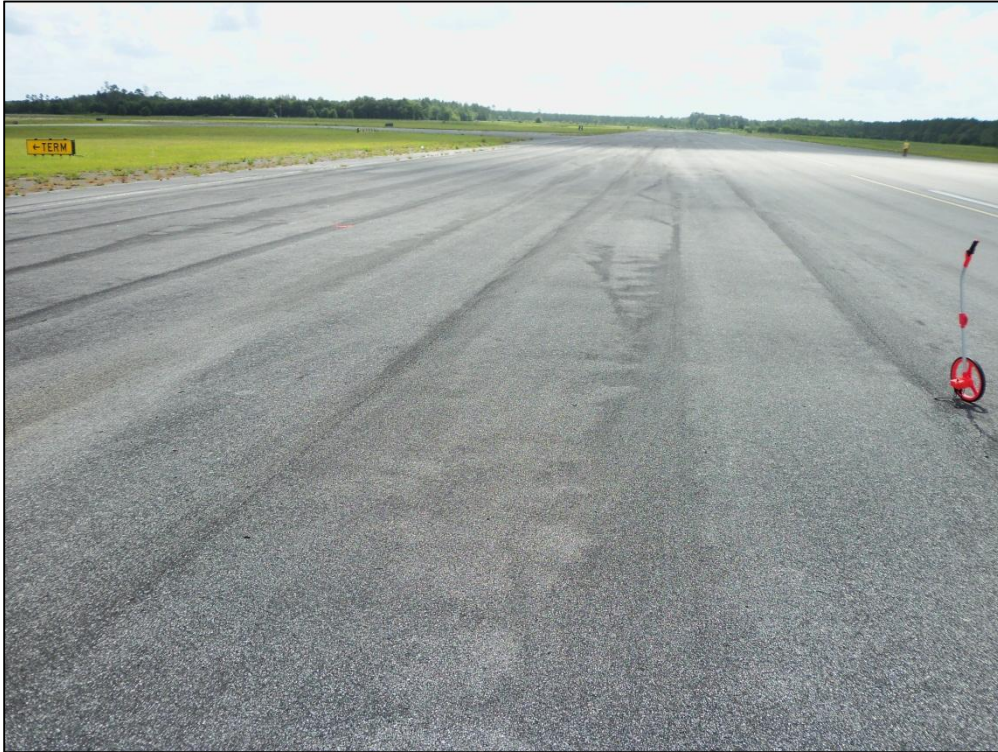
Runway 10-28, Section 6105, Sample Unit 400 – Low Severity (48) Longitudinal and Transverse Cracking, Low Severity (57) Weathering, Low Severity (56) Swelling

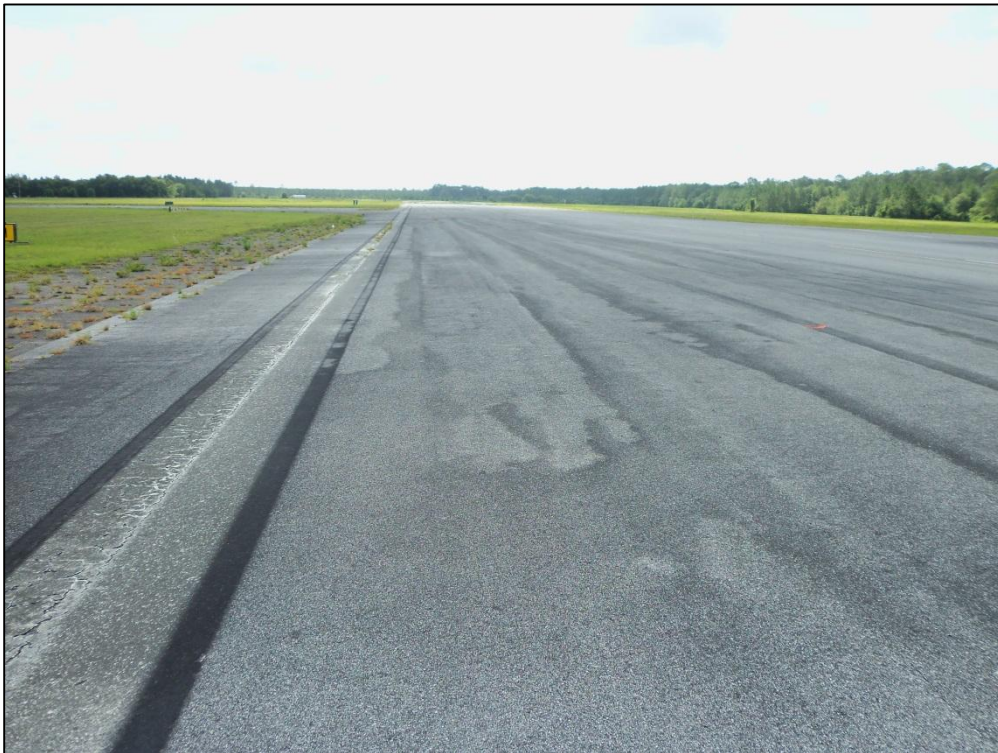
Runway 10-28, Section 6110, Sample Unit 200 – Low Severity (57) Weathering, Low Severity (56) Swelling

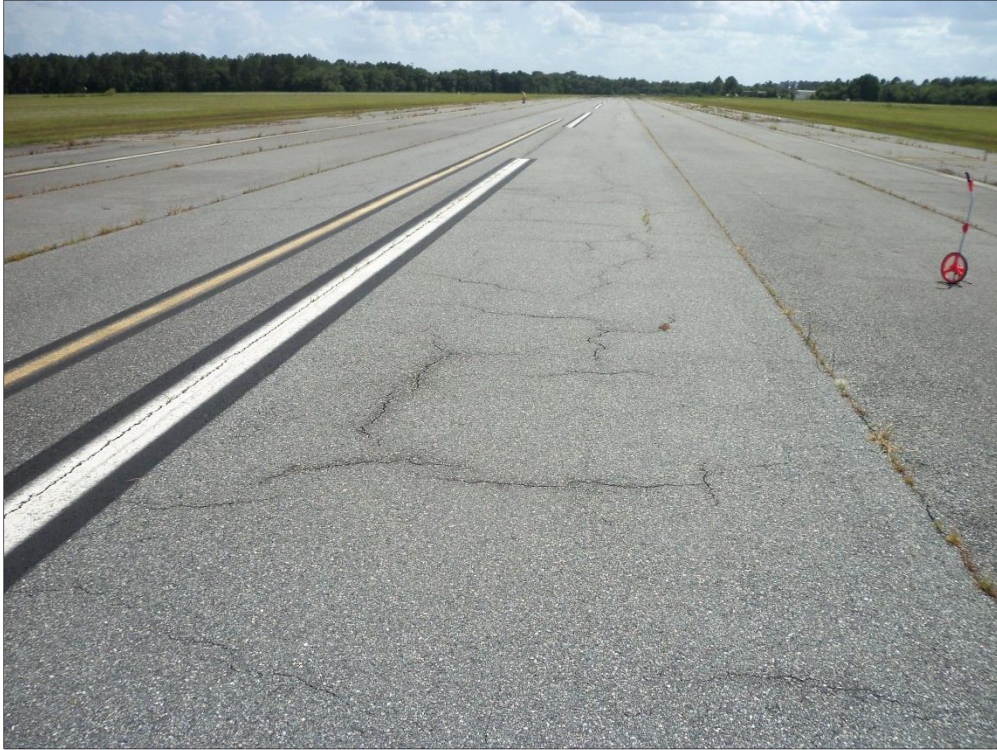
Runway 5-23, Section 6205, Sample Unit 135 – Medium Severity (57) Weathering, Low and Medium Severity (48) Longitudinal and Transverse Cracking, Low Severity (43) Block Cracking

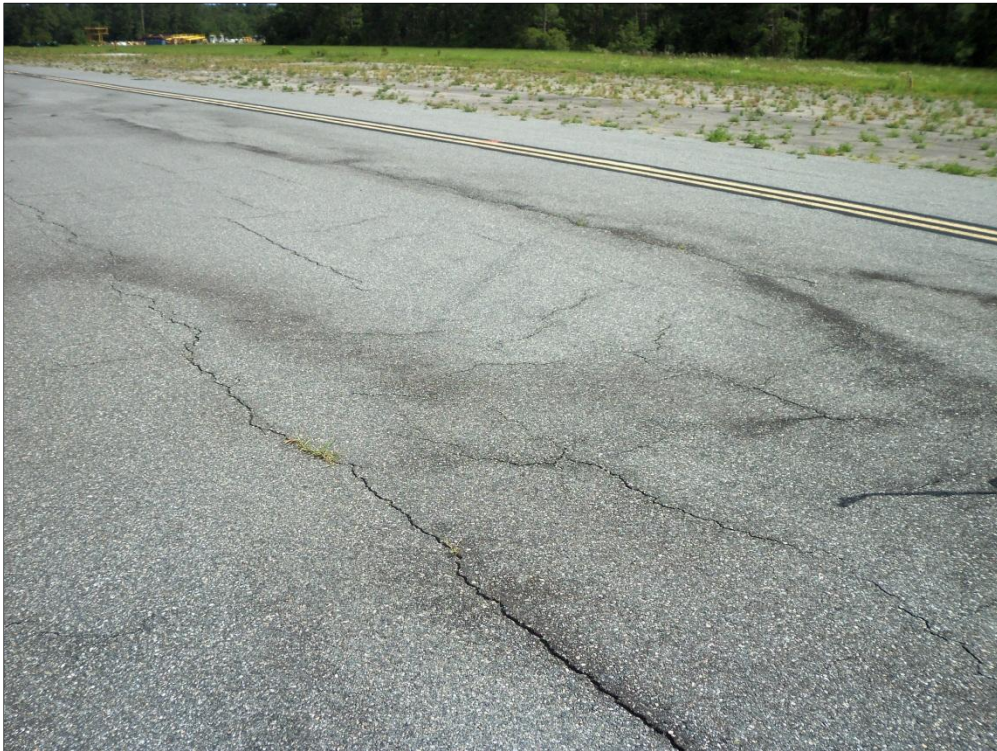
Runway 5-23, Section 6205, Sample Unit 135 – Medium Severity (57) Weathering, Low and Medium Severity (48) Longitudinal and Transverse Cracking, Low Severity (43) Block Cracking

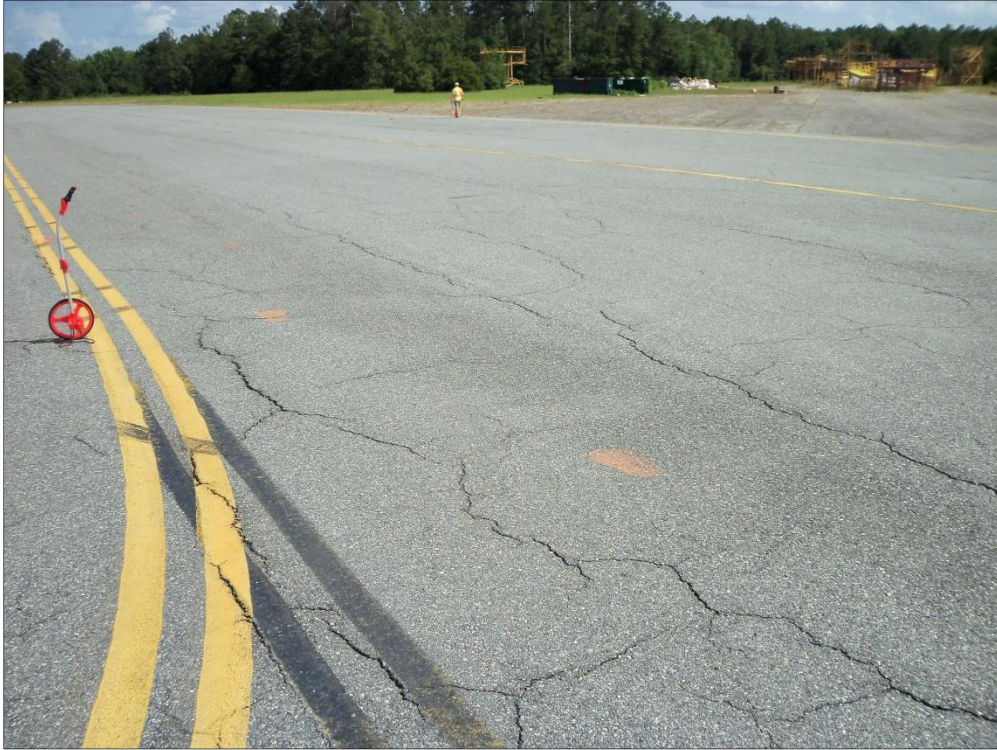
Taxiway B2, Section 220, Sample Unit 139 – Low Severity (43) Block Cracking, Medium Severity (57) Weathering, Low Severity (52) Raveling, Low Severity (53) Rutting

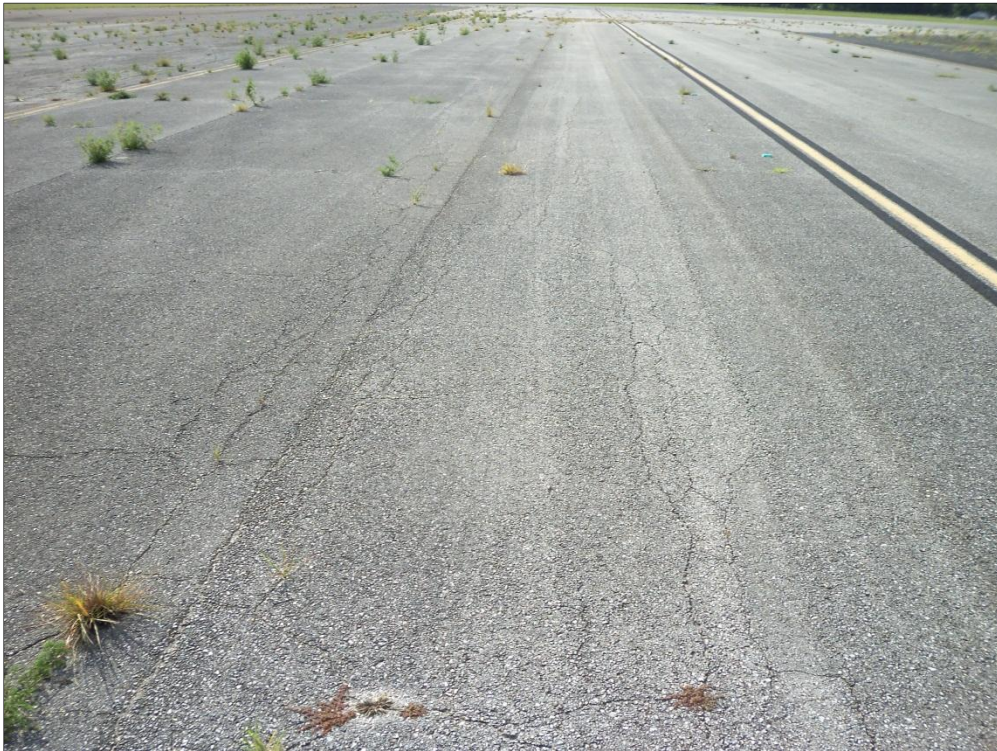
Taxiway B, Section 210, Sample Unit 140 – Low Severity (43) Block Cracking, Low Severity (57) Weathering, Low Severity (52) Raveling, Low Severity (41) Alligator Cracking

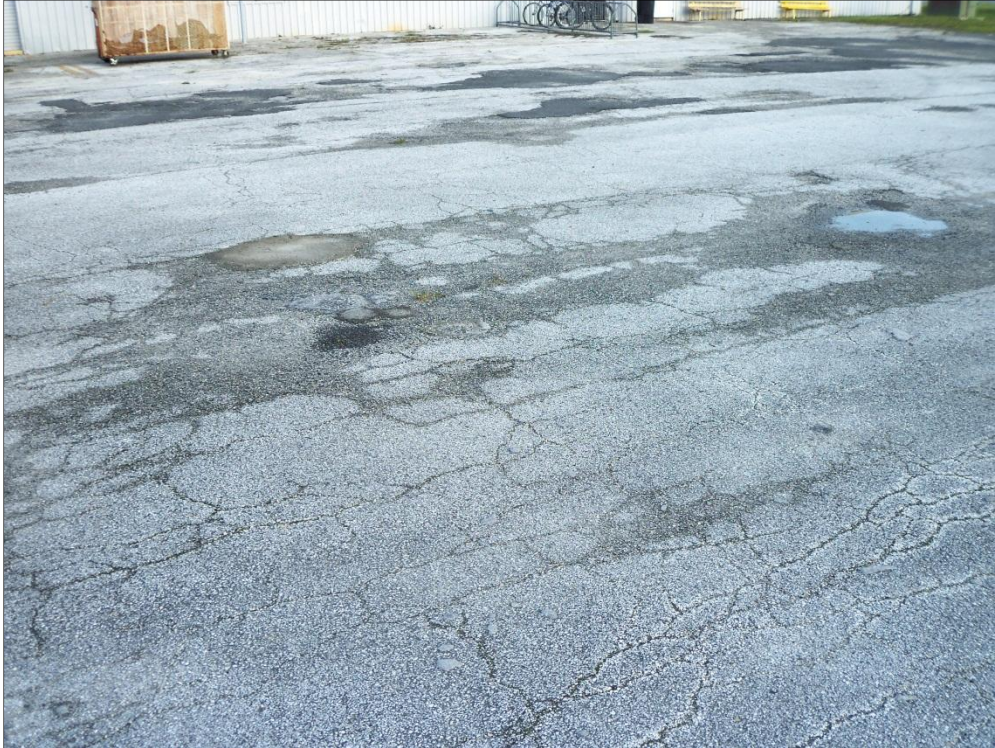
Apron E, Section 4228, Sample Unit 101 – Medium Severity (52) Raveling, High Severity (50) Patching, Medium Severity (45) Depression, Low Severity (43) Block Cracking, Low Severity (41) Alligator Cracking

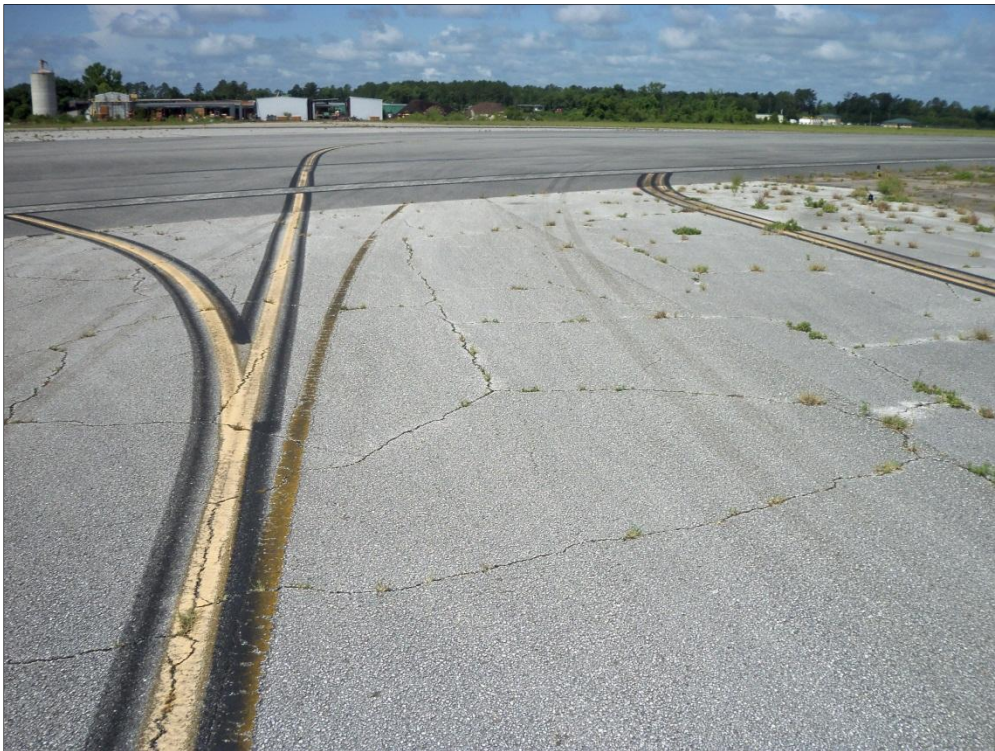
Taxiway C, Section 305, Sample Unit 100 – Low Severity (43) Block Cracking, Low Severity (52) Raveling, Low Severity (57) Weathering

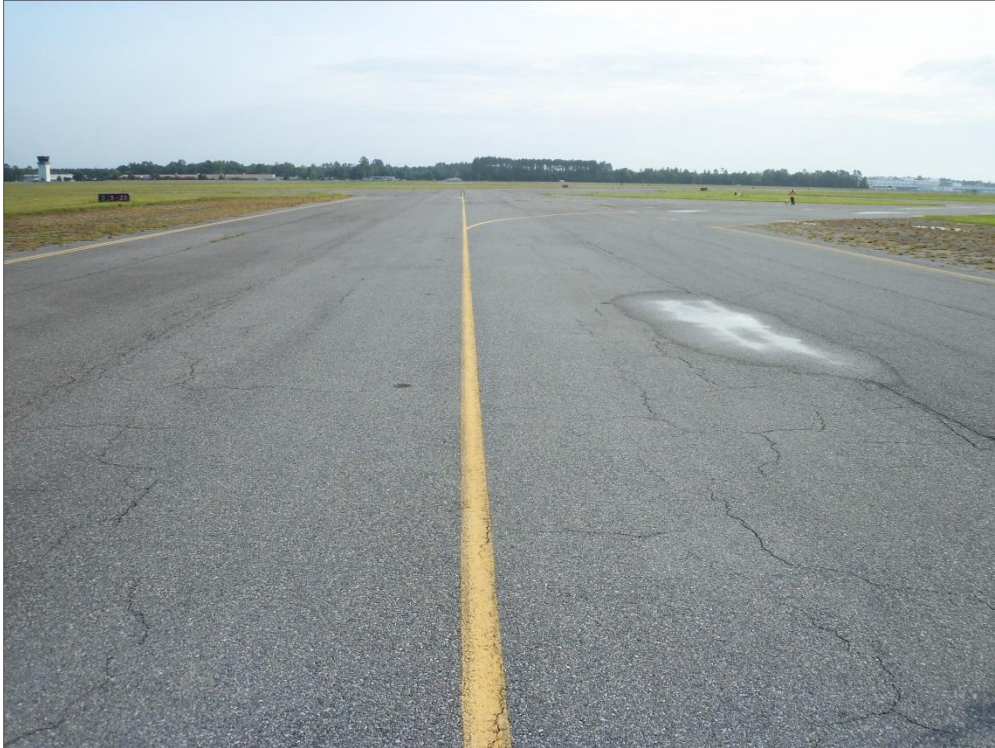
Taxiway D, Section 405, Sample Unit 112 – Low Severity (41) Alligator Cracking, Low and Medium Severity (48) Longitudinal and Transverse Cracking, Low Severity (52) Raveling, Low Severity (53) Rutting, Low Severity (57) Weathering

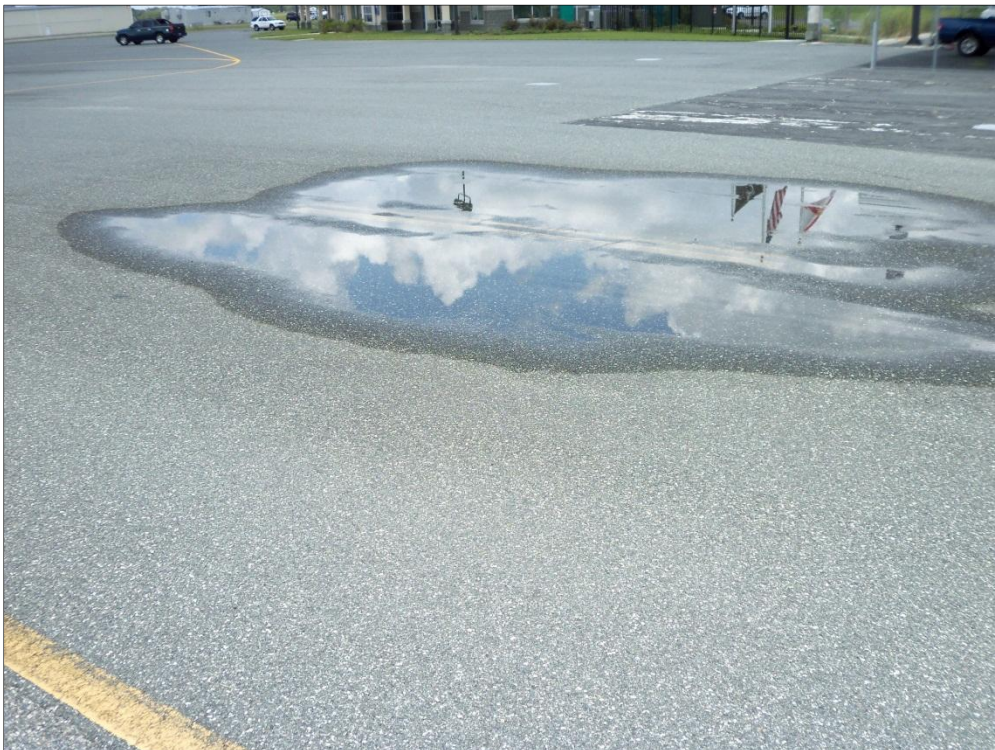
Taxiway D, Section 405, Sample Unit 112 – Low Severity (53) Rutting
