FLORIDA DEPARTMENT OF TRANSPORTATION

AVIATION AND SPACEPORT OFFICE

During MAY 2013, a PCI survey inspection was performed at Marco Island Airport. The results of the inspection indicate that, based on ASTM 5340-11, the airport's airfield pavement facilities had an overall area-weighted average PCI 58, representing a FAIR overall network condition. Table I summarizes the overall condition summary by network level branch in comparison to the FDOT recommended minimum service level.

From the condition survey inspection performed in 2013 at Marco Island Airport, the overall weighted average PCI value is 58 representing a condition rating of FAIR.

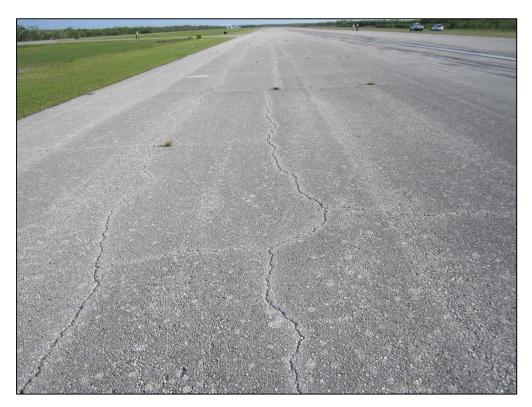
Runway 17-35 exhibited pavement condition indices ranging from 29-30. The pavement on Runway 17-35 exhibited low, medium, and high severity block

cracking; low and medium severity longitudinal/transverse cracking; low and medium severity weathering; and low, medium, and high severity raveling. These distresses are mostly attributed to the climate and age of the pavement.

Runway 17-35, Section 6105, Sample Unit 113 – Low and Medium Severity (43) Block Cracking, Medium Severity (48) Longitudinal and Transverse Cracking, Medium Severity (52) Raveling

- Runway 17-35 Sections 6105, 6110, and 6115.
 - Reconstruction attributed to distresses related to climate and age of pavement.
- North Apron Section 4205
 - Reconstruction attributed to distresses related to climate and age of pavement.
- Taxiway B Section 205
 - Reconstruction attributed to distresses related to climate and age of pavement.

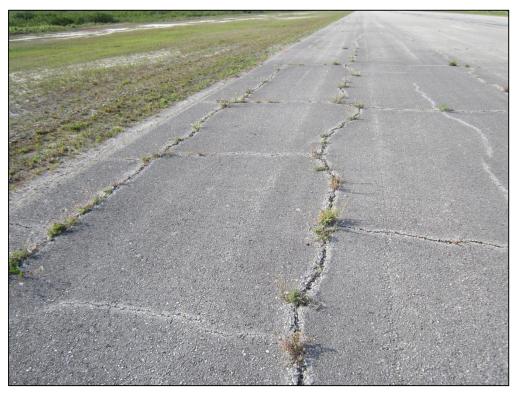
Runway 17-35, Section 6110, Sample Unit 122 – Low, Medium and High Severity (43) Block Cracking, Low Severity (52) Raveling, Low and Medium Severity (57) Weathering

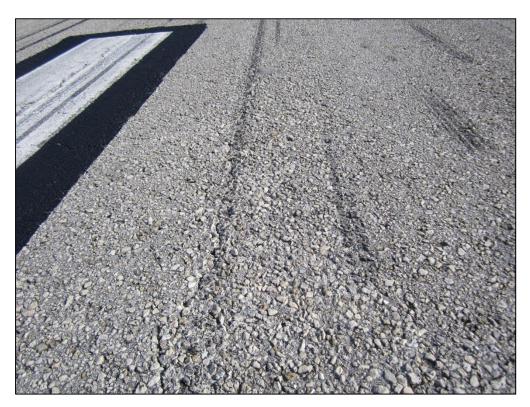
Runway 17-35, Section 6110, Sample Unit 136 – Medium Severity (52) Raveling

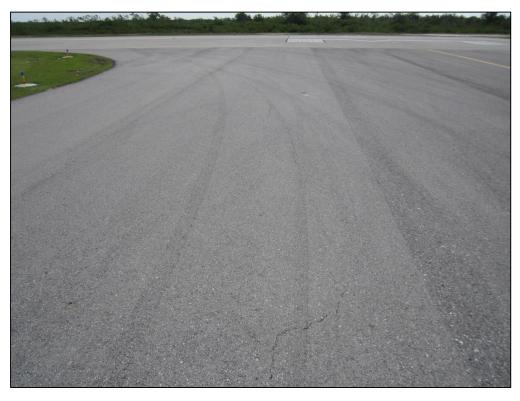
Taxiway A exhibited pavement condition indices ranging from 94-100. Taxiway A exhibited occasional low severity longitudinal/transverse cracking. The North Apron exhibited broad pavement condition indices ranging from 46-100. This is attributed to the varying construction history of the branch. The North Apron exhibited low and medium severity block cracking; low severity weathering; low severity raveling; low severity longitudinal/transverse cracking; and low severity depression.

Taxiway Alpha, Section 105, Sample Unit 101 – Low Severity (48) Longitudinal and Transverse Cracking

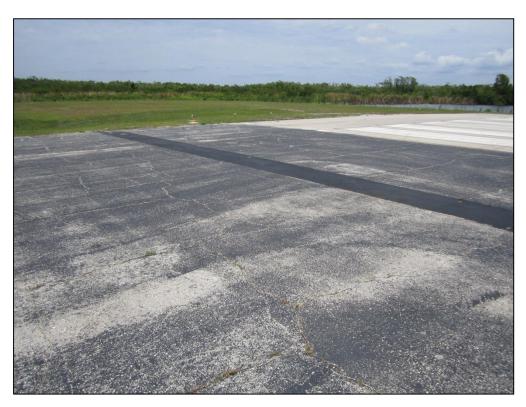
Apron North, Section 4205, Sample Unit 100 – Low and Medium Severity (43) Block Cracking, Low Severity (52) Raveling, Low Severity (57) Weathering

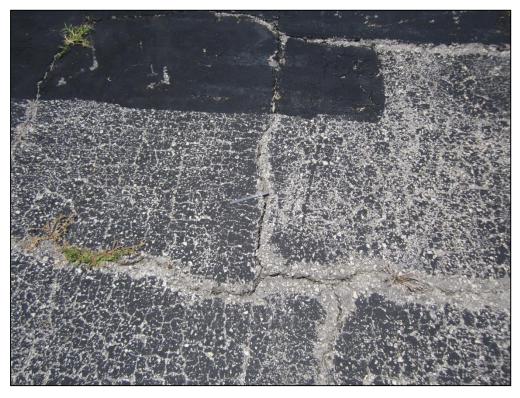
Apron North, Section 4205, Sample Unit 100 – Medium Severity (43) Block Cracking, Low Severity (52) Raveling, Low Severity (57) Weathering

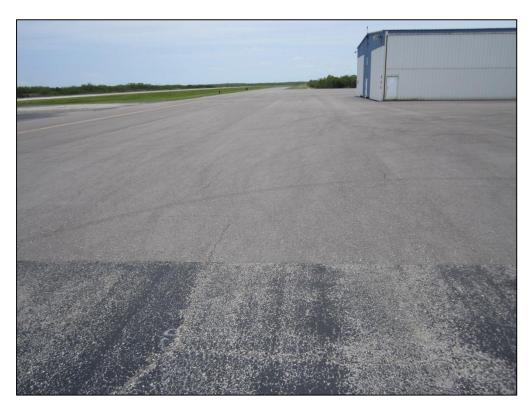
Apron North, Section 4215, Sample Unit 307 – Low Severity (48) Longitudinal and Transverse Cracking

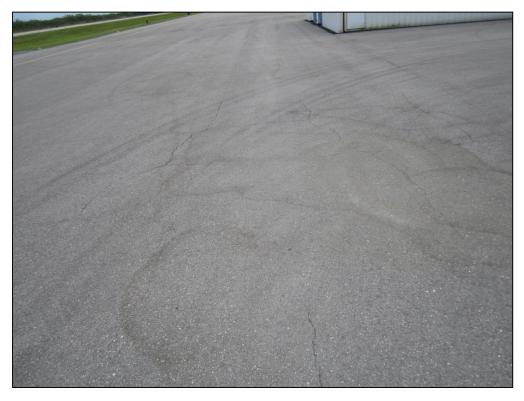
Apron North, Section 4215, Sample Unit 307 – Low Severity (48) Longitudinal and Transverse Cracking
