**OKEECHOBEE
COUNTY
AIRPORT (OBE)**

DISTRICT 1
GENERAL AVIATION
AIRPORT

DECEMBER 2013

STATEWIDE Airfield Pavement Management PROGRAM

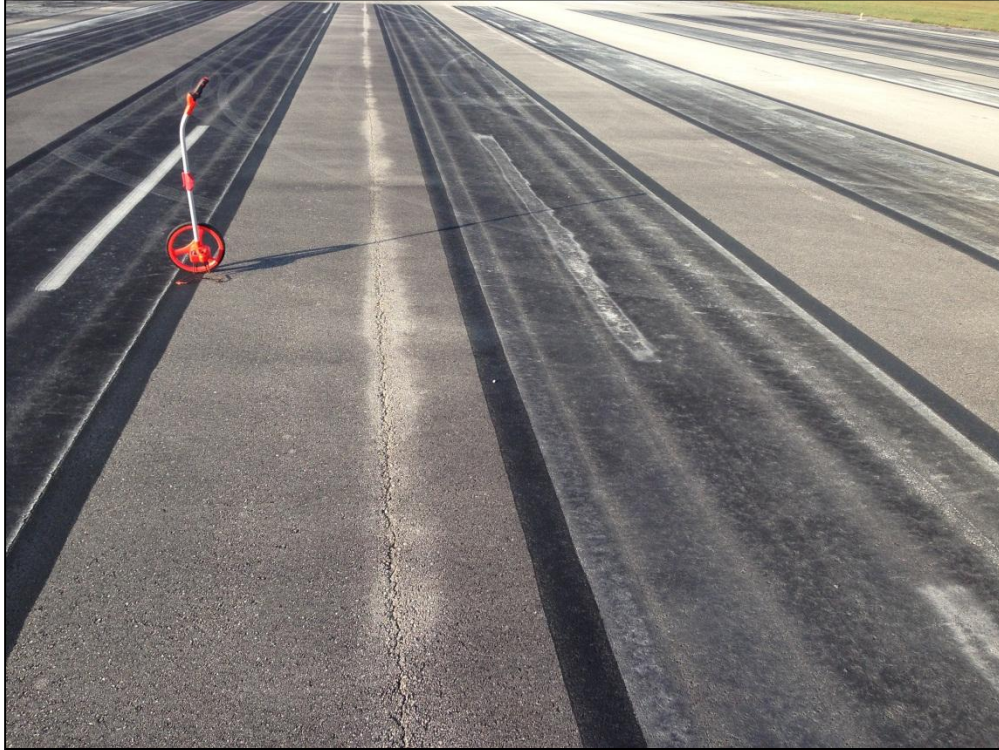
Runway 5-23 exhibited low severity weathering in addition to longitudinal cracks primarily located along the paving joints. Low quantities of both low severity

Runway 5-23, Section 6105, Sample Unit 349 – Low Severity (48) Longitudinal and Transverse Cracking, Low Severity (57) Weathering

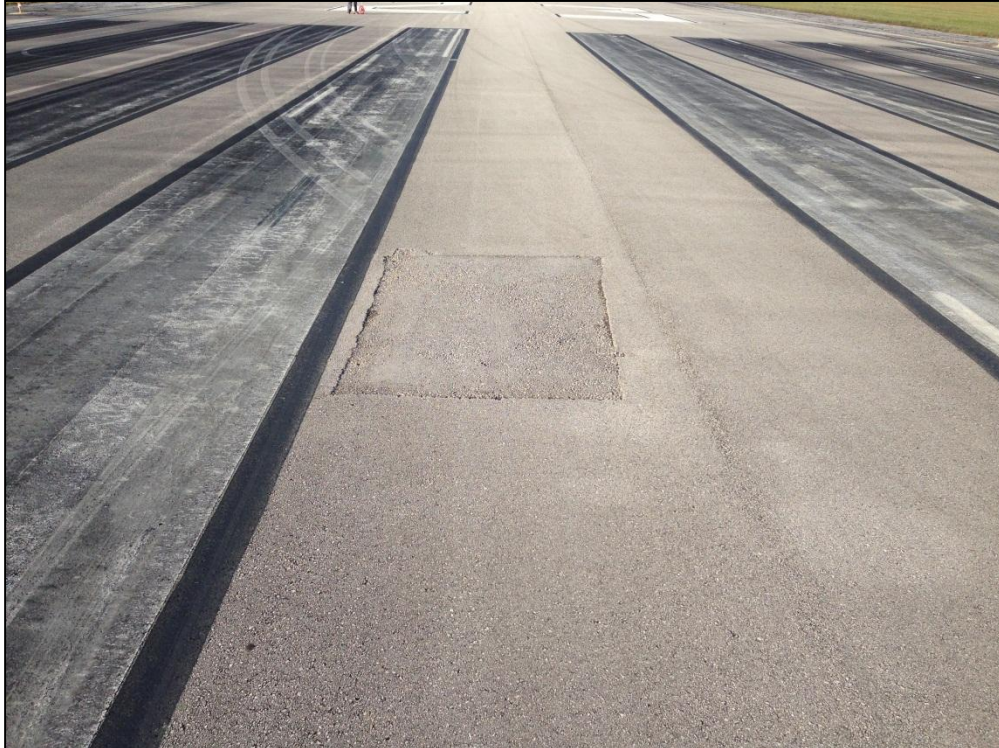
Runway 5-23, Section 6105, Sample Unit 349 – Low Severity (50) Patching, Low Severity (57) Weathering

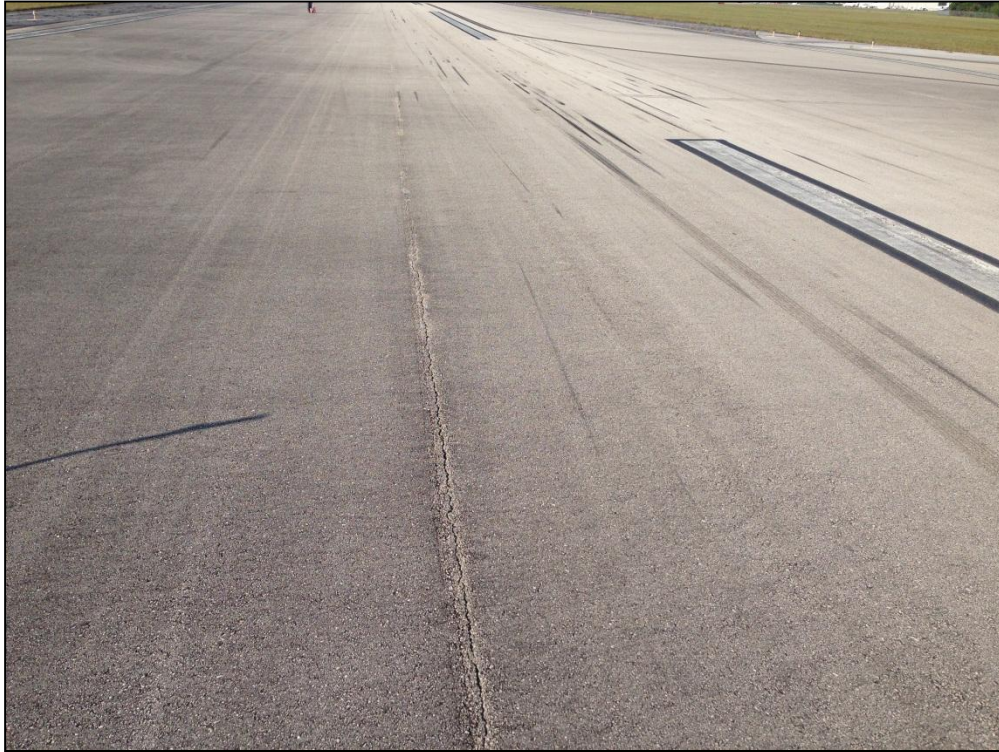
Runway 5-23, Section 6105, Sample Unit 335 – Low Severity (48) Longitudinal and Transverse Cracking, Low Severity (57) Weathering

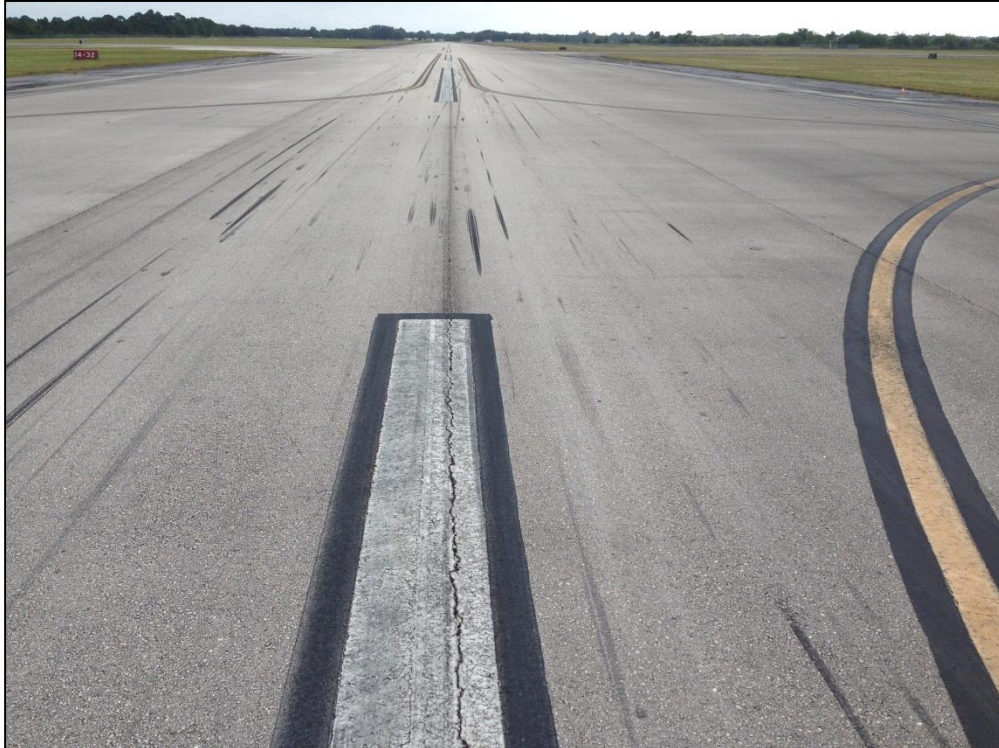
Runway 5-23, Section 6105, Sample Unit 314 – Low Severity (48) Longitudinal and Transverse Cracking, Low Severity (57) Weathering

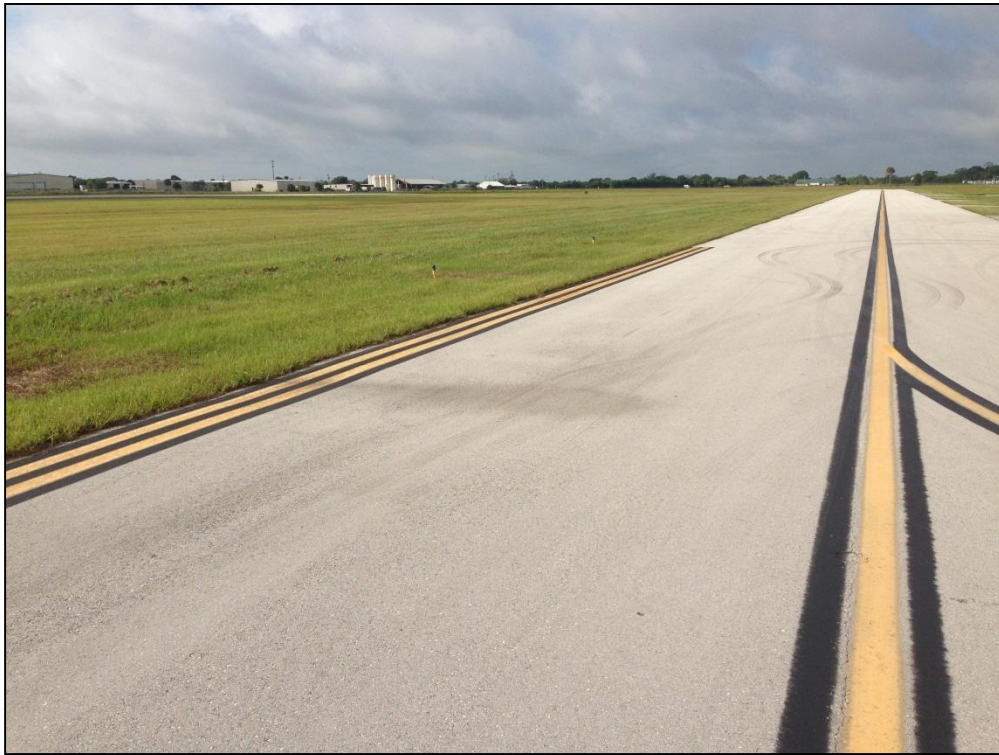
Taxiways Alpha and Charlie recently went through mill and overlay rehabilitation in March of 2011. These pavement sections exhibited small quantities of low severity longitudinal/transverse cracking along with weathering. One depression was identified along Taxiway Alpha which was most likely due to the asphalt placement creating a low spot for water to pond.

Taxiway A, Section 105, Sample Unit 114 – Low Severity (45) Depression, Low Severity (57) Weathering

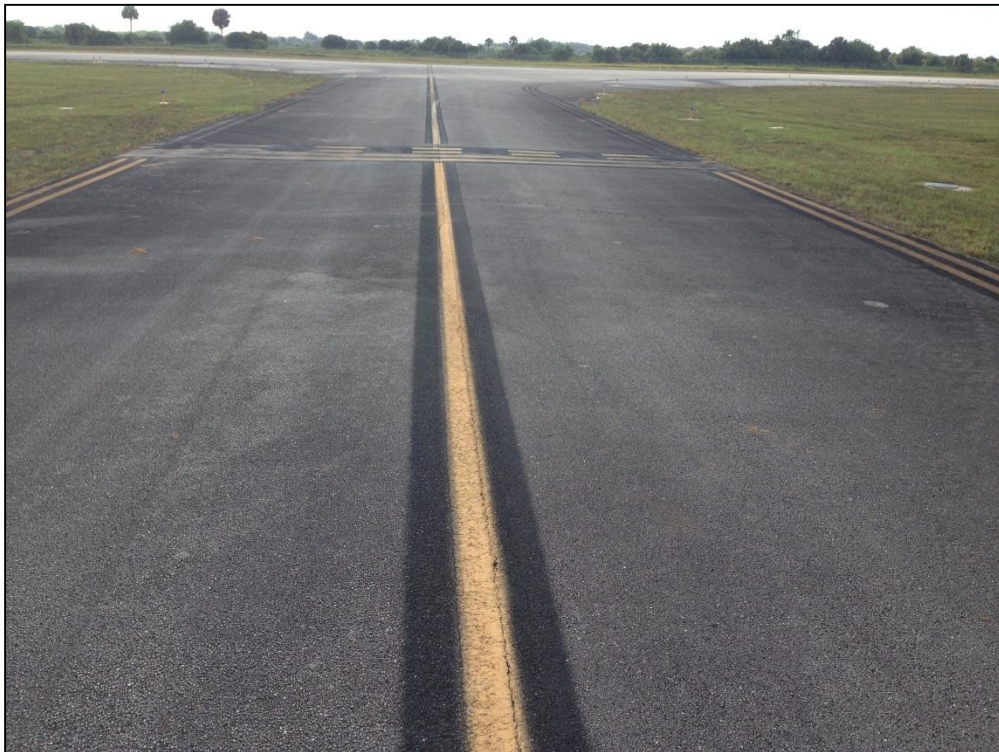
Taxiway D, Section 405, Sample Unit 102 – Low Severity (48) Longitudinal and Transverse Cracking, Low Severity (52) Raveling, Low Severity (57) Weathering

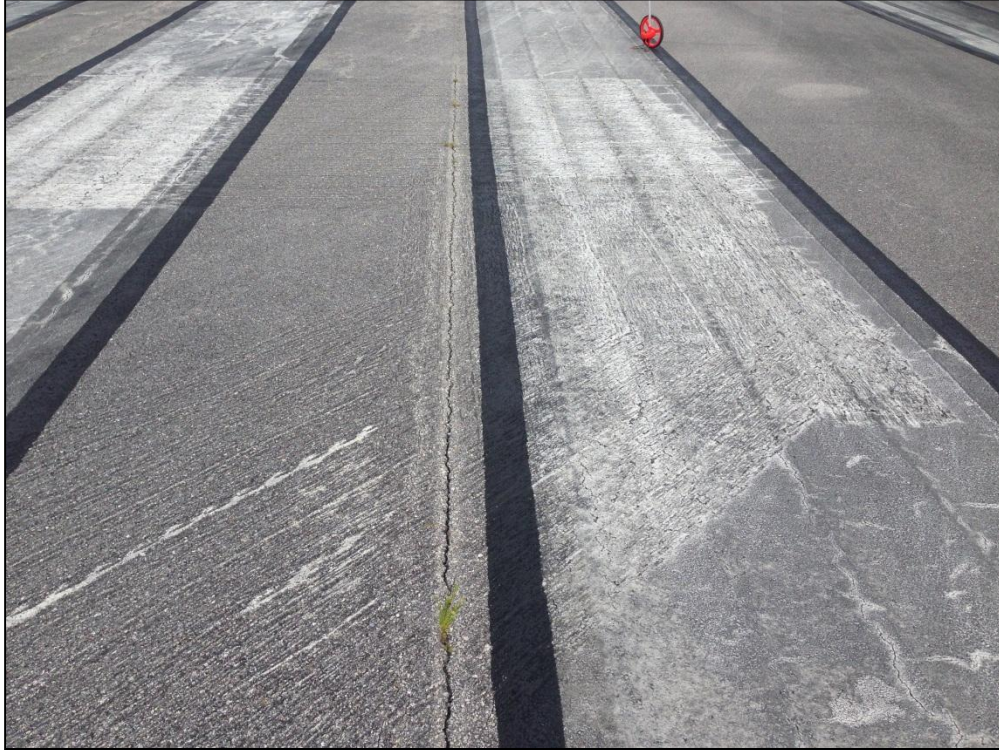
Runway 14-32 exhibited low to medium severity weathering and raveling in addition to longitudinal/transverse cracking. Low severity swelling was also recorded throughout the runway pavement sections. A small quantity of low severity depressions were also recorded at isolated locations on the runway. Runway 14-32 is showing its age, with the primary causes of the current pavement distresses being related to both age and climate.

Runway 14-32, Section 6205, Sample Unit 301 – Medium Severity (48) Longitudinal and Transverse Cracking, Low and Medium Severity (52) Raveling

- Runway 14-32 – Section 6205.
 - Mill and overlay attributed to distresses related to subgrade quality, climate, and age of pavement.
- Taxiway B – Section 205
 - Mill and overlay attributed to distresses related to subgrade quality, climate, and age of pavement.

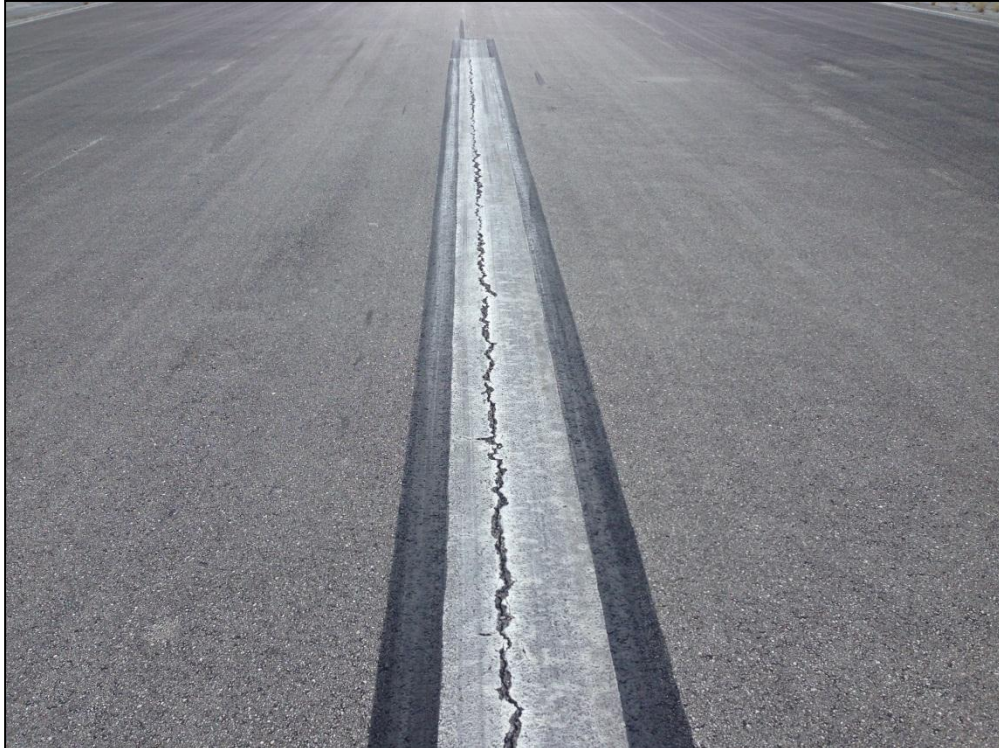
Runway 14-32, Section 6205, Sample Unit 315 – Medium Severity (48) Longitudinal and Transverse Cracking, Low Severity (57) Weathering

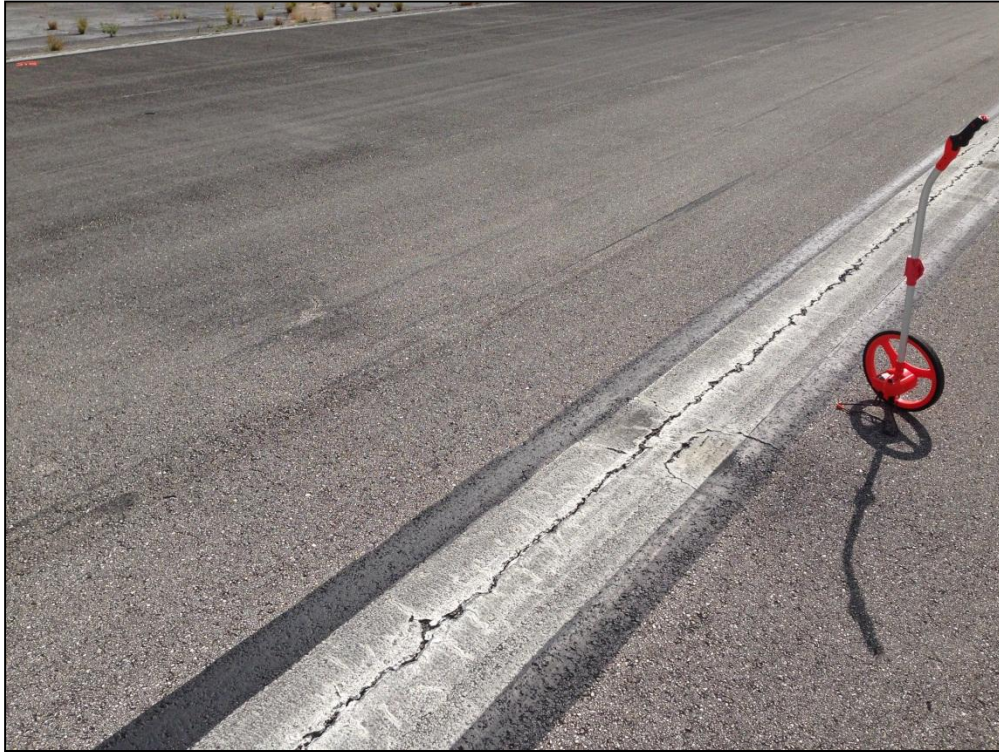
Runway 14-32, Section 6205, Sample Unit 319 – Low Severity (45) Depression, Medium Severity (48) Longitudinal and Transverse Cracking, Low Severity (57) Weathering

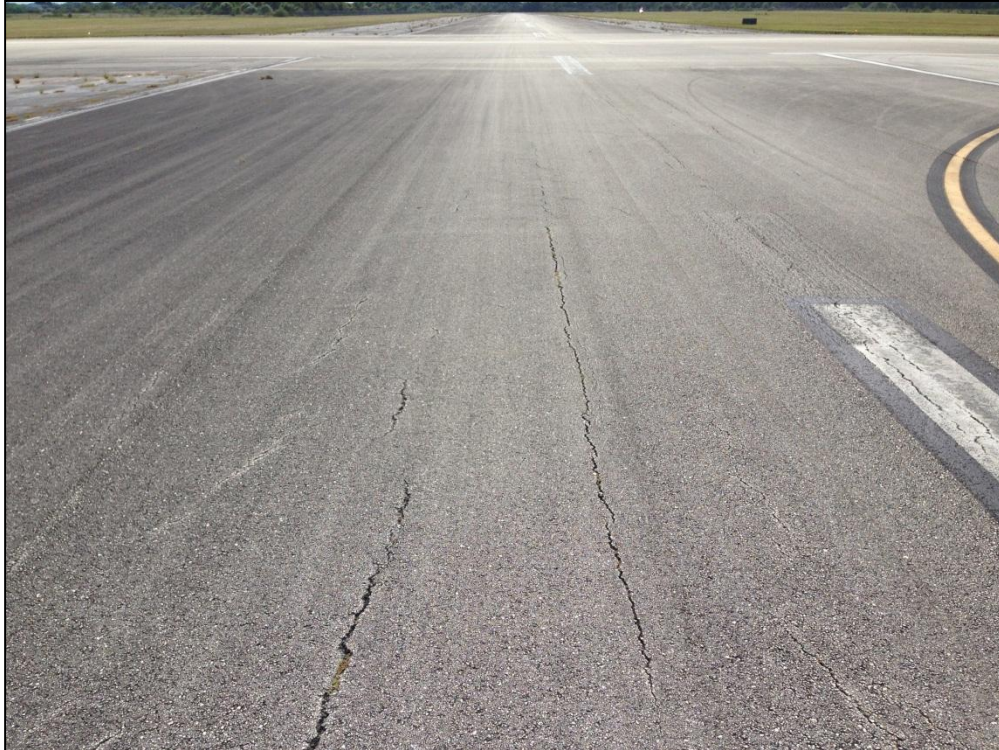
Runway 14-32, Section 6205, Sample Unit 343 – Low and Medium Severity (48) Longitudinal and Transverse Cracking, Low Severity (52) Raveling, Low Severity (57) Weathering

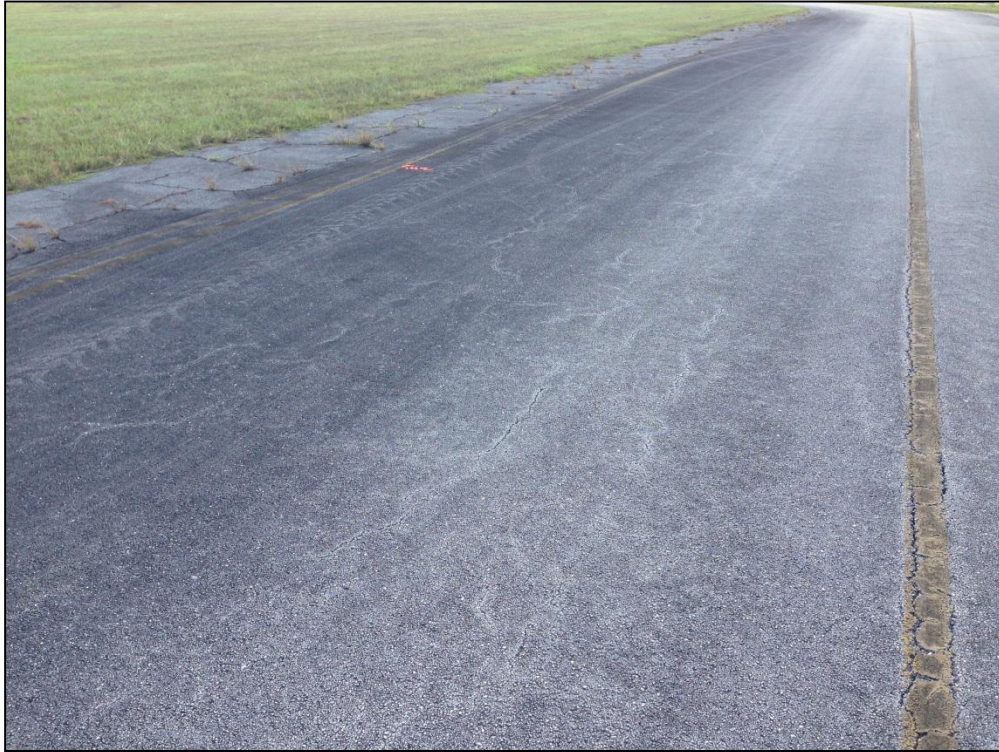
Taxiway Bravo exhibited both low and medium severity longitudinal/transverse cracking along with low severity weathering, raveling and block cracking. A significant amount of swelling was also recorded along Taxiway Bravo which can be attributed to climate and subgrade quality.

Taxiway B, Section 205, Sample Unit 142 – Low Severity (48) Longitudinal and Transverse Cracking, Low Severity (52) Raveling, Low Severity (57) Weathering

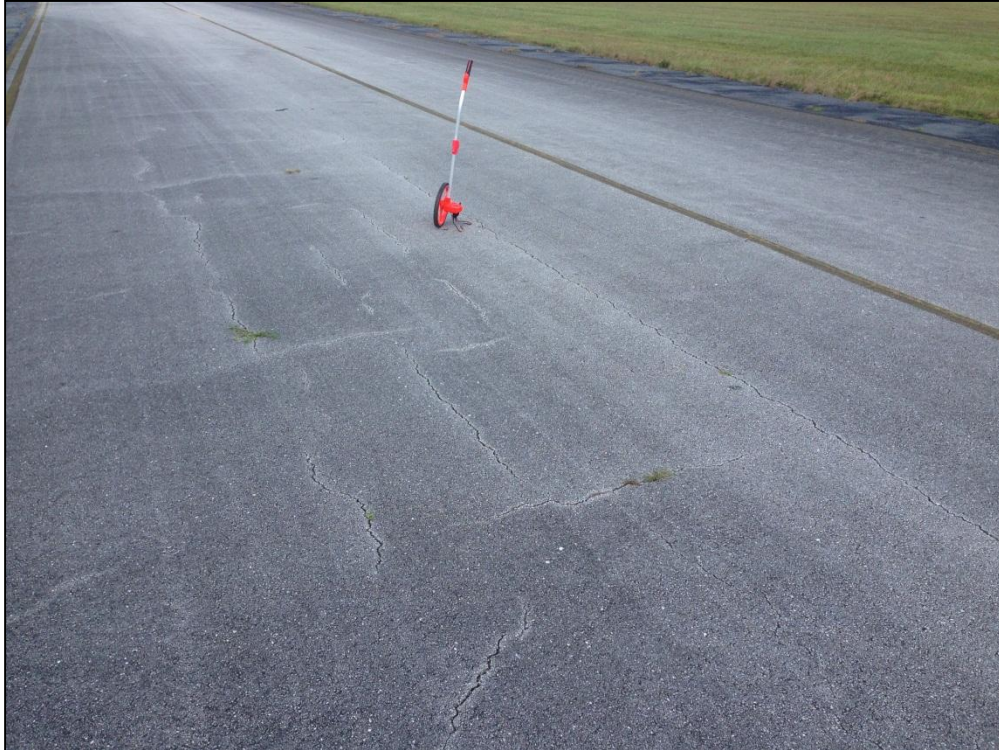
Taxiway B, Section 205, Sample Unit 131 – Low Severity (43) Block Cracking, Low Severity (57) Weathering

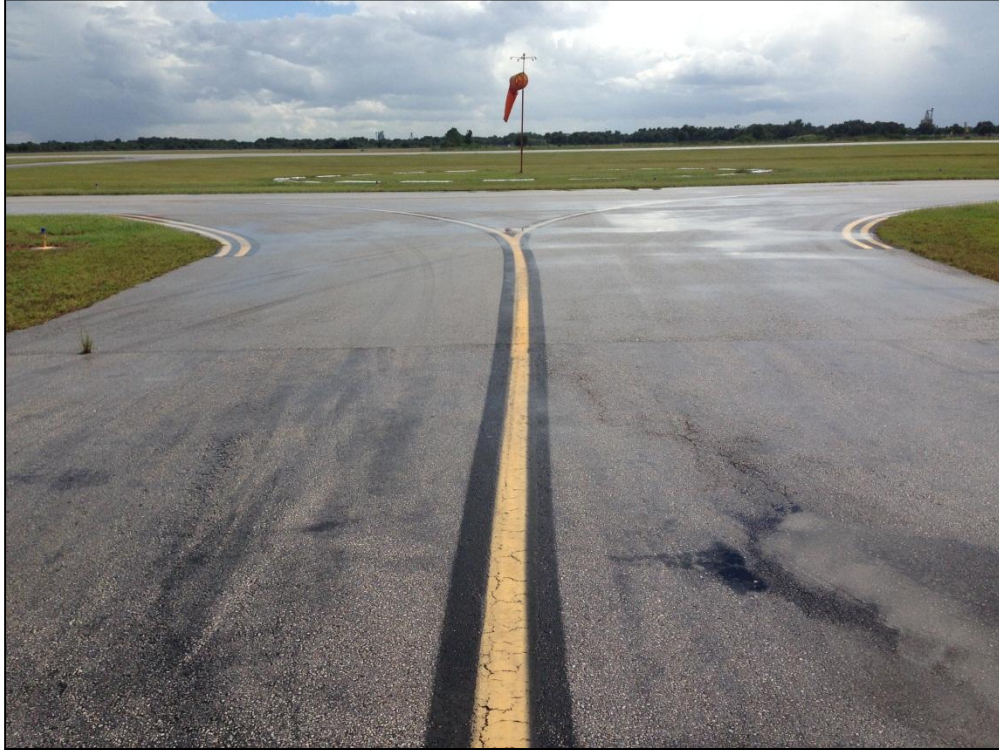
Taxiway A, Section 125, Sample Unit 700 – Low Severity (45) Depression, Low Severity (48) Longitudinal and Transverse Cracking, Low Severity (52) Raveling, Low Severity (57) Weathering
