FLORIDA DEPARTMENT OF TRANSPORTATION AVIATION AND SPACEPORT OFFICE

Pavement Evaluation Report - Plant City Airport

EXECUTIVE SUMMARY

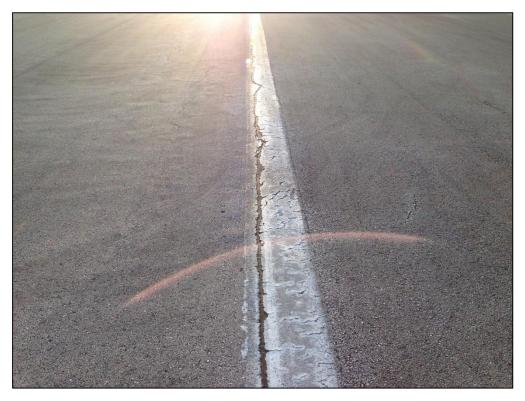
Runway 10-28, Section 6103, Sample Unit 296 – Low Severity (48) Longitudinal and Transverse Cracking, Low Severity (52) Raveling, Low Severity (57) Weathering, Low Severity (56) Swelling

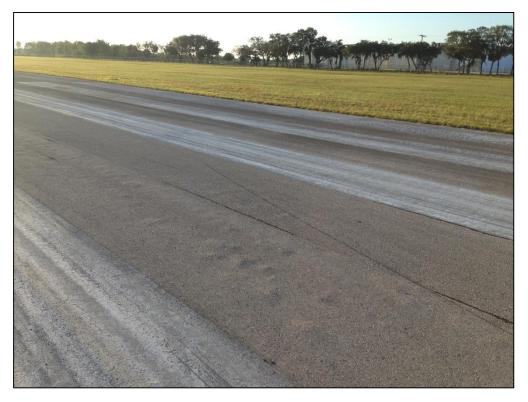
Runway 10-28, Section 6115, Sample Unit 301 – Low Severity (48) Longitudinal and Transverse Cracking, Low Severity (52) Raveling, Low Severity (57) Weathering, Low Severity (56) Swelling

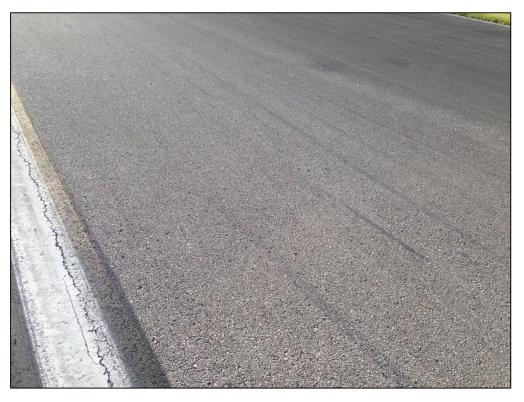
Runway 10-28, Section 6115, Sample Unit 342 – Low Severity (48) Longitudinal and Transverse Cracking, Low Severity (52) Raveling, Low Severity (57) Weathering

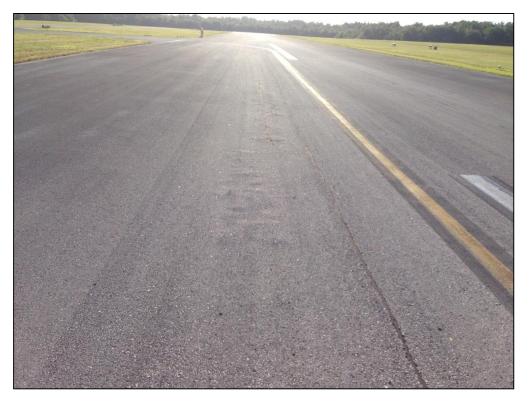
Runway 10-28, Section 6115, Sample Unit 356 – Low Severity (48) Longitudinal and Transverse Cracking, Low Severity (52) Raveling, Low Severity (57) Weathering, Low Severity (56) Swelling

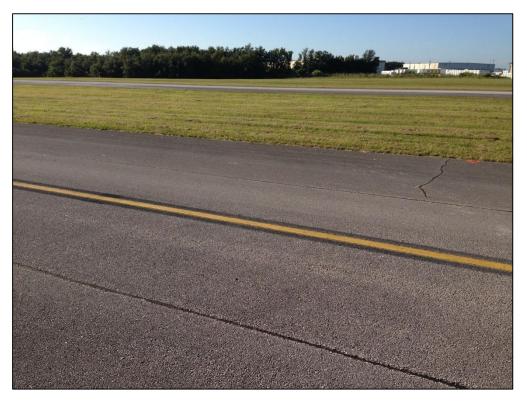
Taxiway A, Section 115, Sample Unit 135 – Low Severity (48) Longitudinal and Transverse Cracking, Low Severity (52) Raveling, Low Severity (57) Weathering

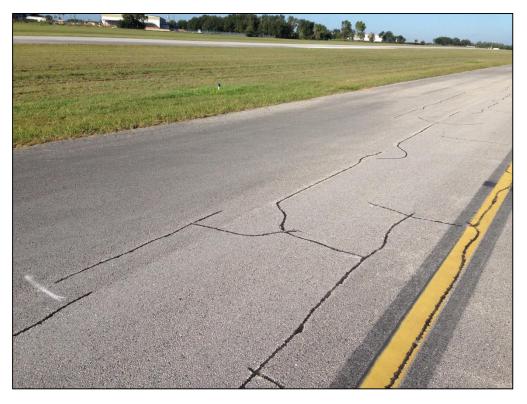
Taxiway A, Section 110, Sample Unit 130 – Low Severity (48) Longitudinal and Transverse Cracking, Low Severity (52) Raveling, Low Severity (57) Weathering

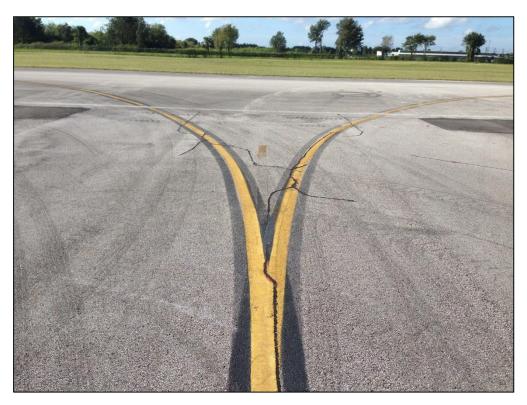
Taxiway A, Section 160, Sample Unit 300 – Low Severity (48) Longitudinal and Transverse Cracking, Low Severity (52) Raveling, Low Severity (57) Weathering, Low Severity (50) Patching

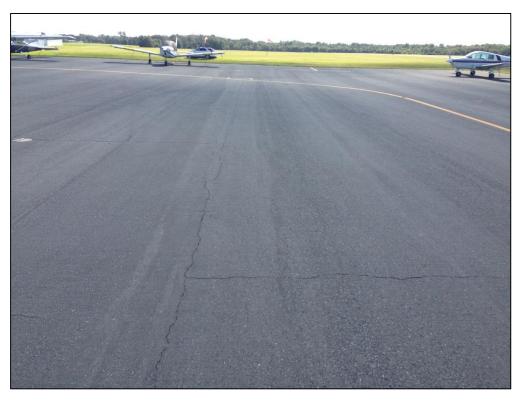
Apron, Section 4130, Sample Unit 209 - Low Severity (48) Longitudinal and Transverse Cracking

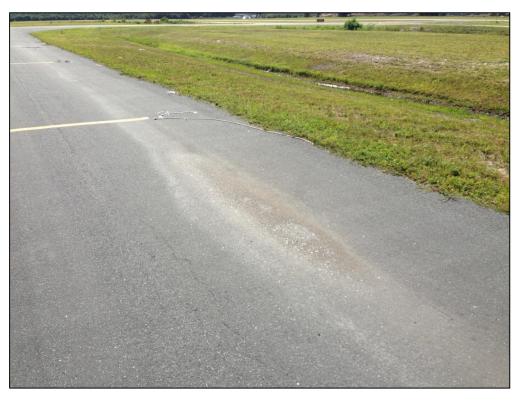
Apron, Section 4110, Sample Unit 105 – Low Severity (48) Longitudinal and Transverse Cracking, Low Severity (45) Depression

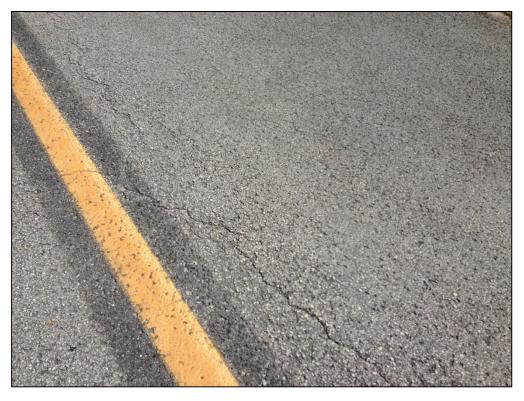
Taxiway T-Hang, Section 720, Sample Unit 100 – Low Severity (48) Longitudinal and Transverse Cracking, Medium Severity (52) Raveling

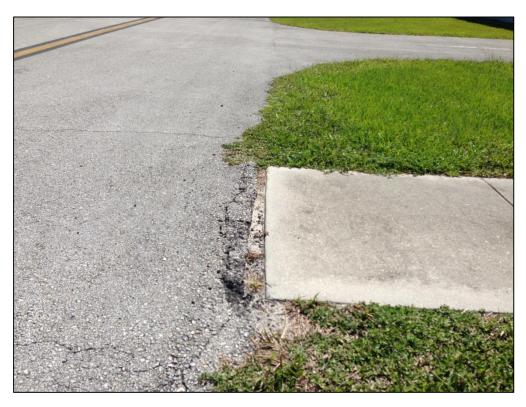
Taxiway T-Hang, Section 725, Sample Unit 400 – Low Severity (48) Longitudinal and Transverse Cracking, Low Severity (52) Raveling, Low Severity (57) Weathering, Medium Severity (54) Shoving
