FLORIDA DEPARTMENT OF TRANSPORTATION  
AVIATION AND SPACEPORT OFFICE

PALM BEACH  
COUNTY GLADES  
AIRPORT (PHK)

DECEMBER 2013

# STATEWIDE Airfield Pavement Management PROGRAM

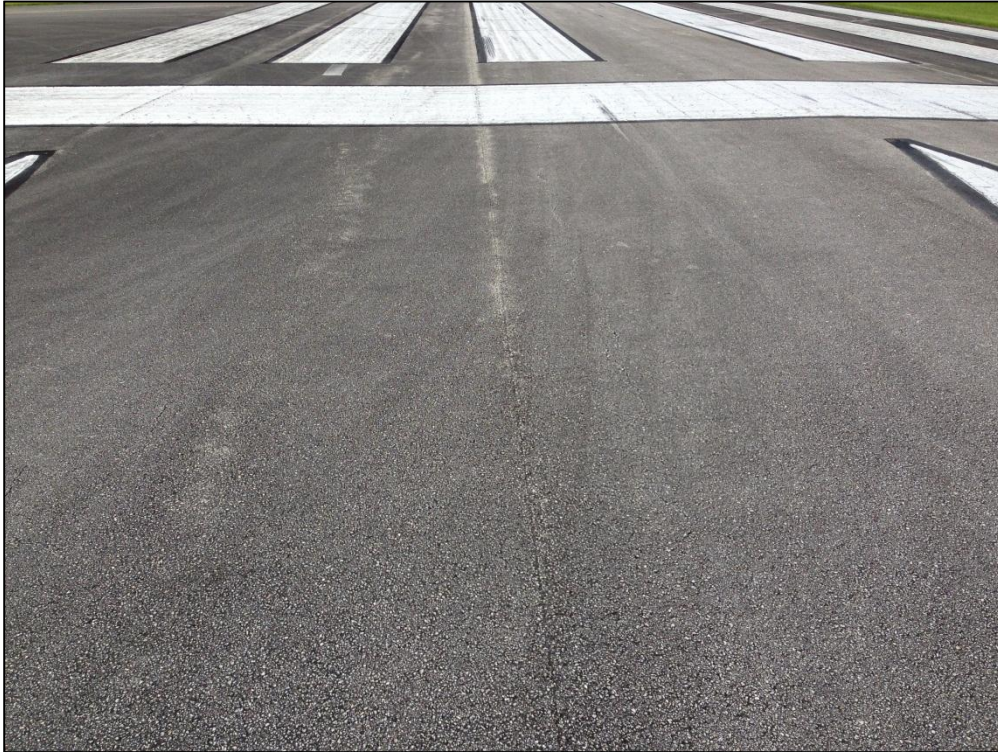
Runway 17-35 exhibited pavement condition indices ranging from 63-68. The runway pavements are in Fair condition. Typical distresses include low severity longitudinal/transverse cracking; low severity swelling; low severity raveling; and

low severity weathering. These are age, climate, and subgrade quality based distresses. The inspection did observe a substantial amount of swelling throughout the length of the runway. Similar quantities of swelling were not generally observed throughout the airport.

Runway 17-35, Section 6110, Sample Unit 180 – Low Severity (48) Longitudinal and Transverse Cracking, Low Severity (52) Raveling, Low Severity (57) Weathering, Low Severity (56) Swelling

- Runway 17-35 – Section 6110
  - Mill and Overlay attributed to distresses related to climate and age of pavement.
- Taxiway D – Section 110
  - Mill and Overlay attributed to distresses related to subgrade quality, climate, and age of pavement.

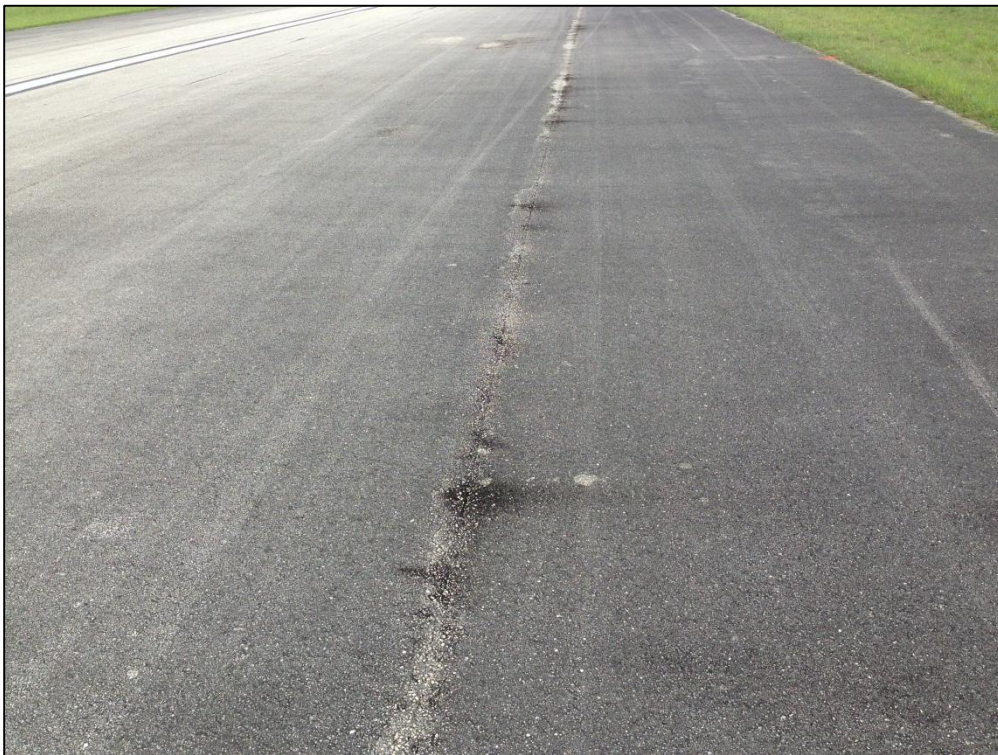
Runway 17-35, Section 6110, Sample Unit 131 – Low and Medium Severity (48) Longitudinal and Transverse Cracking, Low Severity (52) Raveling, Low Severity (57) Weathering, Low Severity (56) Swelling

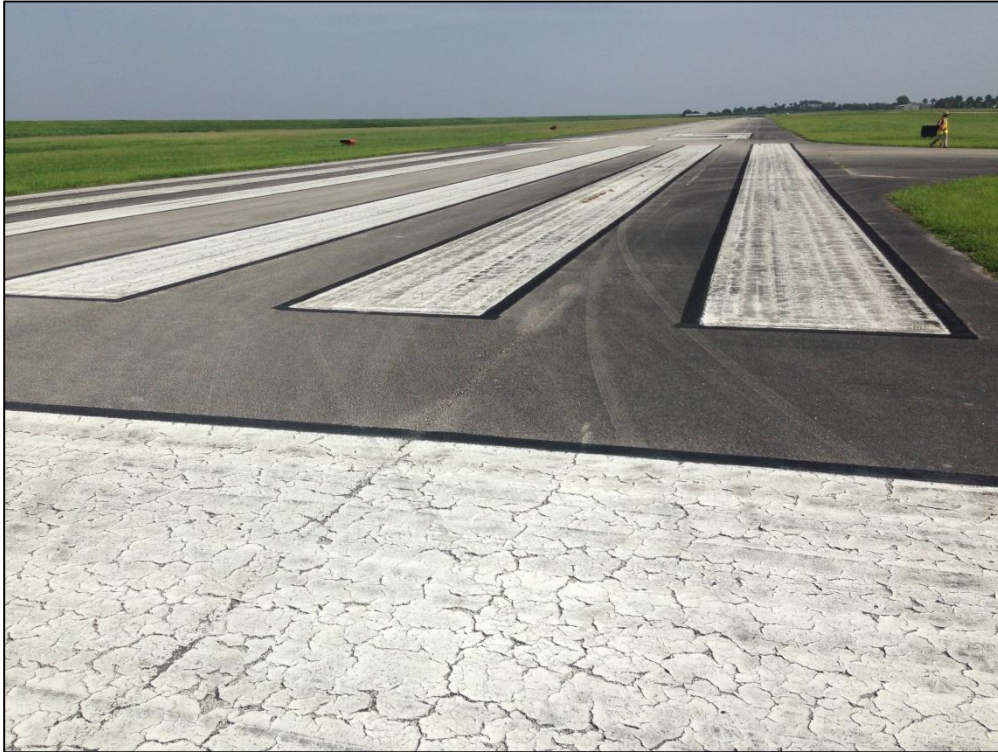
Runway 17-35, Section 6105, Sample Unit 101 – Low Severity (48) Longitudinal and Transverse Cracking, Low Severity (52) Raveling, Low Severity (57) Weathering

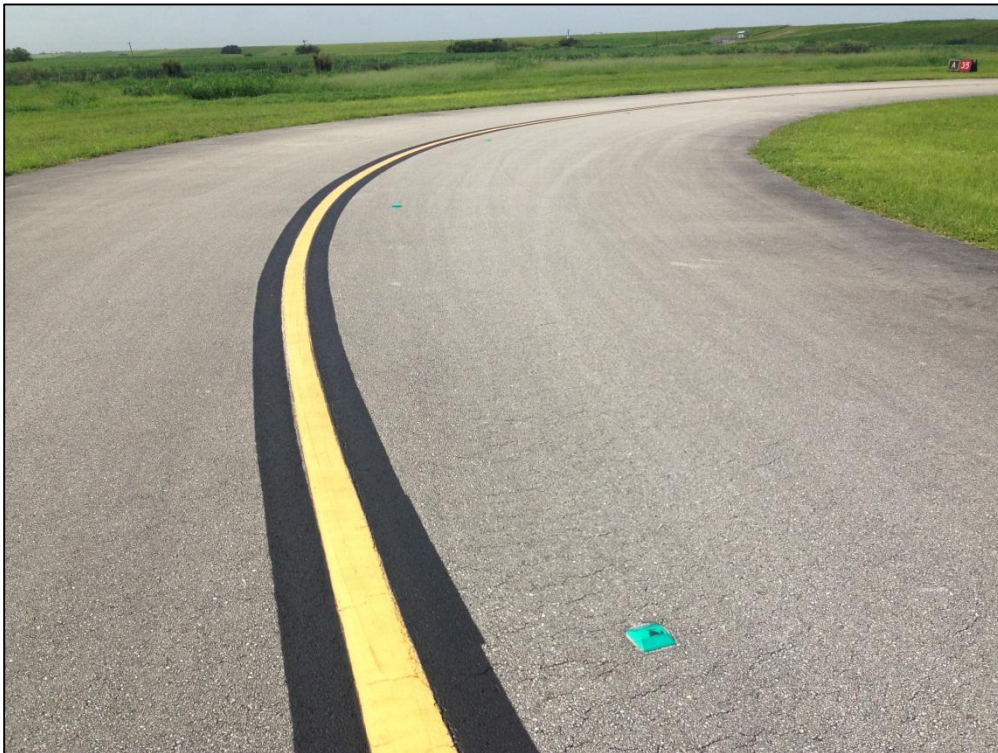
Parallel Taxiway A and the taxiway connectors are in Good to Fair condition. Typical distresses include low severity longitudinal/transverse cracking; low severity weathering; and low and medium severity raveling. These are age and climate based distresses. Taxiway D exhibited a large amount of depression, which should be monitored for increases in severity.

Taxiway Alpha, Section 105, Sample Unit 140 – Low Severity (48) Longitudinal and Transverse Cracking, Low Severity (52) Raveling, Low Severity (57) Weathering

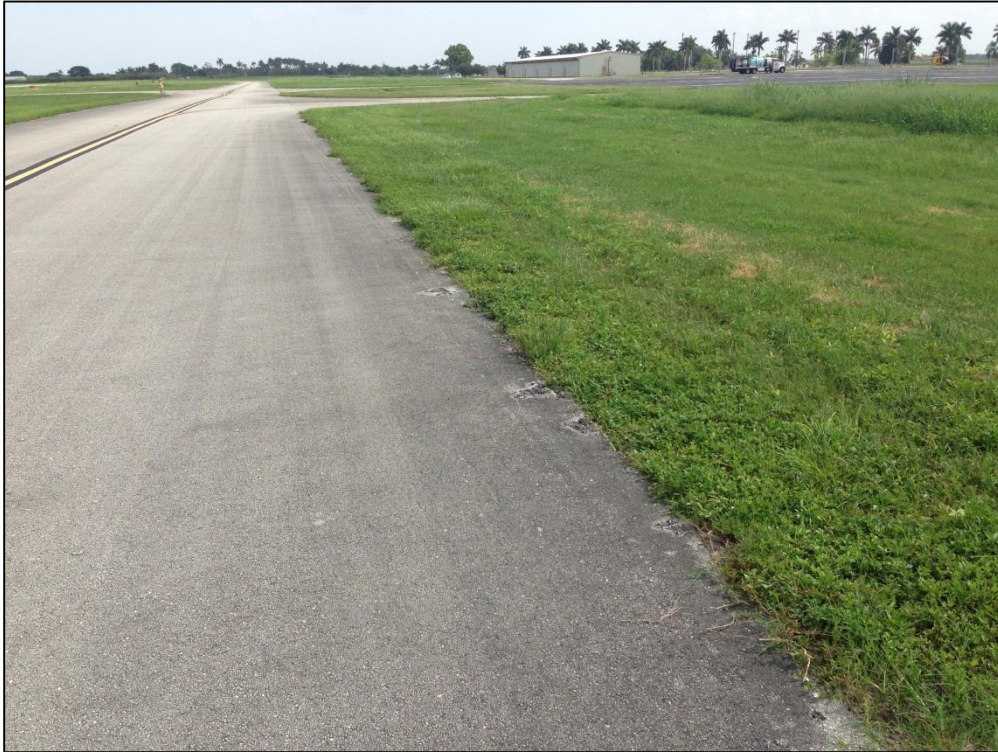
Taxiway Alpha, Section 105, Sample Unit 112 – Medium Severity (52) Raveling, Low Severity (57) Weathering

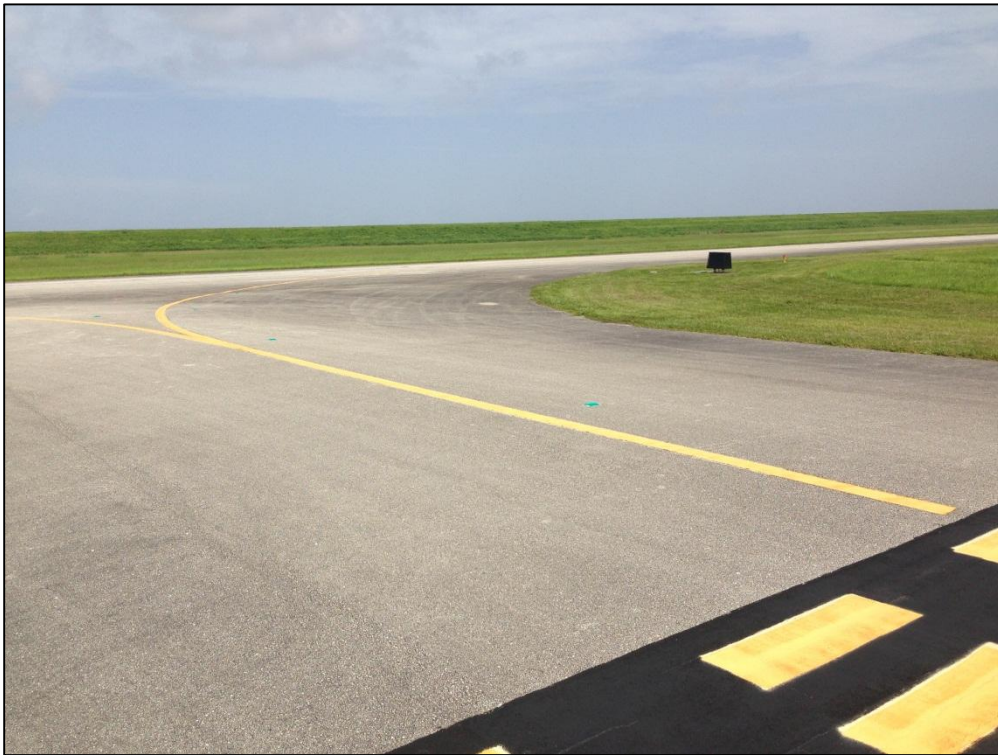
Taxiway Delta, Section 110, Sample Unit 100 – Low Severity (48) Longitudinal and Transverse Cracking, Low Severity (52) Raveling, Low Severity (57) Weathering

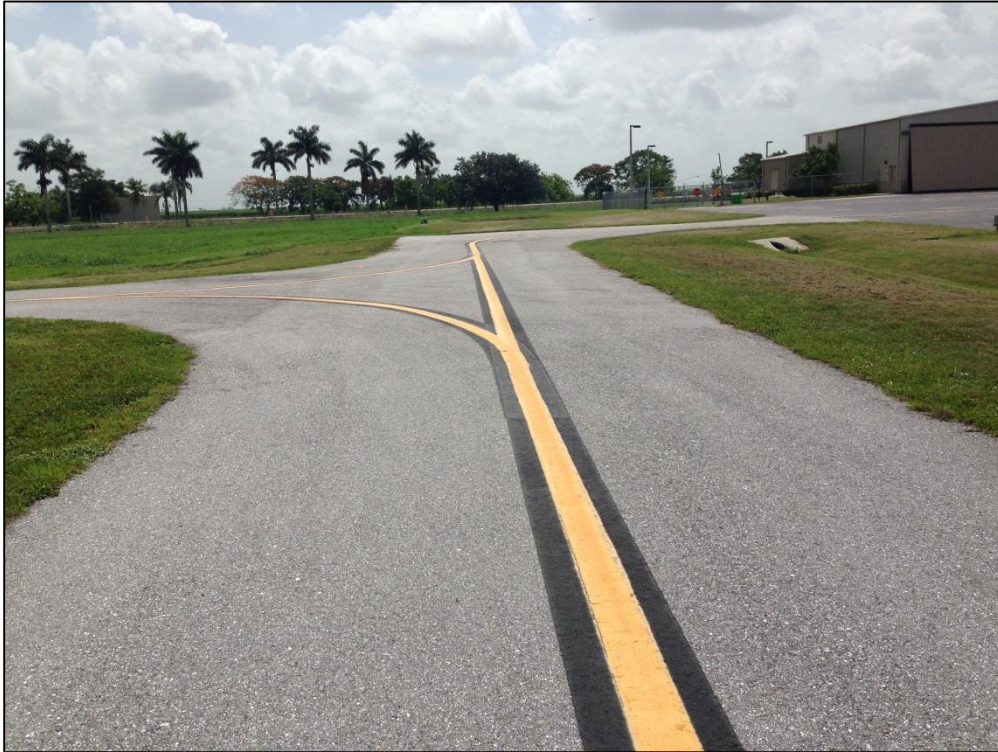
Apron T-Hangar, Section 4205, Sample Unit 101 – Low Severity (52) Raveling, Low Severity (57) Weathering
