FLORIDA DEPARTMENT OF TRANSPORTATION
AVIATION AND SPACEPORT OFFICE

**POMPANO BEACH
AIRPARK (PMP)**

DECEMBER 2013

STATEWIDE
**Airfield
Pavement
Management**
PROGRAM

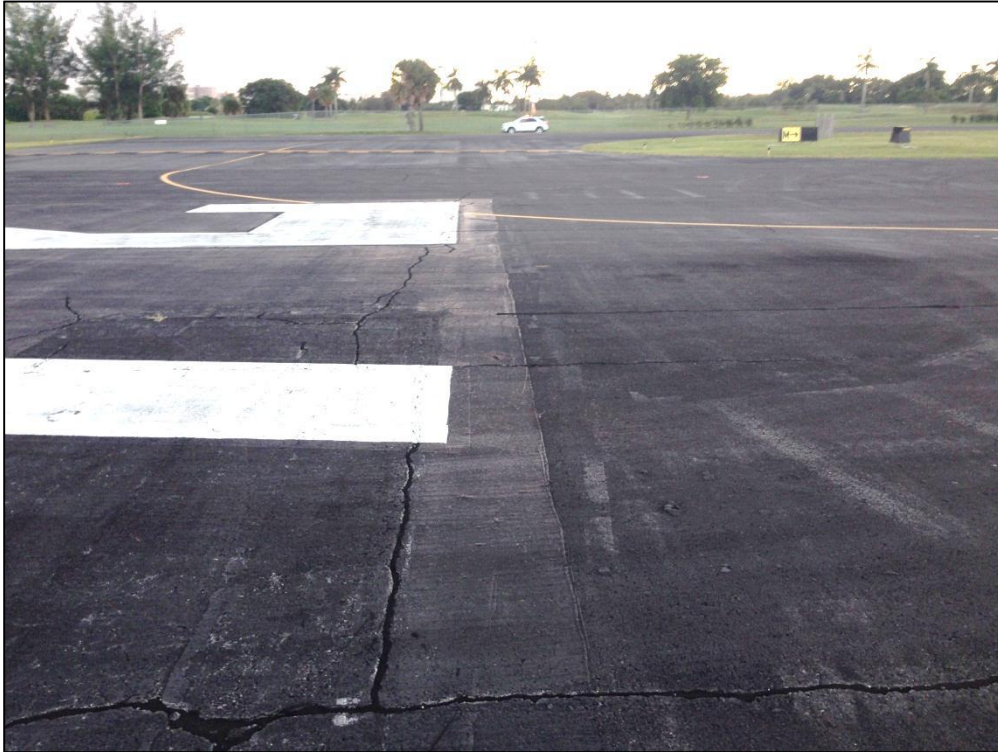
Runway 6-24, Section 6205, Sample Unit 378 – Low Severity (48) Longitudinal and Transverse Cracking, Low Severity (57) Weathering

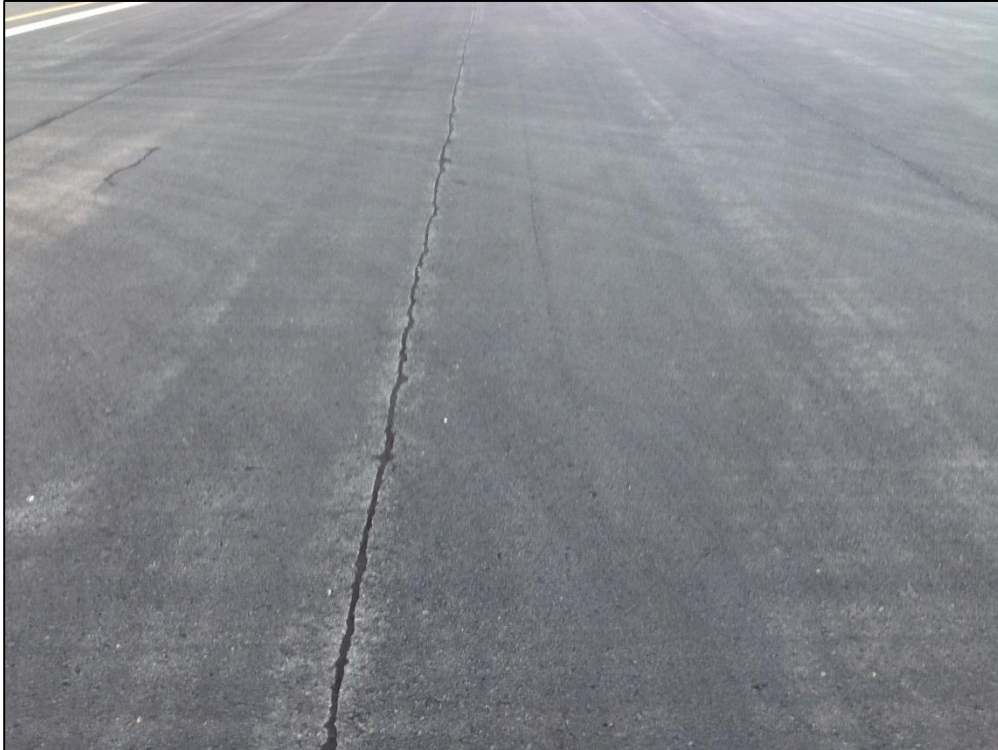
Runway 6-24, Section 6205, Sample Unit 378 – Low Severity (48) Longitudinal and Transverse Cracking, Low Severity (57) Weathering

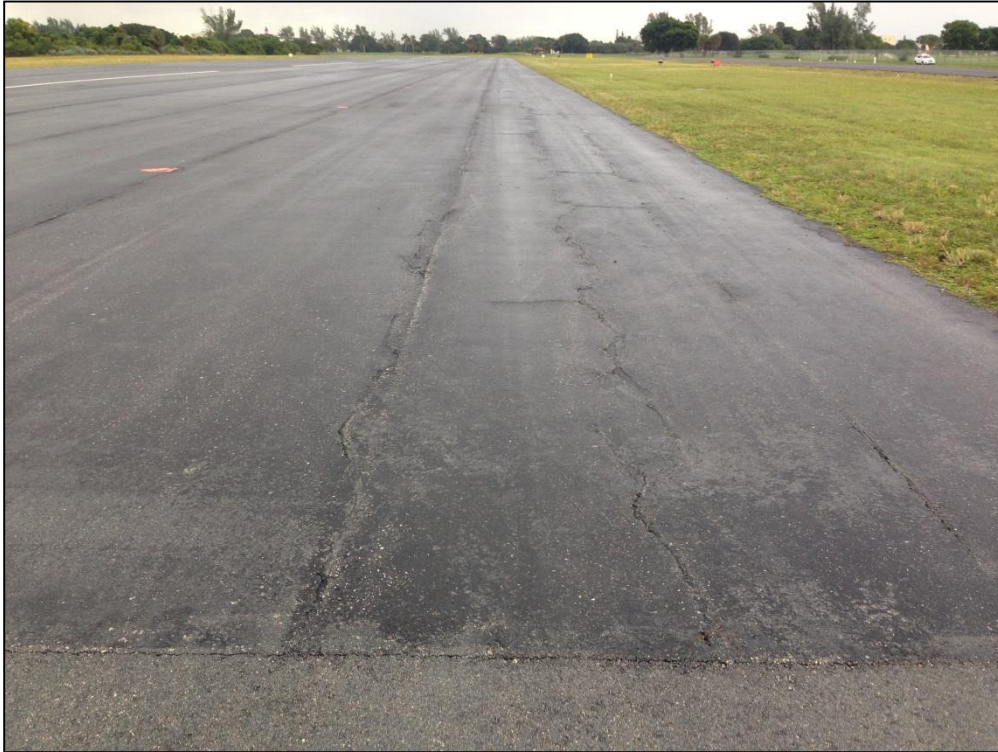
Runway 6-24, Section 6210, Sample Unit 556 – Low Severity (48) Longitudinal and Transverse Cracking, Low Severity (57) Weathering

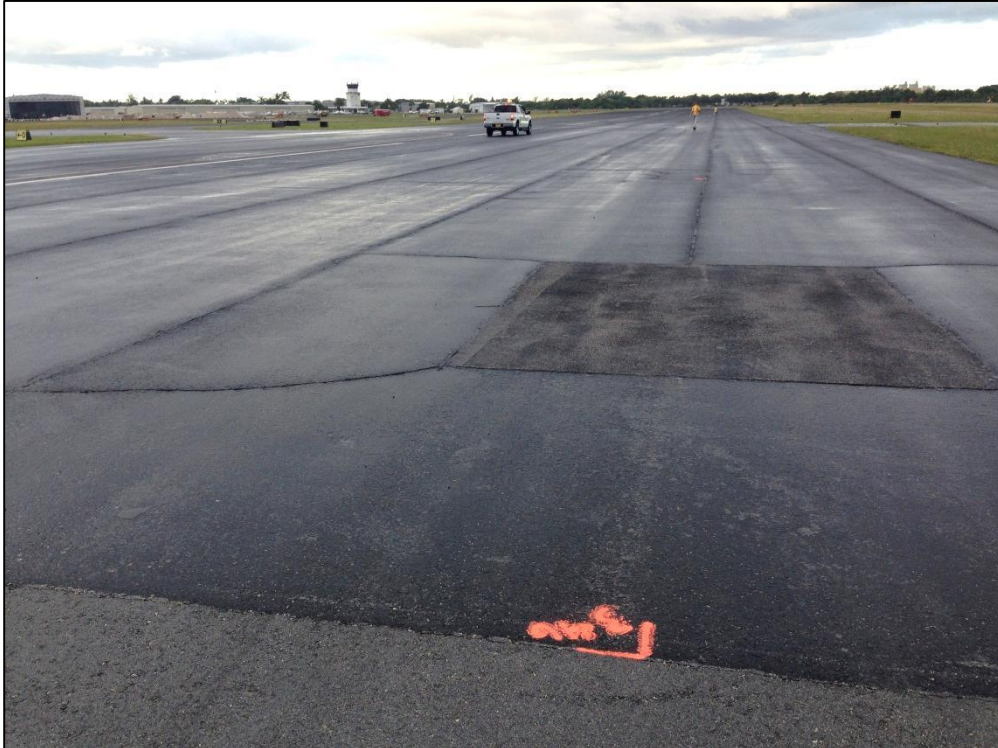
Runway 6-24, Section 6205, Sample Unit 346 – Low Severity (48) Longitudinal and Transverse Cracking, Low Severity (50) Patching, Low Severity (57) Weathering

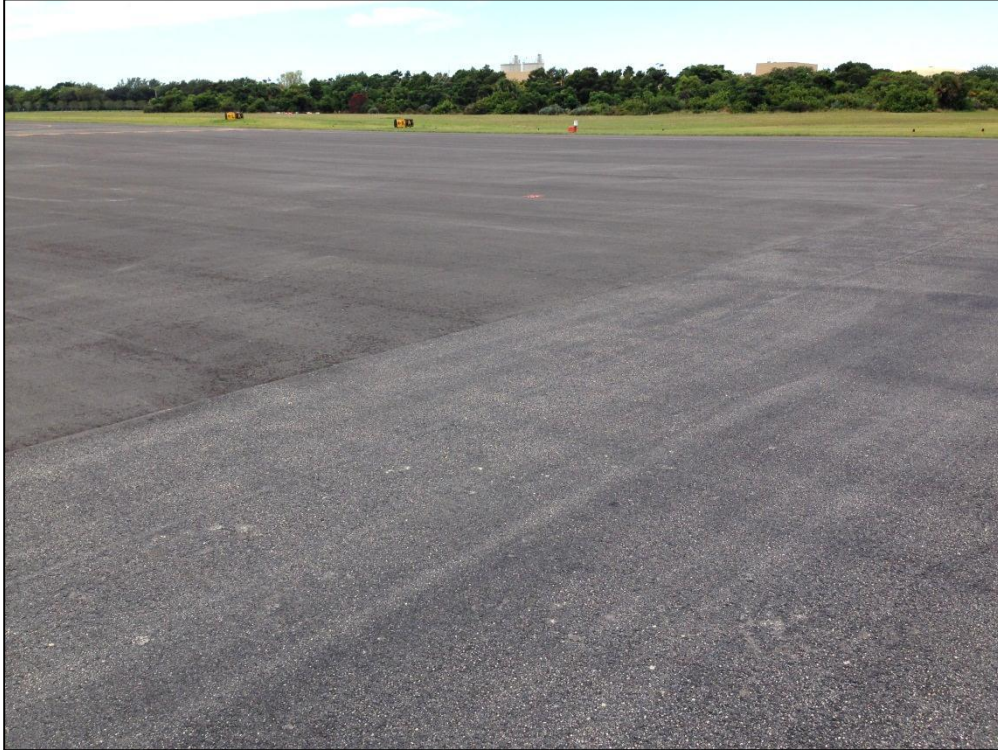
Runway 10-28, Section 6105, Sample Unit 102 – Low Severity (48) Longitudinal and Transverse Cracking, Low Severity (50) Patching, Low Severity (57) Weathering

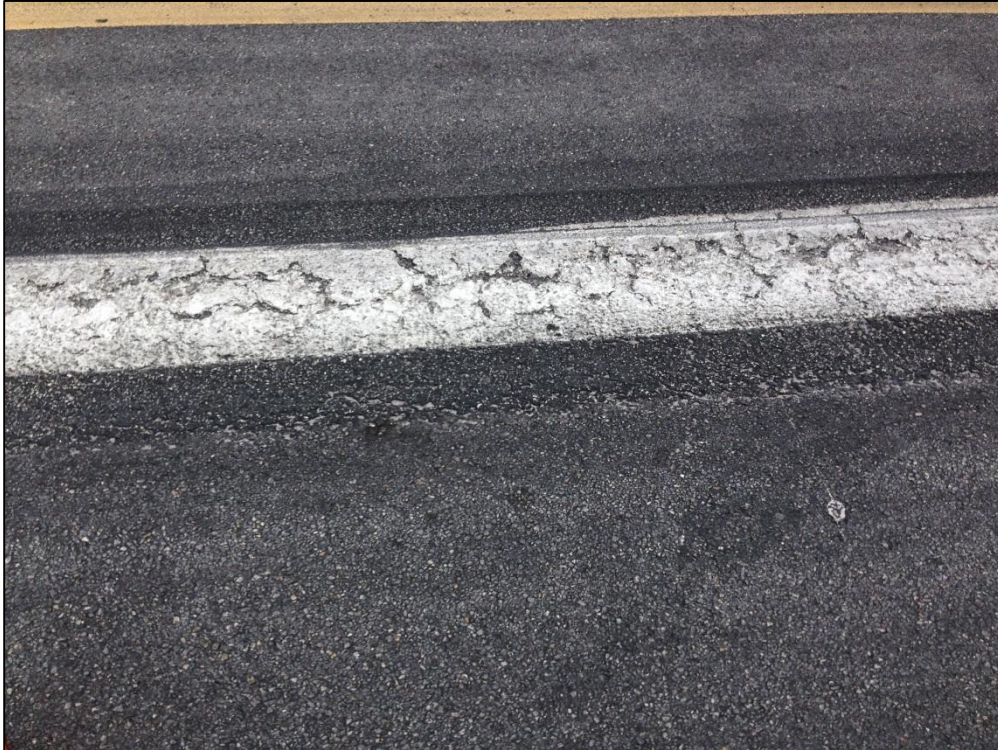
Runway 10-28, Section 6110, Sample Unit 110 – Low Severity (48) Longitudinal and Transverse Cracking, Low Severity (52) Raveling, Low Severity (57) Weathering

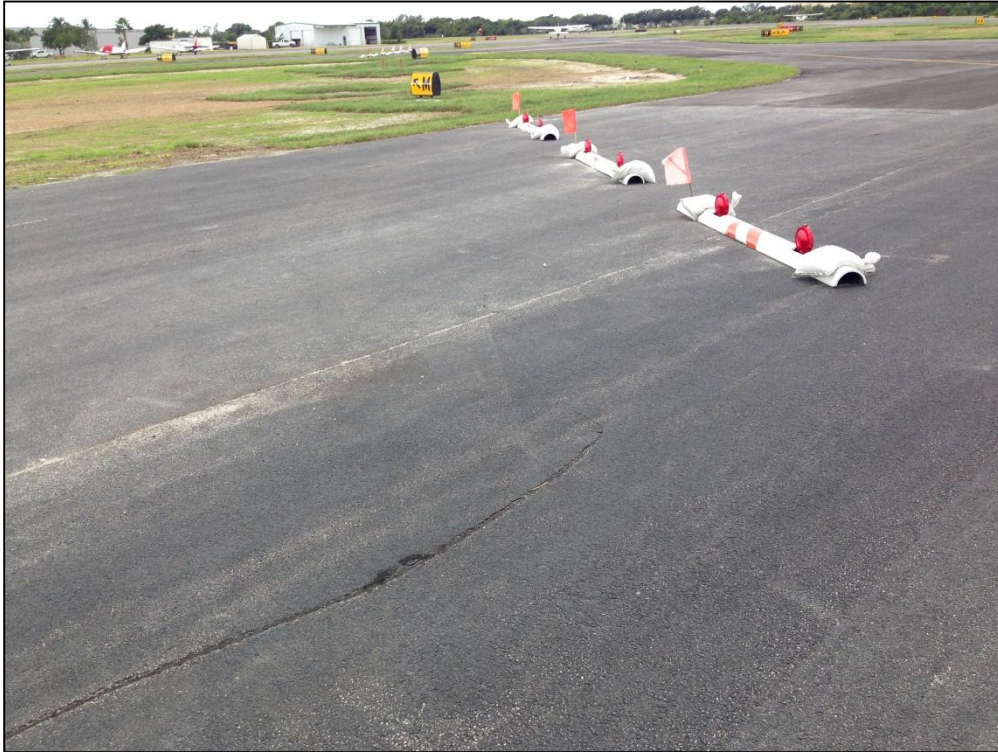
Runway 10-28, Section 6105, Sample Unit 124 – Low Severity (48) Longitudinal and Transverse Cracking, Low Severity (52) Raveling, Low Severity (57) Weathering

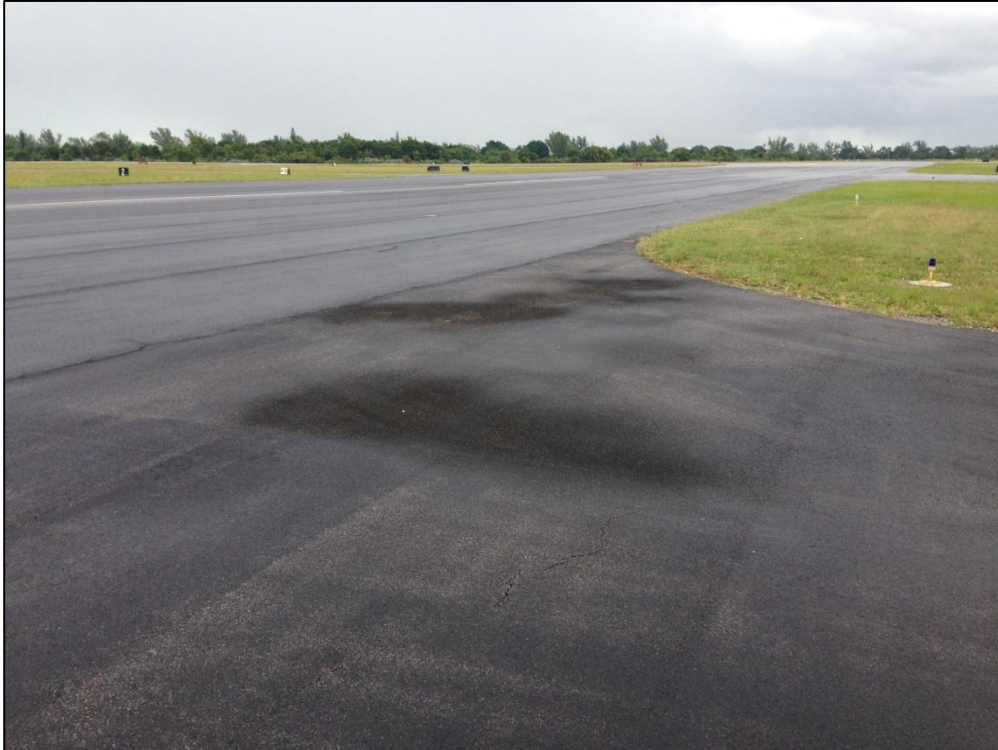
Taxiway C, Section 305, Sample Unit 300 – Low Severity (45) Depression, Low Severity (48) Longitudinal and Transverse Cracking, Low Severity (57) Weathering

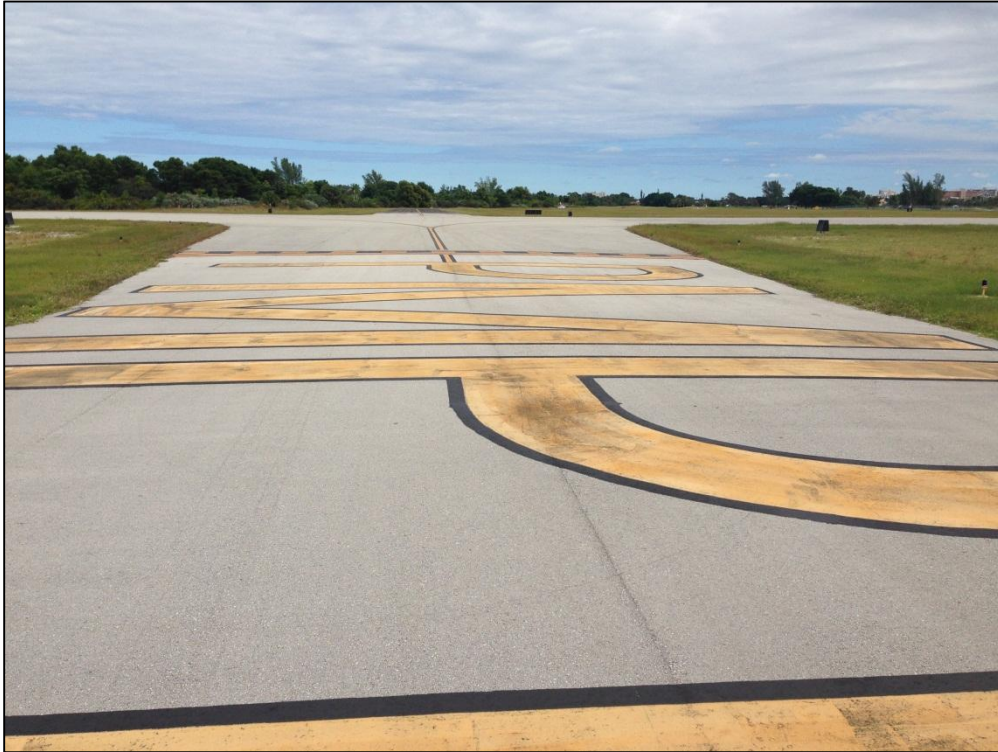
Taxiway F, Section 612, Sample Unit 616 – Low Severity (48) Longitudinal and Transverse Cracking, Low Severity (57) Weathering

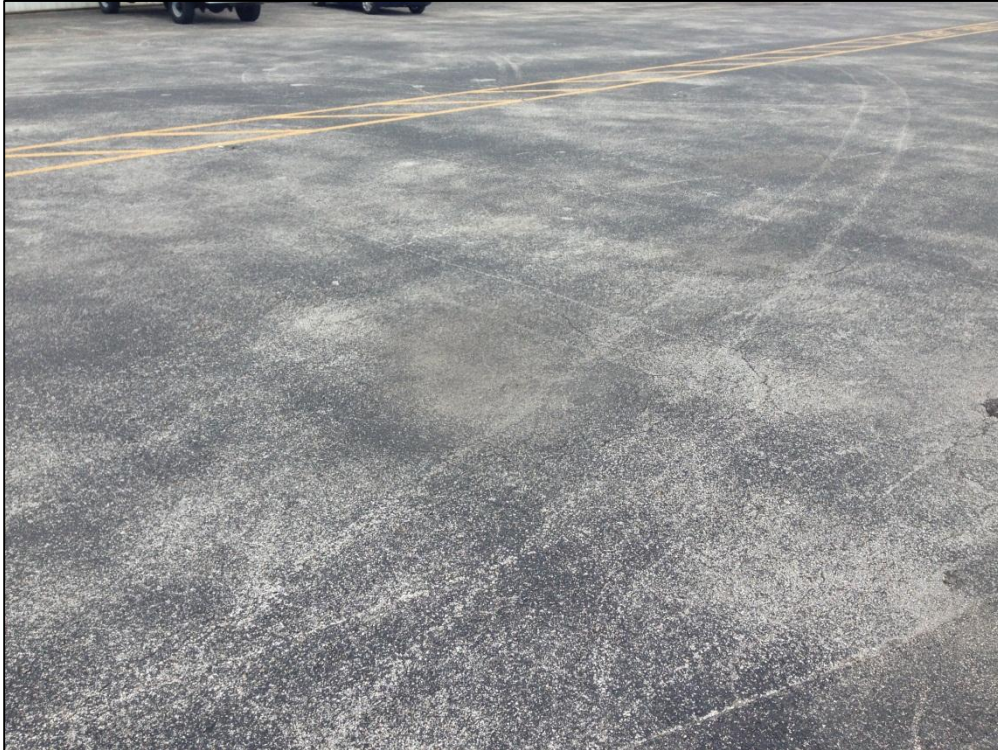
Apron S, Section 4125, Sample Unit 305 – Low Severity (45) Depression, Low Severity (43) Block Cracking, Low Severity (52) Raveling, Low Severity (57) Weathering

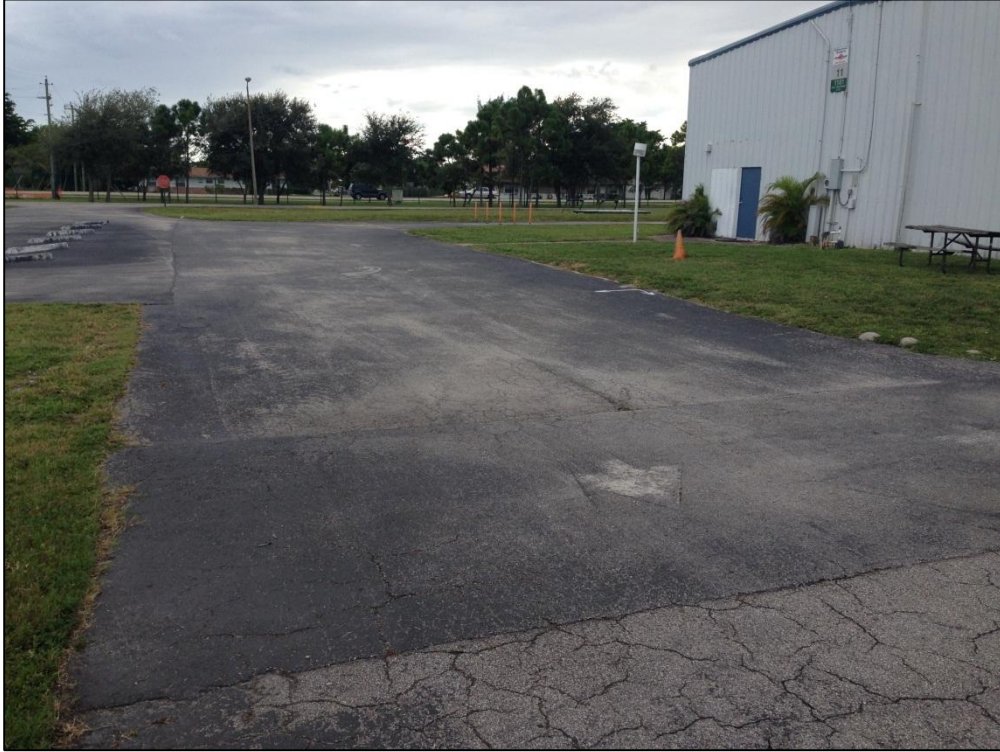
Apron Hang, Section 4315, Sample Unit 700 – Low Severity (43) Block Cracking, Low Severity (50) Patching, Low Severity (52) Raveling, Low Severity (57) Weathering

- Hangar Apron – Sections 4320, 4315, 4310, and 4305
 - Mill and Overlay attributed to distresses related to subgrade quality, climate, and age of pavement.
- South Apron – Sections 4125 and 4110
 - Mill and Overlay attributed to distresses related to subgrade quality, climate, and age of pavement.

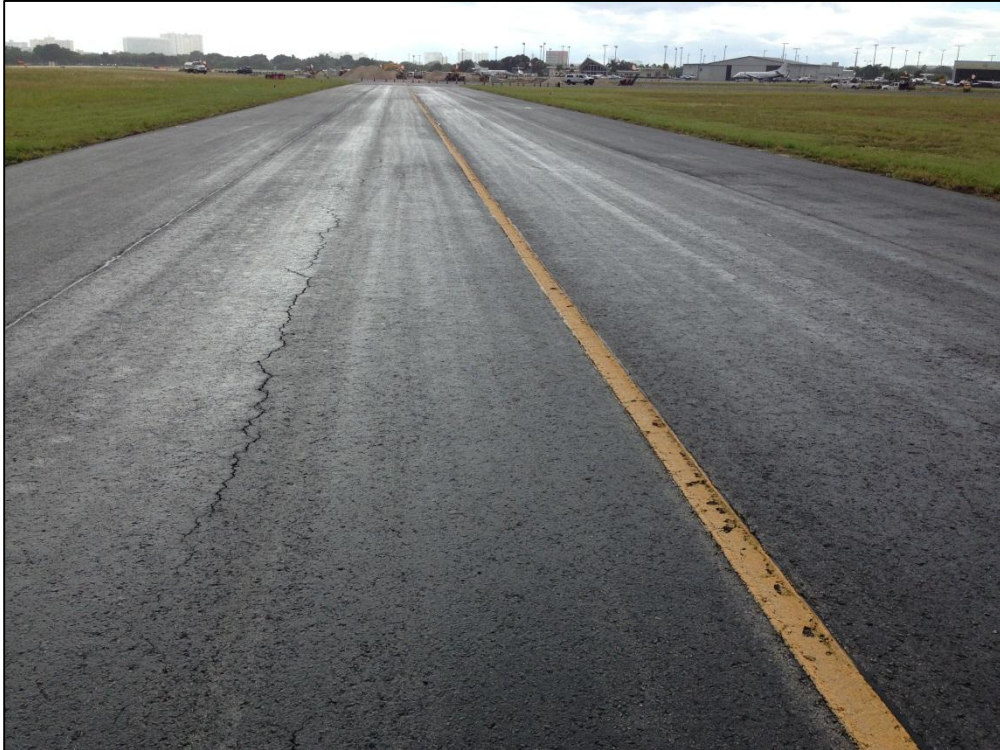
Taxiway D, Section 405, Sample Unit 420 – Low Severity (48) Longitudinal and Transverse Cracking, Low Severity (57) Weathering

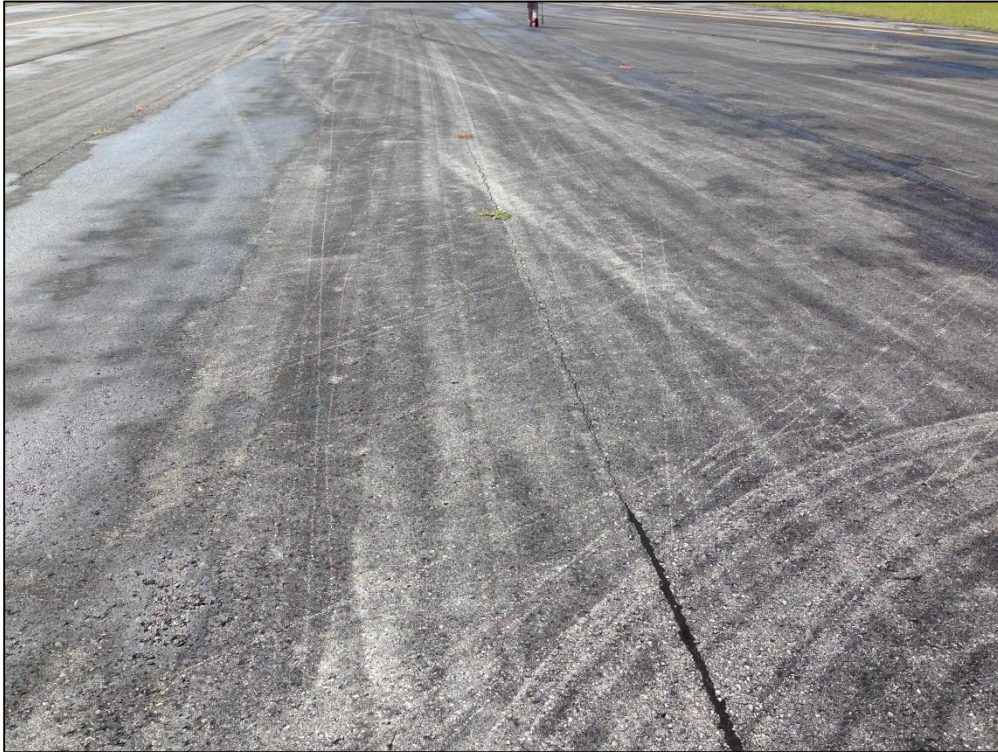
Apron N, Section 4205, Sample Unit 517 – Low Severity (48) Longitudinal and Transverse Cracking, Low Severity (57) Weathering

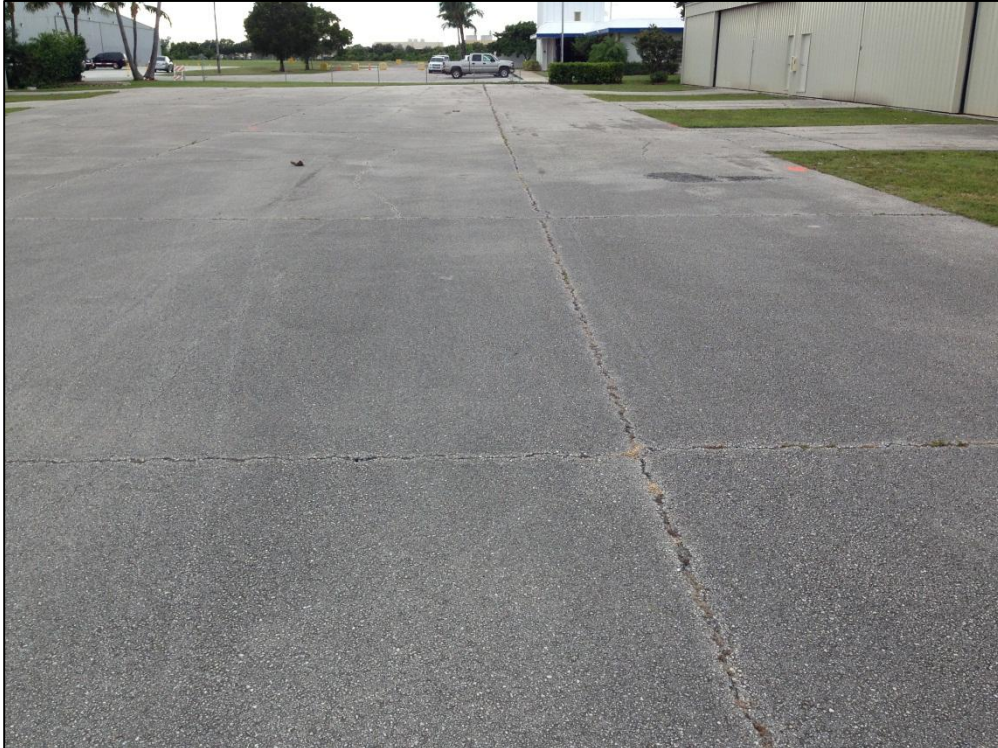
Apron Hang, Section 4320, Sample Unit 208 – Low Severity (47) Joint Reflection Cracking, Low Severity (57) Weathering
