FLORIDA DEPARTMENT OF TRANSPORTATION
AVIATION AND SPACEPORT OFFICE

SEBRING REGIONAL
AIRPORT (SEF)

DECEMBER 2013

STATEWIDE
**Airfield
Pavement
Management**
PROGRAM

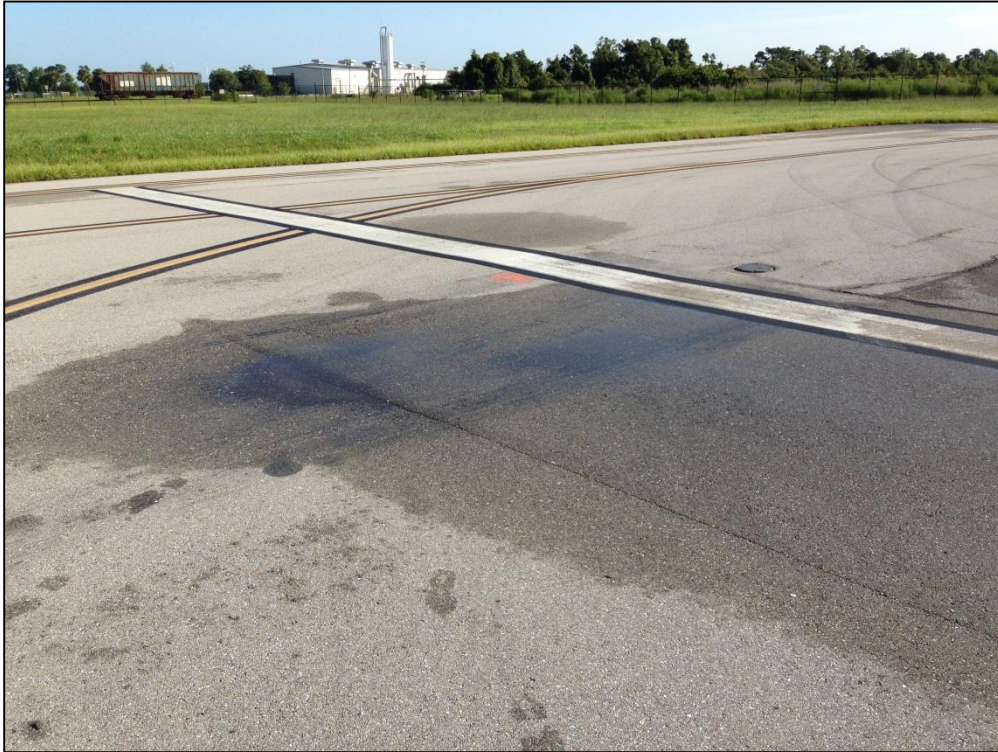
Runway 14-32, Section 6205, Sample Unit 198 – Low Severity (48) Longitudinal and Transverse Cracking, Low Severity (57) Weathering, Low Severity (45) Depression

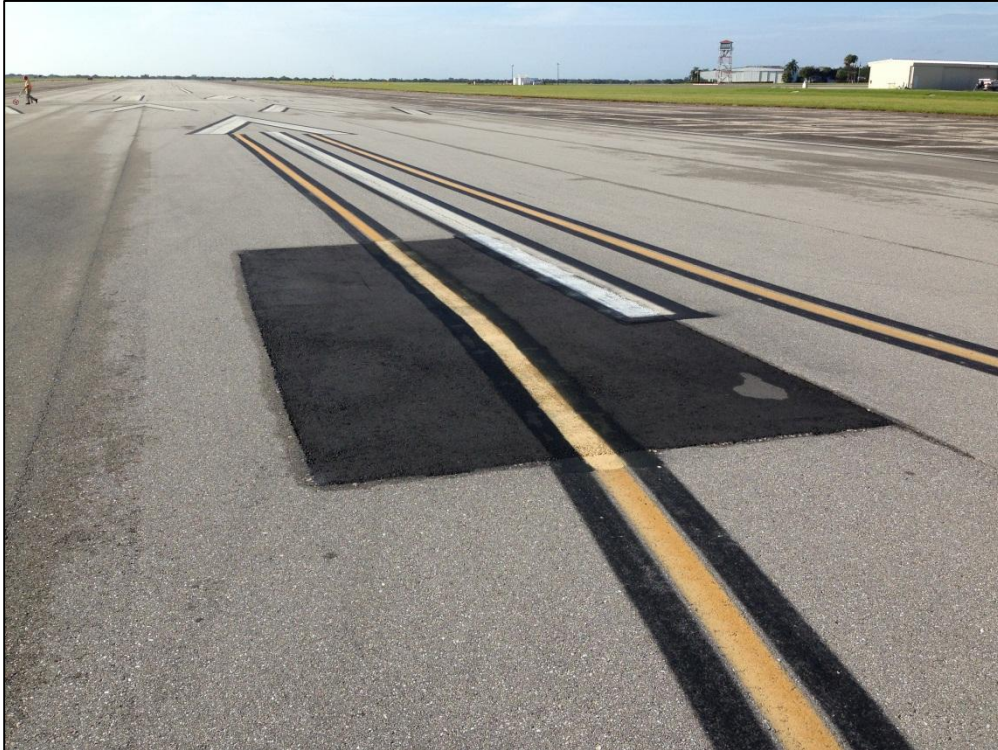
Runway 14-32, Section 6205, Sample Unit 198 –Low Severity (57) Weathering, Low Severity (50) Patch

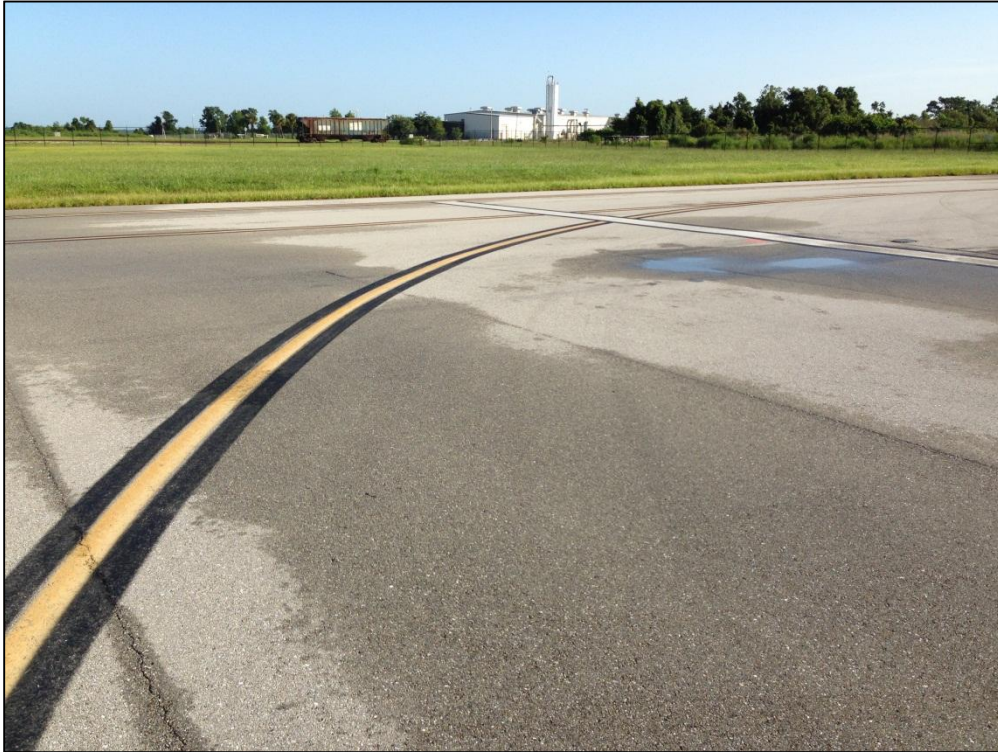
Runway 14-32, Section 6205, Sample Unit 198 – Low Severity (48) Longitudinal and Transverse Cracking, Low Severity (57) Weathering, Low Severity (45) Depression

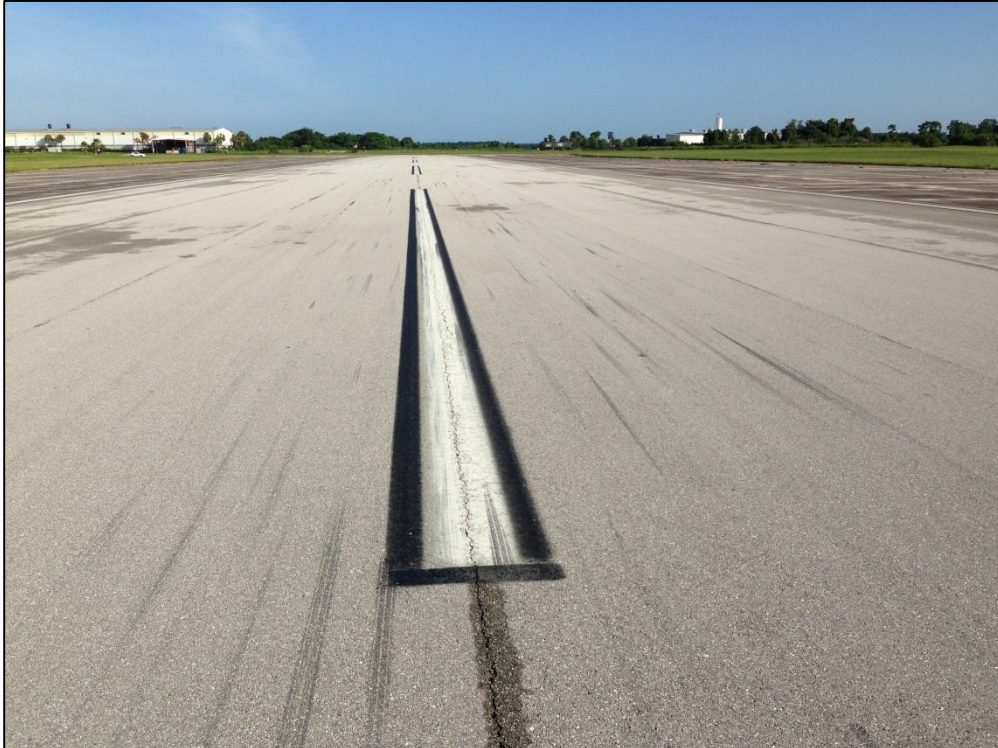
Runway 14-32, Section 6205, Sample Unit 177 – Low Severity (48) Longitudinal and Transverse Cracking, Low Severity (57) Weathering

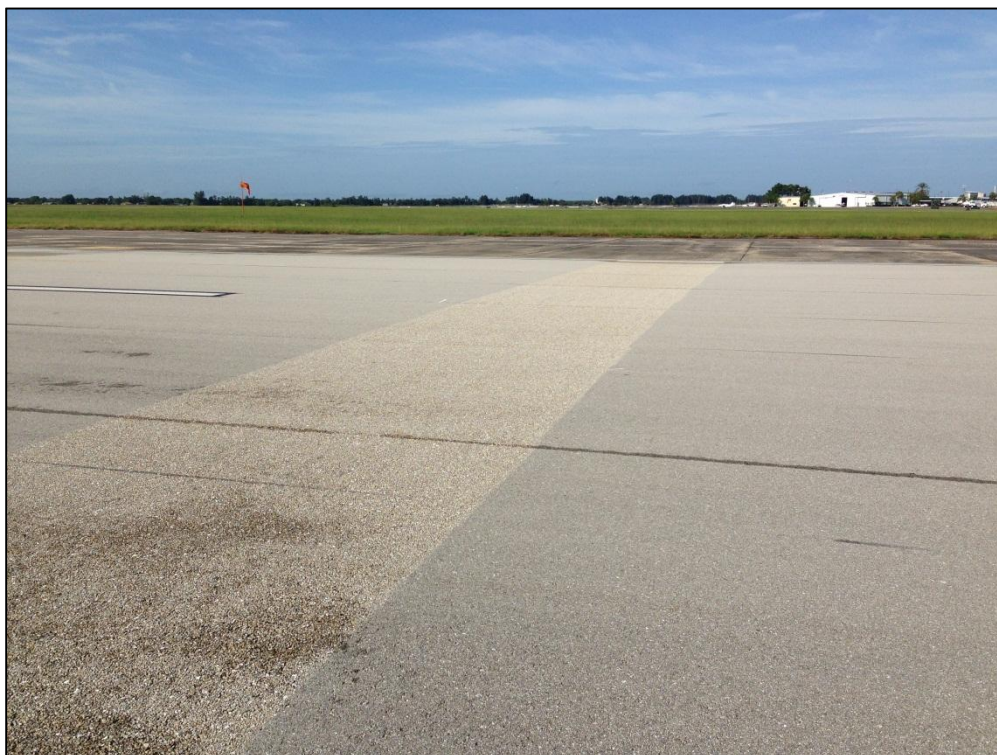
Runway 14-32, Section 6205, Sample Unit 149 – Low Severity (48) Longitudinal and Transverse Cracking, Low Severity (57) Weathering, Low Severity (52) Raveling

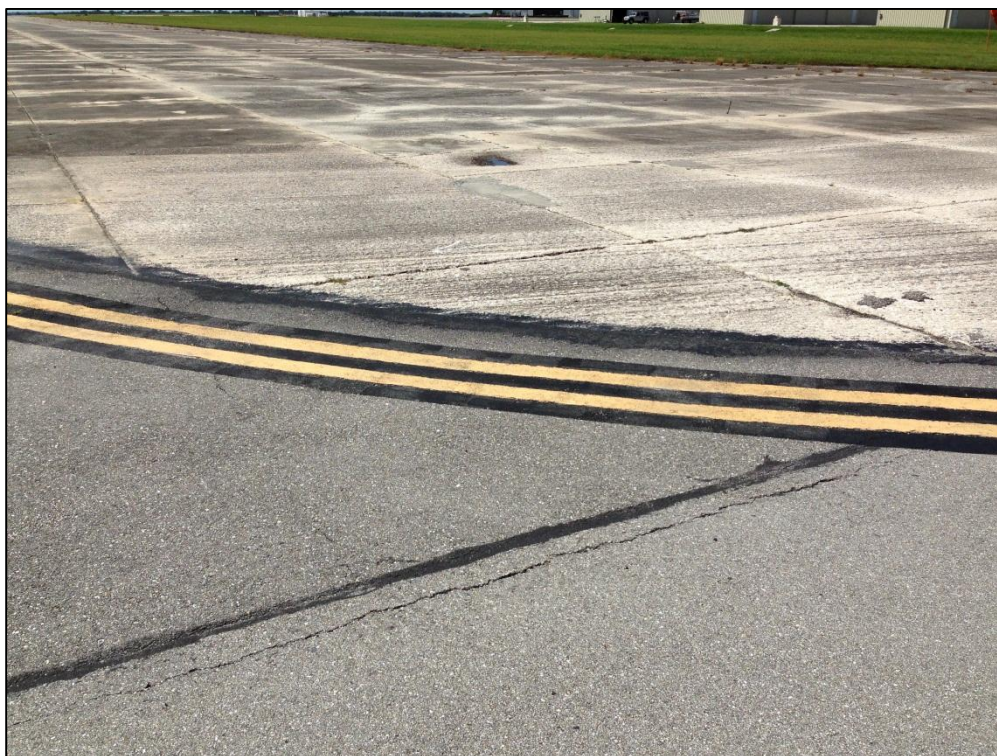
Taxiway Charlie, Section 305, Sample Unit 100 – Low Severity (57) Weathering, Low Severity (48) Longitudinal and Transverse Cracking

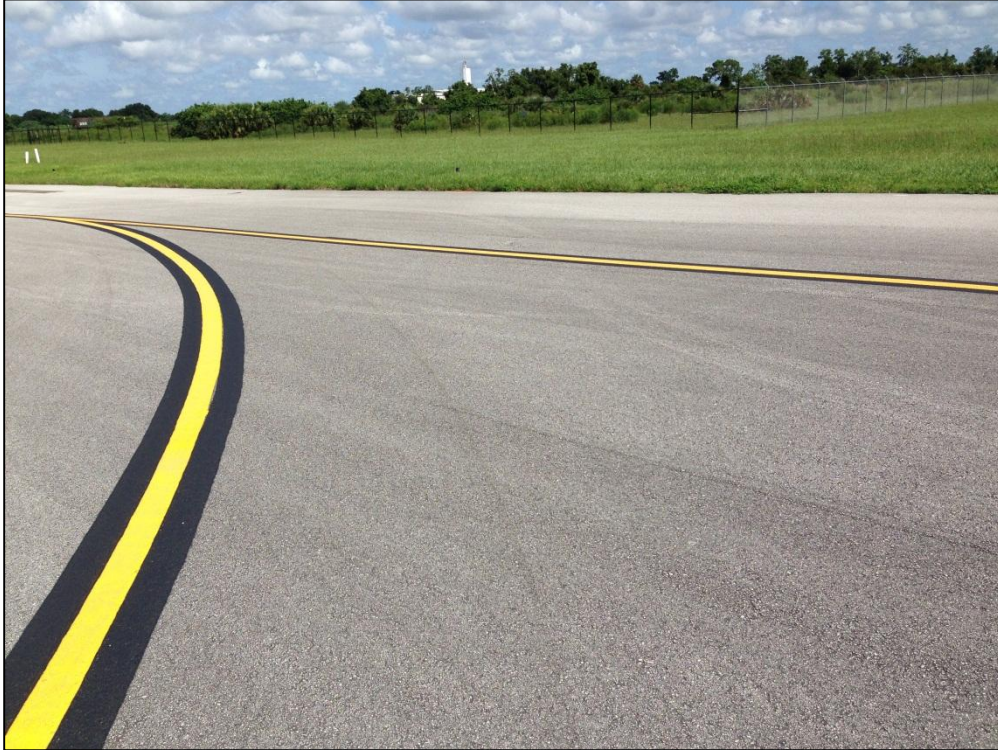
Apron RU, Section 415, Sample Unit 103 – Low Severity (57) Weathering

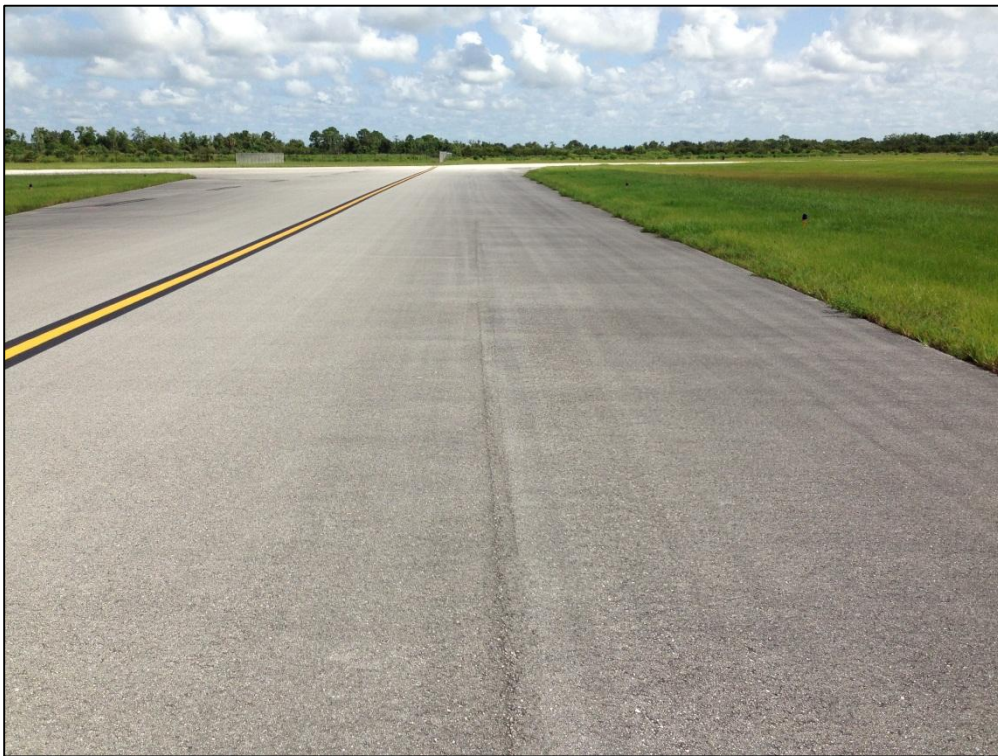
Taxiway Alpha, Section 420, Sample Unit 250 – Low Severity (48) Longitudinal and Transverse Cracking, Low Severity (57) Weathering

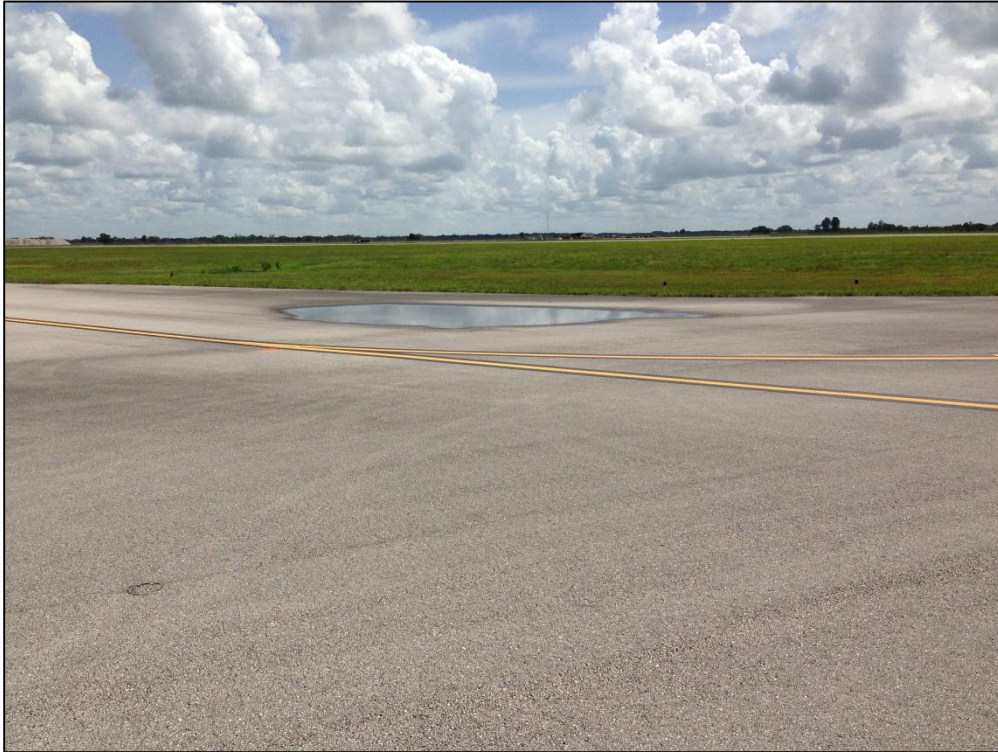
Taxiway A2, Section 110, Sample Unit 108 – Low Severity (57) Weathering, Low Severity (45) Depression

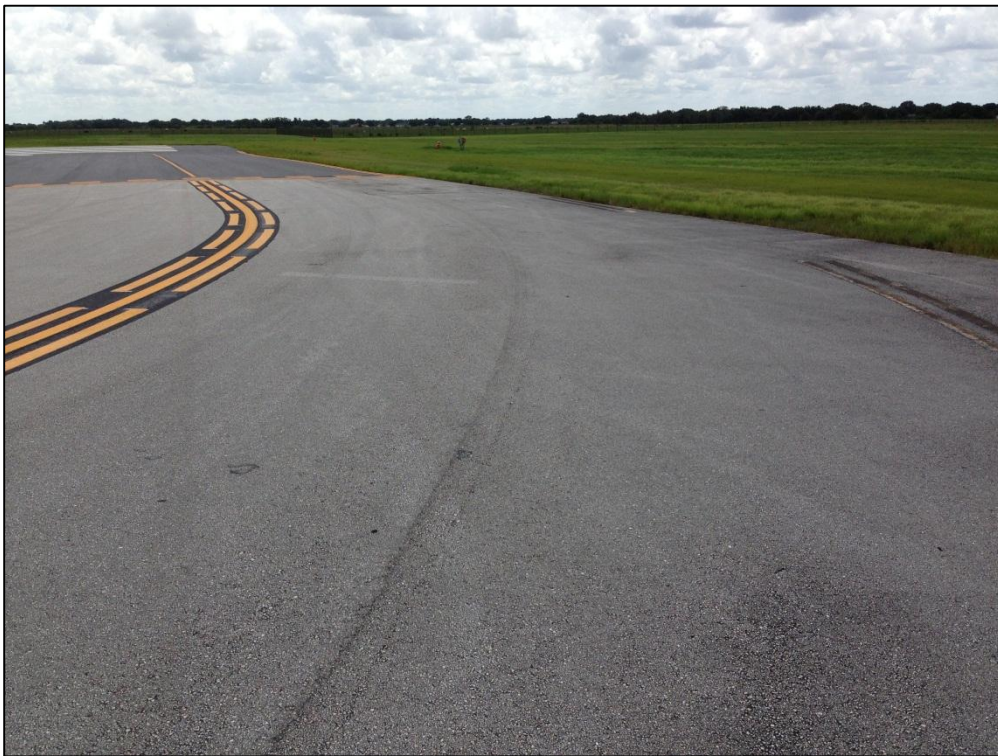
Taxiway A1, Section 605, Sample Unit 202 – Low Severity (57) Weathering, Low Severity (52) Raveling

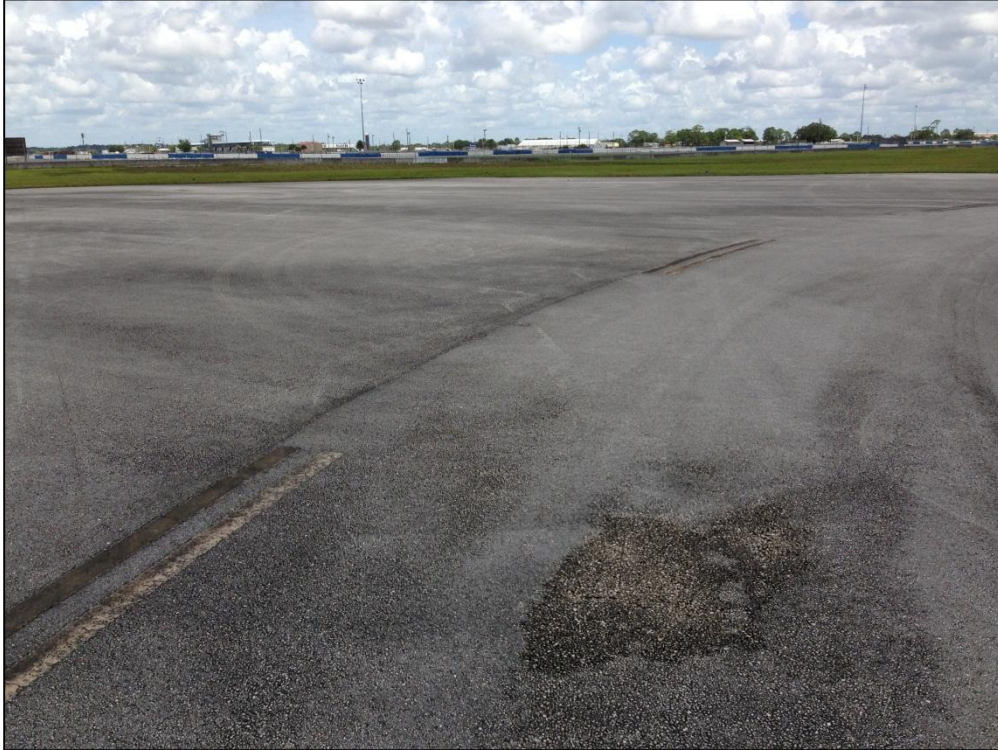
Taxiway A1, Section 605, Sample Unit 202 – Low Severity (57) Weathering, Low Severity (52) Raveling

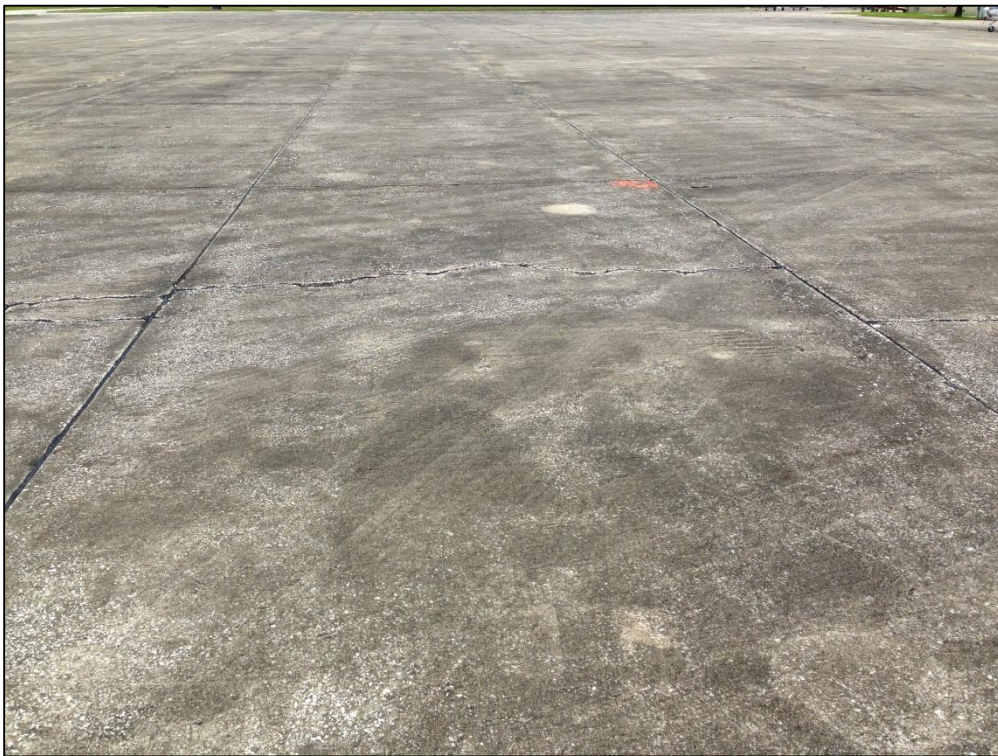
Apron West, Section 4105, Sample Unit 312 – Low and Medium Severity (63) Longitudinal, Transverse, Diagonal Cracking, Low Severity (65) Joint Seal Damage

- T-Hangar Taxiway – Section 505
 - Mill and overlay attributed to distresses related to climate, age, and subgrade quality of pavement.
- West Apron – Section 4105
 - Reconstruction attributed to distresses related to climate, age, subgrade quality, and loading of pavement.

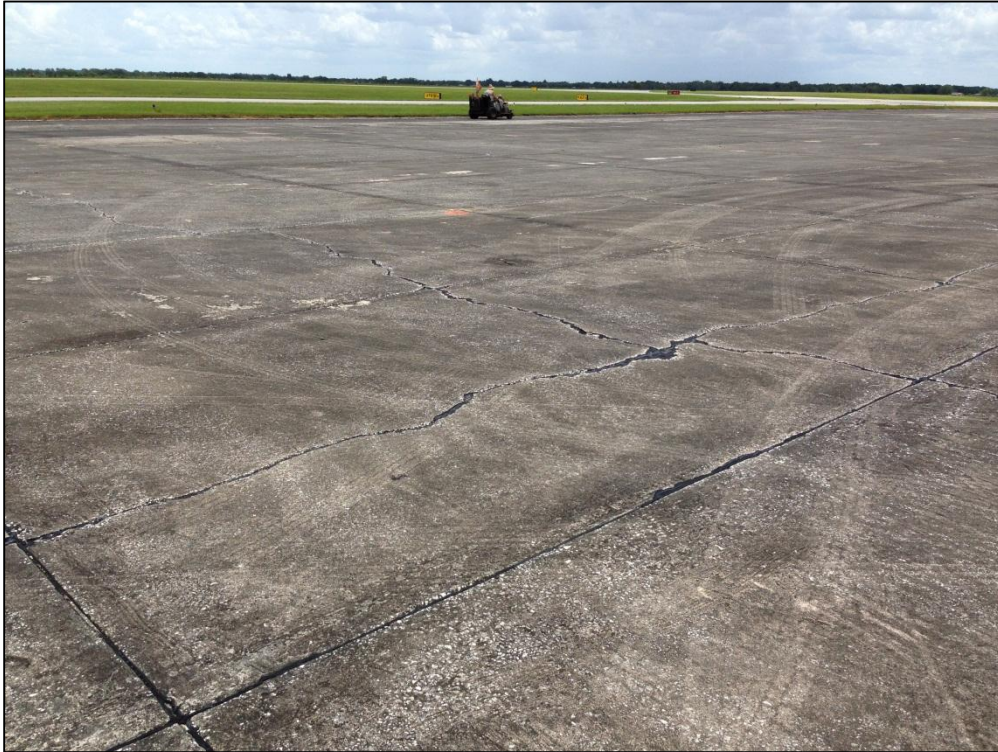
Apron West, Section 4105, Sample Unit 312 – Medium Severity (72) Shattered Slab, Low Severity (65) Joint Seal Damage

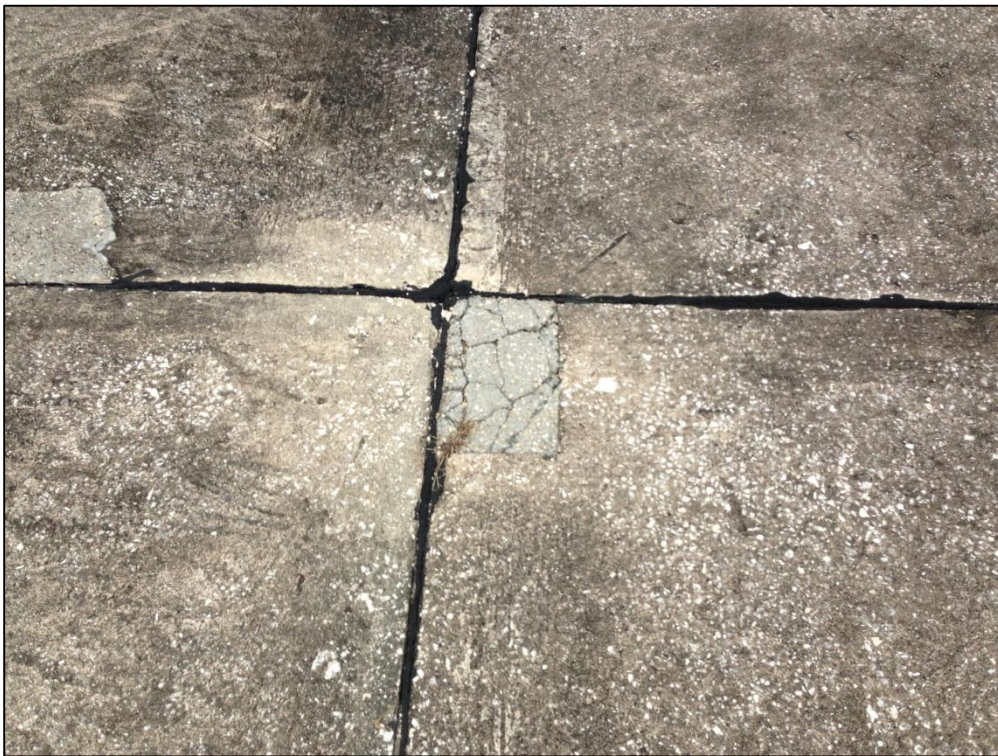
Apron West, Section 4105, Sample Unit 312 – Medium Severity (66) Patching, Low Severity (65) Joint Seal Damage

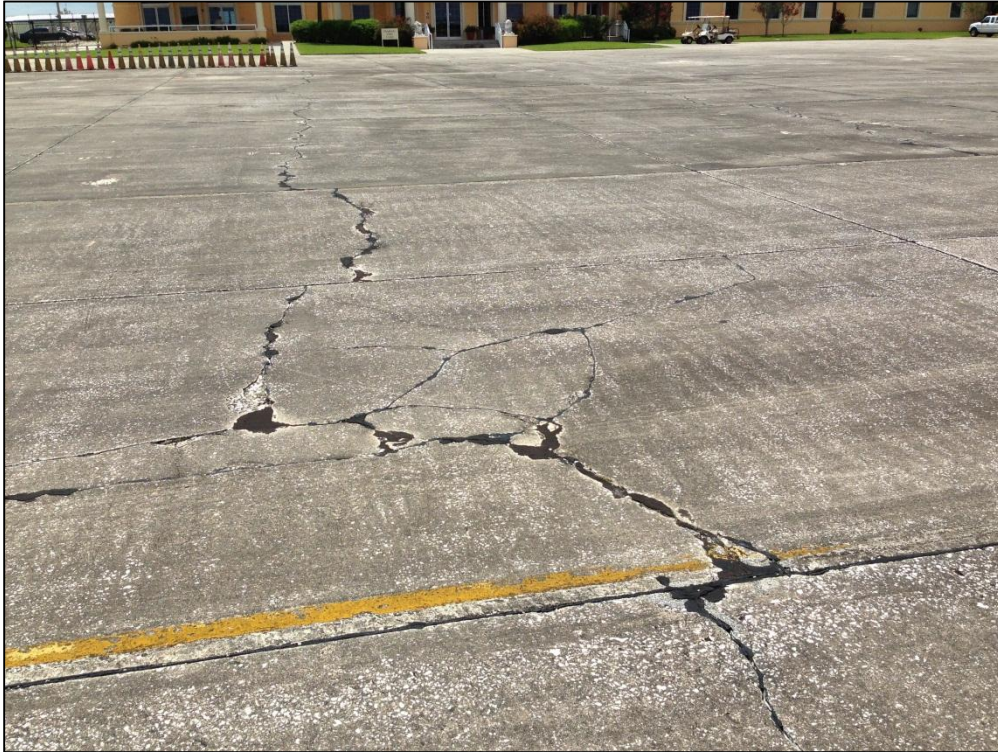
Apron West, Section 4105, Sample Unit 114 – Medium Severity (72) Shattered Slab, Medium Severity (63) Longitudinal, Transverse, Diagonal Cracking, Low Severity (65) Joint Seal Damage

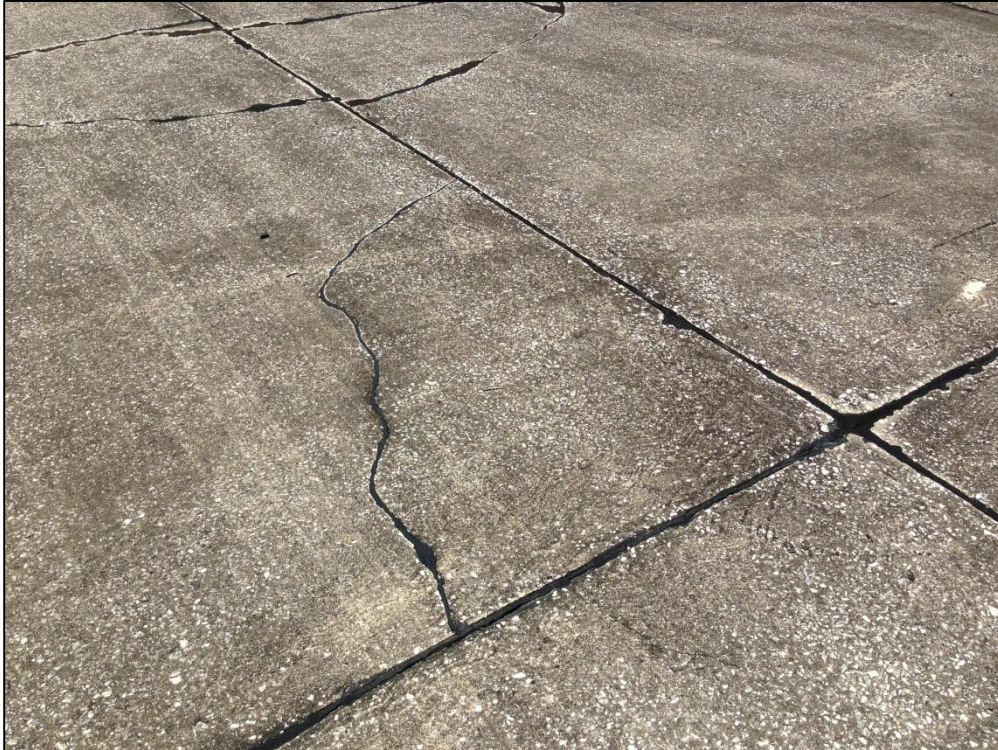
Apron West, Section 4105, Sample Unit 114 – Low Severity (62) Corner Break, Low Severity (70) Scaling, Map Cracking, Crazing, Low Severity (65) Joint Seal Damage

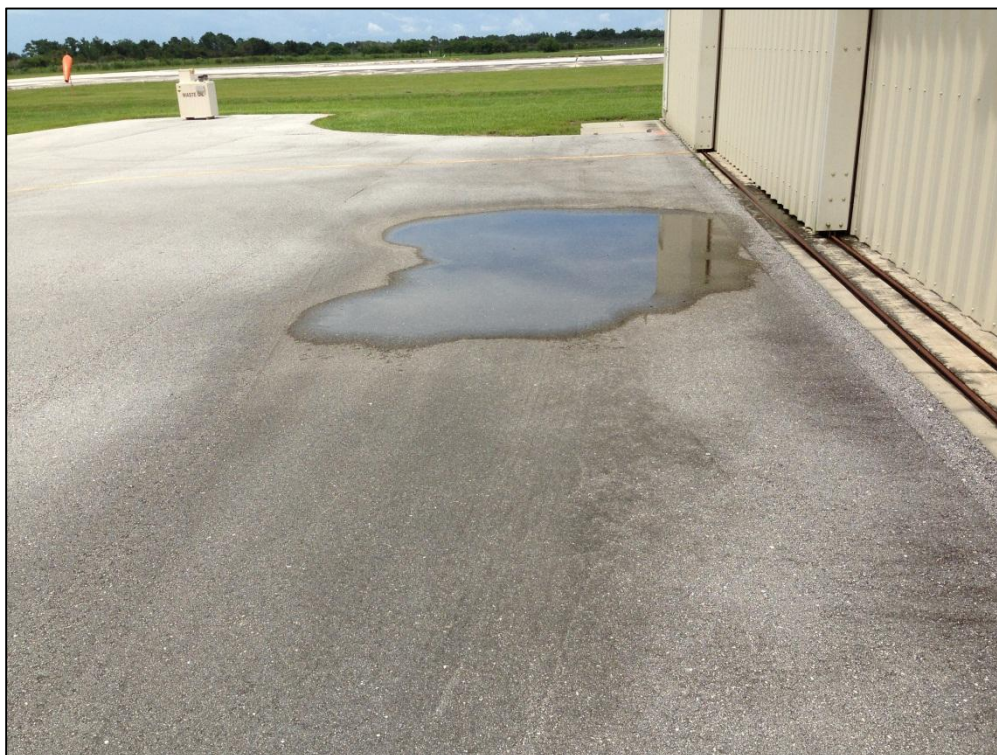
Apron West, Section 4115, Sample Unit 203 – Low Severity (48) Longitudinal and Transverse Cracking, Low Severity (52) Raveling, Low Severity (57) Weathering, Low Severity (45) Depression

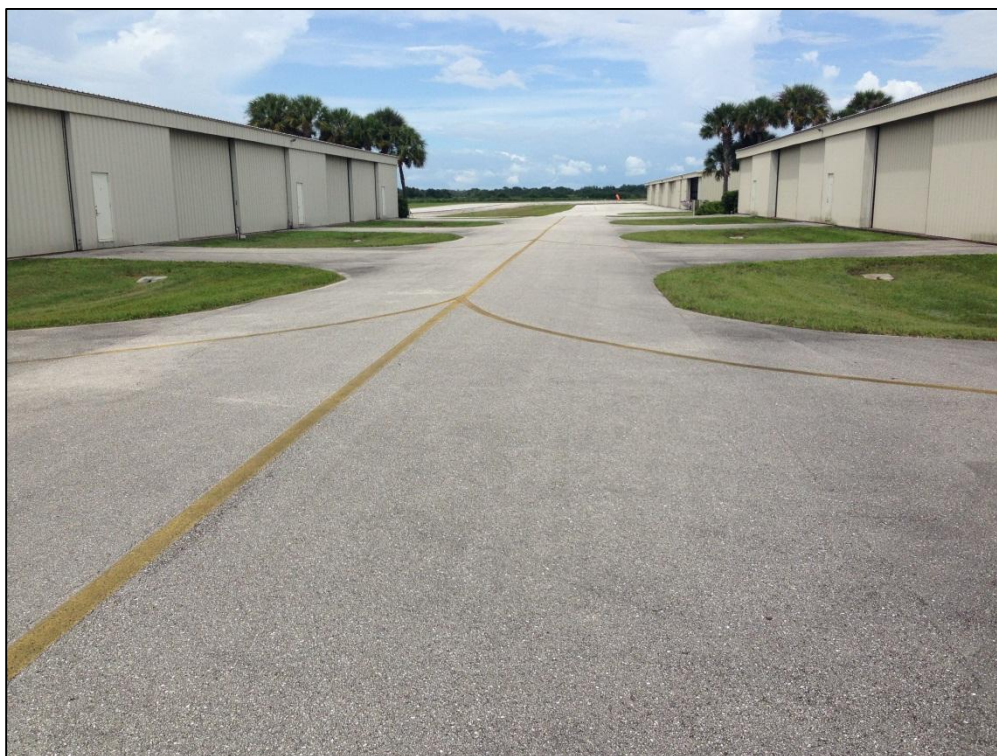
Taxiway T-Hangar, Section 505, Sample Unit 302 –Low and Medium Severity (57) Weathering

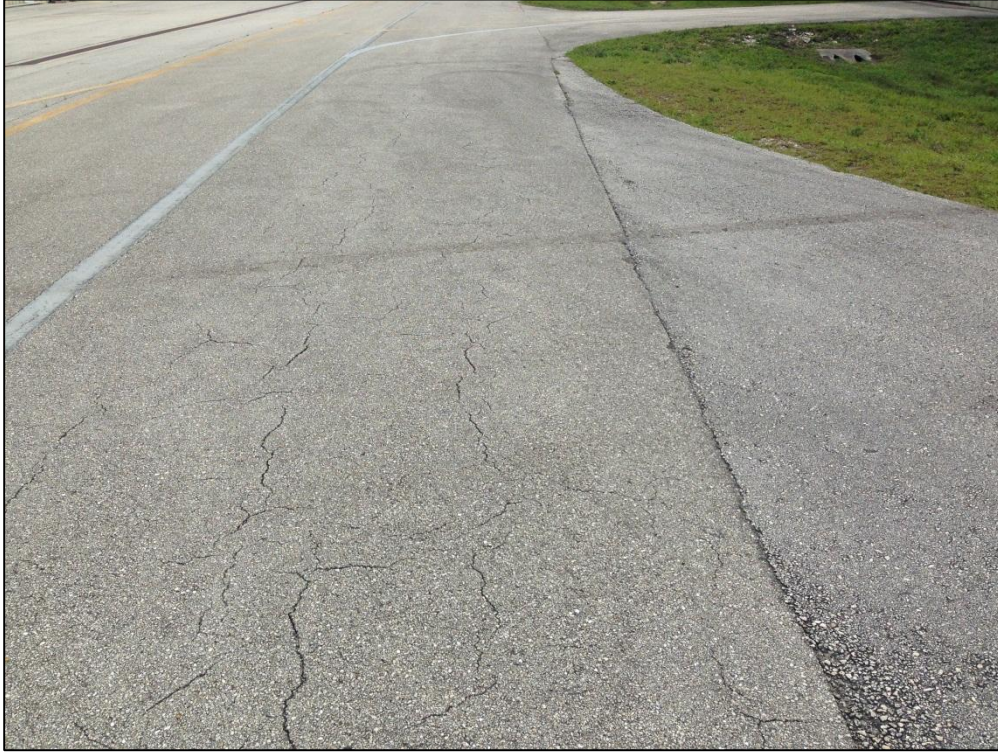
Taxiway T-Hangar, Section 505, Sample Unit 100 – Low Severity (48) Longitudinal and Transverse Cracking, Low Severity (57) Weathering, Low Severity (43) Block Cracking
