**WITHAM FIELD/
MARTIN COUNTY
AIRPORT (SUA)**

DISTRICT 4
GENERAL AVIATION
AIRPORT

DECEMBER 2013

STATEWIDE
**Airfield
Pavement
Management**
PROGRAM

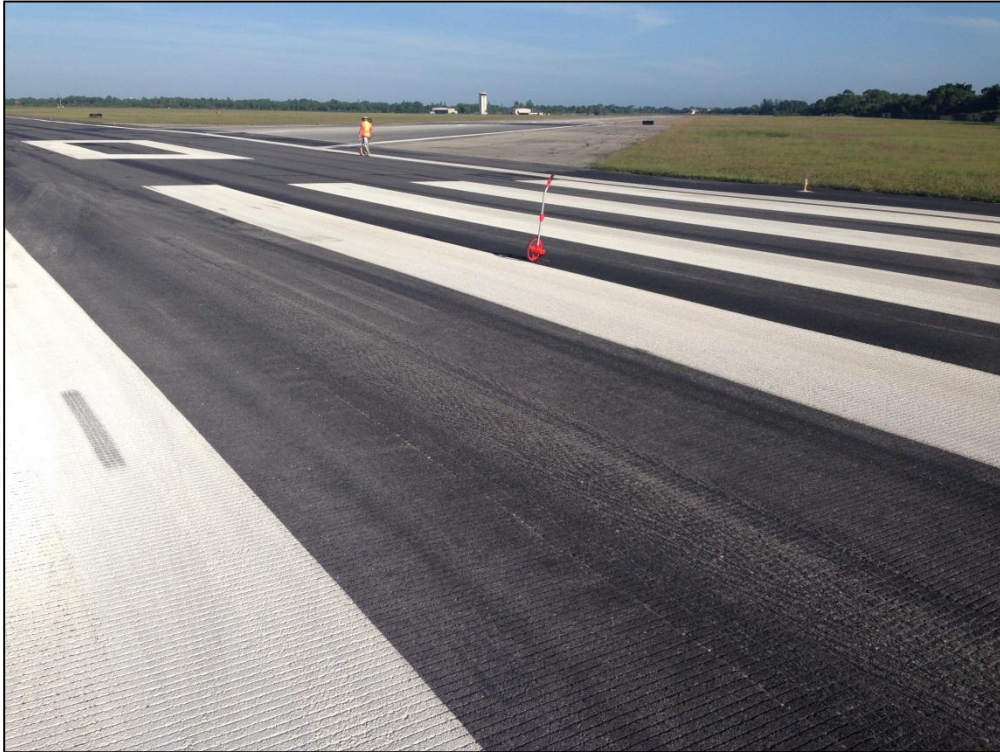
Runway 12-30, Section 6120, Sample Unit 400 – Low Severity (52) Raveling, Low Severity (57) Weathering

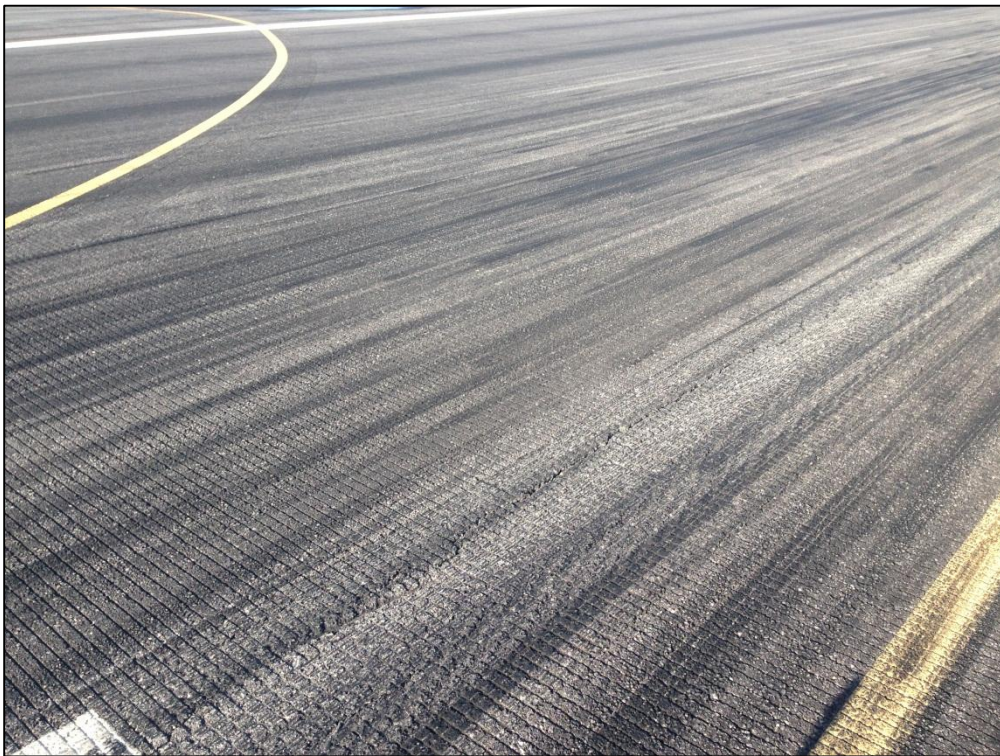
Runway 12-30, Section 6105, Sample Unit 385 – Low Severity (48) Longitudinal and Transverse Cracking, Low Severity (52) Raveling, Low Severity (57) Weathering

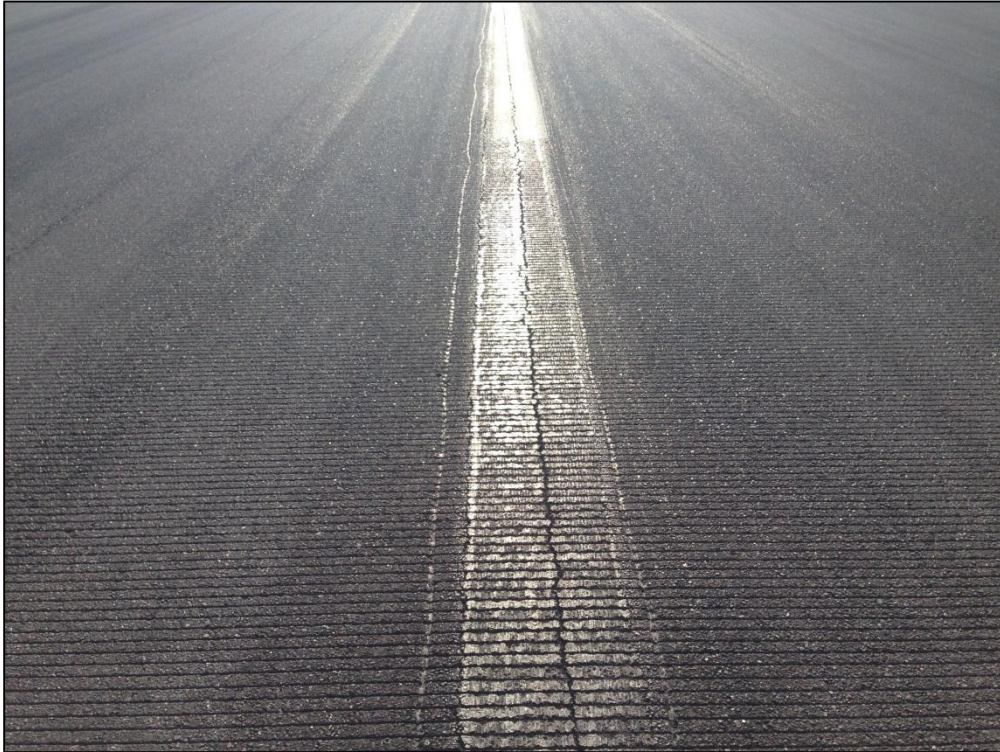
Runway 12-30, Section 6105, Sample Unit 357 – Low Severity (48) Longitudinal and Transverse Cracking, Low Severity (57) Weathering

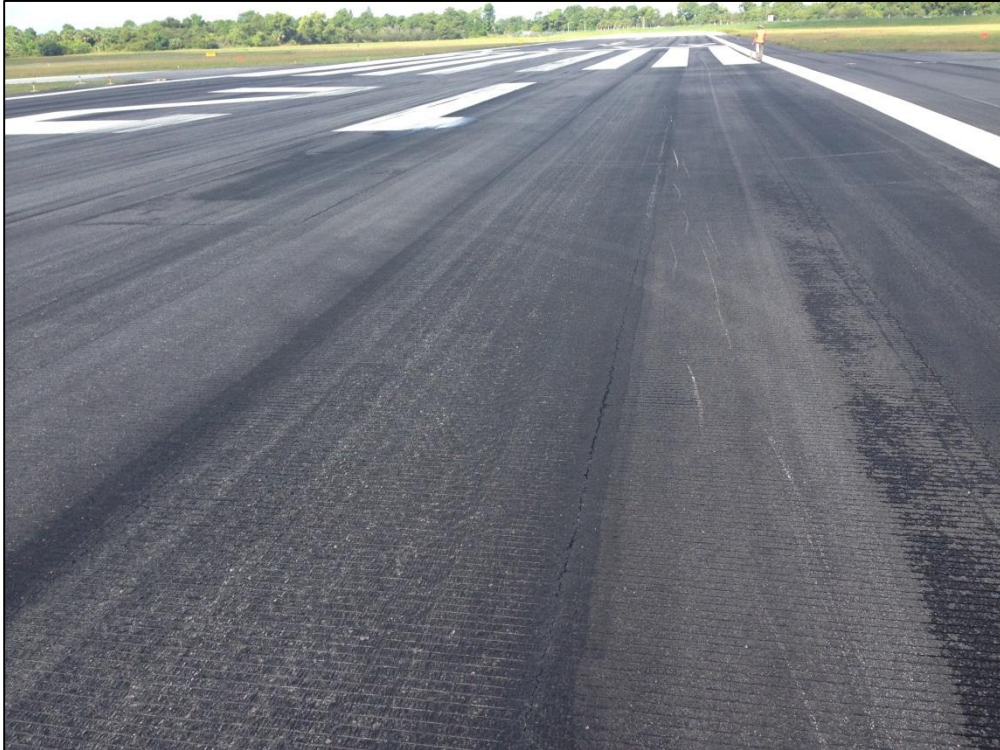
Runway 12-30, Section 6105, Sample Unit 301 – Low Severity (48) Longitudinal and Transverse Cracking, Low Severity (52) Raveling, Low Severity (57) Weathering

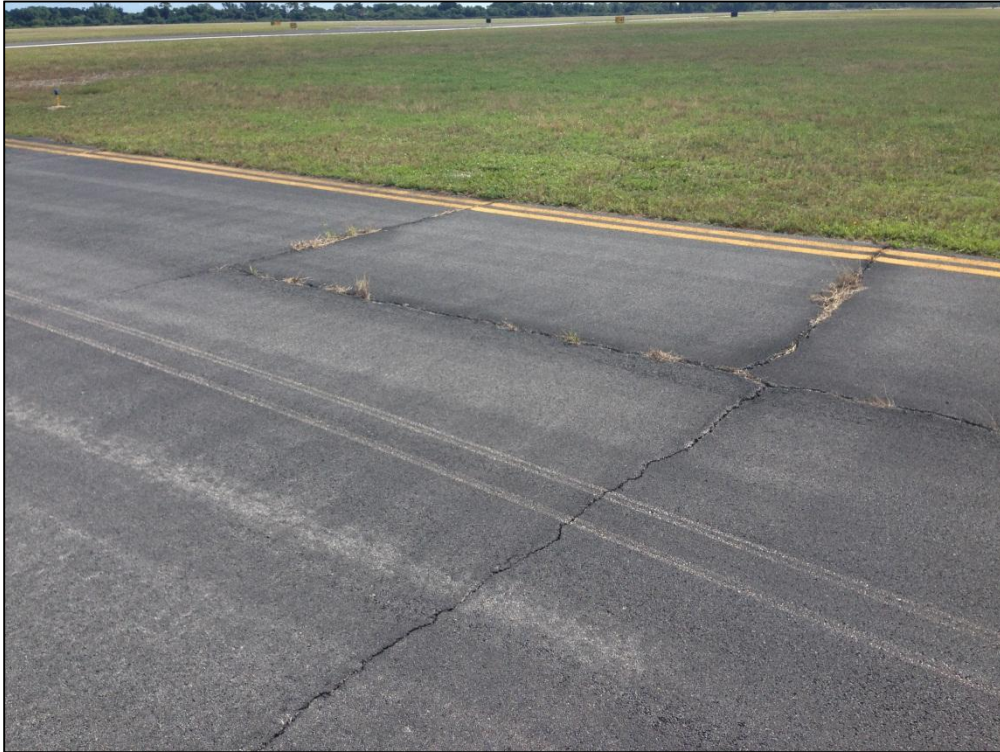
Taxiway B, Section 208, Sample Unit 200 – Medium Severity (43) Block Cracking, Low Severity (52) Raveling, Low Severity (57) Weathering

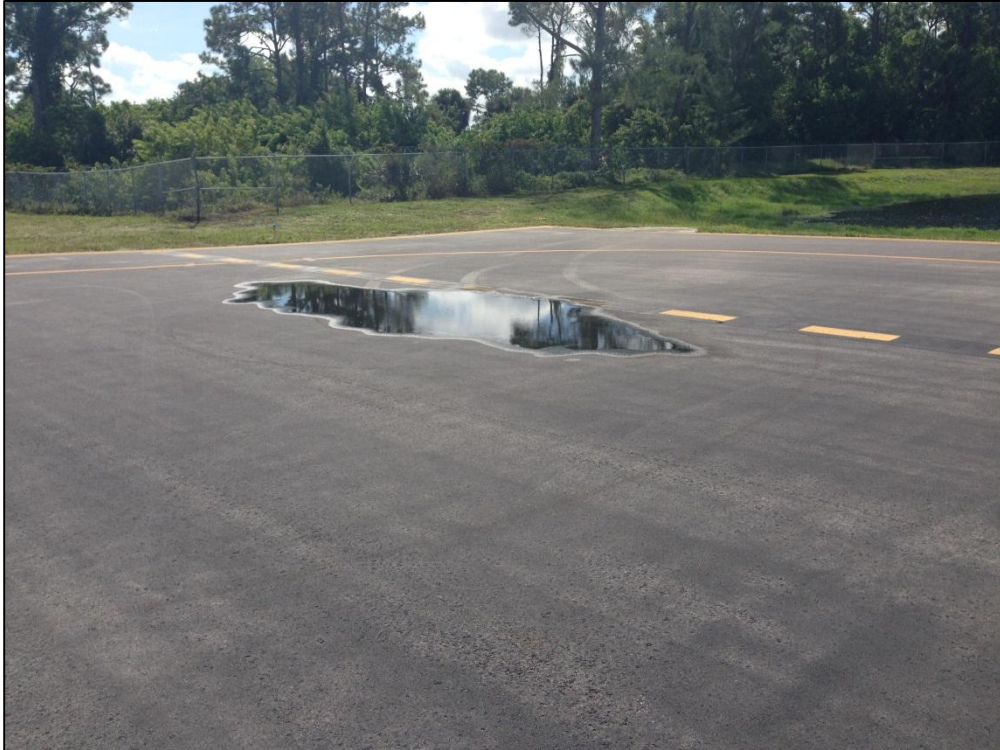
Taxiway D, Section 412, Sample Unit 101 – Low Severity (45) Depression, Low Severity (48) Longitudinal and Transverse Cracking, Low Severity (57) Weathering

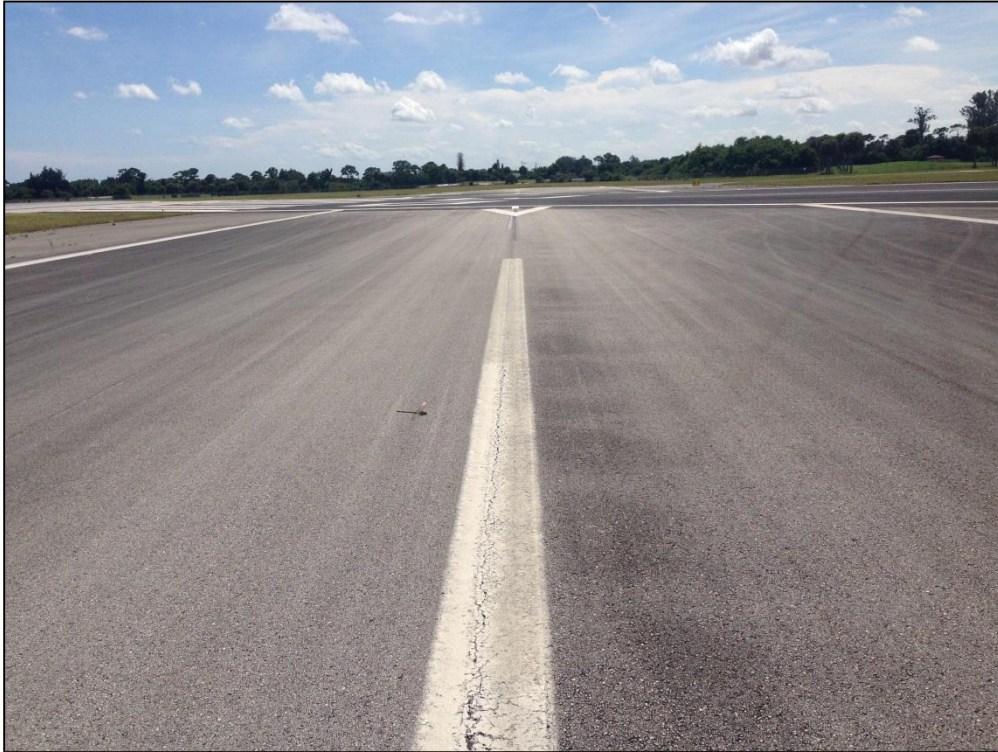
Runway 16-34, Section 6305, Sample Unit 310 – Low Severity (48) Longitudinal and Transverse Cracking, Low Severity (57) Weathering

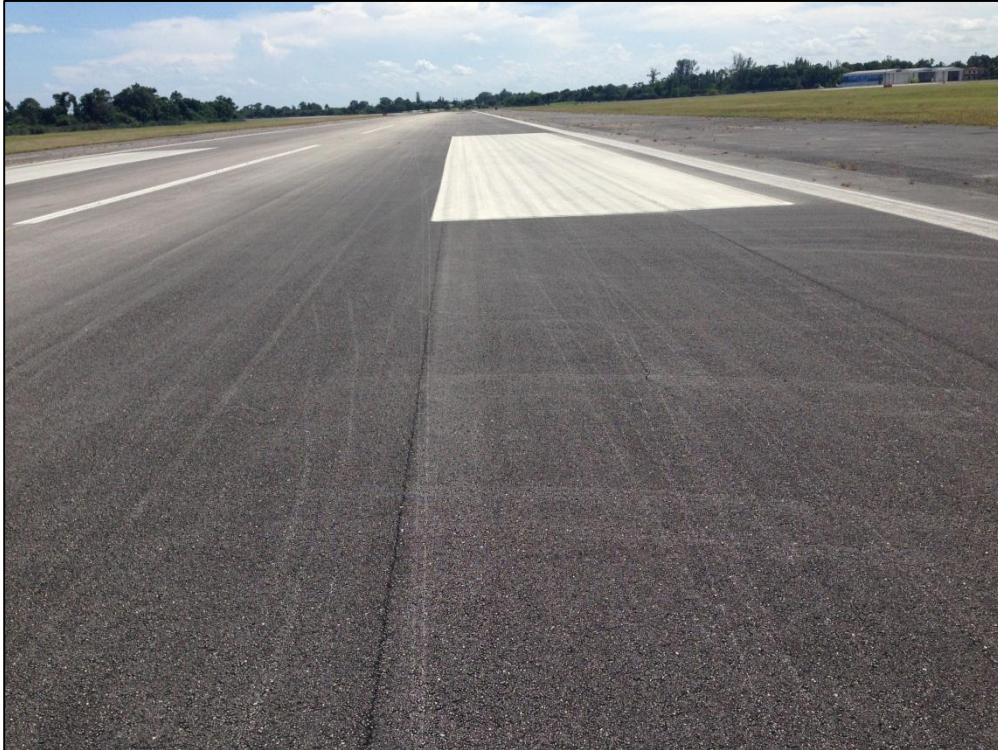
Runway 16-34, Section 6305, Sample Unit 341 – Low Severity (48) Longitudinal and Transverse Cracking, Low Severity (57) Weathering

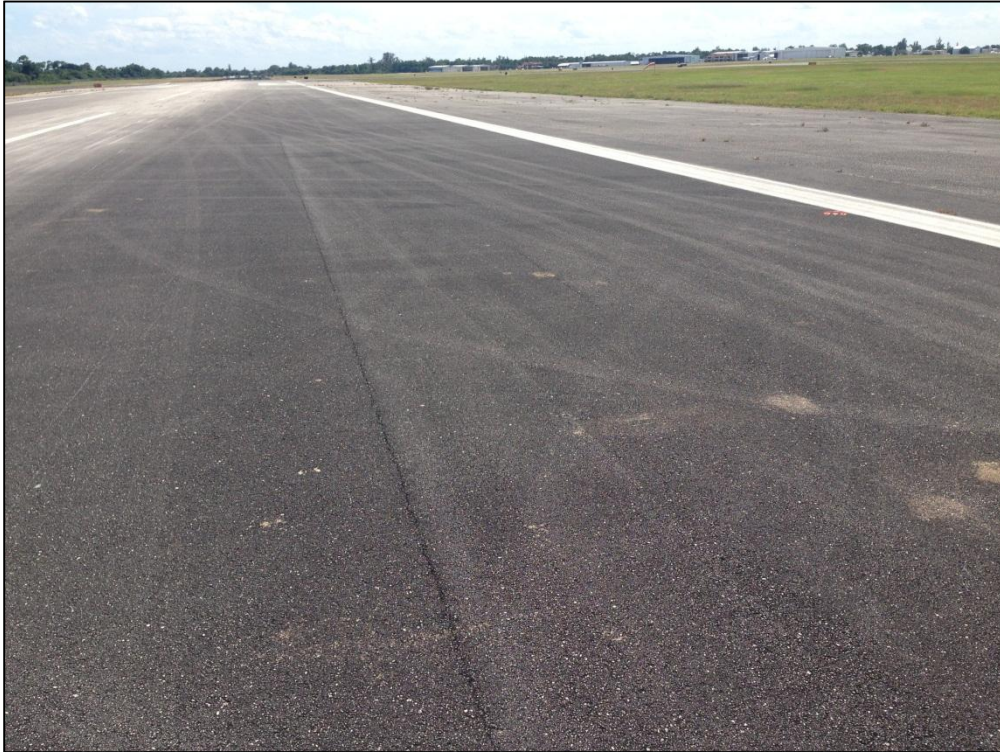
Runway 16-34, Section 6305, Sample Unit 390 – Low Severity (48) Longitudinal and Transverse Cracking, Low Severity (57) Weathering

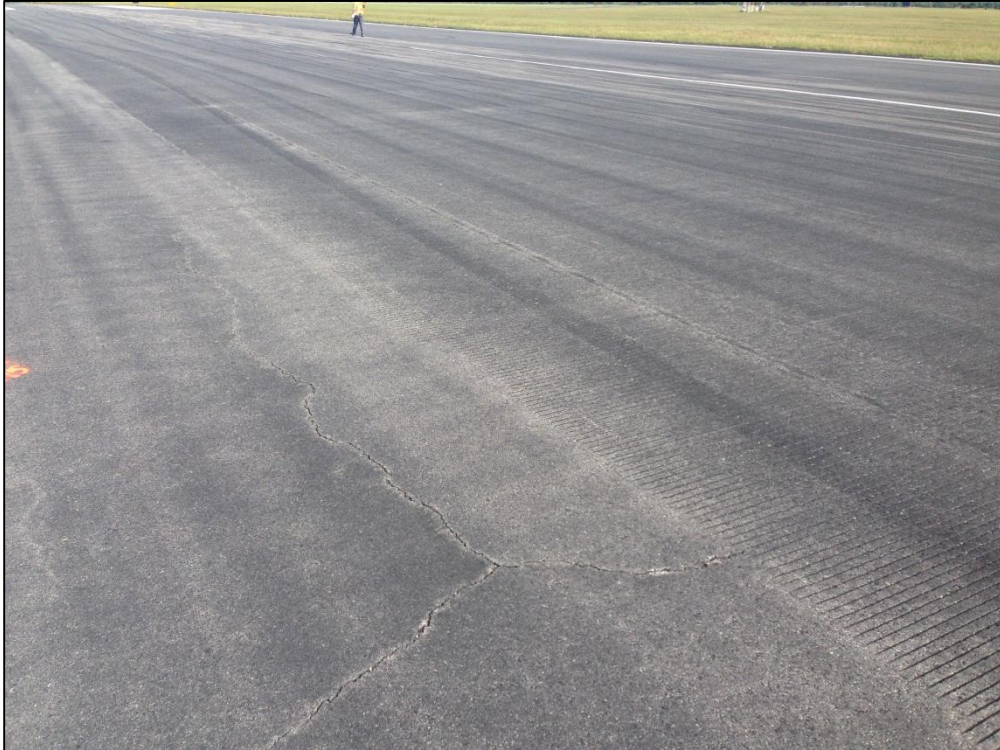
Runway 7-25, Section 6205, Sample Unit 315 – Low Severity (48) Longitudinal and Transverse Cracking, Low Severity (57) Weathering

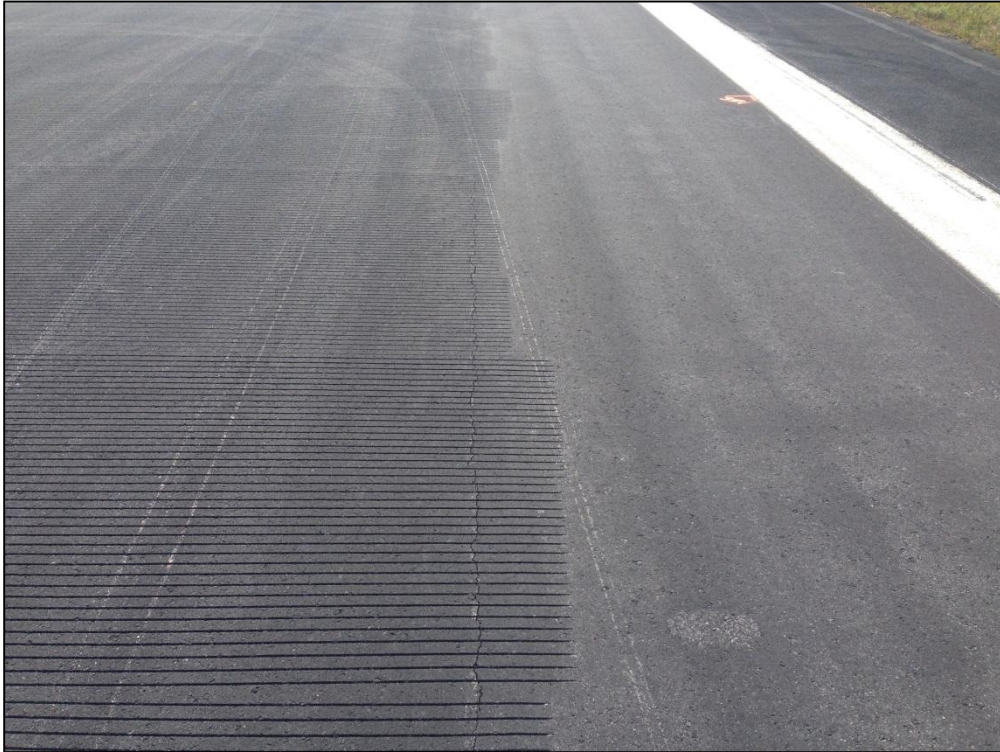
Runway 7-25, Section 6205, Sample Unit 354 – Low Severity (48) Longitudinal and Transverse Cracking, Low Severity (57) Weathering

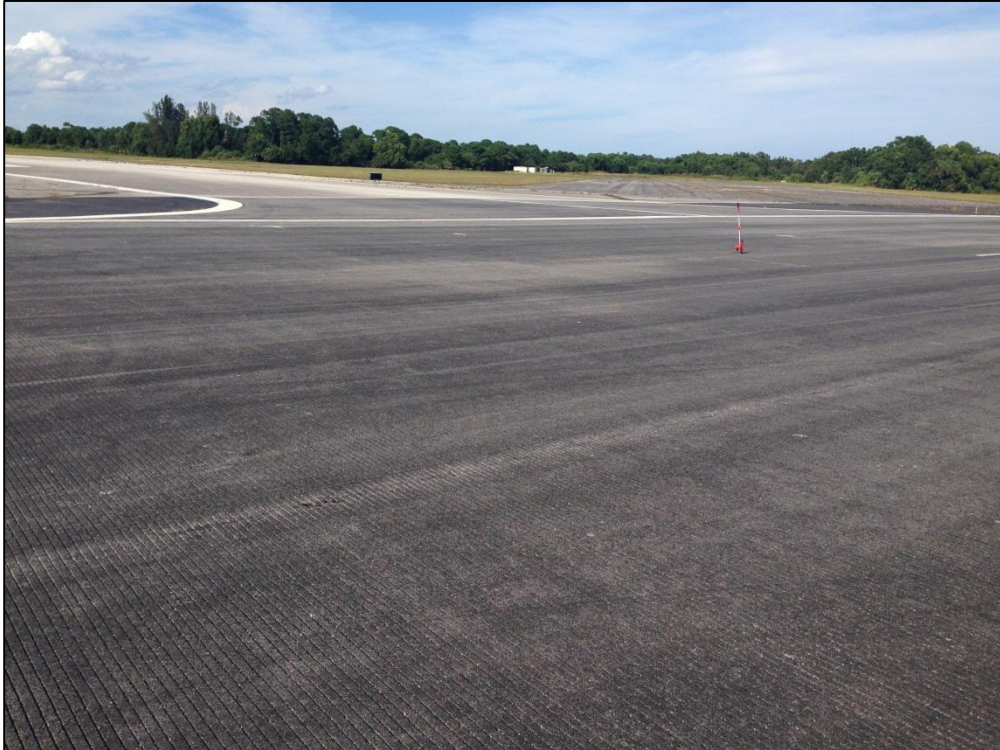
Runway 7-25, Section 6205, Sample Unit 368 – Low Severity (57) Weathering

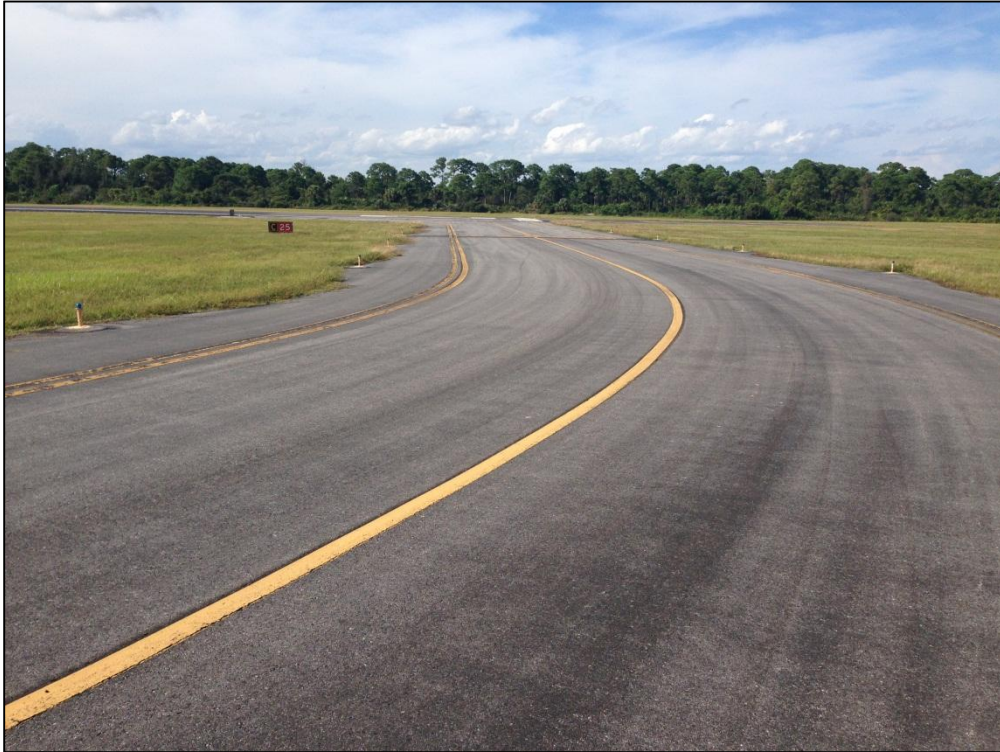
Taxiway C, Section 305, Sample Unit 403 – Low Severity (48) Longitudinal and Transverse Cracking, Low Severity (57) Weathering

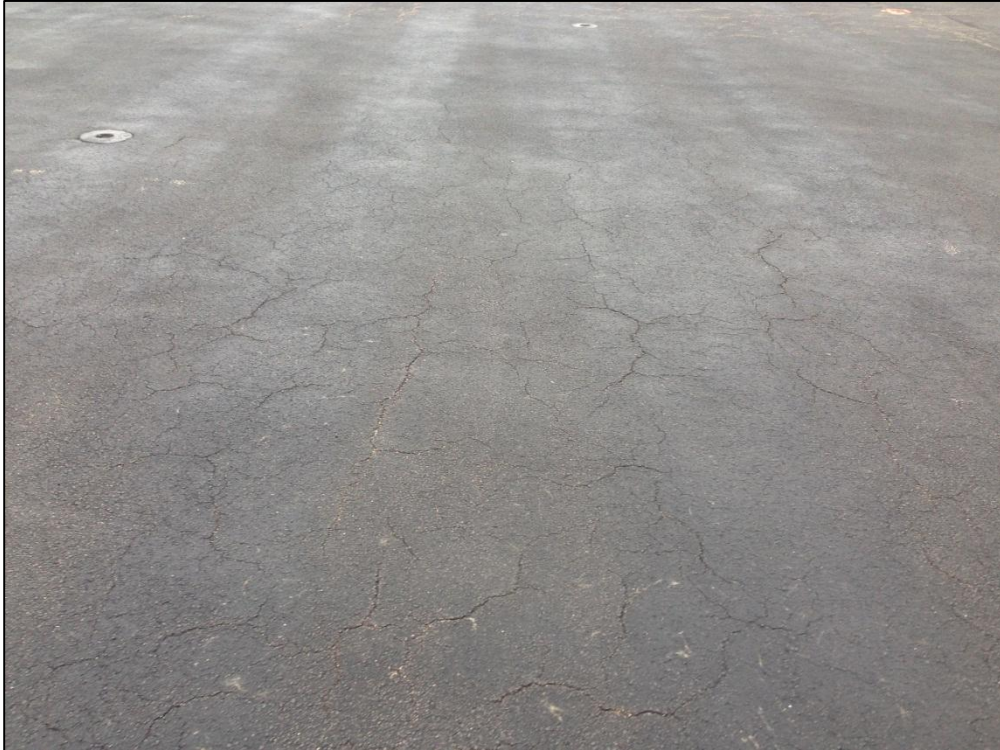
Apron E, Section 4205, Sample Unit 208 – Low Severity (43) Block Cracking, Low Severity (57) Weathering

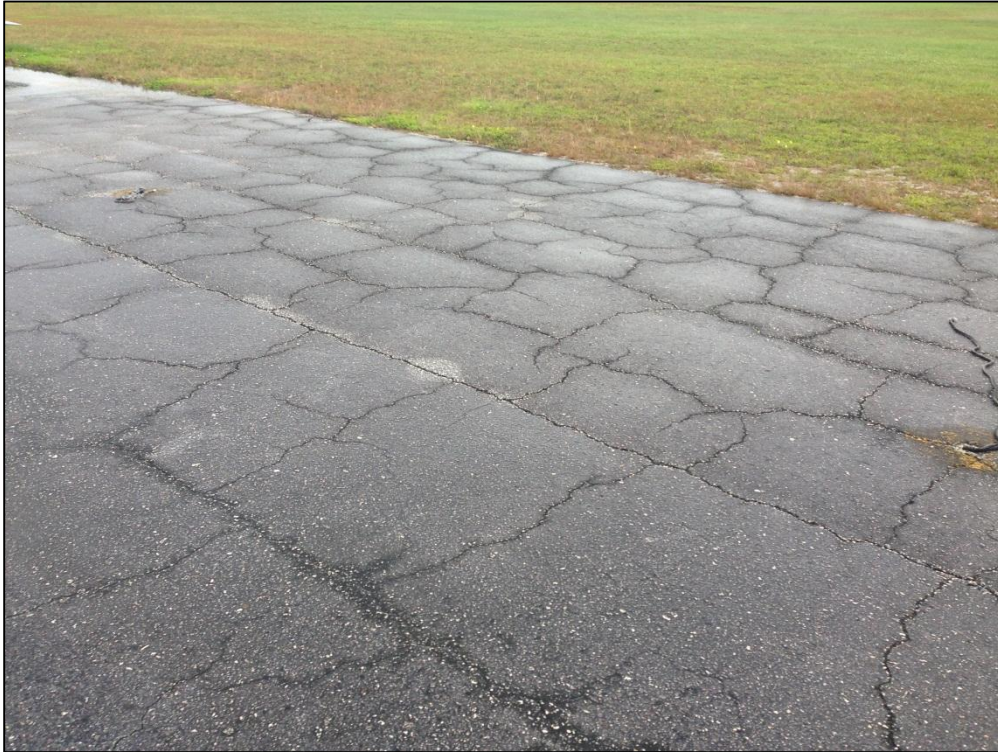
Apron E, Section 4235, Sample Unit 54 – Low Severity (43) Block Cracking, Low Severity (57) Weathering, Low Severity (52) Raveling

- East Apron – Section 4235
 - Mill and Overlay attributed to distresses related to subgrade quality, climate, and age of pavement.
- West Apron – Sections 4125, 4110, 4108, and 4107
 - PCC Restoration attributed to distresses related to loading and construction quality.
- West Apron – Section 4105
 - Reconstruction attributed to distresses related to subgrade quality, climate, and age of pavement.
- Taxiway C – Section 330
 - Reconstruction attributed to distresses related to subgrade quality, climate, loading, and age of pavement.
- Taxiway B – Section 208
 - Mill and Overlay attributed to distresses related to climate and age of pavement.
- Taxiway B – Section 205
 - Reconstruction attributed to distresses related to loading, climate, and age of pavement.

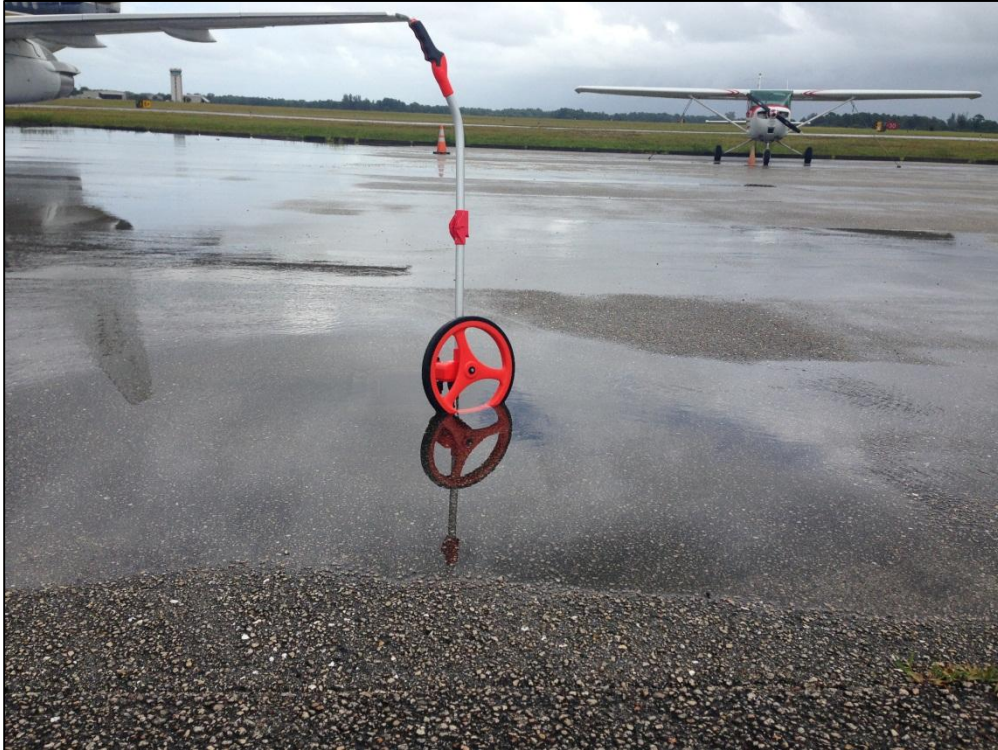
Apron W, Section 4120, Sample Unit 700 – High Severity (45) Depression, Low Severity (48) Longitudinal and Transverse Cracking, Low Severity (57) Weathering

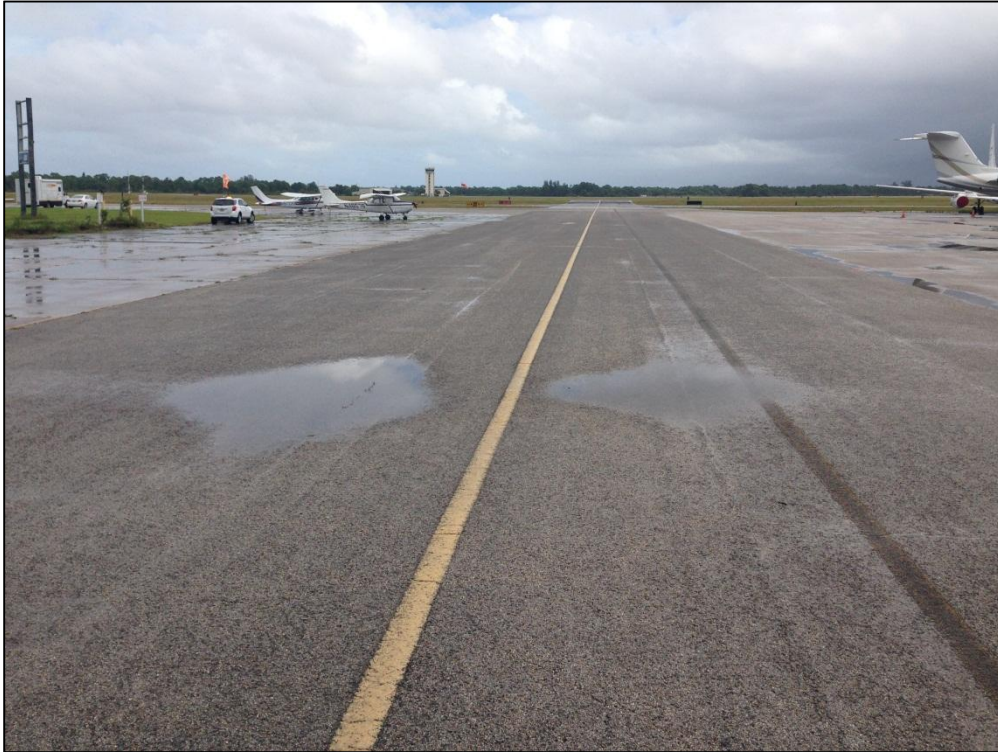
Taxiway B, Section 205, Sample Unit 207 – Medium Severity (52) Raveling, Low Severity (53) Rutting

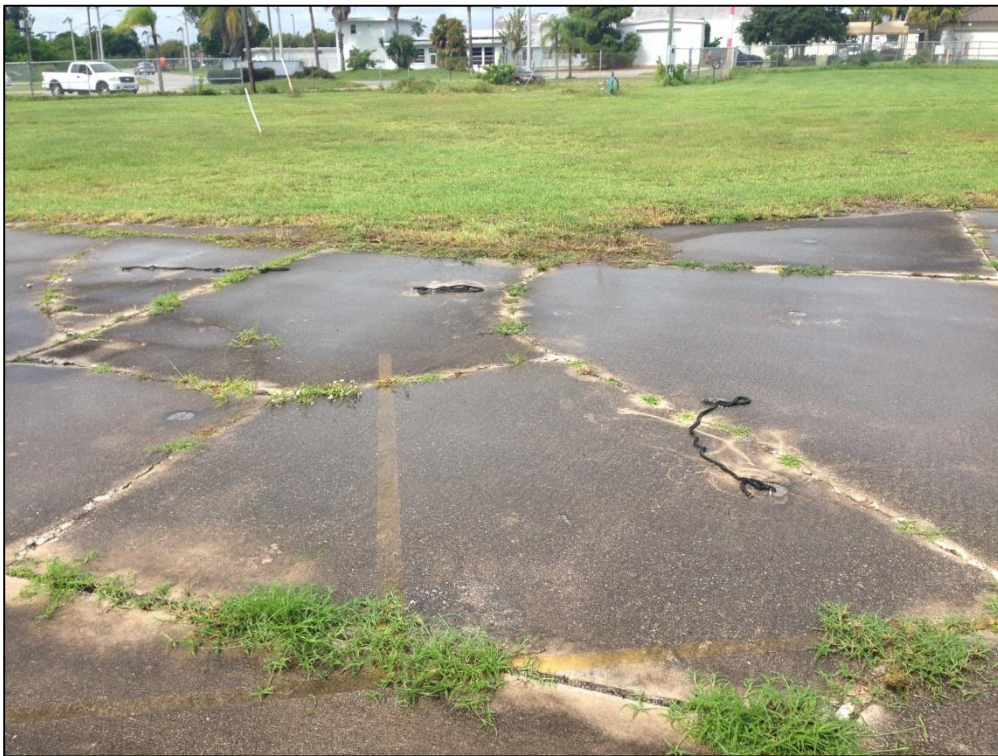
Apron W, Section 4110, Sample Unit 404 – High Severity (65) Joint Seal Damage, Medium Severity (72) Shattered Slab

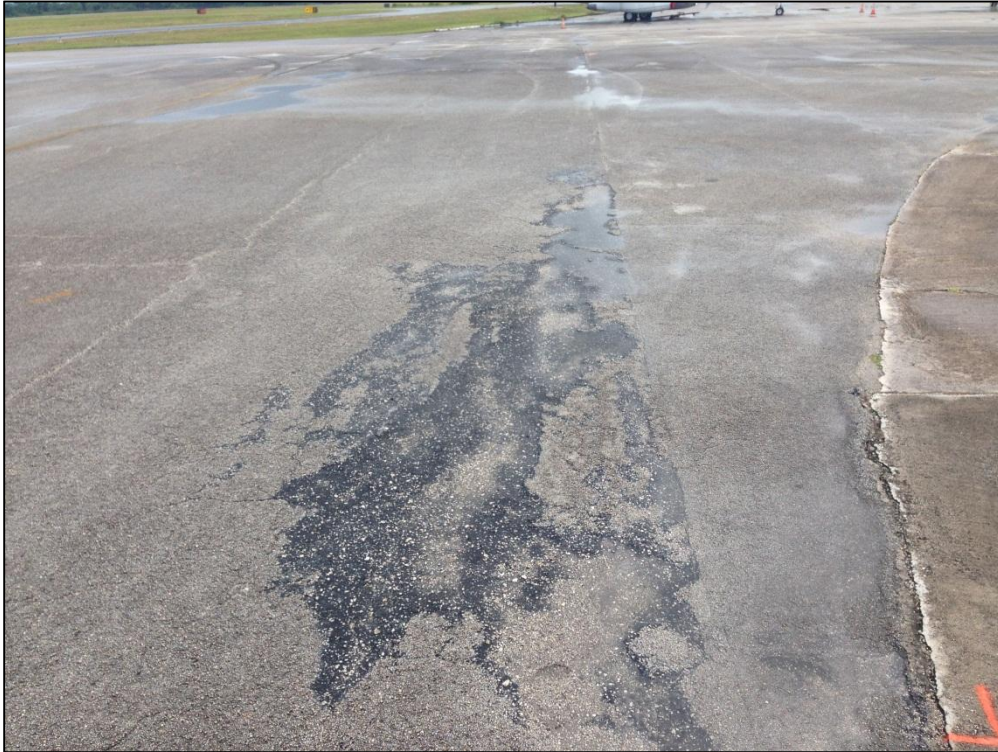
Apron W, Section 4105, Sample Unit 300 – Low Severity (43) Block Cracking, Low Severity (57) Weathering, High Severity (52) Raveling

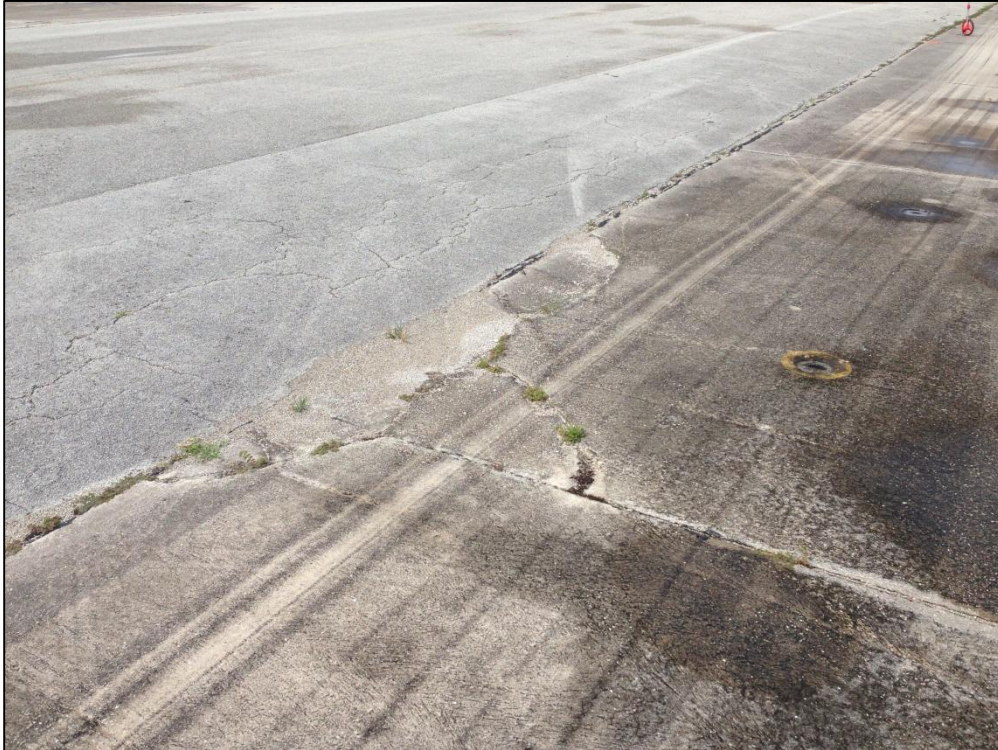
Apron W, Section 4107, Sample Unit 202 – High Severity (65) Joint Seal Damage, Medium Severity (62) Corner Break, Medium Severity (74) Joint Spalling
