FLORIDA DEPARTMENT OF TRANSPORTATION
AVIATION AND SPACEPORT OFFICE

DADE-COLLIER
TRAINING AND
TRANSITION
CENTER (TNT)

DECEMBER 2013

STATEWIDE
**Airfield
Pavement
Management**
PROGRAM

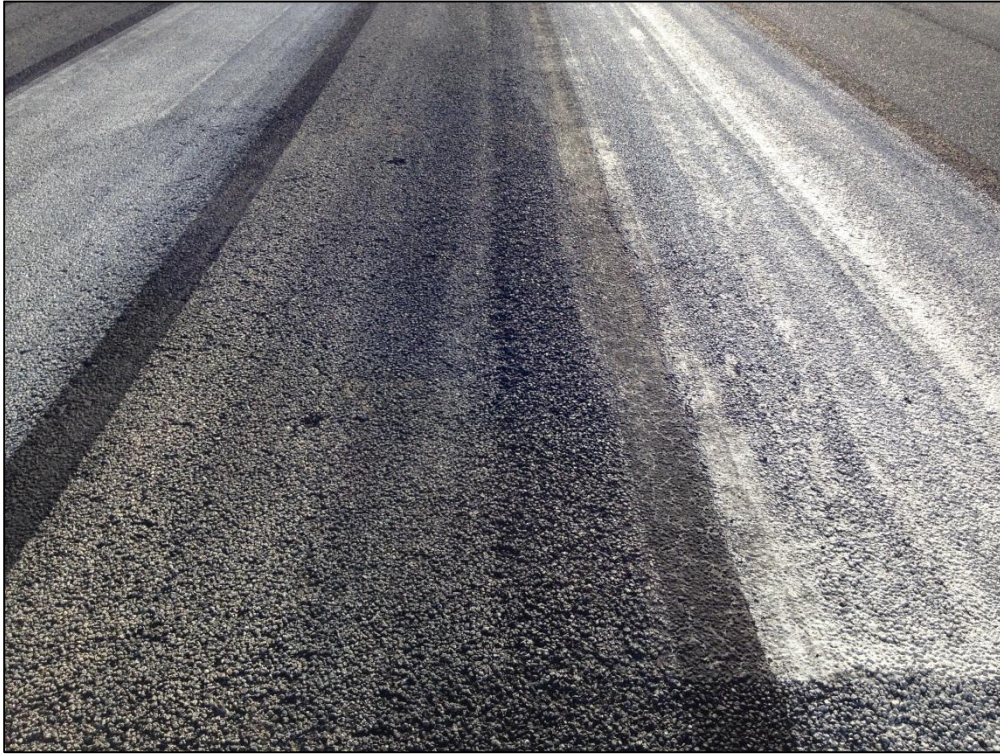
Runway 9-27, Section 6105, Sample Unit 403 – Medium Severity (57) Weathering, Low Severity (52) Raveling

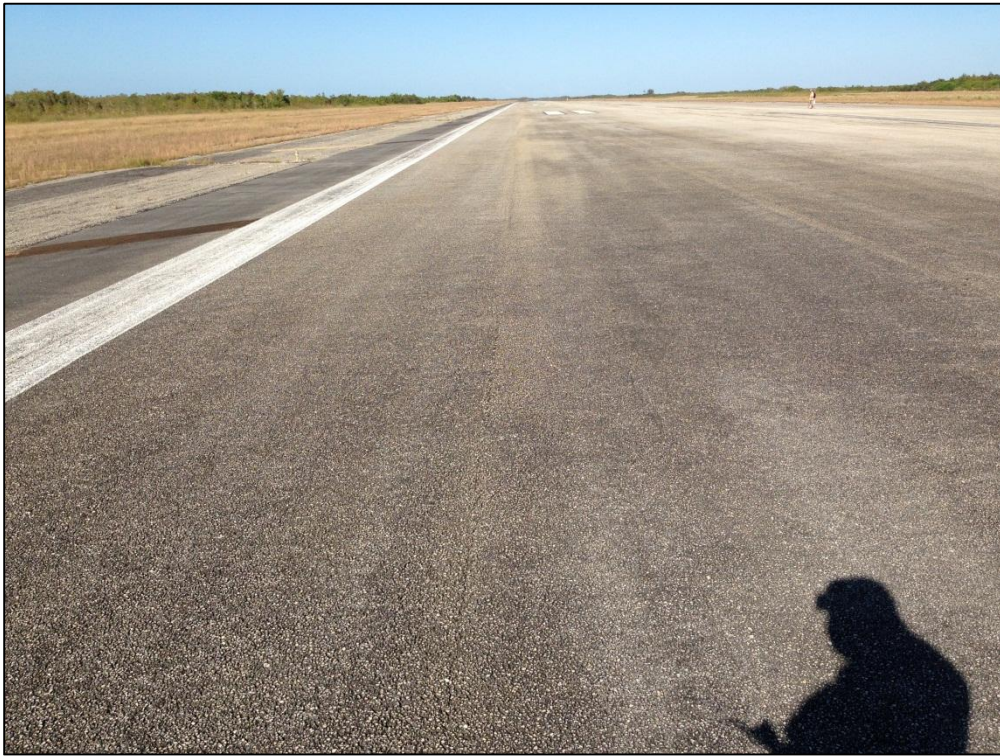
Runway 9-27, Section 6105, Sample Unit 592 – Low Severity (48) Longitudinal and Transverse Cracking, Medium Severity (57) Weathering, Low Severity (52) Raveling

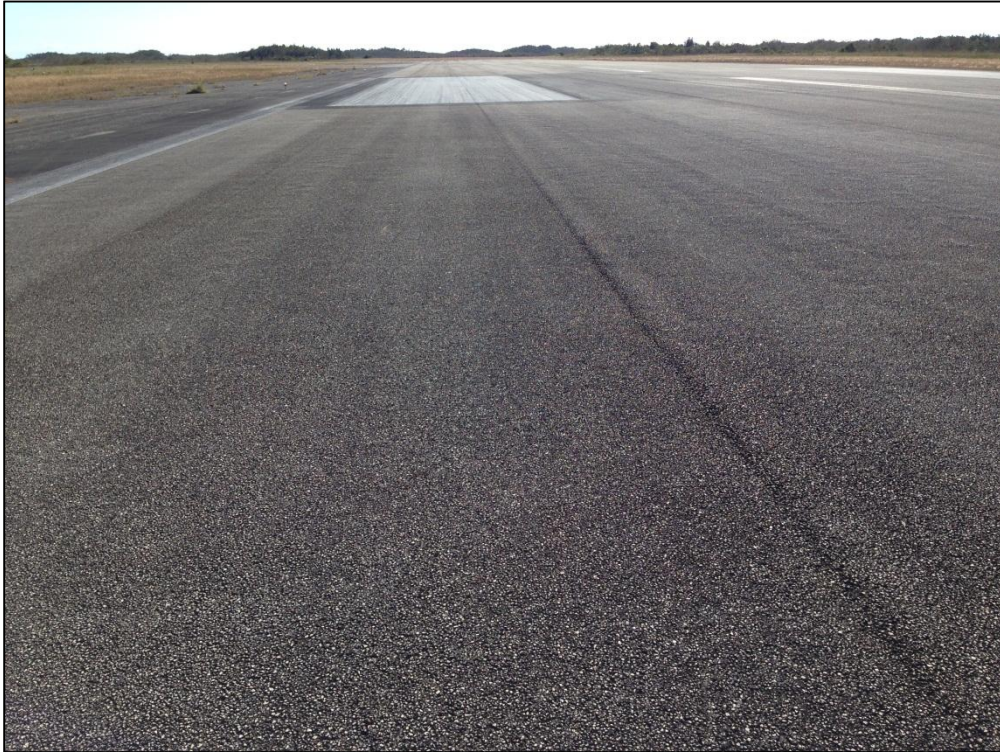
Runway 9-27, Section 6105, Sample Unit 192 – Low Severity (48) Longitudinal and Transverse Cracking, Medium Severity (57) Weathering, Low Severity (52) Raveling

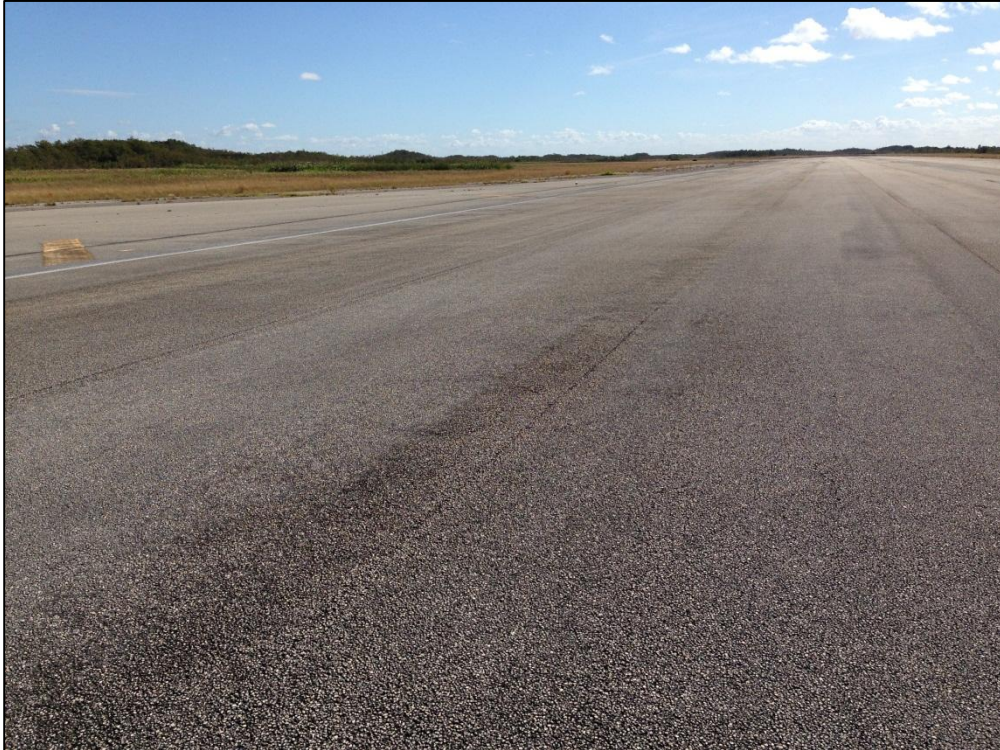
Runway 9-27, Section 6105, Sample Unit 168 – Low Severity (48) Longitudinal and Transverse Cracking, Medium Severity (57) Weathering, Low Severity (52) Raveling, Low Severity (56) Swelling

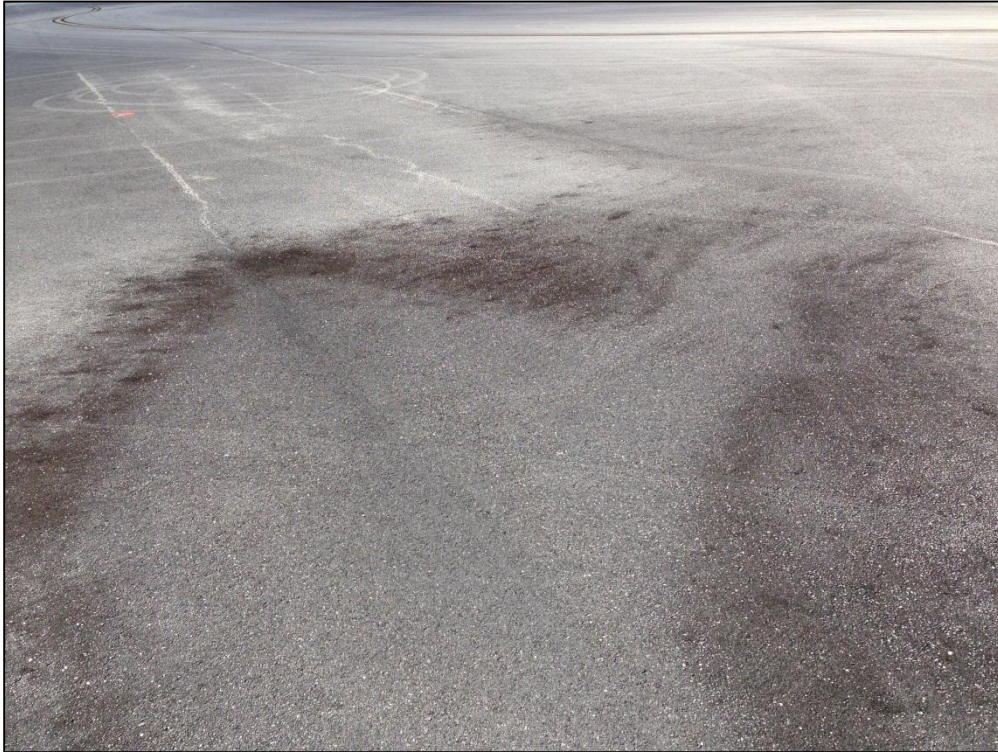
Taxiway A4, Section 150, Sample Unit 435 – Low Severity (45) Depression, Low Severity (48) Longitudinal and Transverse Cracking, Medium Severity (57) Weathering

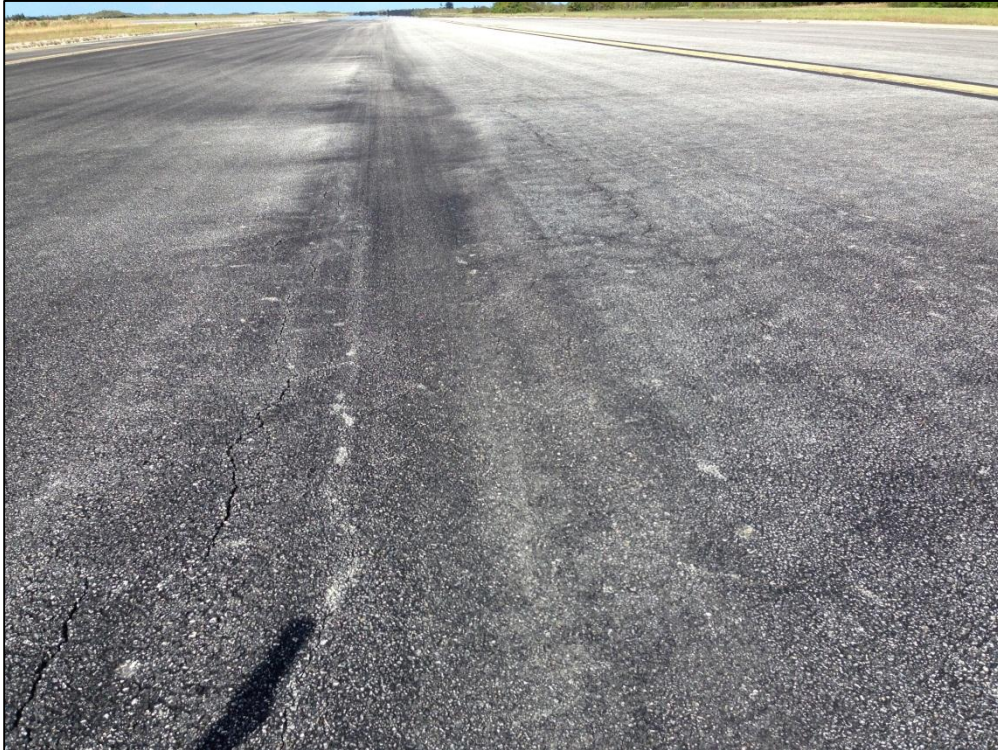
Taxiway A, Section 105, Sample Unit 237 – Low Severity (53) Rutting, Medium Severity (57) Weathering

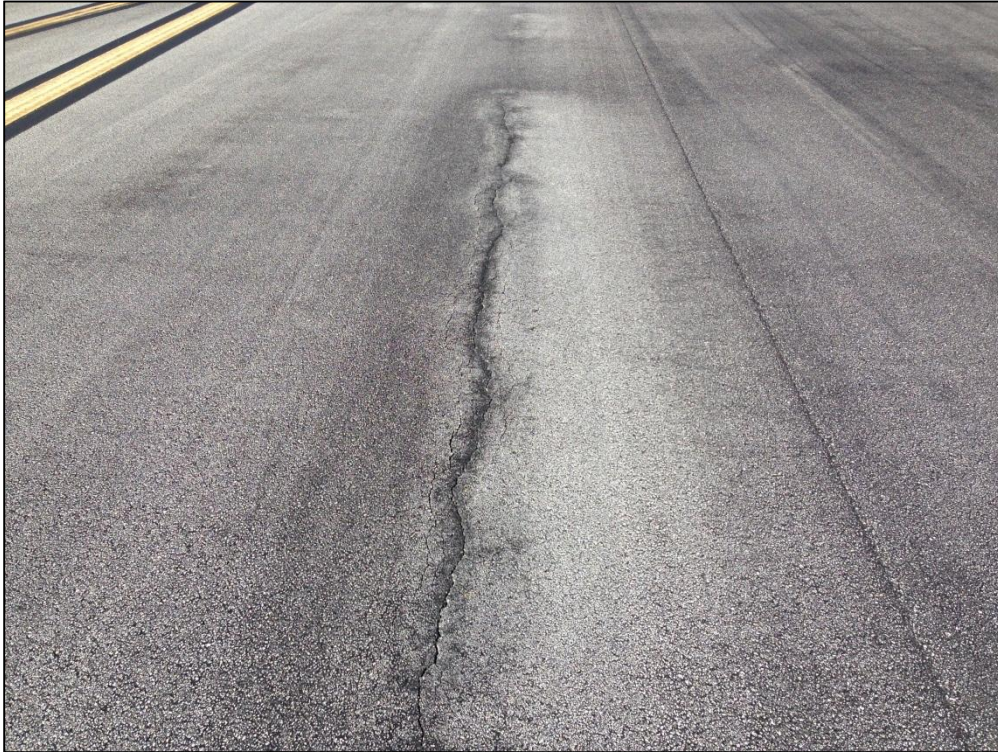
Taxiway A, Section 105, Sample Unit 261 – Low Severity (48) Longitudinal and Transverse Cracking, Medium Severity (56) Swelling, Medium Severity (57) Weathering

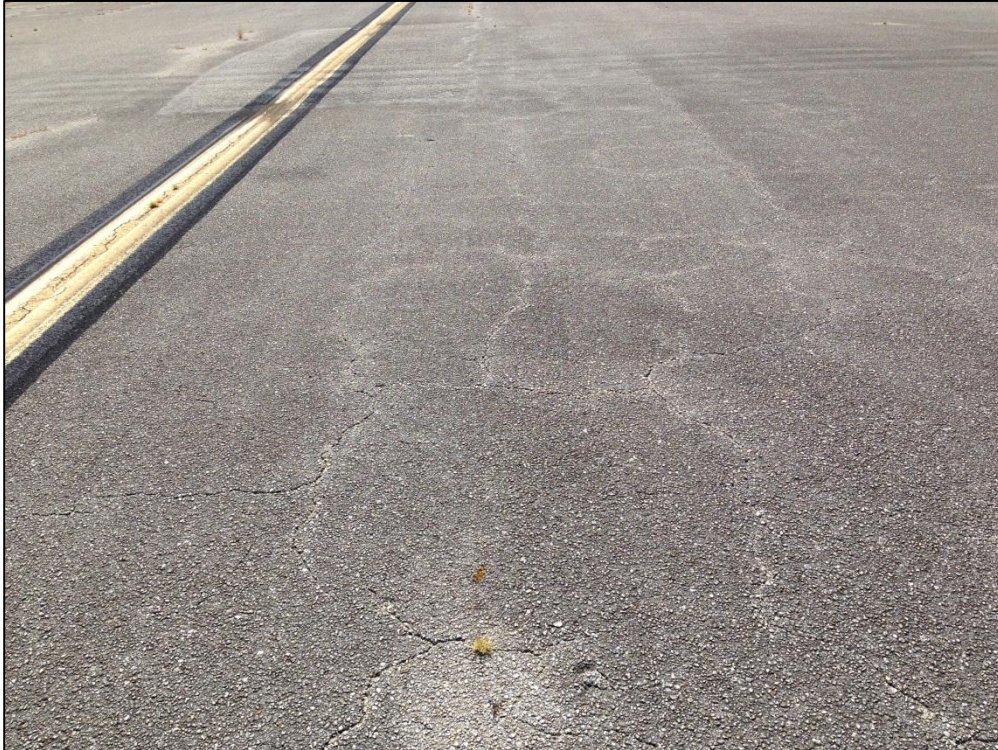
Taxiway A6, Section 170, Sample Unit 608 – Low Severity (48) Longitudinal and Transverse Cracking, Low Severity (43) Block Cracking, Medium Severity (57) Weathering

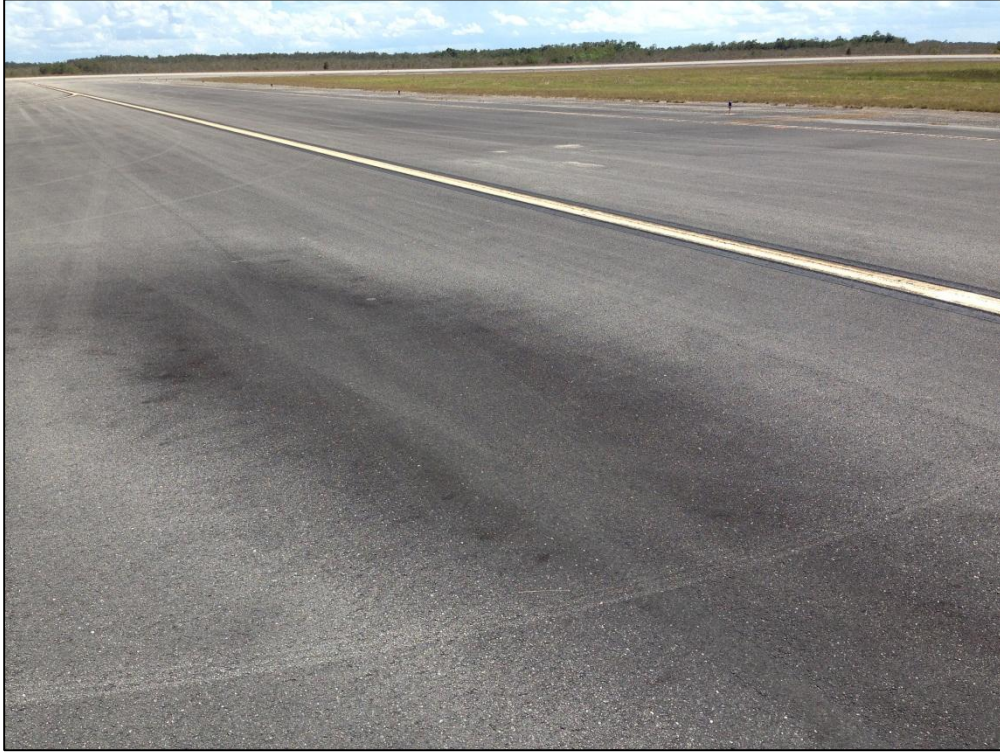
Taxiway A2, Section 130, Sample Unit 214 – Low Severity (45) Depression, Low Severity (57) Weathering

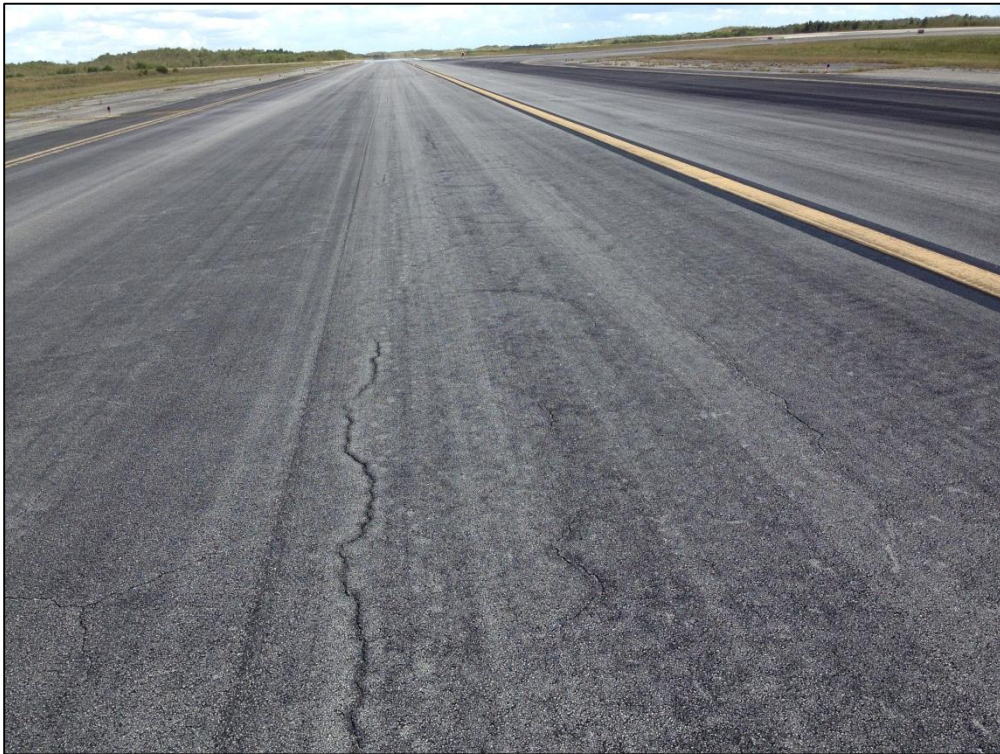
Taxiway A, Section 105, Sample Unit 159 – Low Severity (43) Block Cracking, Low Severity (56) Swelling, Low Severity (57) Weathering

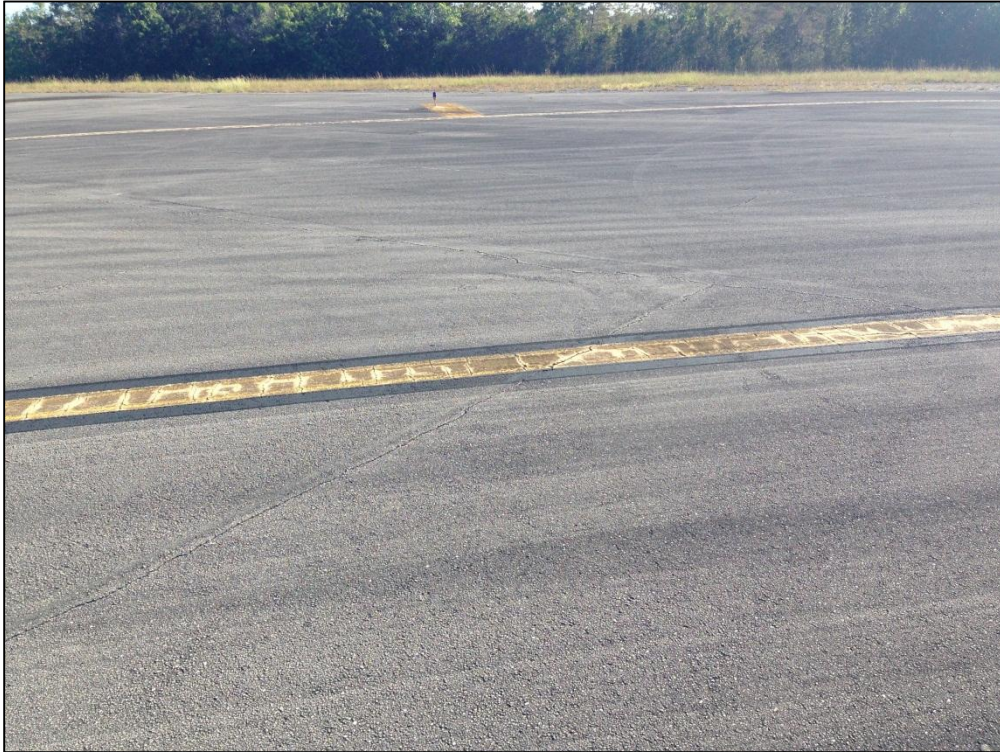
Taxiway B, Section 210, Sample Unit 100 – Low Severity (48) Longitudinal and Transverse Cracking, Low Severity (57) Weathering

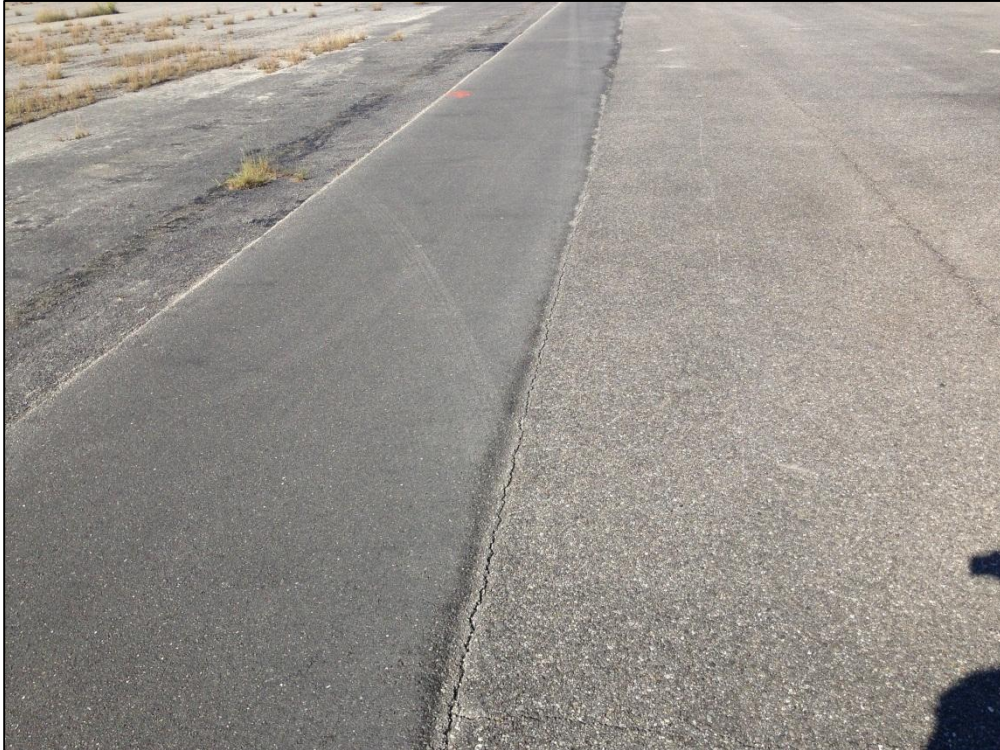
Apron N, Section 4105, Sample Unit 115 – Low Severity (48) Longitudinal and Transverse Cracking, Low Severity (52) Raveling, Medium Severity (57) Weathering, Low Severity (50) Patching
