FLORIDA DEPARTMENT OF TRANSPORTATION  
AVIATION AND SPACEPORT OFFICE

**CECIL AIRPORT (VOQ)**

DECEMBER 2013

STATEWIDE  
**Airfield  
Pavement  
Management**  
PROGRAM

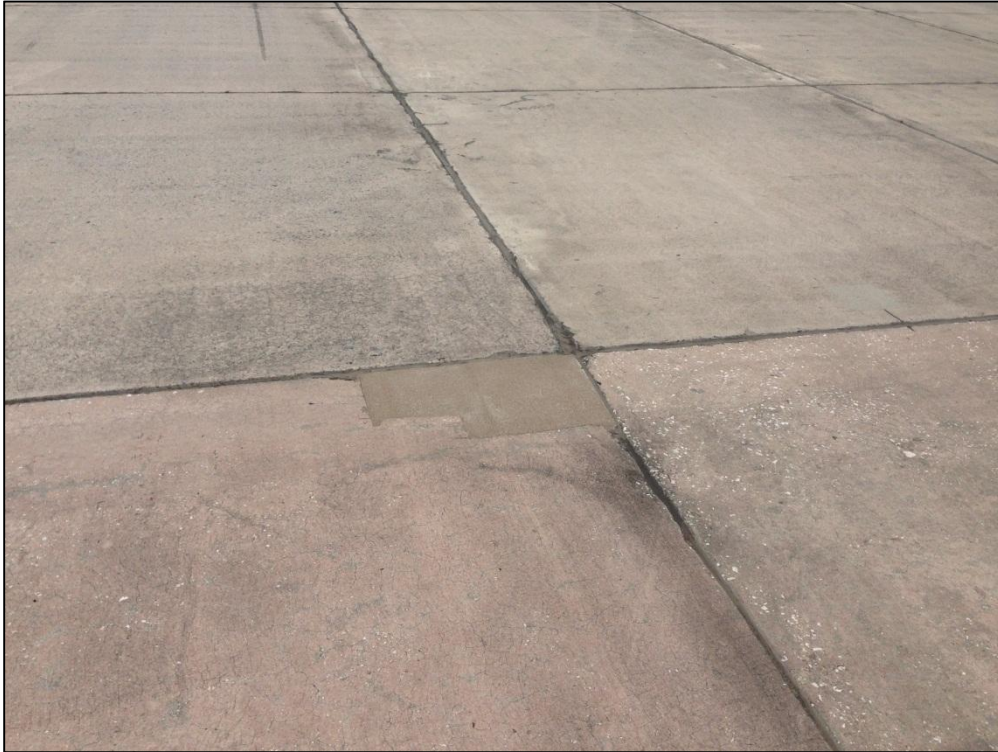
Runway 18L-36R, Section 6235, Sample Unit 384 – Low Severity (70) Map Cracking, Low Severity (66) Patching

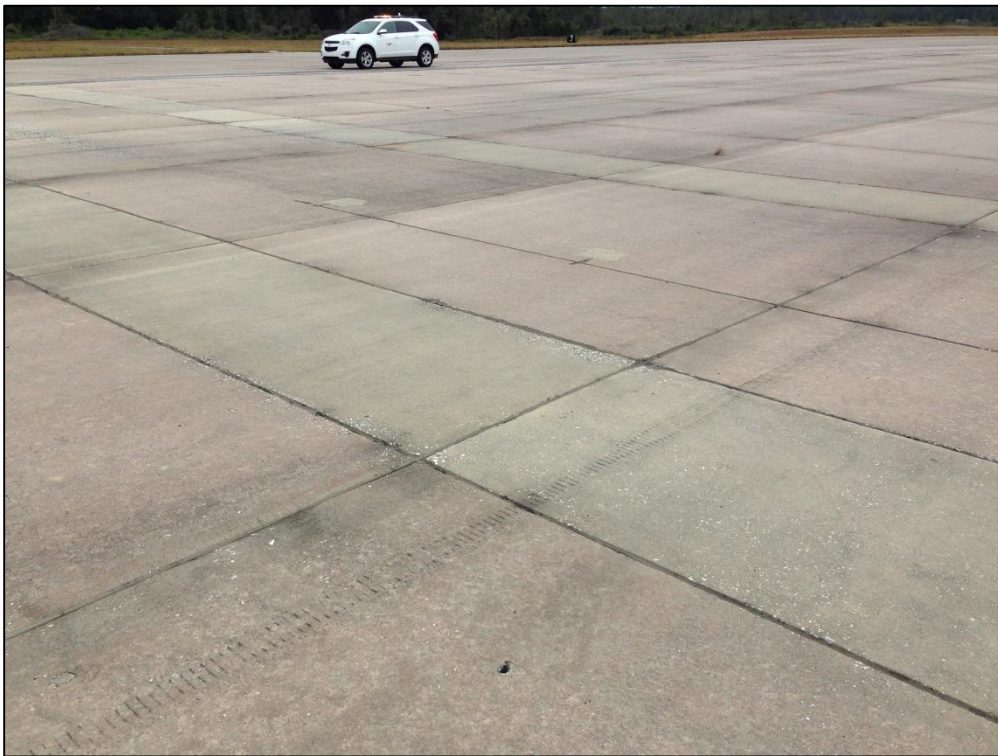
Runway 18L-36R, Section 6240, Sample Unit 797 – Low Severity (70) Map Cracking, Low Severity (66) Small Patching, Low Severity (67) Large Patching

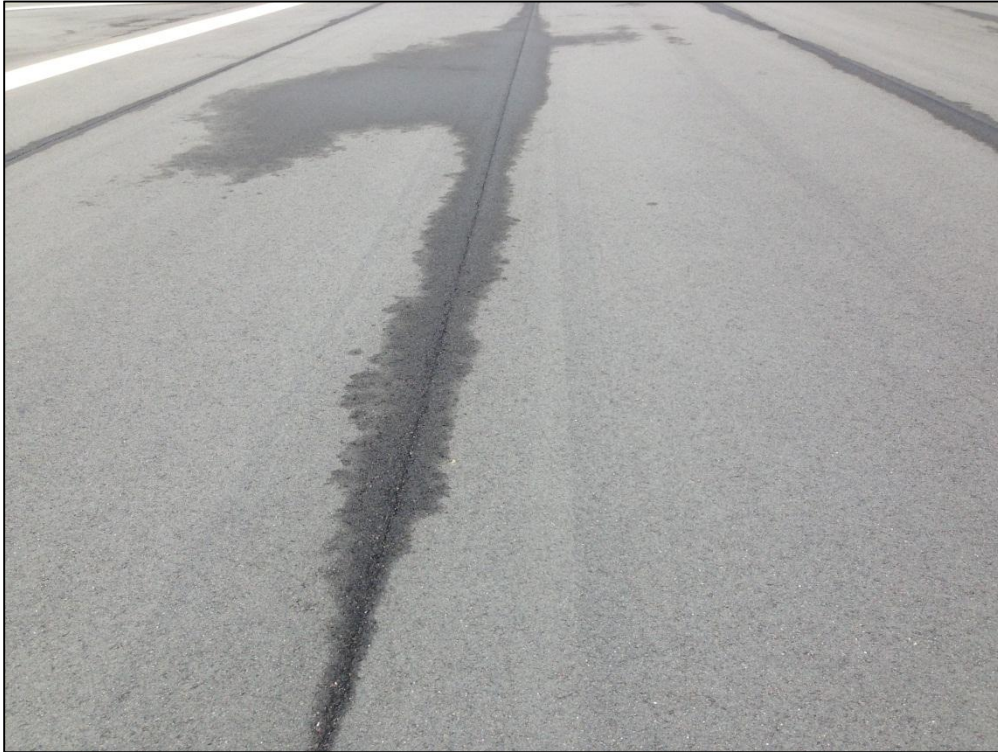
Runway 18L-36R, Section 6220, Sample Unit 773 – Low Severity (48) Longitudinal and Transverse Cracking

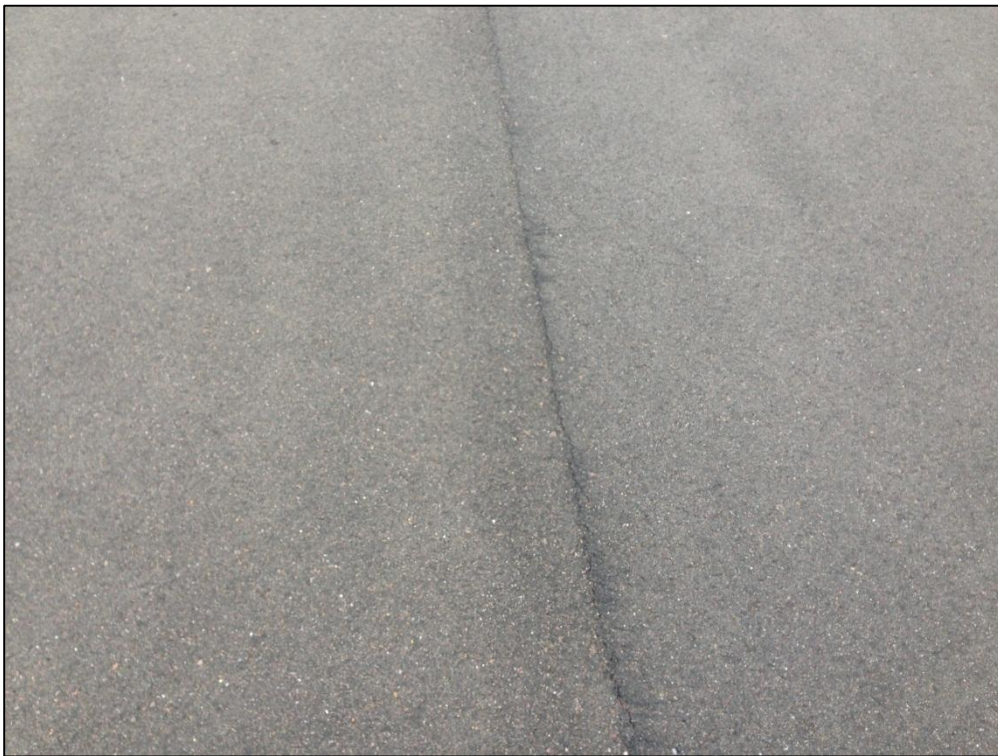
Runway 9R-27L, Section 6320, Sample Unit 741 – Low Severity (48) Longitudinal and Transverse Cracking

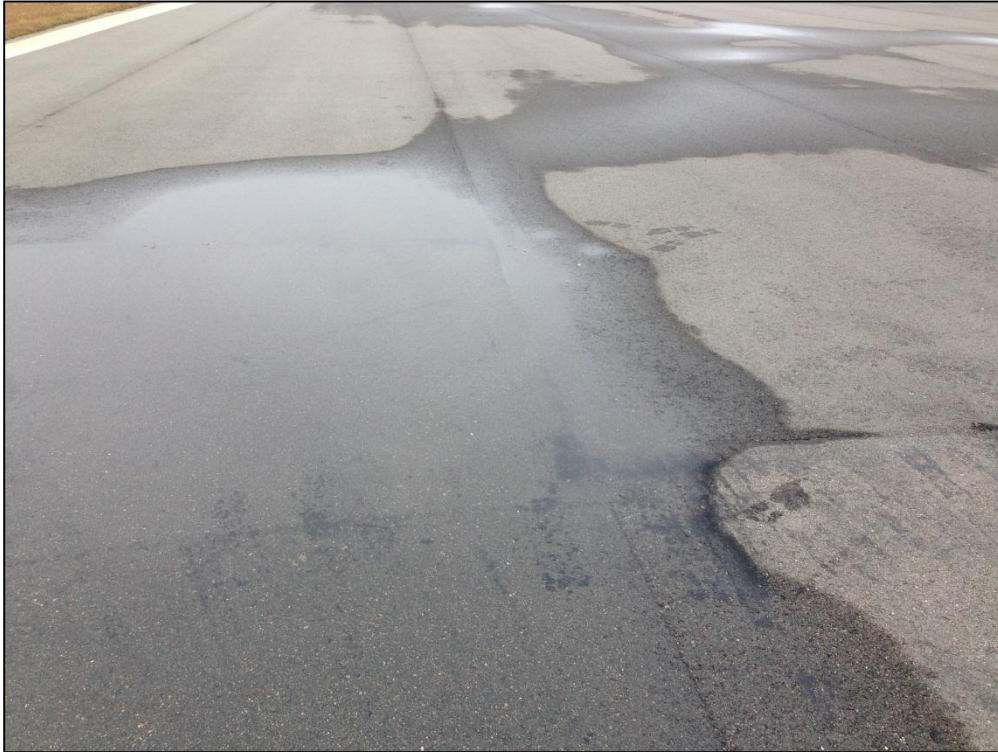
Runway 9R-27L, Section 6320, Sample Unit 154 – Low Severity (48) Longitudinal and Transverse Cracking, Low Severity (45) Depression

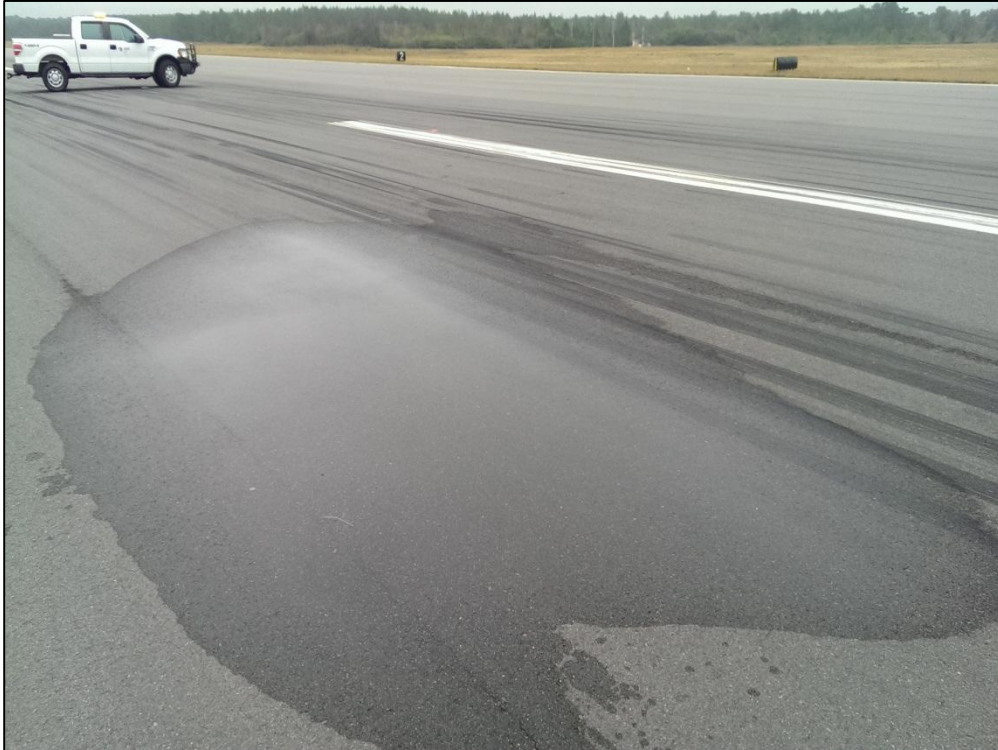
Runway 9R-27L, Section 6315, Sample Unit 359 – Low Severity (48) Longitudinal and Transverse Cracking, Low Severity (45) Depression

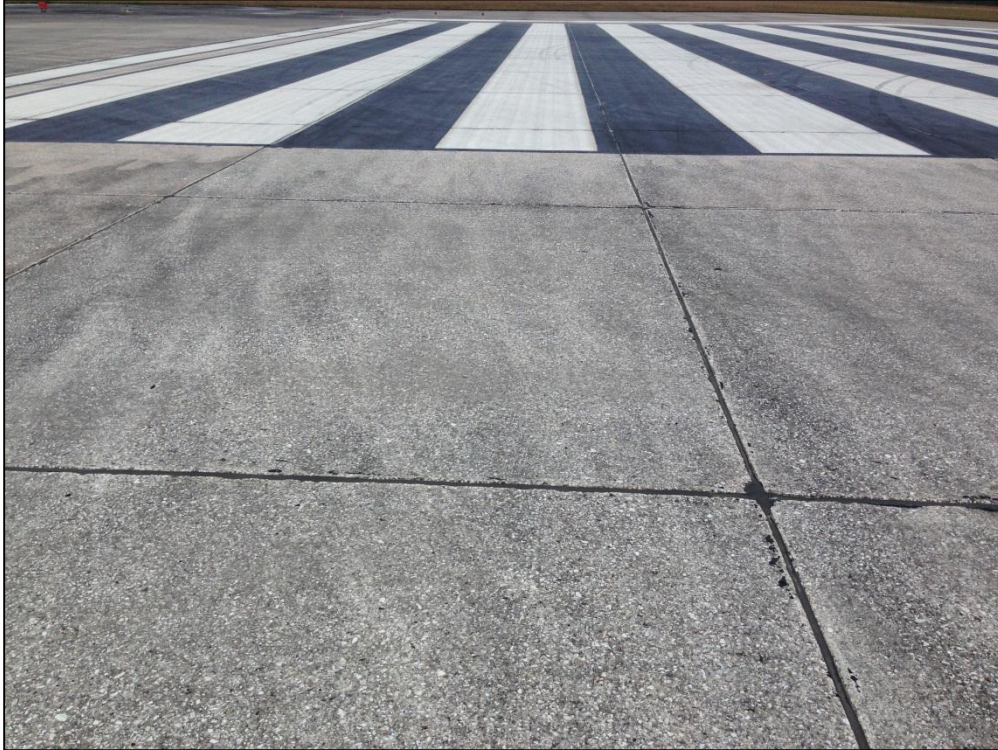
Runway 9R-27L, Section 6340, Sample Unit 183 – Low Severity (70) Map Cracking

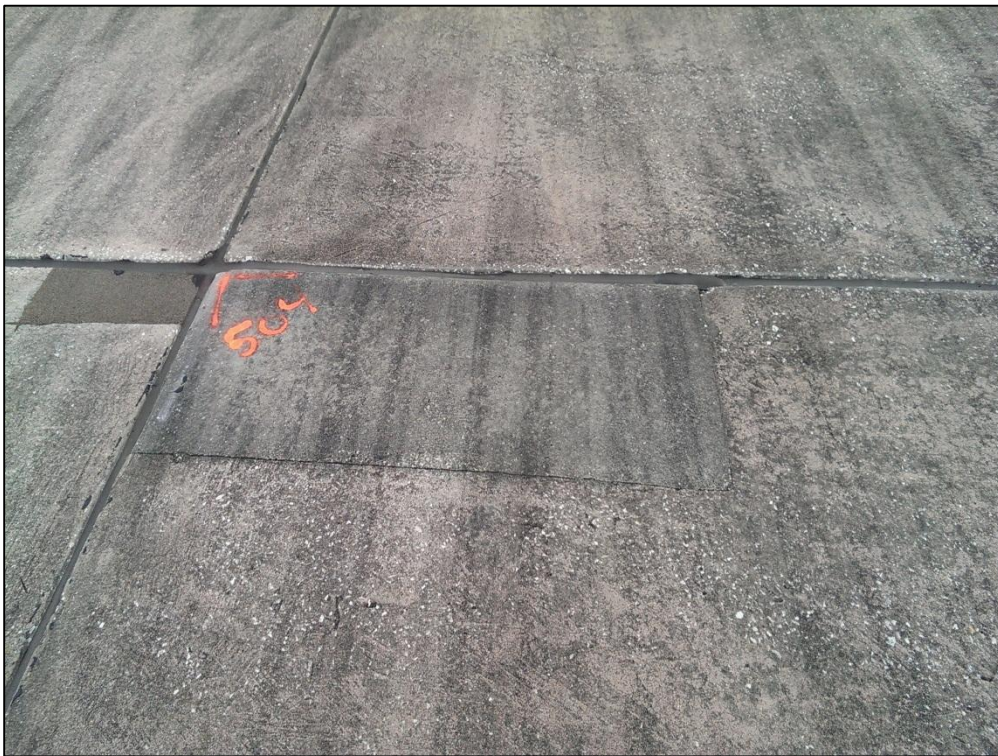
Runway 9R-27L, Section 6305, Sample Unit 504 – Low Severity (70) Map Cracking, Low Severity (66) Small Patching

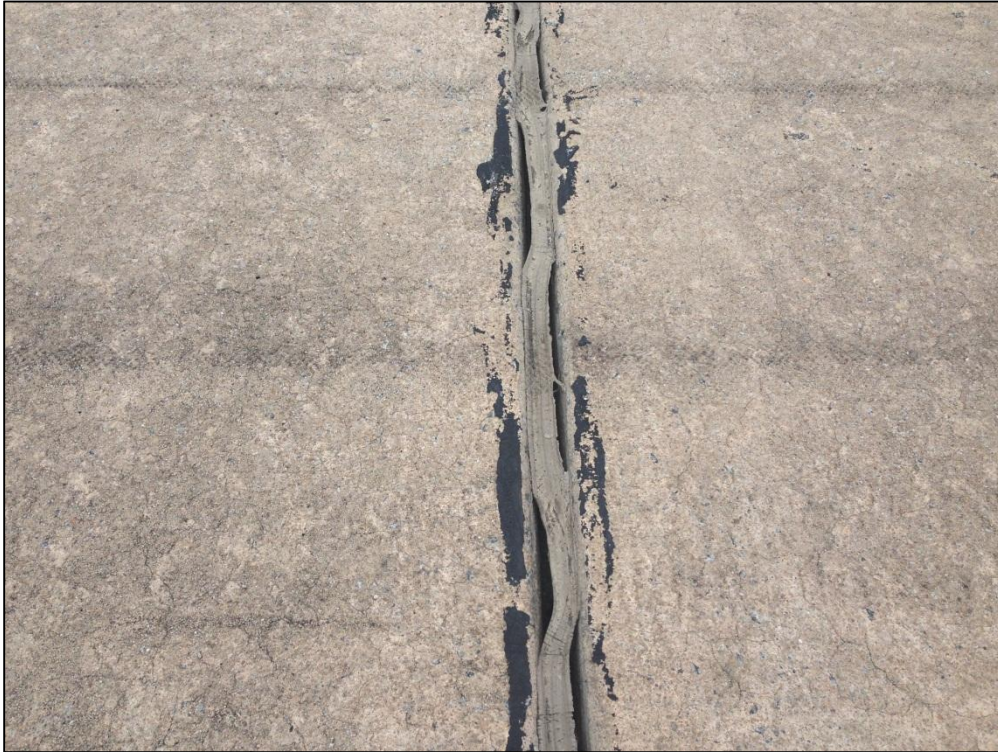
Runway 9L-27R, Section 6410, Sample Unit 105 – Medium Severity (65) Joint Seal Damage, Low Severity (70) Map Cracking

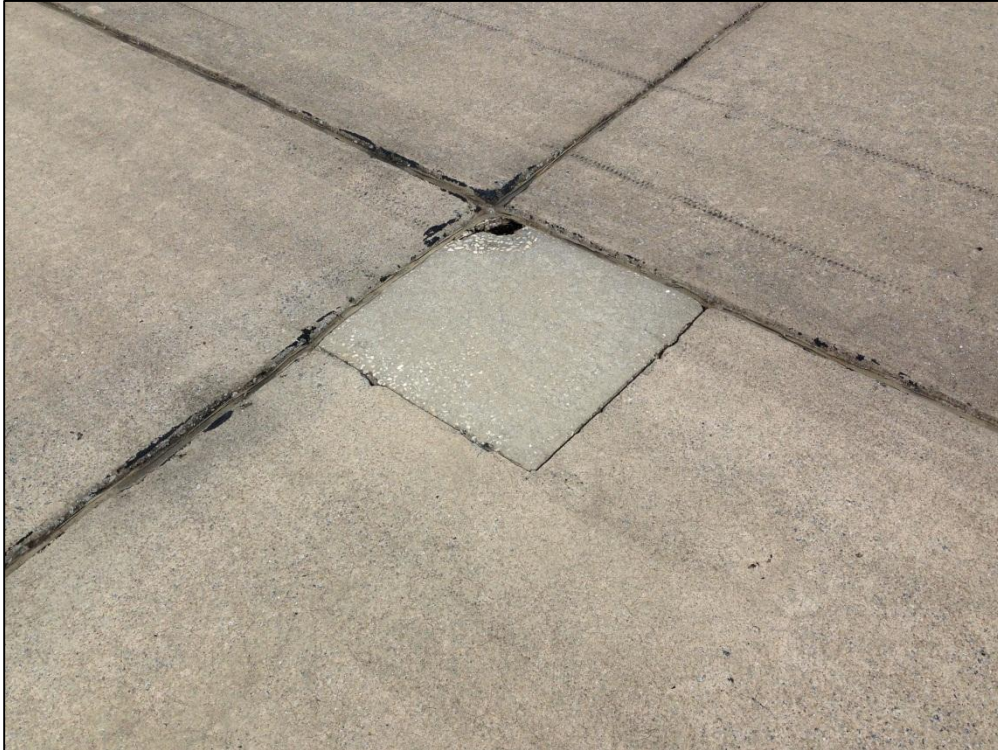
Runway 9L-27R, Section 6410, Sample Unit 702 – Low Severity (70) Map Cracking, Medium Severity (66) Small Patching

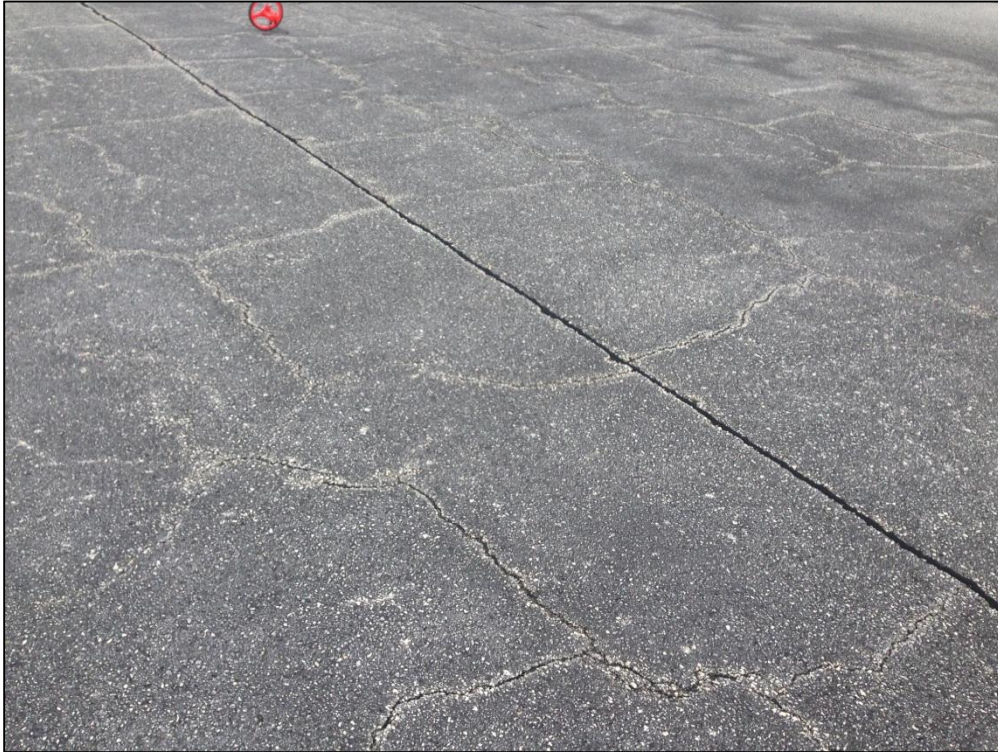
Runway 9L-27R, Section 6420, Sample Unit 126 – Low Severity (43) Block Cracking, Low Severity (52) Raveling, Low Severity (52) Swelling, Low Severity (57) Weathering

- Runway 9L-27R – Sections 6420, 6415, and 6414
  - Mill and Overlay attributed to distresses related to loading, subgrade quality, climate, and age of pavement.
- Runway 18R-36L – Sections 6120 and 6115
  - Mill and Overlay attributed to distresses related to loading, subgrade quality, climate, and age of pavement.
- N Hot Refueling and Compass Rose AP – Section 5140
  - PCC Restoration attributed to distresses related to loading.
- W Hot Refueling and Compass Rose AP – Section 5055
  - Reconstruction attributed to distresses related to loading and construction quality.
- W Hot Refueling and Compass Rose AP – Section 5020
  - PCC Restoration attributed to distresses related to loading and construction quality.

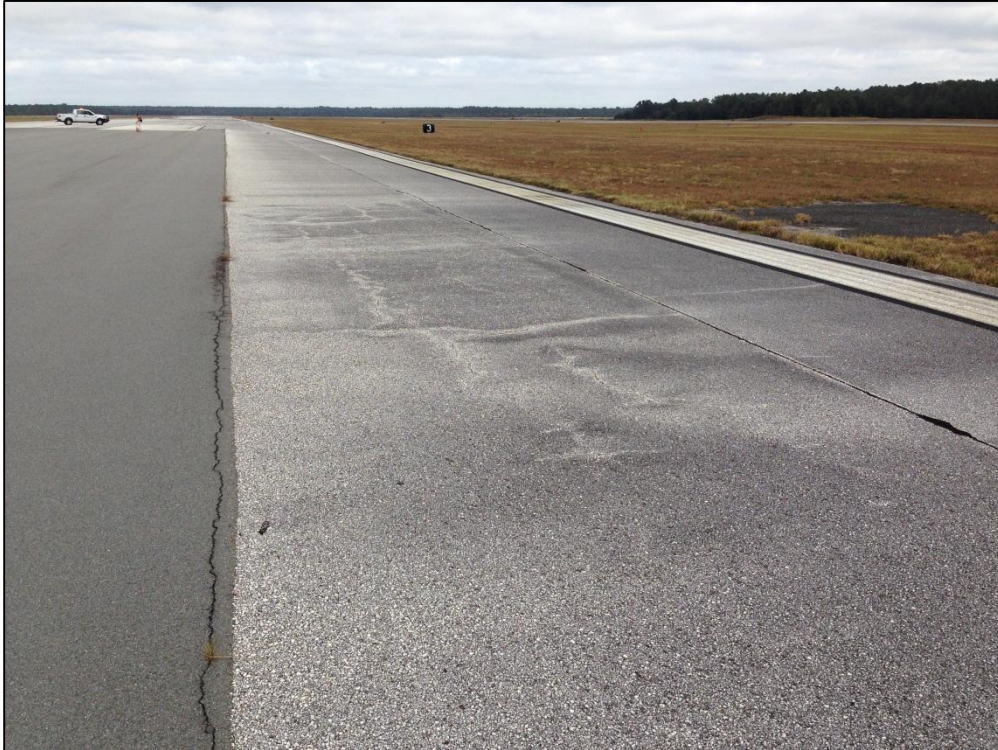
Runway 9L-27R, Section 6420, Sample Unit 709 – Low Severity (43) Block Cracking, Low Severity (48) Longitudinal and Transverse Cracking, Low Severity (52) Raveling, Low Severity (52) Swelling, Low Severity (57) Weathering

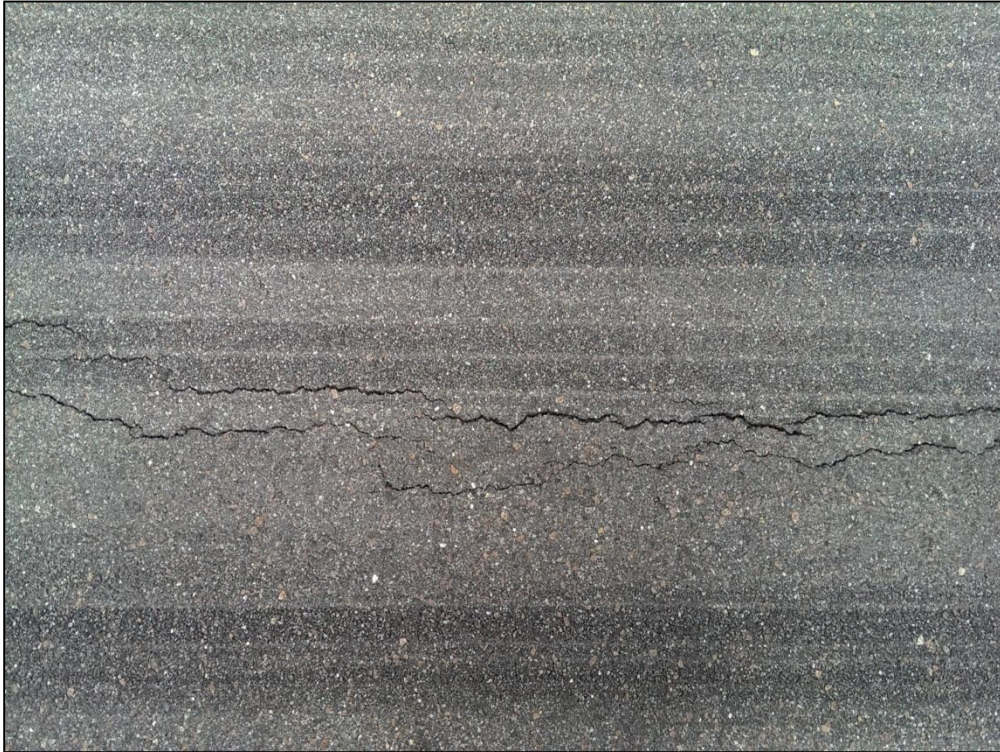
Runway 9L-27R, Section 6414, Sample Unit 511 – Low Severity (41) Alligator Cracking

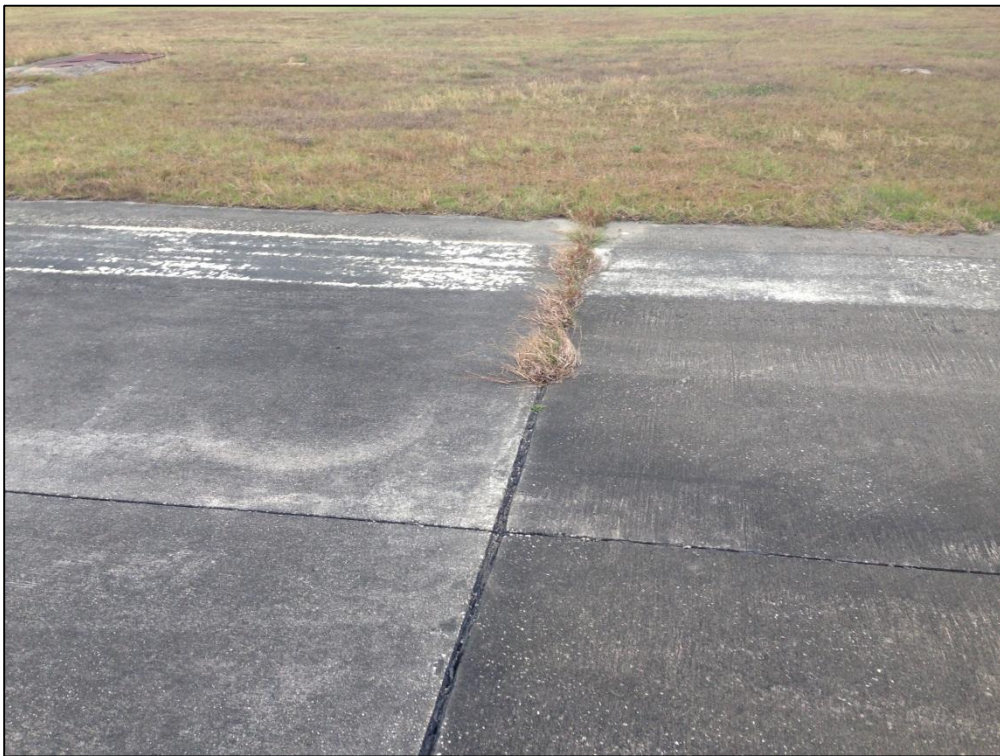
Runway 18R-36L, Section 6130, Sample Unit 474 – Medium Severity (65) Joint Seal Damage

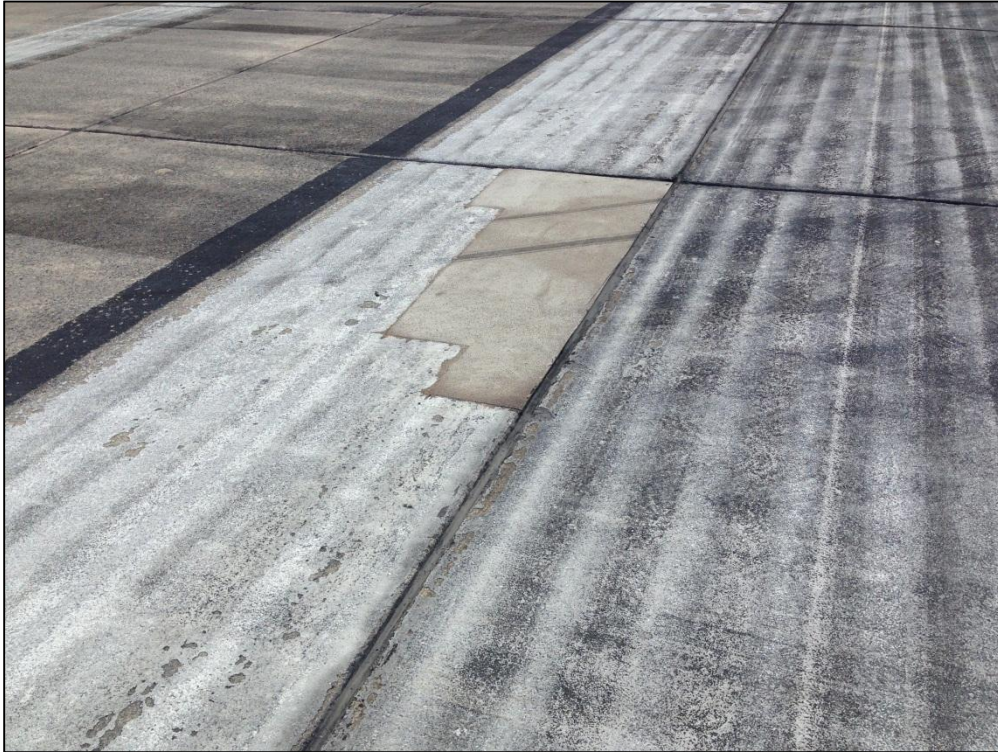
Runway 18R-36L, Section 6110, Sample Unit 101 – Low Severity (67) Large Patching, Low Severity (70) Map Cracking

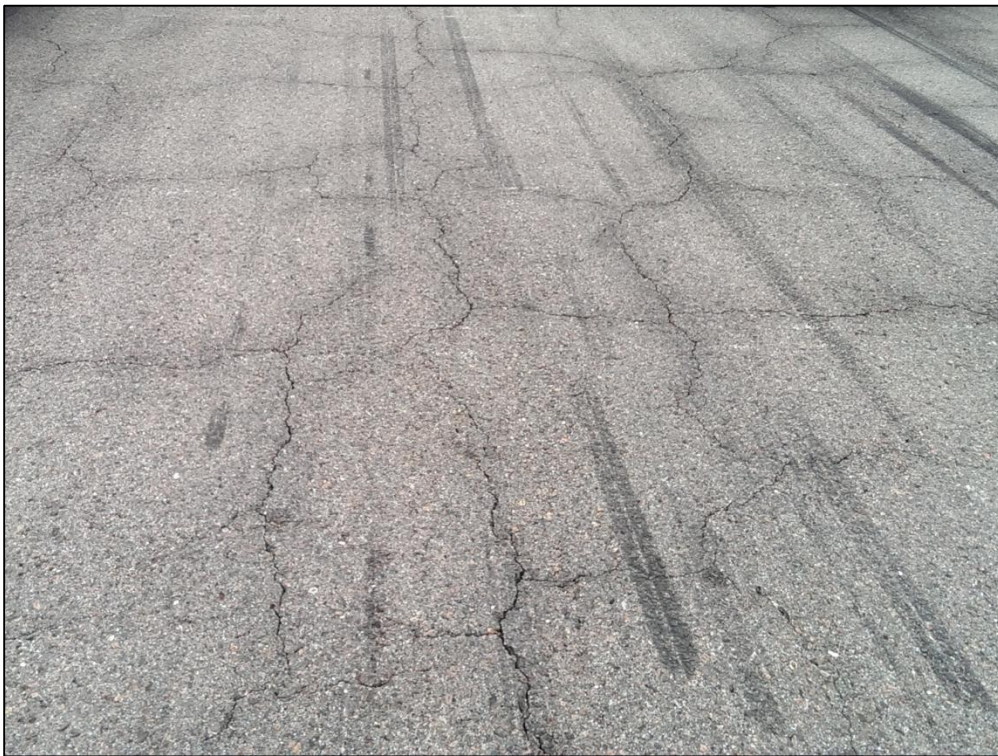
Runway 18R-36L, Section 6115, Sample Unit 369 – Low Severity (43) Block Cracking, Low Severity (52) Raveling, Low Severity (57) Weathering

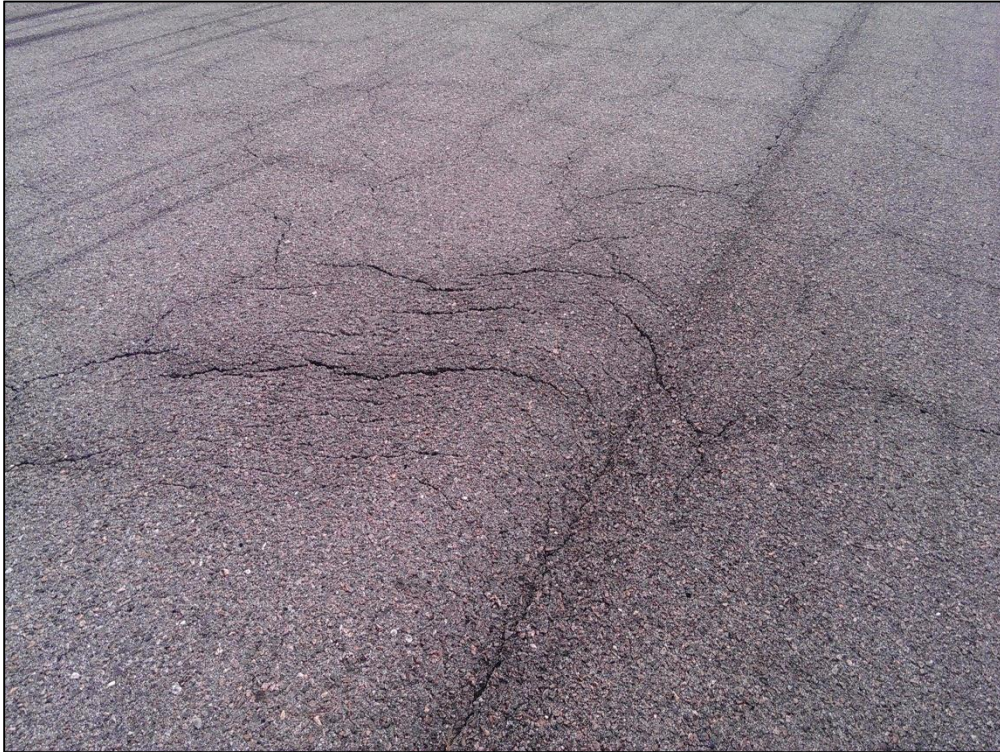
Runway 18R-36L, Section 6115, Sample Unit 313 – (55) Slippage Cracking, Low Severity (52) Raveling, Low Severity (57) Weathering

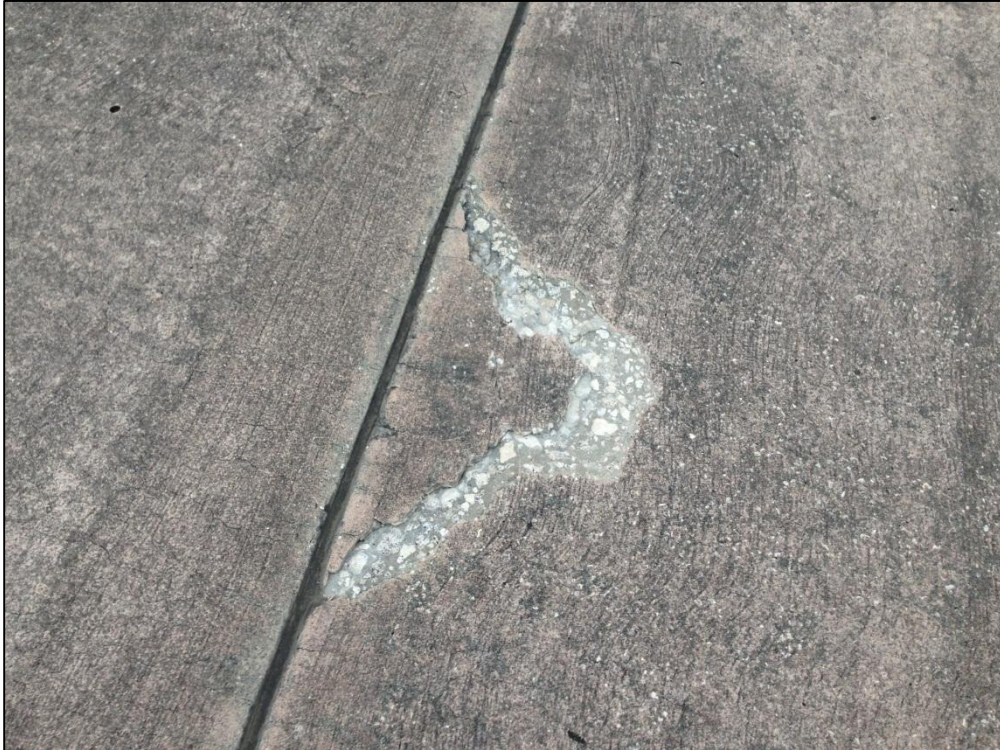
Taxiway A, Section 105, Sample Unit 302 – Low Severity (70) Map Cracking, High Severity (74) Joint Spalling

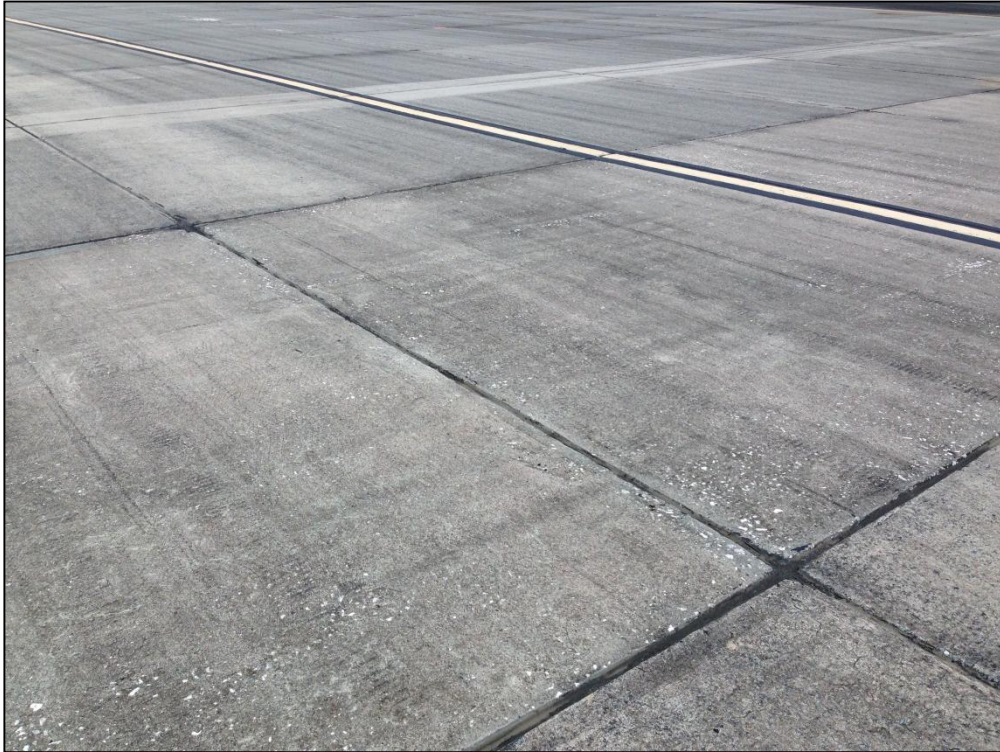
Taxiway A4, Section 805, Sample Unit 501 – Low Severity (70) Map Cracking

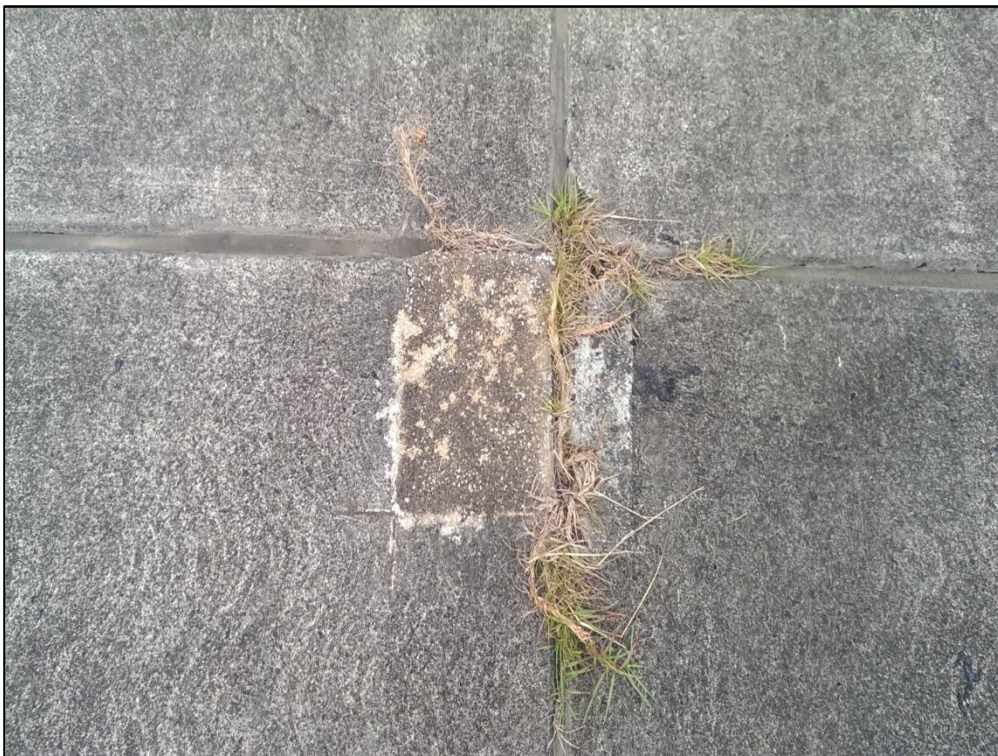
Taxiway B, Section 205, Sample Unit 148 – Low Severity (70) Map Cracking, Low Severity (66) Small Patching

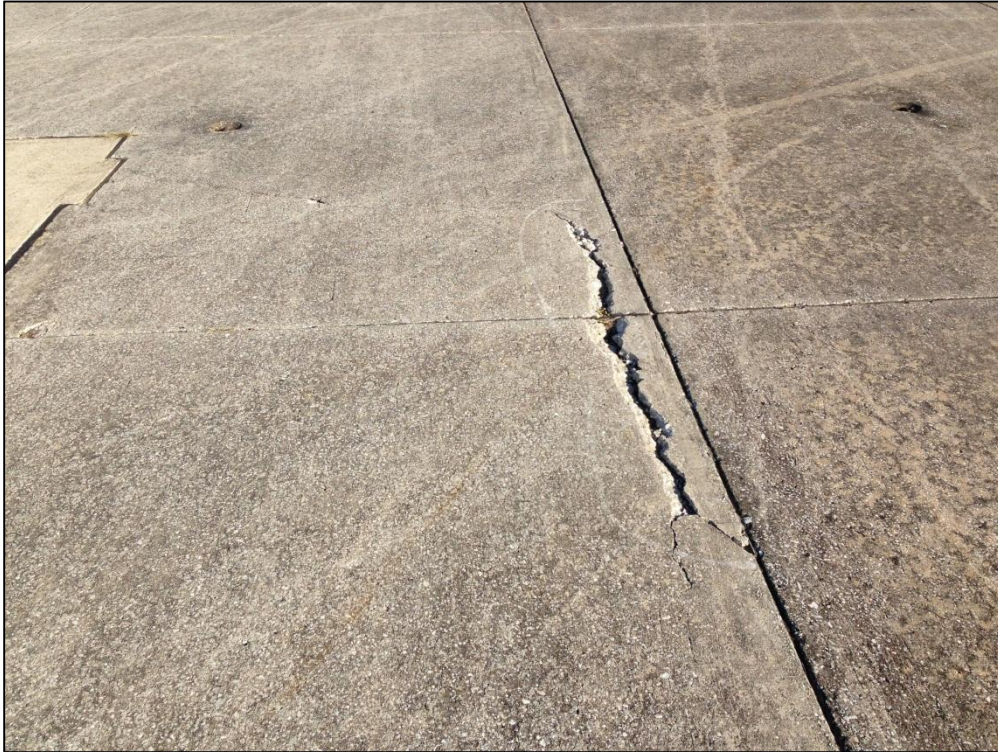
Apron North, Section 4110, Sample Unit 211 – Low Severity (70) Map Cracking, Medium Severity (62) Corner Break, Low Severity (67) Large Patching

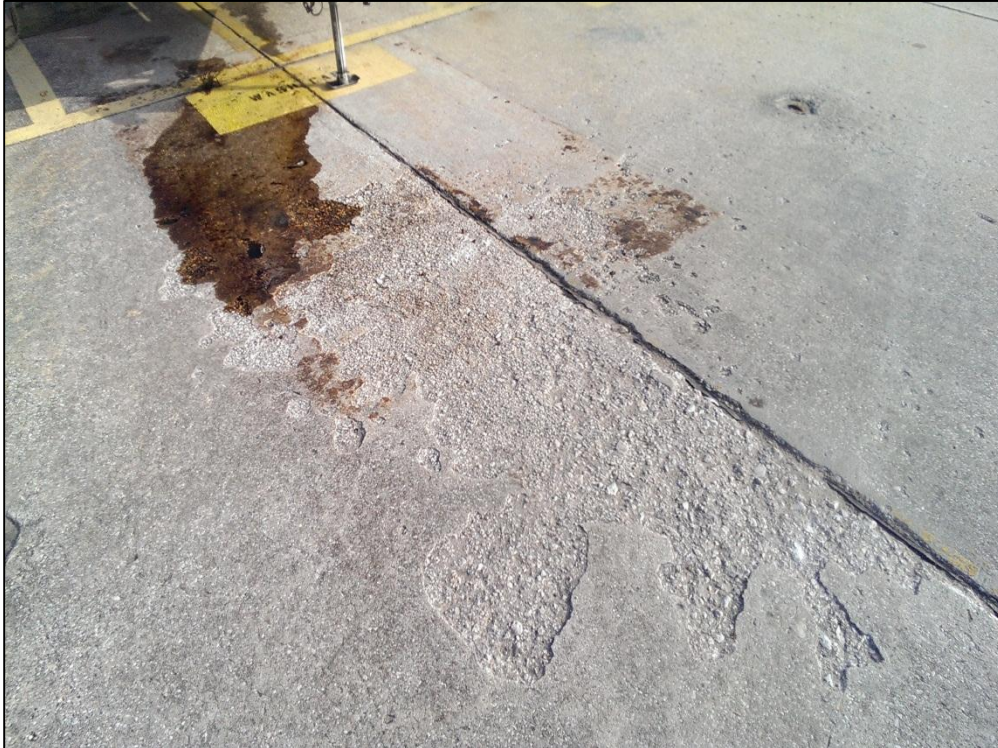
Apron North, Section 4110, Sample Unit 411 – High Severity (70) Map Cracking, Low Severity (65) Joint Seal Damage

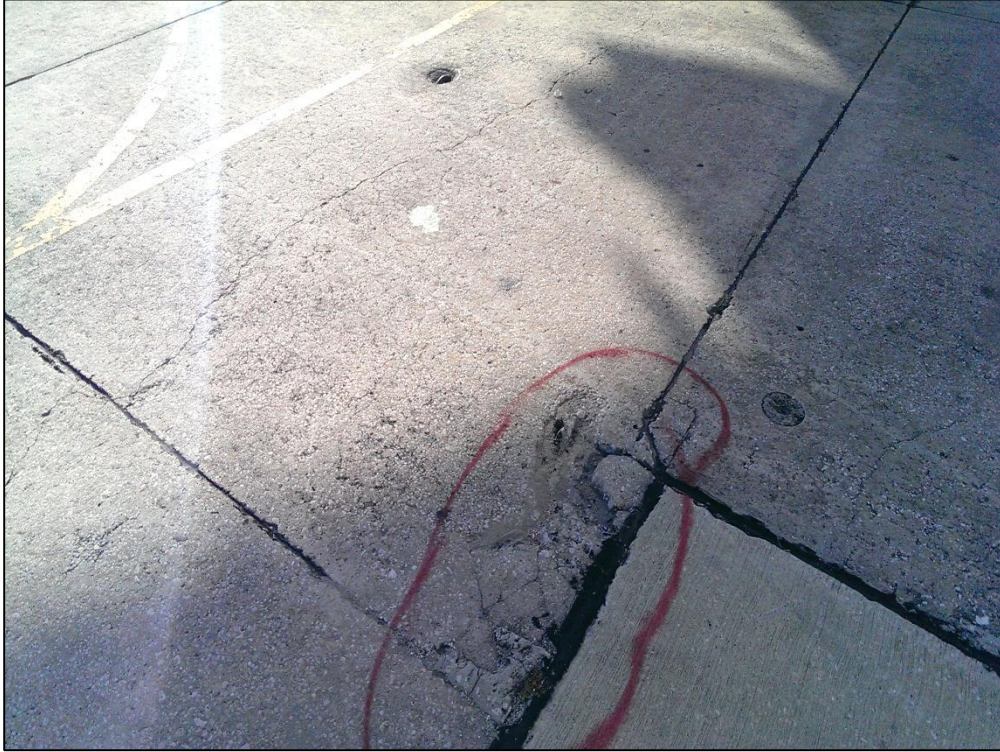
Apron North, Section 4110, Sample Unit 407 – Medium Severity (70) Map Cracking, Low Severity (63) Longitudinal, Transverse, and Diagonal Cracking, High Severity (75) Corner Spalling

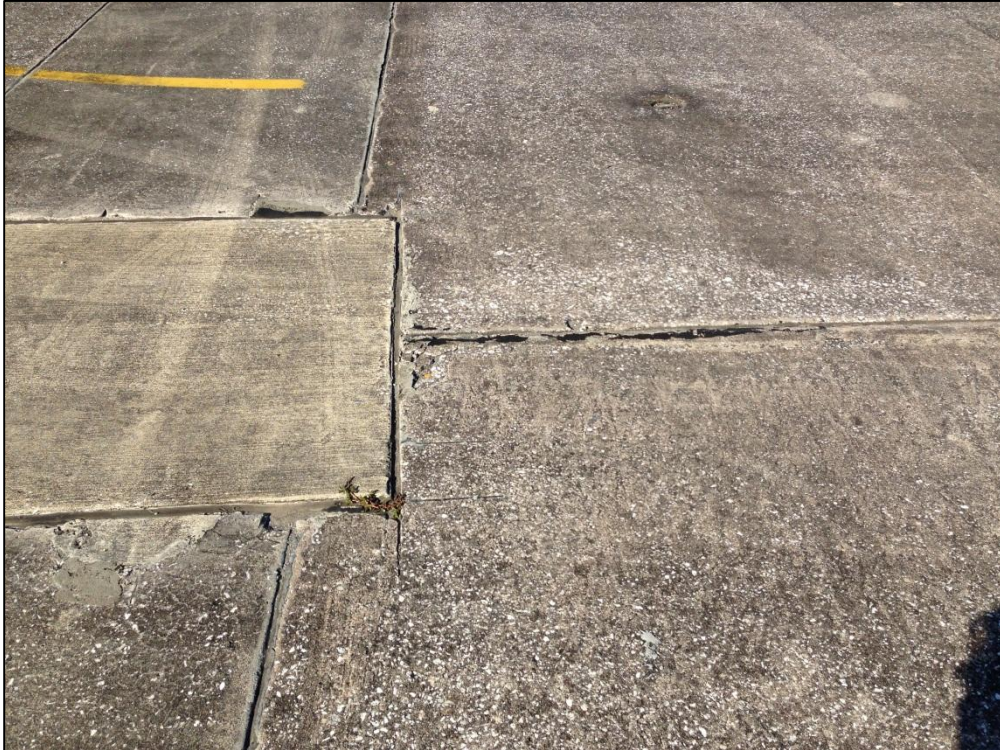
Apron North, Section 4120, Sample Unit 288 – Low Severity (65) Joint Seal Damage, Low Severity (70) Map Cracking, Low Severity (66) Small Patching

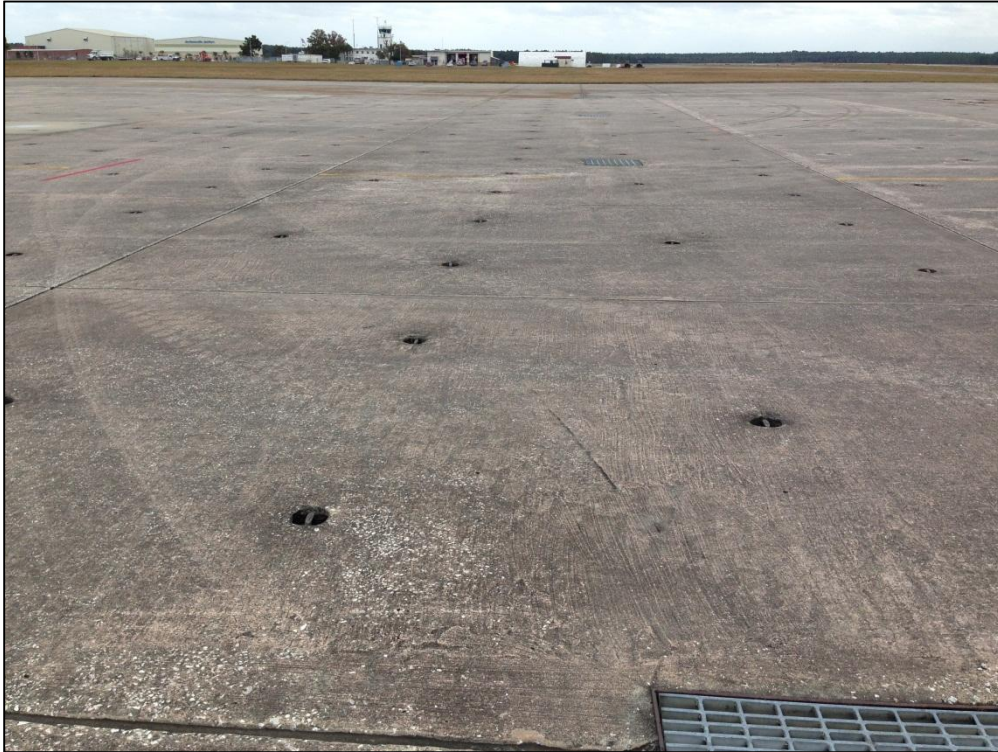
Apron West, Section 4210, Sample Unit 253 –Low Severity (70) Map Cracking

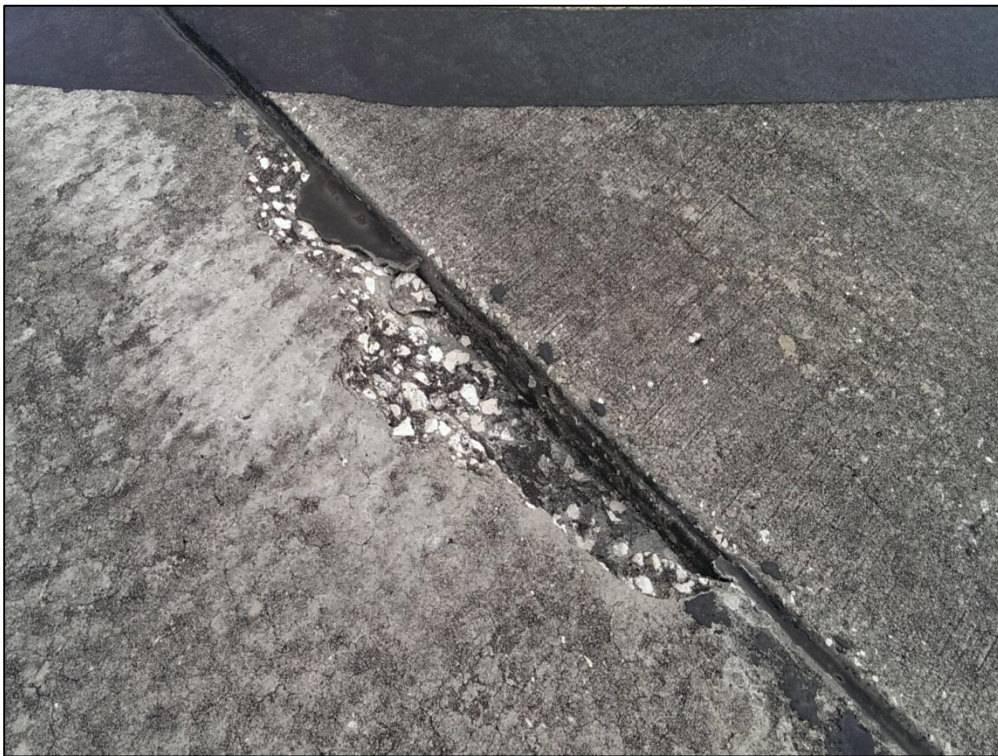
Apron West, Section 4250, Sample Unit 453 – Low Severity (70) Map Cracking, Low Severity (74) Joint Spalling
