FLORIDA DEPARTMENT OF TRANSPORTATION
AVIATION AND SPACEPORT OFFICE

LAKE WALES
MUNICIPAL
AIRPORT (X07)

DECEMBER 2013

STATEWIDE
**Airfield
Pavement
Management**
PROGRAM

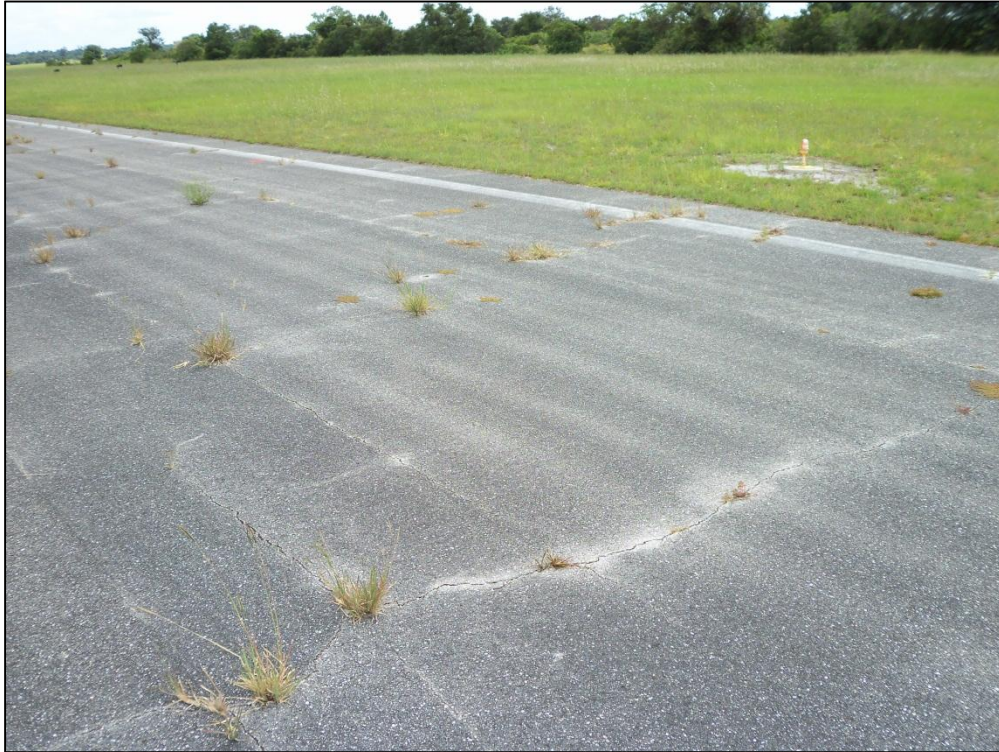
Runway 6-24, Section 6105, Sample Unit 107 – Medium Severity (57) Weathering, Low Severity (52) Raveling, Low Severity (43) Block Cracking

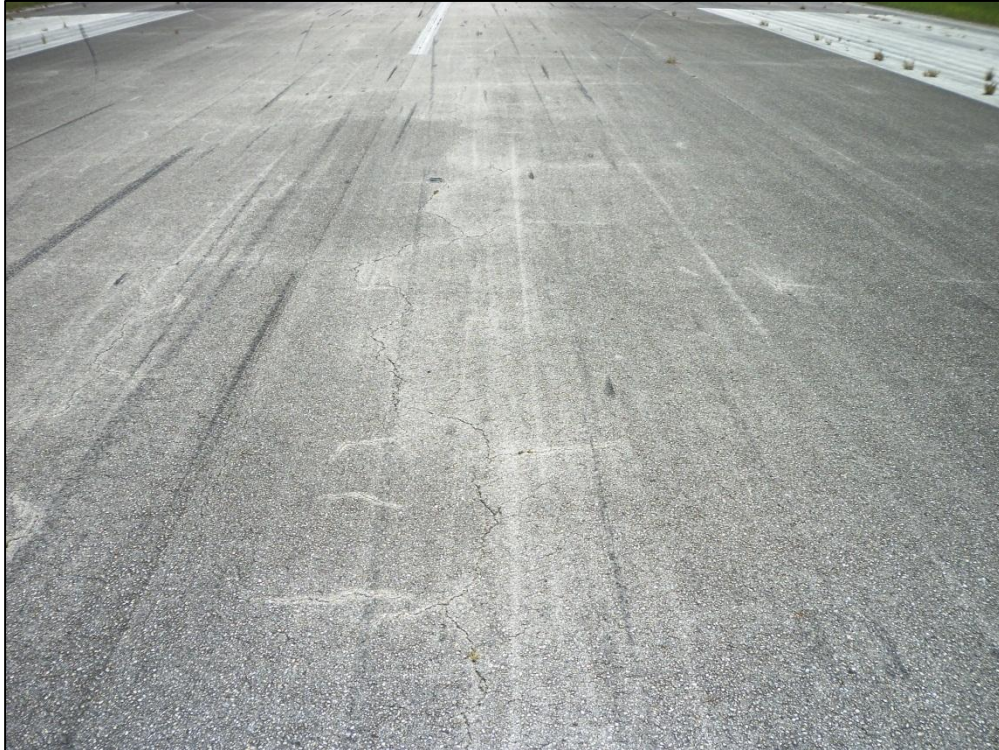
Runway 6-24, Section 6105, Sample Unit 121 – Low Severity (48) Longitudinal and Transverse Cracking, Medium Severity (57) Weathering, Low Severity (52) Raveling

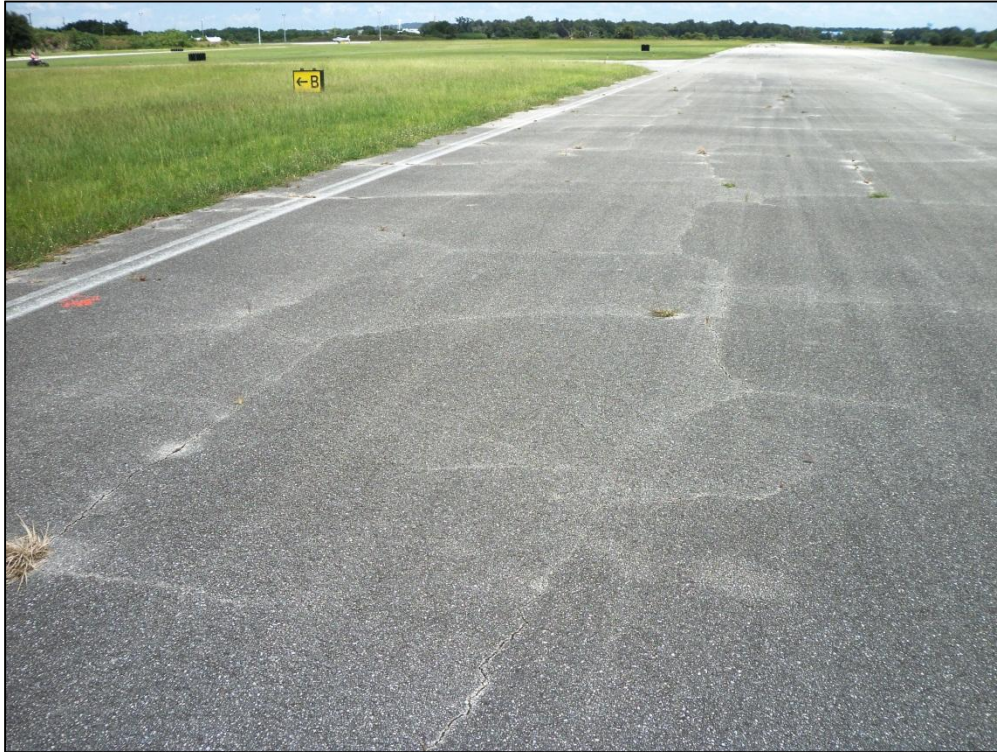
Runway 6-24, Section 6105, Sample Unit 145 – Medium Severity (57) Weathering, Low Severity (52) Raveling, Low Severity (43) Block Cracking

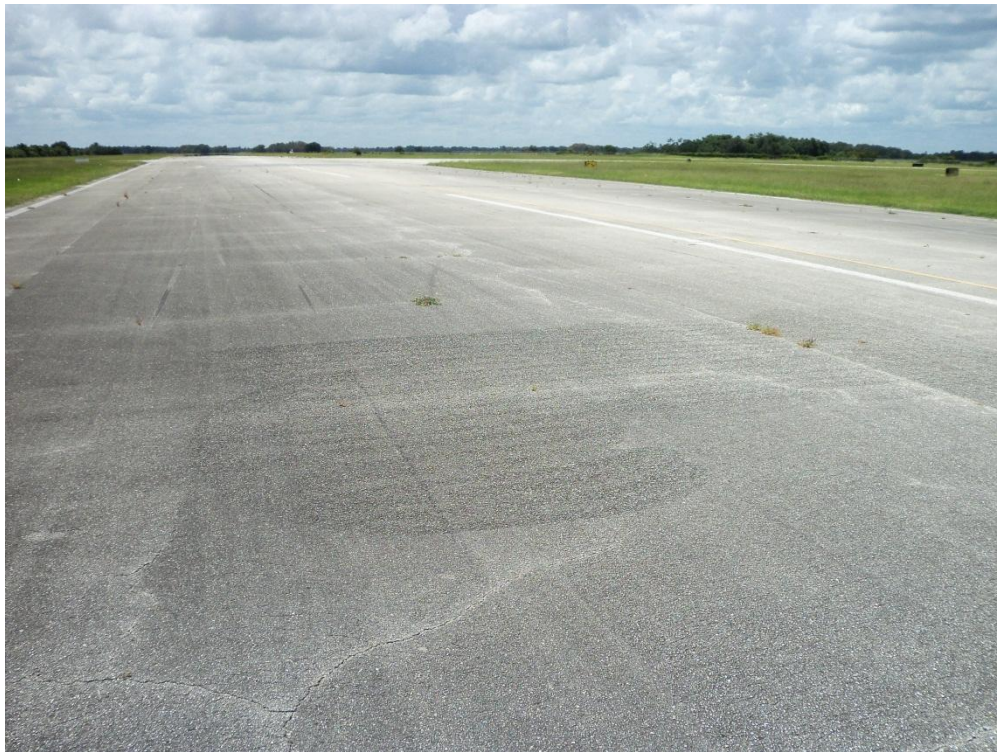
Runway 6-24, Section 6105, Sample Unit 149 – Low Severity (48) Longitudinal and Transverse Cracking, Medium Severity (57) Weathering, Low and Medium Severity (52) Raveling

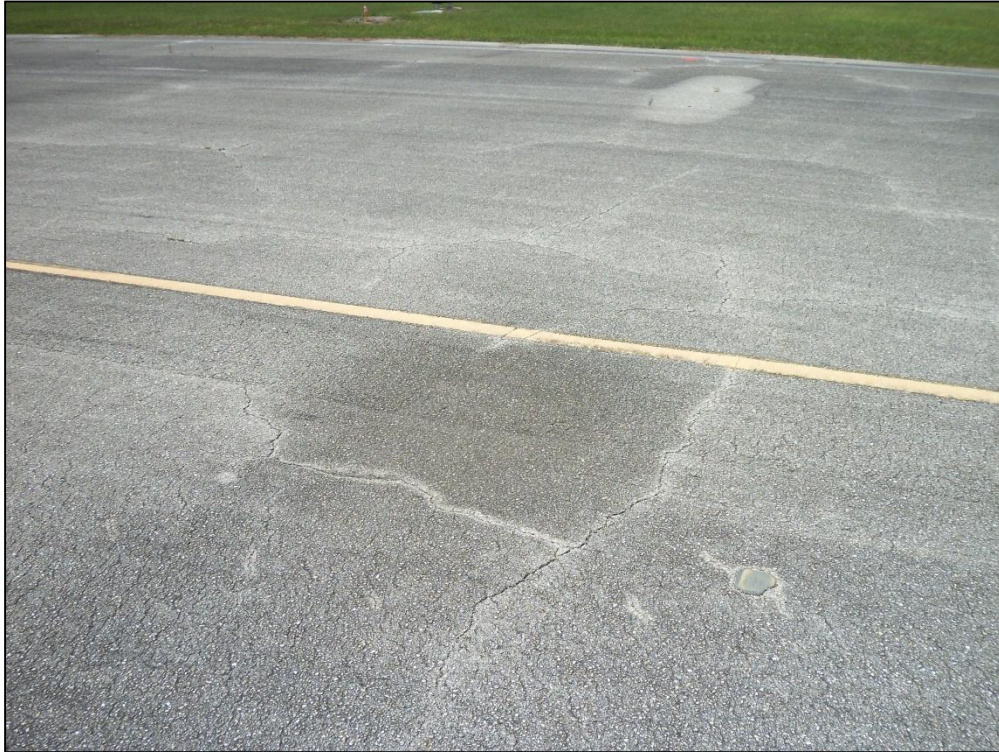
Runway 6-24, Section 6105, Sample Unit 154 – Low Severity (48) Longitudinal and Transverse Cracking, Medium Severity (57) Weathering, Low Severity (52) Raveling, Medium Severity (45) Depression

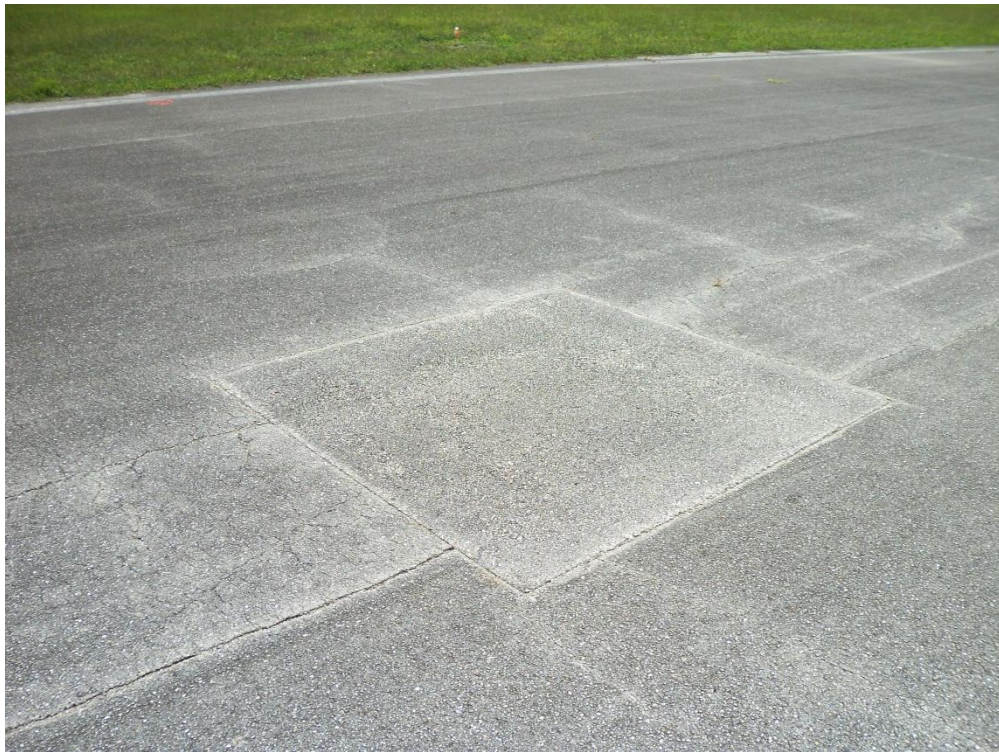
Runway 6-24, Section 6105, Sample Unit 154 – Low Severity (48) Longitudinal and Transverse Cracking, Medium Severity (57) Weathering, Low Severity (52) Raveling, Low Severity (50) Patching

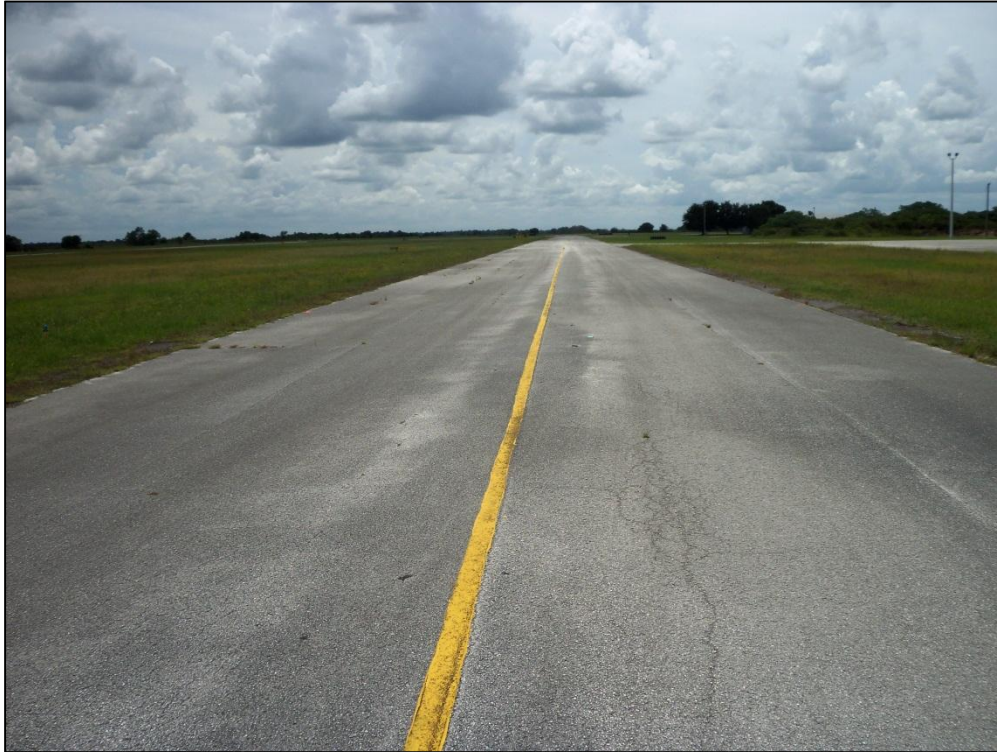
Taxiway A, Section 105, Sample Unit 104 – Low Severity (48) Longitudinal and Transverse Cracking, Medium Severity (52) Raveling, Low Severity (41) Alligator Cracking

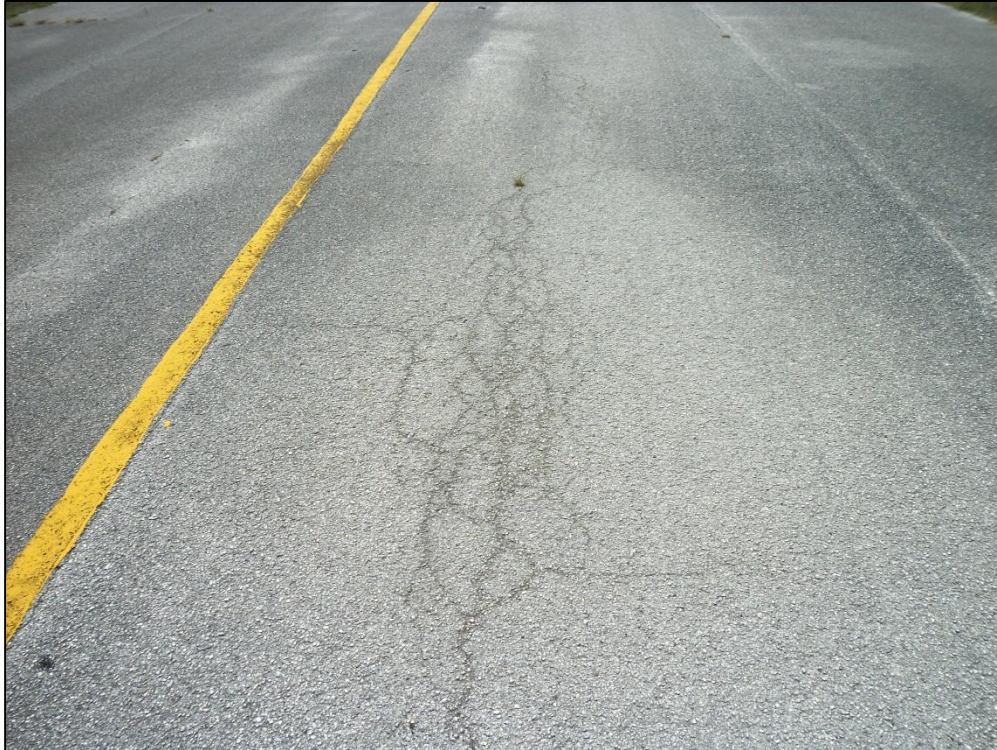
Taxiway A, Section 105, Sample Unit 104 – Medium Severity (52) Raveling, Low Severity (41) Alligator Cracking

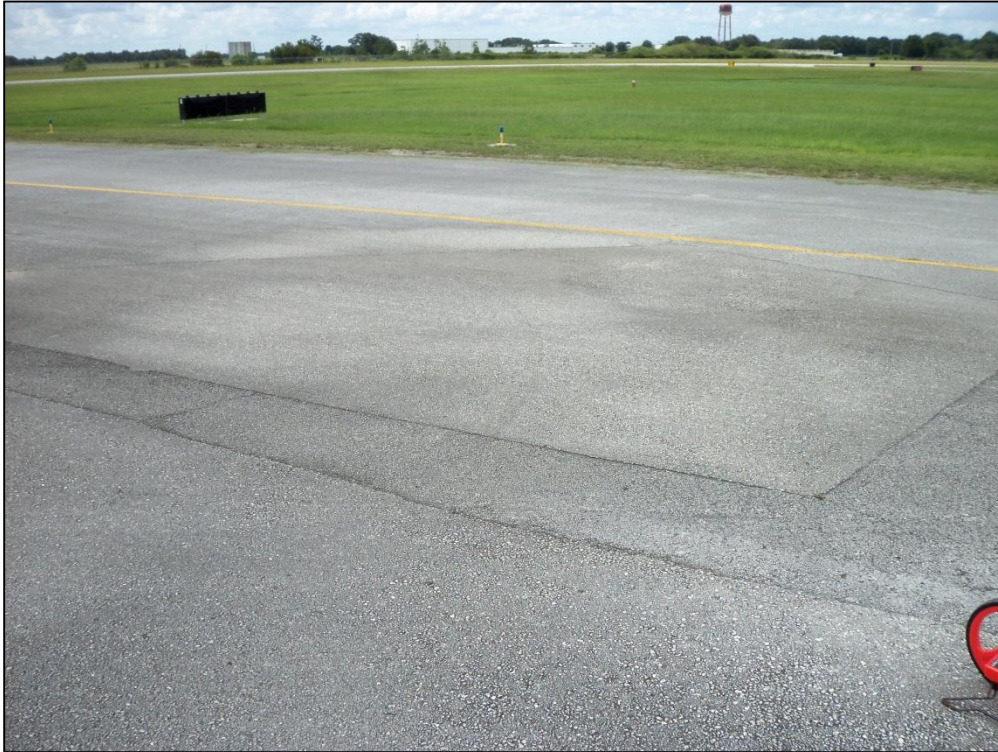
Taxiway A, Section 105, Sample Unit 118 – Low Severity (52) Raveling, Medium Severity (57) Weathering, Low Severity (50) Patching

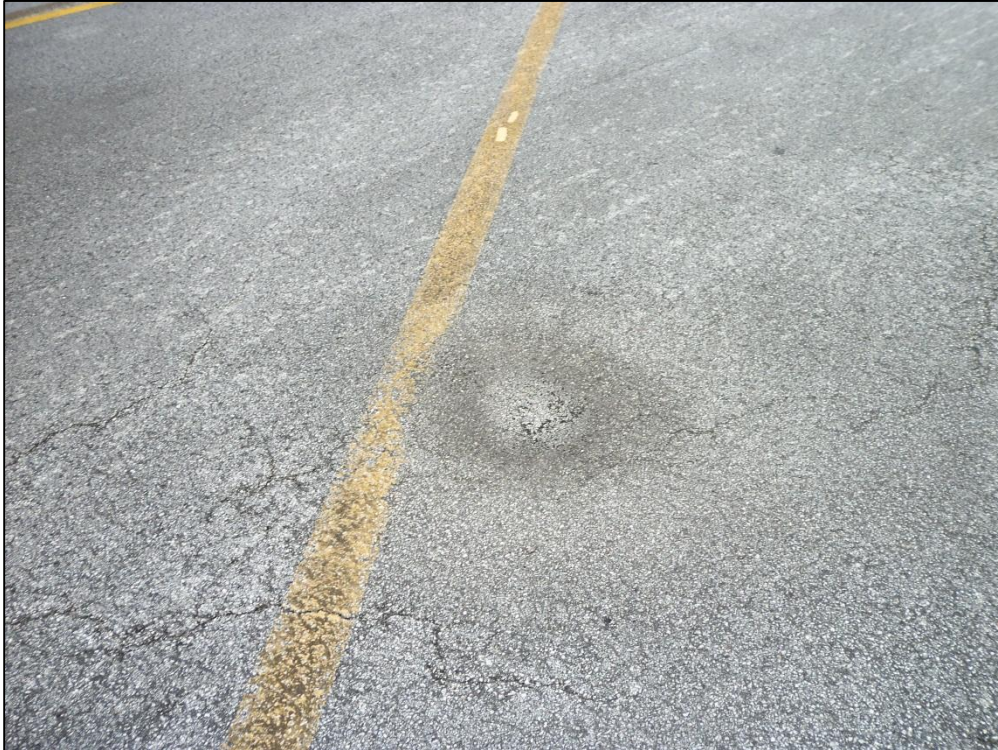
Taxiway A, Section 105, Sample Unit 118 – Low Severity (48) Longitudinal and Transverse Cracking, Low Severity (52) Raveling, Medium Severity (57) Weathering, High Severity (45) Depression

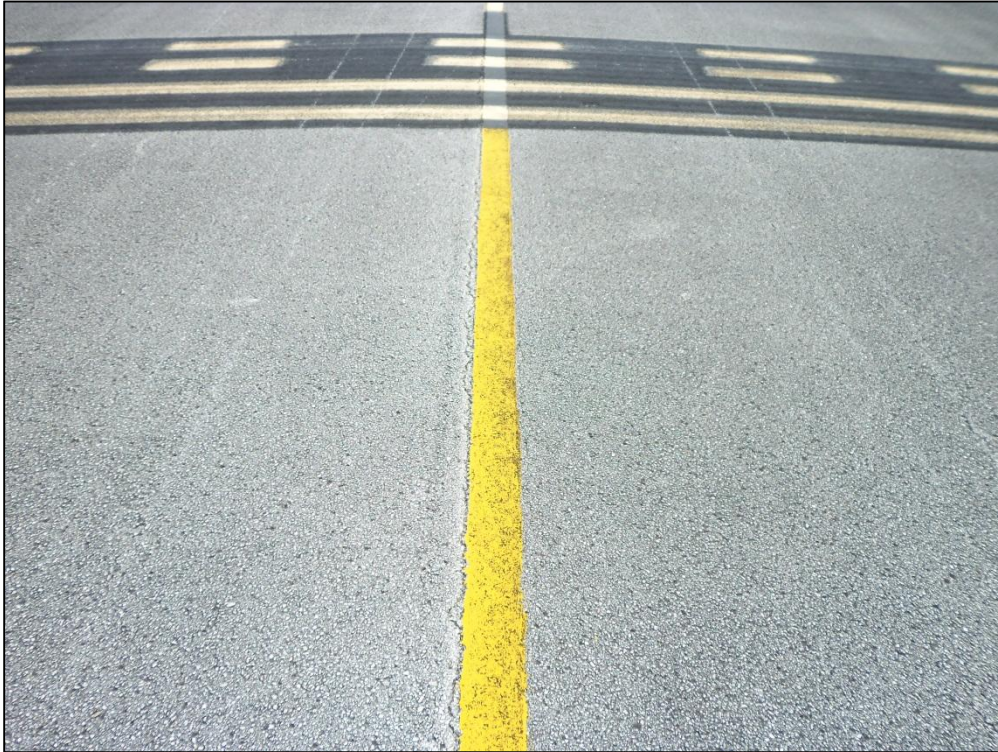
Taxiway B, Section 205, Sample Unit 101 – Low Severity (48) Longitudinal and Transverse Cracking, Low Severity (52) Raveling, Medium Severity (57) Weathering

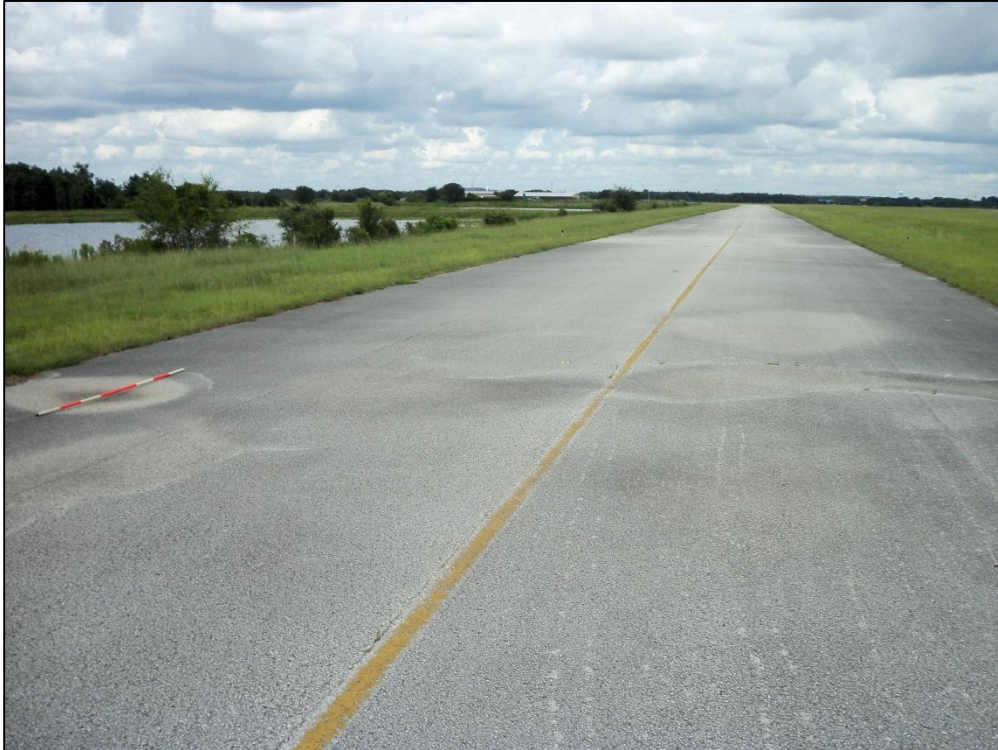
Taxiway D, Section 410, Sample Unit 102 – Low Severity (48) Longitudinal and Transverse Cracking, Low Severity (52) Raveling, Medium Severity (57) Weathering, Low, Medium, and High Severity (45) Depression

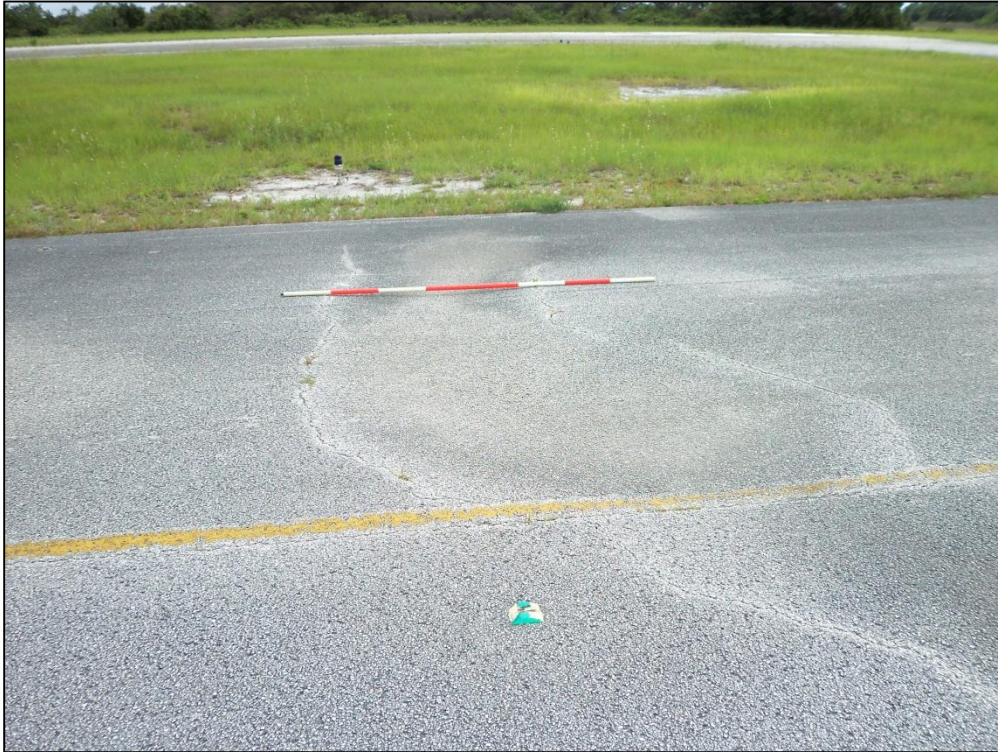
Taxiway D, Section 410, Sample Unit 102 – Low Severity (48) Longitudinal and Transverse Cracking, Low Severity (52) Raveling, Medium Severity (57) Weathering, High Severity (45) Depression

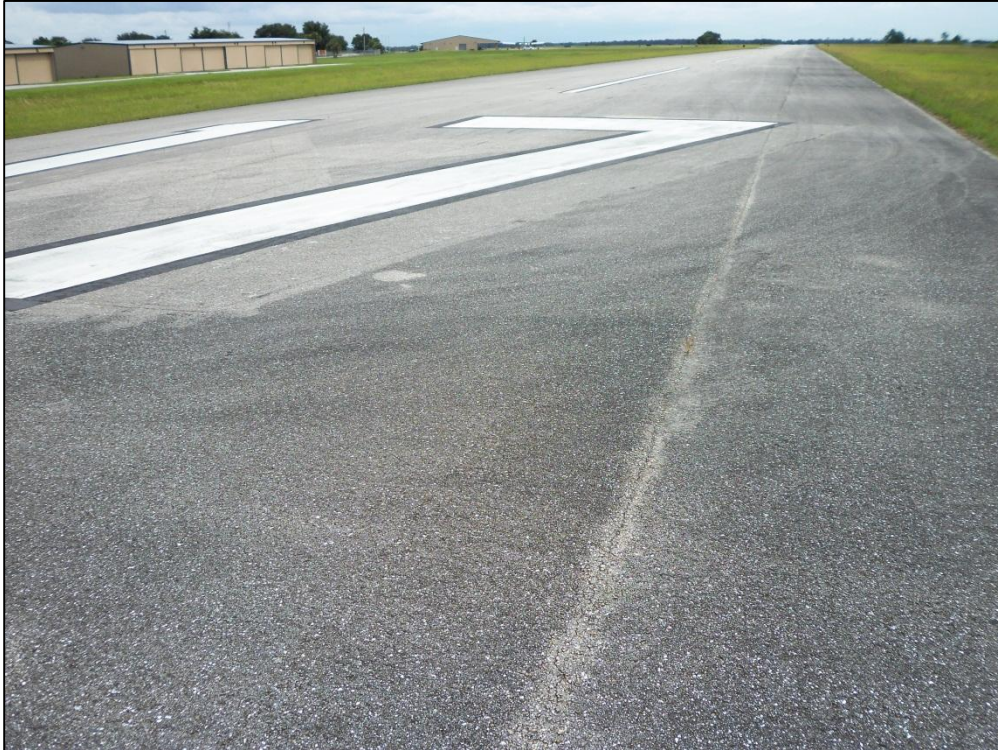
Runway 17-35, Section 6205, Sample Unit 179 – Low Severity (48) Longitudinal and Transverse Cracking, Low Severity (57) Weathering, Low Severity (52) Raveling

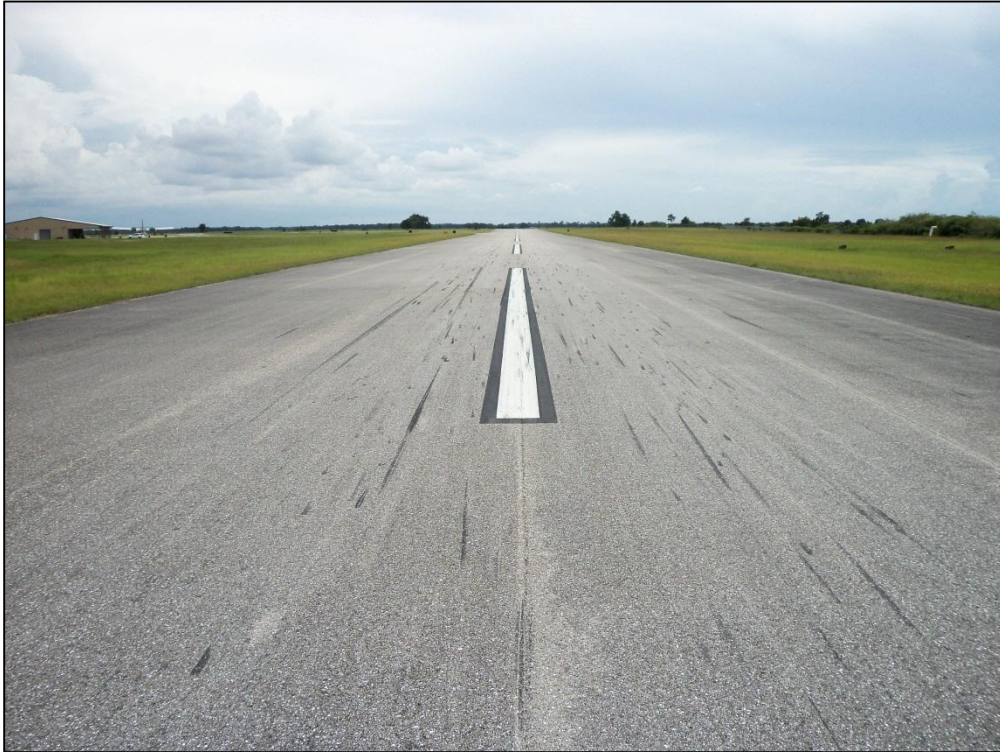
Runway 17-35, Section 6205, Sample Unit 170 – Low Severity (48) Longitudinal and Transverse Cracking, Low Severity (57) Weathering, Low Severity (52) Raveling

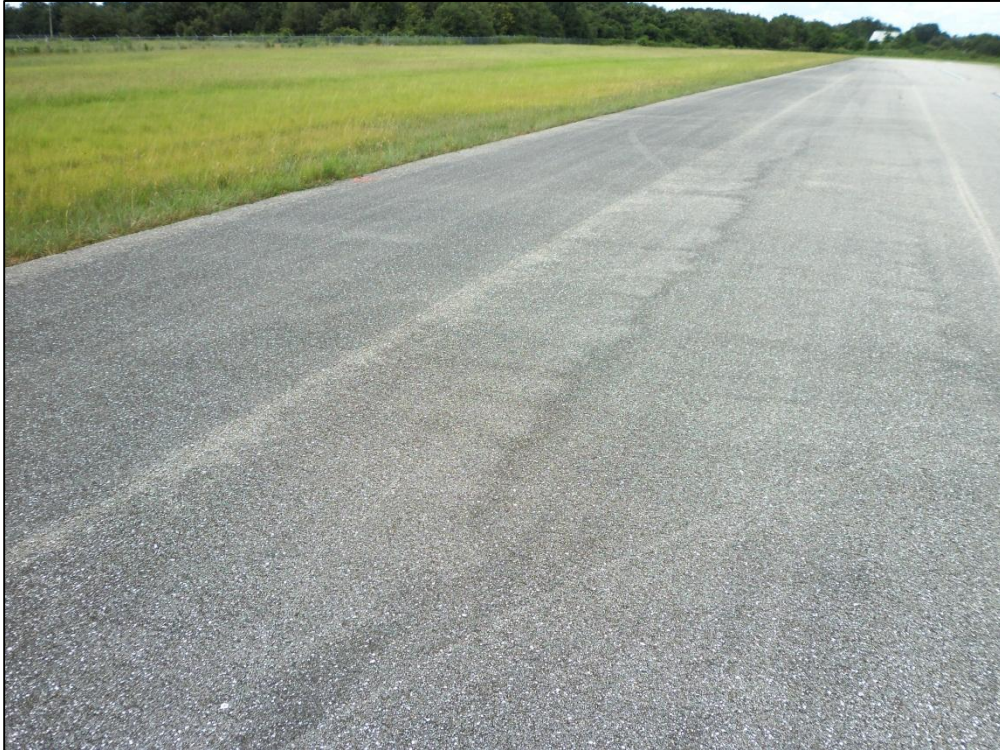
Runway 17-35, Section 6205, Sample Unit 166 – Low Severity (57) Weathering, Low Severity (52) Raveling, Low Severity (56) Swelling
