FLORIDA DEPARTMENT OF TRANSPORTATION
AVIATION AND SPACEPORT OFFICE

BELLE GLADE
STATE MUNICIPAL
AIRPORT (X10)

DECEMBER 2013

STATEWIDE
**Airfield
Pavement
Management**
PROGRAM

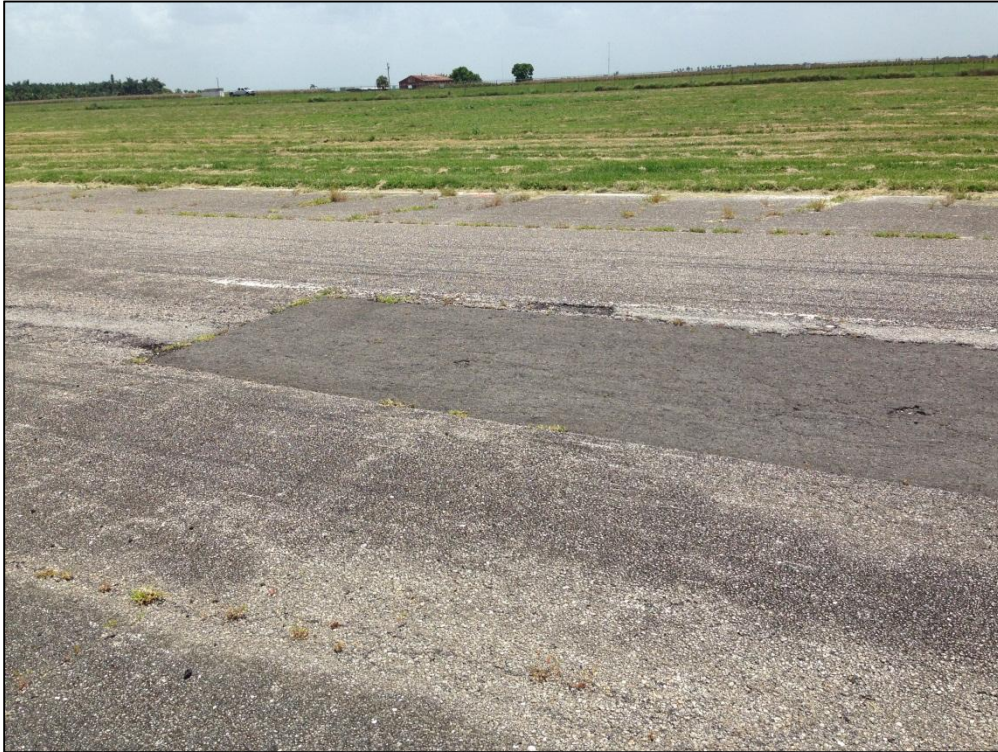
Runway 9-27, Section 6105, Sample Unit 129 – Medium Severity (48) Longitudinal and Transverse Cracking, Medium and High Severity (52) Raveling, High Severity (50) Patching

- Runway 9-27 – Sections 6105
 - Reconstruction attributed to distresses related to climate and age of pavement.
- Apron – Sections 4115 and 4110
 - Reconstruction attributed to distresses related to loading, climate, and age of pavement.
- Taxiway – Sections 115, 110, and 105
 - Reconstruction attributed to distresses related to loading, climate, and age of pavement.

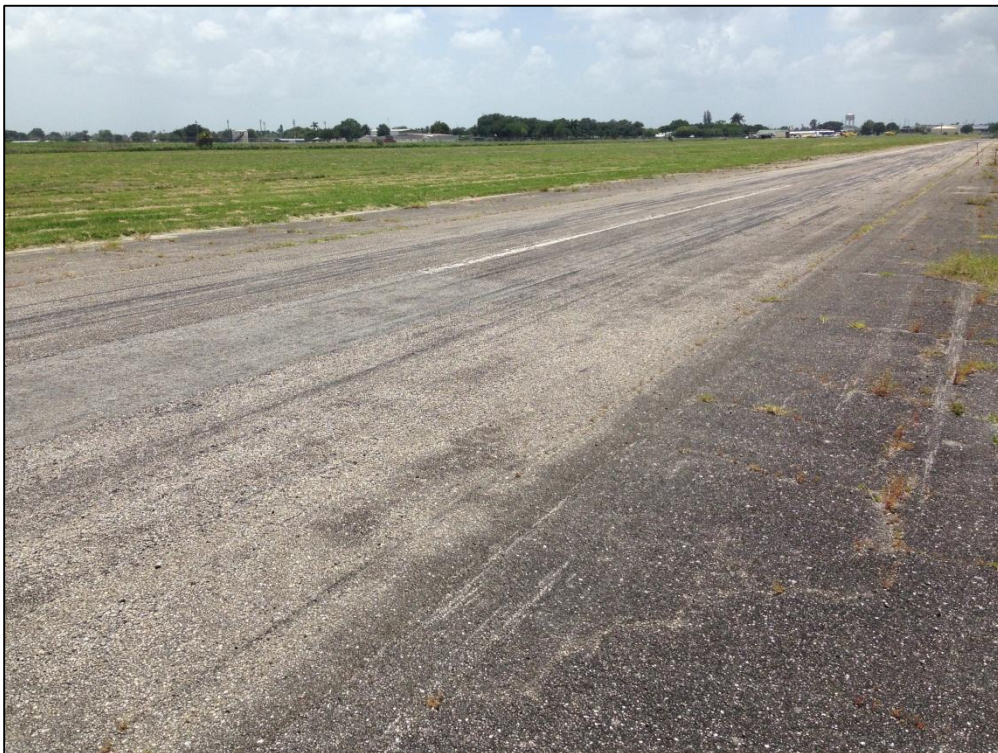
Runway 9-27, Section 6105, Sample Unit 129 – Medium Severity (48) Longitudinal and Transverse Cracking, Medium and High Severity (52) Raveling, Medium Severity (43) Block Cracking

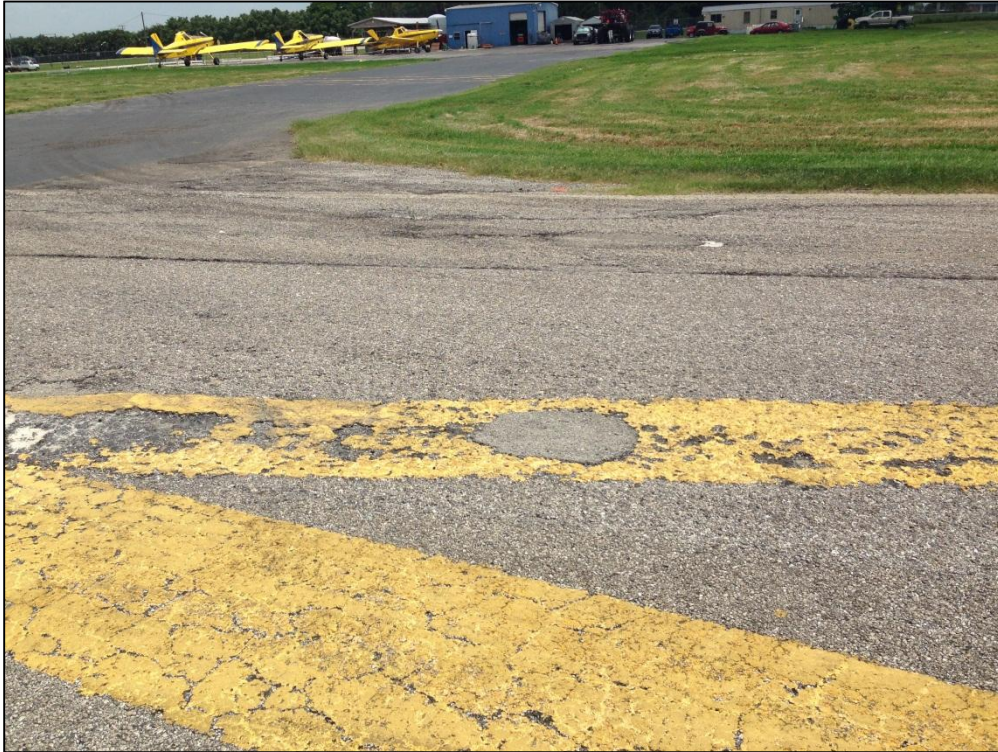
Runway 9-27, Section 6105, Sample Unit 101 – Medium and High Severity (48) Longitudinal and Transverse Cracking, Medium and High Severity (52) Raveling, High Severity (50) Patching

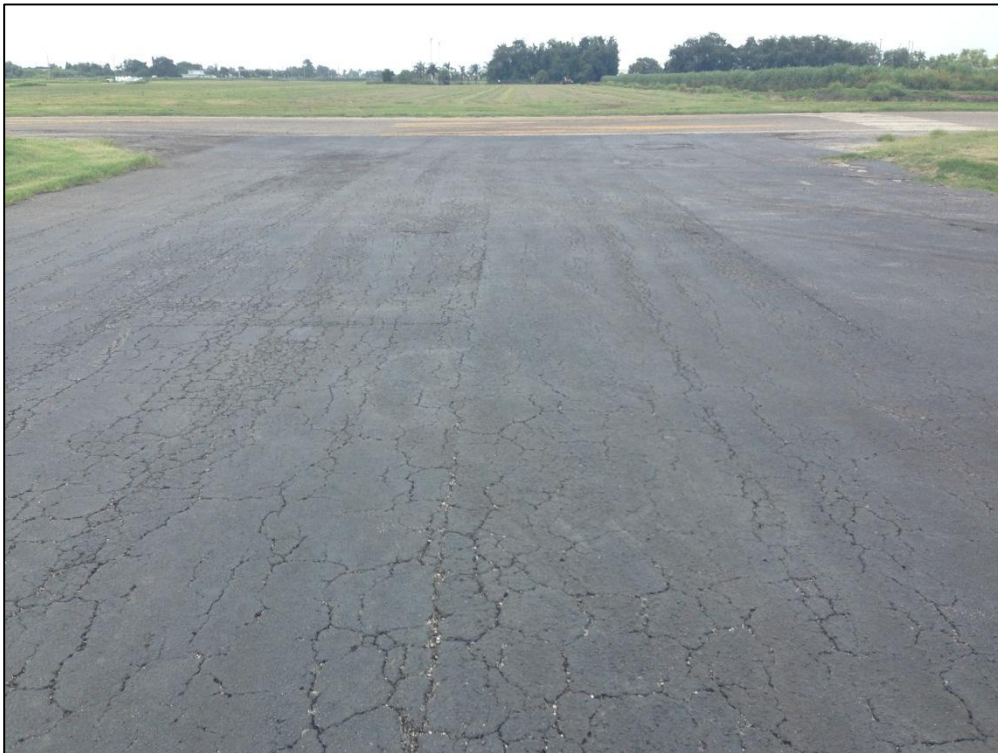
Taxiway, Section 105, Sample Unit 100 – High Severity (52) Raveling, High Severity (41) Alligator Cracking

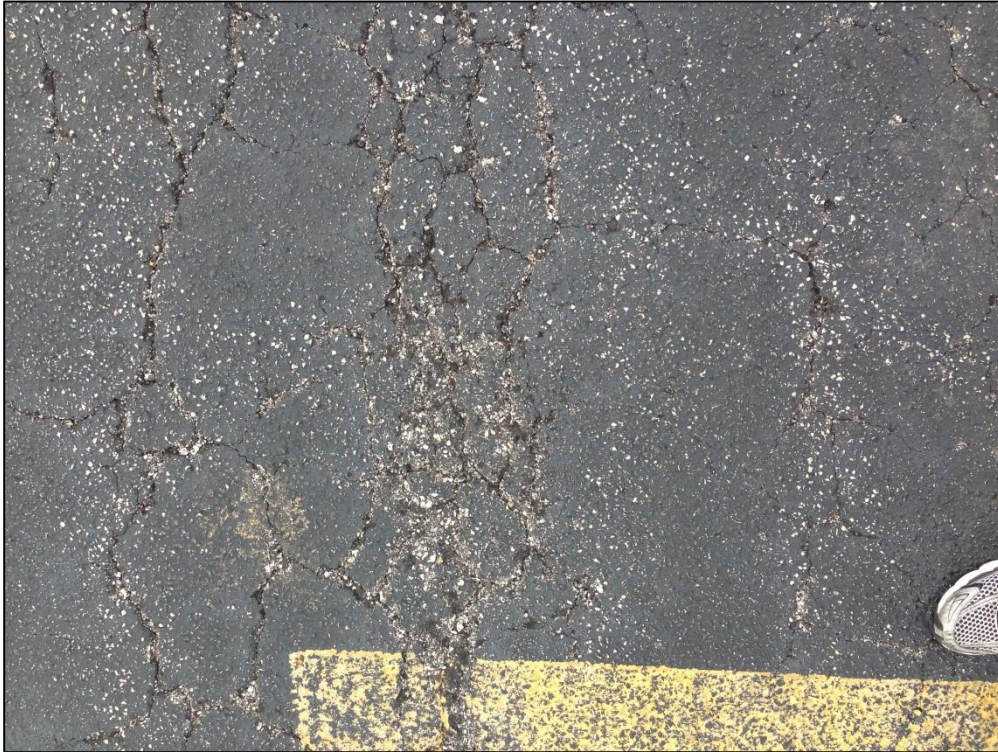
Taxiway, Section 105, Sample Unit 100 – High Severity (52) Raveling, High Severity (41) Alligator Cracking

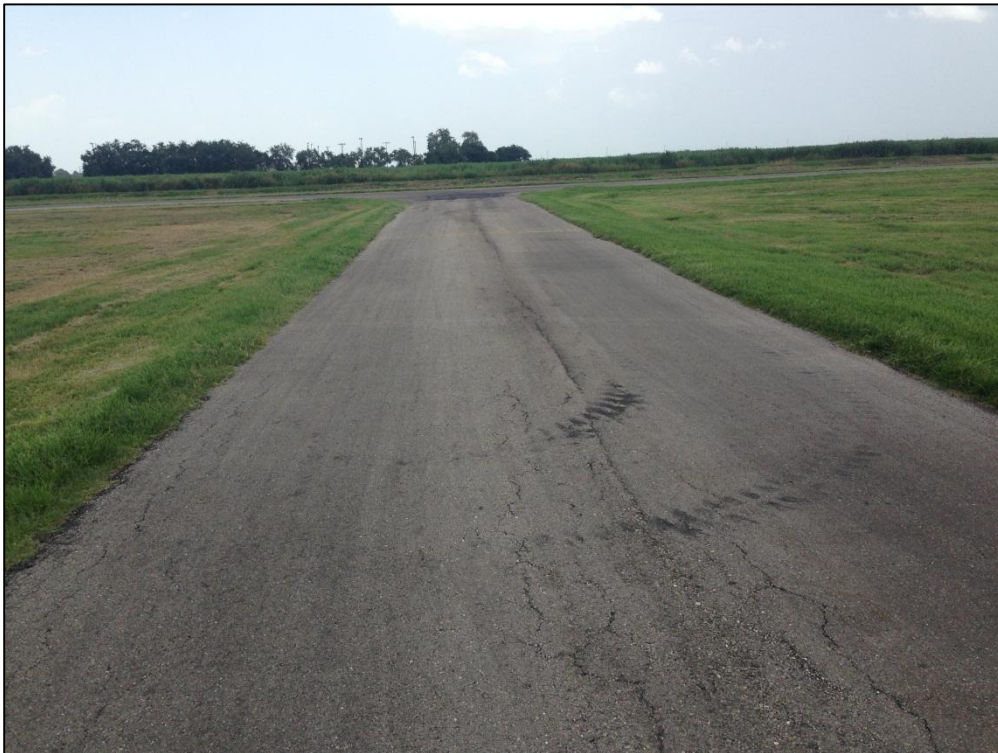
Taxiway, Section 115, Sample Unit 100 – Low Severity (48) Longitudinal and Transverse Cracking, Low and Medium Severity (52) Raveling, Low and Medium Severity (41) Alligator Cracking
