FLORIDA DEPARTMENT OF TRANSPORTATION
AVIATION AND SPACEPORT OFFICE

CARRABELLE-
THOMPSON
AIRPORT (X13)

DECEMBER 2013

STATEWIDE Airfield Pavement Management PROGRAM

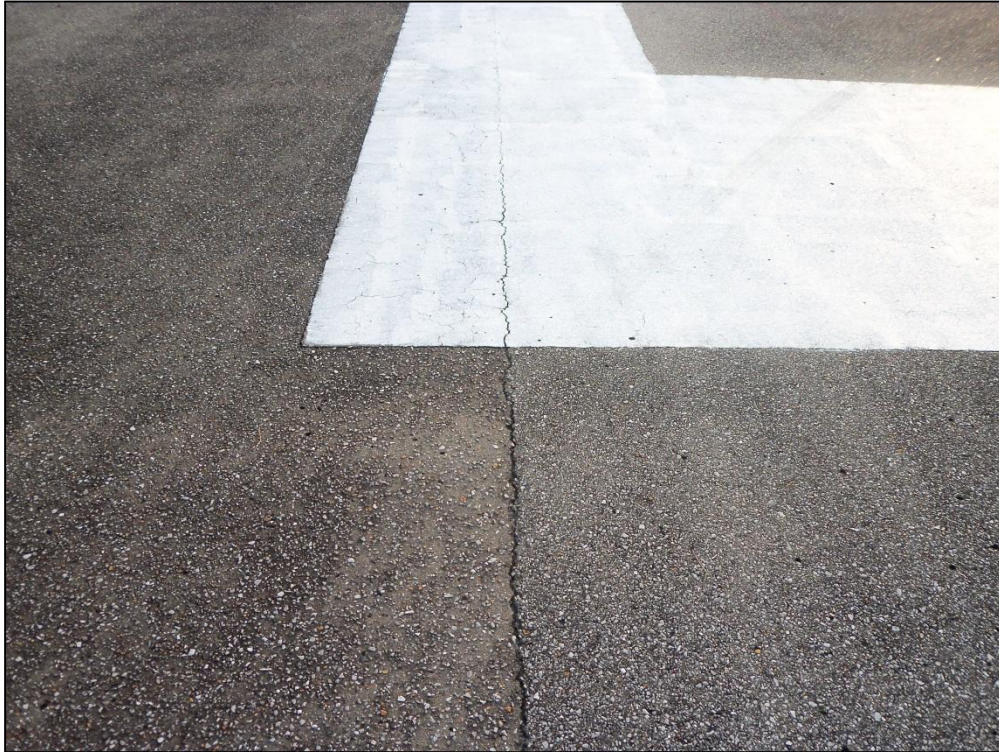
Runway 5-23, Section 6105, Sample Unit 101 – Low Severity (48) Longitudinal and Transverse Cracking, Low Severity (52) Raveling, Low Severity (57) Weathering

- Runway 5-23 – Section 6105
 - Mill and Overlay attributed to distresses related to climate and age of pavement.
- Apron – Sections 4120, 4110, and 4105
 - Mill and Overlay attributed to distresses related to subgrade quality, climate, and age of pavement.
- Taxiway A – Section 105
 - Mill and Overlay attributed to distresses related to climate and age of pavement.

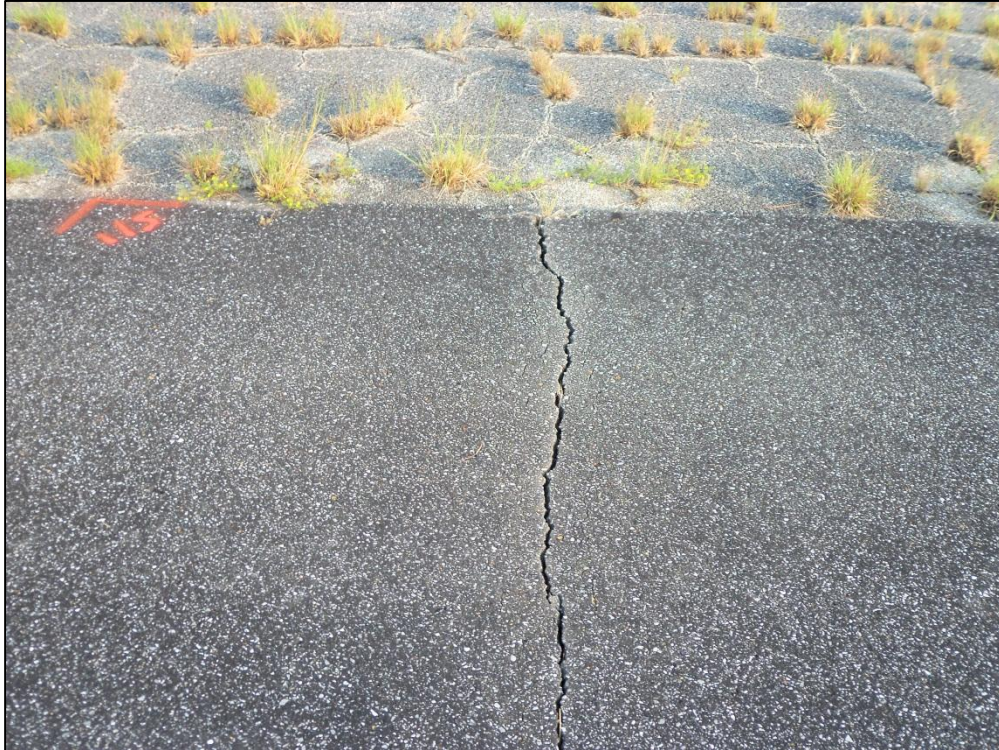
Runway 5-23, Section 6105, Sample Unit 115 – Medium Severity (48) Longitudinal and Transverse Cracking, Low Severity (52) Raveling, Low Severity (57) Weathering

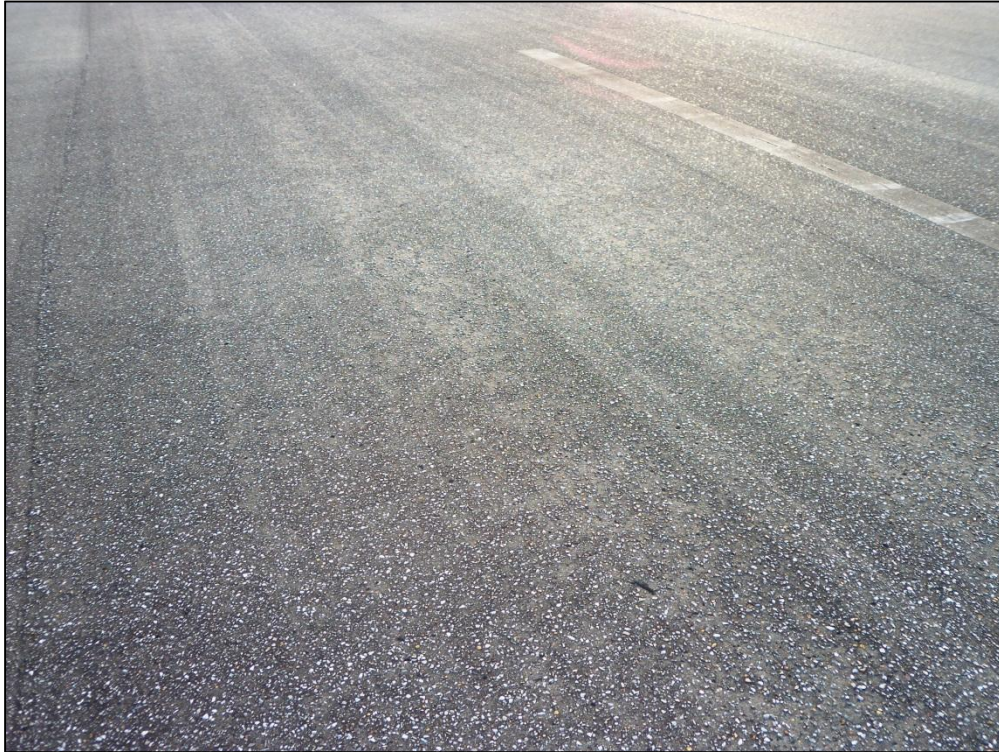
Runway 5-23, Section 6105, Sample Unit 115 - Medium Severity (57) Weathering

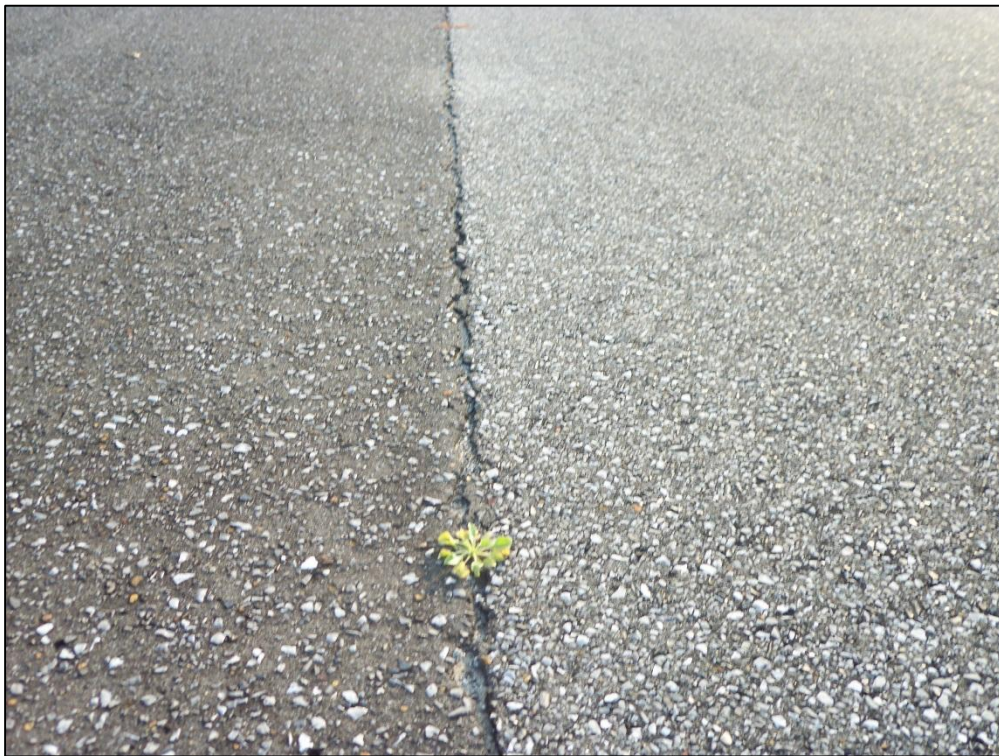
Runway 5-23, Section 6105, Sample Unit 145 - Medium Severity (48) Longitudinal and Transverse Cracking

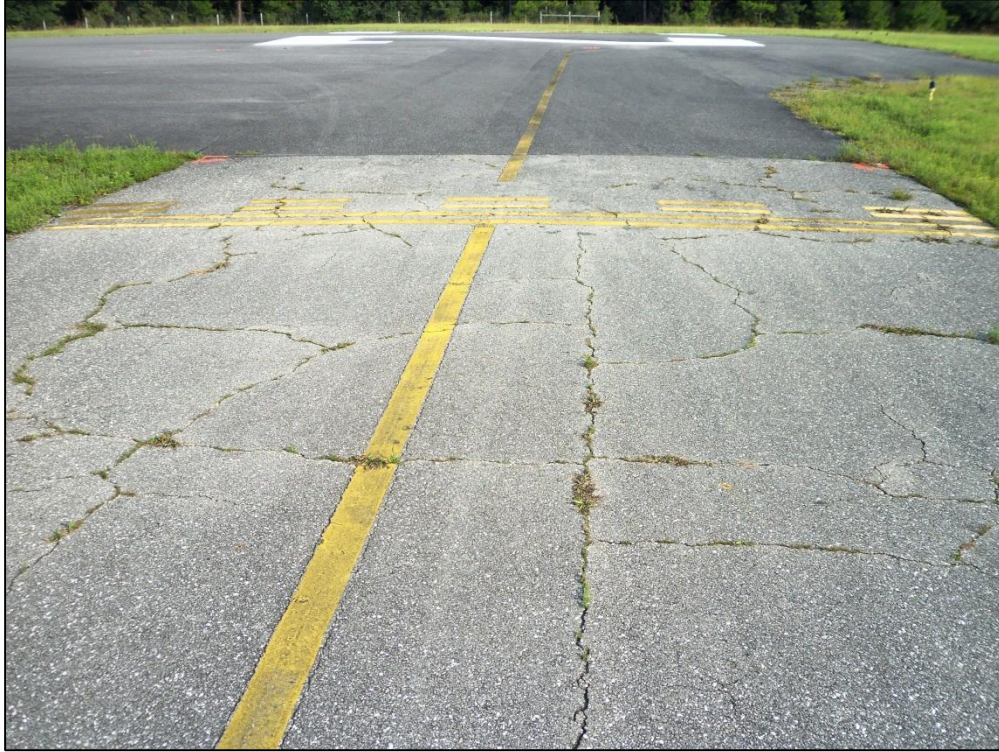
Taxiway A, Section 105, Sample Unit 101 – Low Severity (43) Block Cracking, Low Severity (52) Raveling, Low Severity (57) Weathering

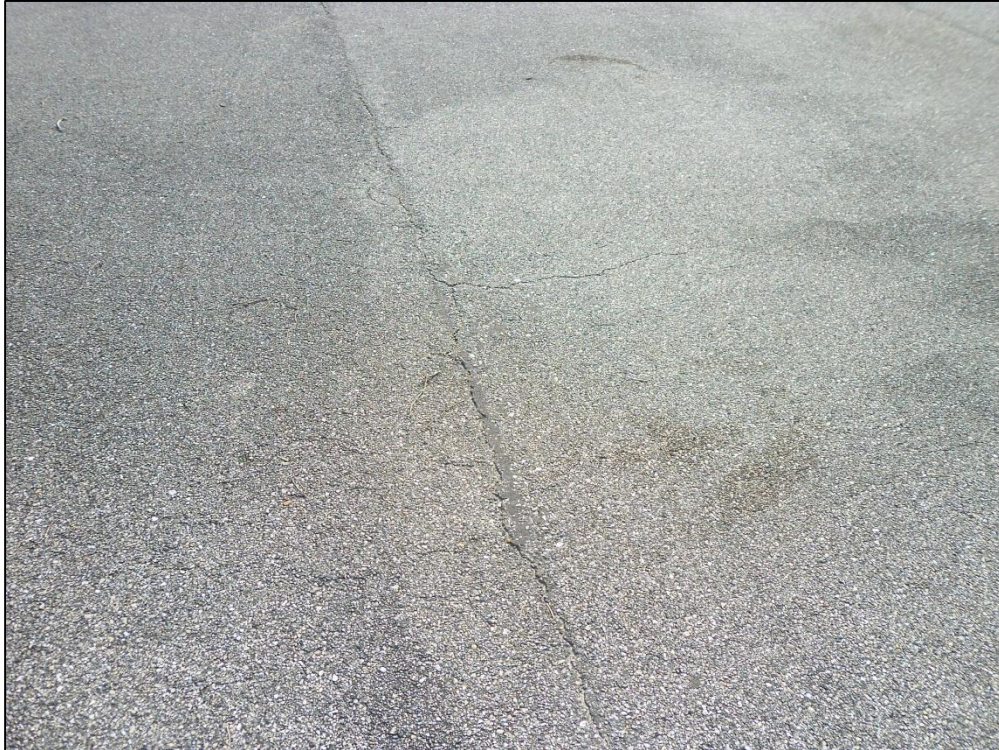
Apron, Section 4120, Sample Unit 501 – Low Severity (48) Longitudinal and Transverse Cracking, Low Severity (52) Raveling, Low Severity (57) Weathering
