FLORIDA DEPARTMENT OF TRANSPORTATION
AVIATION AND SPACEPORT OFFICE

LA BELLE
MUNICIPAL
AIRPORT (X14)

DECEMBER 2013

STATEWIDE
**Airfield
Pavement
Management**
PROGRAM

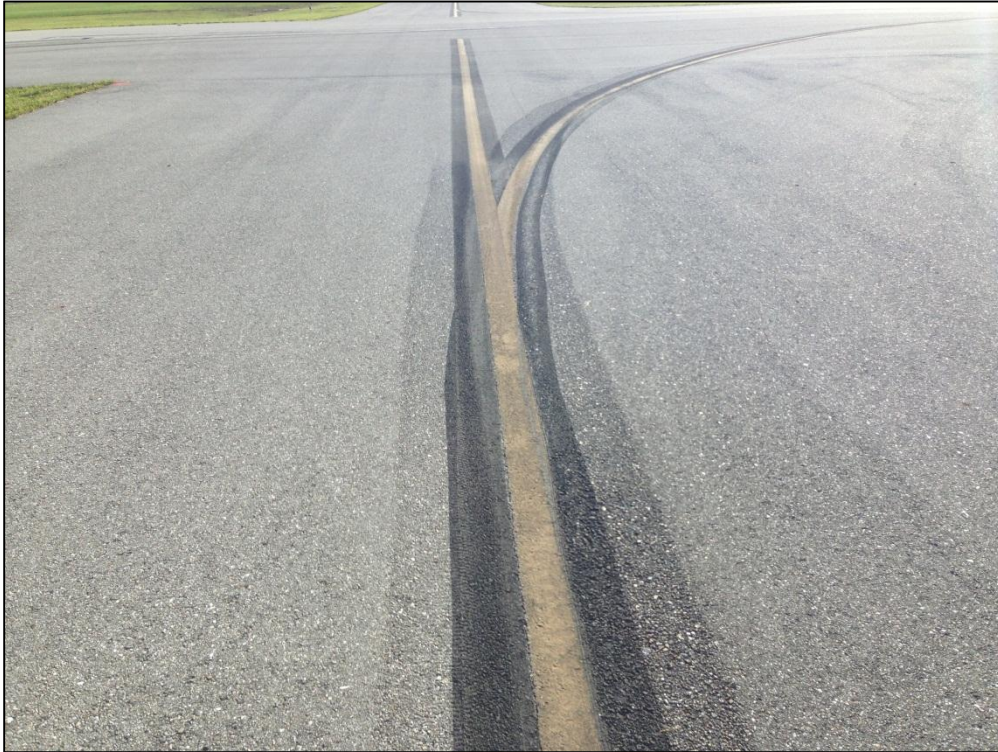
Taxiway to Hangar, Section 510, Sample Unit 100 – Low Severity (52) Raveling

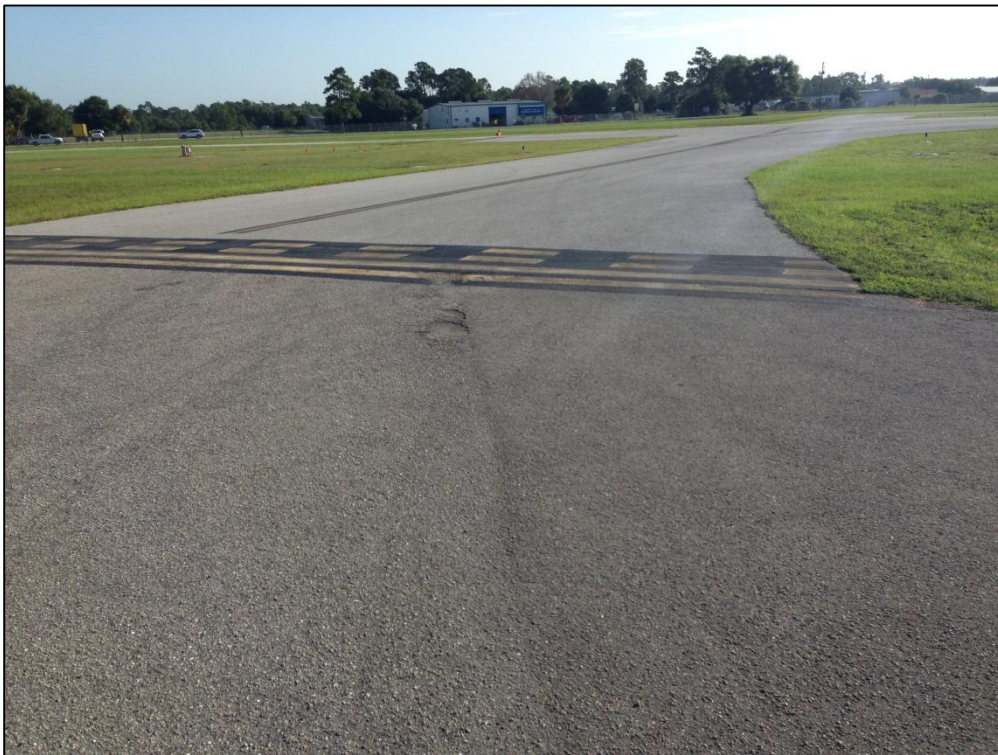
Taxiway to Hangar, Section 505, Sample Unit 102 – Low Severity (48) Longitudinal and Transverse Cracking, Medium and High Severity (52) Raveling

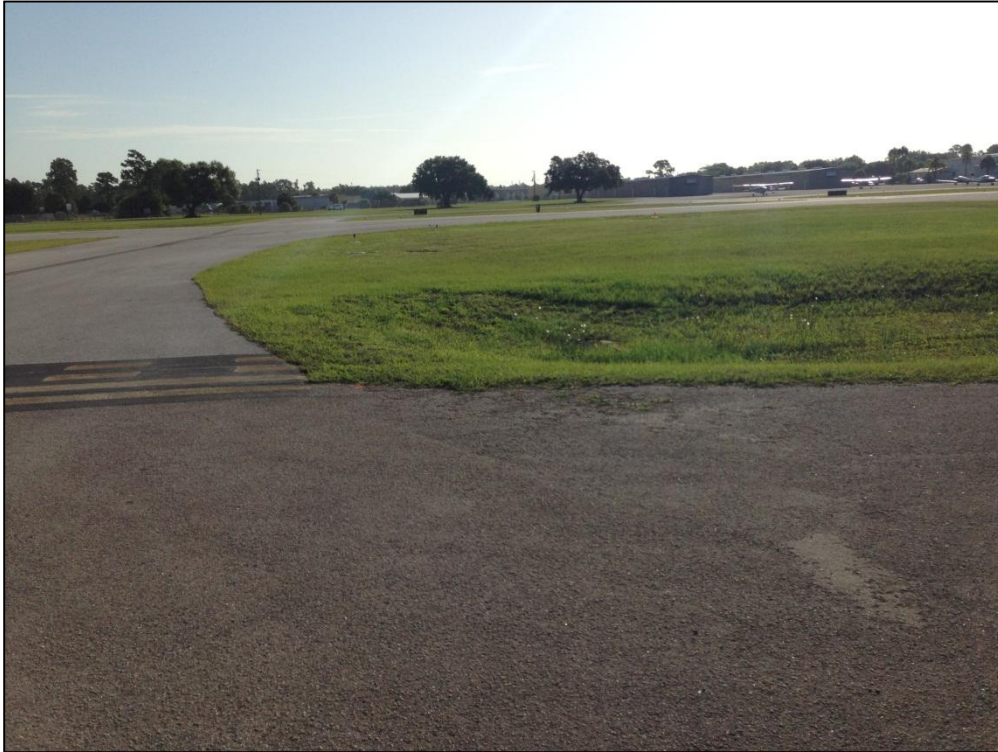
Taxiway to Hangar, Section 505, Sample Unit 102 – Low Severity (48) Longitudinal and Transverse Cracking, Medium and High Severity (52) Raveling

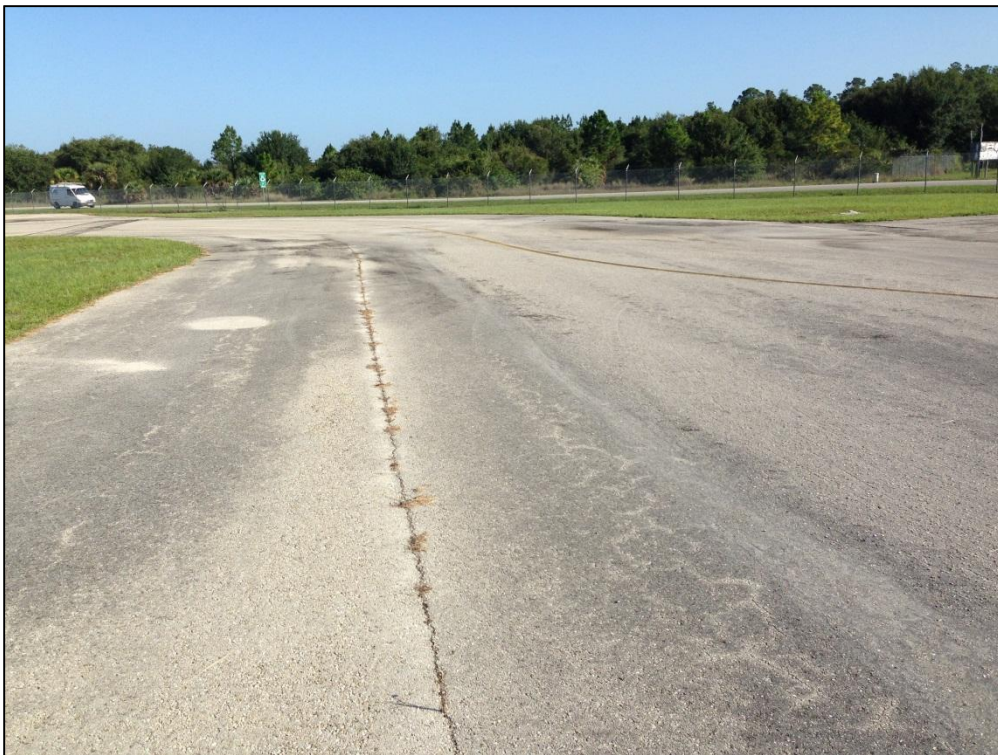
Northwest Apron, Section 4160, Sample Unit 104 – Low Severity (48) Longitudinal and Transverse Cracking, Medium Severity (52) Raveling, Low Severity (43) Block Cracking

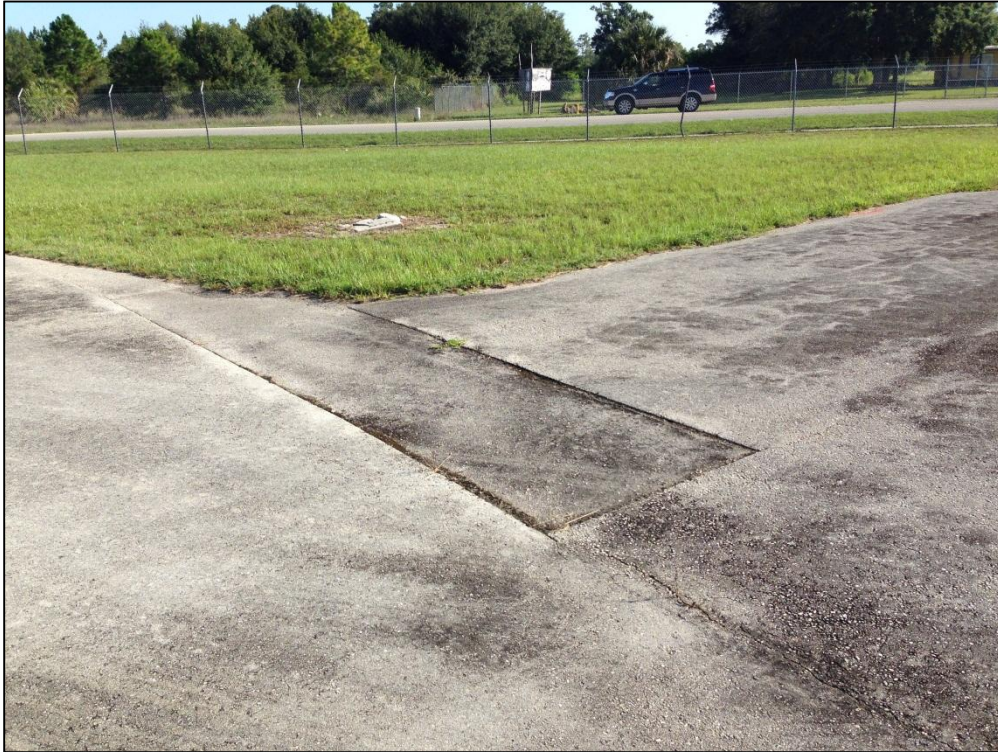
Northwest Apron, Section 4160, Sample Unit 104 – Low Severity (48) Longitudinal and Transverse Cracking, Medium Severity (52) Raveling, Medium Severity (50) Patching, Low Severity (43) Block Cracking

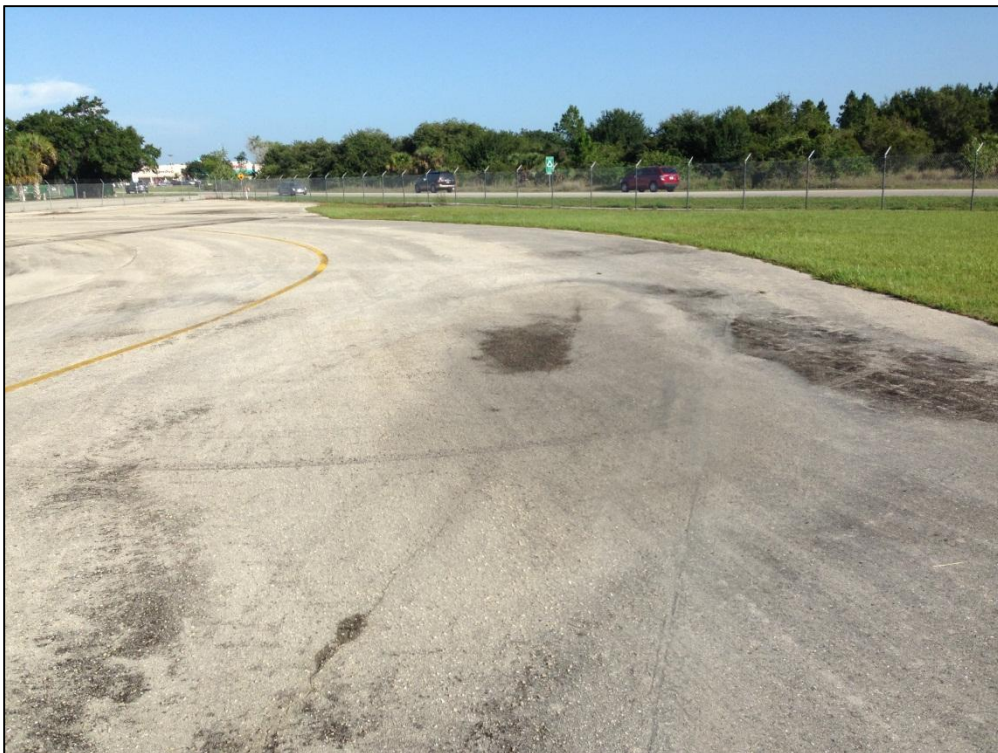
Northwest Apron, Section 4160, Sample Unit 104 – Low Severity (48) Longitudinal and Transverse Cracking, Medium Severity (52) Raveling, Medium Severity (45) Depression

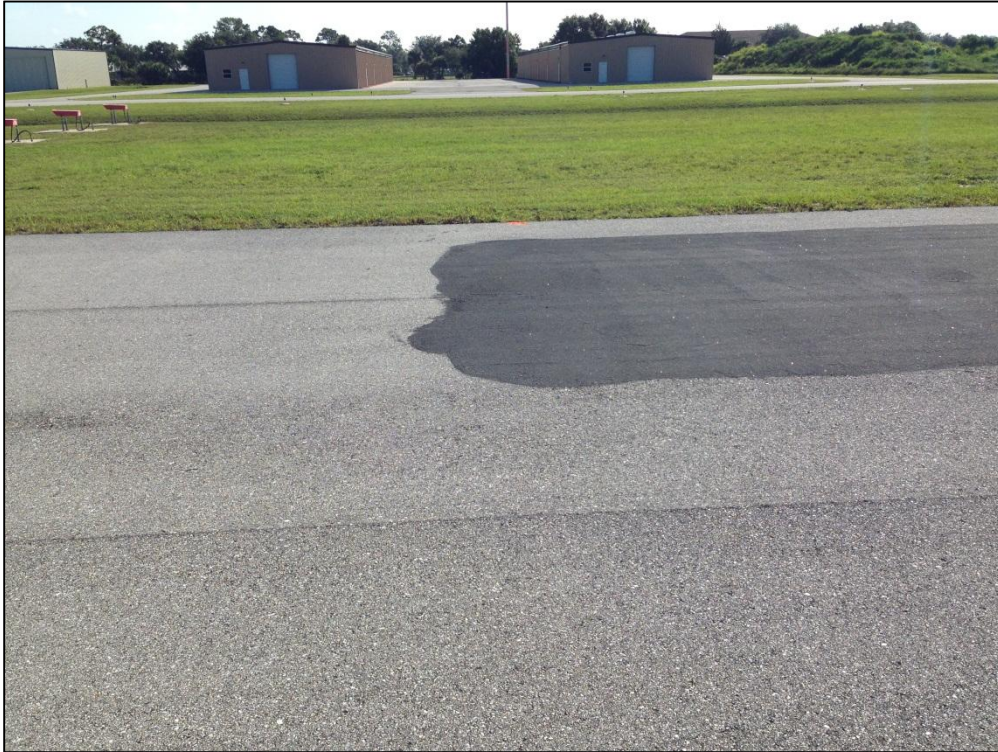
Runway 14-32, Section 6105, Sample Unit 115 – Low Severity (48) Longitudinal and Transverse Cracking, Low Severity (52) Raveling, Low Severity (57) Weathering

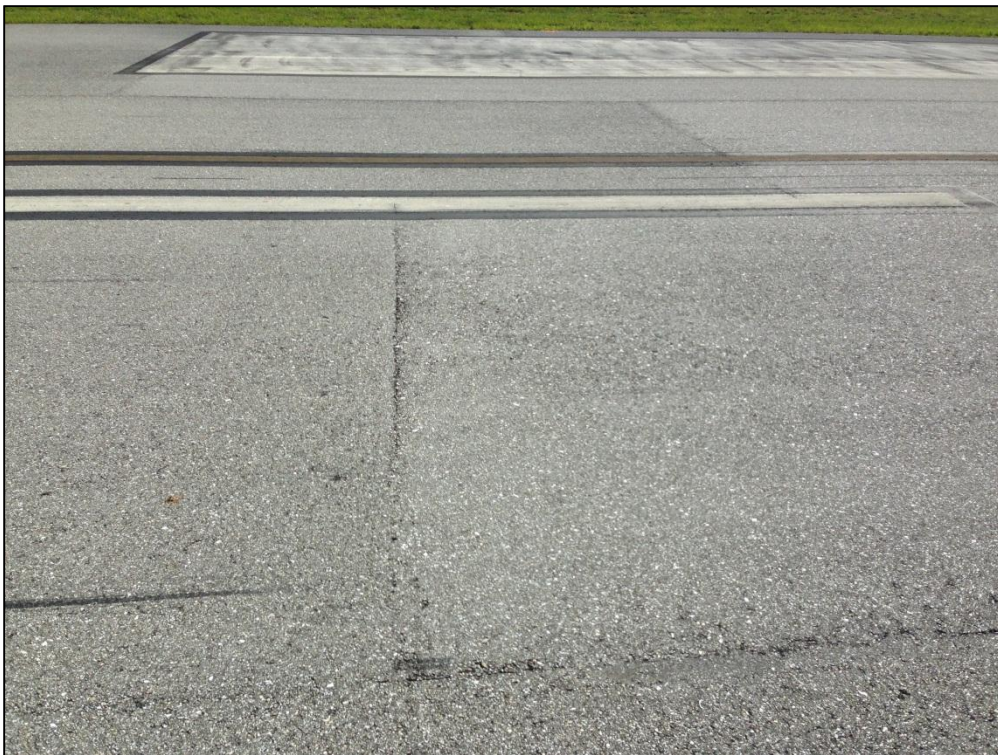
Runway 14-32, Section 6105, Sample Unit 143 – Low Severity (48) Longitudinal and Transverse Cracking, Low Severity (57) Weathering

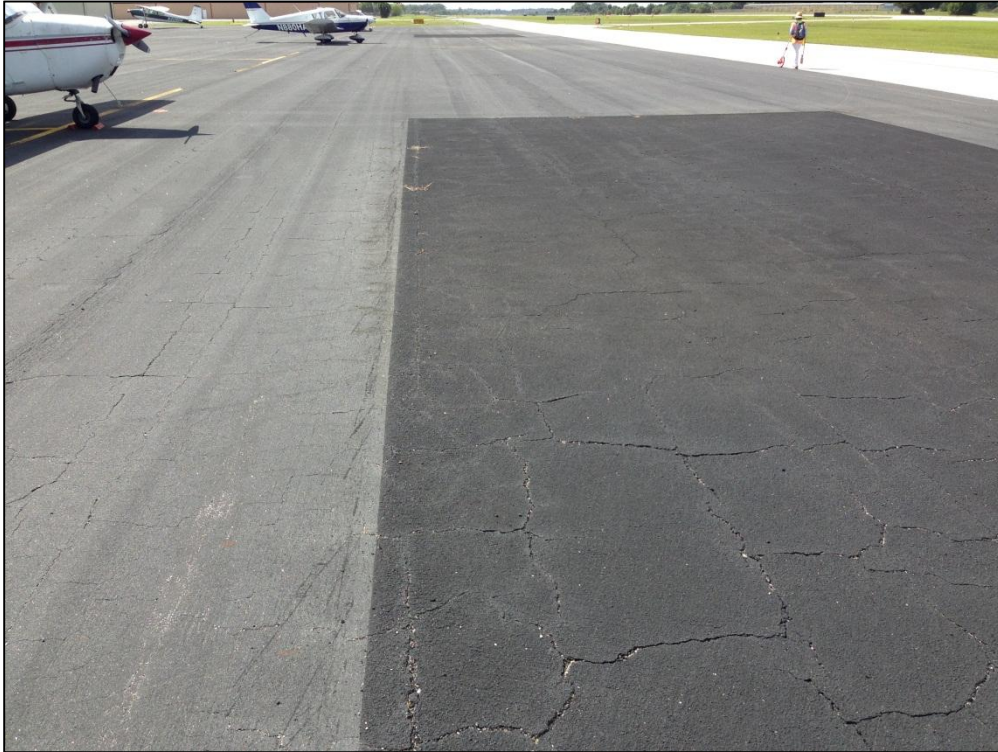
Apron North, Section 4110, Sample Unit 200 – Low Severity (43) Block Cracking, Medium Severity (52) Raveling, Low Severity (57) Weathering

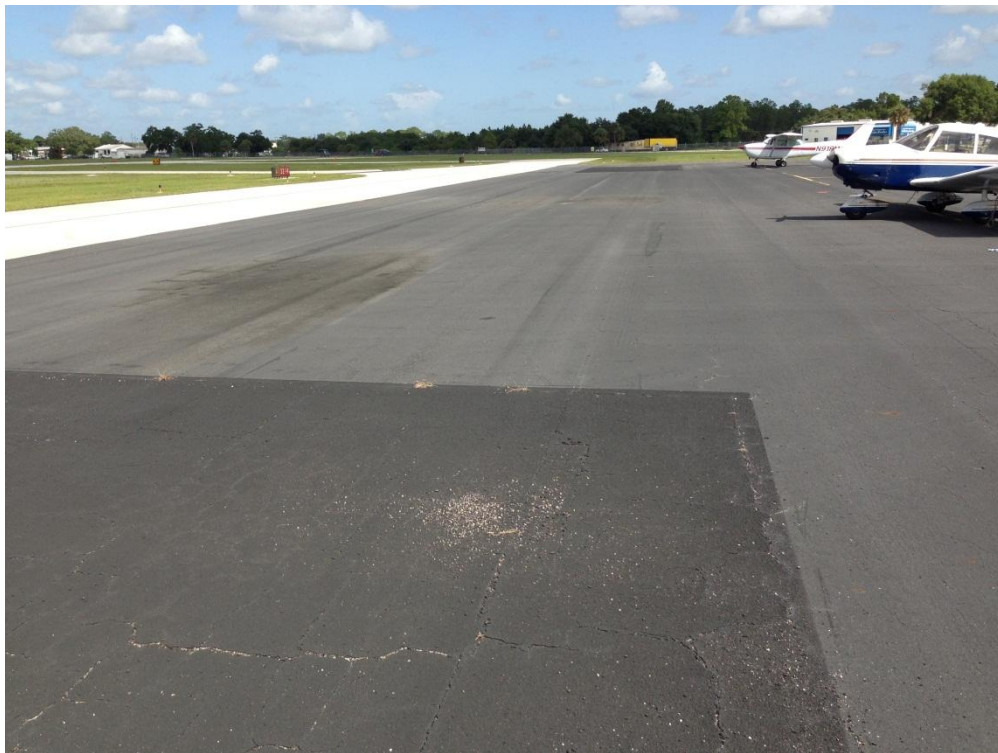
Apron North, Section 4110, Sample Unit 202 – Low Severity (43) Block Cracking, Low Severity (52) Raveling, Low Severity (57) Weathering, Low Severity (45) Depression

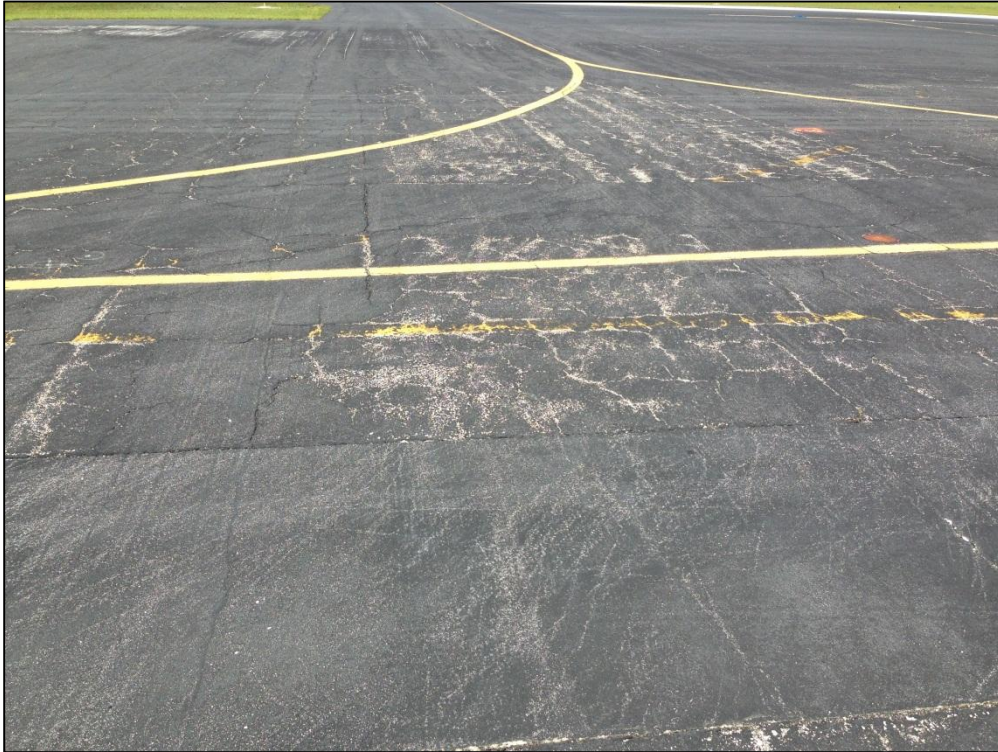
Apron North, Section 4110, Sample Unit 505 – Low and Medium Severity (43) Block Cracking, Low Severity (52) Raveling

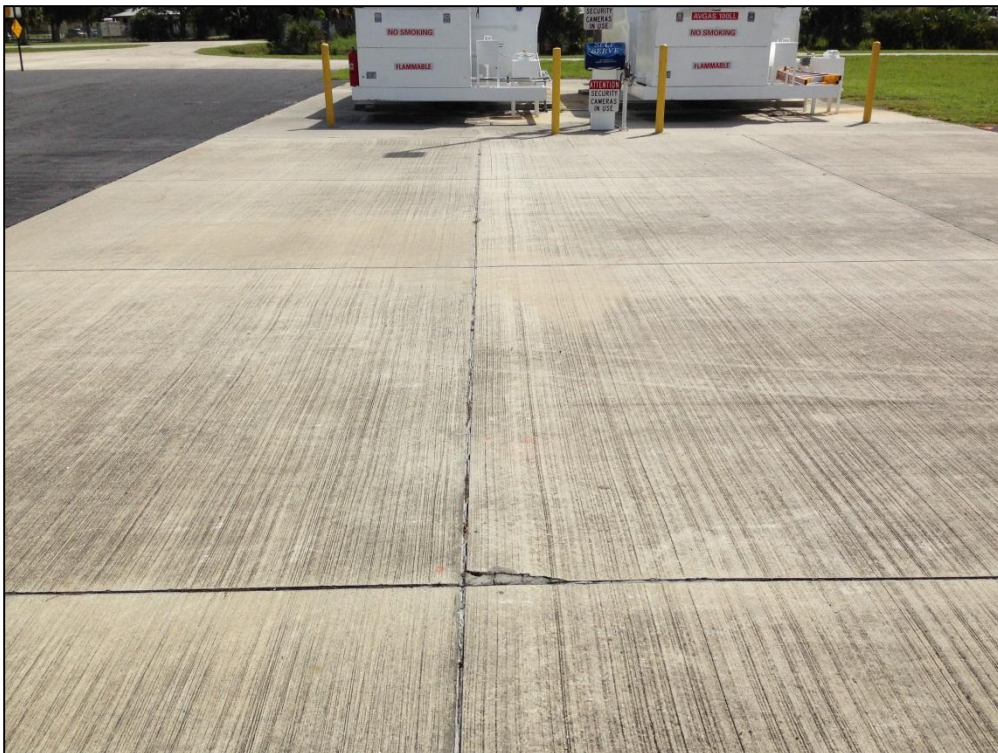
Apron North, Section 4180, Sample Unit 900 – Medium Severity (65) Joint Seal Damage, Medium Severity (75) Corner Spalling

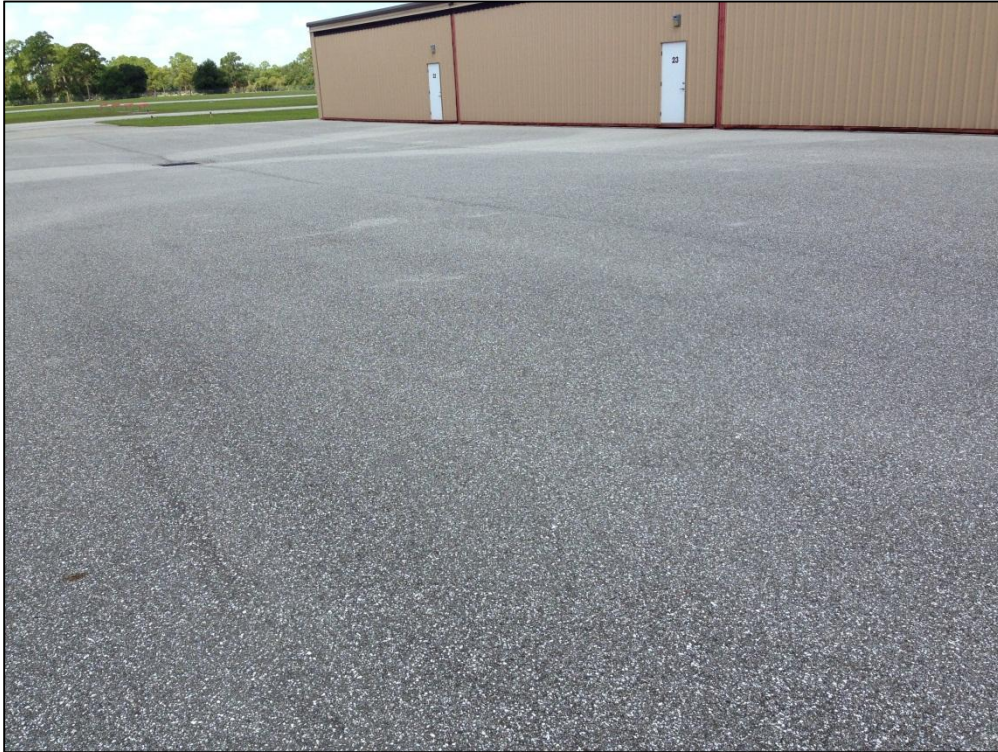
Apron T-Hangar, Section 4305, Sample Unit 202 – Low Severity (48) Longitudinal and Transverse Cracking, Medium Severity (57) Weathering

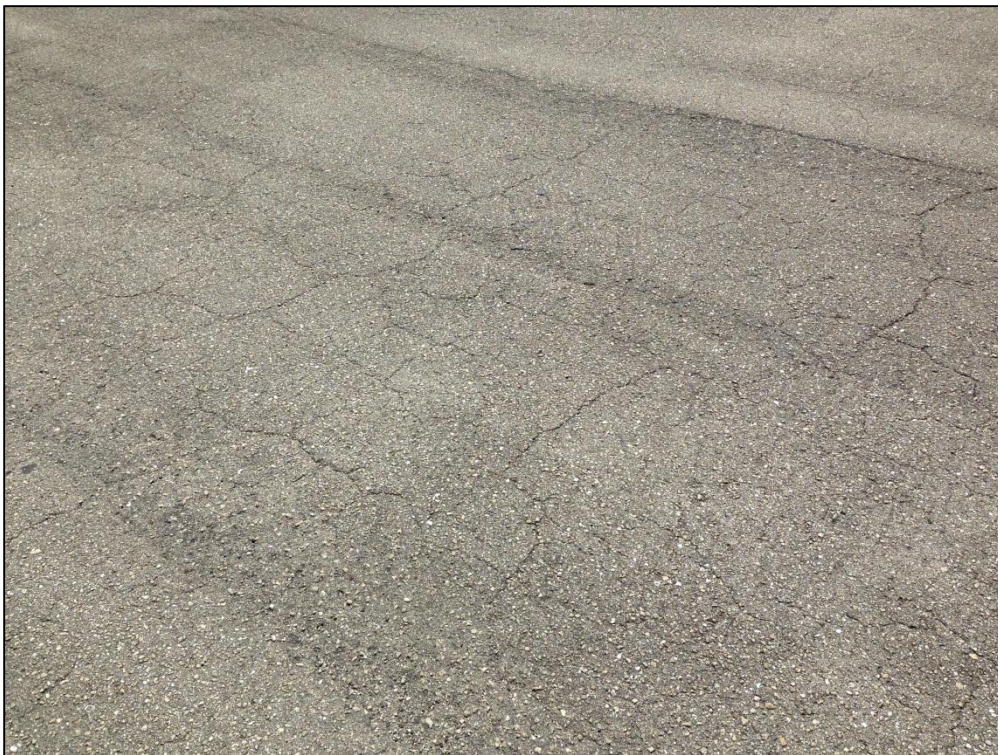
Apron North, Section 4135, Sample Unit 600 – Low Severity (43) Block Cracking, Low, Medium and High Severity (52) Raveling
