FLORIDA DEPARTMENT OF TRANSPORTATION  
AVIATION AND SPACEPORT OFFICE

ARTHUR DUNN  
AIRPARK (X21)

DECEMBER 2013

# STATEWIDE Airfield Pavement Management PROGRAM

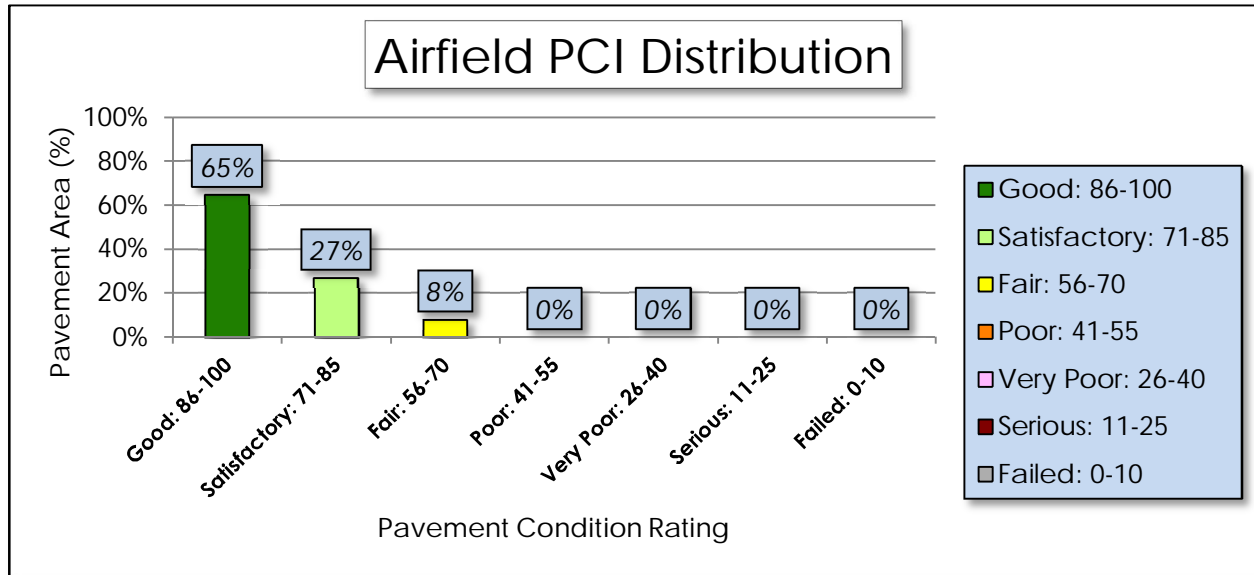
Figure 3-1: Airfield Pavement Condition Index Rating Summary

From the condition survey inspection performed in 2013 at Arthur Dunn Air Park, the overall weighted average PCI value is 83 representing a condition rating of SATISFACTORY.

The airport's airfield pavements exhibited distresses typically associated with climate, age, and subgrade quality based distresses. The predominant AC and AAC pavement distresses observed include: weathering and longitudinal/transverse cracking.

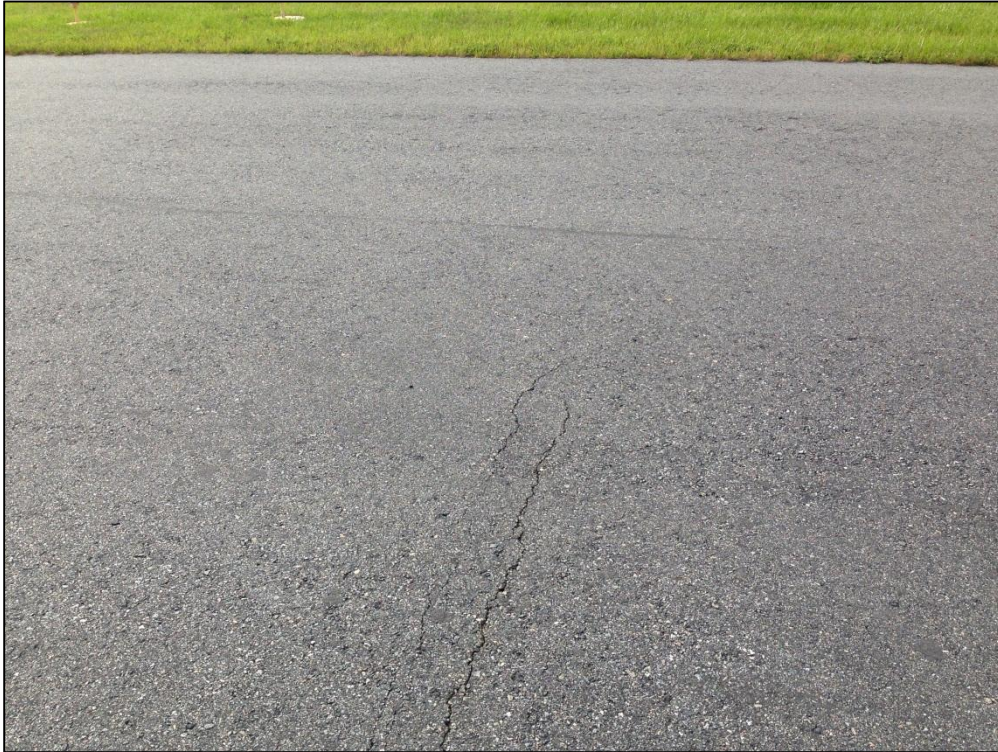
Runway 15-23, Section 6105, Sample Unit 129 – Low Severity (57) Weathering, Low Severity (48) Longitudinal and Transverse Cracking, Low Severity (56) Swelling

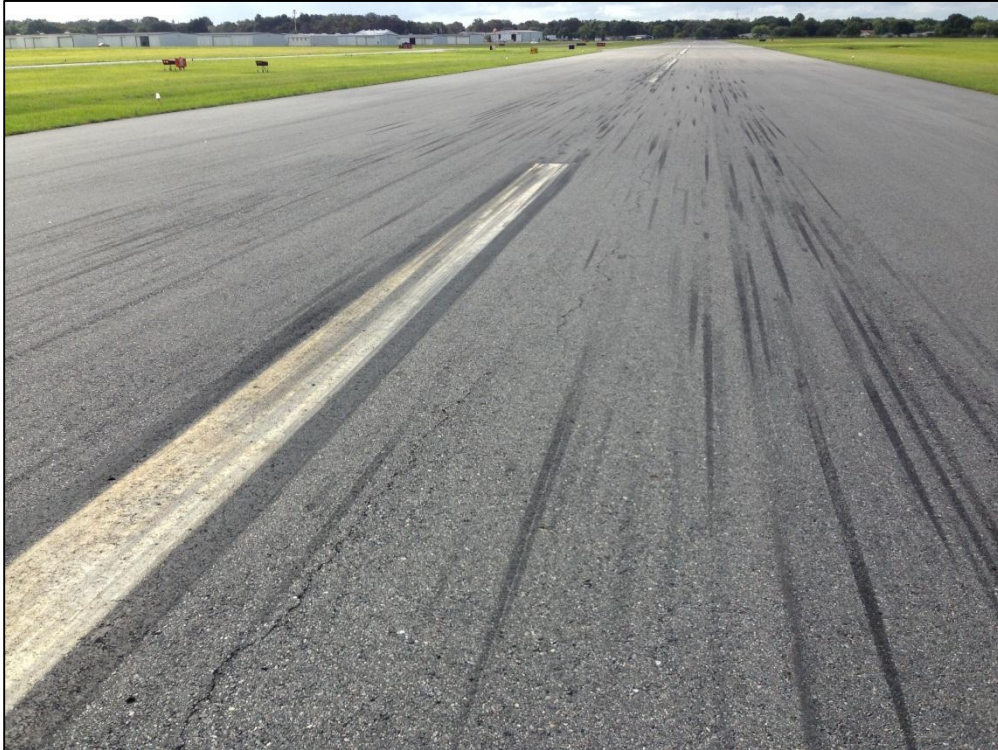
Runway 15-23, Section 6105, Sample Unit 105 – Low Severity (57) Weathering, Low Severity (48) Longitudinal and Transverse Cracking

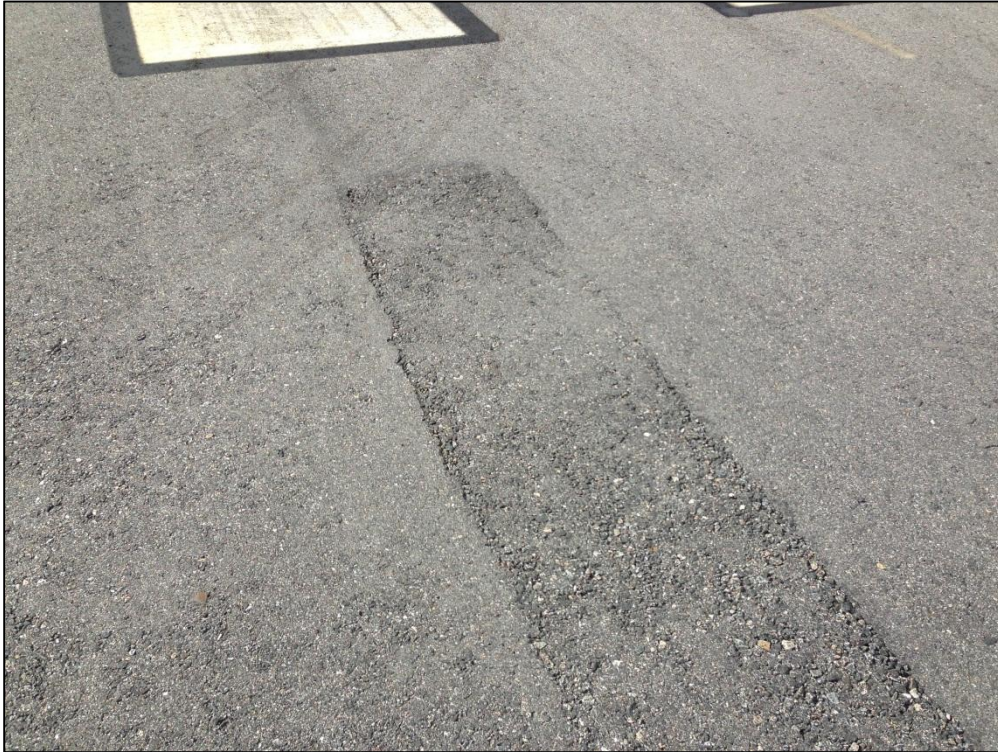
Runway 15-23, Section 6105, Sample Unit 100 – Low Severity (57) Weathering, Low Severity (52) Raveling

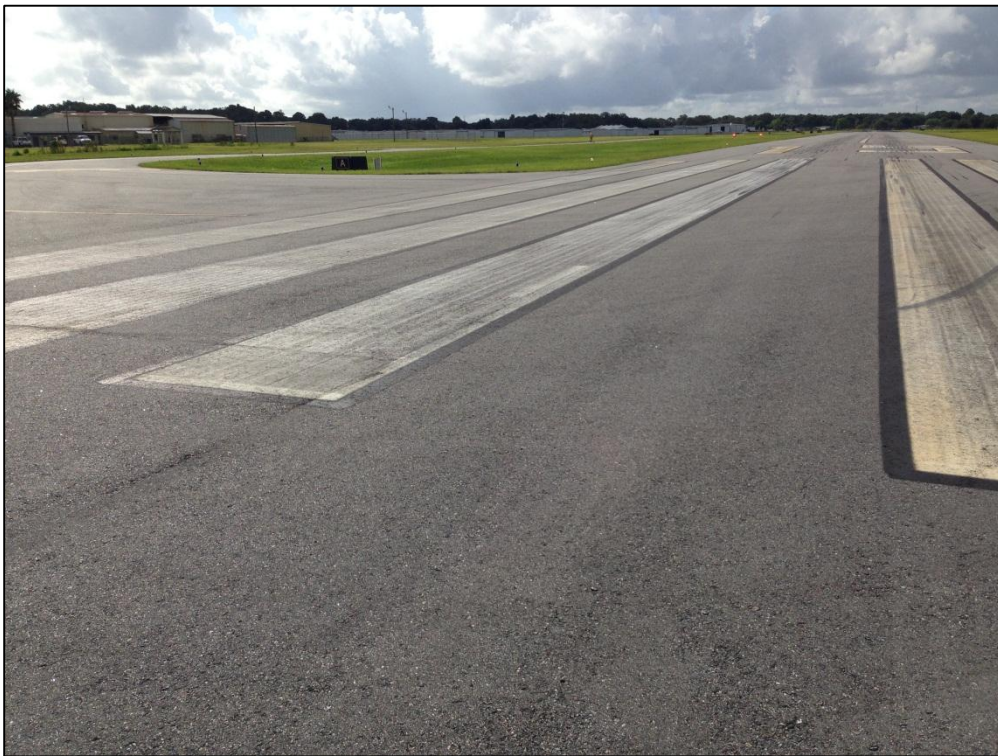
Runway 15-23, Section 6105, Sample Unit 100 – Low Severity (57) Weathering

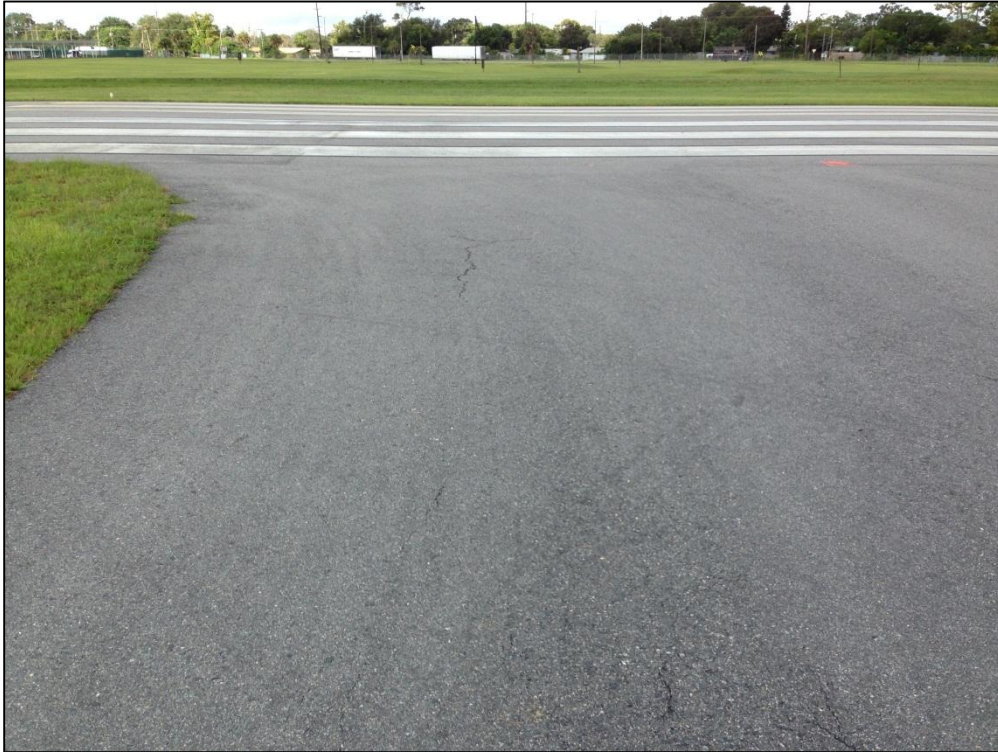
Taxiway A, Section 105, Sample Unit 100 – Low Severity (57) Weathering, Low Severity (48) Longitudinal and Transverse Cracking

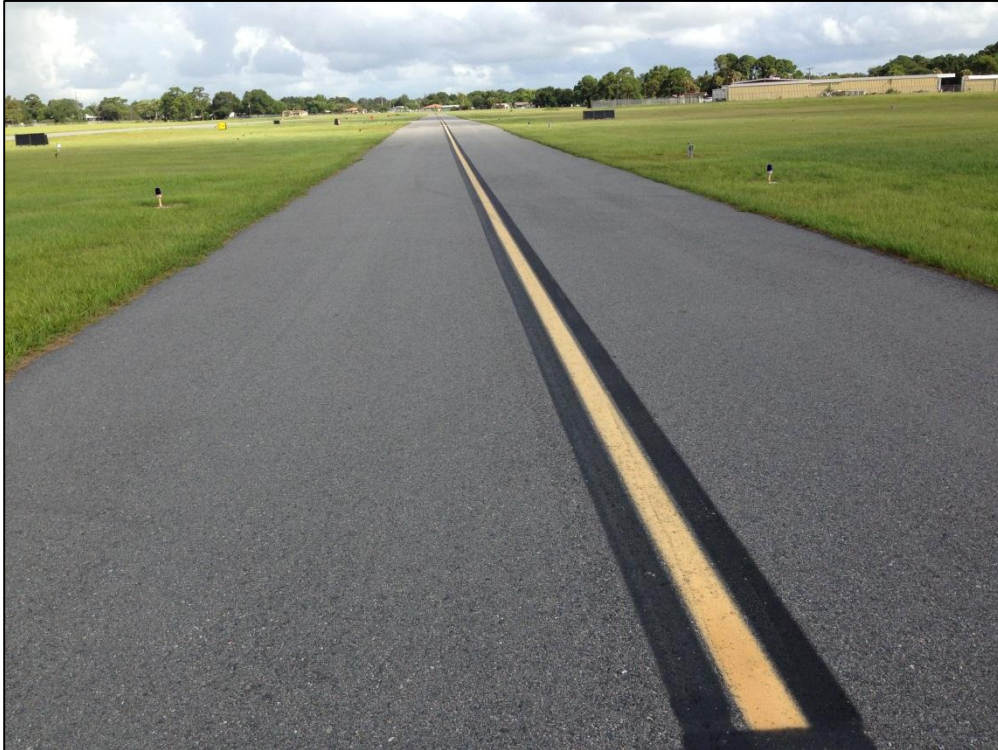
Taxiway A, Section 105, Sample Unit 110 – Low Severity (57) Weathering

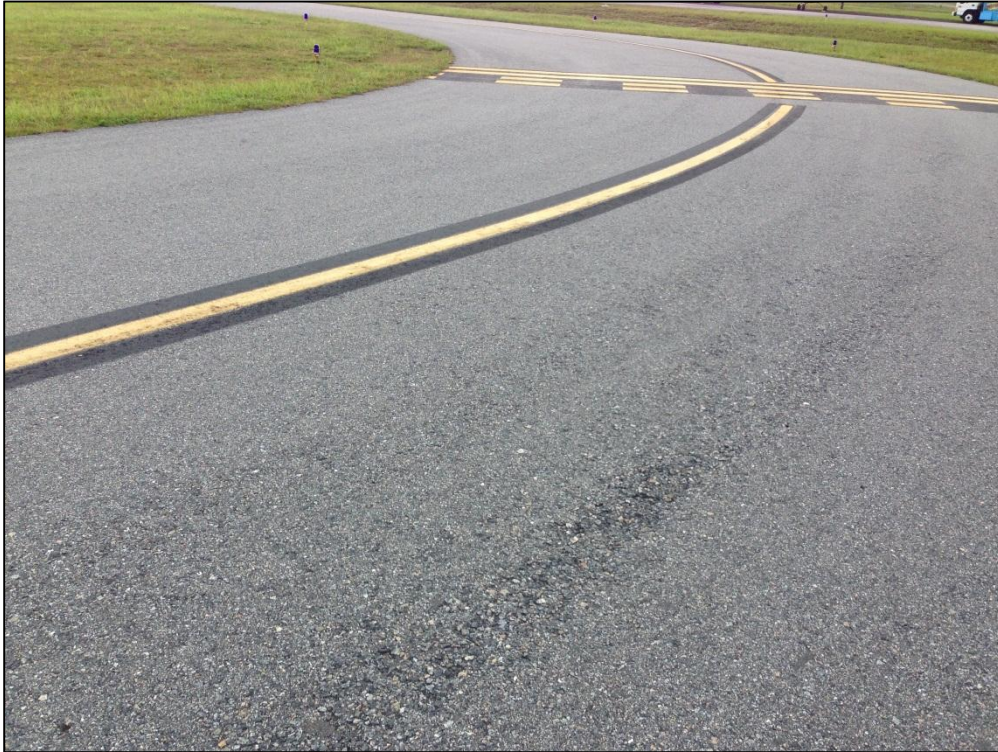
Taxiway A, Section 110, Sample Unit 100 – Low Severity (57) Weathering, Low Severity (52) Raveling

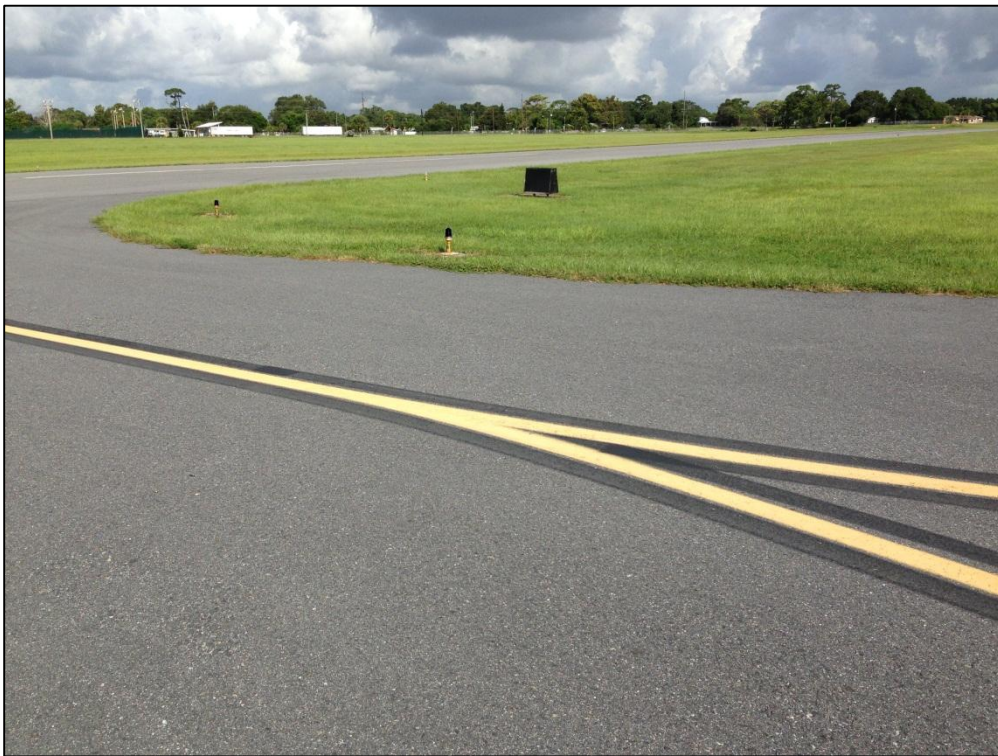
Taxiway D, Section 405, Sample Unit 100 – Low Severity (57) Weathering

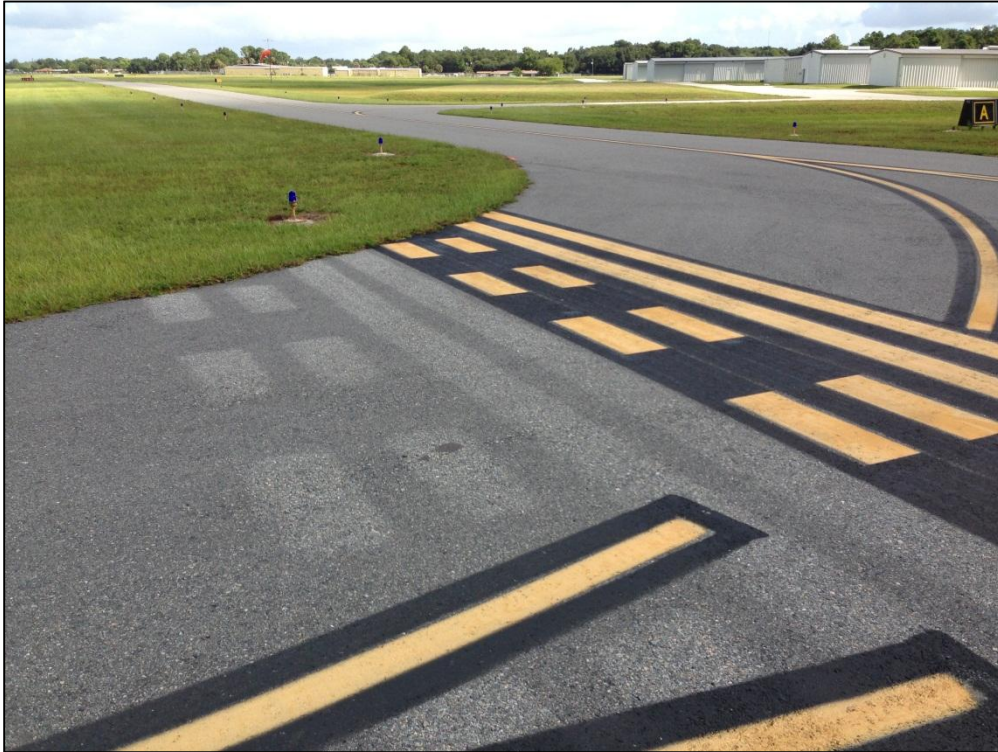
Taxiway B, Section 205, Sample Unit 100 – Low Severity (57) Weathering

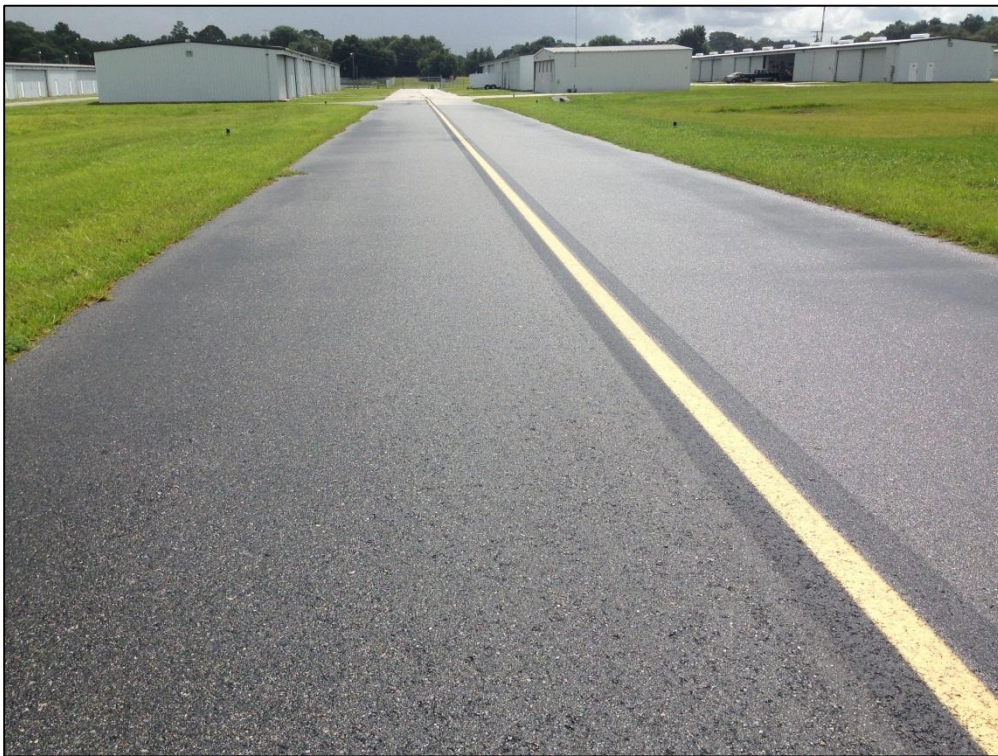
Taxiway C, Section 310, Sample Unit 101 – Low Severity (57) Weathering

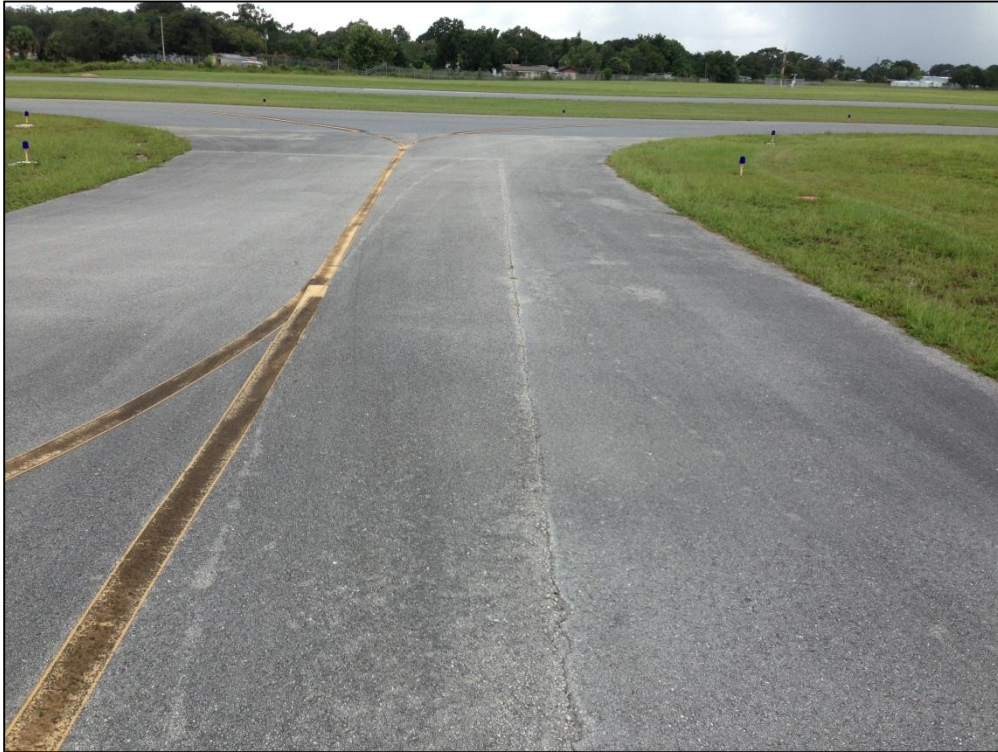
Taxiway AP, Section 115, Sample Unit 115 – Low Severity (57) Weathering, Low Severity (48) Longitudinal and Transverse Cracking

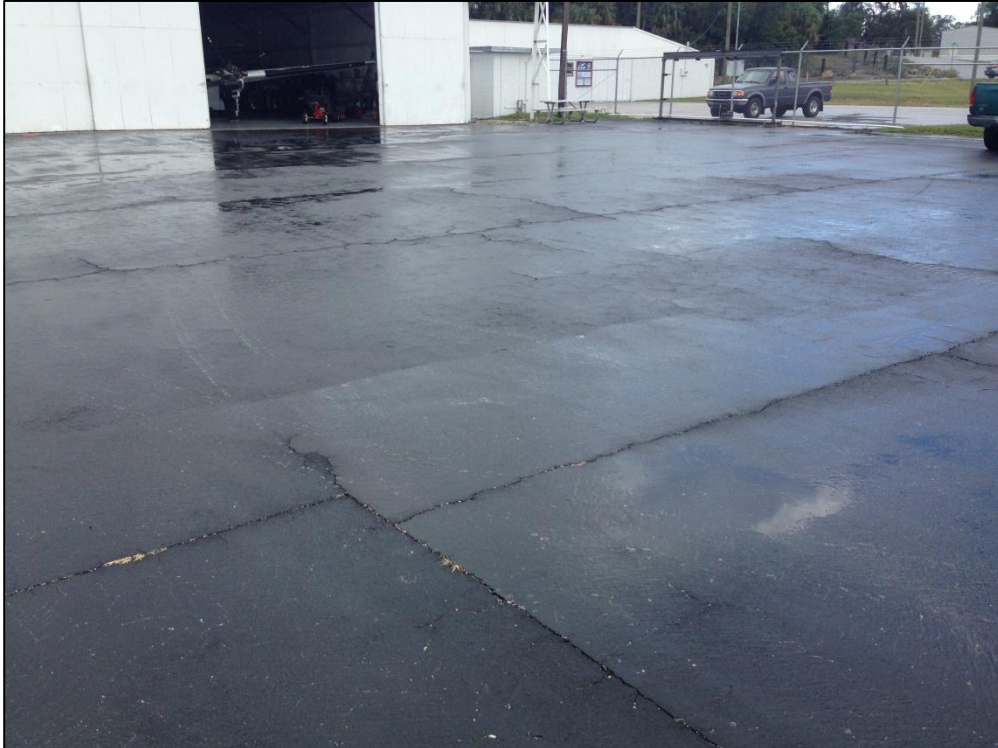
Apron, Section 4107, Sample Unit 203 – Low Severity (57) Weathering, Low Severity (48) Longitudinal and Transverse Cracking

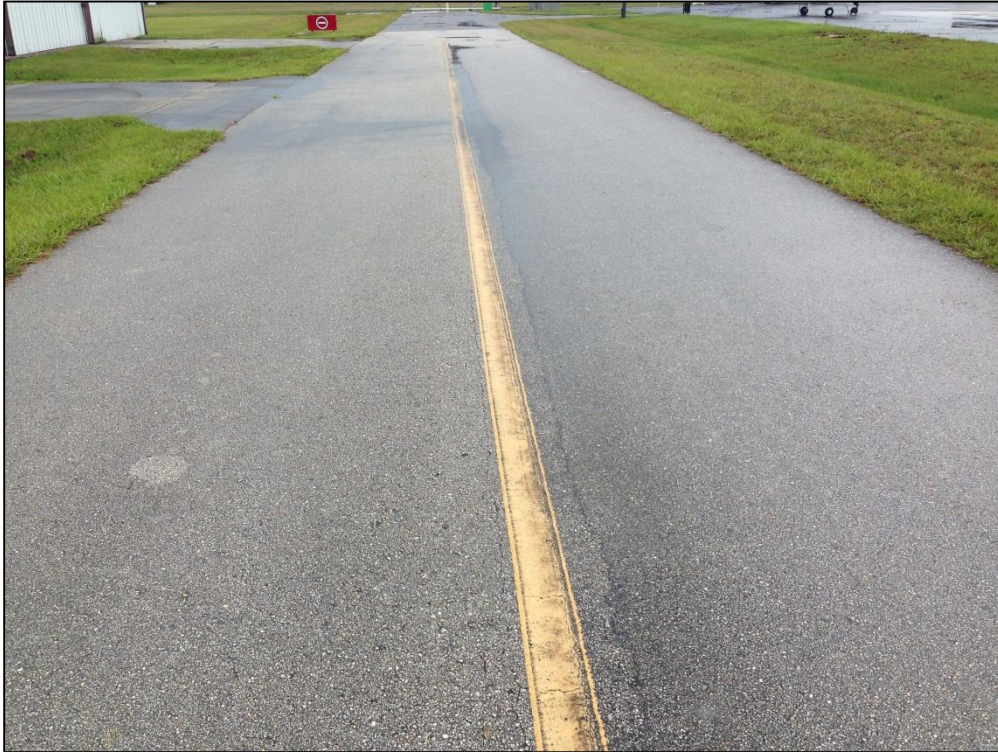
Apron T-Hangar, Section 4210, Sample Unit 501 – Low Severity (57) Weathering, Low Severity (48) Longitudinal and Transverse Cracking

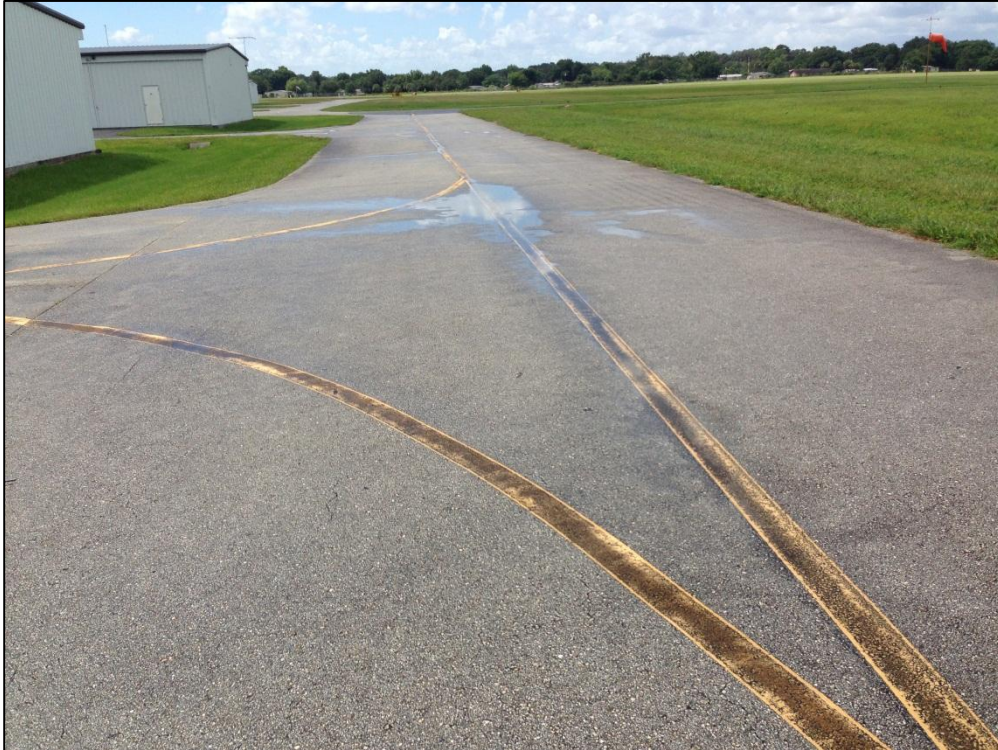
Apron T-Hangar, Section 4205, Sample Unit 102 – Low Severity (45) Depression, Low Severity (57) Weathering, Low Severity (52) Raveling

- T-Hangar Apron – Section 4205
  - Mill and Overlay attributed to distresses related to subgrade quality, climate, and age of pavement.
