FLORIDA DEPARTMENT OF TRANSPORTATION
AVIATION AND SPACEPORT OFFICE

UMATILLA
MUNICIPAL
AIRPORT (X23)

DECEMBER 2013

STATEWIDE
**Airfield
Pavement
Management**
PROGRAM

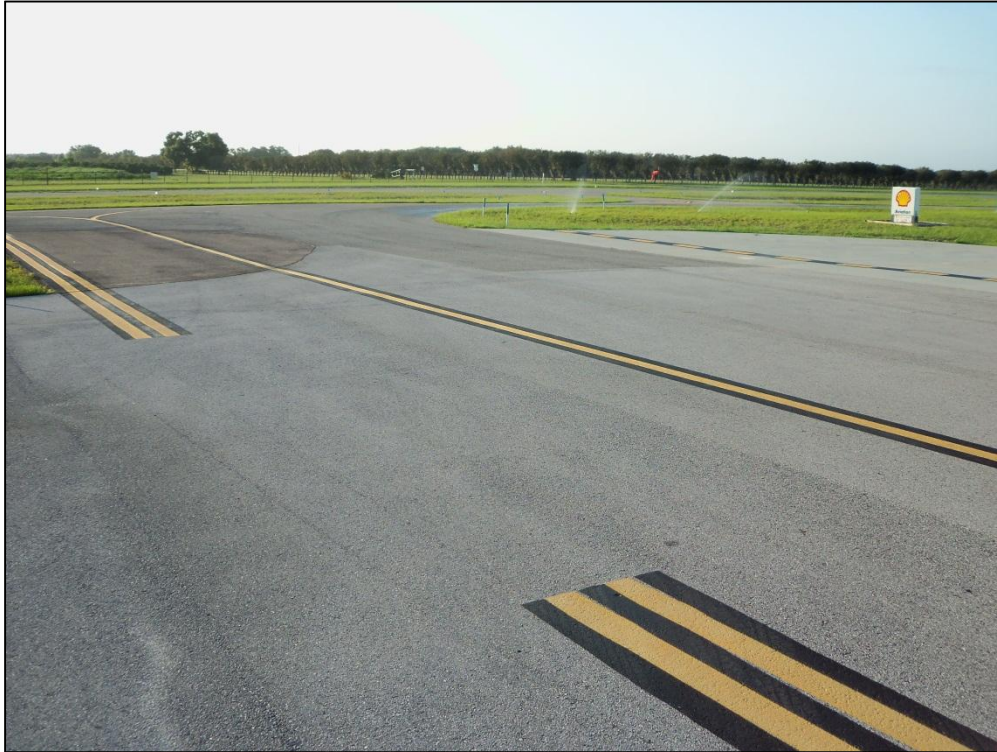
Apron Term, Section 4110, Sample Unit 301 – Low Severity (57) Weathering, Low Severity (52) Raveling

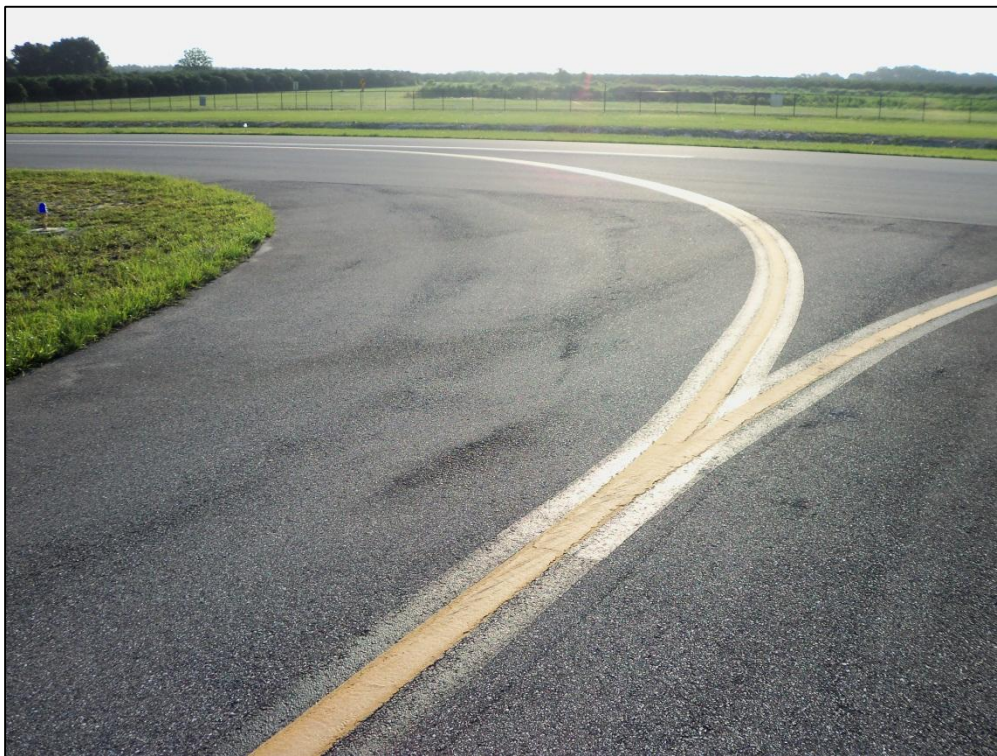
Apron Term, Section 4105, Sample Unit 100 – Low Severity (57) Weathering, Low Severity (52) Raveling

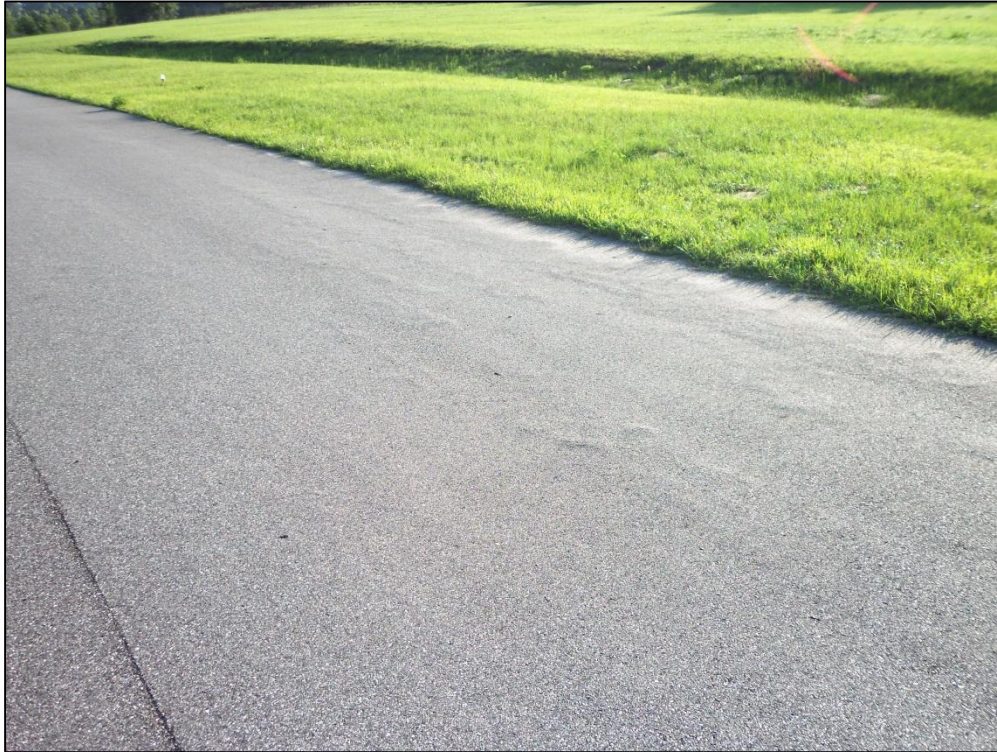
Overall the airport exhibited pavement distresses associated with climate and age distress. Runway 1-19 exhibited low severity longitudinal/transverse cracking, raveling and weathering. Portions of low severity swelling were also observed towards the 19 end of the runway. There were portions of pavement on the runway where the old runway numbers were milled away based on the new runway designation and these areas were classified as low and medium severity raveling.

Runway 01-19, Section 6105, Sample Unit 222 – Low Severity (57) Weathering, Low Severity (48) Longitudinal and Transverse Cracking, Low Severity (56) Swelling

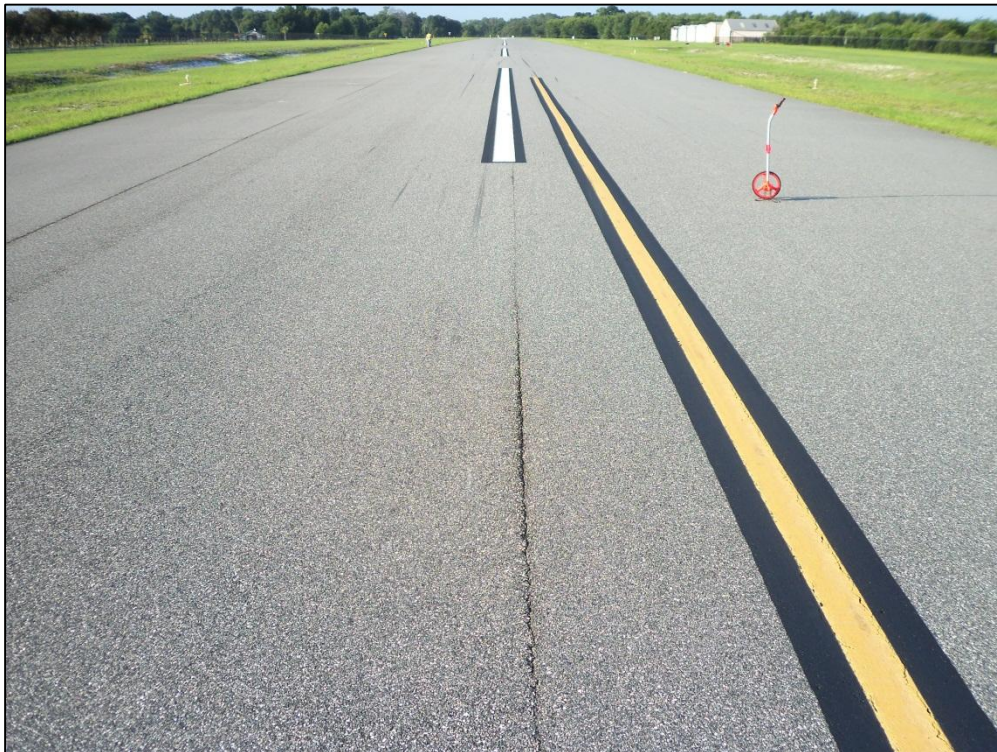
Runway 01-19, Section 6105, Sample Unit 212 – Low Severity (57) Weathering, Low Severity (52) Raveling, Low Severity (48) Longitudinal and Transverse Cracking

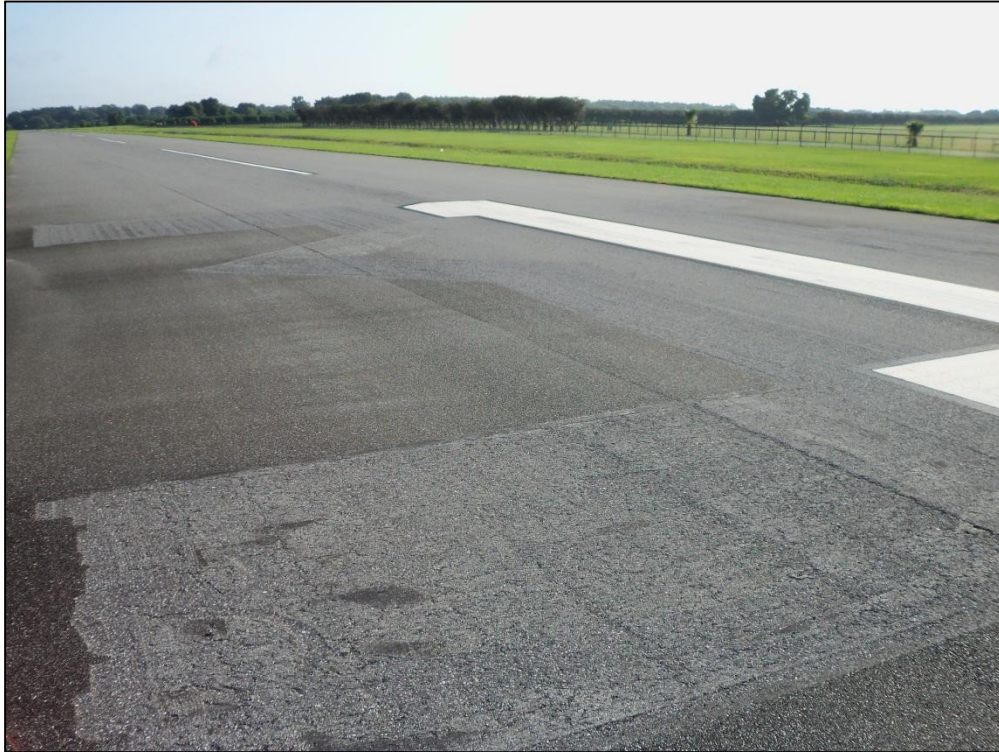
Runway 01-19, Section 6105, Sample Unit 202 – Low Severity (57) Weathering, Low and Medium Severity (52) Raveling

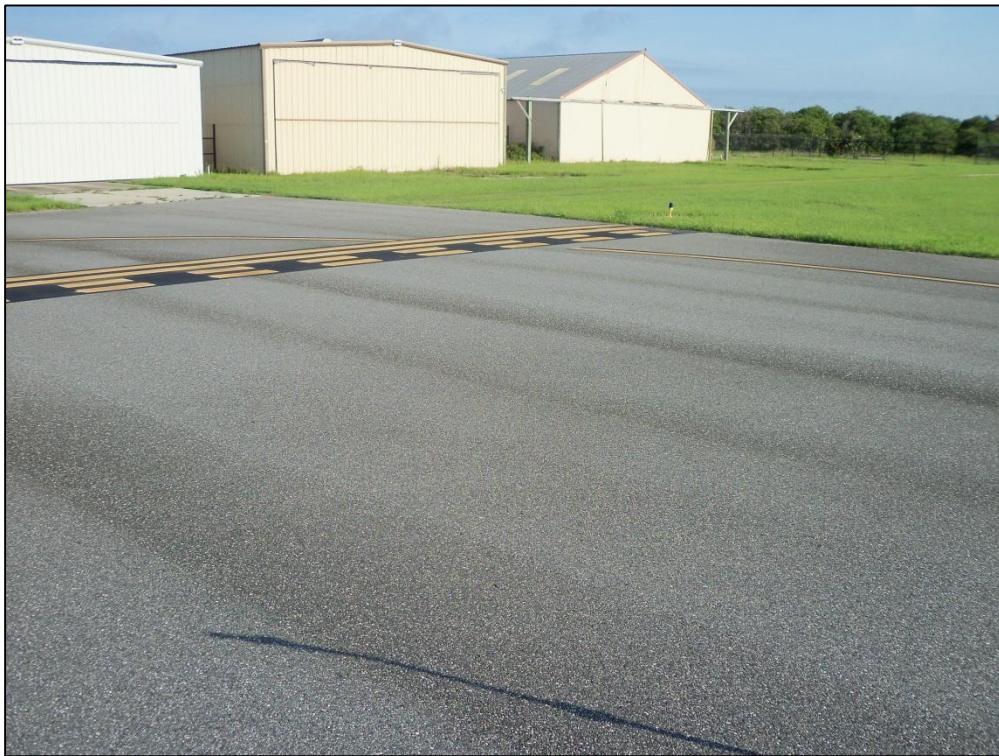
The apron and hangar pavement areas exhibited low severity weathering and raveling with small portions of medium severity weathering. A medium severity patch was also observed on the apron area.

Apron T-Hangar, Section 4205, Sample Unit 102 – Low Severity (57) Weathering, Low Severity (52) Raveling
