FLORIDA DEPARTMENT OF TRANSPORTATION
AVIATION AND SPACEPORT OFFICE

**SEBASTIAN
MUNICIPAL
AIRPORT (X26)**

DECEMBER 2013

STATEWIDE Airfield Pavement Management PROGRAM

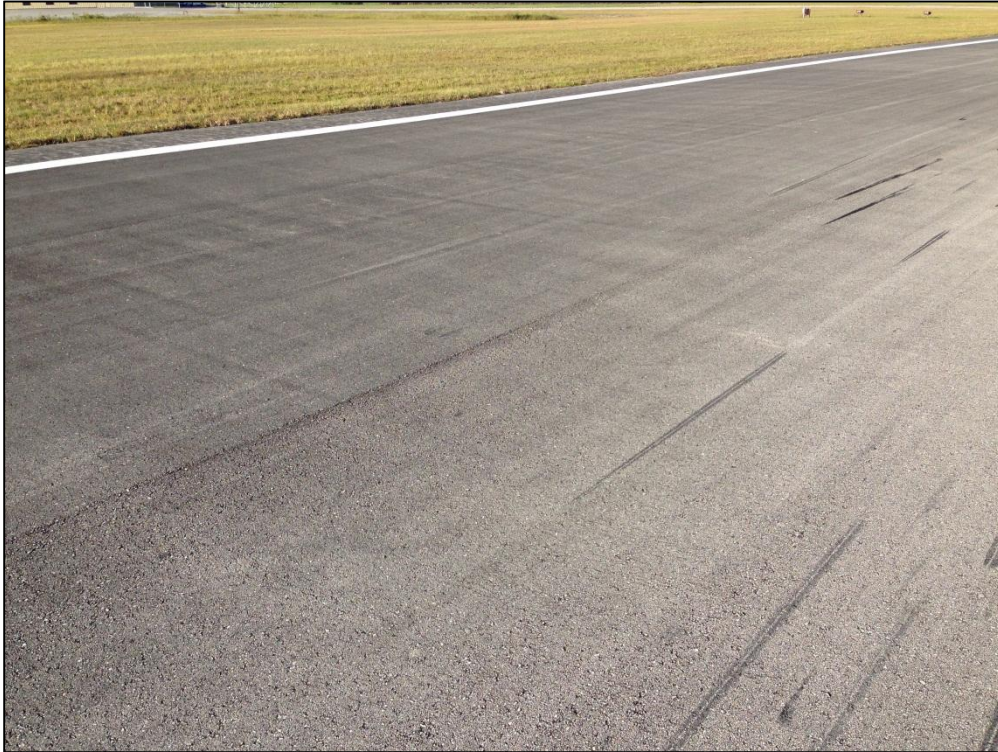
Runway 10-28, Section 6315, Sample Unit 554 – Low Severity (57) Weathering

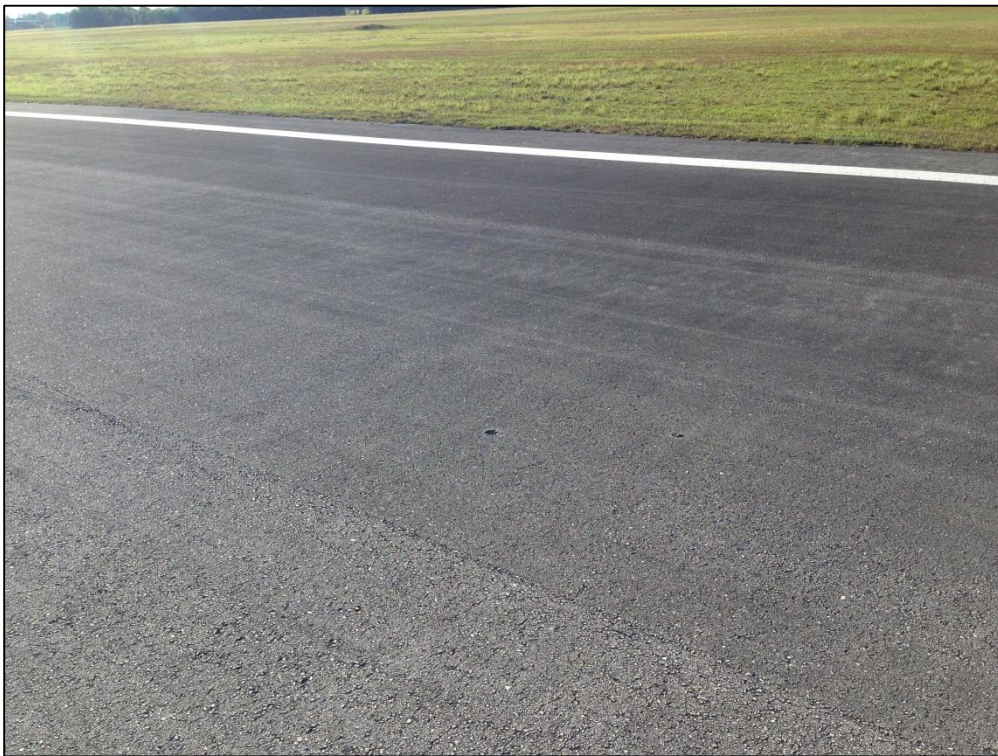
Runway 10-28, Section 6305, Sample Unit 514 – Low Severity (57) Weathering

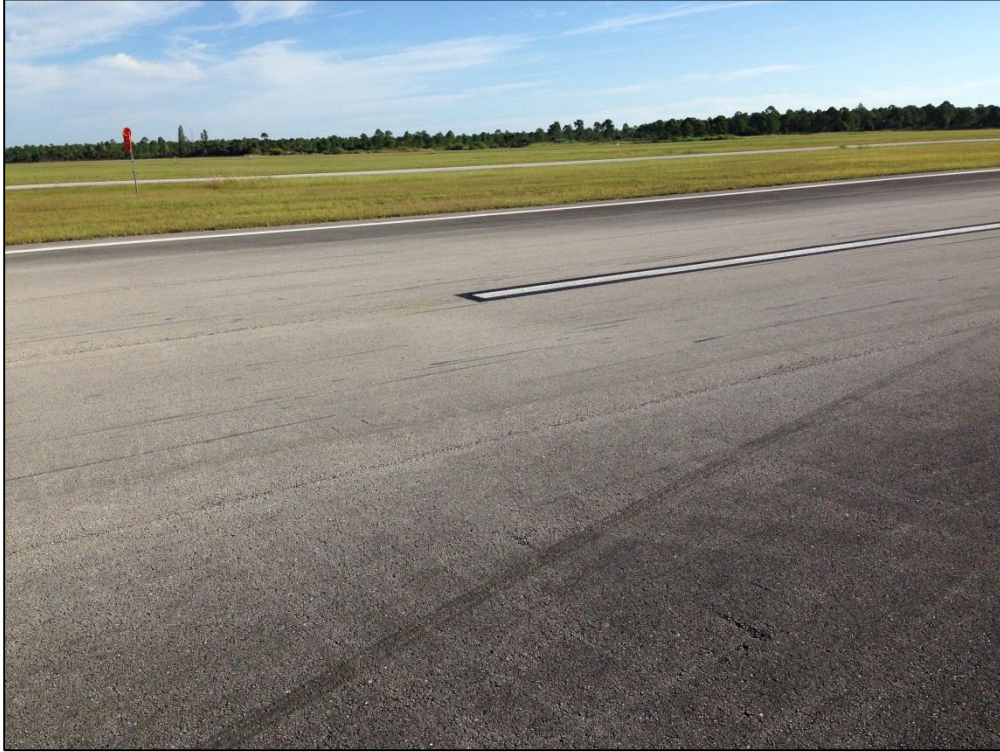
Runway 10-28, Section 6305, Sample Unit 502 – Low Severity (48) Longitudinal and Transverse Cracking, Low Severity (57) Weathering

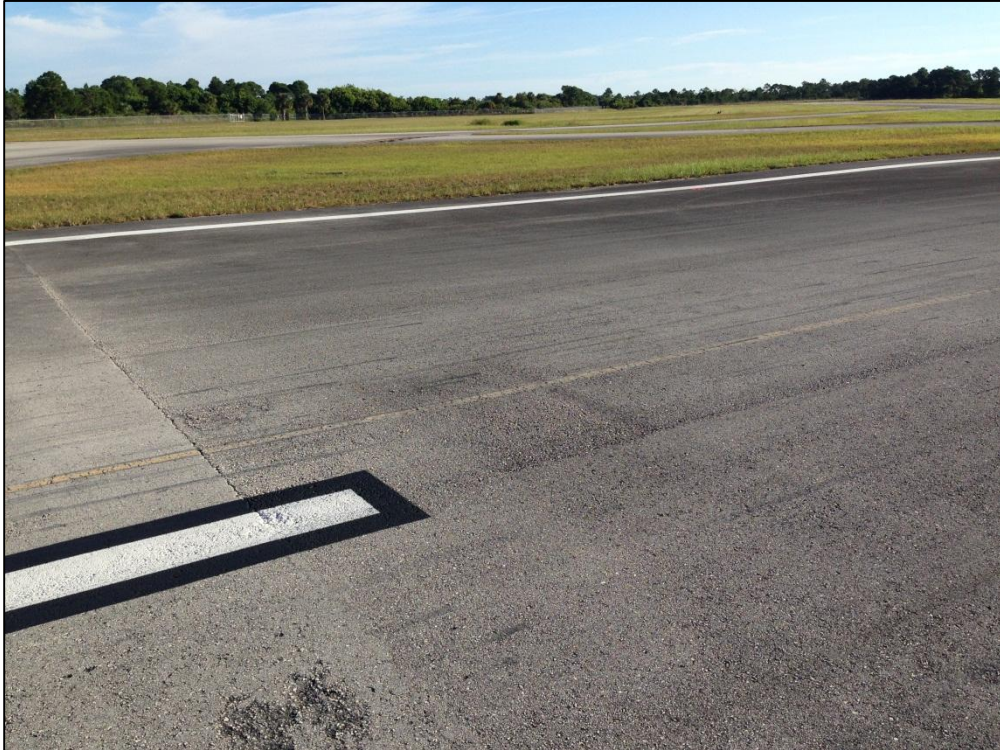
Runway 10-28, Section 6305, Sample Unit 534 – Low Severity (48) Longitudinal and Transverse Cracking, Low Severity (52) Raveling, Low Severity (57) Weathering

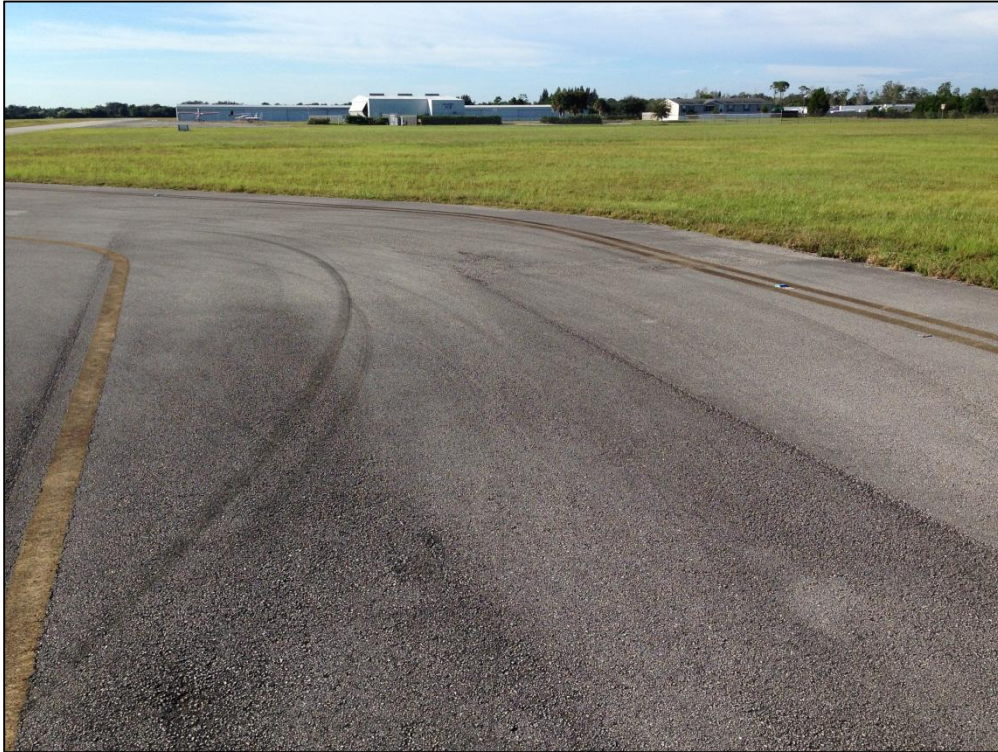
Runway 10-28, Section 6305, Sample Unit 502 – Low Severity (52) Raveling, Low Severity (57) Weathering

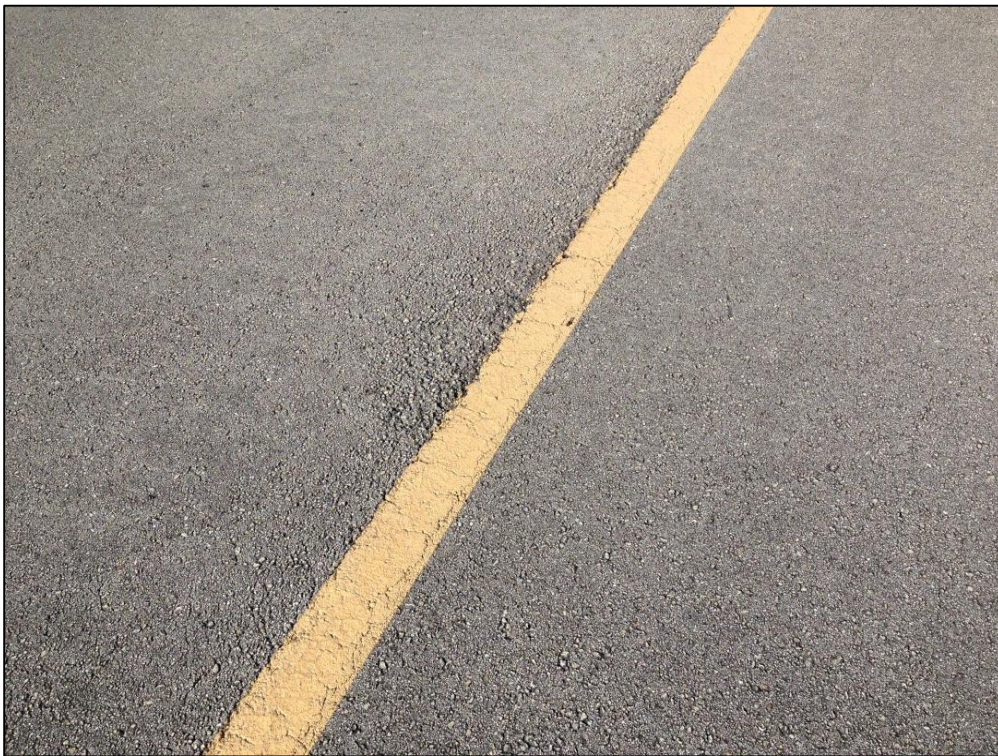
Taxiway B, Section 610, Sample Unit 118 – Low Severity (52) Raveling, Low Severity (57) Weathering

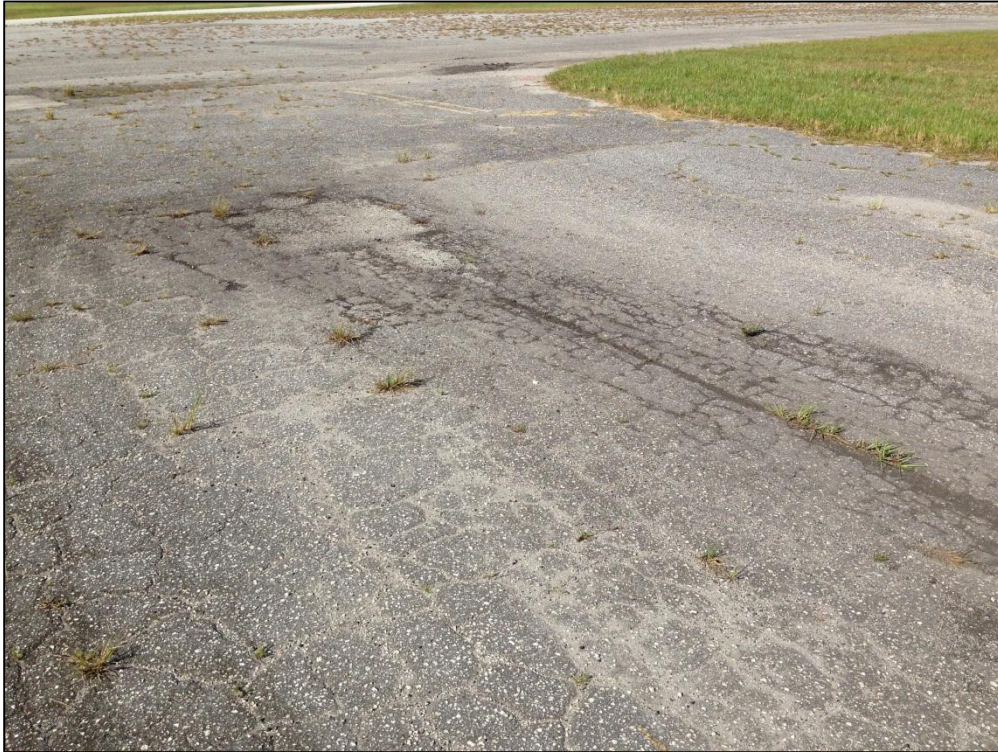
Taxiway C, Section 305, Sample Unit 300 – Low Severity (41) Alligator Cracking, Low Severity (52) Raveling, Low Severity (53) Rutting, Low Severity (57) Weathering

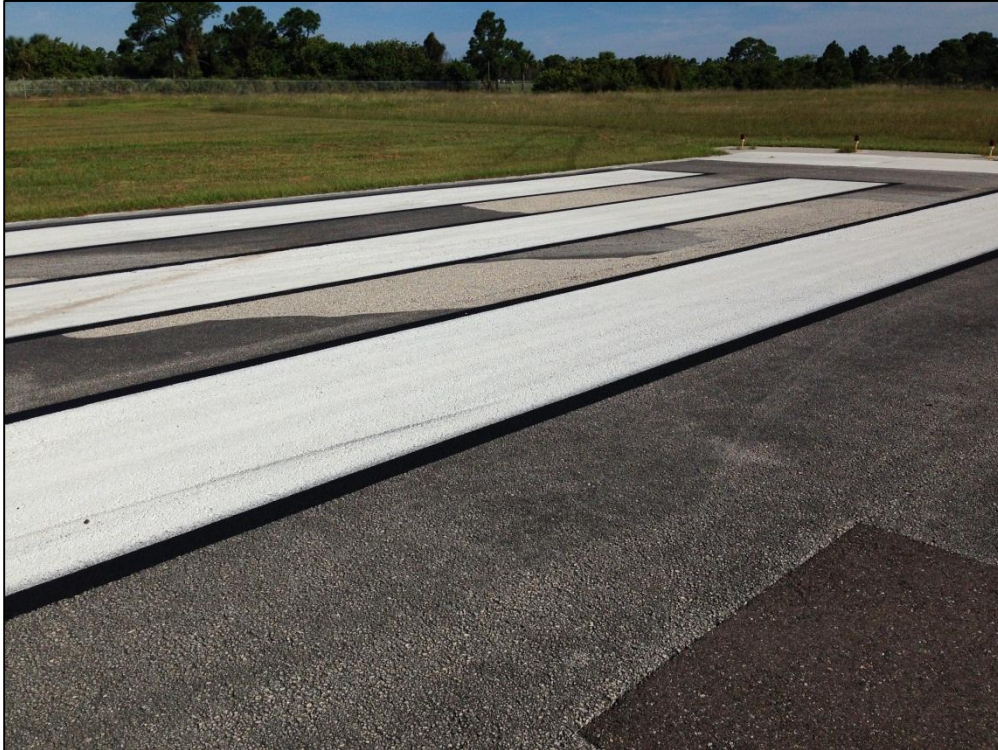
Runway 5-23, Section 6205, Sample Unit 379 – Low Severity (50) Patching, Low Severity (52) Raveling, Low Severity (57) Weathering

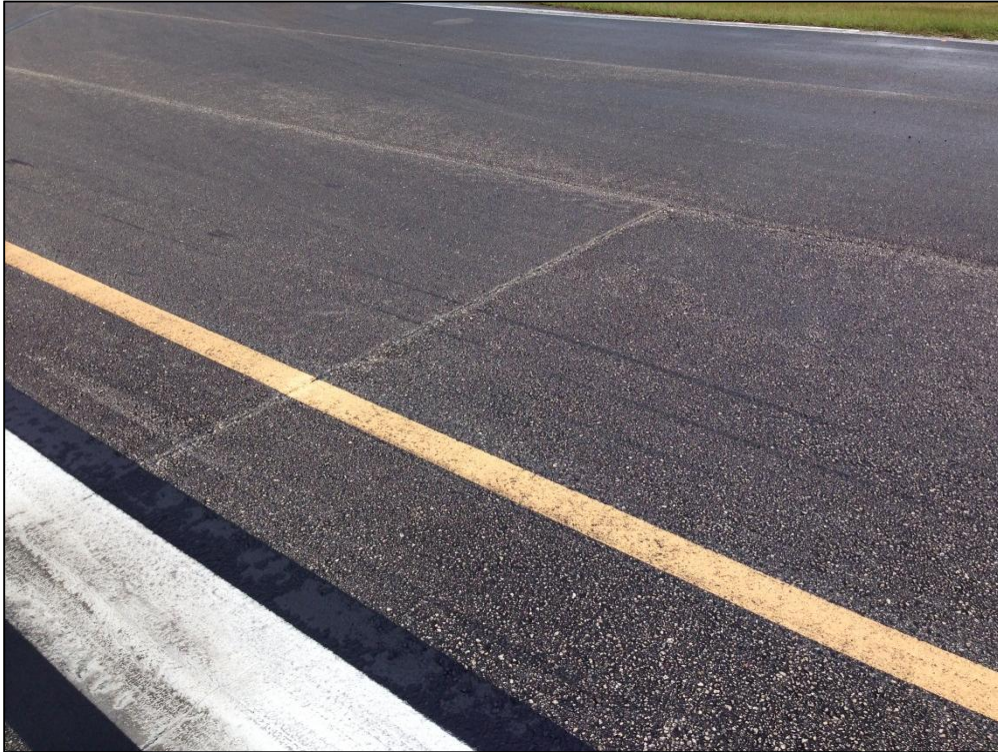
Runway 5-23, Section 6205, Sample Unit 307 – Low Severity (48) Longitudinal and Transverse Cracking, Low Severity (57) Weathering

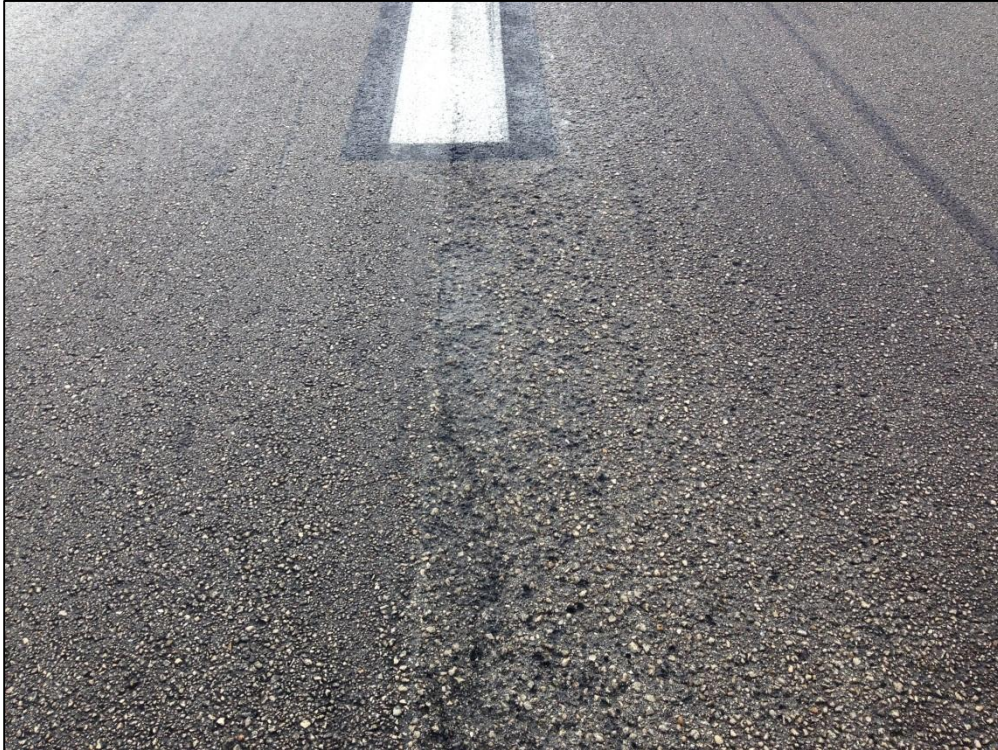
Runway 5-23, Section 6205, Sample Unit 314 – Low Severity (52) Raveling, Low Severity (57) Weathering

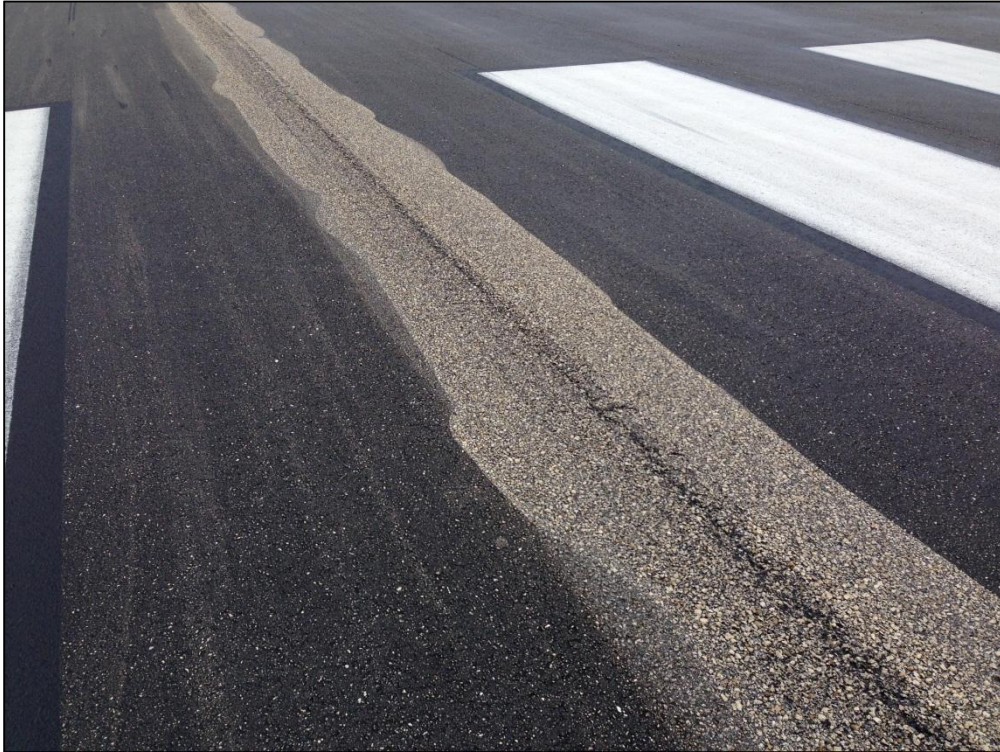
Runway 5-23, Section 6205, Sample Unit 377 – Low Severity (48) Longitudinal and Transverse Cracking, Low Severity (52) Raveling, Low Severity (57) Weathering

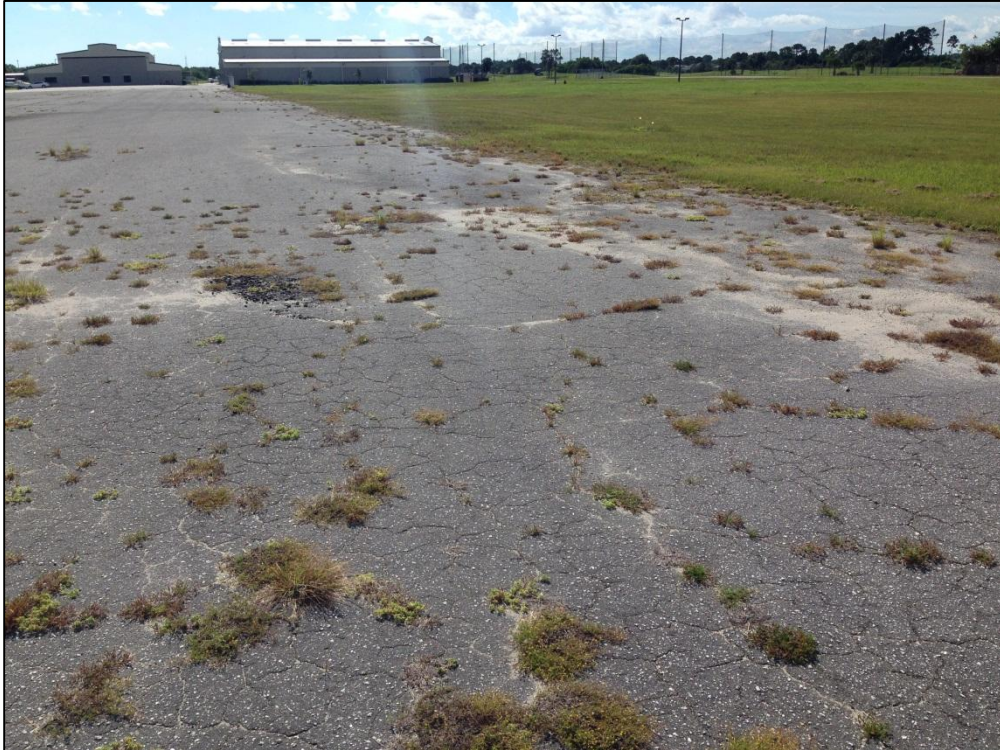
Apron SE, Section 5605, Sample Unit 101 – Low Severity (43) Block Cracking, Low, Medium, and High Severity (52) Raveling

- Southeast Apron – Section 5605
 - Mill and Overlay attributed to distresses related to subgrade quality, climate, and age of pavement.
- West Apron – Section 5115
 - Reconstruction attributed to distresses related to climate and age of pavement.
- Taxiway C – Sections 306 and 305
 - Reconstruction attributed to distresses related to loading, climate, and age of pavement.

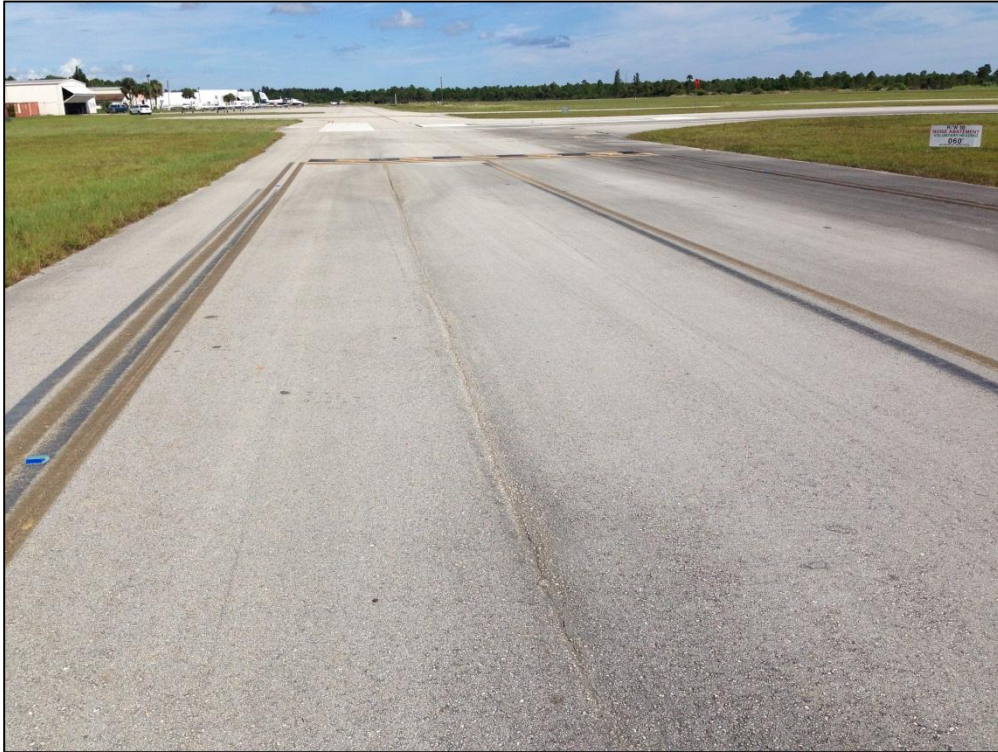
Taxiway A, Section 425, Sample Unit 99 – Low Severity (45) Depression, Low Severity (48) Longitudinal and Transverse Cracking, Low Severity (52) Raveling, Low Severity (57) Weathering

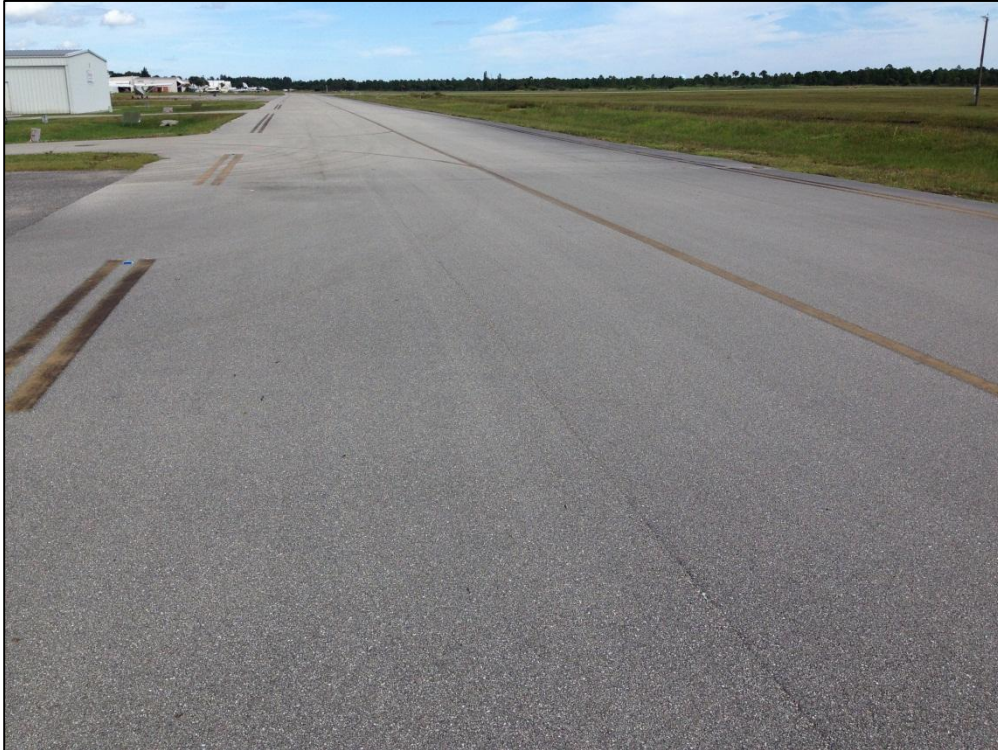
Taxiway A, Section 405, Sample Unit 108 – Low Severity (48) Longitudinal and Transverse Cracking, Low Severity (57) Weathering

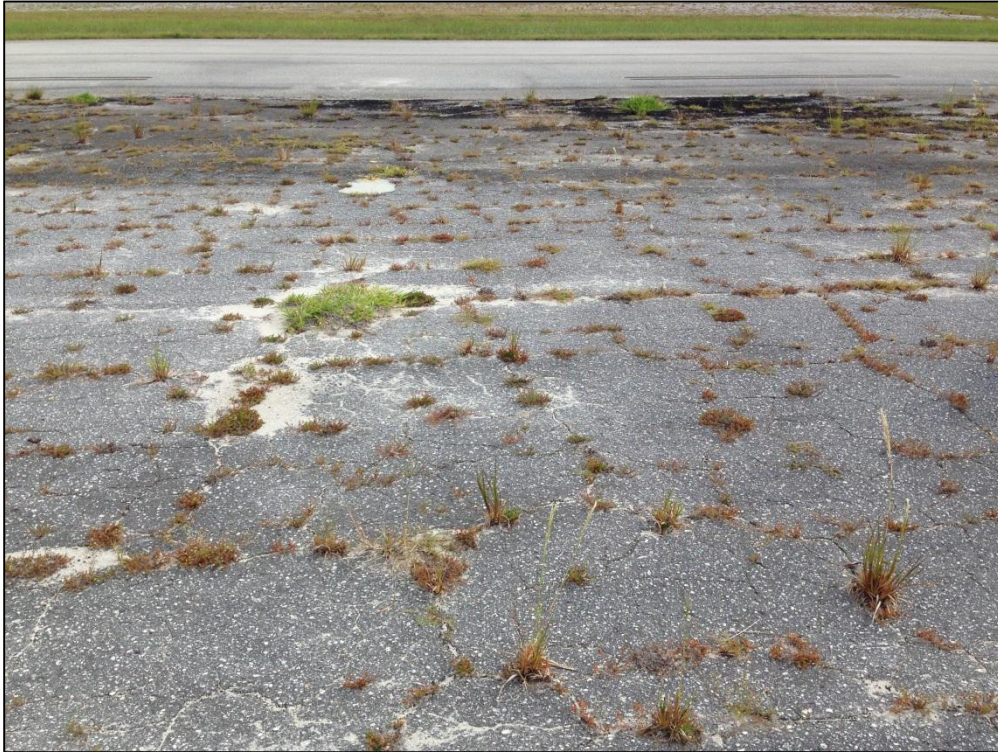
Apron W, Section 5115, Sample Unit 435 – Medium Severity (43) Block Cracking, Medium Severity (52) Raveling

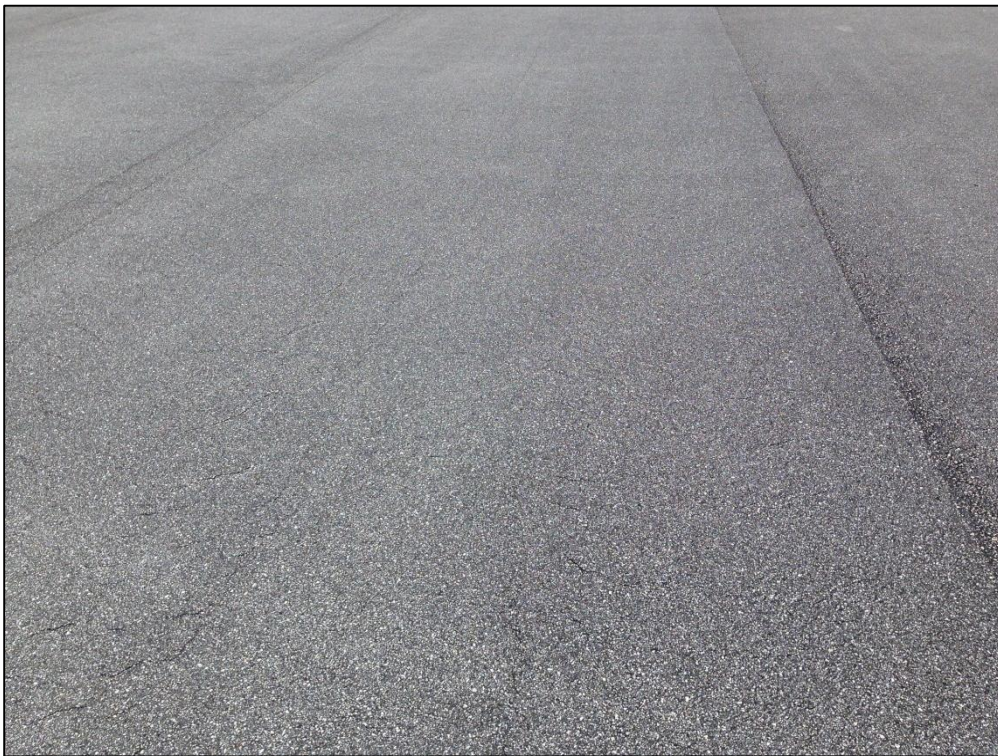
Apron W, Section 5105, Sample Unit 431 – Low Severity (48) Longitudinal and Transverse Cracking, Low Severity (57) Weathering
