FLORIDA DEPARTMENT OF TRANSPORTATION
AVIATION AND SPACEPORT OFFICE

**DUNNELLON/
MARION COUNTY
AIRPORT (X35)**

DECEMBER 2013

STATEWIDE
**Airfield
Pavement
Management**
PROGRAM

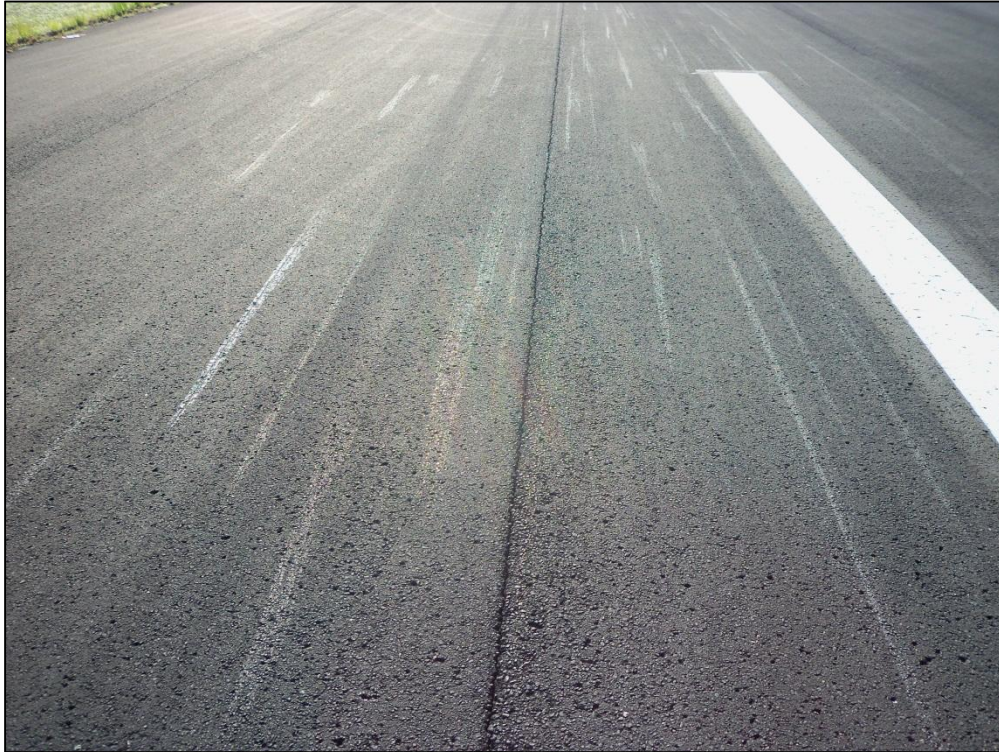
Runway 10-28, Section 6105, Sample Unit 185 – Low Severity (48) Longitudinal and Transverse Cracking, Low Severity (52) Raveling

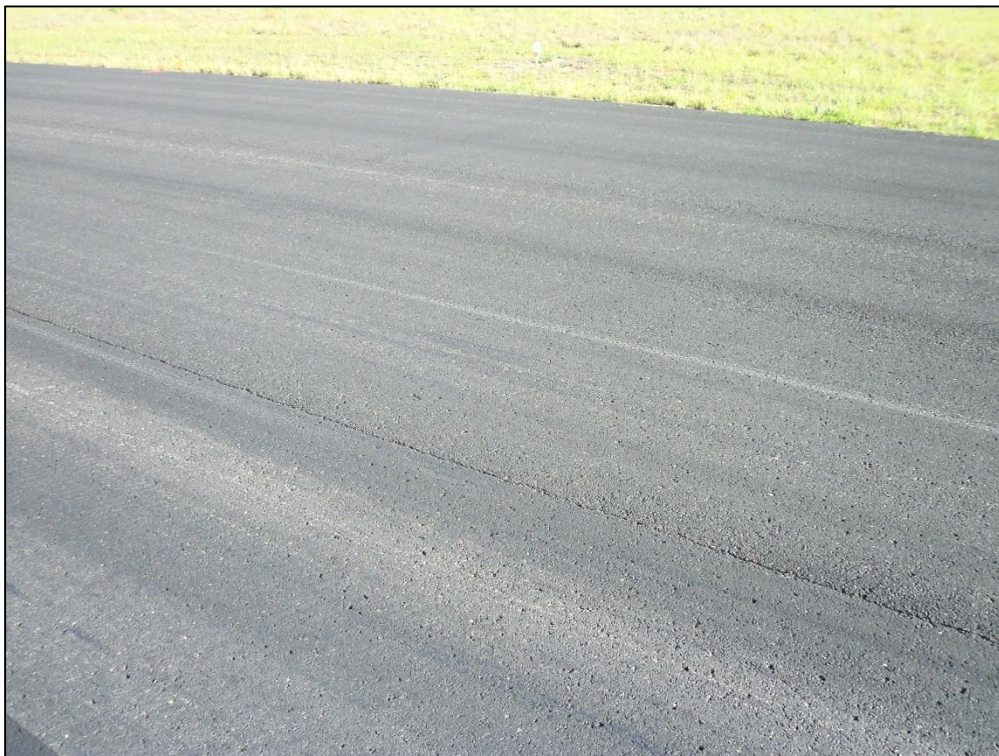
Runway 10-28, Section 6105, Sample Unit 157 – Low Severity (48) Longitudinal and Transverse Cracking, Low Severity (52) Raveling

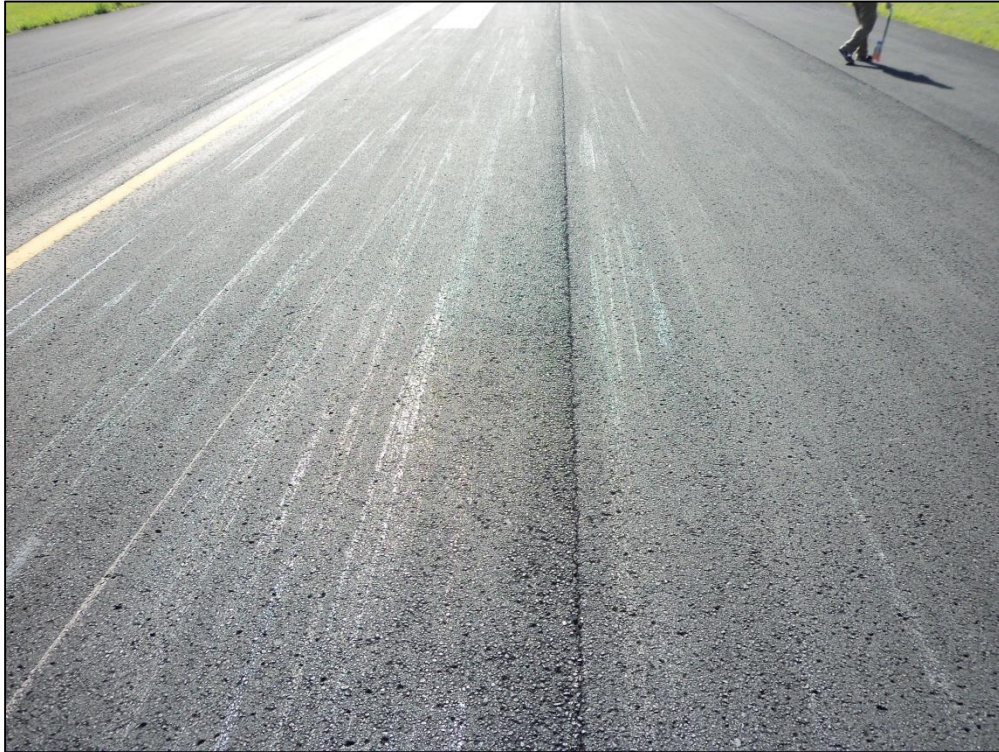
Runway 10-28, Section 6105, Sample Unit 105 – Low Severity (48) Longitudinal and Transverse Cracking, Low Severity (52) Raveling

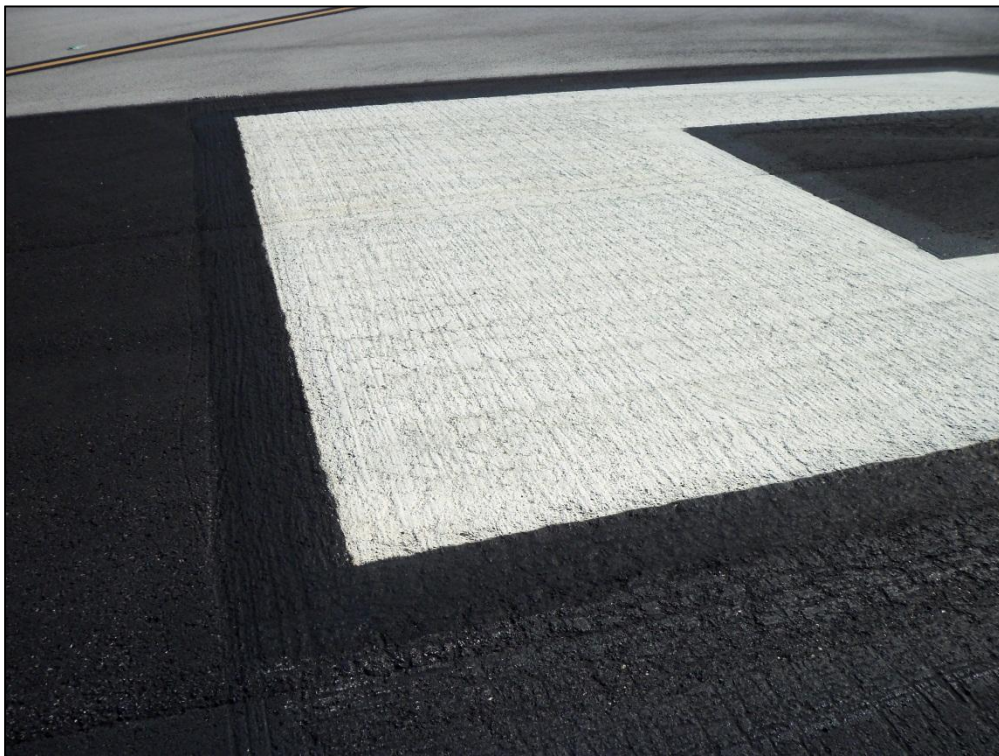
Runway 10-28, Section 6105, Sample Unit 101 –Low Severity (52) Raveling

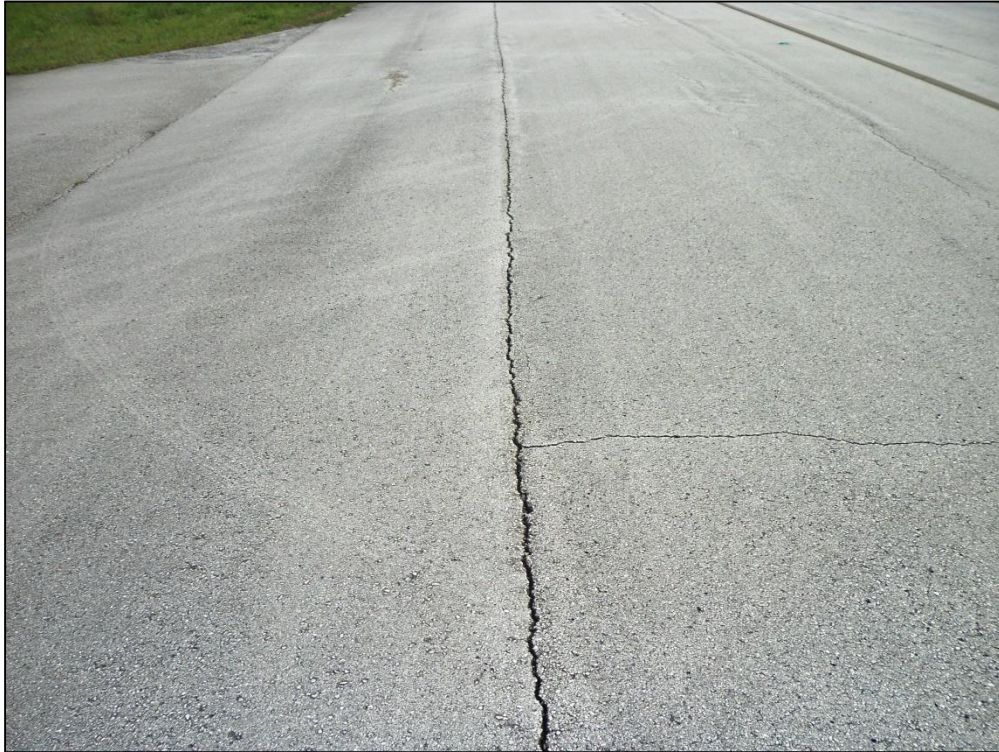
Taxiway East, Section 110, Sample Unit 105 – Low and Medium Severity (48) Longitudinal and Transverse Cracking, Low Severity (52) Raveling, Low Severity (57) Weathering

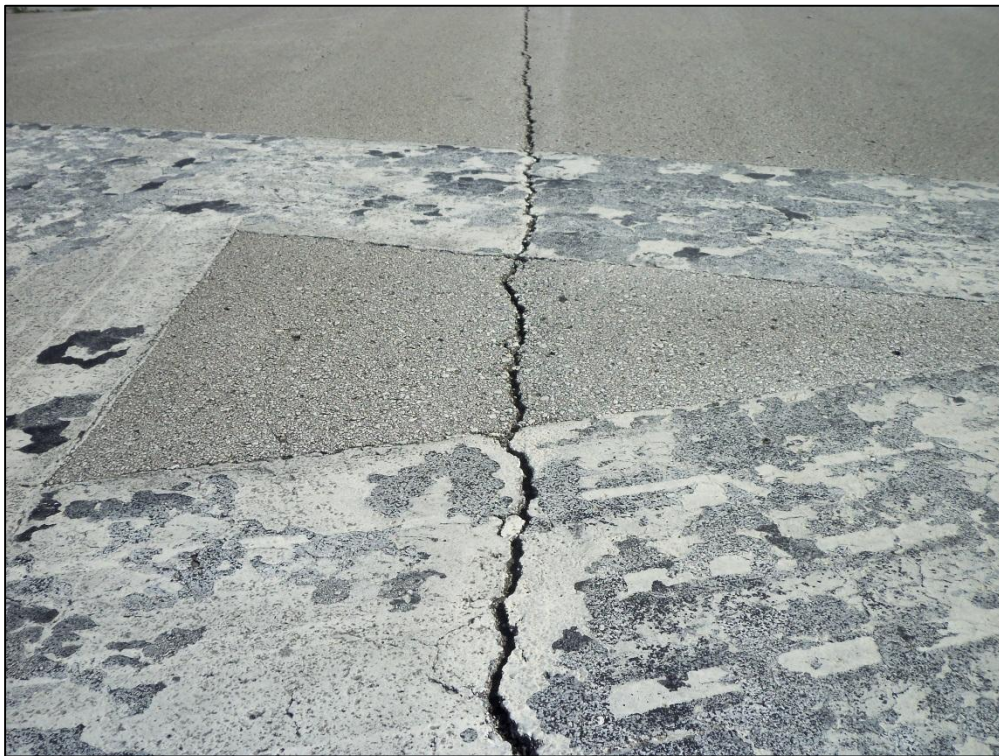
Taxiway East, Section 110, Sample Unit 113 – Medium Severity (48) Longitudinal and Transverse Cracking, Low Severity (52) Raveling, Low Severity (57) Weathering

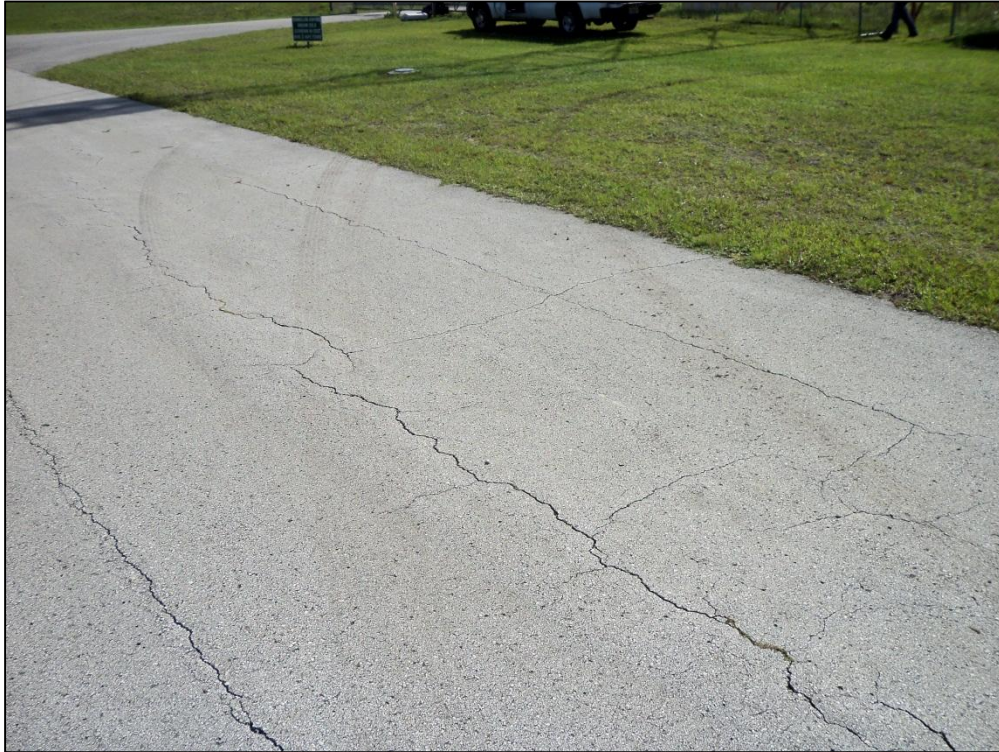
Taxiway East, Section 110, Sample Unit 113 – Low Severity (48) Longitudinal and Transverse Cracking, Low Severity (52) Raveling, Low Severity (57) Weathering, Low Severity (43) Block Cracking

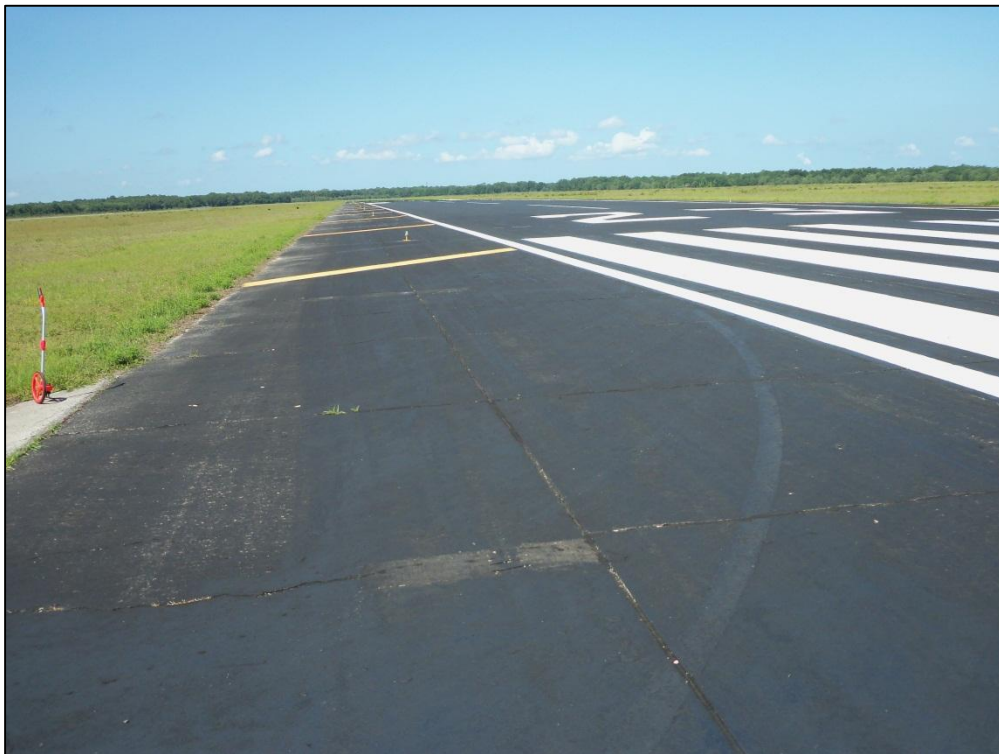
Taxiway East, Section 115, Sample Unit 135 – Low Severity (63) Longitudinal, Transverse, Diagonal Cracking, Low Severity (65) Joint Seal Damage

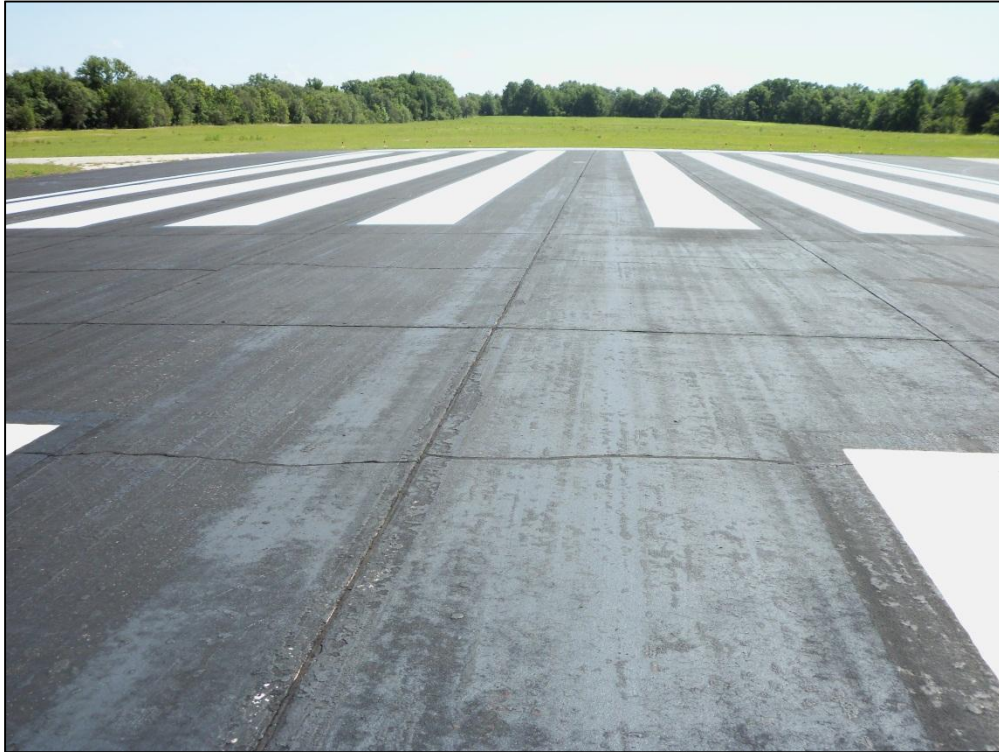
Runway 5-23, Section 6215, Sample Unit 195 – Low Severity (63) Longitudinal, Transverse, Diagonal Cracking

- ⦿ Runway 5-23 – Section 6215
 - PCC Restoration attributed to load repetition, overloading and pavement repair.
- ⦿ Hangar Apron – Sections 4210, 4220 and 4230
 - Mill and Overlay along with Reconstruction attributed to load repetition, overloading, pavement repair, climate and age of pavement.
- ⦿ Apron – Section 4105
 - Mill and Overlay attributed to climate and age of pavement.
- ⦿ Taxiway E – Sections 110 and 115
 - Mill and Overlay along with Reconstruction attributed to subgrade quality, climate and age of pavement.

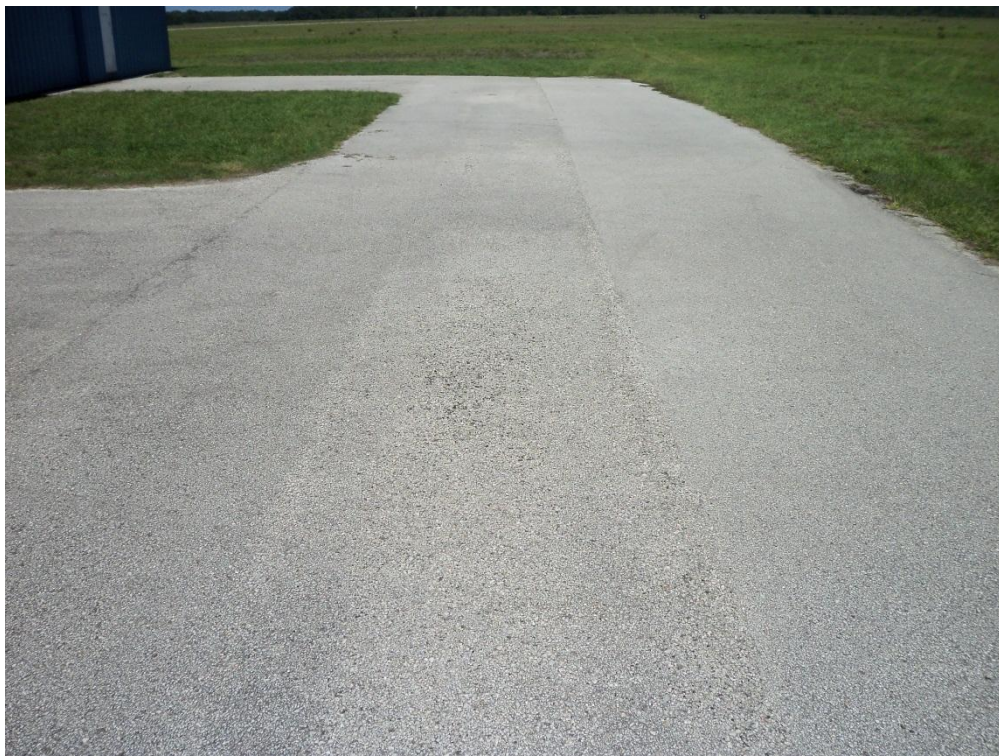
Apron Hangar, Section 4210, Sample Unit 100 – Low Severity (48) Longitudinal and Transverse Cracking, Low and Medium Severity (52) Raveling, Low Severity (57) Weathering

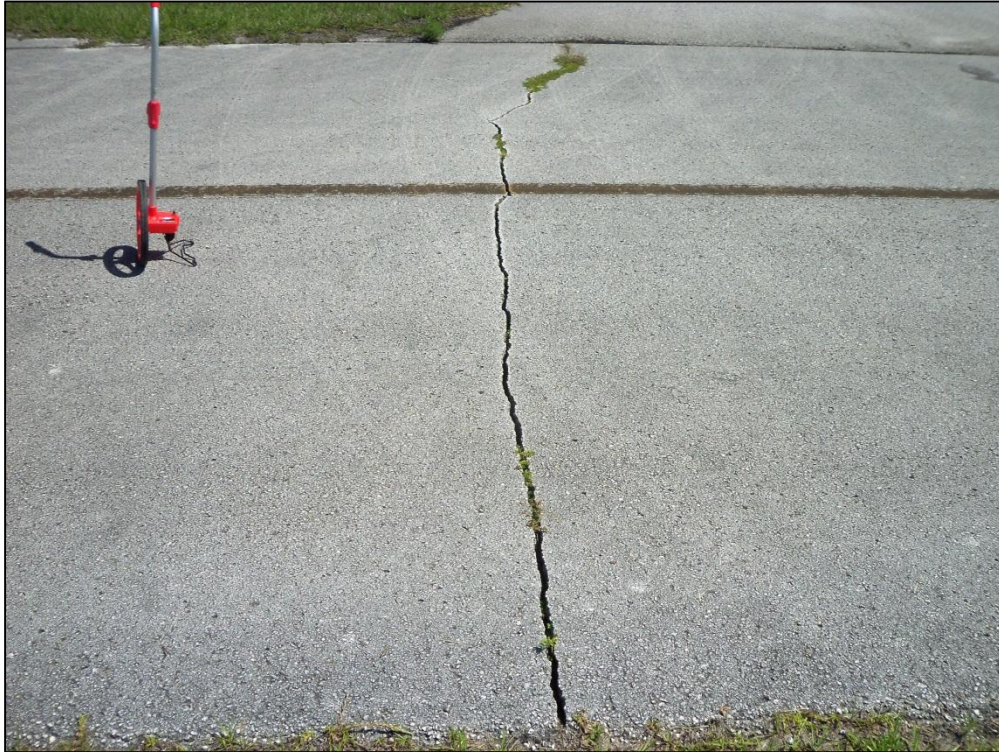
Apron Hangar, Section 4220, Sample Unit 300 – High Severity (48) Longitudinal and Transverse Cracking, Low and Medium Severity (52) Raveling, Low Severity (57) Weathering

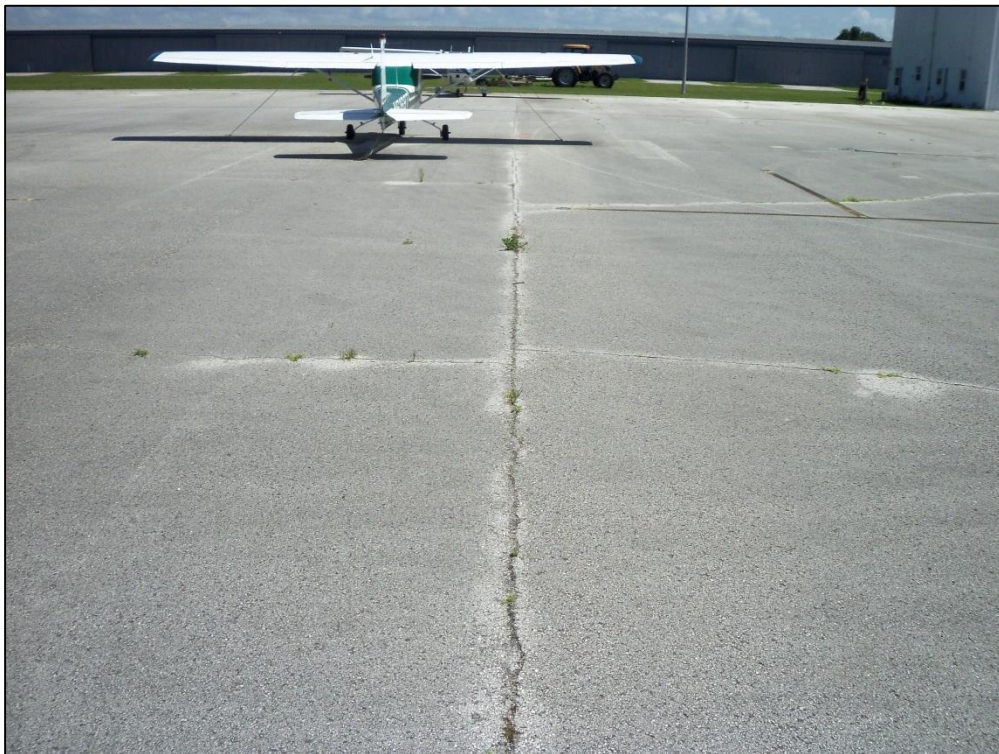
Apron, Section 4105, Sample Unit 204 – Low and Medium Severity (48) Longitudinal and Transverse Cracking, Low and Medium Severity (52) Raveling, Low Severity (57) Weathering

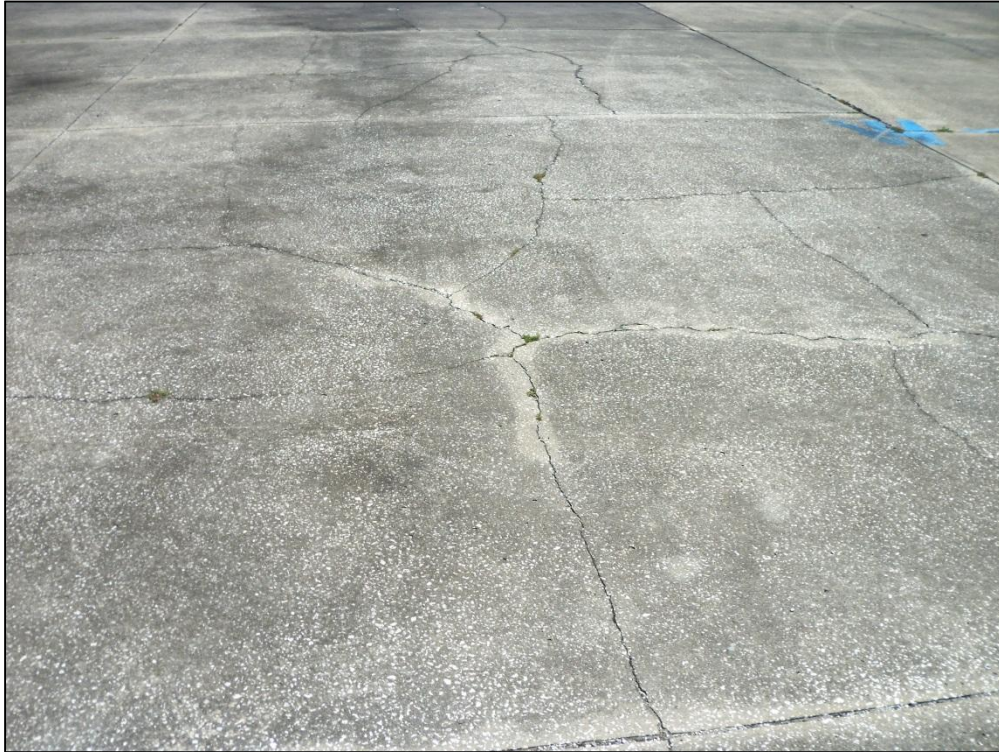
Apron Hangar, Section 4230, Sample Unit 401 – Medium Severity (65) Joint Seal Damage, Low Severity (72) Shattered Slab

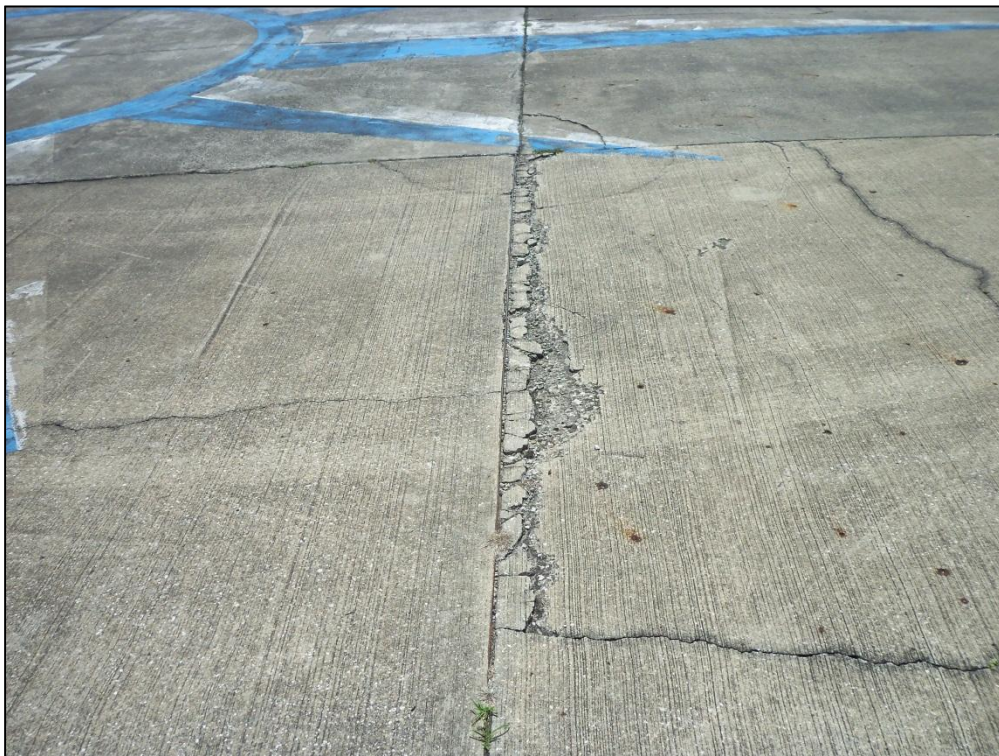
Apron Hangar, Section 4230, Sample Unit 401 – Medium Severity (65) Joint Seal Damage, High Severity (74) Joint Spalling, Low Severity (63) Longitudinal, Transverse, Diagonal Cracking, Low Severity (62) Corner Break

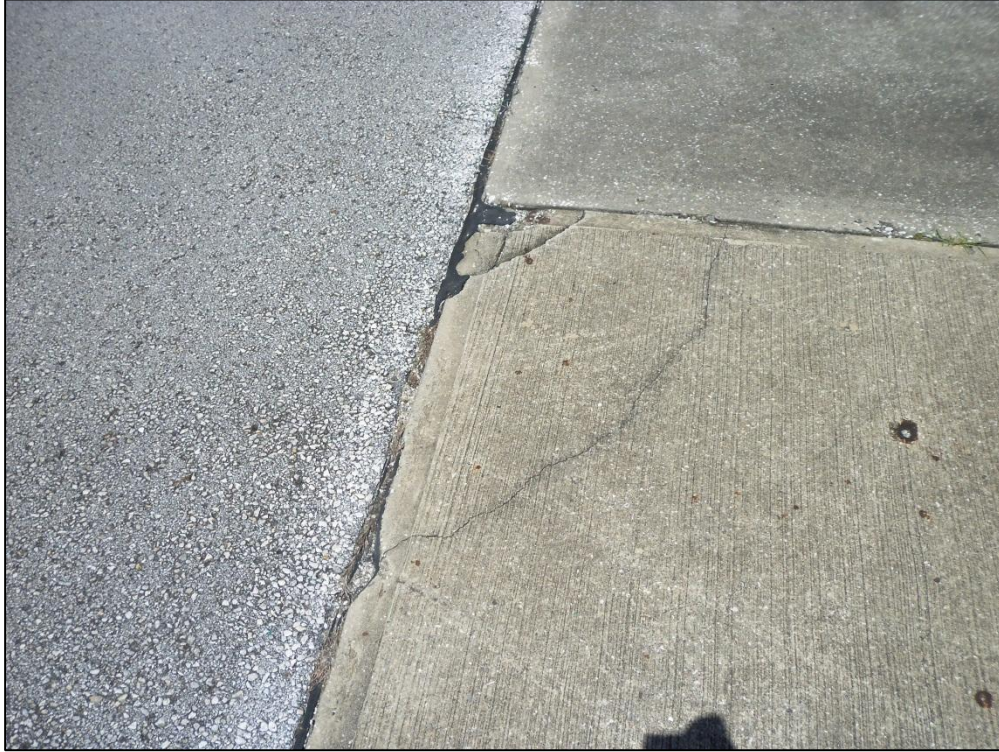
Apron Hangar, Section 4230, Sample Unit 401 – Medium Severity (65) Joint Seal Damage, Medium Severity (62) Corner Break
