FLORIDA DEPARTMENT OF TRANSPORTATION  
AVIATION AND SPACEPORT OFFICE

**HOMESTEAD  
GENERAL AVIATION  
AIRPORT (X51)**

DECEMBER 2013

# STATEWIDE Airfield Pavement Management PROGRAM

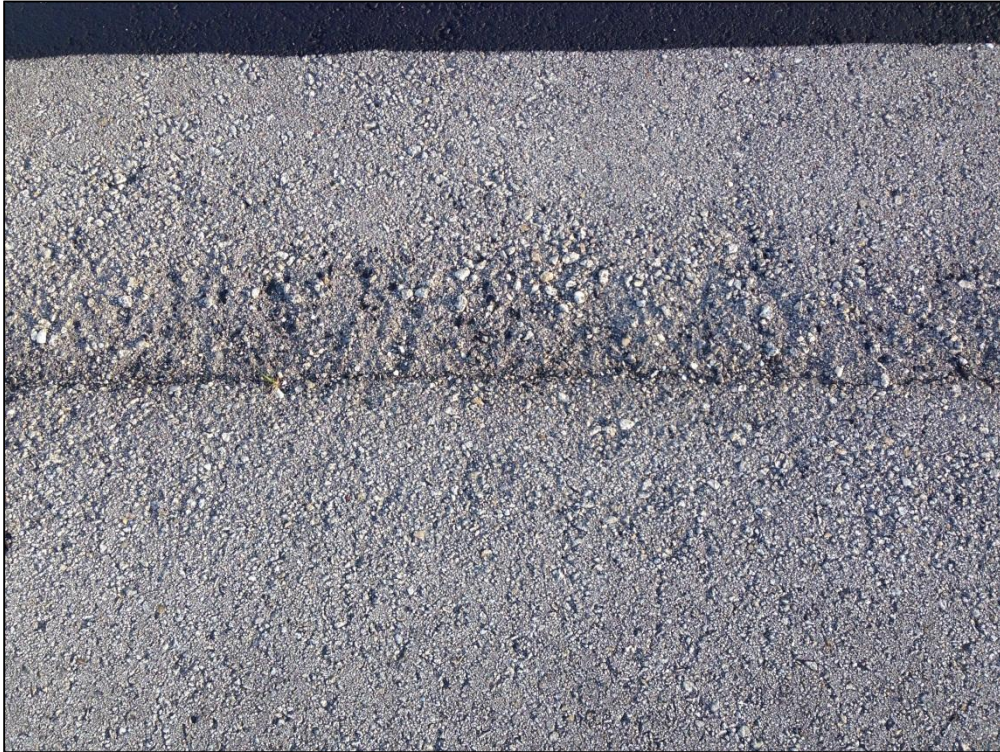
Runway 10-28, Section 6205, Sample Unit 159 – Low Severity (48) Longitudinal and Transverse Cracking, Medium Severity (52) Raveling

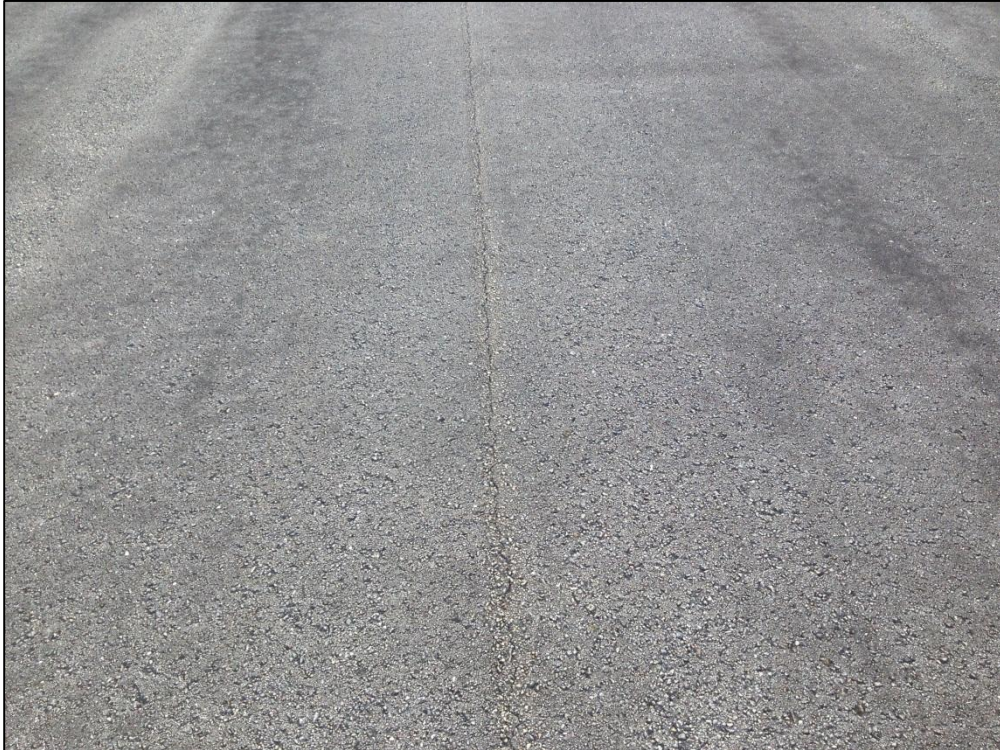
Runway 10-28, Section 6205, Sample Unit 149 – Low Severity (48) Longitudinal and Transverse Cracking, Low Severity (57) Weathering

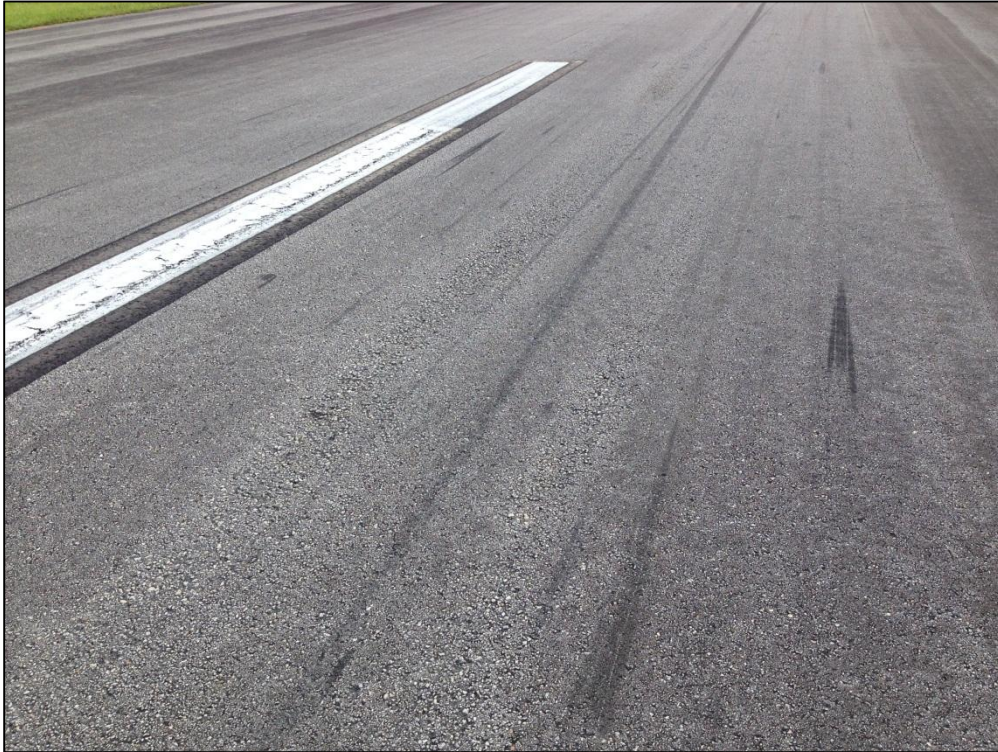
Runway 10-28, Section 6205, Sample Unit 149 – Low Severity (52) Raveling, Low Severity (57) Weathering

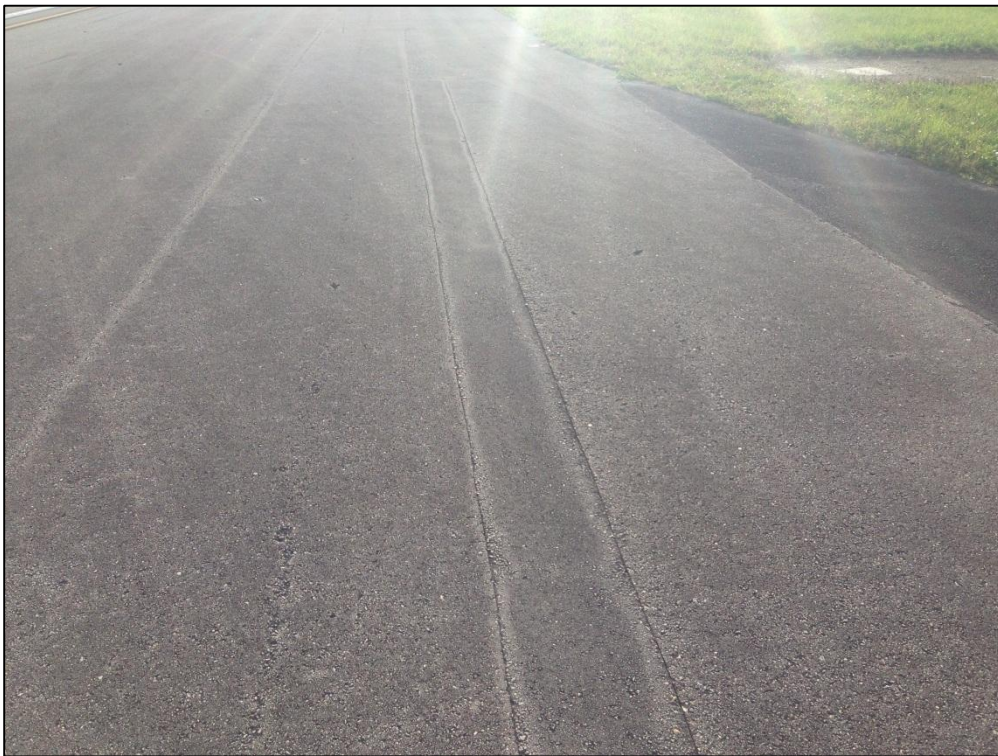
Runway 10-28, Section 6205, Sample Unit 131 – Low Severity (48) Longitudinal and Transverse Cracking, Low Severity (57) Weathering, Low Severity (50) Patching

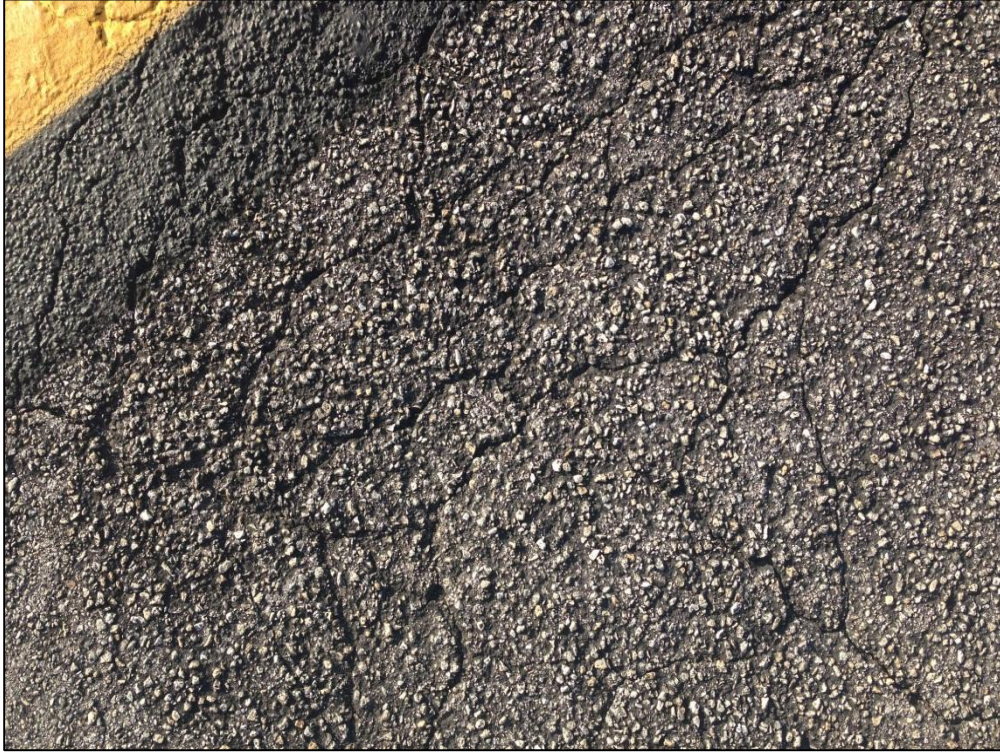
Taxiway A1, Section 230, Sample Unit 100 – Low Severity (41) Alligator Cracking

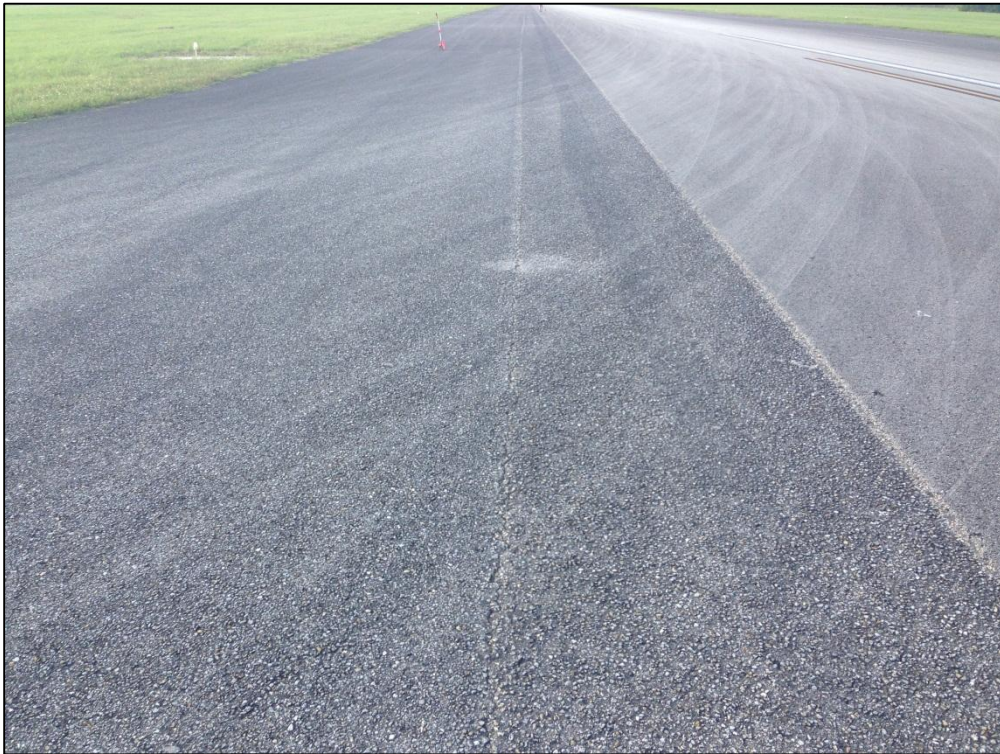
Runway 18-36, Section 6110, Sample Unit 576 – Low Severity (48) Longitudinal and Transverse Cracking, Medium Severity (57) Weathering, Low Severity (52) Raveling

- Runway 18-36 – Section 6110
  - Mill and Overlay attributed to distresses related to climate and age of pavement.
- Taxiway C – Section 400
  - Mill and Overlay attributed to distresses related to climate and age of pavement.
- Taxiway to Apron – Section 305
  - Mill and Overlay attributed to distresses related to climate and age of pavement.
- Taxiway A – Sections 295, 290, 280, 270, 260, 205, and 160
  - Mill and Overlay attributed to distresses related to subgrade quality, climate, and age of pavement.
- Taxiway A3 – Section 250
  - Mill and Overlay attributed to distresses related to climate and age of pavement.

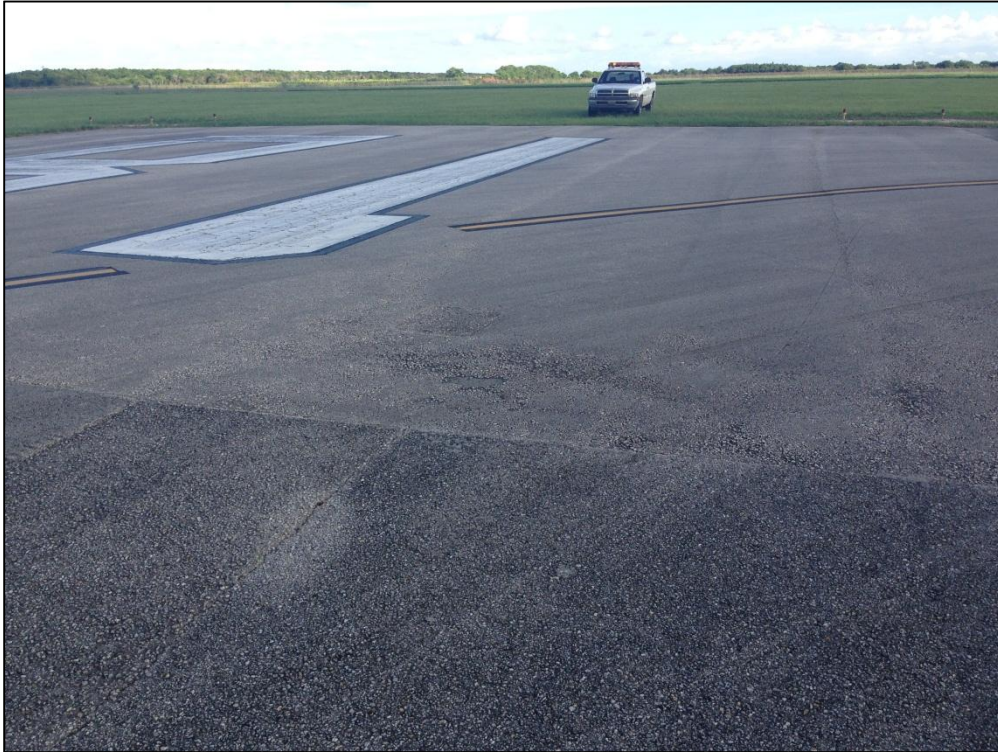
Runway 18-36, Section 6110, Sample Unit 576 – Low Severity (48) Longitudinal and Transverse Cracking, Medium Severity (57) Weathering, Low Severity (52) Raveling

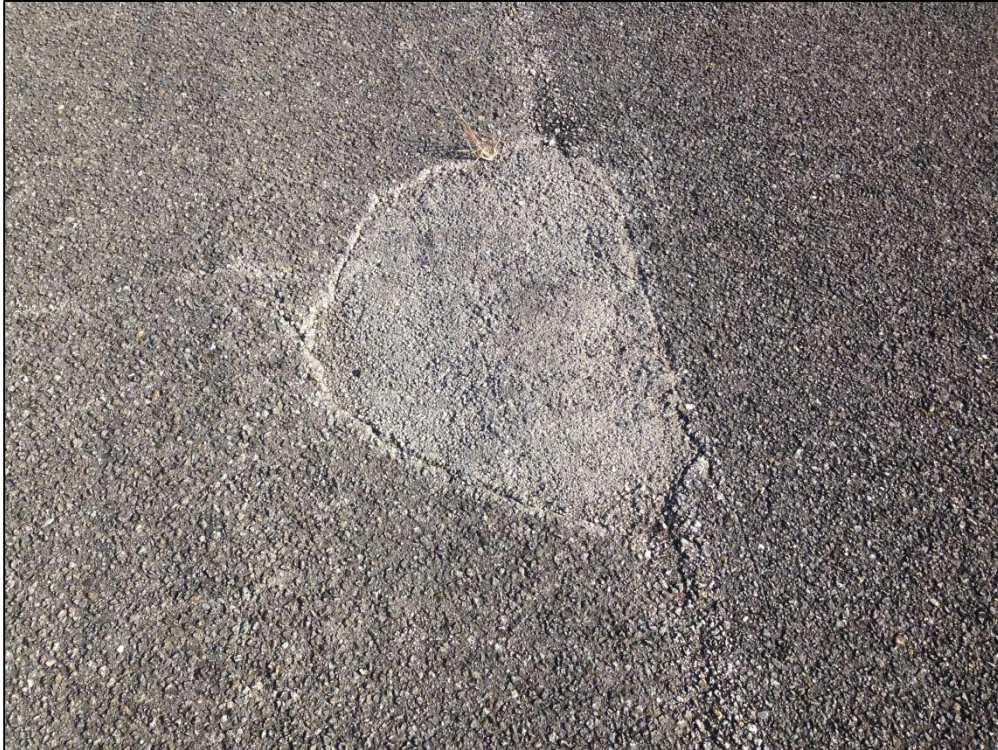
Runway 18-36, Section 6110, Sample Unit 560 – Low Severity (48) Longitudinal and Transverse Cracking, Medium Severity (57) Weathering, Low Severity (52) Raveling, Medium Severity (50) Patching

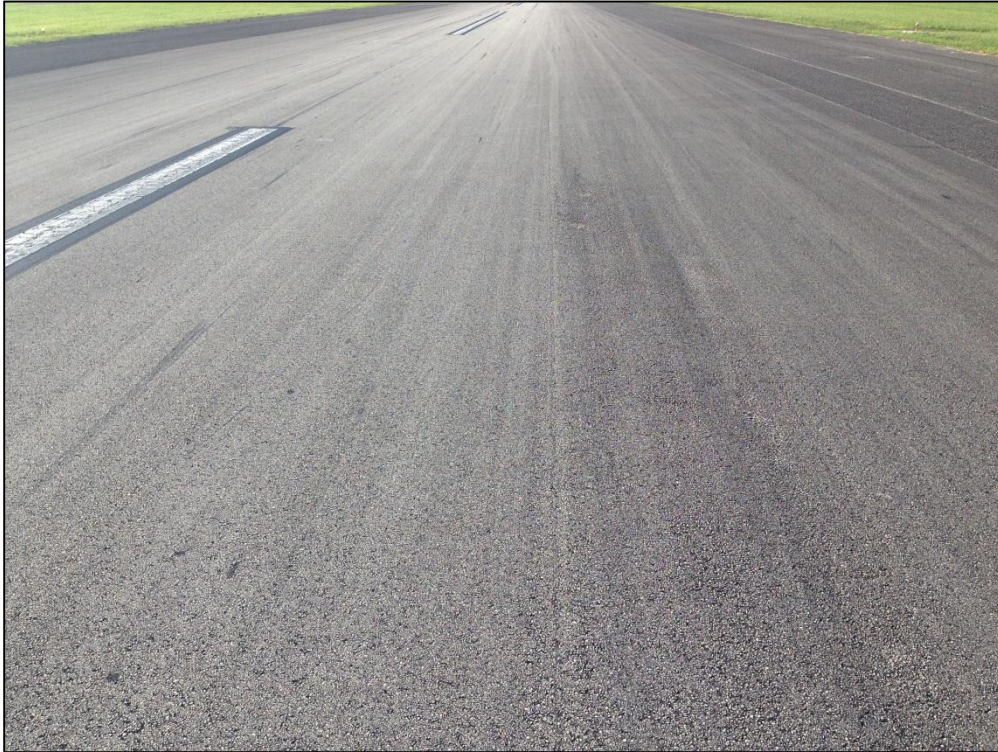
Runway 18-36, Section 6105, Sample Unit 329 – Low Severity (57) Weathering

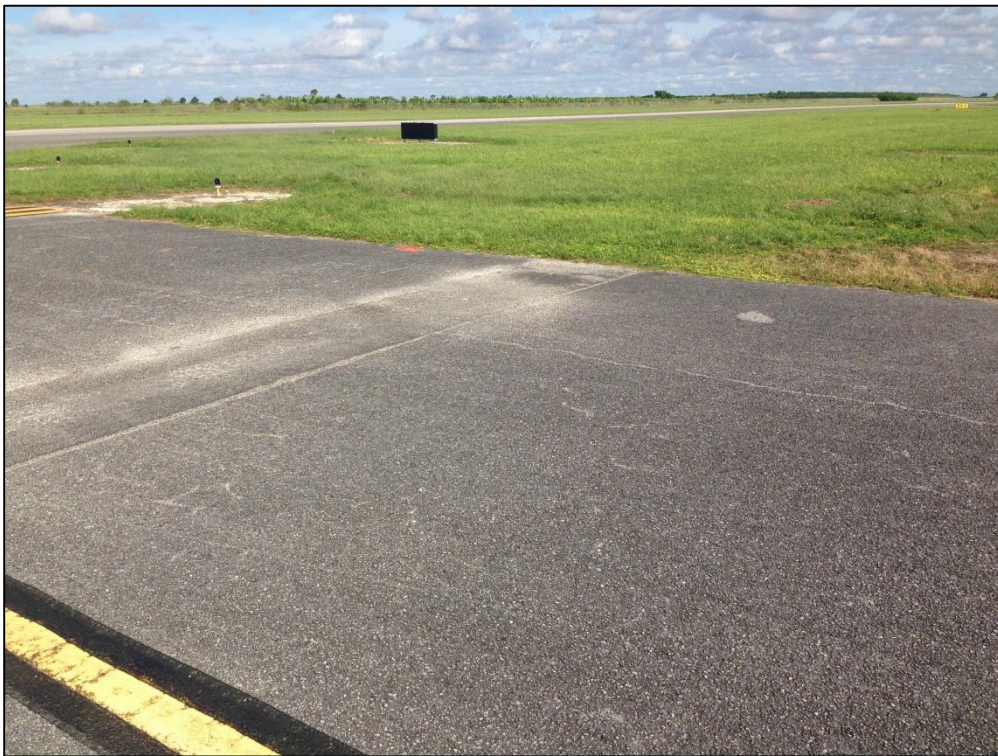
Taxiway B3, Section 130, Sample Unit 302 – Low Severity (48) Longitudinal and Transverse Cracking, Low Severity (52) Raveling, Low Severity (50) Patching

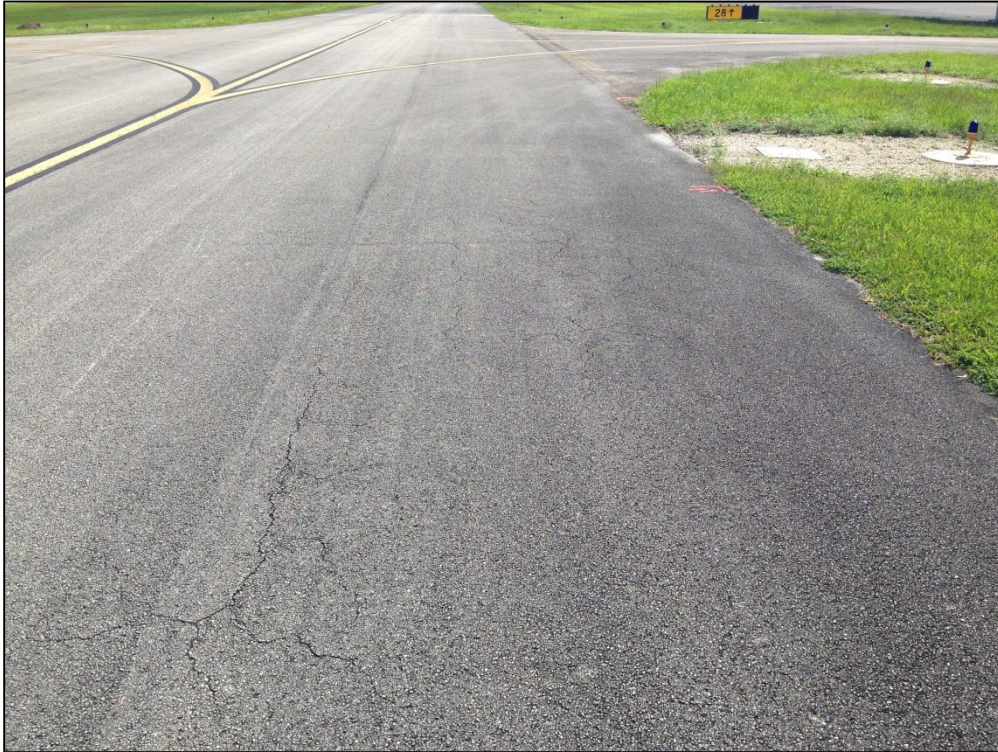
Taxiway A, Section 215, Sample Unit 117 – Low Severity (43) Block Cracking, Medium Severity (57) Weathering

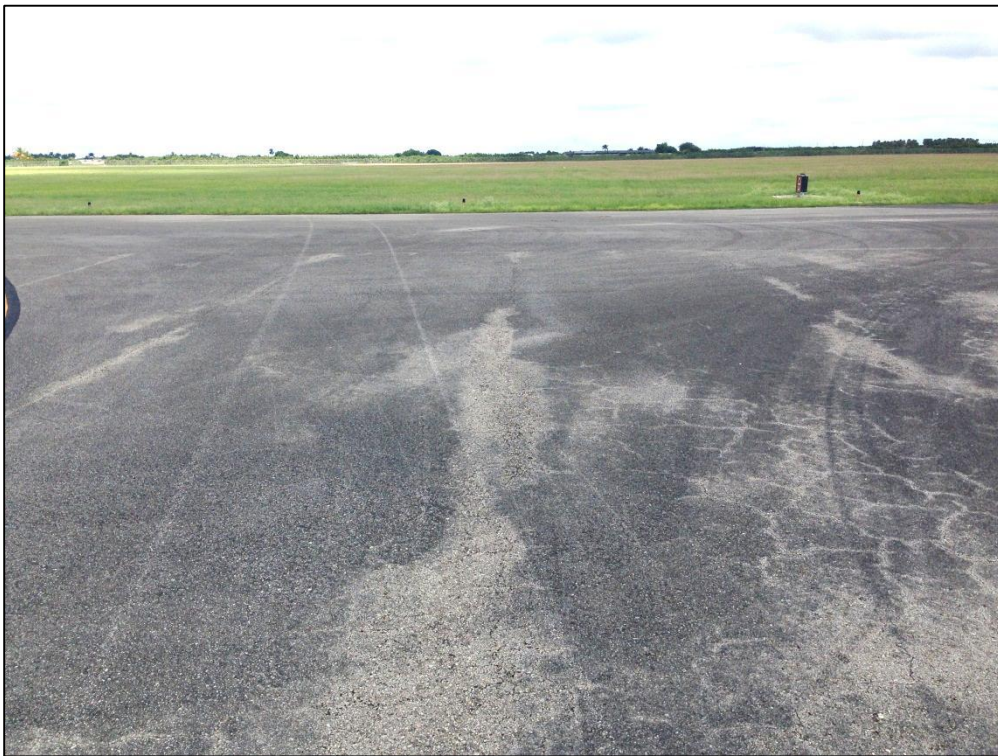
Taxiway AP, Section 305, Sample Unit 100 – Low Severity (48) Longitudinal and Transverse Cracking, Low and Medium Severity (52) Raveling, Low Severity (43) Block Cracking

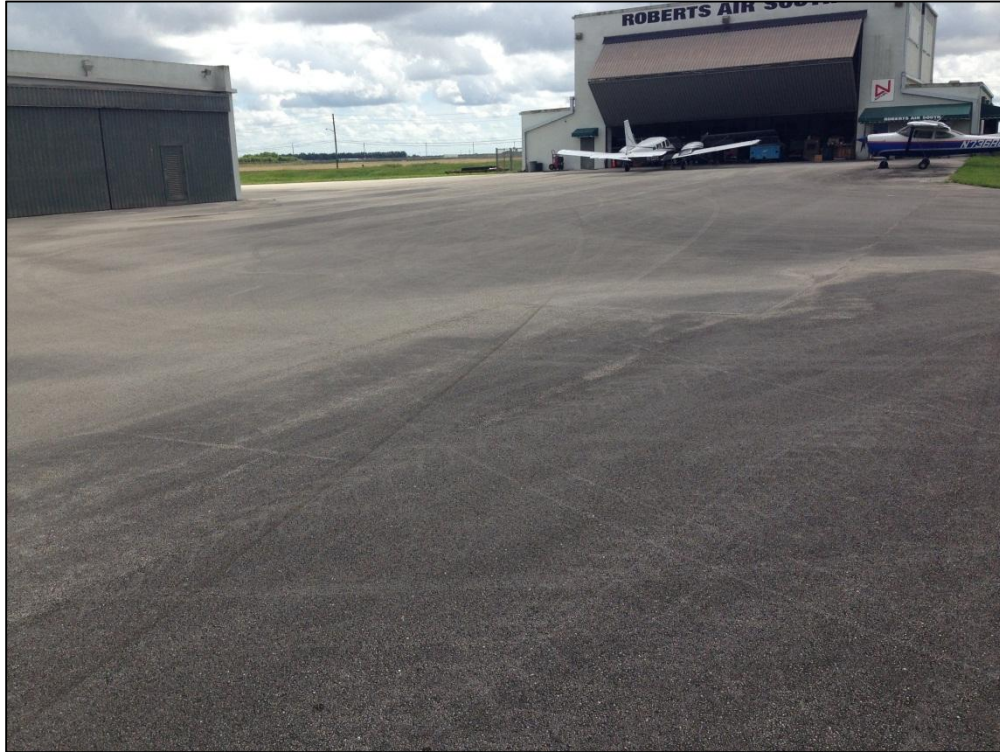
Apron NE, Section 4305, Sample Unit 204 – Low Severity (48) Longitudinal and Transverse Cracking, Low Severity (57) Weathering

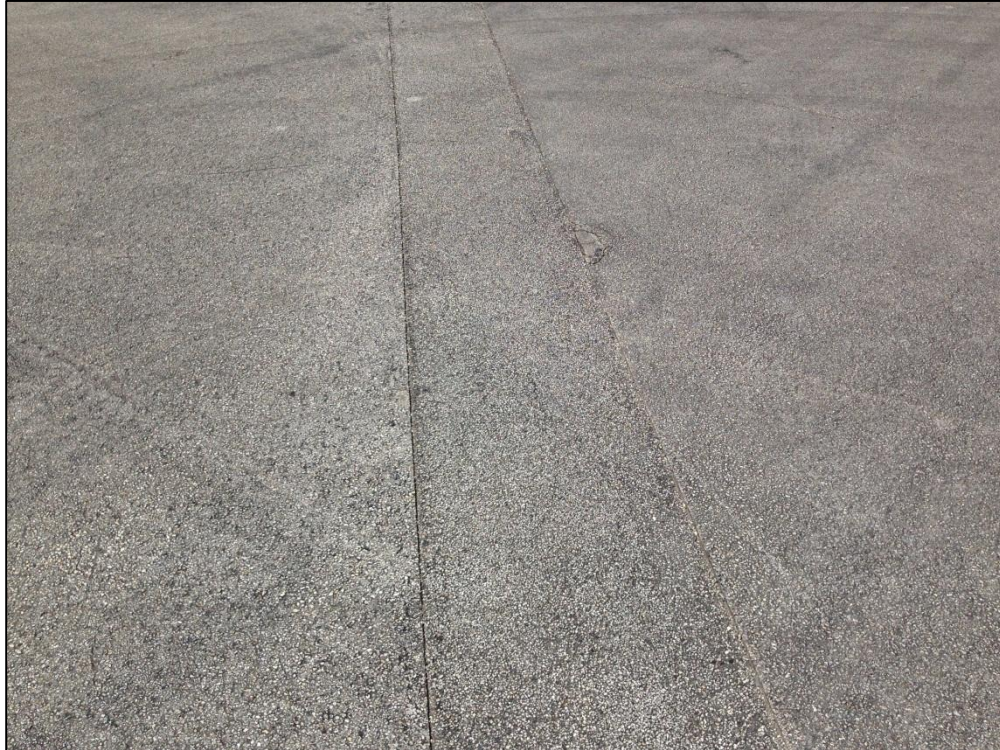
Apron NE, Section 4205, Sample Unit 403 – Low Severity (48) Longitudinal and Transverse Cracking, Medium Severity (57) Weathering, Low Severity (50) Patching

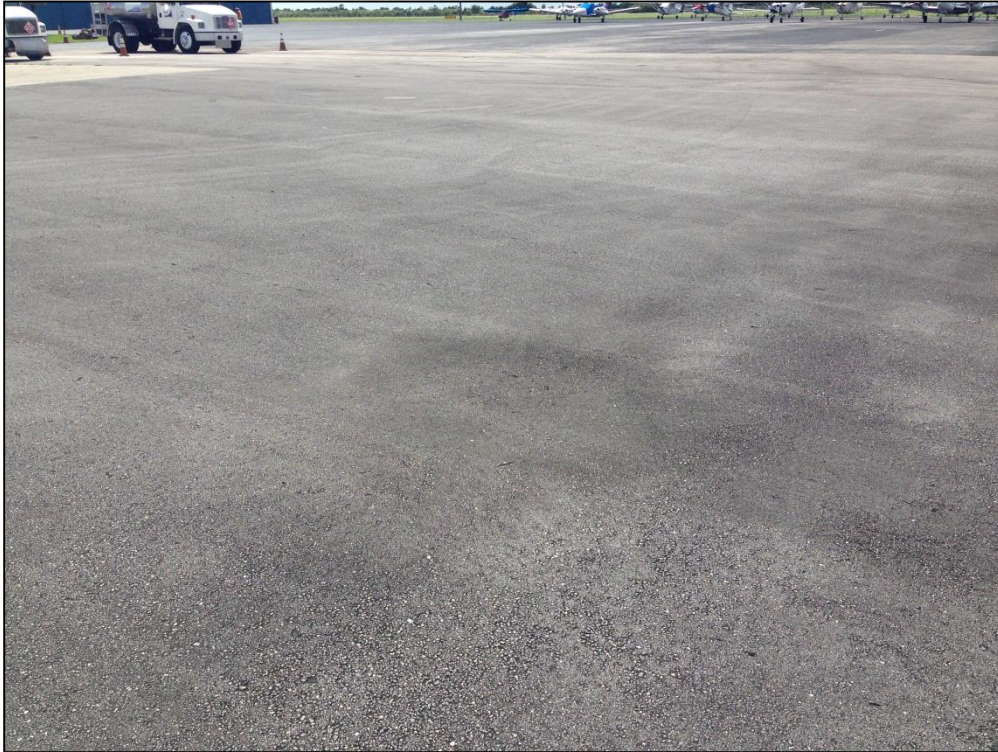
Apron NW, Section 4110, Sample Unit 200 – Low Severity (45) Depression, Low Severity (57) Weathering

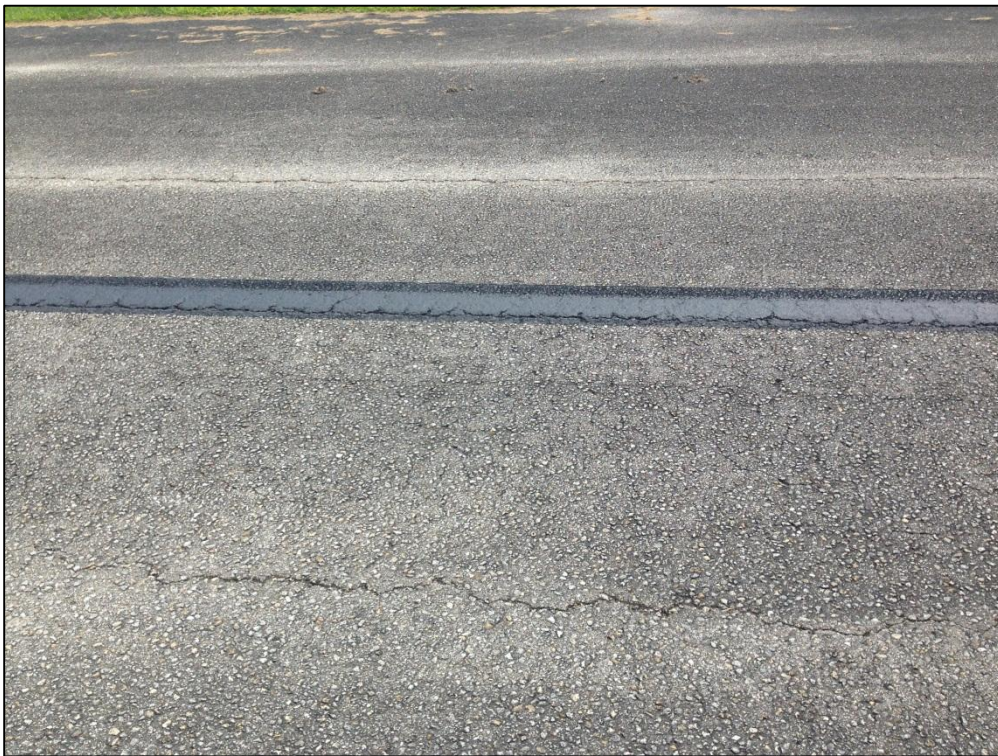
Taxiway B, Section 180, Sample Unit 801 – Low Severity (48) Longitudinal and Transverse Cracking, Low Severity (57) Weathering, Low Severity (52) Raveling
