FLORIDA DEPARTMENT OF TRANSPORTATION
AVIATION AND SPACEPORT OFFICE

FLAGLER COUNTY
AIRPORT (XFL)

DECEMBER 2013

STATEWIDE
**Airfield
Pavement
Management**
PROGRAM

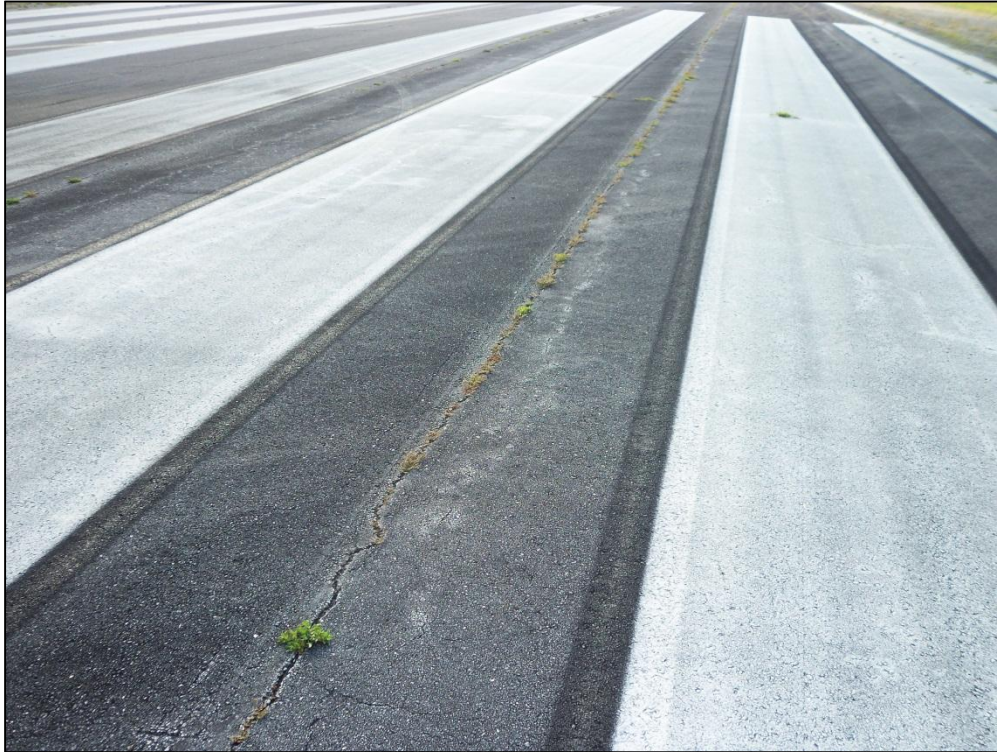
Runway 11-29, Section 6105, Sample Unit 199 – Low and Medium Severity (48) Longitudinal and Transverse Cracking, Low Severity (52) Raveling, Low Severity (57) Weathering, Low Severity (56) Swelling

- ⦿ Runway 6-24 – Section 6205
 - Mill and Overlay attributed to distresses related to subgrade quality, climate, and age of pavement.
- ⦿ Runway 11-29 – Section 6105
 - Mill and Overlay attributed to distresses related to subgrade quality, climate, and age of pavement.
- ⦿ Run-Up at Apron at Runway 11 – Section 5105
 - Mill and Overlay attributed to distresses related to subgrade quality, climate, and age of pavement.
- ⦿ Run-Up at Apron at Runway 11 – Section 5103
 - Reconstruction attributed to distresses related to climate and age of pavement.
- ⦿ Apron at T-Hangars – Sections 4315 and 4310
 - Mill and Overlay attributed to distresses related to subgrade quality, climate, and age of pavement.
- ⦿ Apron – Section 4115
 - Reconstruction attributed to distresses related to subgrade quality, climate and age of pavement.

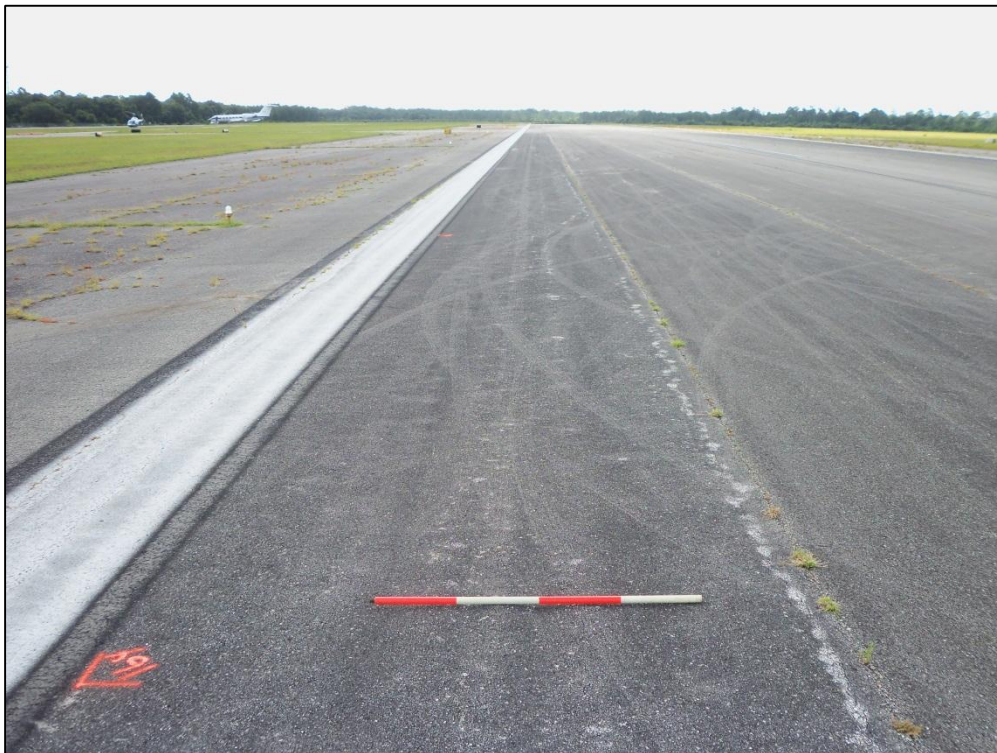
Runway 11-29, Section 6105, Sample Unit 164 – Low and Medium Severity (48) Longitudinal and Transverse Cracking, Low Severity (52) Raveling, Low Severity (57) Weathering, Low and Medium Severity (56) Swelling

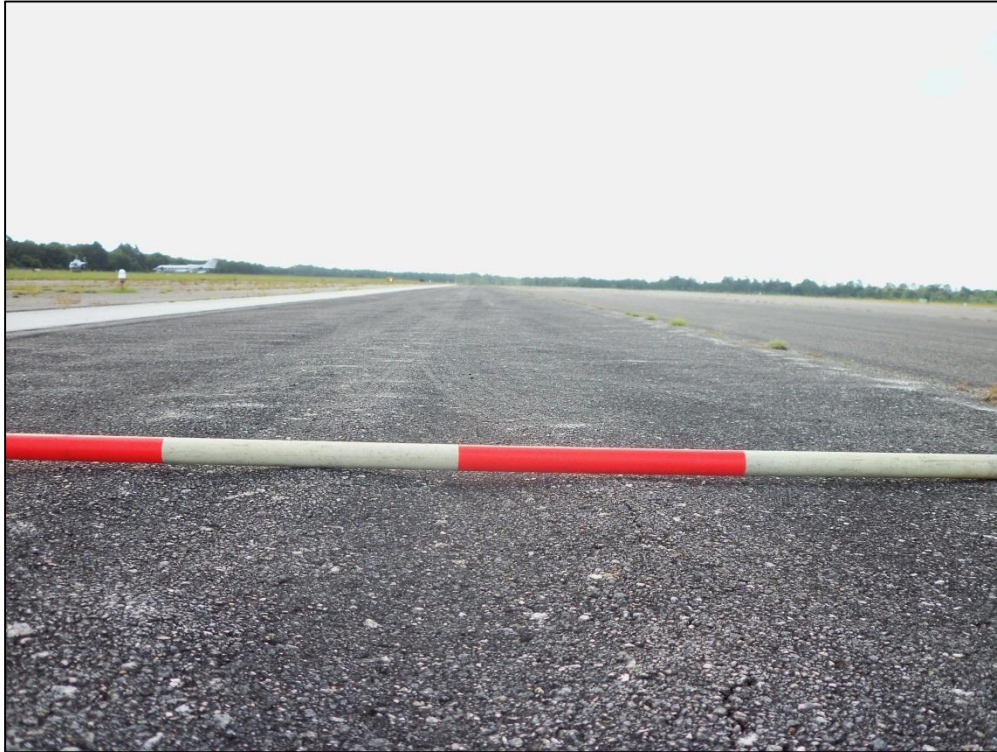
Runway 11-29, Section 6105, Sample Unit 164 – Low Severity (52) Raveling, Low Severity (57) Weathering, Low and Medium Severity (56) Swelling

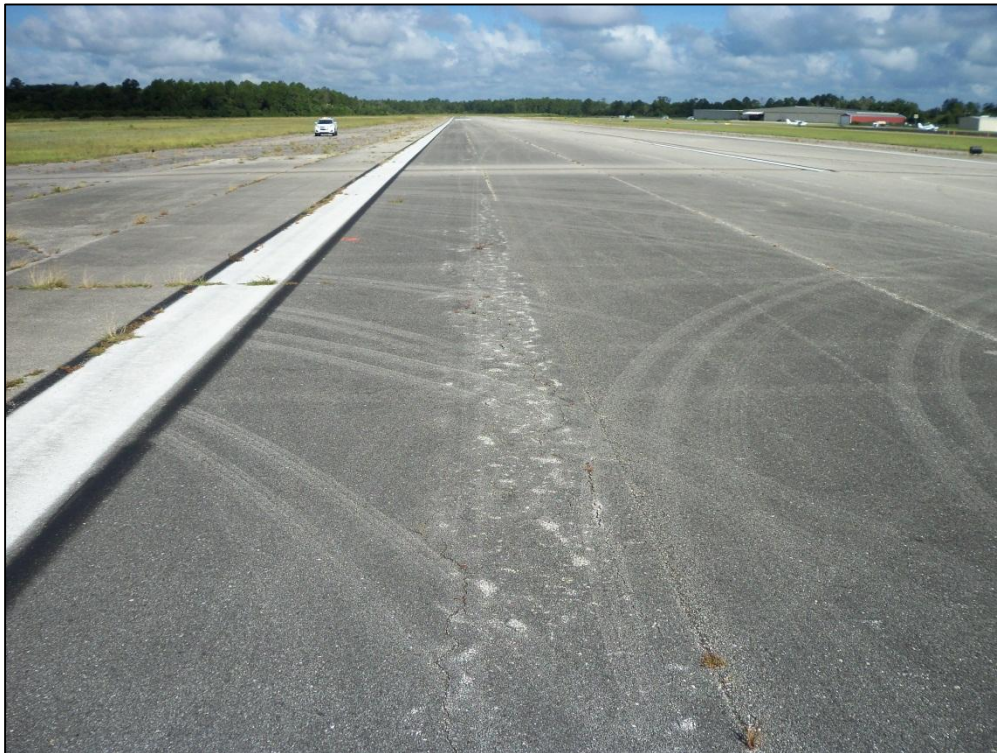
Runway 11-29, Section 6105, Sample Unit 153 – Low and Medium Severity (48) Longitudinal and Transverse Cracking, Low Severity (52) Raveling, Low Severity (57) Weathering, Low Severity (56) Swelling

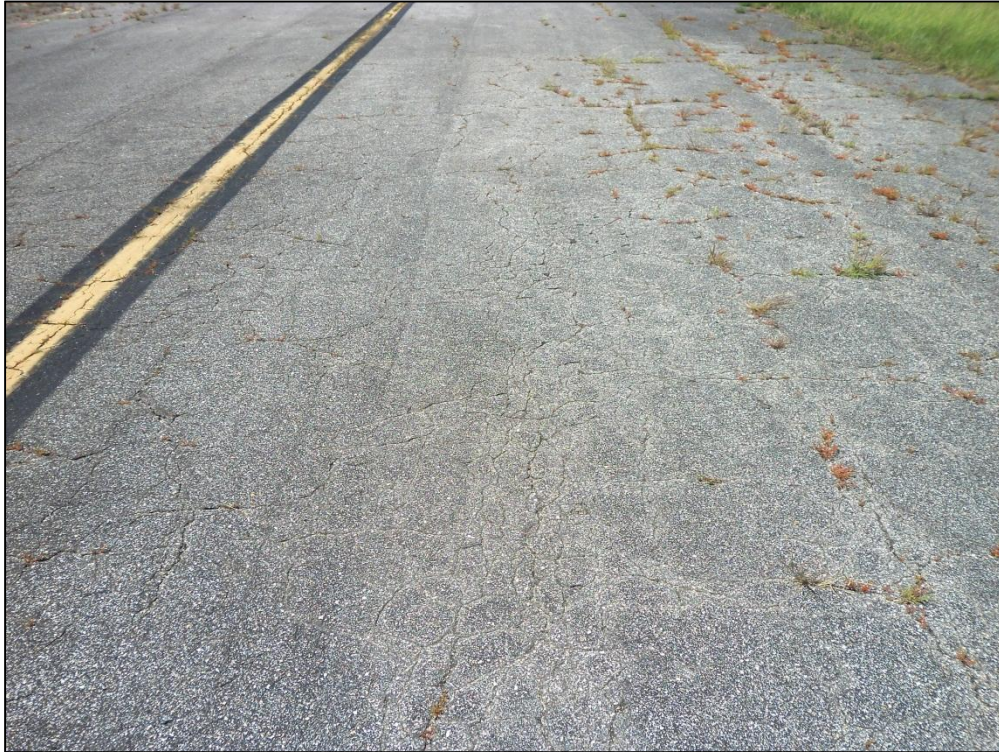
Taxiway Delta, Section 405, Sample Unit 101 – Low Severity (52) Raveling, Low Severity (57) Weathering, Low and Medium Severity (43) Block Cracking, Low Severity (41) Alligator Cracking

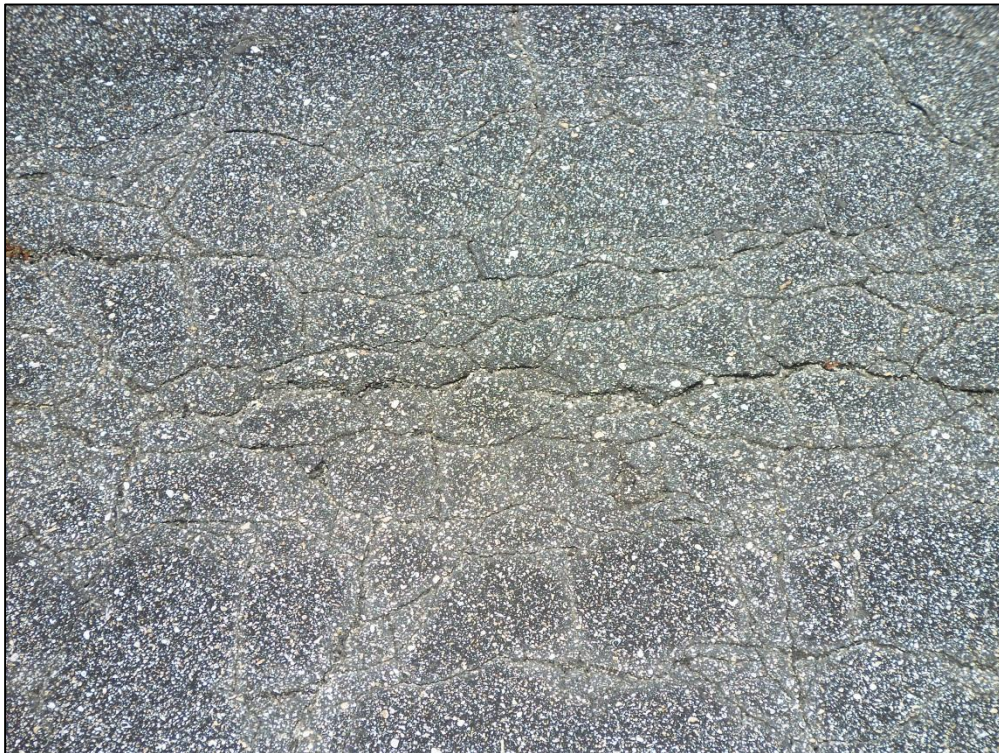
Taxiway Delta, Section 405, Sample Unit 101 – Low Severity (52) Raveling, Low Severity (57) Weathering, Low Severity (41) Alligator Cracking

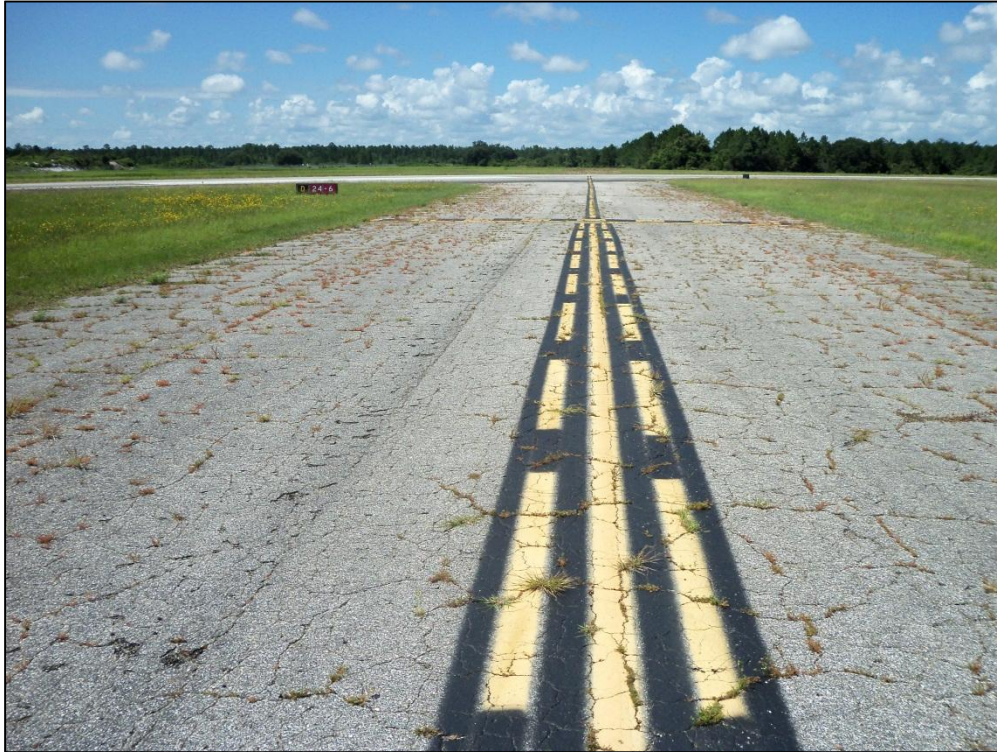
Taxiway Delta, Section 405, Sample Unit 103 – Medium Severity (52) Raveling, Medium Severity (43) Block Cracking, Medium Severity (41) Alligator Cracking

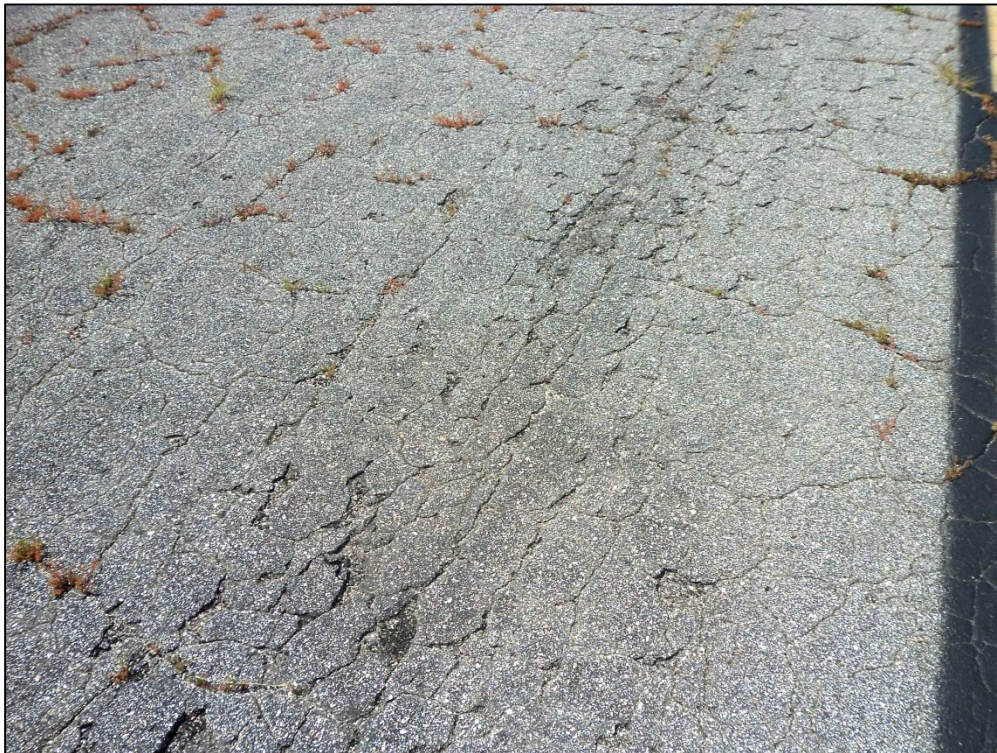
Taxiway D, Section 405, Sample Unit 103 – Low Severity (52) Raveling, Low Severity (57) Weathering, Medium Severity (43) Block Cracking, Medium Severity (41) Alligator Cracking

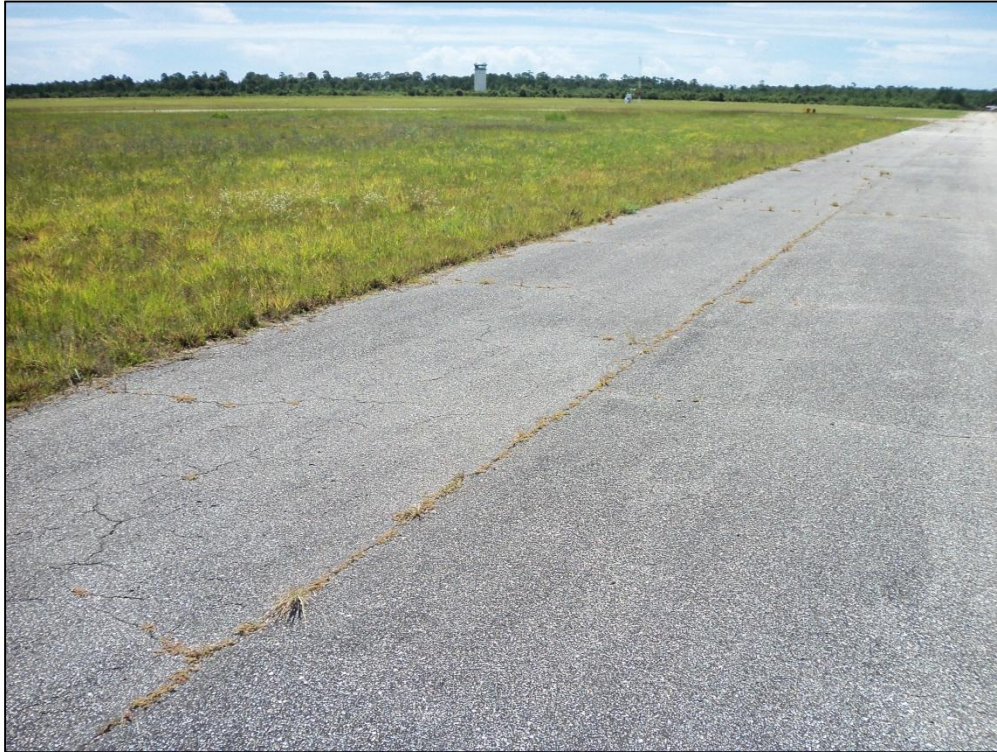
Taxiway Charlie, Section 315, Sample Unit 111 – Low and Medium Severity (48) Longitudinal and Transverse Cracking, Low Severity (52) Raveling, Low Severity (57) Weathering, Low Severity (43) Block Cracking

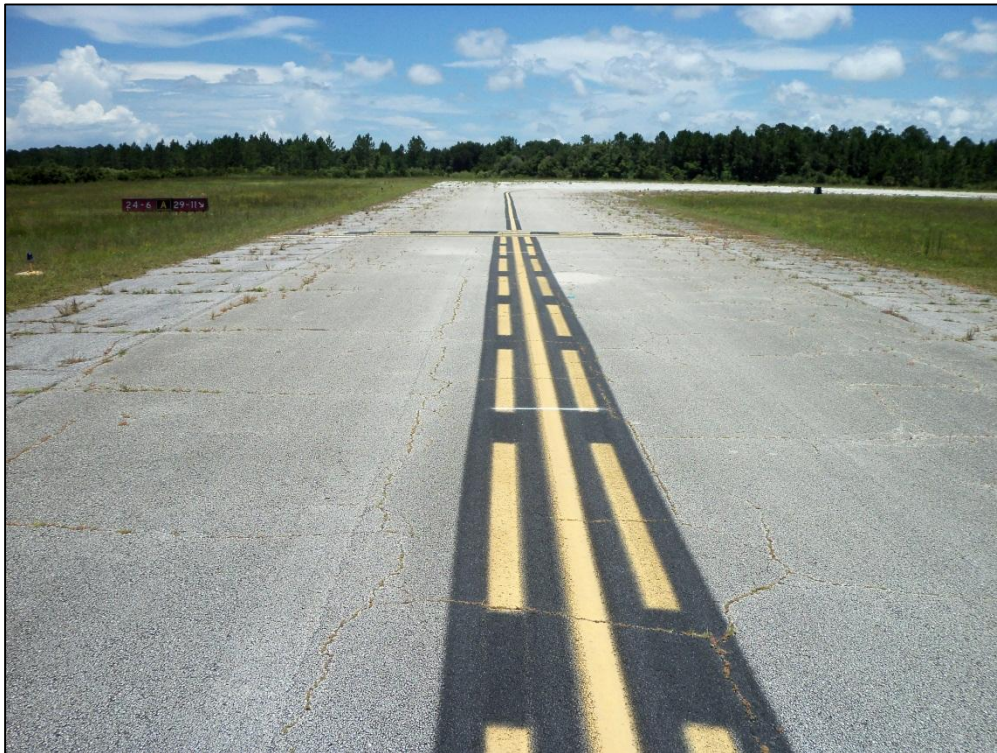
Taxiway Alpha, Section 110, Sample Unit 148 – Low Severity (52) Raveling, Medium Severity (57) Weathering, Medium Severity (43) Block Cracking

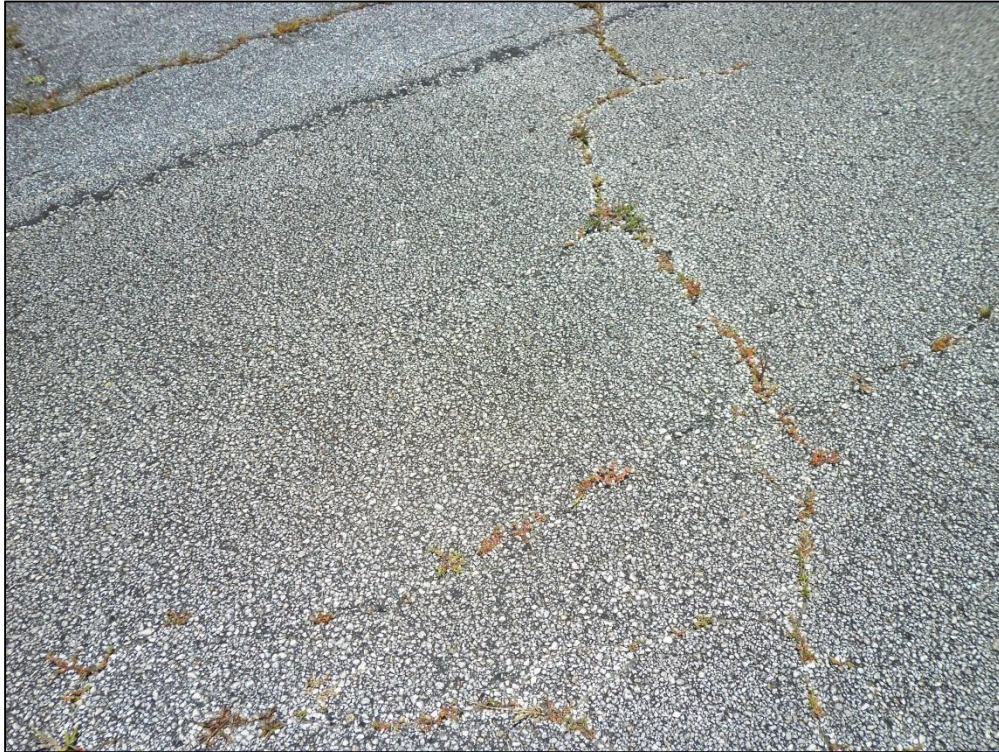
Taxiway Alpha, Section 110, Sample Unit 148 – Low Severity (52) Raveling, Medium Severity (57) Weathering, Medium Severity (43) Block Cracking

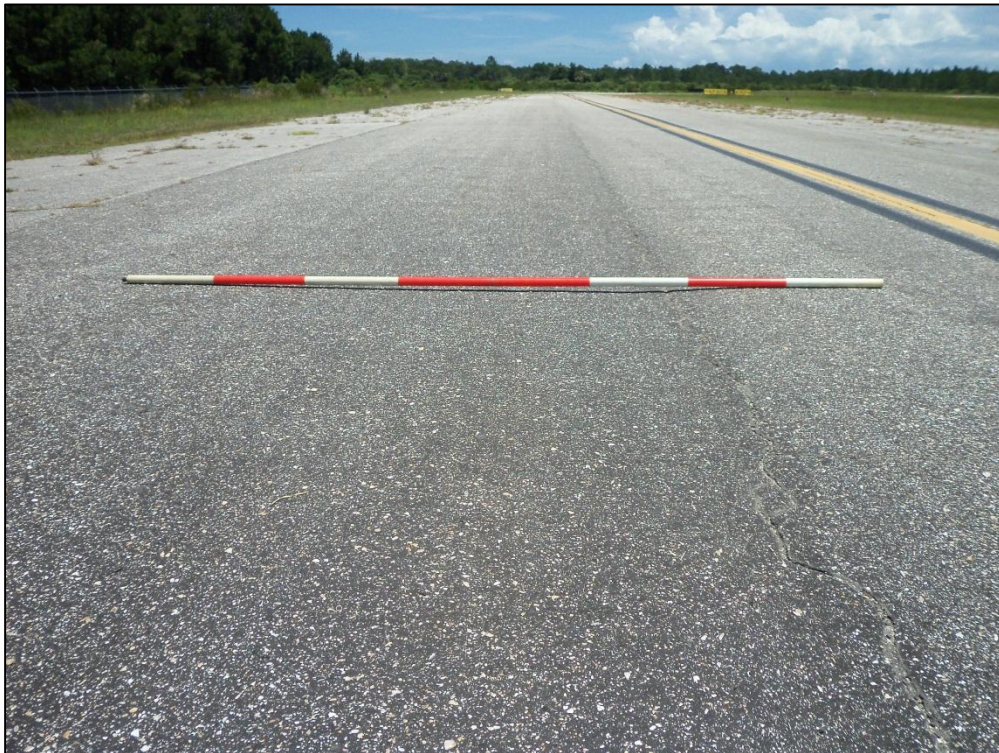
Taxiway Alpha, Section 105, Sample Unit 141 – Low Severity (57) Weathering, Low Severity (52) Raveling, Low Severity (43) Block Cracking, Low Severity (53) Rutting

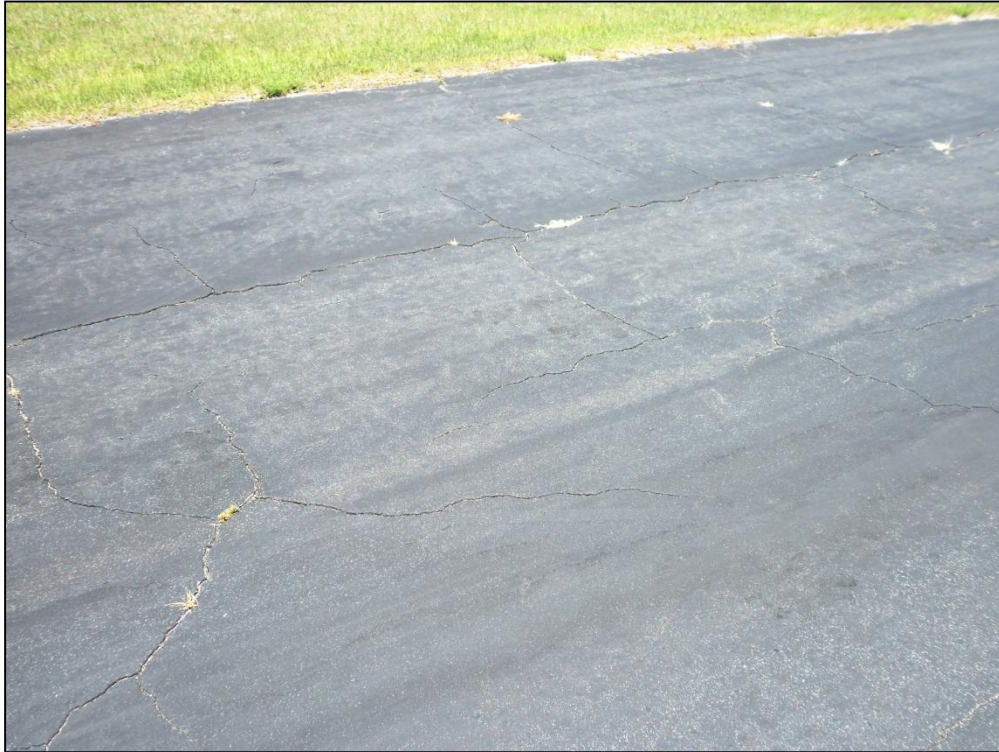
Taxiway Alpha, Section 105, Sample Unit 129 – Low and Medium Severity (43) Block Cracking

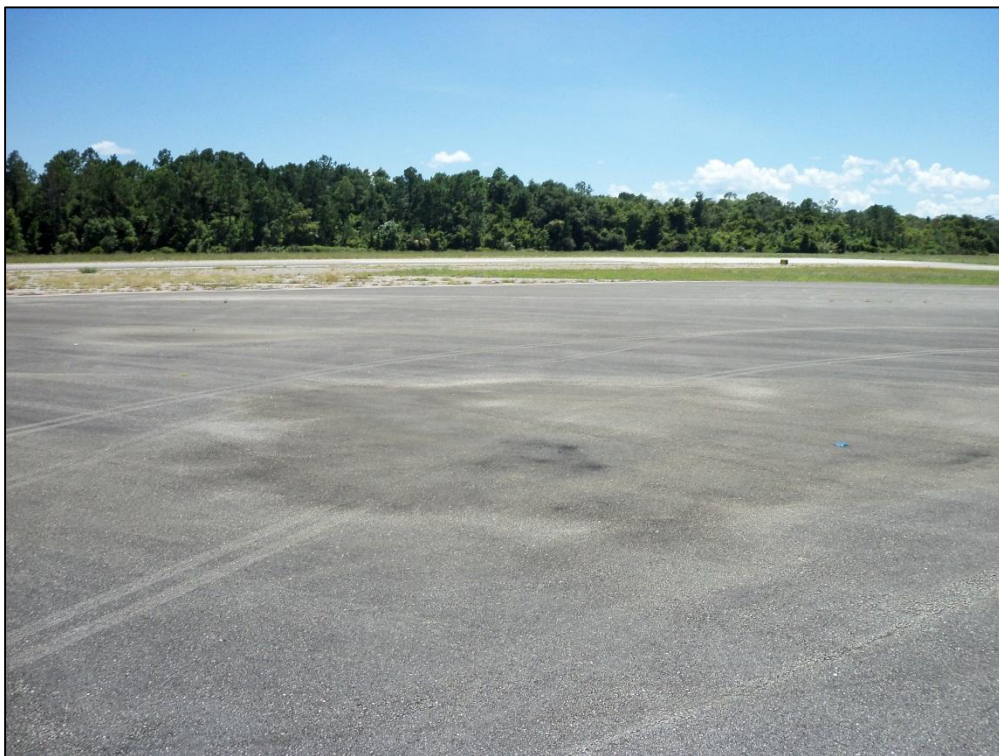
Apron Run-Up 11, Section 5105, Sample Unit 301 – Low Severity (48) Longitudinal and Transverse Cracking, Low Severity (52) Raveling, Low Severity (57) Weathering, Low Severity (45) Depression

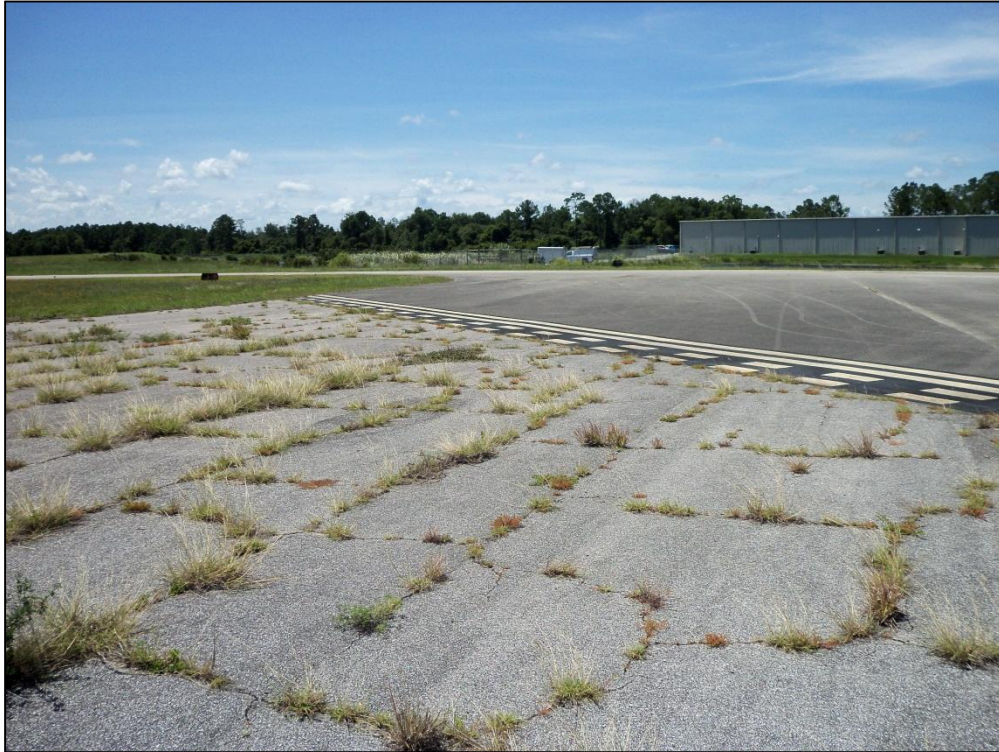
Apron Run-Up 11, Section 5103, Sample Unit 602 – Low Severity (52) Raveling, Low Severity (57) Weathering, Medium Severity (43) Block Cracking

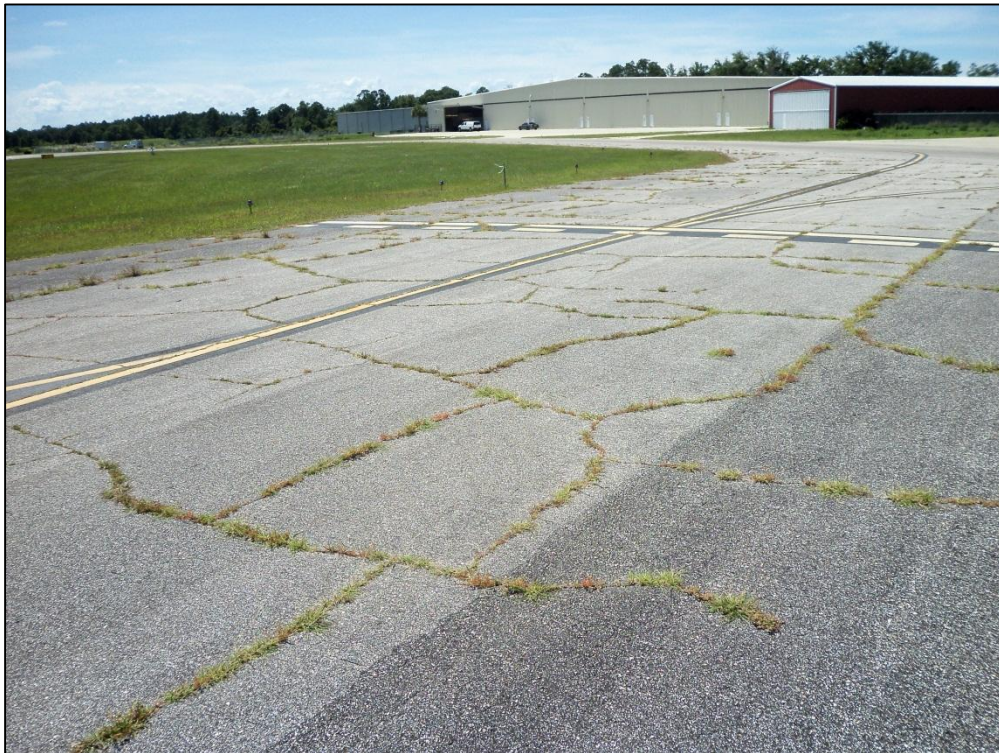
Taxiway Charlie, Section 307, Sample Unit 104 – Low Severity (52) Raveling, Low Severity (57) Weathering, Medium Severity (43) Block Cracking

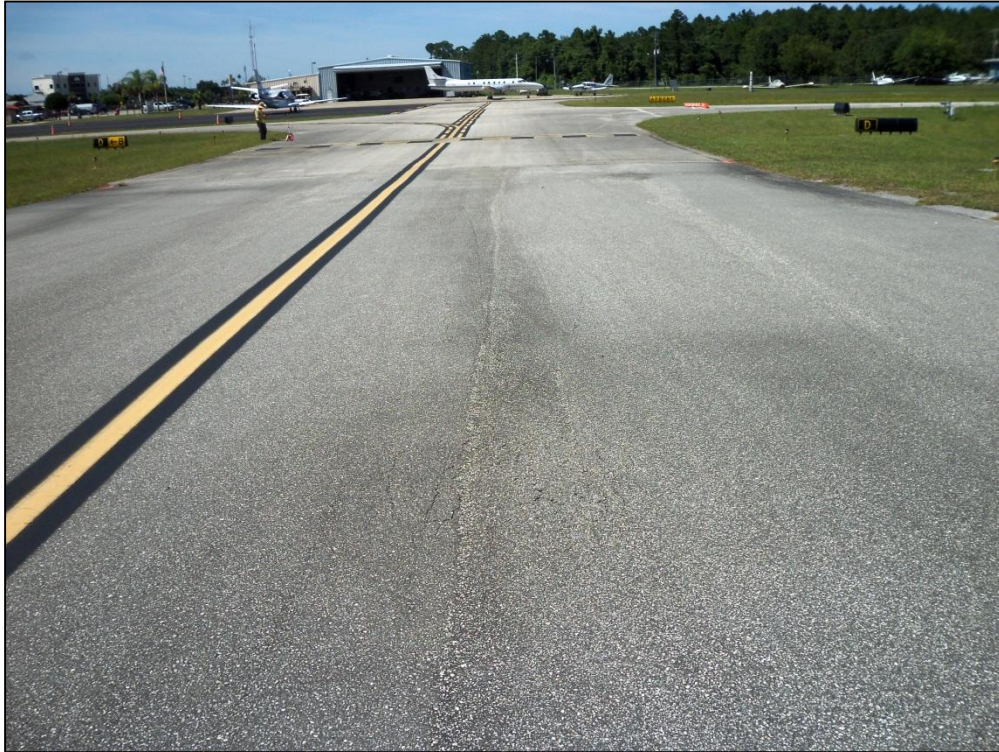
Taxiway Delta, Section 414, Sample Unit 100 – Low Severity (48) Longitudinal and Transverse Cracking, Low Severity (57) Weathering, Low Severity (53) Rutting

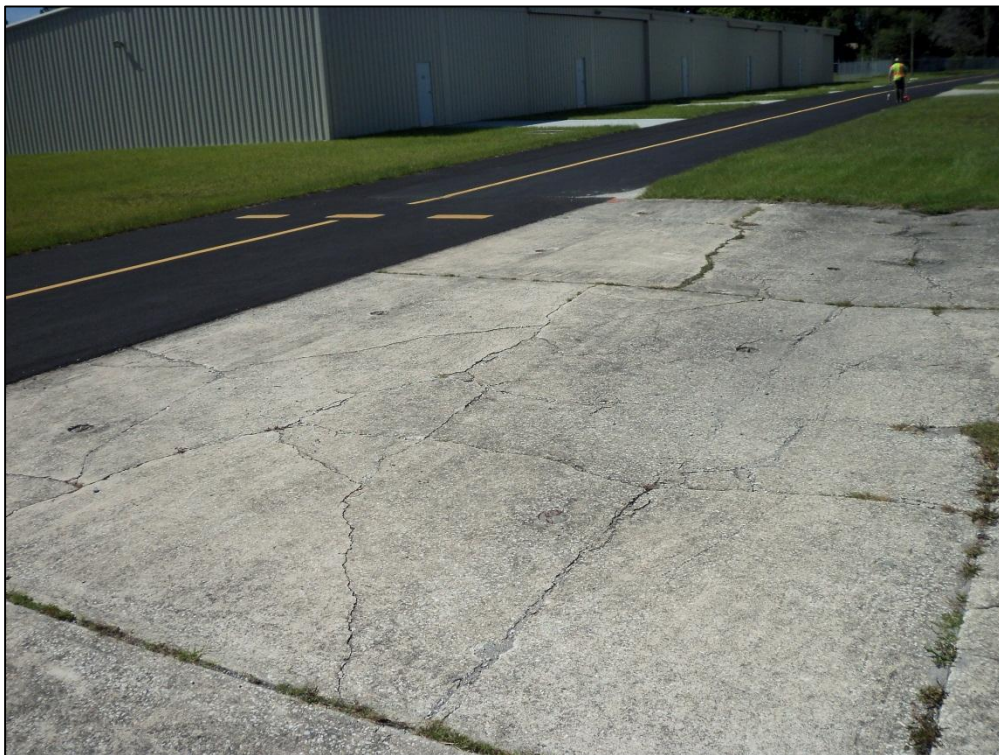
Apron, Section 4105, Sample Unit 101 – High Severity (72) Shattered Slab

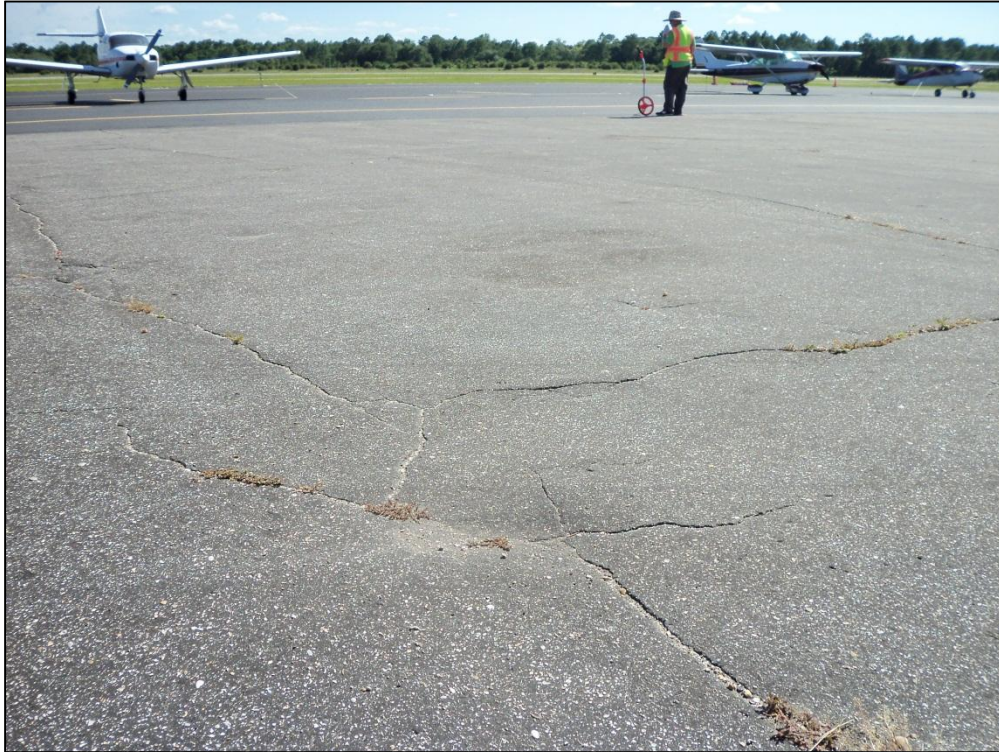
Apron, Section 4115, Sample Unit 401 – Low Severity (57) Weathering, Medium Severity (43) Block Cracking, Low Severity (45) Depression

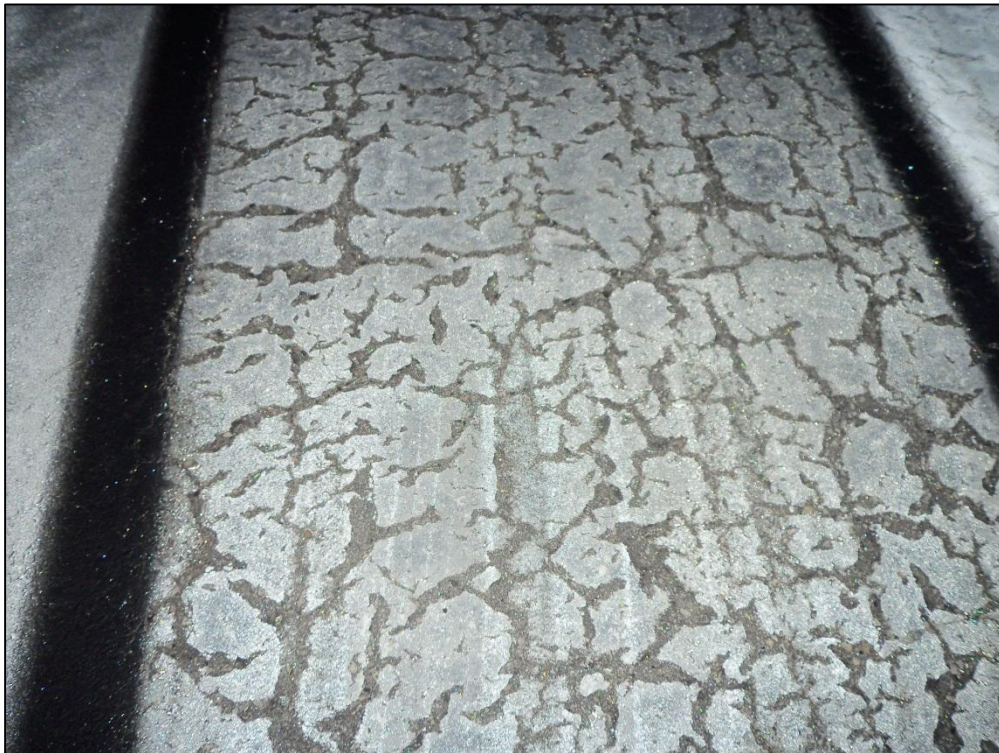
Runway 6-24, Section 6205, Sample Unit 100 – Medium Severity (52) Raveling

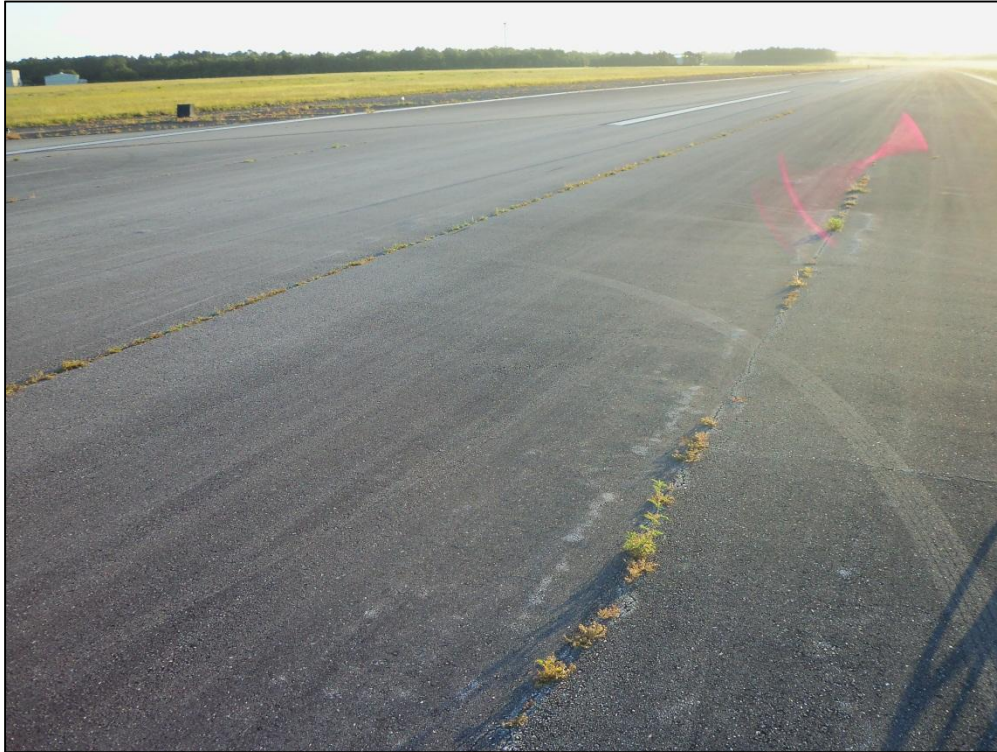
Runway 6-24, Section 6205, Sample Unit 145 – Low and Medium Severity (48) Longitudinal and Transverse Cracking, Low Severity (52) Raveling, Low Severity (57) Weathering, Low Severity (56) Swelling

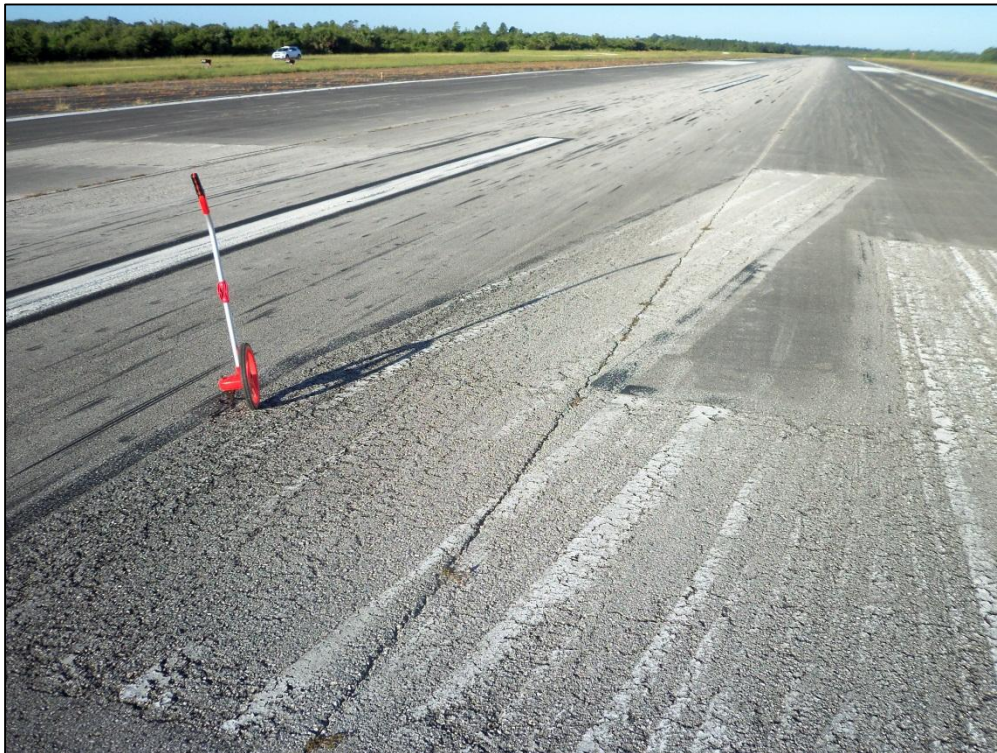
Runway 6-24, Section 6205, Sample Unit 188 – Low and Medium Severity (48) Longitudinal and Transverse Cracking, Low and High Severity (52) Raveling

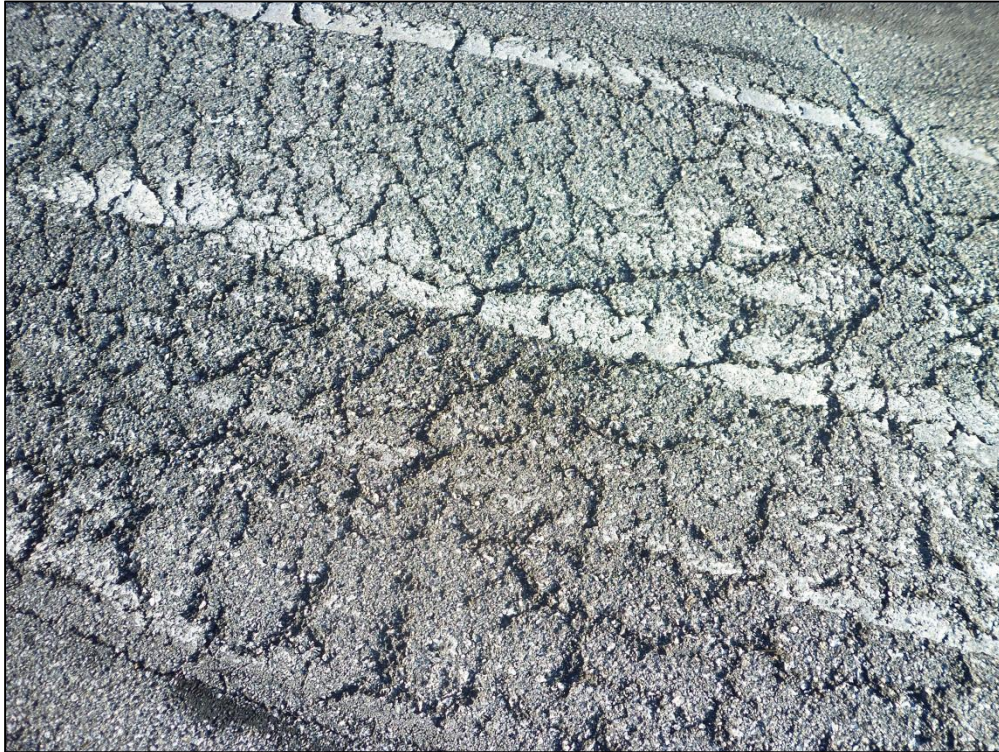
Runway 6-24, Section 6205, Sample Unit 188 – High Severity (52) Raveling

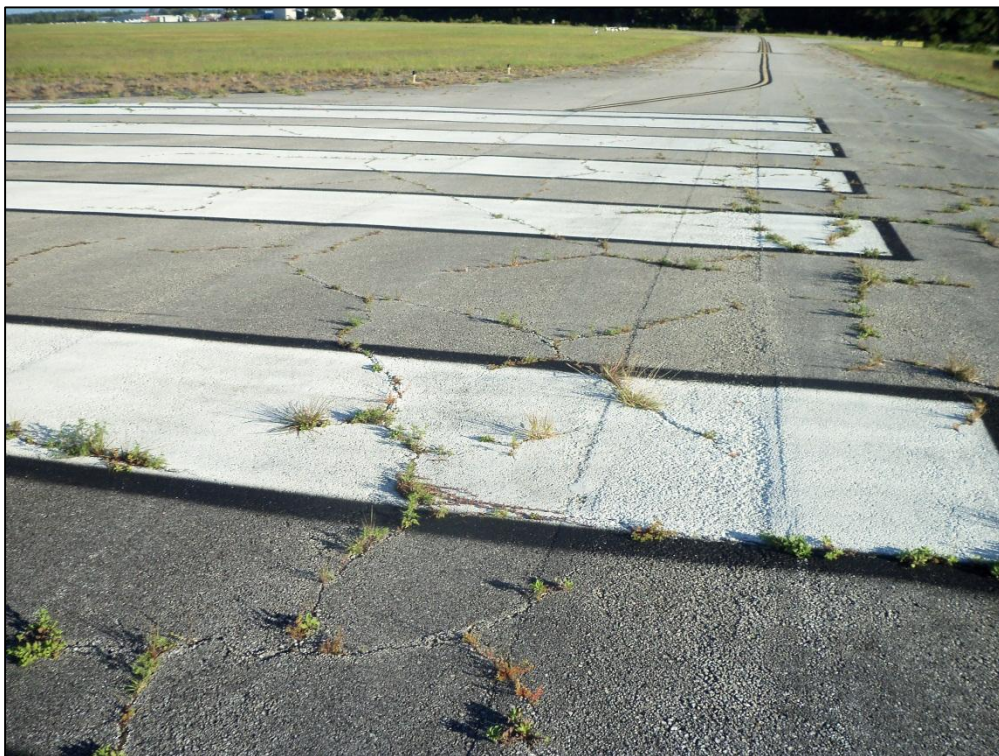
Runway 6-24, Section 6205, Sample Unit 199– Low and Medium Severity (48) Longitudinal and Transverse Cracking, Low and Medium Severity (52) Raveling, Low Severity (43) Block Cracking
