FLORIDA DEPARTMENT OF TRANSPORTATION
AVIATION AND SPACEPORT OFFICE

ZEPHYRHILLS
MUNICIPAL
AIRPORT (ZPH)

DECEMBER 2013

STATEWIDE
**Airfield
Pavement
Management**
PROGRAM

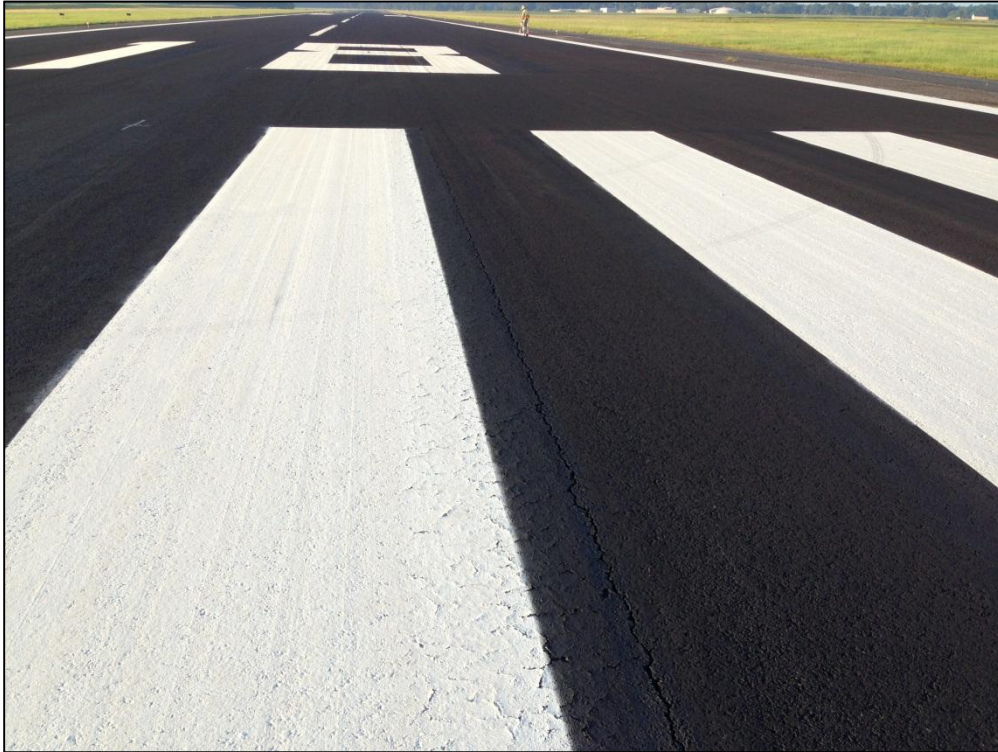
Runway 18-36 pavements were in Fair condition with a pavement condition index of 67. Typical distresses include low severity longitudinal/transverse cracking, low severity raveling, low severity weathering, and low severity swelling. These are climate, age, and subgrade quality related distresses. Large quantities of swelling were observed in some areas. These areas should be monitored as swelling can affect ride quality and exacerbate other existing distresses, such as cracking.

Runway 18-36, Section 6205, Sample Unit 390 – Low Severity (48) Longitudinal and Transverse Cracking, Low Severity (52) Raveling, Low Severity (57) Weathering

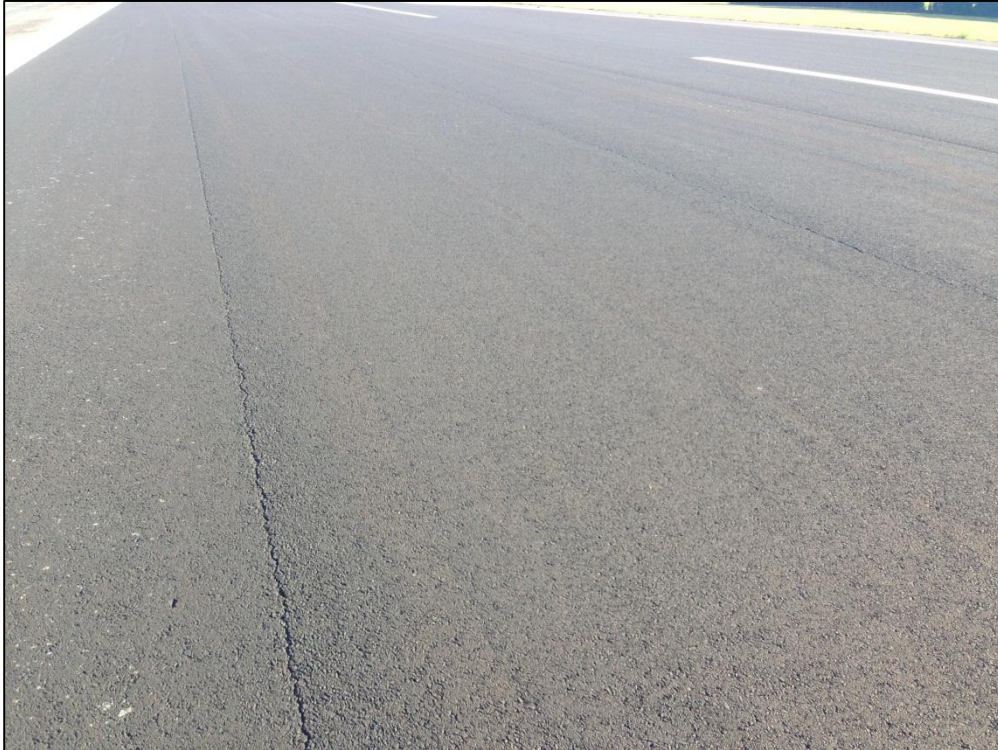
Runway 18-36, Section 6205, Sample Unit 320 – Low Severity (48) Longitudinal and Transverse Cracking, Low Severity (57) Weathering

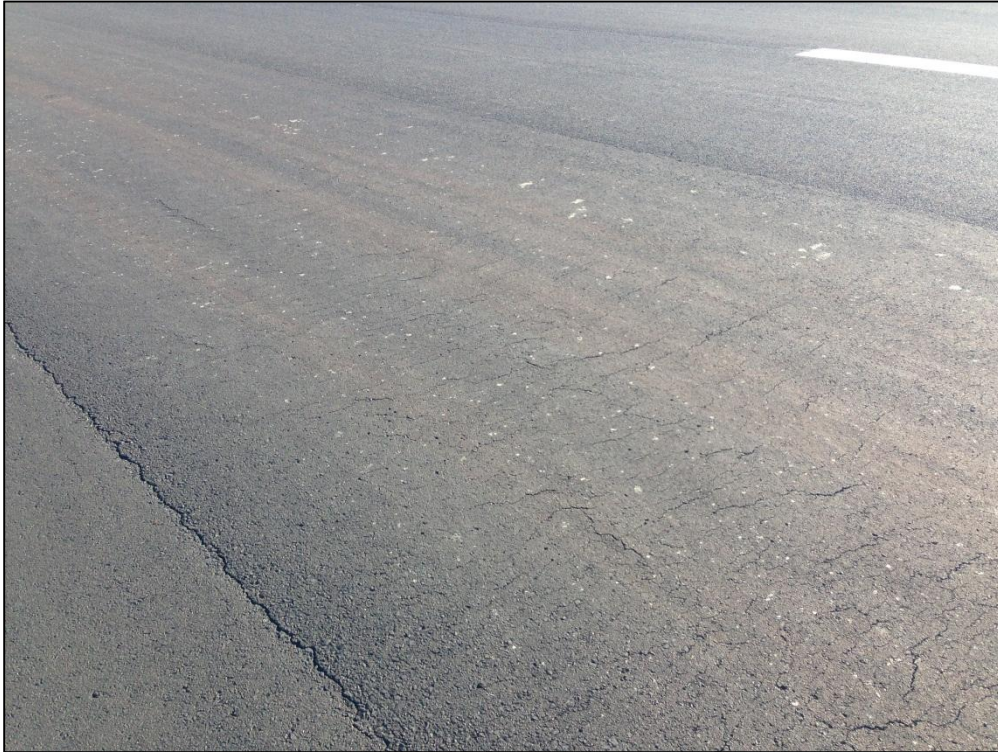
Runway 18-36, Section 6205, Sample Unit 313 – Low Severity (48) Longitudinal and Transverse Cracking, Low Severity (57) Weathering, Check Cracking

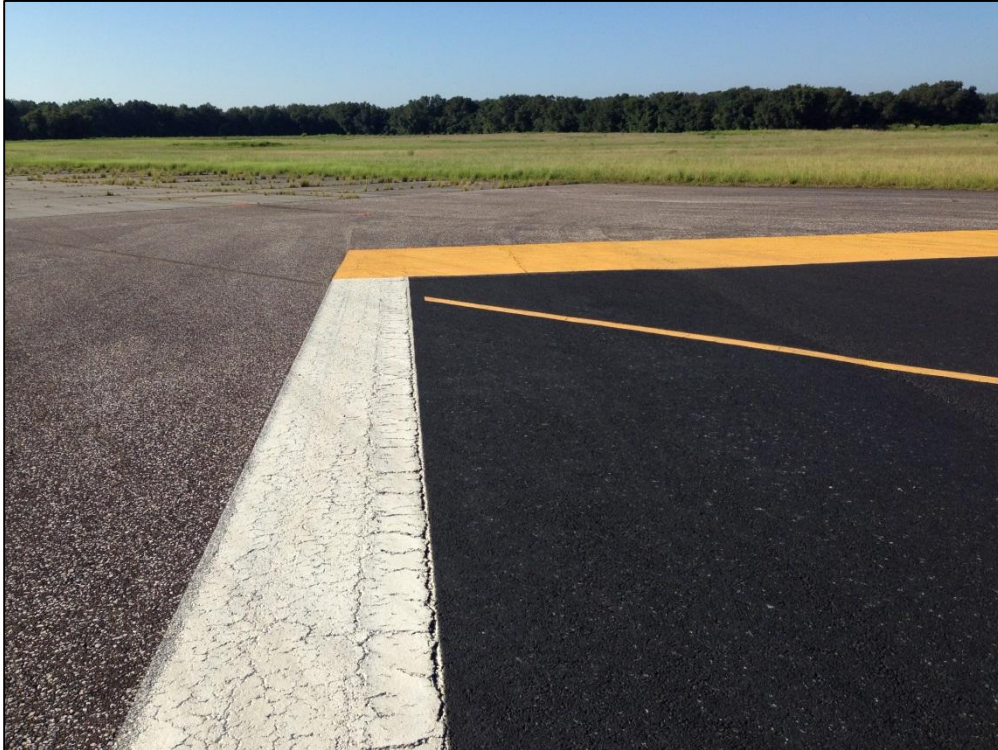
Runway 18-36, Section 6205, Sample Unit 299 – Low Severity (52) Raveling, Low Severity (57) Weathering

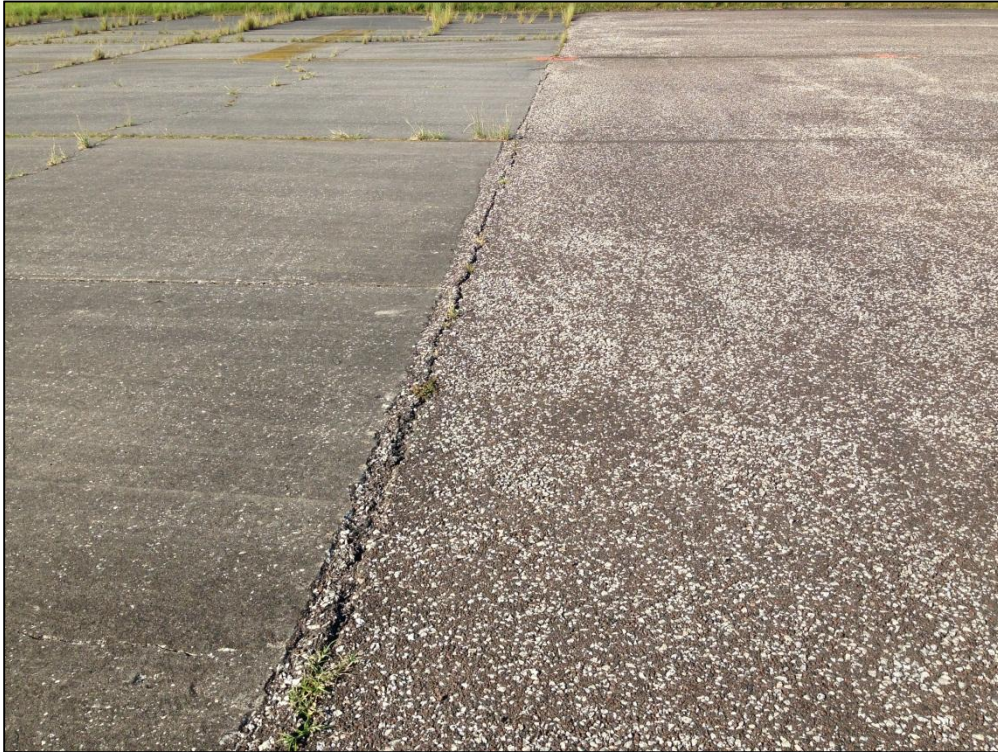
Taxiway B, Section 245, Sample Unit 134 – Medium Severity (52) Raveling, Low Severity (54) Shoving

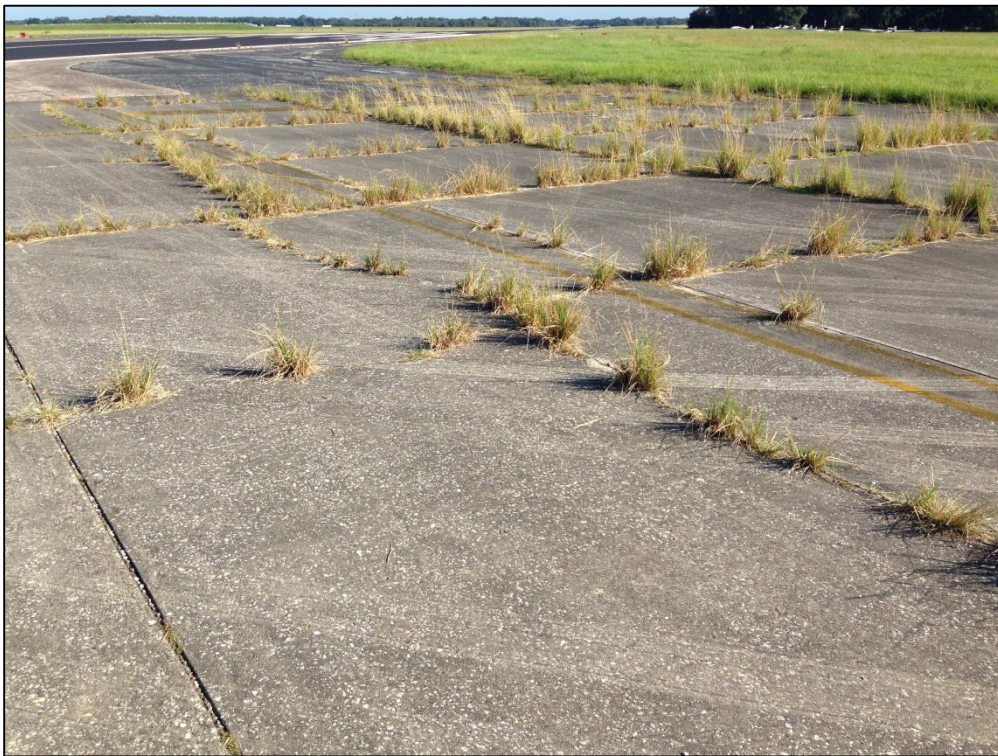
Taxiway B, Section 230, Sample Unit 135 – Medium Severity (72) Shattered Slab

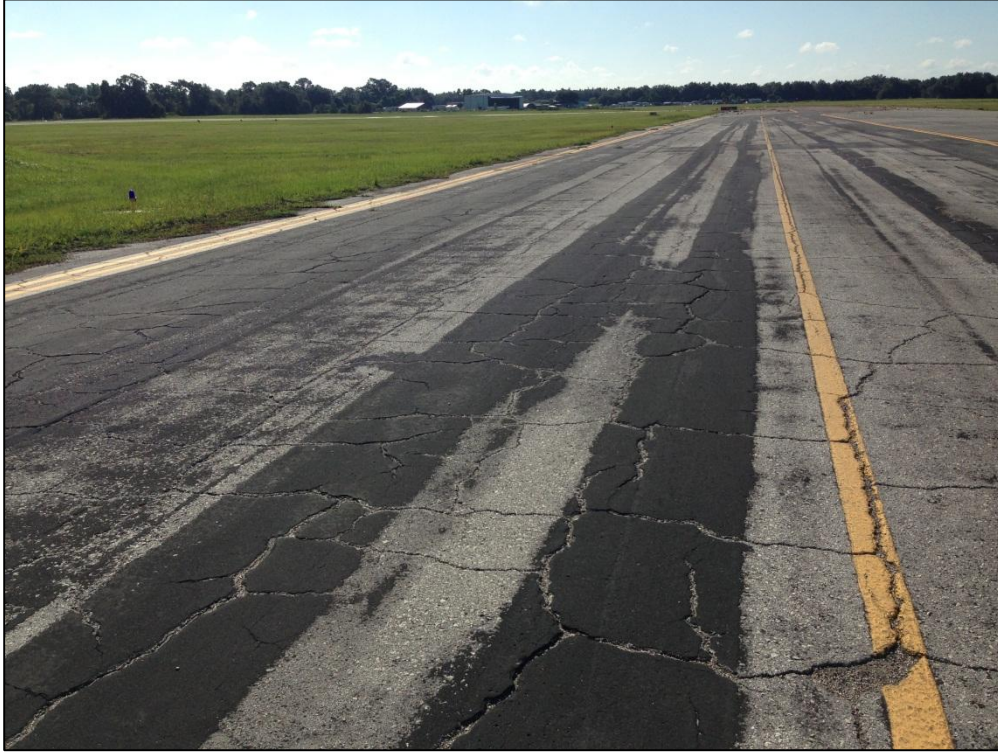
Taxiway B, Section 220, Sample Unit 219 – High Severity (43) Block Cracking, Medium Severity (52) Raveling

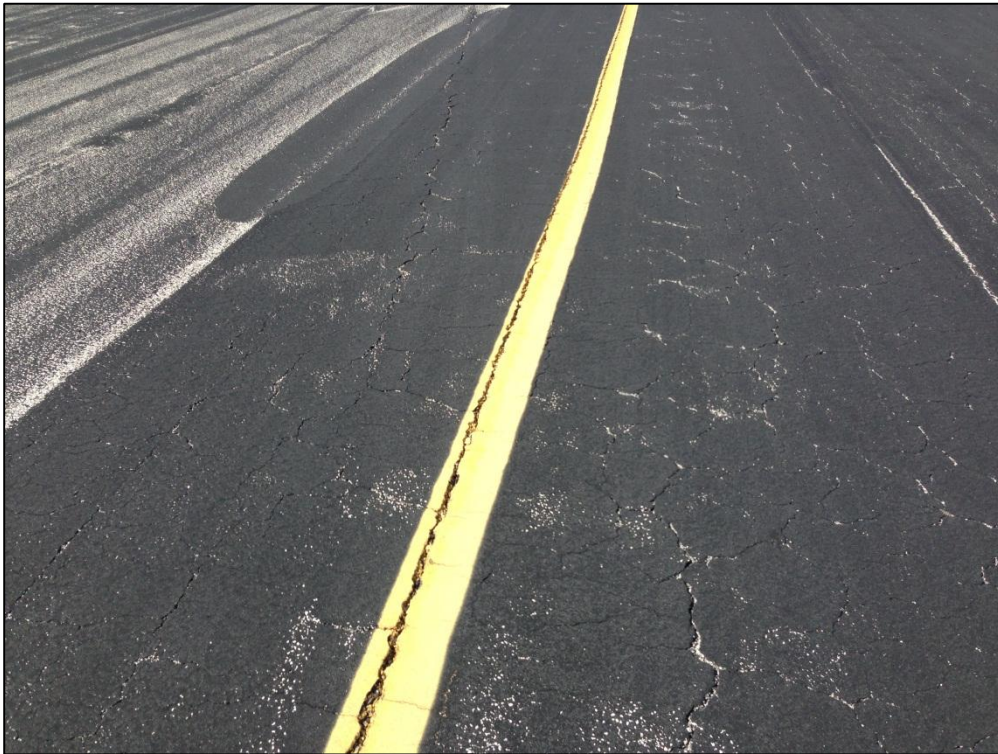
Taxiway A, Section 105, Sample Unit 149 – Low and Medium Severity (48) Longitudinal and Transverse Cracking, Low Severity (52) Raveling, Low Severity (57) Weathering

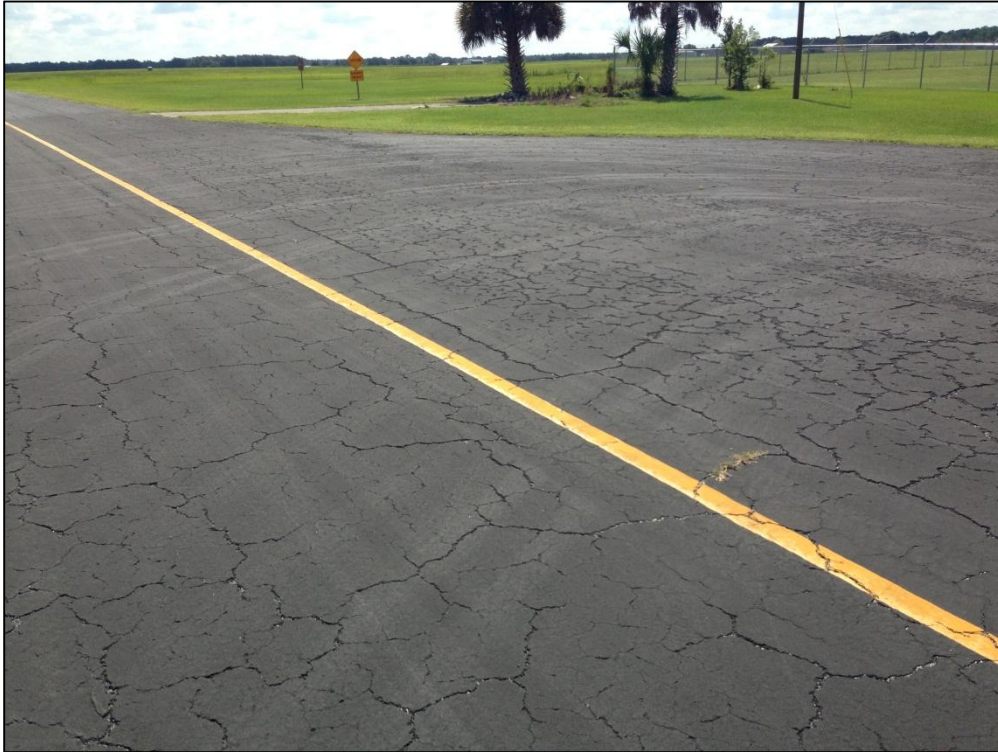
Apron TW D, Section 5205, Sample Unit 201 – Low Severity (43) Block Cracking, Low Severity (52) Raveling, Low Severity (57) Weathering

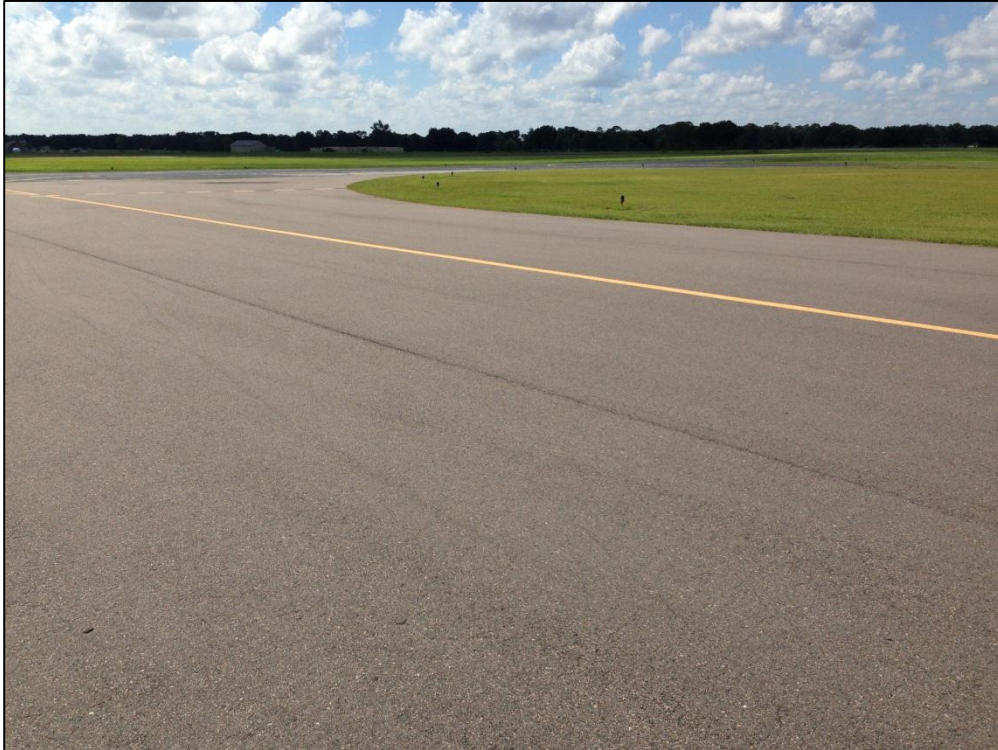
Taxiway C, Section 320, Sample Unit 101 – Low Severity (48) Longitudinal and Transverse Cracking, Low Severity (57) Weathering

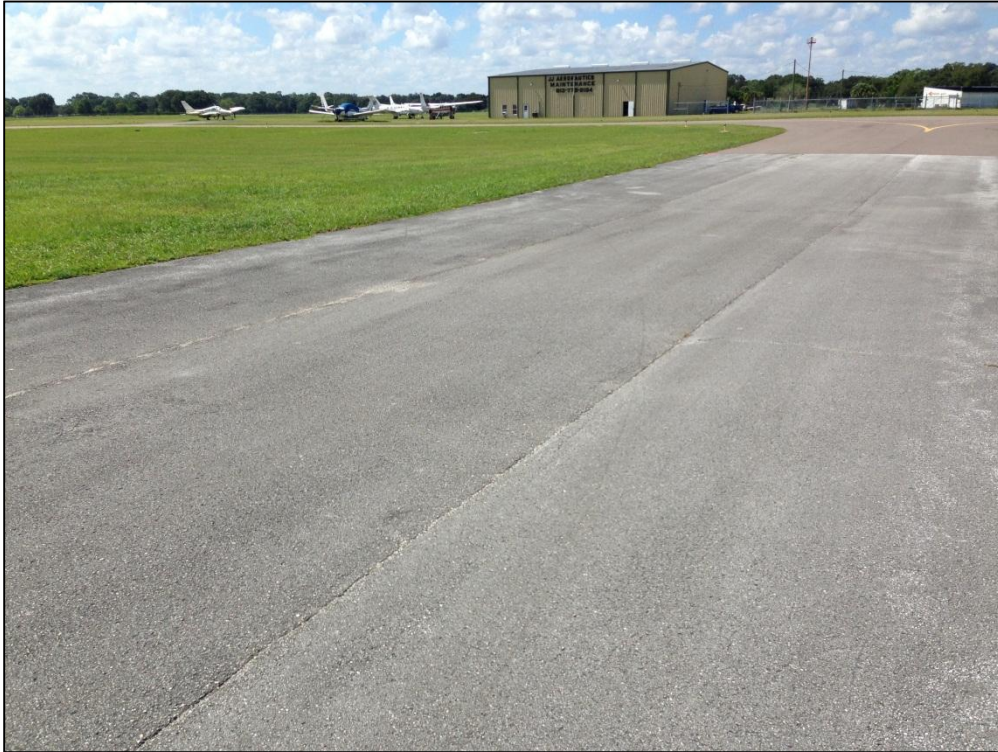
Taxiway C-1, Section 505, Sample Unit 101 – Low Severity (48) Longitudinal and Transverse Cracking, Low Severity (52) Raveling, Low Severity (57) Weathering

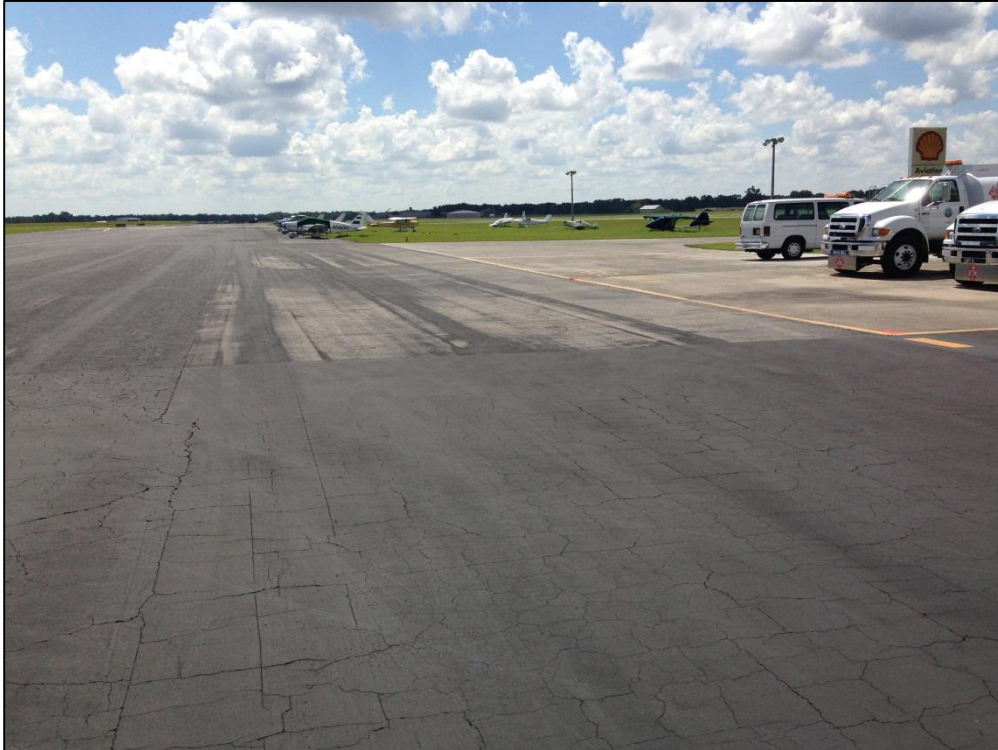
Apron NE, Section 5105, Sample Unit 200 – Low Severity (43) Block Cracking, Low Severity (52) Raveling, Low Severity (57) Weathering

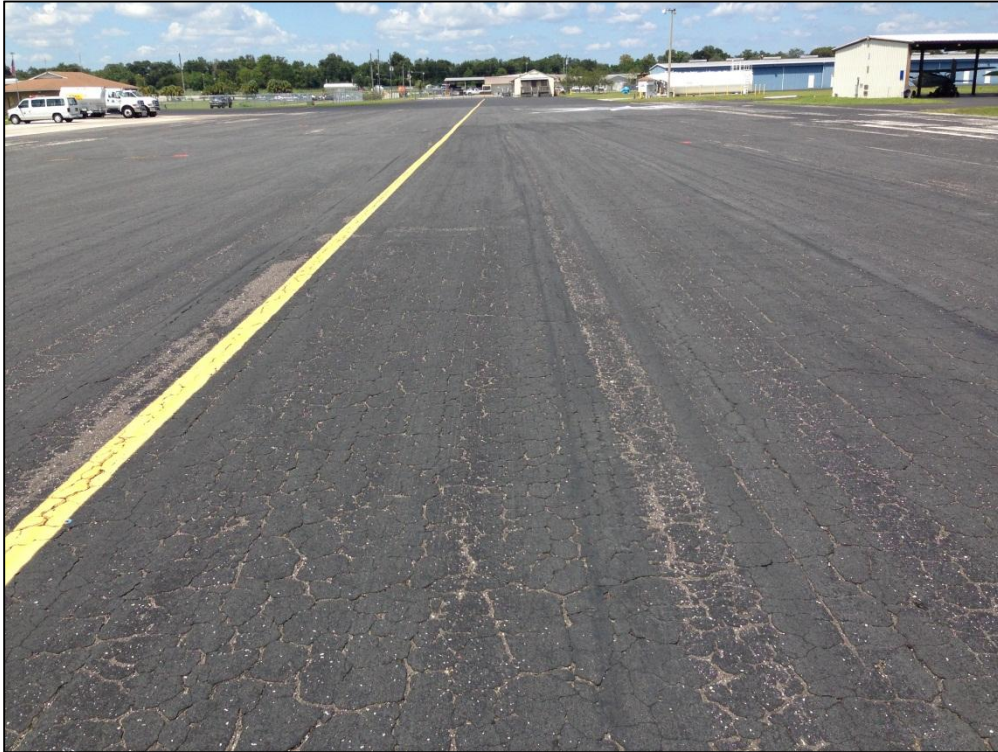
Taxiway B, Section 205, Sample Unit 108 – Medium Severity (43) Block Cracking, Medium Severity (52) Raveling

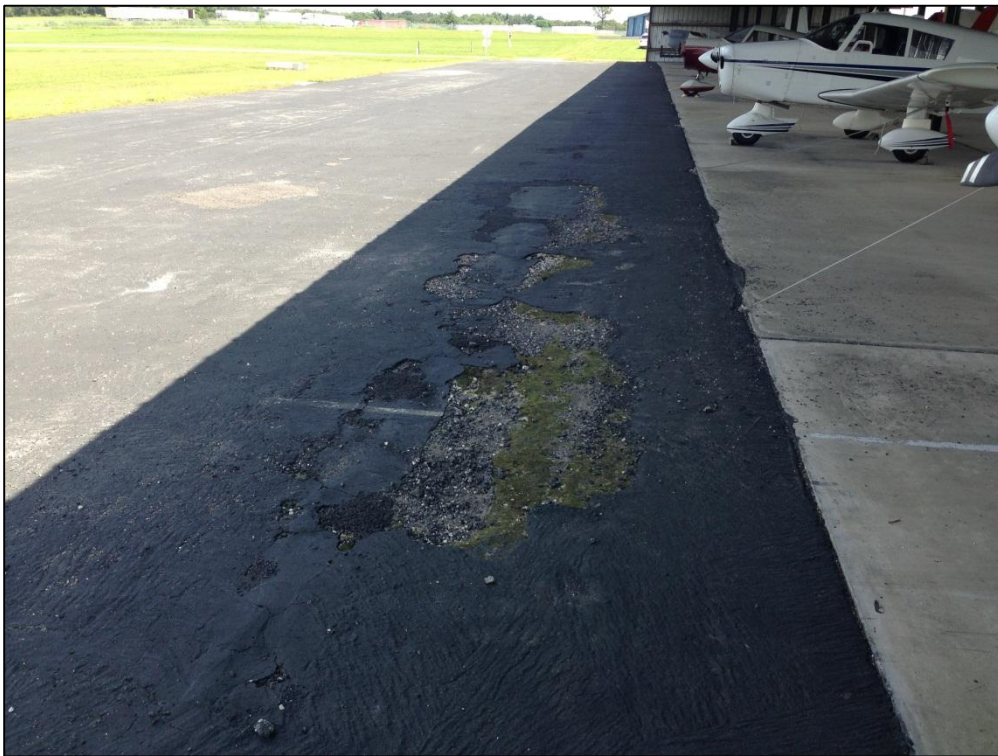
Apron T-Hang, Section 5305, Sample Unit 400 – High Severity (52) Raveling

- East Apron – Section 5405
 - Reconstruction attributed to distresses related to construction quality and overloading.
- Apron T-Hangers – Section 5305
 - Mill and Overlay attributed to distresses related to subgrade quality, climate, and age of pavement.
- Apron at end of TW D – Section 5205
 - Mill and Overlay attributed to distresses related to climate and age of pavement.
- Northeast Apron – Section 5105
 - Reconstruction attributed to distresses related to PCC movement, climate, and age of pavement.
- Northwest Apron – Section 4110
 - Mill and Overlay attributed to distresses related to climate and age of pavement.
- Northwest Apron – Section 4105
 - PCC Restoration attributed to distresses related to loading and construction quality.

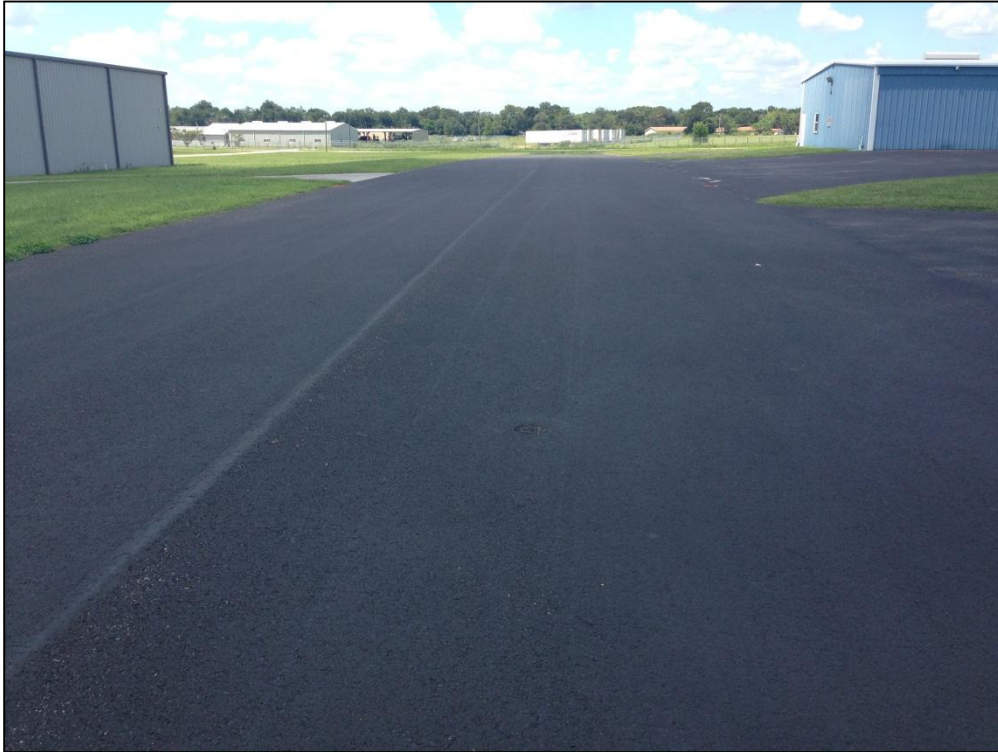
Taxiway E, Section 610, Sample Unit 104 – Low Severity (57) Weathering

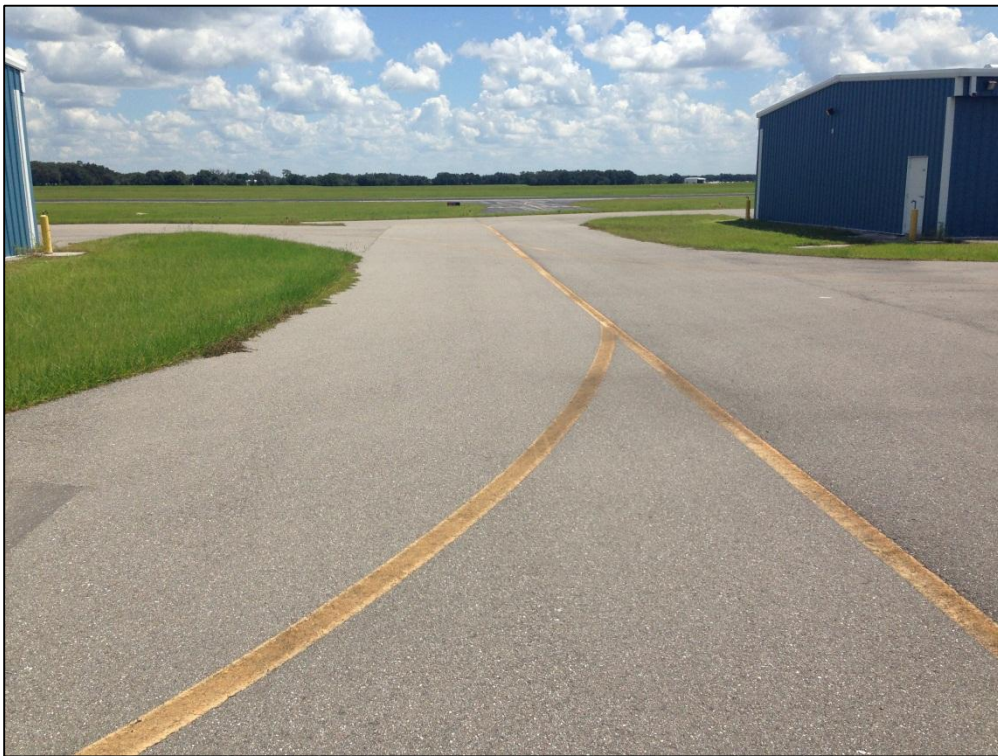
Apron T-Hang3, Section 5510, Sample Unit 102 – Low Severity (45) Depression, Low Severity (57) Weathering
