**BOCA RATON
AIRPORT (BCT)**

DISTRICT 4
REGIONAL RELIEVER
AIRPORT
JUNE 2015

STATEWIDE Airfield Pavement Management PROGRAM

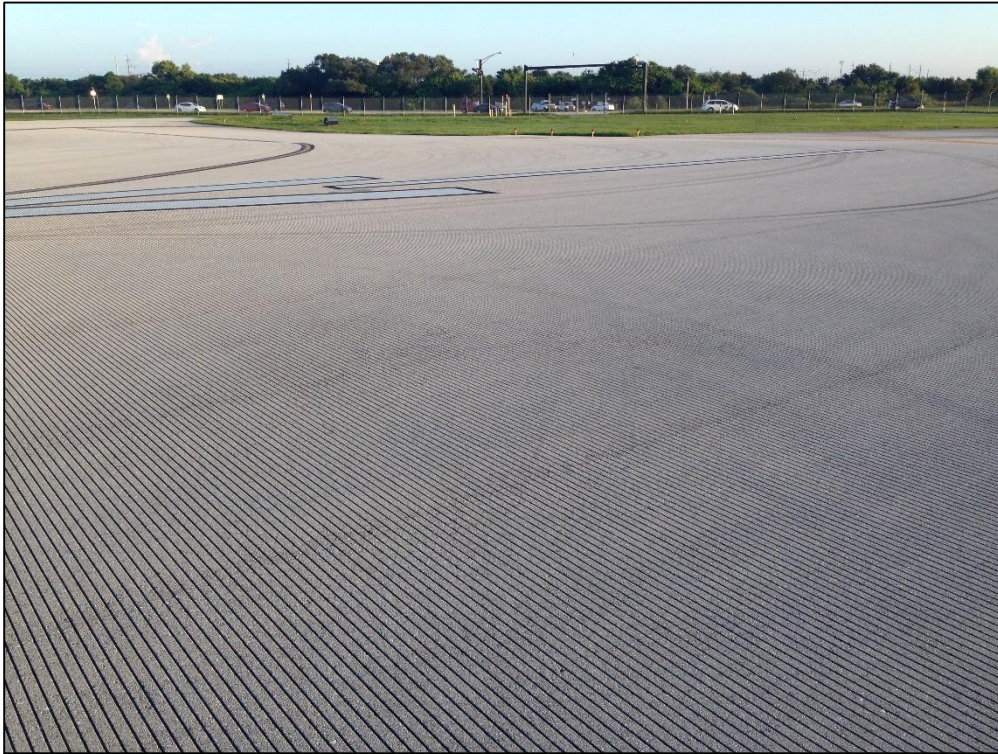
Runway 5-23, Section 6107, Sample Unit 409 – Low Severity (57) Weathering

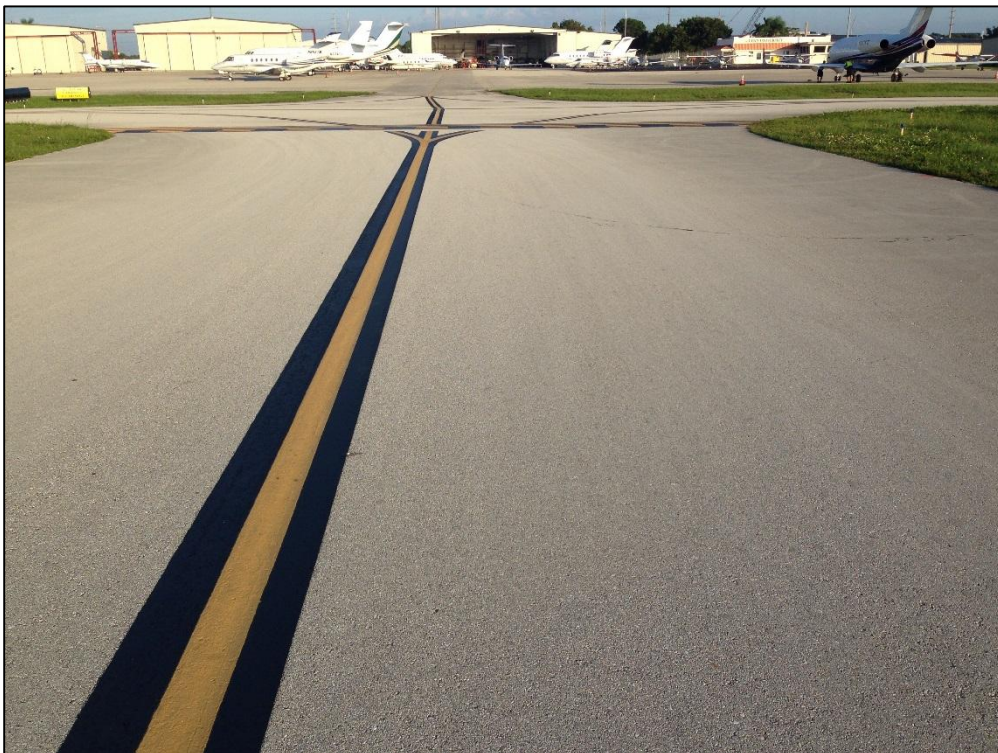
Taxiway Bravo, Section 125, Sample Unit 400 – Low Severity (57) Weathering

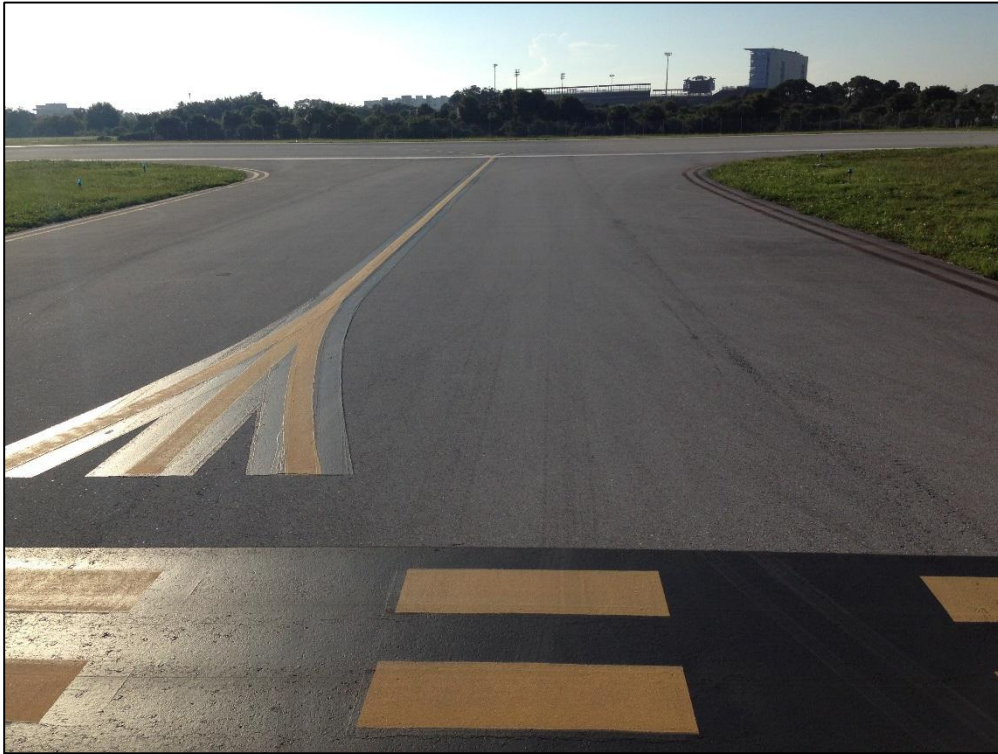
Taxiway Charlie, Section 120, Sample Unit 300 – Low Severity (57) Weathering

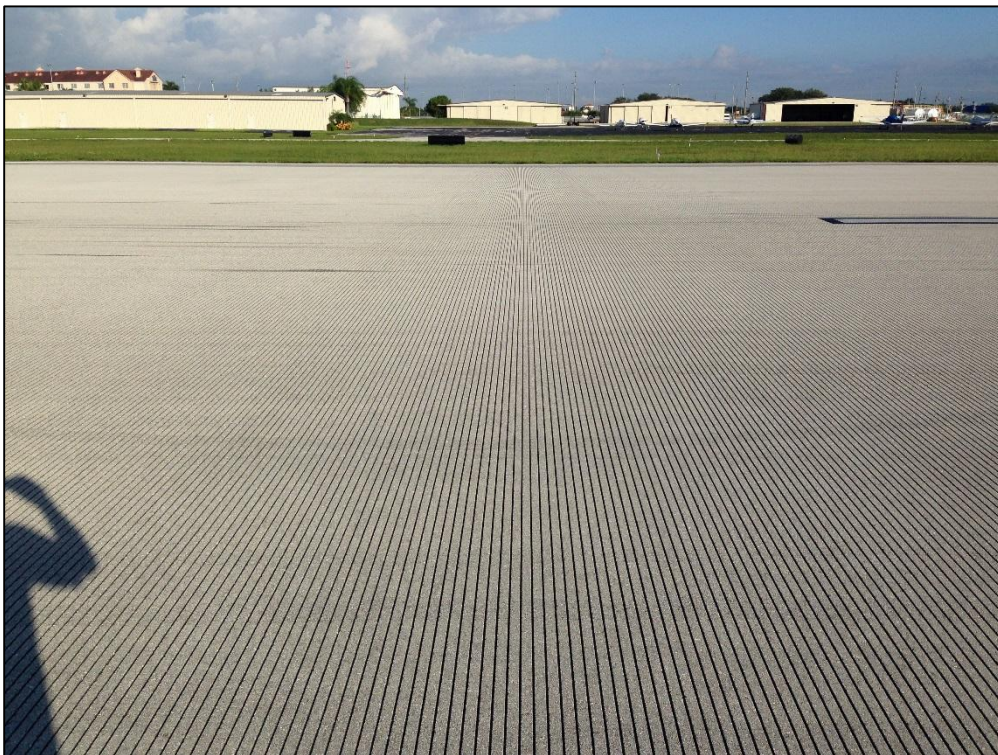
Runway 5-23, Section 6105, Sample Unit 357 – Low Severity (57) Weathering

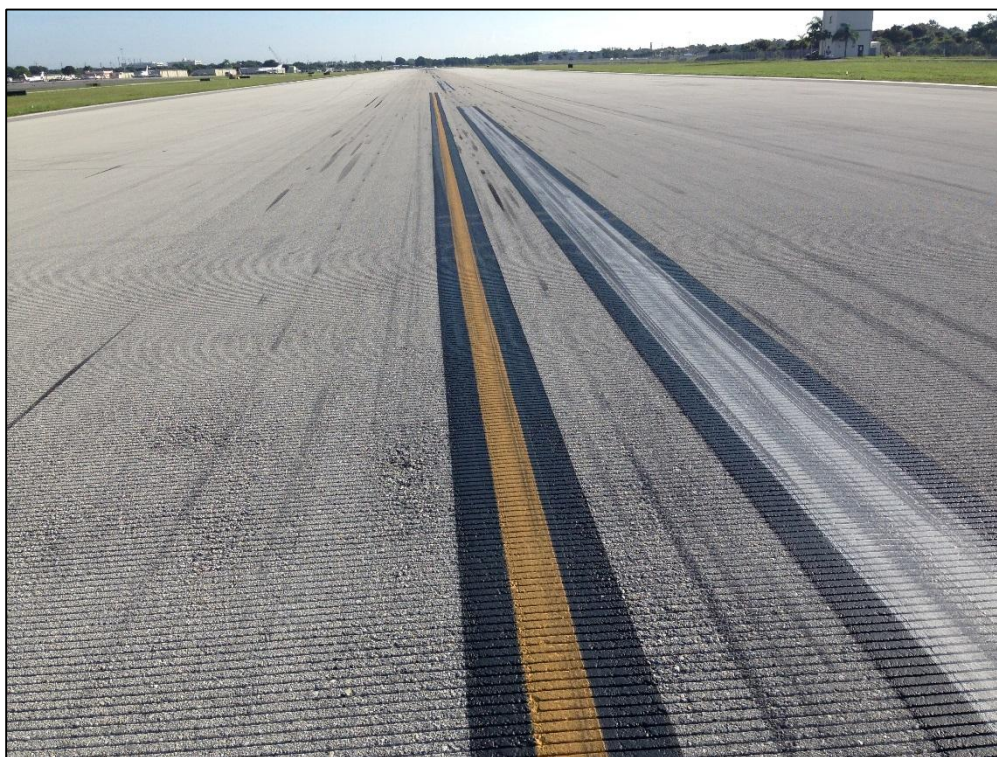
Runway 5-23, Section 6105, Sample Unit 350 – Low Severity (52) Raveling, Low Severity (57) Weathering

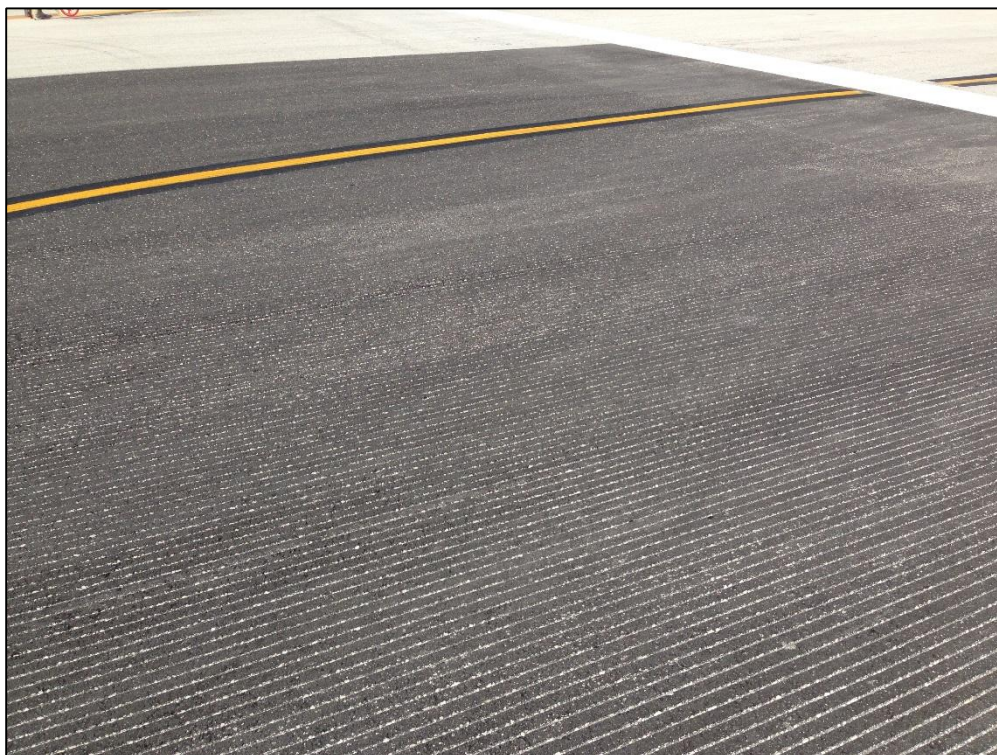
Runway 5-23, Section 6111, Sample Unit 84 – Low Severity (50) Patching, Low Severity (57) Weathering

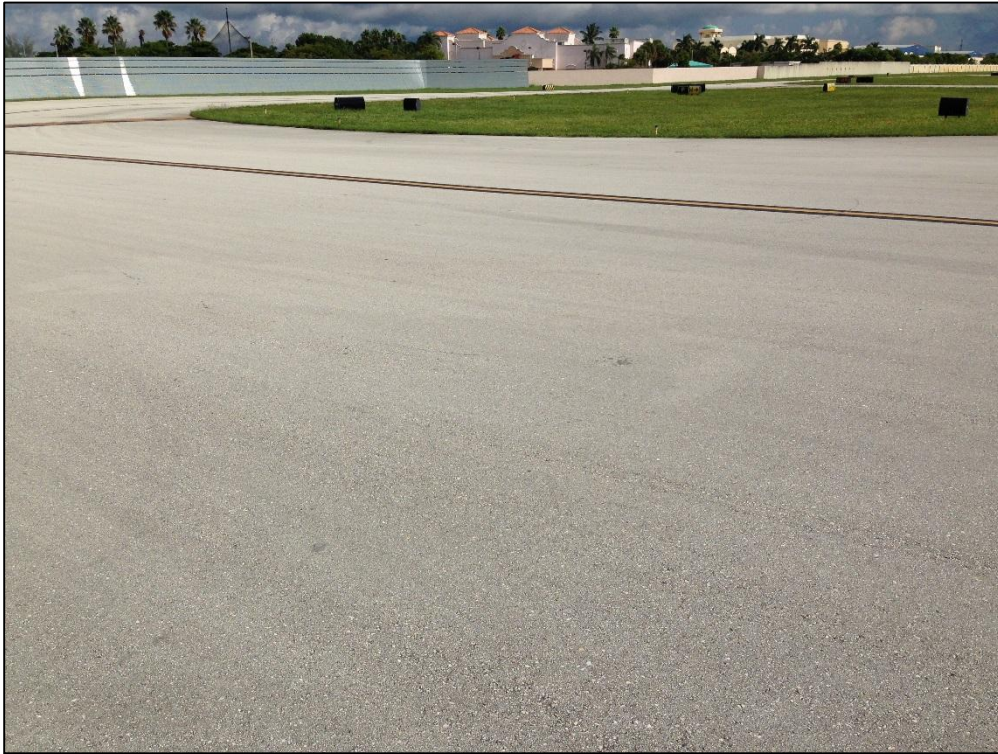
Taxiway Papa, Section 112, Sample Unit 100 – Low Severity (57) Weathering

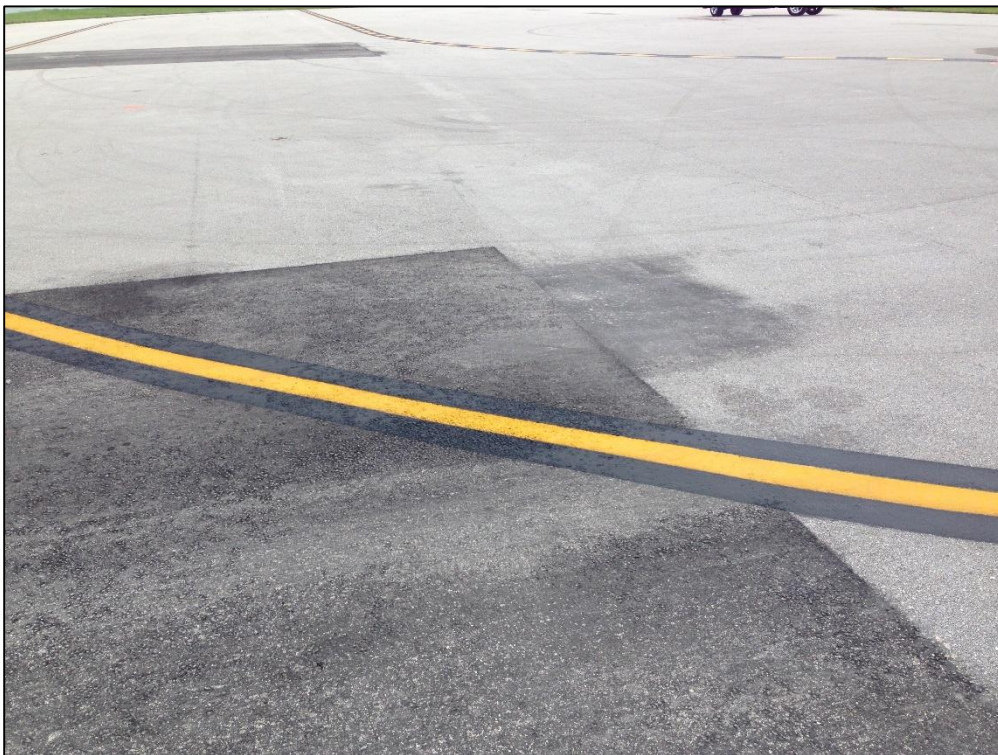
Apron Run-Up, Section 5115, Sample Unit 201 – Low Severity (50) Patching, Low Severity (57) Weathering

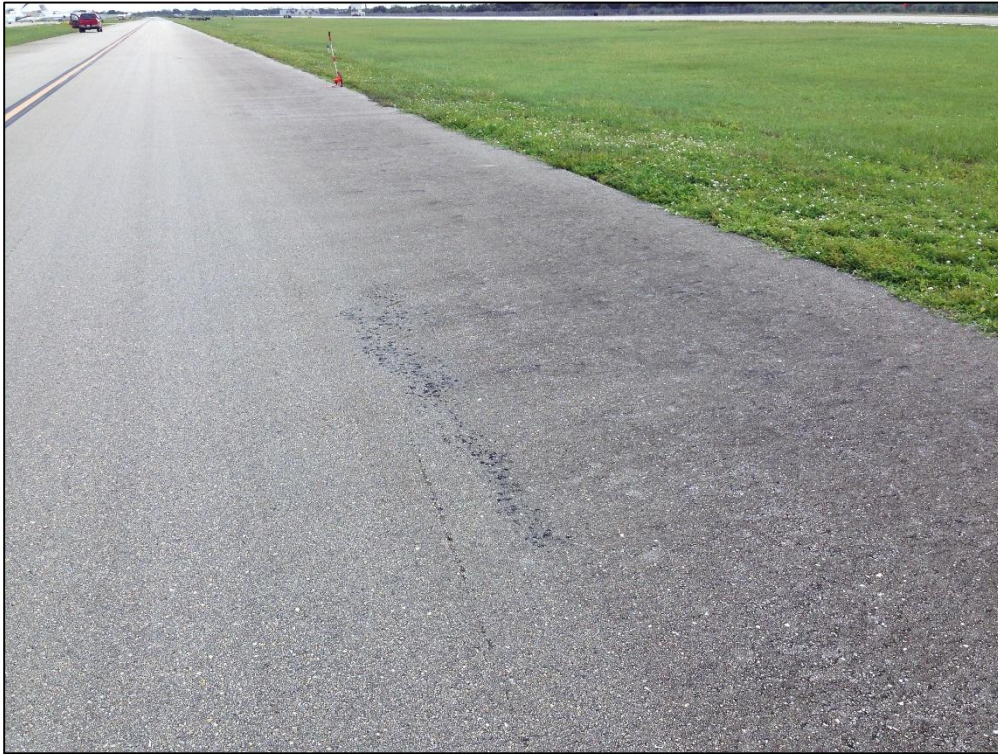
Taxiway Papa, Section 105, Sample Unit 105 – (42) Bleeding, Low Severity (57) Weathering

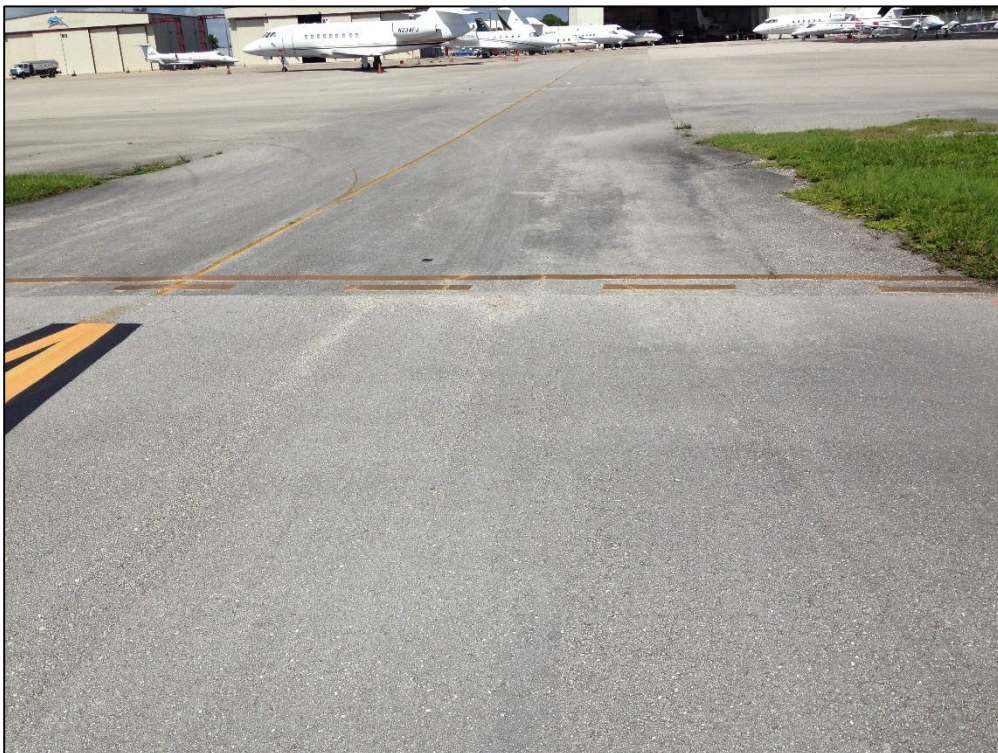
Taxiway Connector, Section 225, Sample Unit 803 – Low Severity (57) Weathering, Medium Severity (57) Weathering

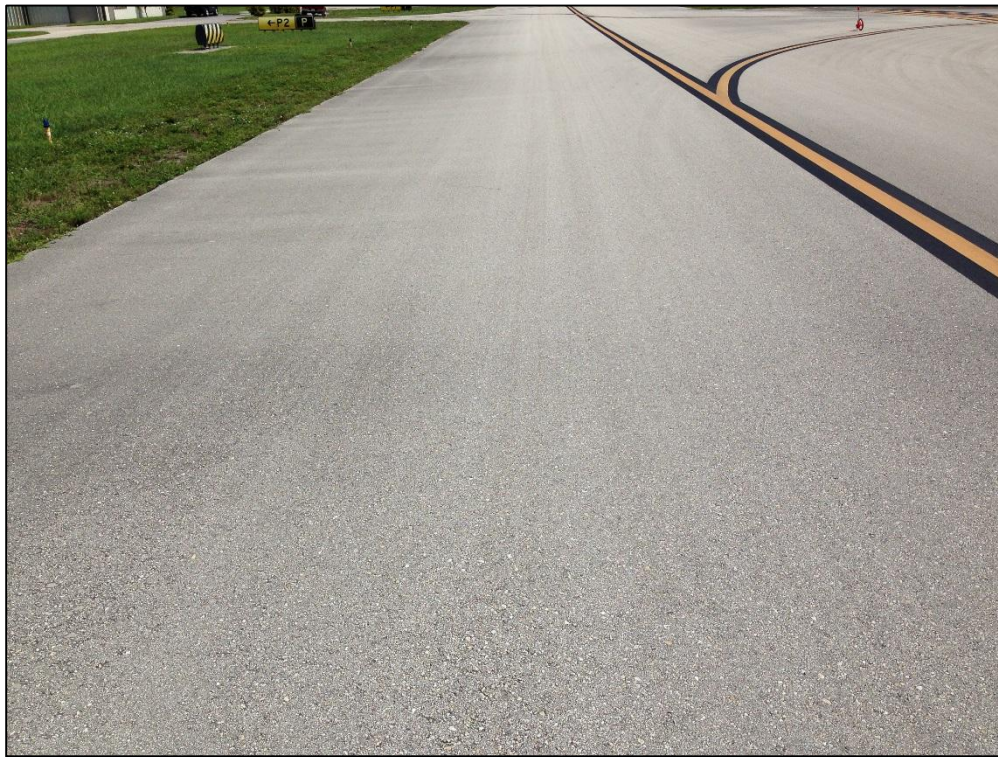
Taxiway Papa, Section 105, Sample Unit 150 – Low Severity (57) Weathering

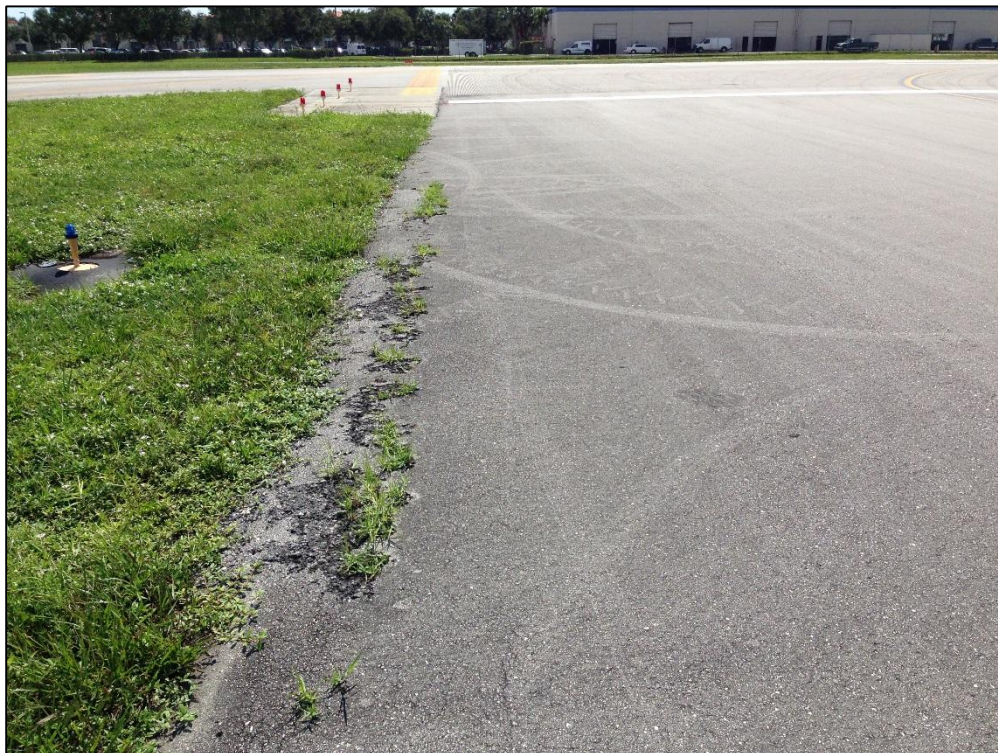
Taxiway Papa, Section 131, Sample Unit 100 – Low Severity (52) Raveling, Medium Severity (52) Raveling, Low Severity (57) Weathering
