**CLEARWATER
AIRPARK (CLW)**

DISTRICT 7
REGIONAL RELIEVER
AIRPORT
JUNE 2015

STATEWIDE
**Airfield
Pavement
Management**
PROGRAM

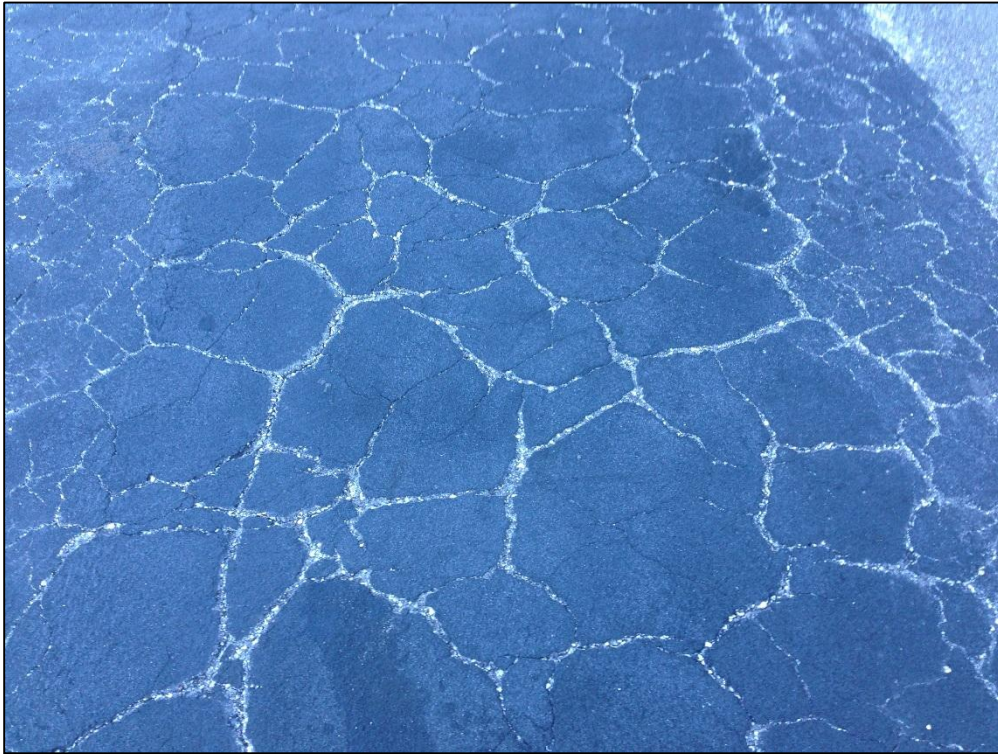
Apron North, Section 4505, Sample Unit 400 – Low Severity (43) Block Cracking, Low Severity (52) Raveling

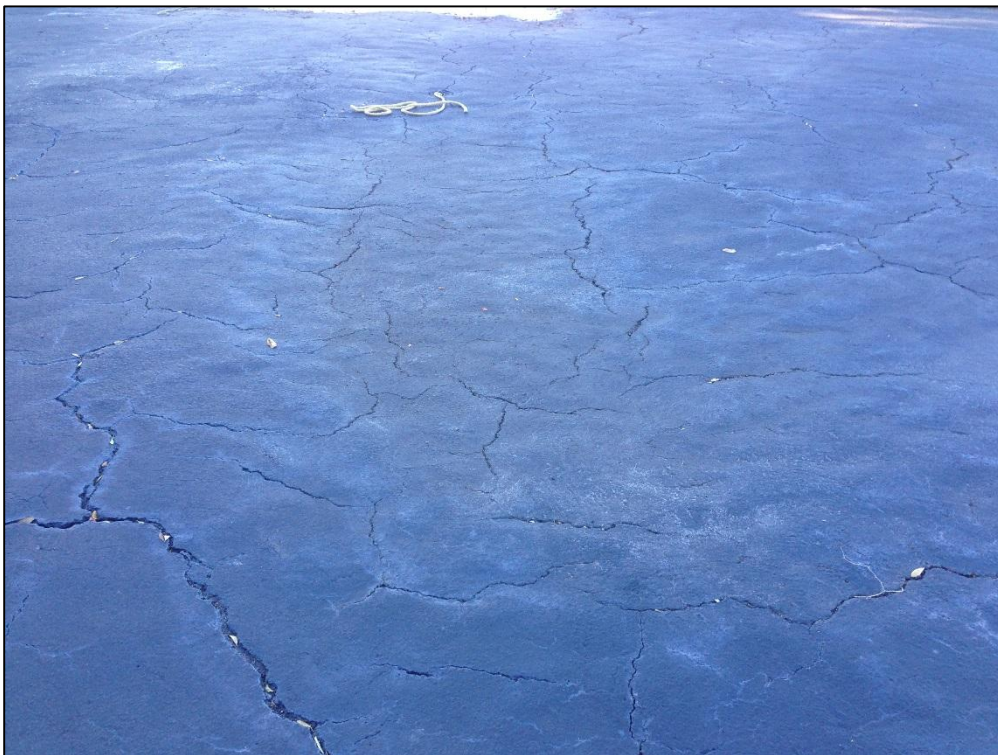
Apron Center, Section 4405, Sample Unit 501 – Low Severity (43) Block Cracking, Low Severity (48) Longitudinal and Transverse Cracking, Medium Severity (48) Longitudinal and Transverse Cracking, Low Severity (57) Weathering

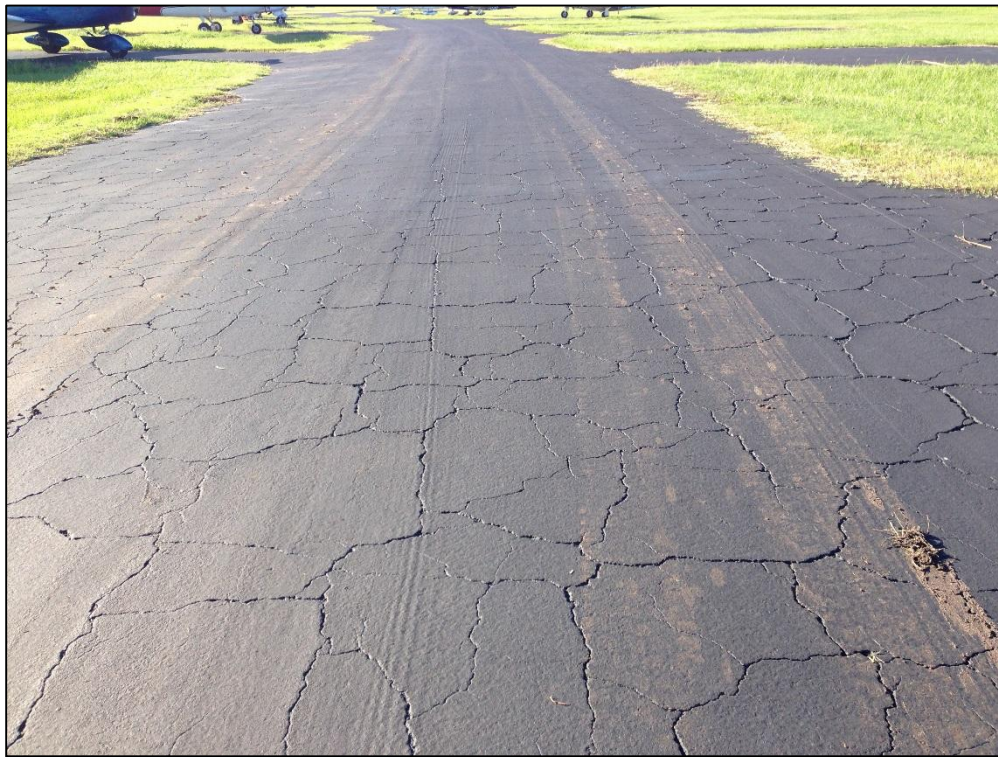
Apron Center, Section 4410, Sample Unit 304 – Low Severity (43) Block Cracking, Low Severity (57) Weathering

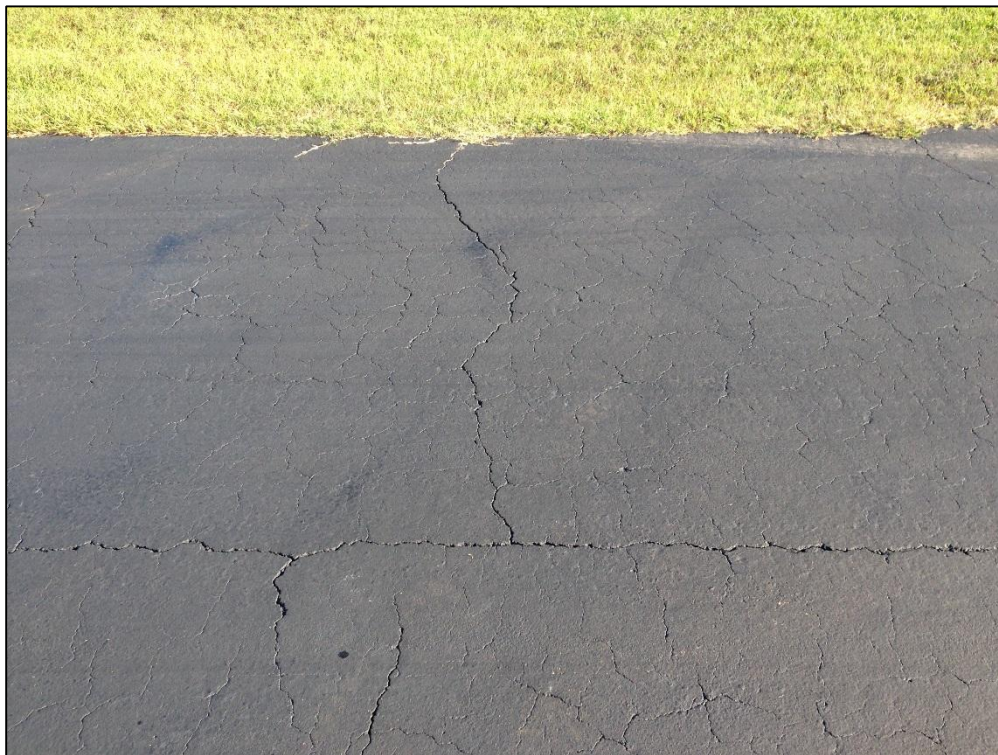
Taxiway Alpha, Section 130, Sample Unit 101 – Low Severity (43) Block Cracking, Low Severity (57) Weathering

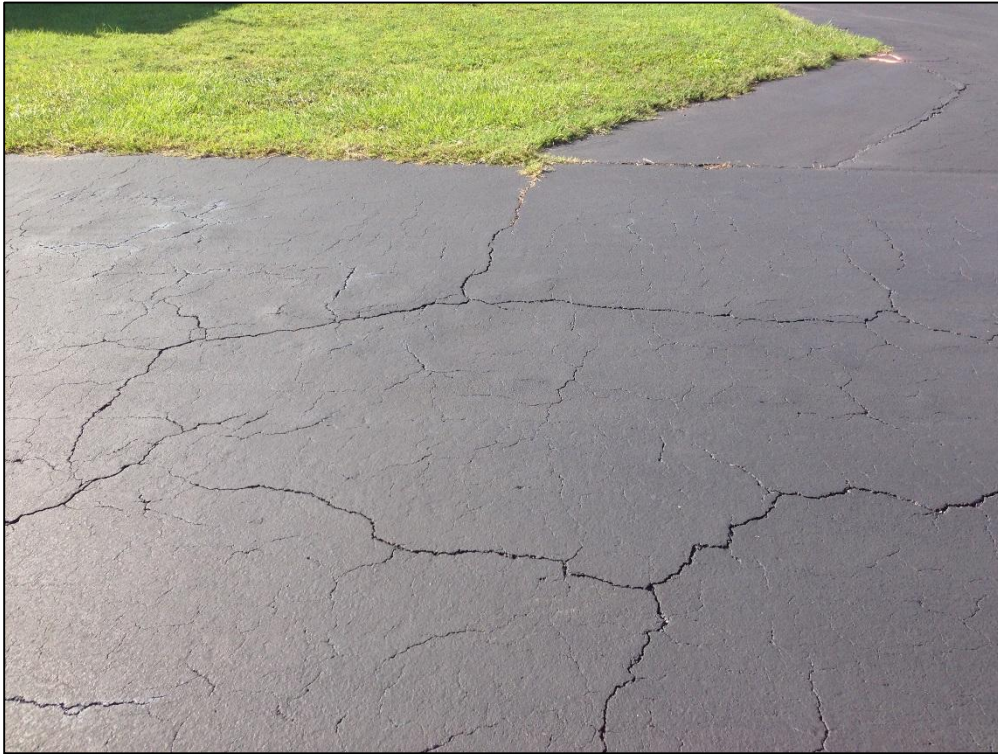
Apron T-Hangar 1, Section 4305, Sample Unit 600 – Low Severity (43) Block Cracking, Low Severity (48) Longitudinal and Transverse Cracking, Medium Severity (57) Weathering

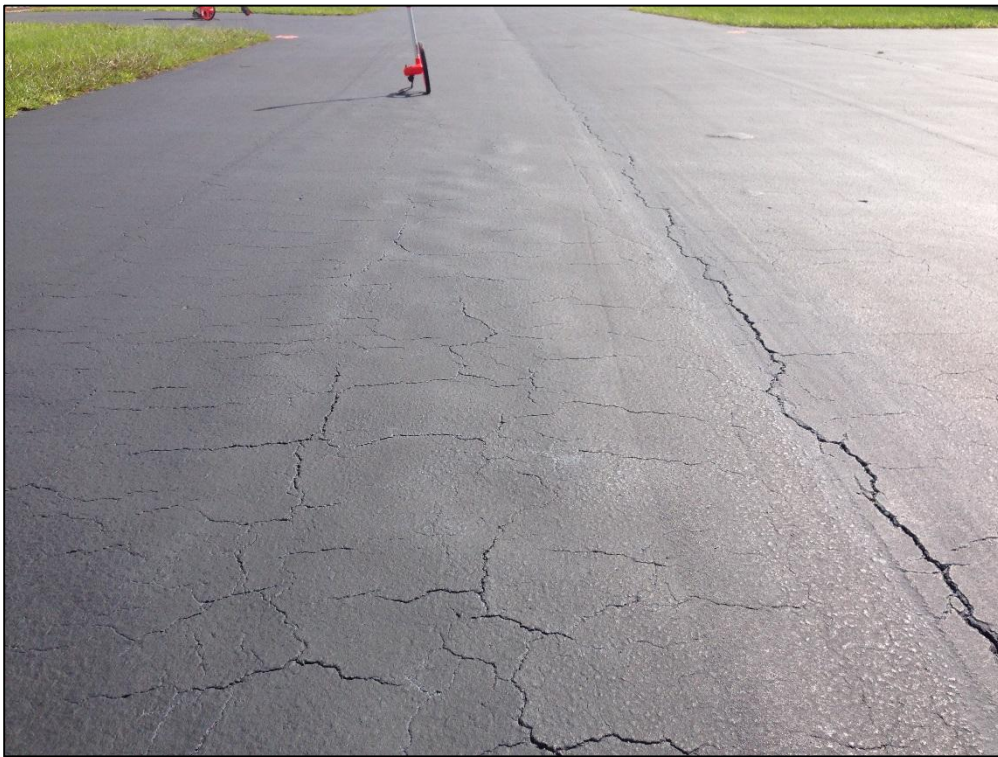
Apron T-Hangar 3, Section 4205, Sample Unit 101 – Low Severity (48) Longitudinal and Transverse Cracking, Low Severity (56) Swelling, Medium Severity (57) Weathering
