**JACKSONVILLE
EXECUTIVE AT
CRAIG AIRPORT (CRG)**

DISTRICT 2
REGIONAL RELIEVER
AIRPORT
JUNE 2015

STATEWIDE
**Airfield
Pavement
Management**
PROGRAM

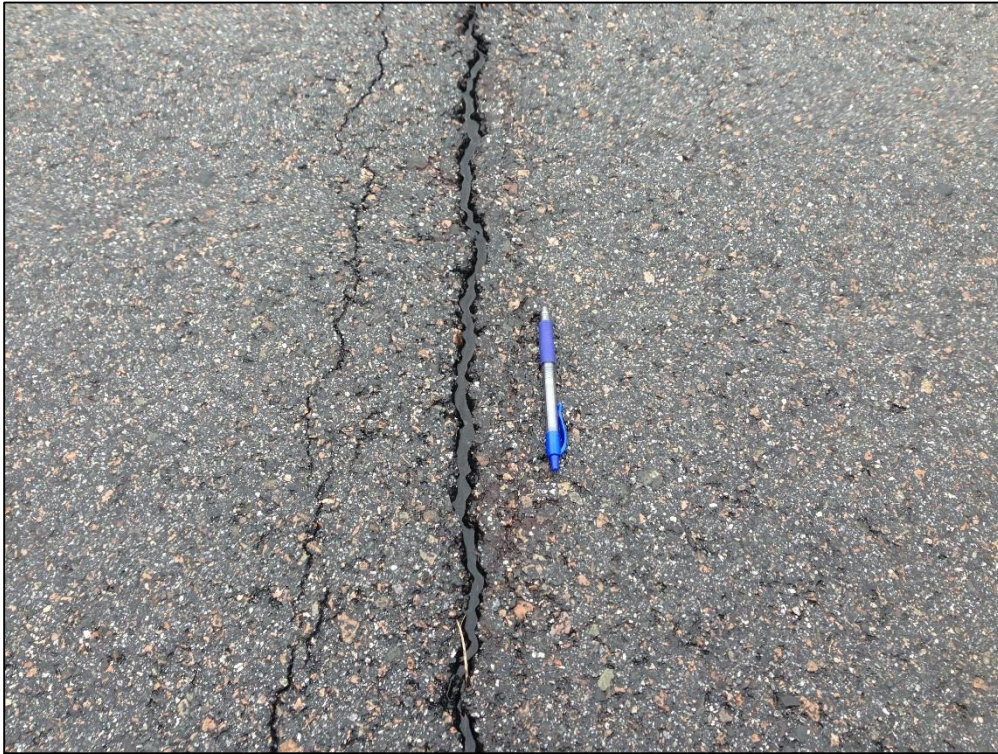
Runway 14-32, Section 6210, Sample Unit 163 – Low and Medium Severity (48) Longitudinal and Transverse Cracking, Low Severity (57) Weathering

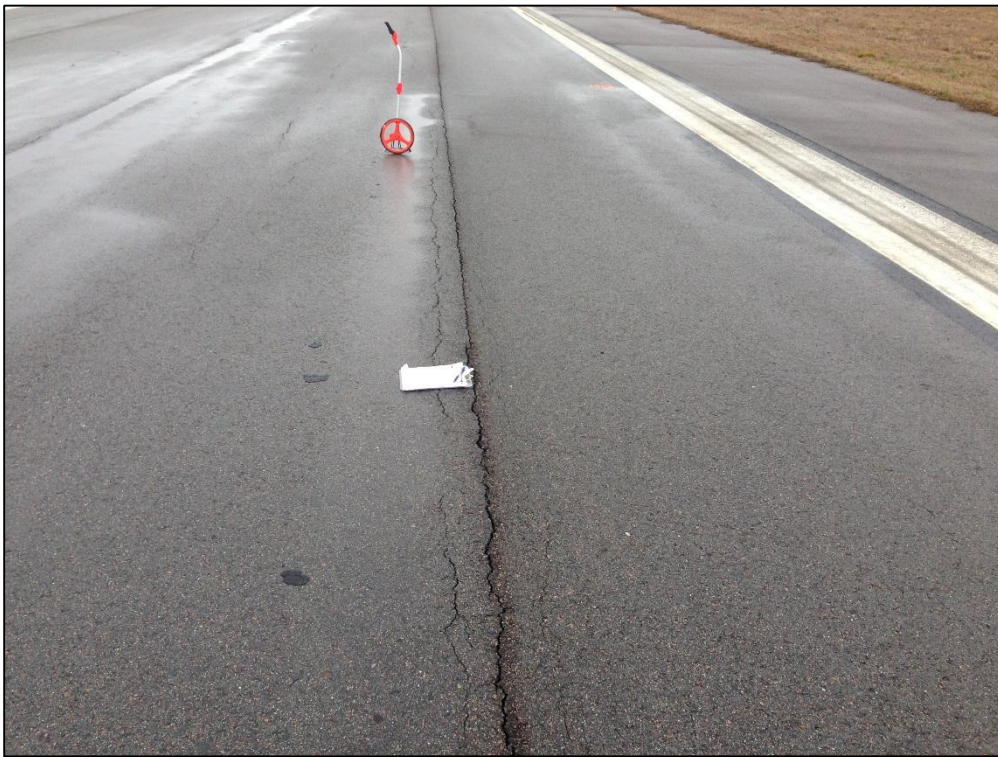
Runway 14-32, Section 6210, Sample Unit 174 – (42) Bleeding, Low and Medium Severity (48) Longitudinal and Transverse Cracking, Low Severity (52) Raveling, Low Severity (56) Swelling, Low Severity (57) Weathering

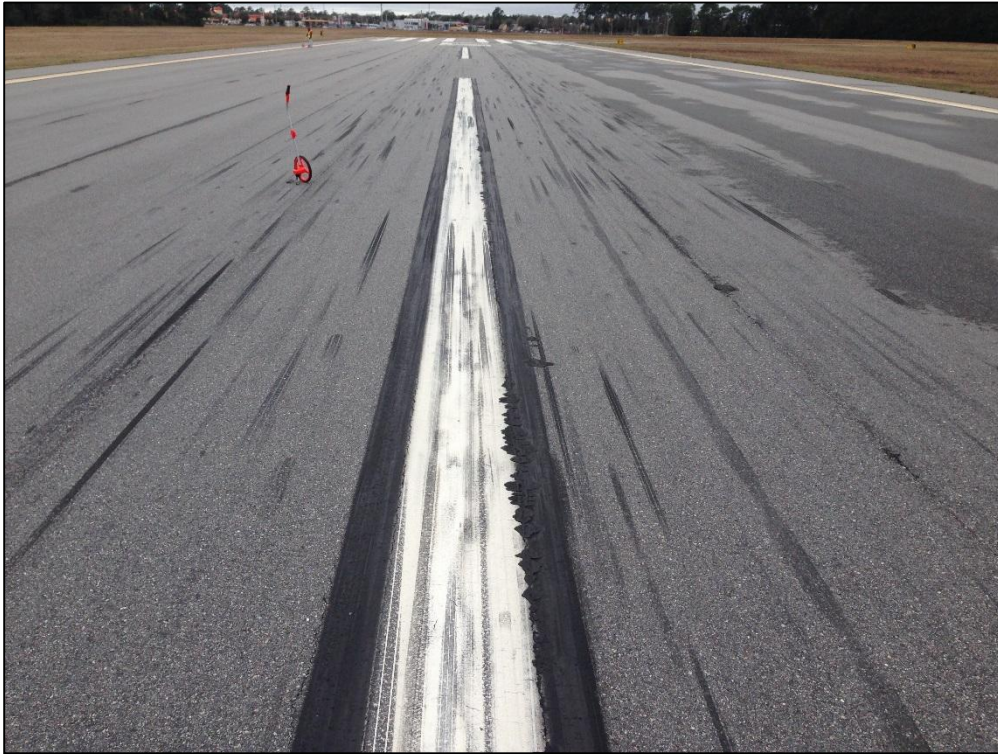
Runway 5-23, Section 6105, Sample Unit 112 – (42) Bleeding, Low Severity (48) Longitudinal and Transverse Cracking, Low Severity (57) Weathering

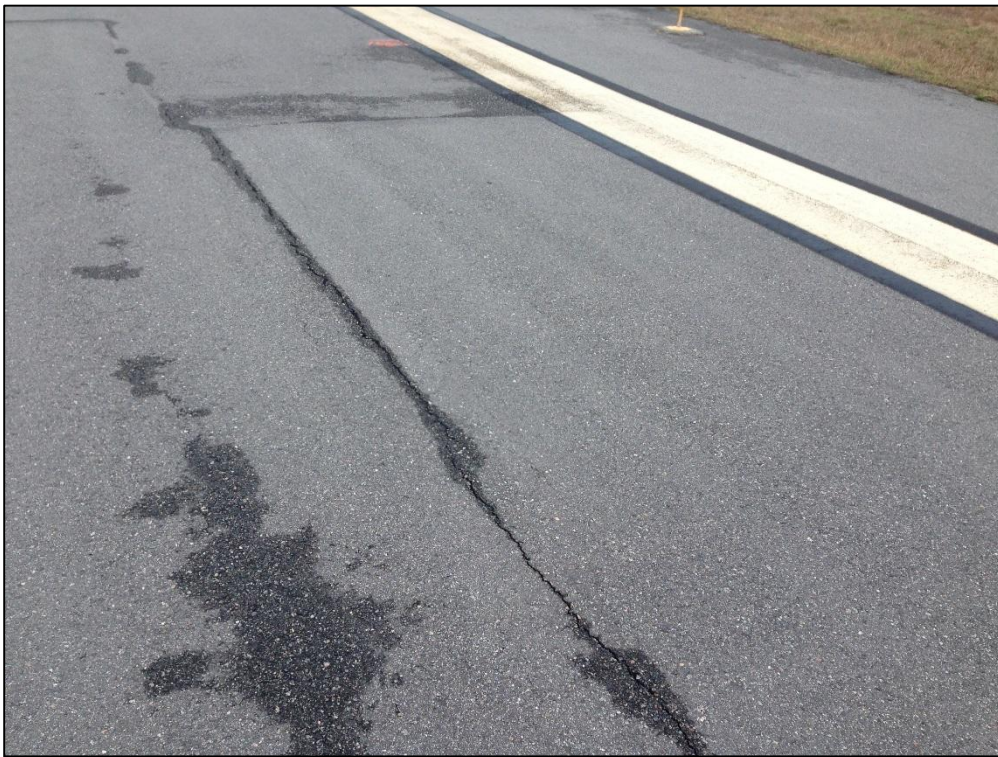
Runway 5-23, Section 6105, Sample Unit 168 – Low Severity (48) Longitudinal and Transverse Cracking, Low Severity (57) Weathering

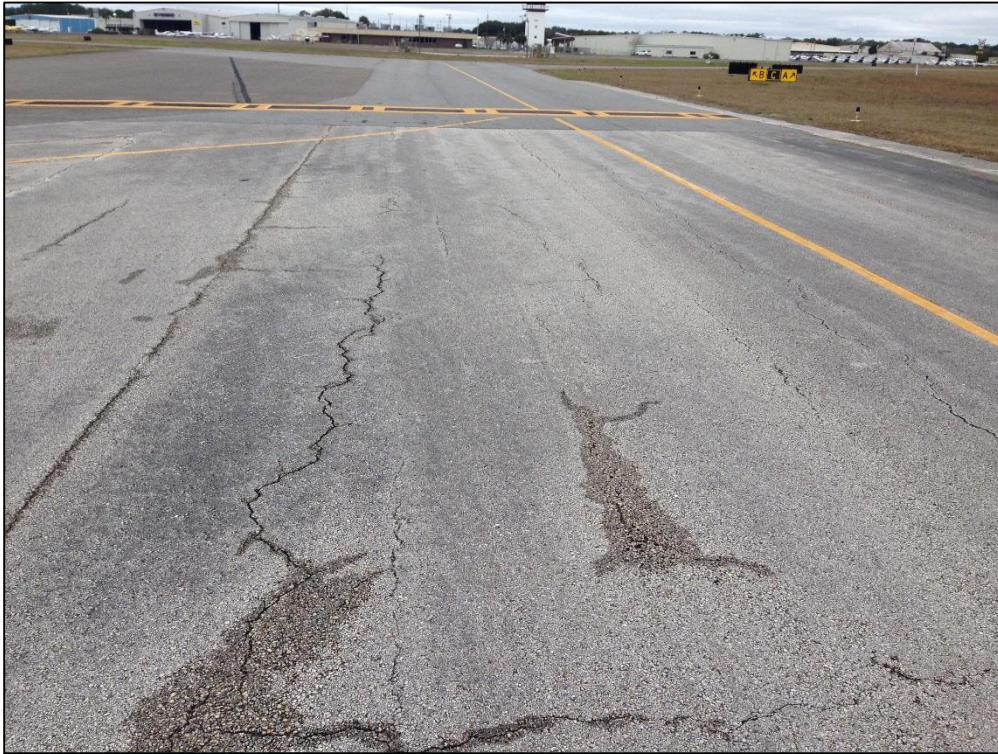
Taxiway Charlie, Section 305, Sample Unit 304 – Low Severity (48) Longitudinal and Transverse Cracking, Low Severity (52) Raveling, Low Severity (56) Swelling

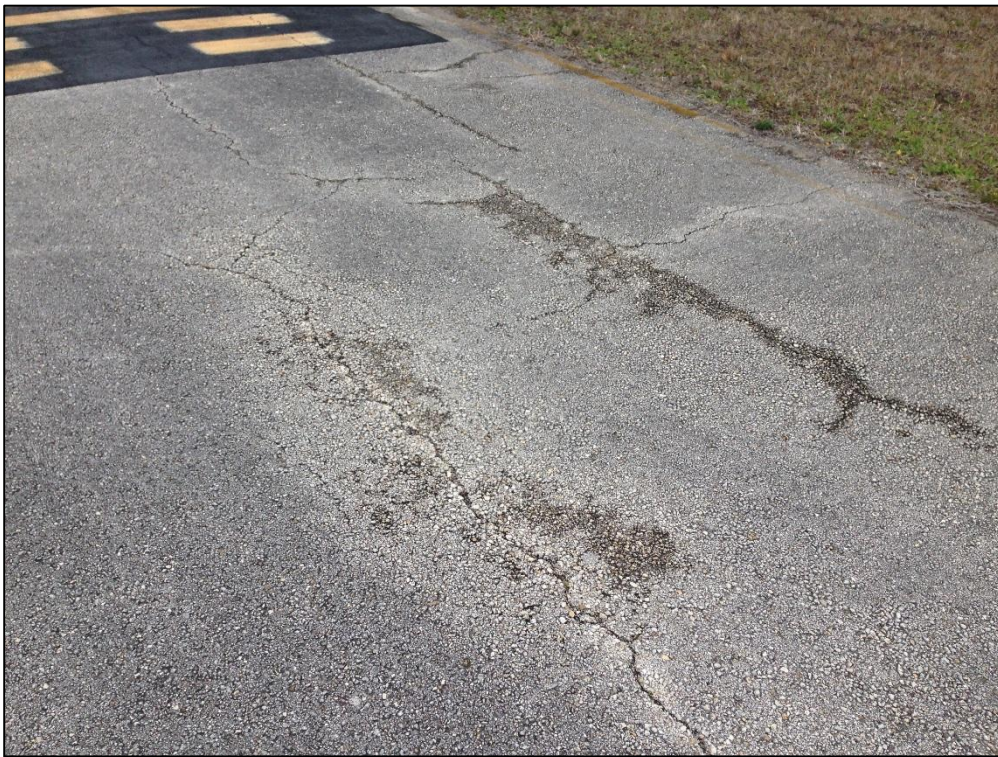
Taxiway Foxtrot, Section 605, Sample Unit 601 – Low Severity (48) Longitudinal and Transverse Cracking, Low Severity (52) Raveling, Medium Severity (52) Raveling

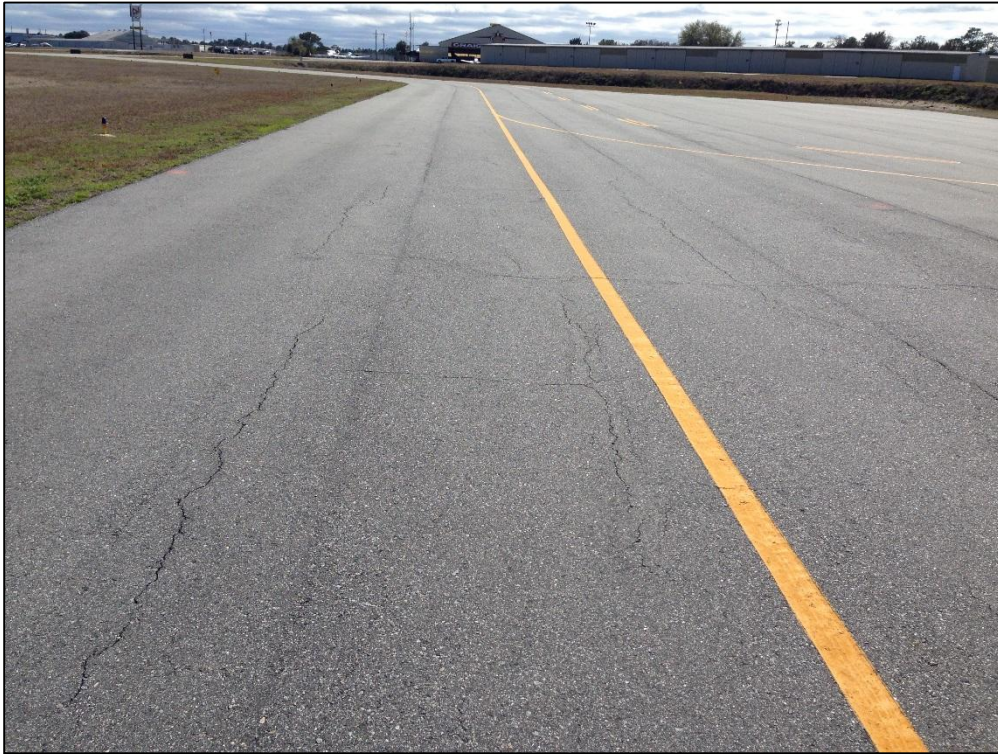
Taxiway Alpha, Section 105, Sample Unit 161 – Low Severity (48) Longitudinal and Transverse Cracking, Low Severity (52) Raveling, Low Severity (56) Swelling

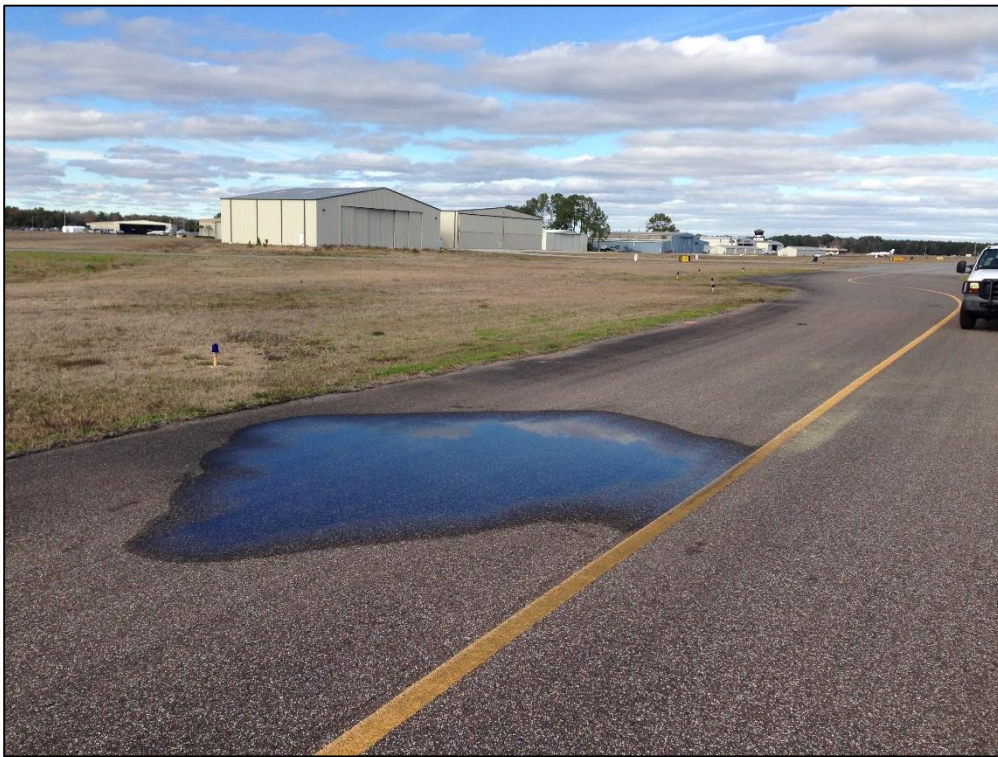
Taxiway Bravo, Section 235, Sample Unit 127 – Low Severity (45) Depression, Low Severity (52) Raveling, Low Severity (57) Weathering

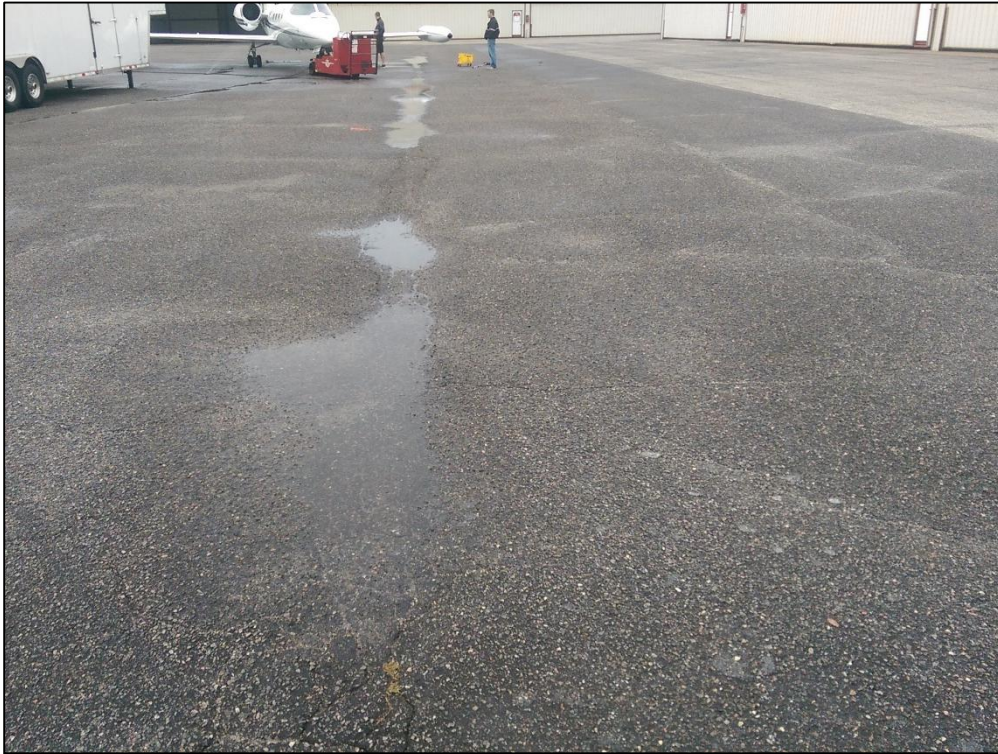
Apron Northwest, Section 4310, Sample Unit 554 – Low Severity (43) Block Cracking, Low Severity (45) Depression, Low Severity (52) Raveling, Medium Severity (57) Weathering

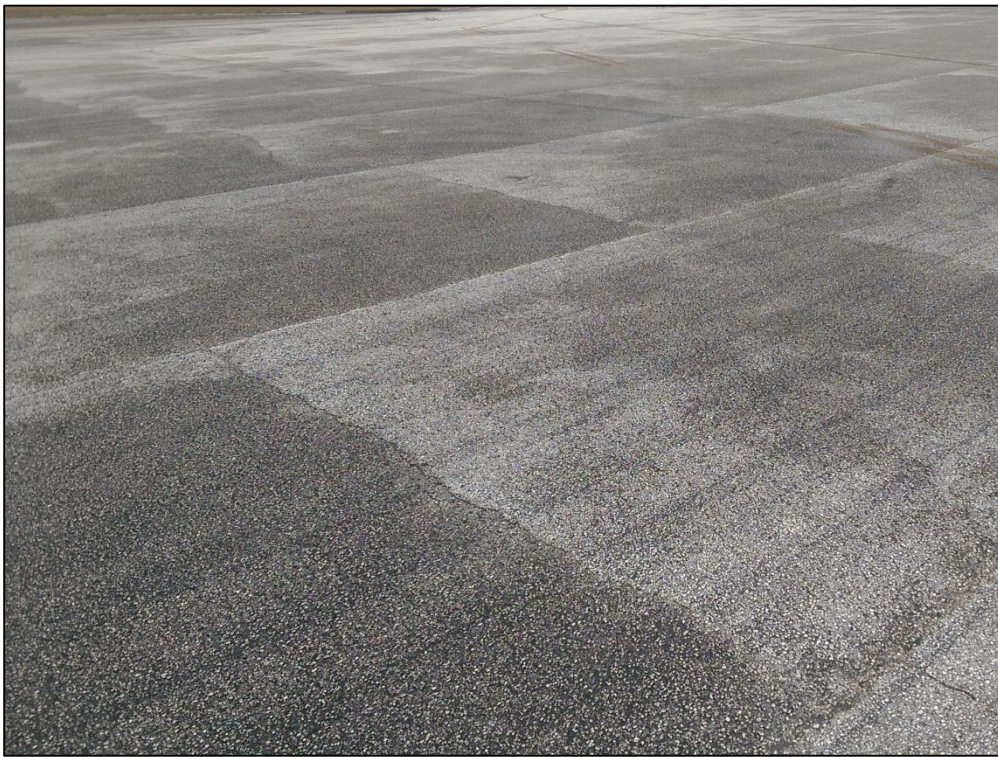
Apron Northwest, Section 4310, Sample Unit 251 – Low Severity (43) Block Cracking, Low Severity (52) Raveling, Medium Severity (57) Weathering

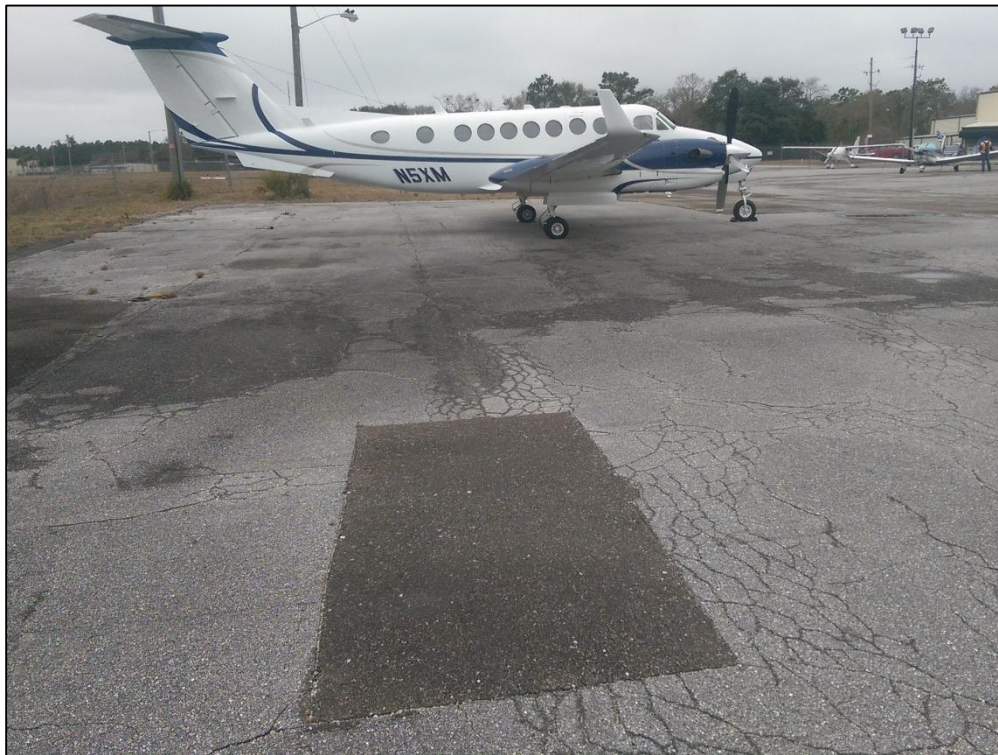
Apron Northwest, Section 4315, Sample Unit 103 – Medium Severity (41) Alligator Cracking, Low Severity (43) Block Cracking, Medium Severity (45) Depression, Medium Severity (50) Patching, Low Severity (52) Raveling, Medium Severity (57) Weathering

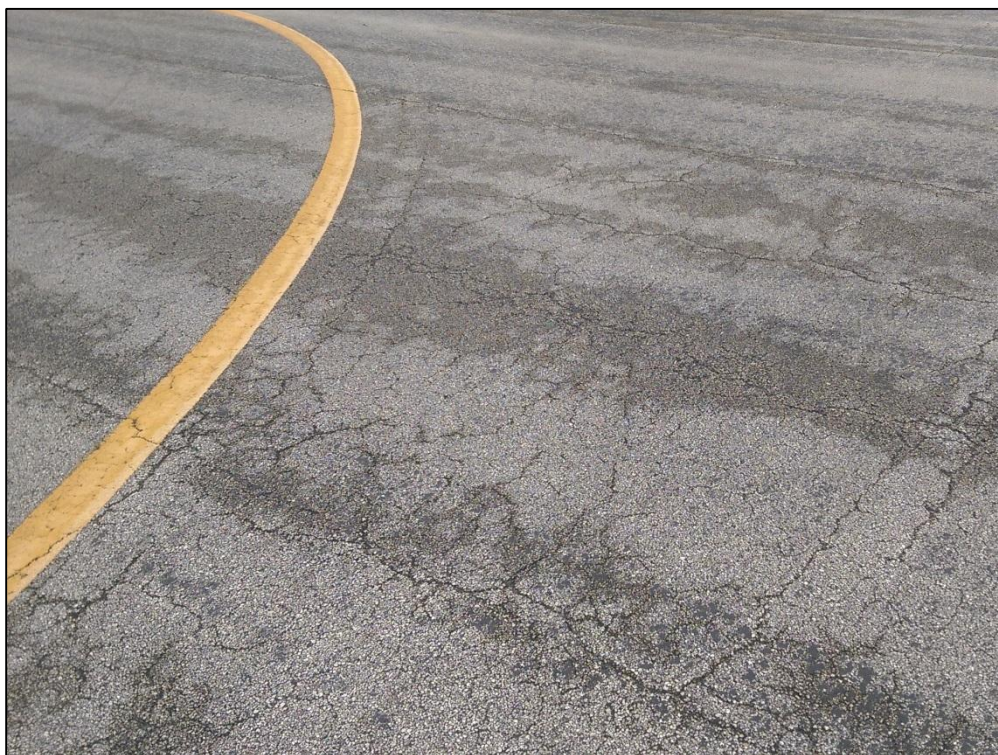
Apron North, Section 4210, Sample Unit 406 – Low Severity (43) Block Cracking, Low Severity (56) Swelling, Low Severity (57) Weathering

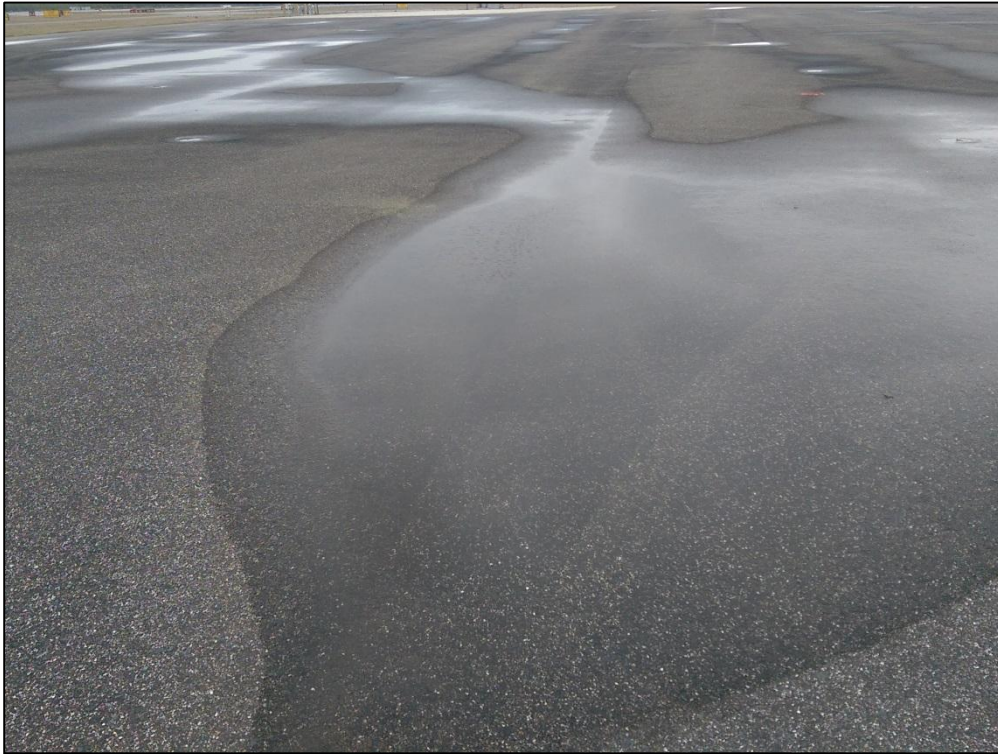
Apron FAA, Section 4510, Sample Unit 603 – Low Severity (45) Depression, Low Severity (57) Weathering

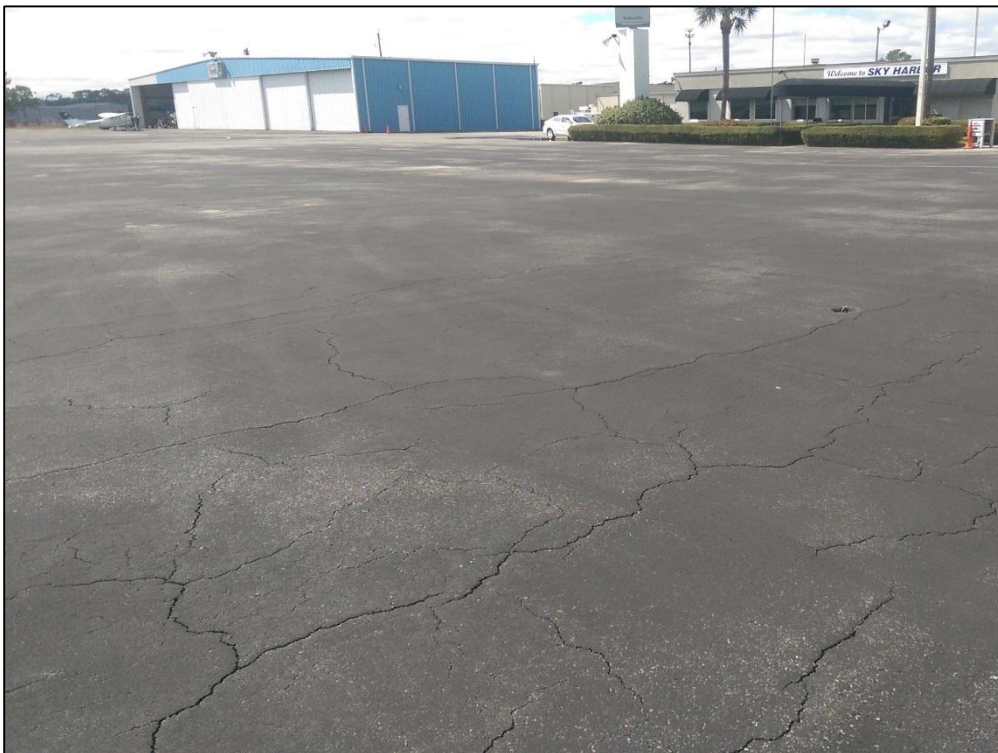
Apron South, Section 4105, Sample Unit 404 – Low Severity (43) Block Cracking, Low Severity (52) Raveling, Low Severity (57) Weathering
