FLORIDA DEPARTMENT OF TRANSPORTATION  
AVIATION AND SPACEPORT OFFICE

**DELAND  
MUNICIPAL  
AIRPORT - SIDNEY H  
TAYLOR FIELD (DED)**

JUNE 2015

STATEWIDE  
**Airfield  
Pavement  
Management**  
PROGRAM

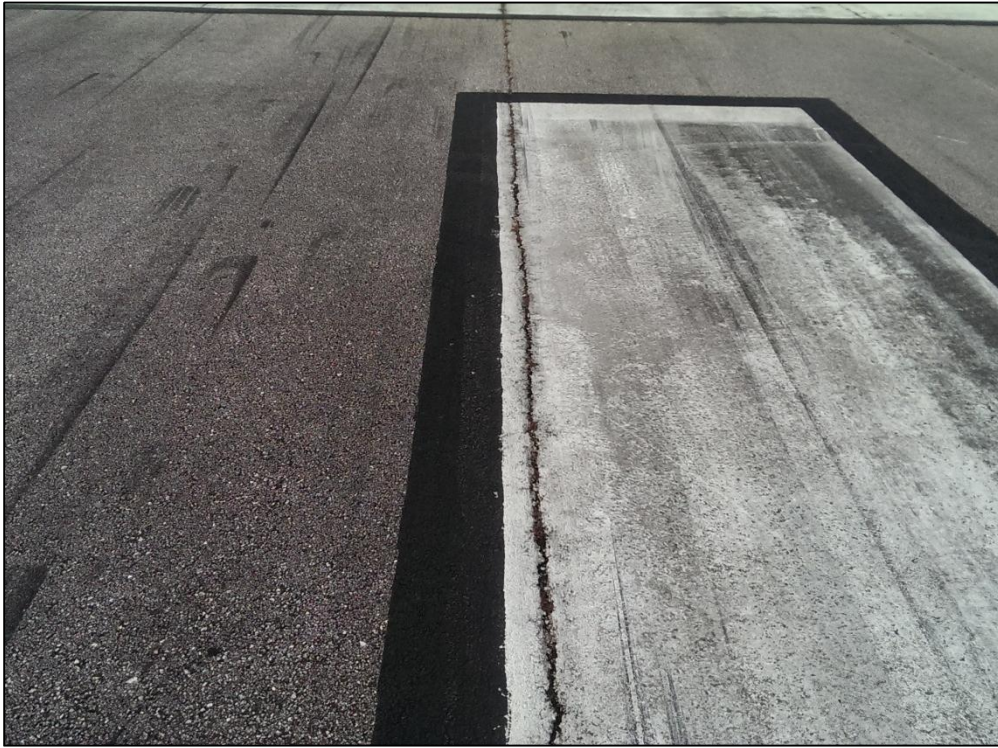
Runway 5-23, Section 6210, Sample Unit 108 – Low and Medium Severity (48) Longitudinal and Transverse Cracking, Low Severity (57) Weathering

- Runway 5-23 – Section 6210
  - Mill and Overlay attributed to climate and age of pavement.
- East Apron – Sections 4205 and 4210
  - Mill and Overlay attributed to climate and age of pavement.
- Taxiway B – Sections 205 and 215
  - Mill and Overlay attributed to climate and age of pavement.
- West Ramp – Sections 150, 160, 162, and 165
  - Reconstruction and Mill and Overlay attributed to load, climate, and age of pavement.

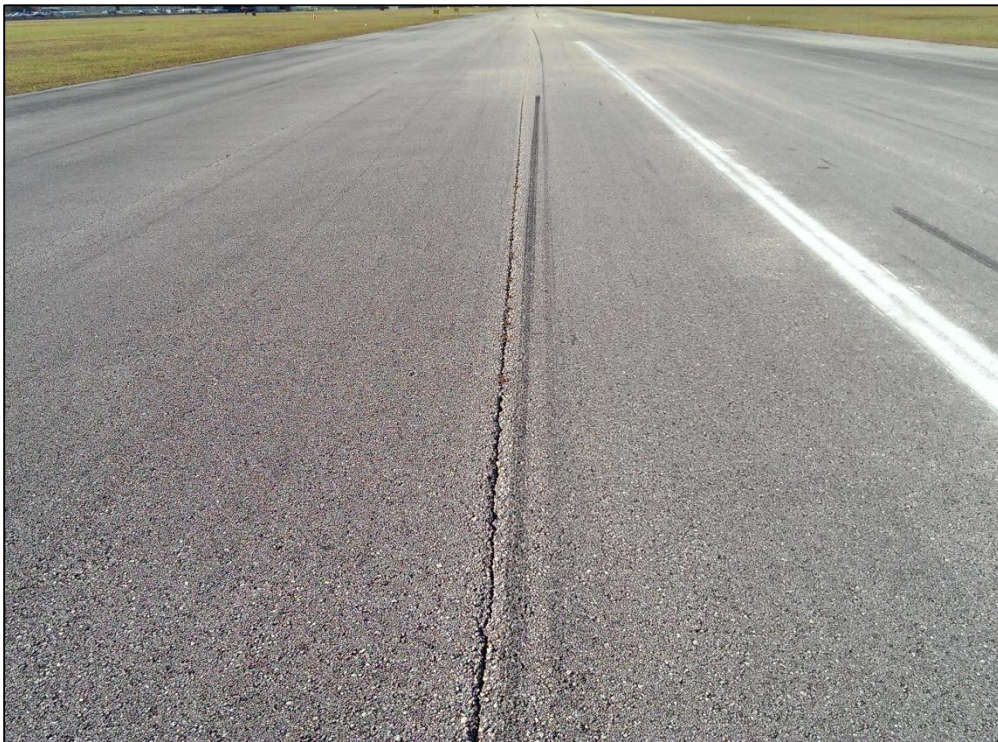
Runway 5-23, Section 6210, Sample Unit 156 – Low and Medium Severity (48) Longitudinal and Transverse Cracking, Low Severity (57) Weathering

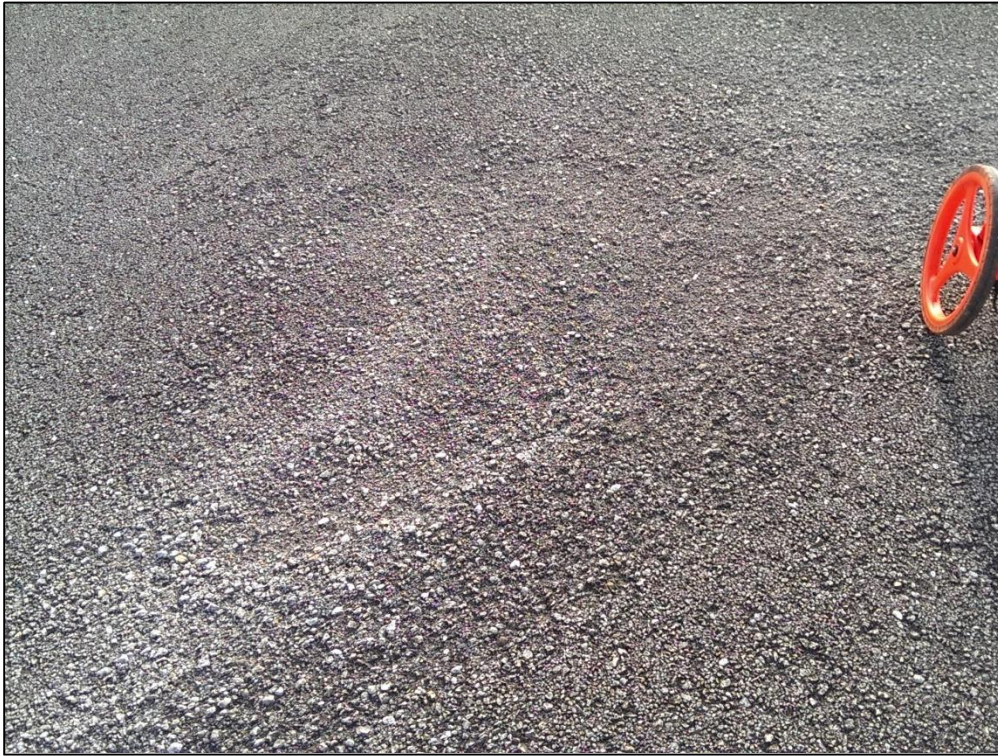
Taxiway Bravo, Section 205, Sample Unit 203 – Low Severity (52) Raveling, Medium Severity (52) Raveling

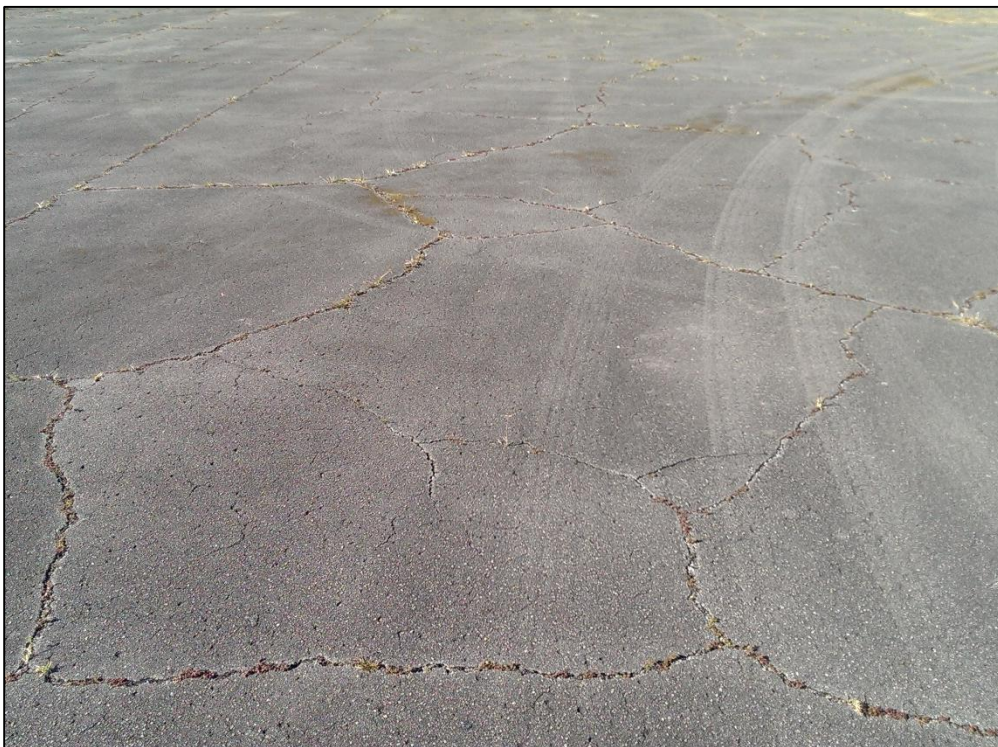
Apron East, Section 4210, Sample Unit 103 – Medium Severity (43) Block Cracking, Low Severity (57) Weathering

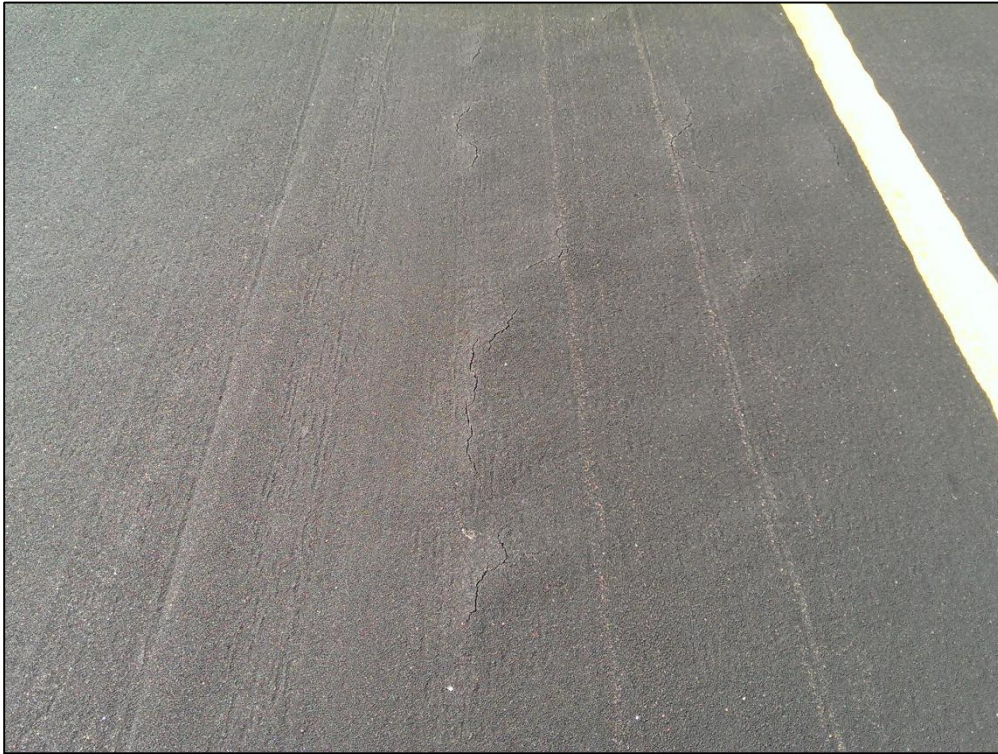
Taxiway Alpha, Section 110, Sample Unit 522 – Low Severity (48) Longitudinal and Transverse Cracking

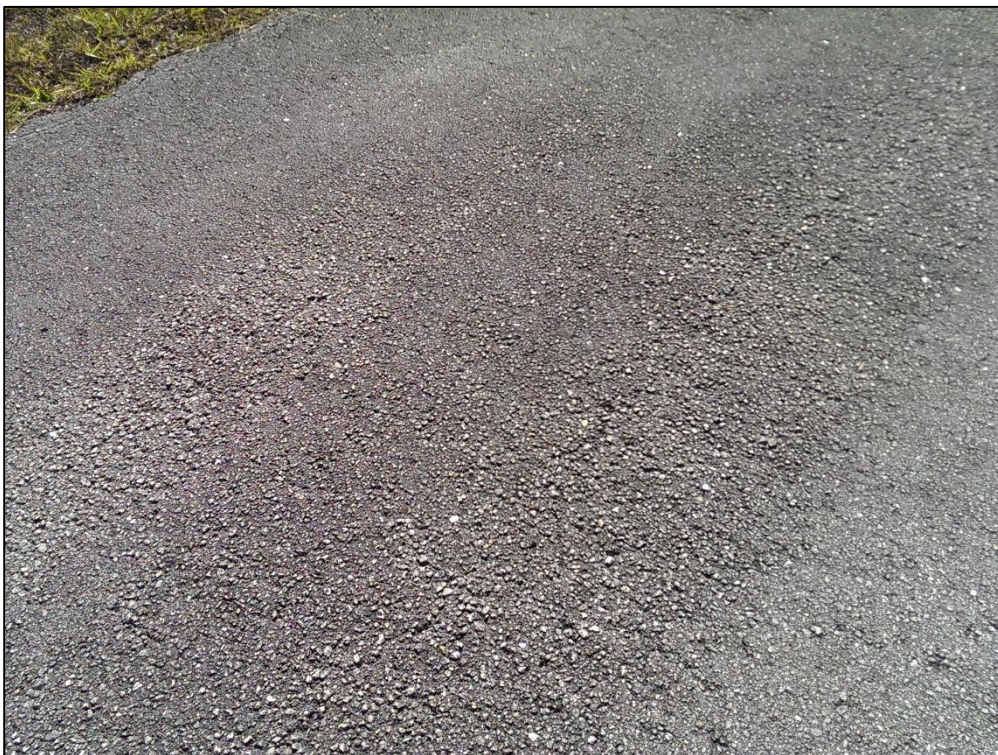
Apron South, Section 5305, Sample Unit 301 – Low Severity (52) Raveling, Low Severity (57) Weathering

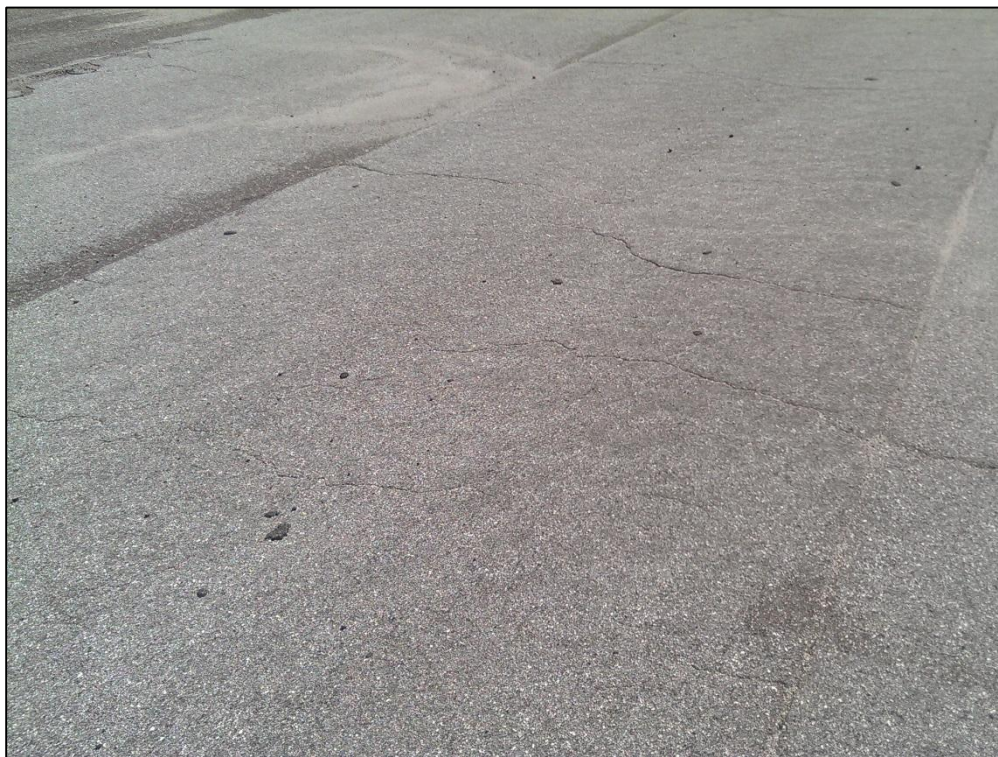
West Ramp, Section 162, Sample Unit 226 – Low Severity (43) Block Cracking, Low Severity (52) Raveling

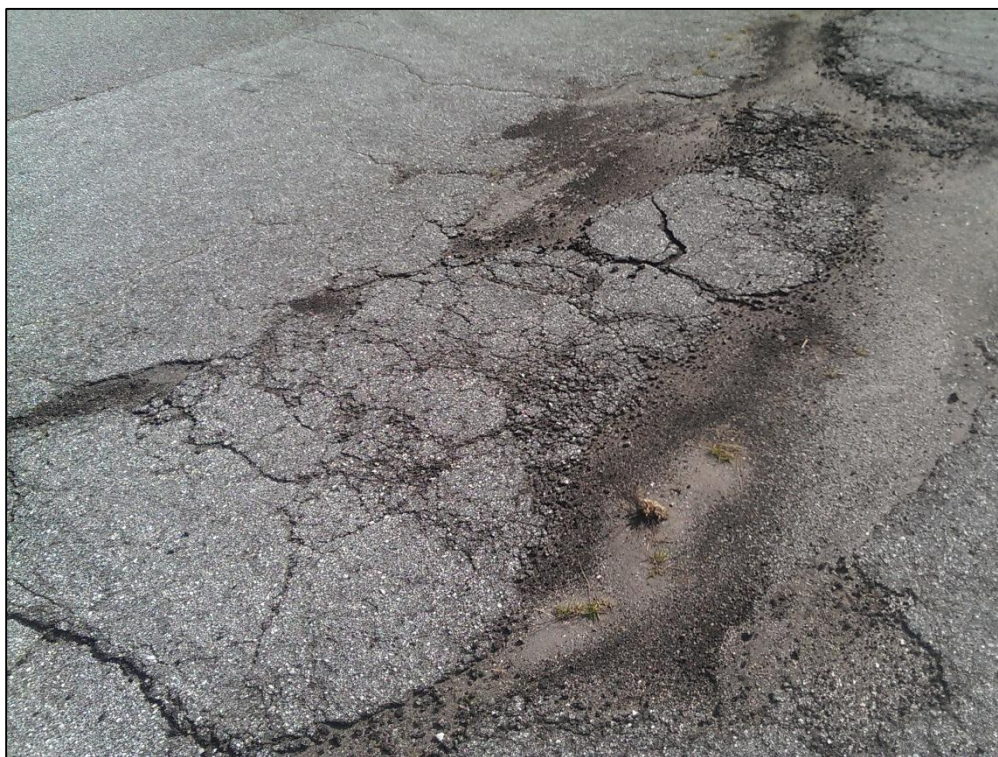
West Ramp, Section 160, Sample Unit 123 – Low Severity (43) Block Cracking, Low Severity (45) Depression, Low Severity (52) Raveling, Medium Severity (52) Raveling

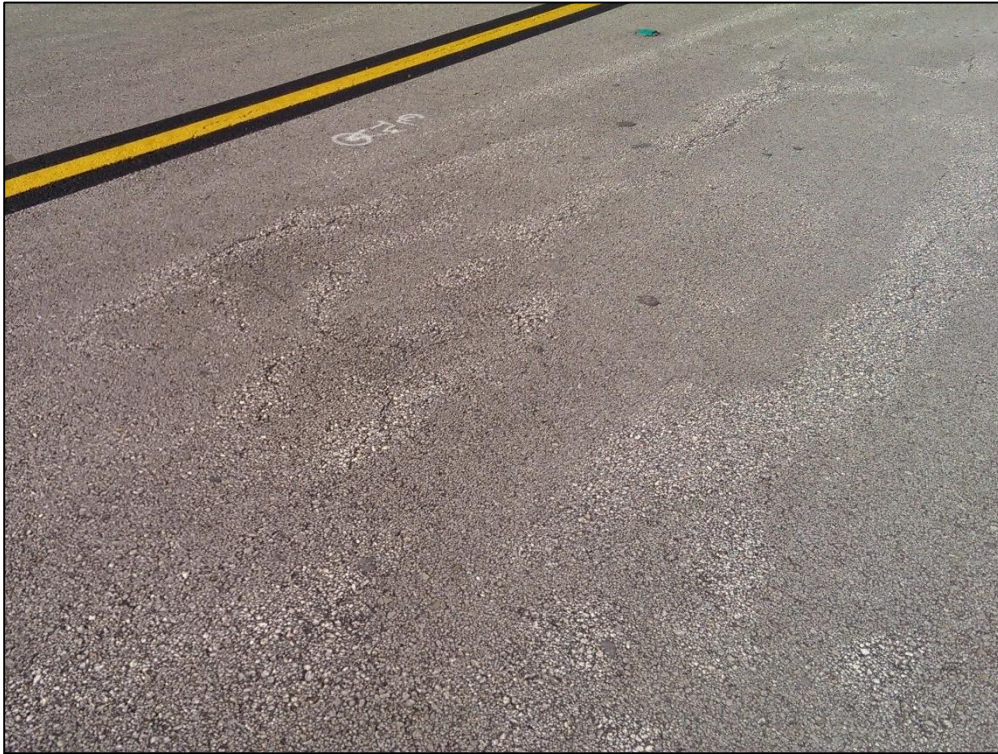
Taxiway Bravo, Section 220, Sample Unit 219 – Low Severity (48) Longitudinal and Transverse Cracking, Low Severity (52) Raveling, Low Severity (57) Weathering

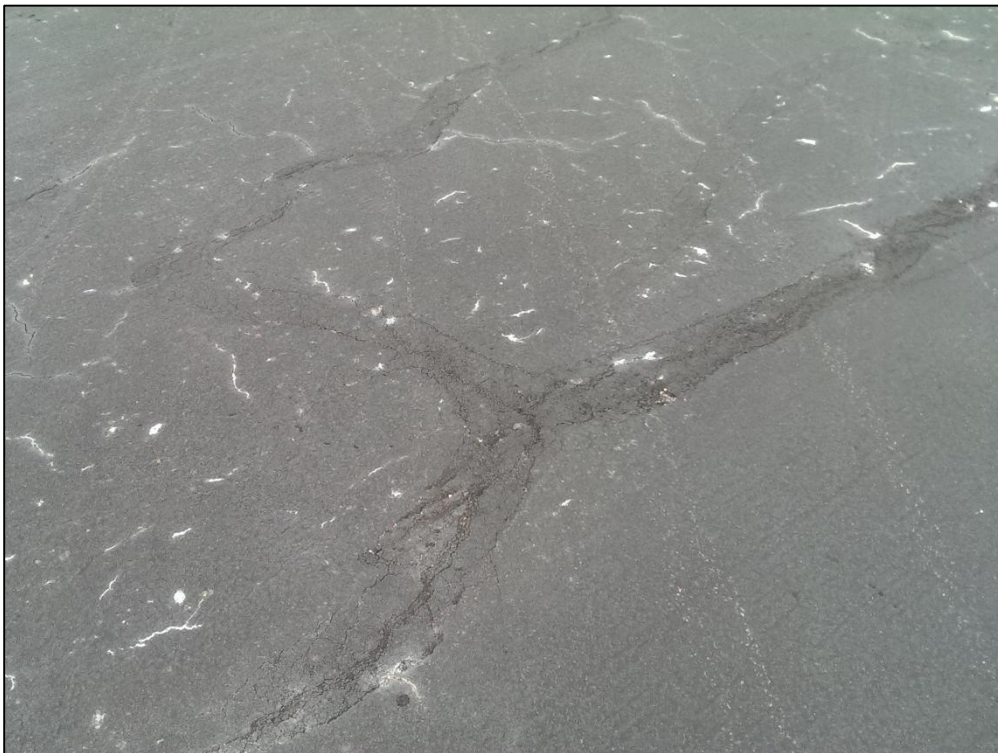
Apron SE, Section 4112, Sample Unit 250 – Low Severity (48) Longitudinal and Transverse Cracking
