**NORTHWEST
FLORIDA BEACHES
INTERNATIONAL
AIRPORT (ECP)**

JUNE 2015

STATEWIDE
**Airfield
Pavement
Management**
PROGRAM

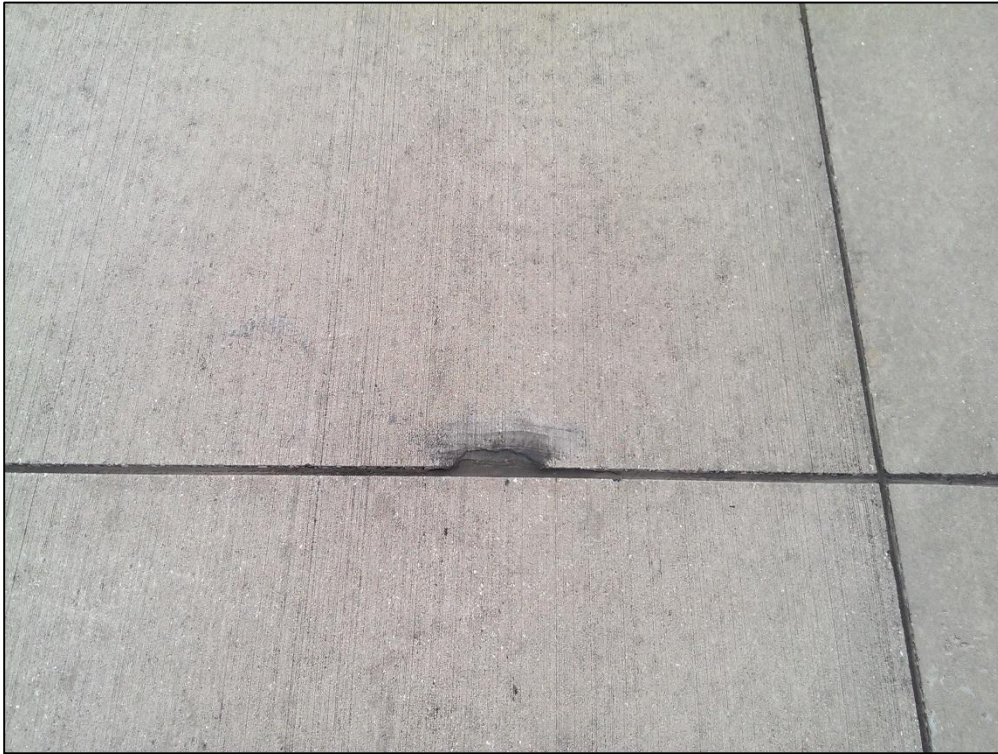
Taxiway Uniform, Section 2105, Sample Unit 100 – Low Severity (74) Joint Spalling

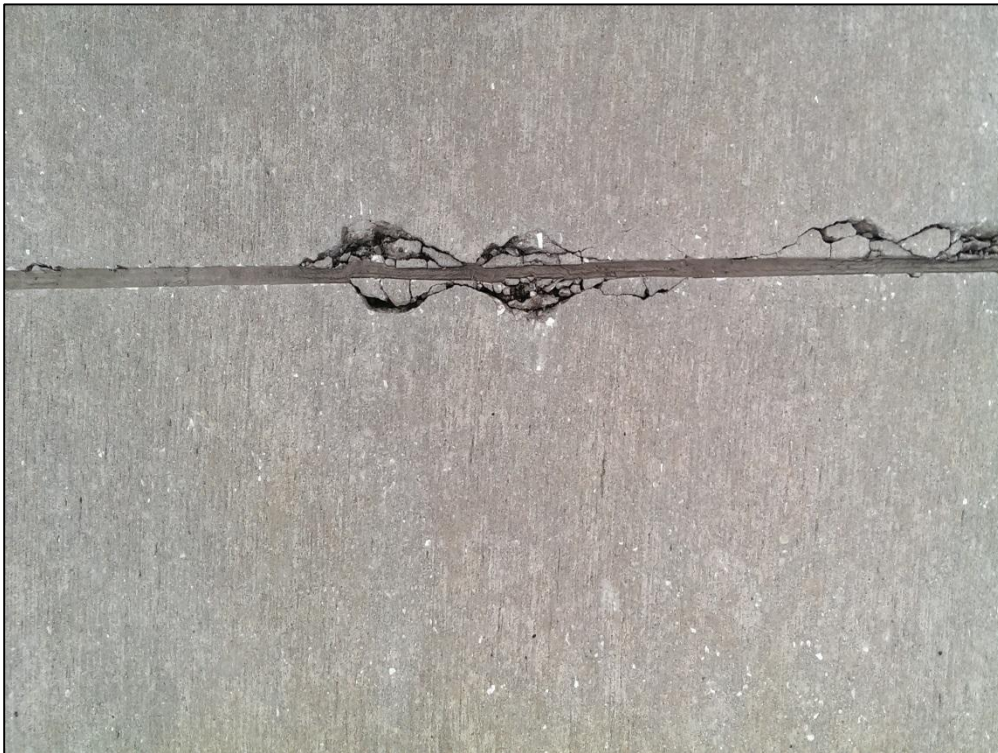
Taxiway Sierra, Section 1905, Sample Unit 300 – Low Severity (74) Joint Spalling

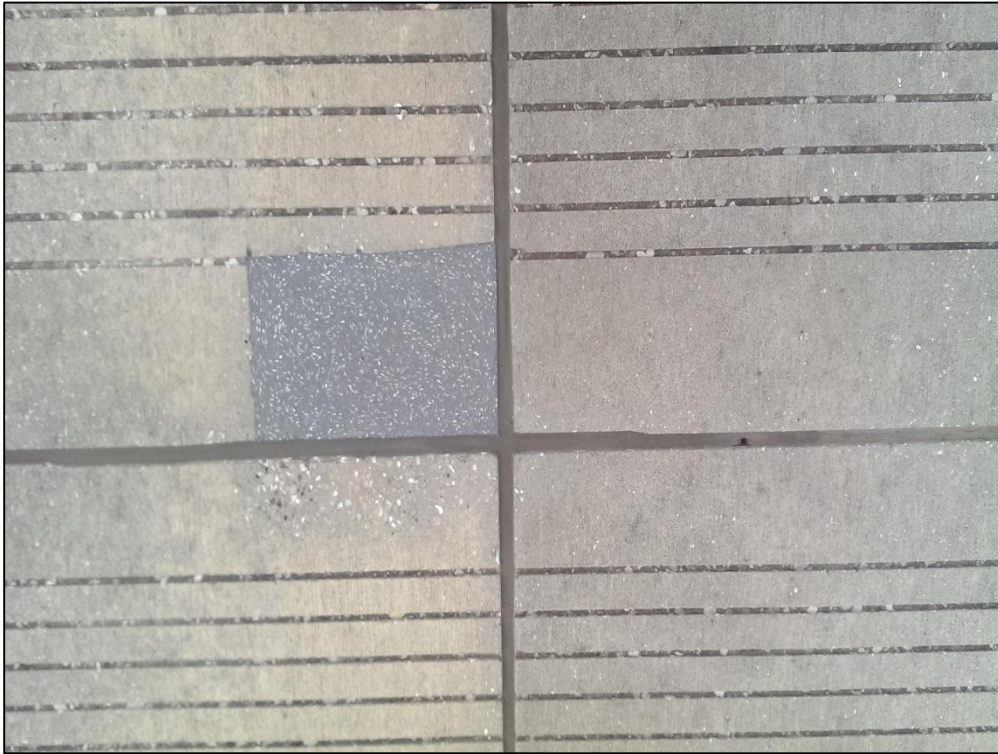
Runway 16-34, Section 6110, Sample Unit 168 – Low Severity (66) Small Patching

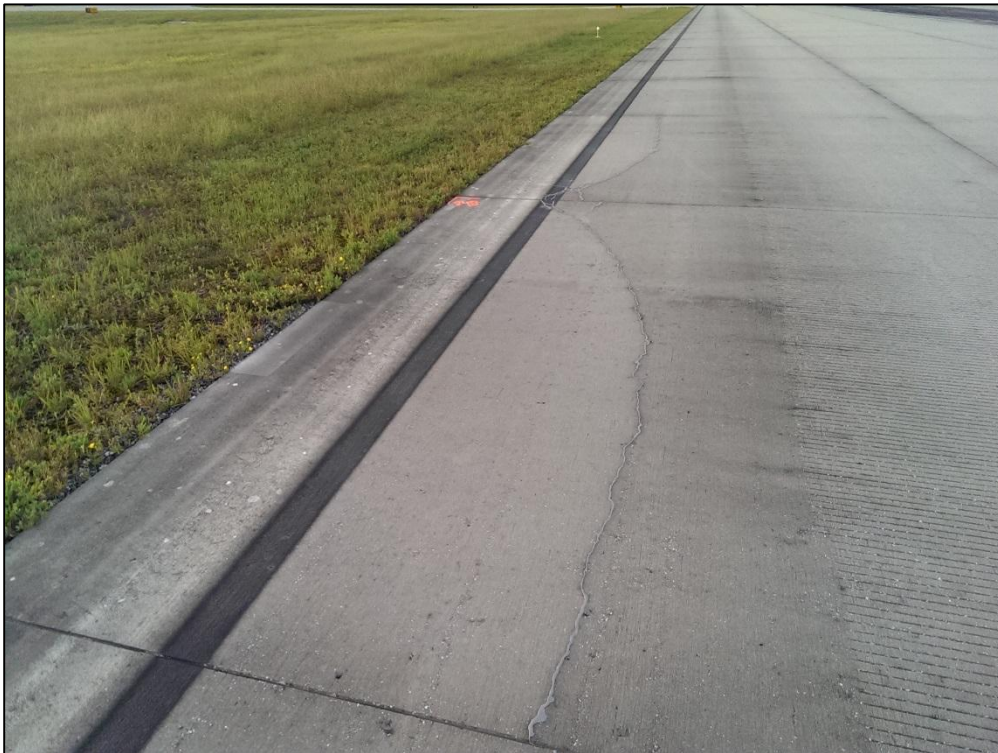
Runway 16-34, Section 6110, Sample Unit 248 – Low Severity (63) Longitudinal, Transverse, and Diagonal Cracking

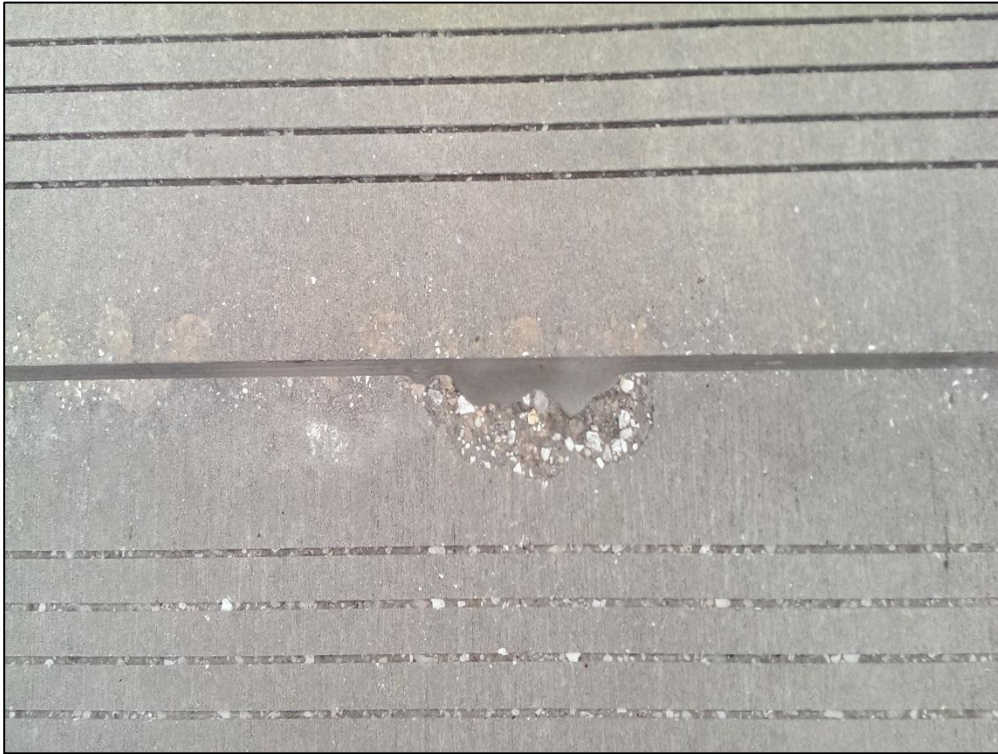
Runway 16-34, Section 6105, Sample Unit 379 – Low Severity (74) Joint Spalling

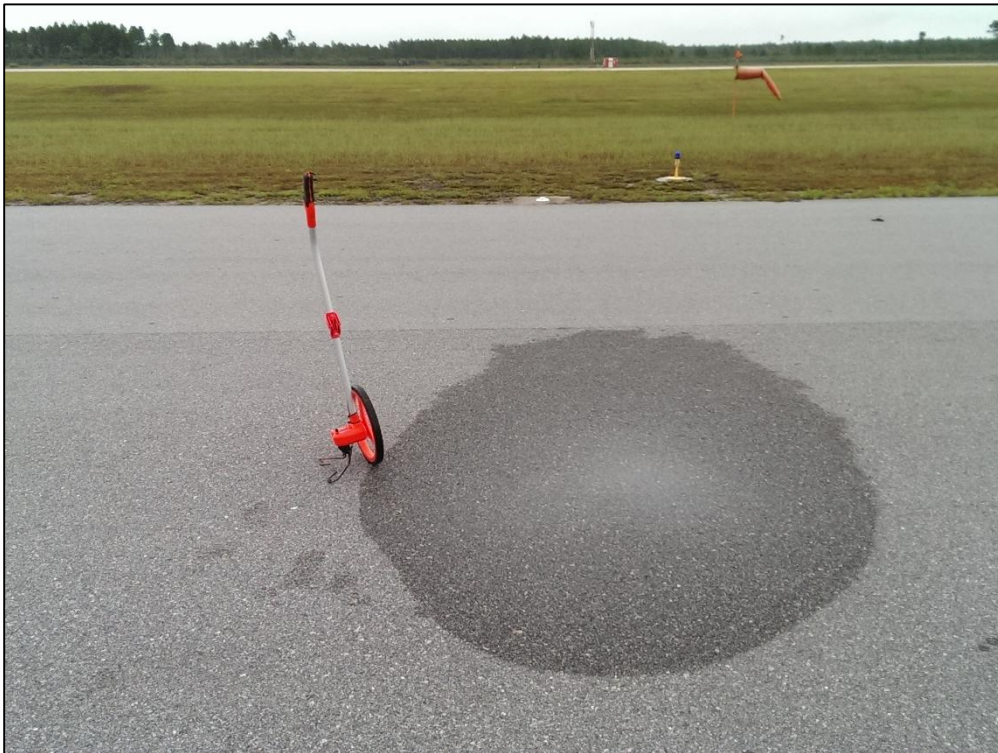
Taxiway Delta, Section 405, Sample Unit 129 – Low Severity (45) Depression, Low Severity (57) Weathering

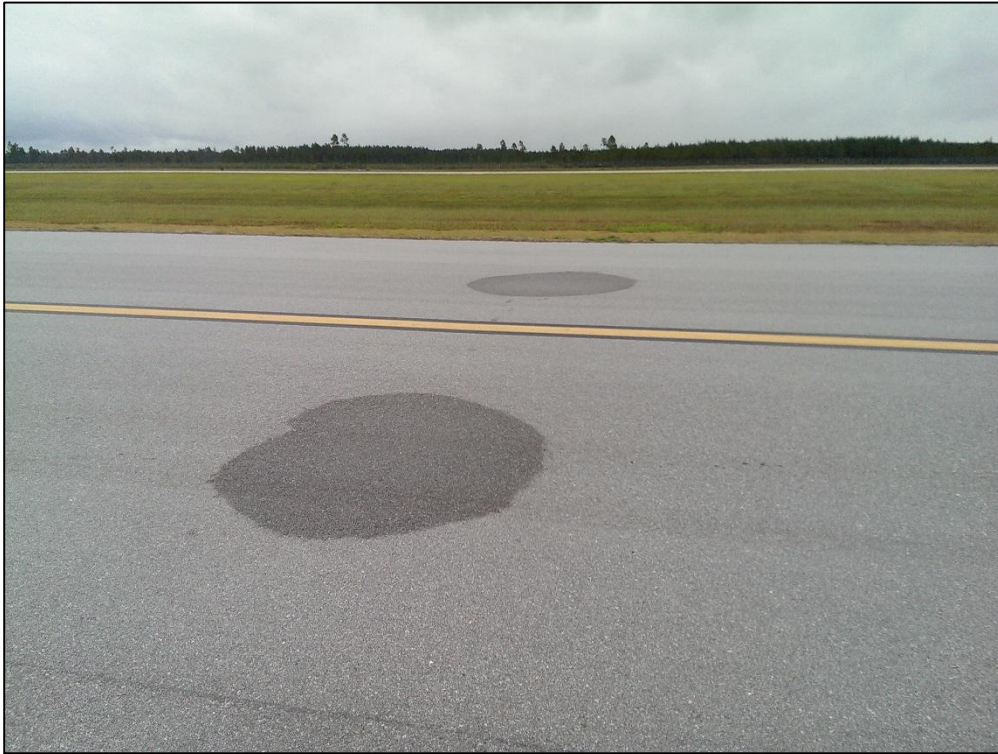
Taxiway Delta, Section 405, Sample Unit 159 – Low Severity (45) Depression, Low Severity (57) Weathering

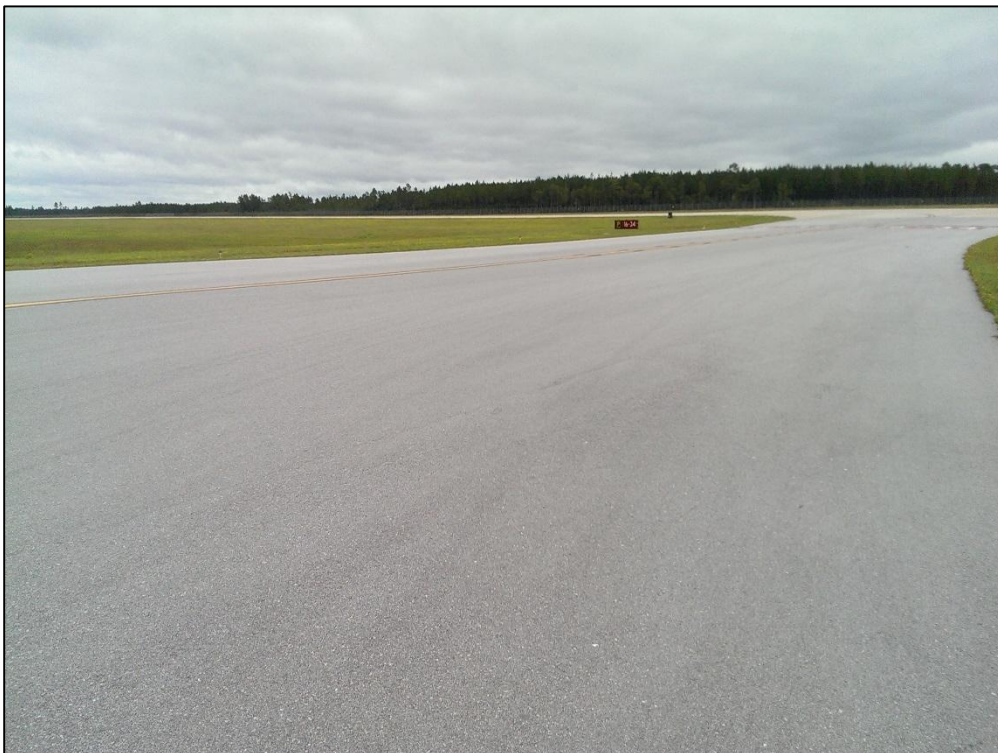
Taxiway Papa, Section 1610, Sample Unit 408 – Low Severity (57) Weathering

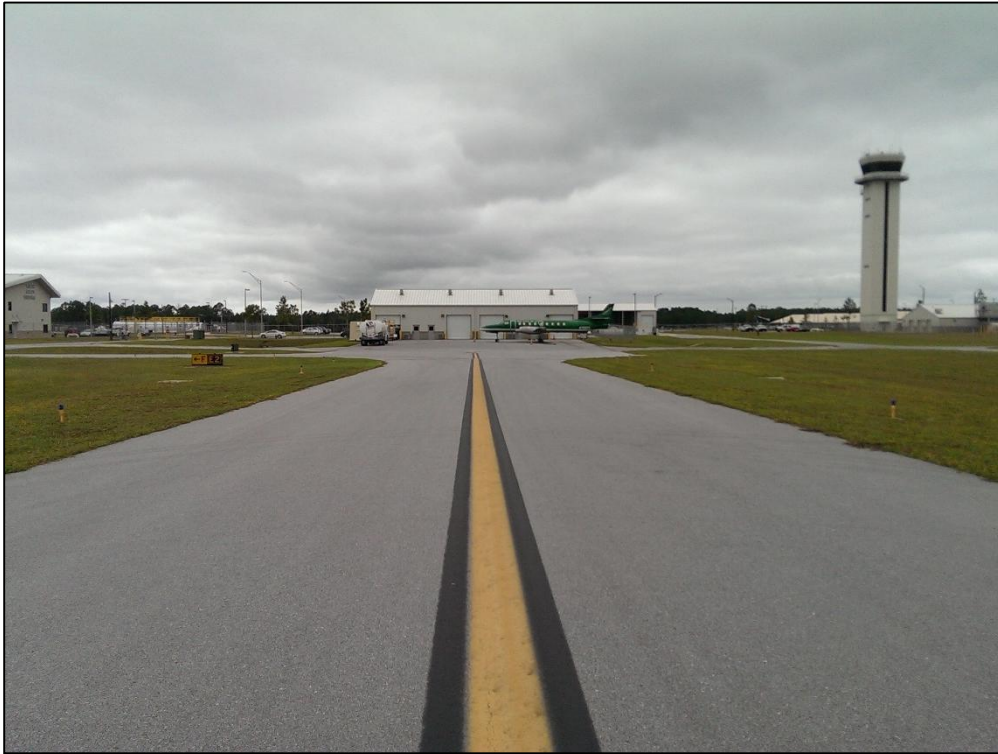
Taxiway E2, Section 505, Sample Unit 351 – Low Severity (57) Weathering

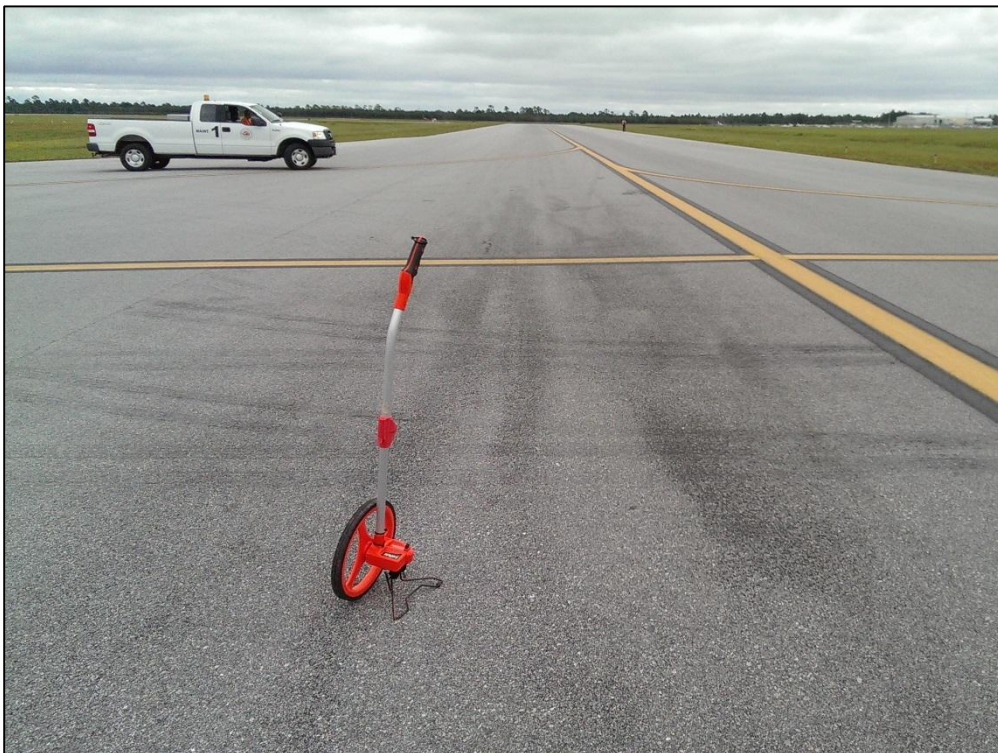
Taxiway Delta, Section 405, Sample Unit 266 – (42) Bleeding, Low Severity (57) Weathering

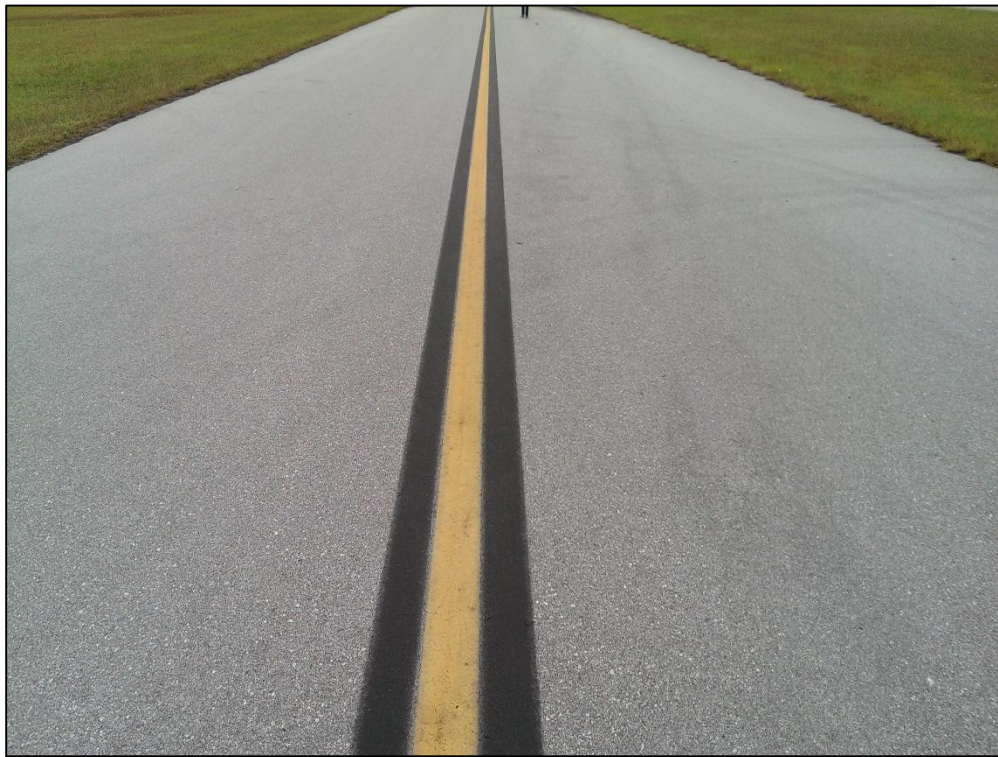
Taxiway Foxtrot, Section 605, Sample Unit 392 – Low Severity (57) Weathering

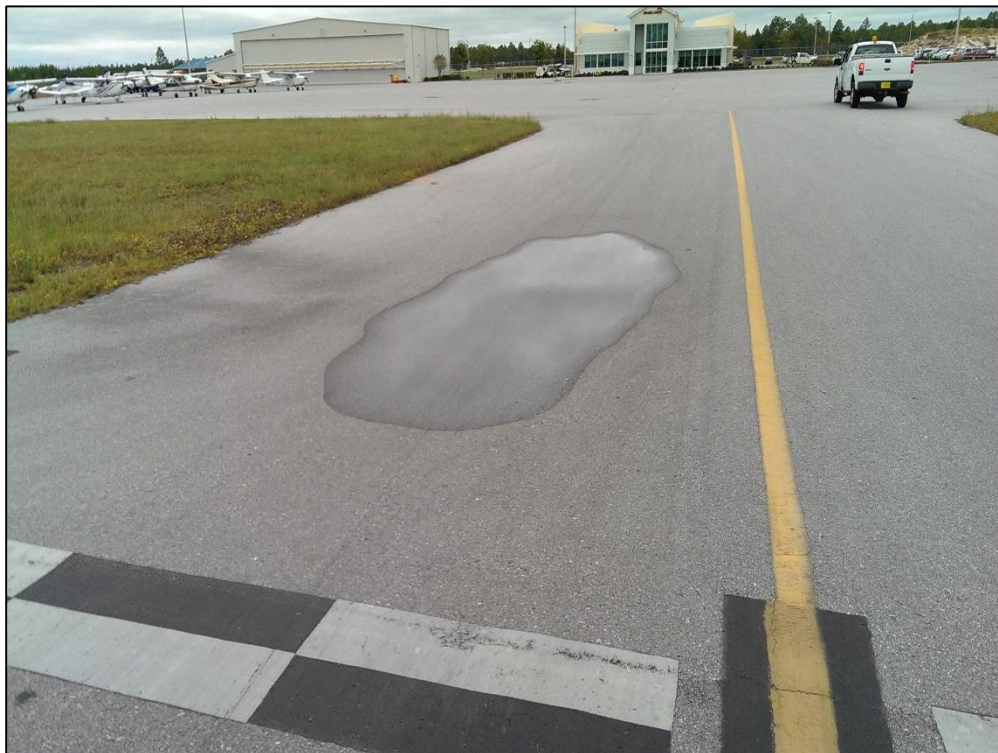
Taxiway Juliet, Section 1020, Sample Unit 754 – Medium Severity (45) Depression, Low Severity (57) Weathering

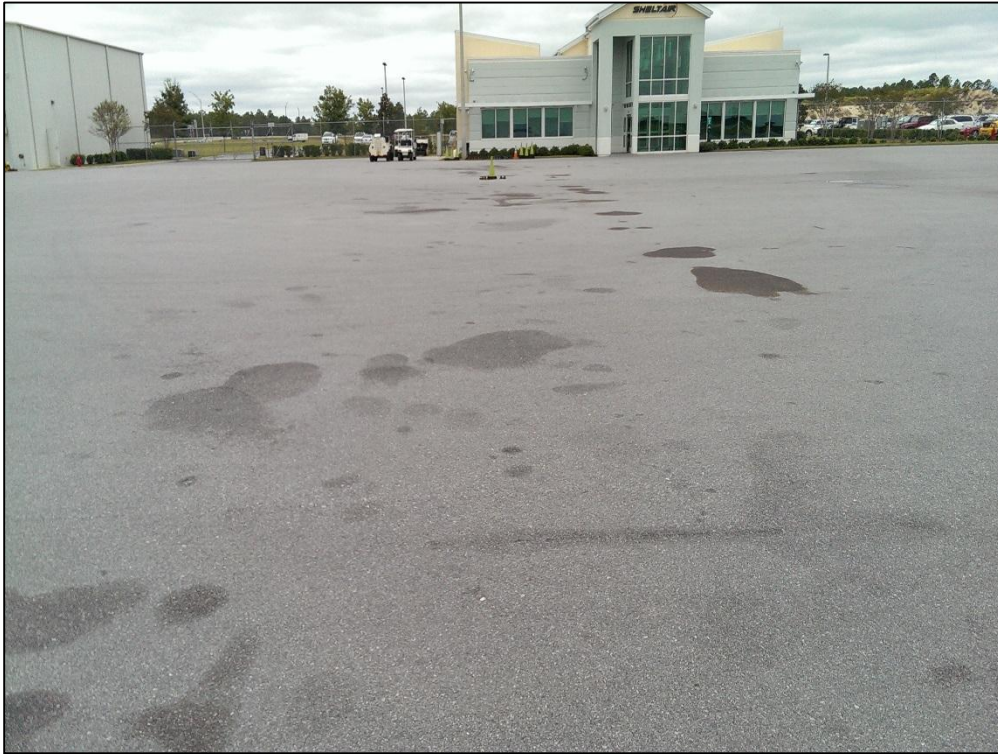
Apron GA, Section 4405, Sample Unit 251 – (49) Oil Spillage, Low Severity (57) Weathering

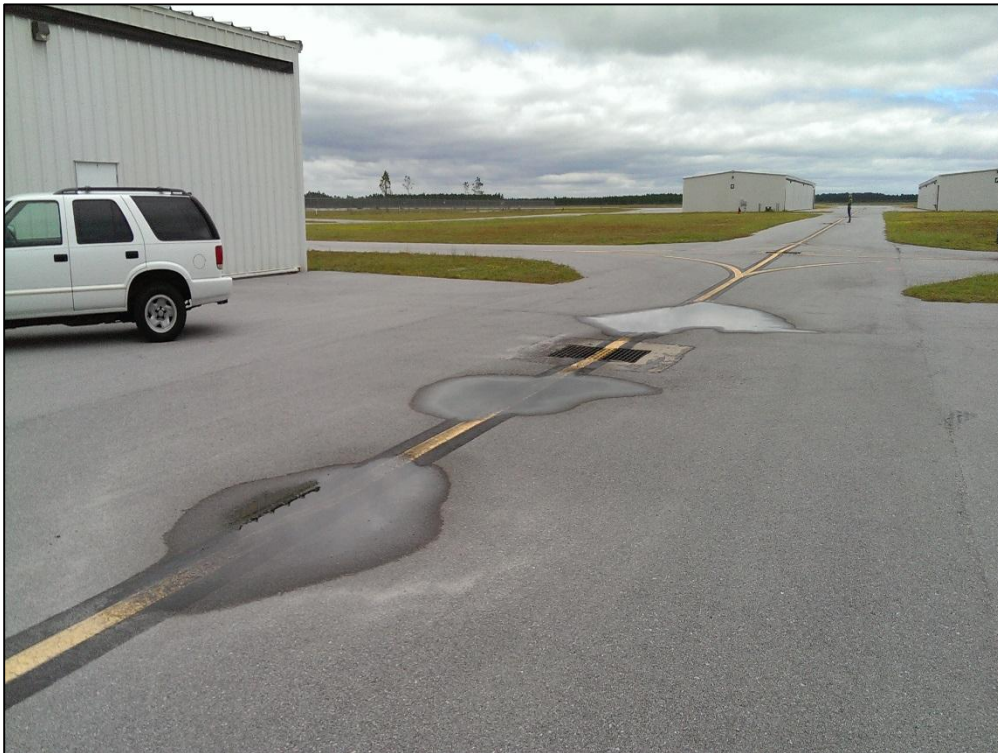
Apron T-Hangar, Section 4310, Sample Unit 304 – Low Severity (45) Depression, Low Severity (57) Weathering

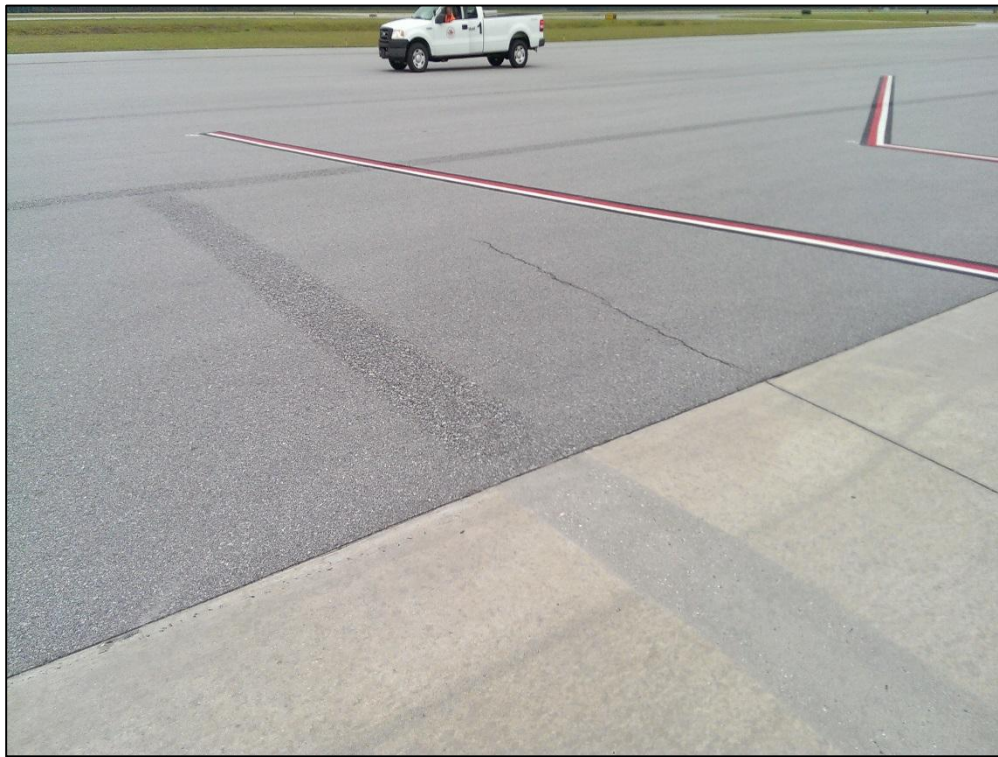
Terminal Apron, Section 4110, Sample Unit 204 – Low Severity (48) Longitudinal and Transverse Cracking, Low Severity (52) Raveling, Low Severity (57) Weathering

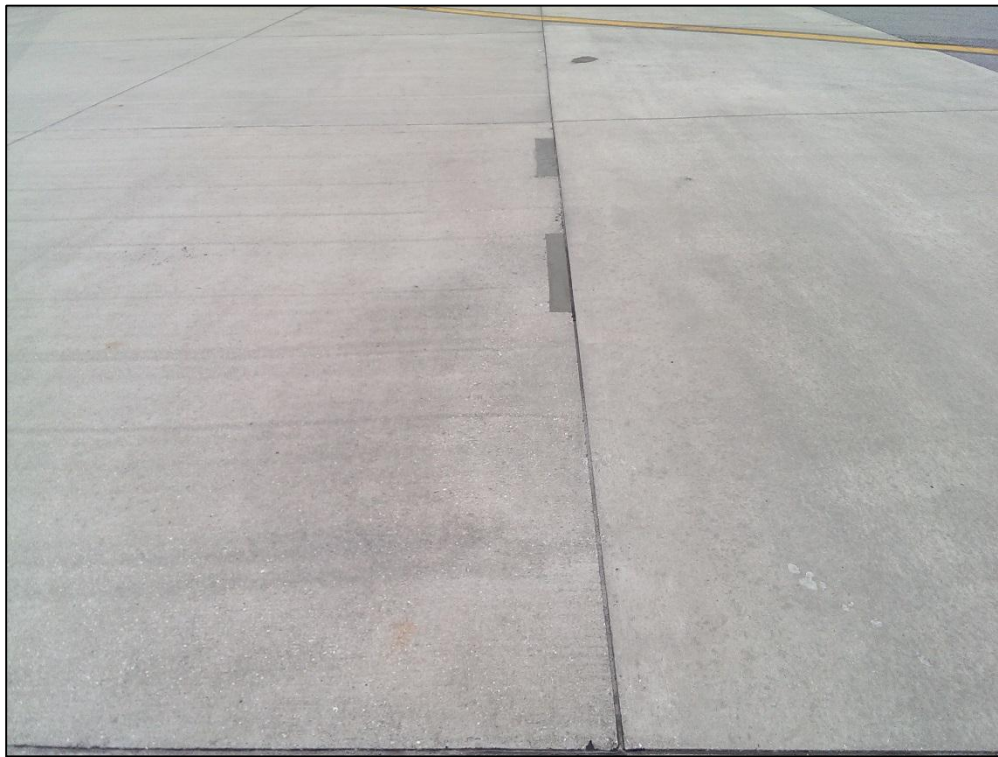
Terminal Apron, Section 4115, Sample Unit 950 – Low Severity (66) Small Patching
