**NEW SMYRNA
BEACH MUNICIPAL
AIRPORT (EVB)**

DISTRICT 5
REGIONAL RELIEVER
AIRPORT
JUNE 2015

STATEWIDE
**Airfield
Pavement
Management**
PROGRAM

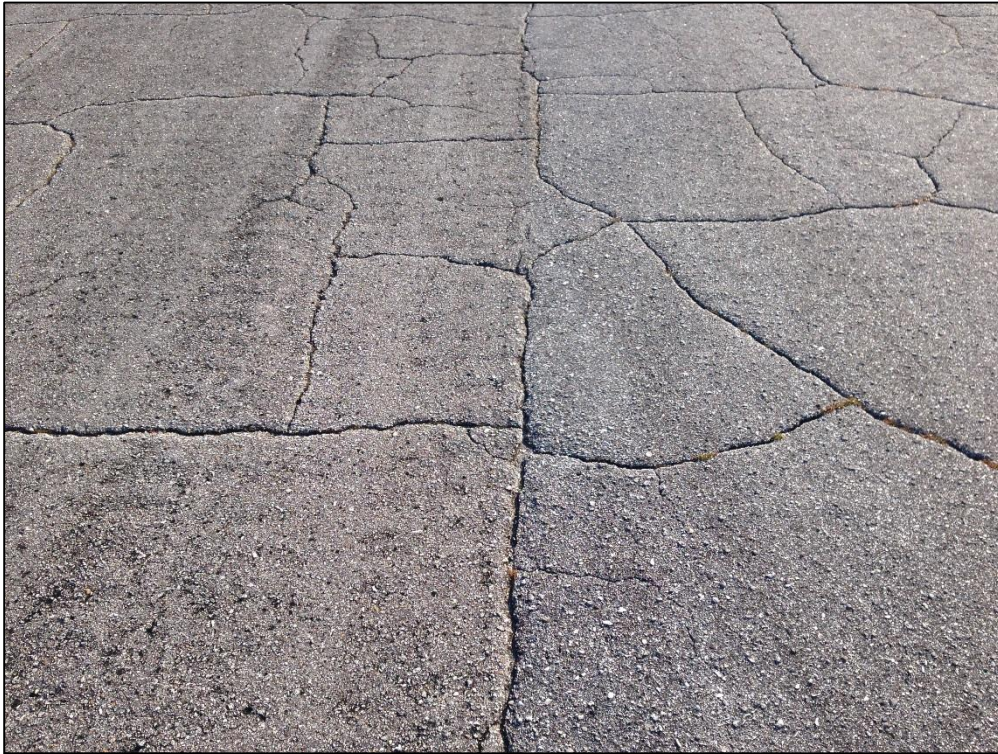
Runway 02-20, Section 6405, Sample Unit 102 – Medium Severity (43) Block Cracking, Low Severity (52) Raveling

- ⦿ Runway 2-20 – Sections 6405, 6425, 6430, 6445, and 6450
 - Reconstruction and Mill and Overlay attributed to climate/age, structural, and construction quality.
- ⦿ Apron Runway 15-33– Section 6345
 - Reconstruction attributed to climate/age.
- ⦿ South Apron – Sections 4215 and 4220
 - Reconstruction attributed to structural, climate/age, and construction quality.
- ⦿ Apron – Sections 4102, 4105, 4110, 4115, 4130, 4165, and 4185
 - Reconstruction attributed to structural, climate/age, and construction quality.
- ⦿ Apron – Sections 4104, 4135, 4140, and 4160
 - Reconstruction and Mill and Overlay attributed to structural, climate/age, and construction quality.
- ⦿ Taxiway D – Sections 415 and 420
 - Reconstruction attributed to structural, climate/age, and construction quality.
- ⦿ Taxiway C – Section 310

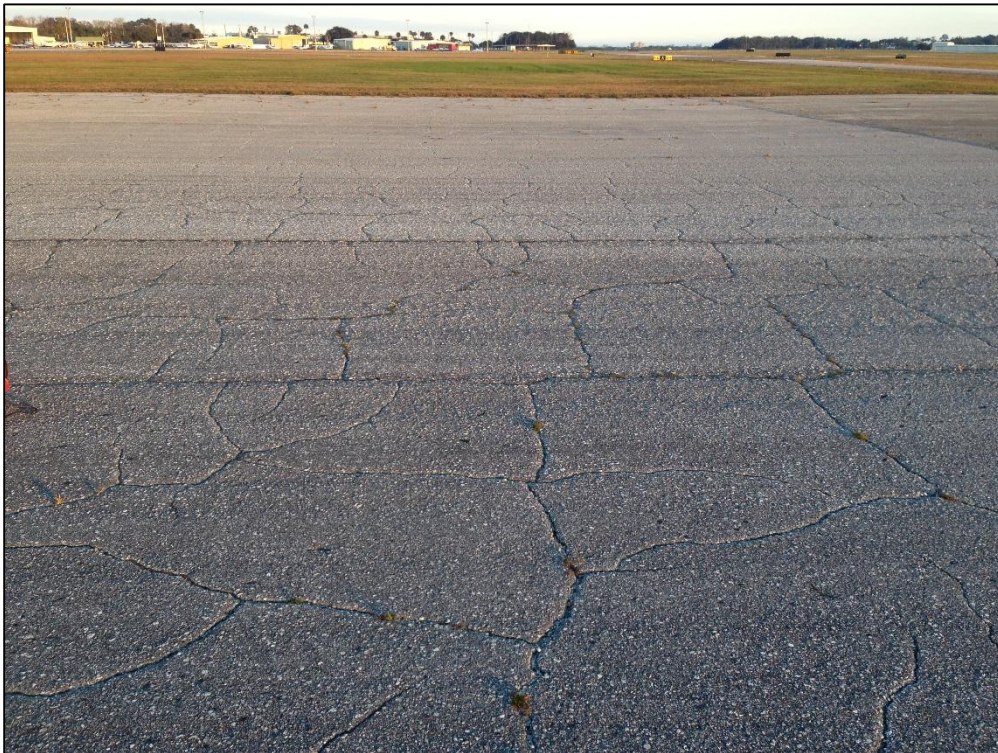
Runway 02-20, Section 6425, Sample Unit 153 – Medium Severity (43) Block Cracking, Low Severity (52) Raveling

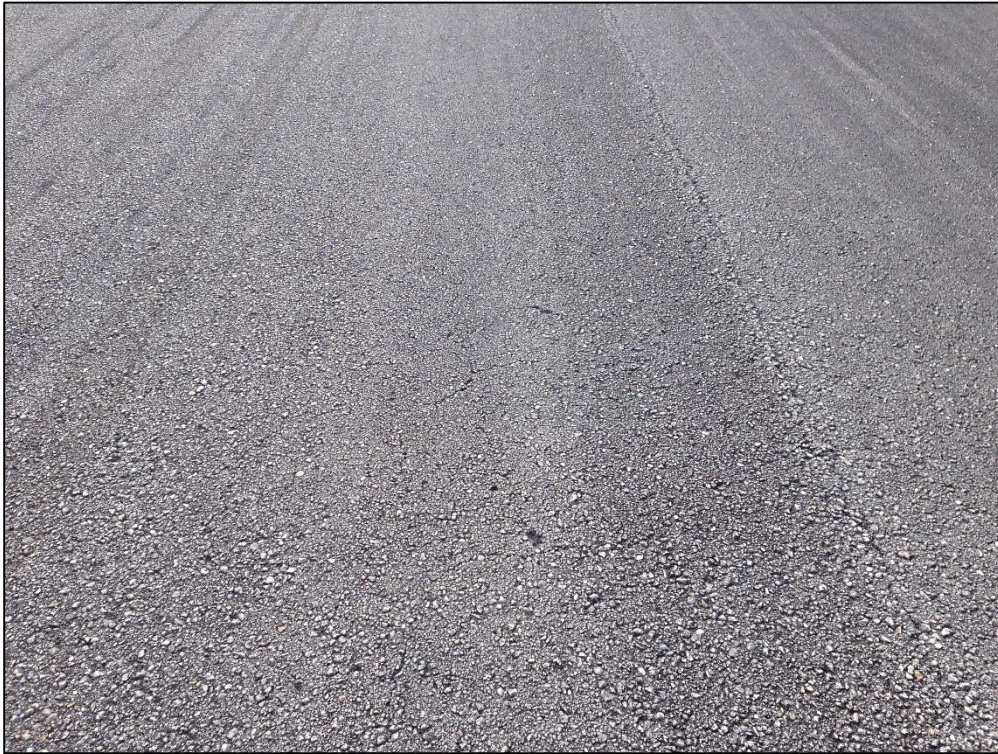
Runway 7-25, Section 6205, Sample Unit 114 – Low Severity (48) Longitudinal and Transverse Cracking, Low Severity (52) Raveling, Low Severity (57) Weathering

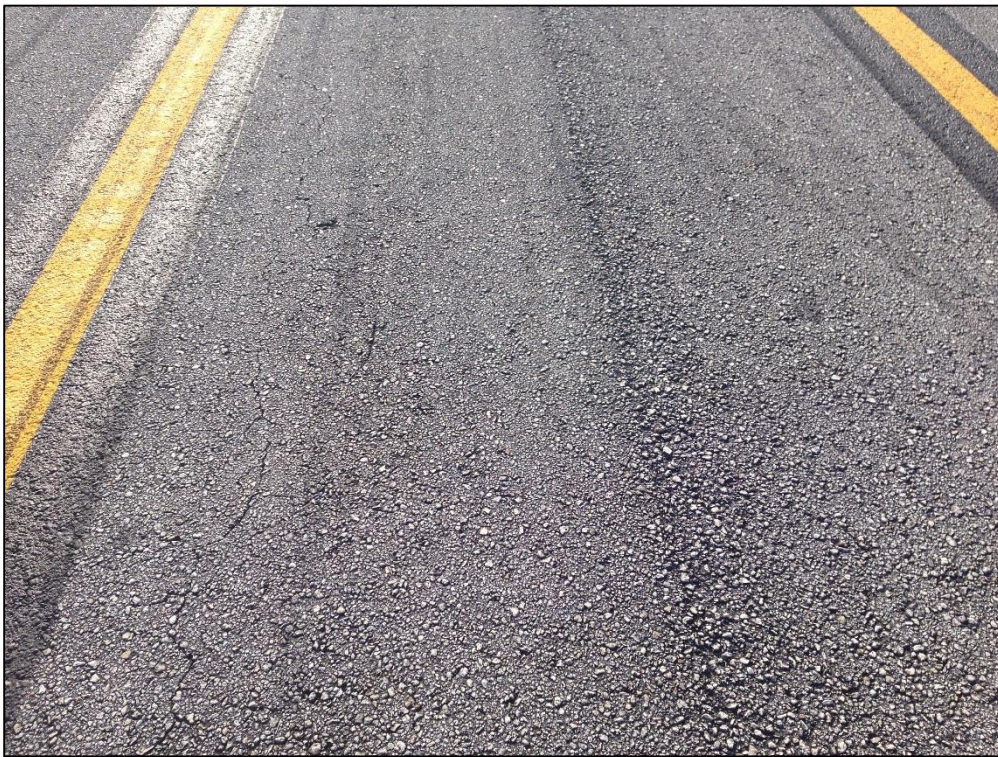
Runway 7-25, Section 6205, Sample Unit 176 – Low Severity (48) Longitudinal and Transverse Cracking, Low Severity (52) Raveling

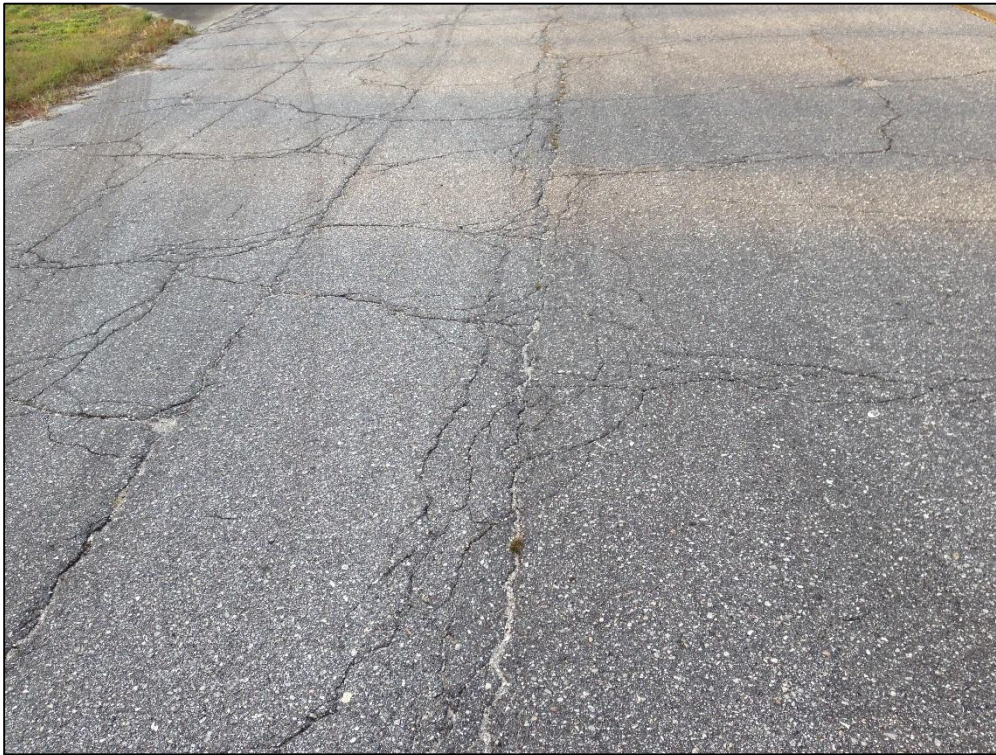
Taxiway Delta, Section 415, Sample Unit 105 – Low Severity (43) Block Cracking, Medium Severity (43) Block Cracking, Low Severity (52) Raveling, Medium Severity (57) Weathering

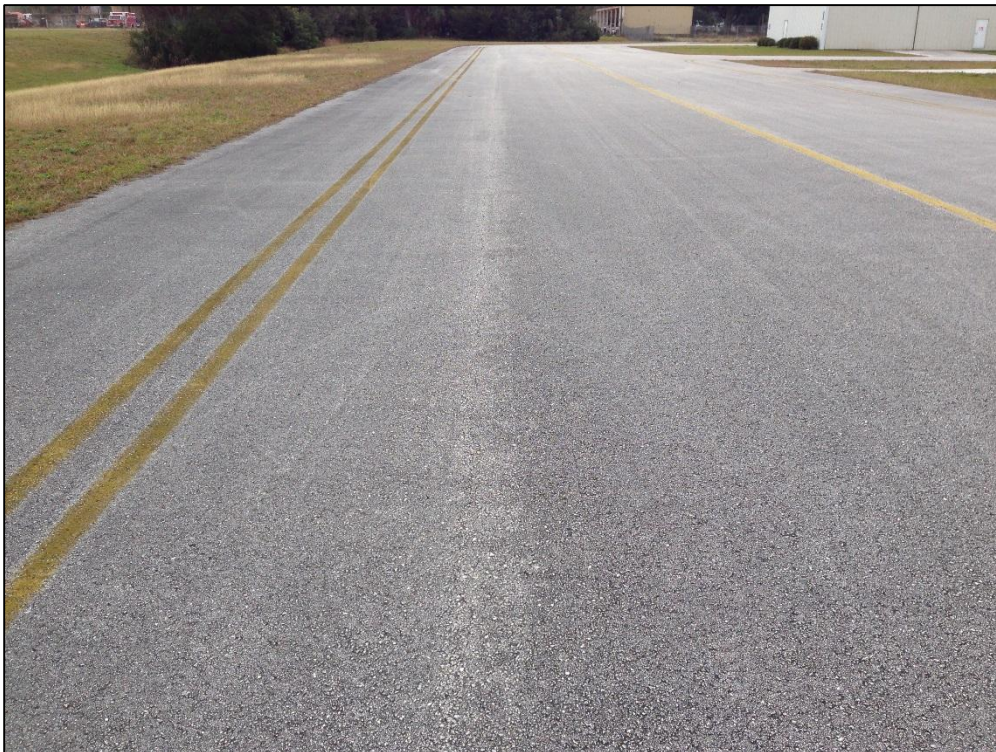
Taxiway Charlie, Section 315, Sample Unit 154 – Low Severity (52) Raveling, Low Severity (57) Weathering

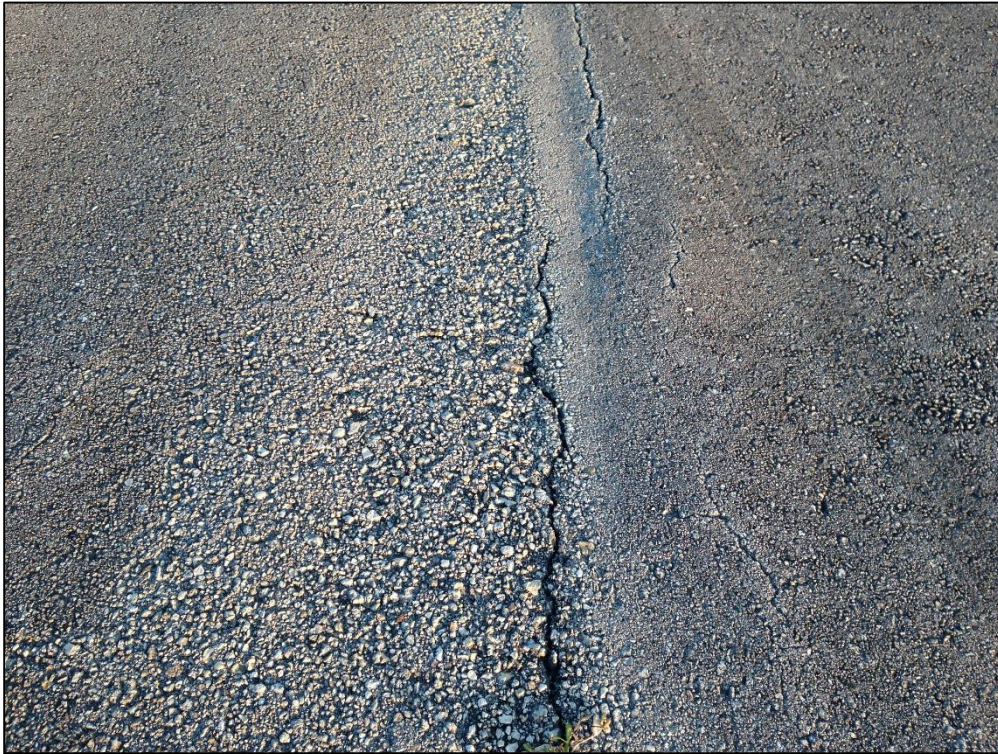
Taxiway Alpha, Section 125, Sample Unit 108 – Low Severity (48) Longitudinal and Transverse Cracking, Low Severity (52) Raveling, Medium Severity (52) Raveling, Low Severity (56) Swelling

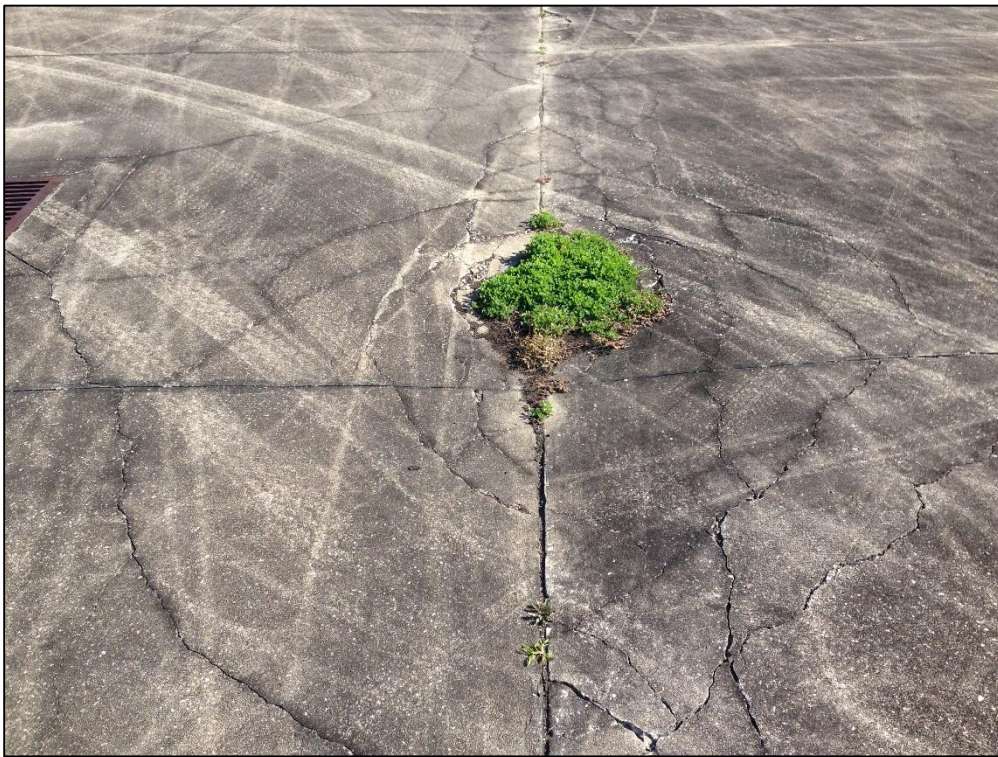
Apron, Section 4102, Sample Unit 101 – Low Severity (72) Shattered Slab, Low Severity (62) Corner Break

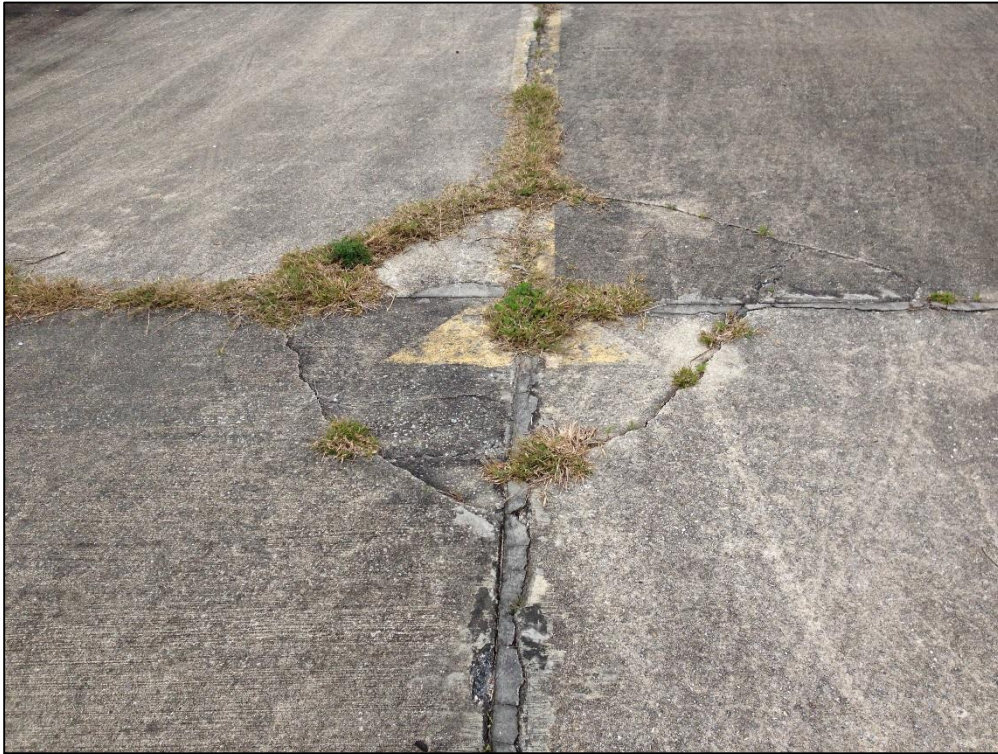
Apron South, Section 4220, Sample Unit 100 – High Severity (62) Corner Break, High Severity (65) Joint Seal Damage, Medium Severity (66) Small Patching

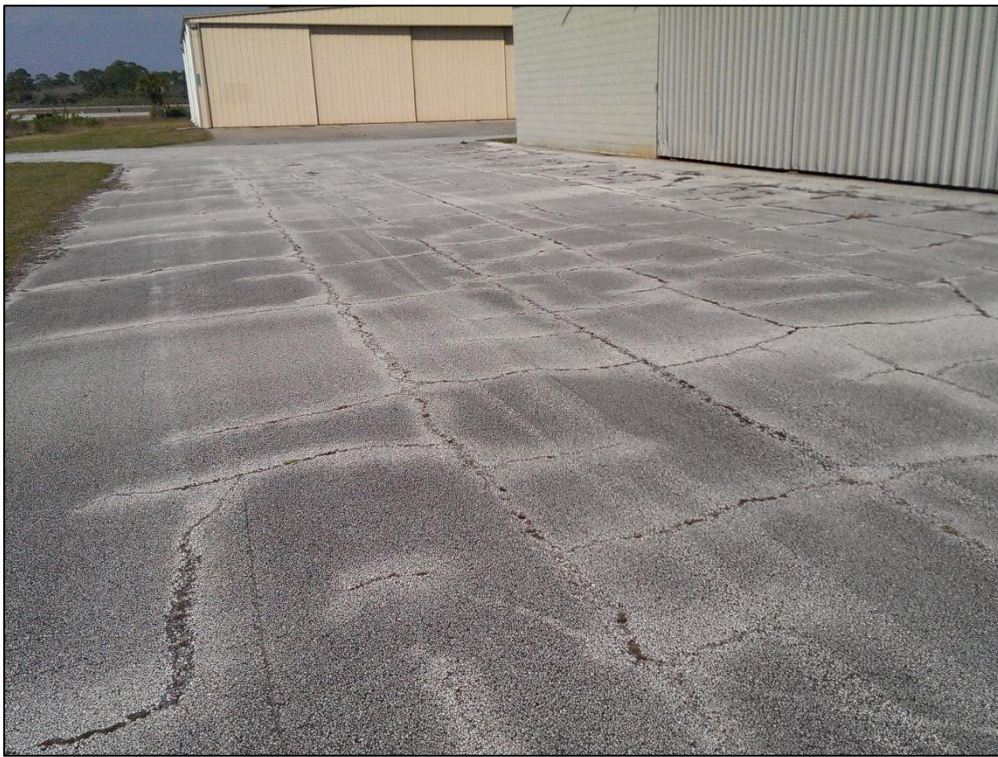
Apron, Section 4140, Sample Unit 316 – Medium Severity (43) Block Cracking, Low Severity (52) Raveling, Medium Severity (57) Weathering
