FLORIDA DEPARTMENT OF TRANSPORTATION  
AVIATION AND SPACEPORT OFFICE

**KEY WEST  
INTERNATIONAL  
AIRPORT (EYW)**

JUNE 2015

STATEWIDE  
**Airfield  
Pavement  
Management**  
PROGRAM

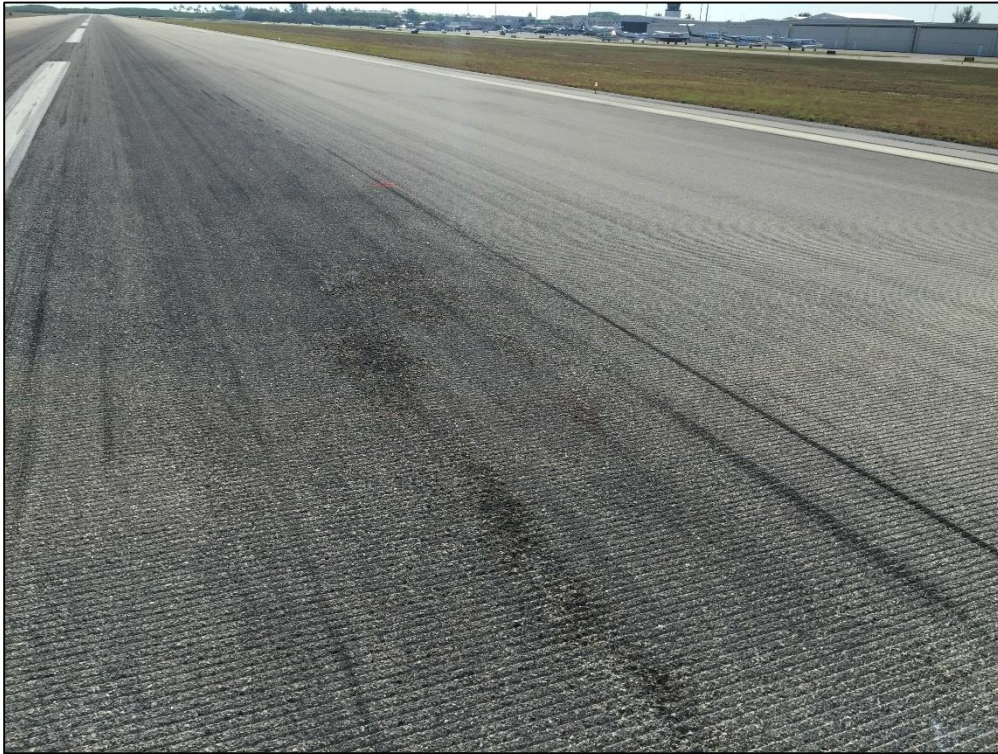
Runway 9-27, Section 6105, Sample Unit 142 – Low Severity (48) Longitudinal and Transverse Cracking, Low Severity (52) Raveling, Medium Severity (52) Raveling

- ⦿ Runway 9-27 – Sections 6110 and 6105
  - Mill and Overlay attributed to climate and age of pavement.
- ⦿ West Apron – Section 4210
  - Mill and Overlay attributed to climate and age of pavement.
- ⦿ East Apron – Sections 4150, 4145, 4130, 4125, 4120, 4115, 4110, and 4105
  - Reconstruction and Mill and Overlay attributed to load, climate, and age of pavement.
- ⦿ Taxiway E – Sections 610 and 605
  - Reconstruction and Mill and Overlay attributed to load, climate, and age of pavement.
- ⦿ Taxiway D – Sections 520, 510, and 505
  - Mill and Overlay attributed to climate and age of pavement.
- ⦿ Taxiway B – Section 205
  - Mill and Overlay attributed to climate and age of pavement.

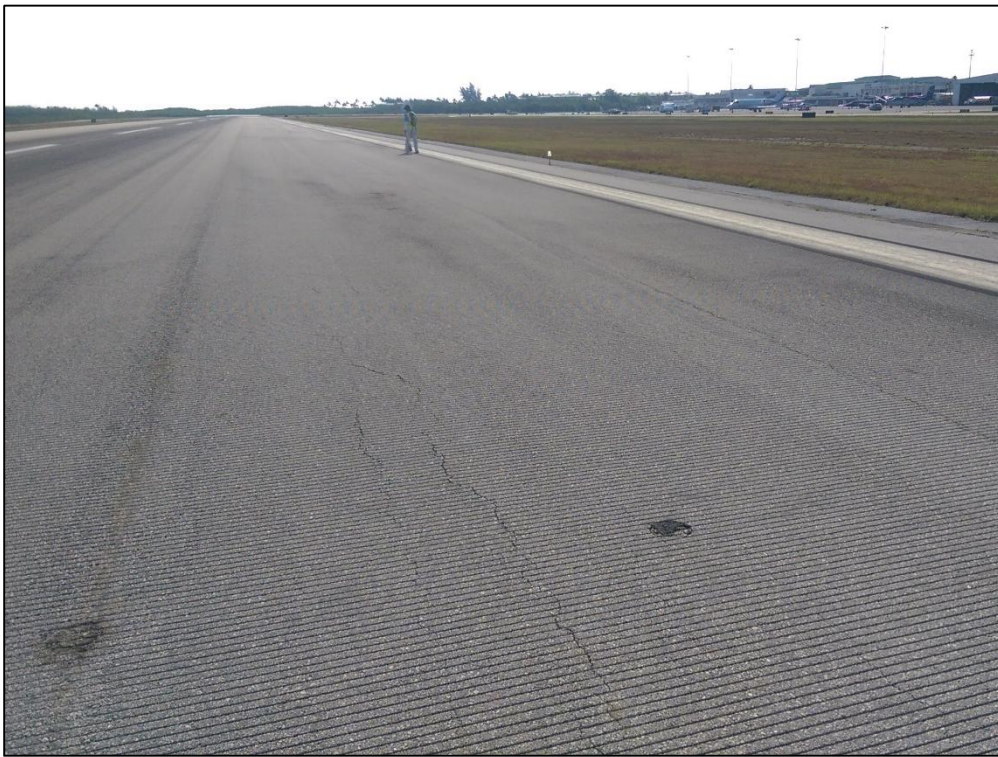
Runway 9-27, Section 6110, Sample Unit 325 – Low Severity (48) Longitudinal and Transverse Cracking, Low Severity (50) Patching, Low Severity (52) Raveling

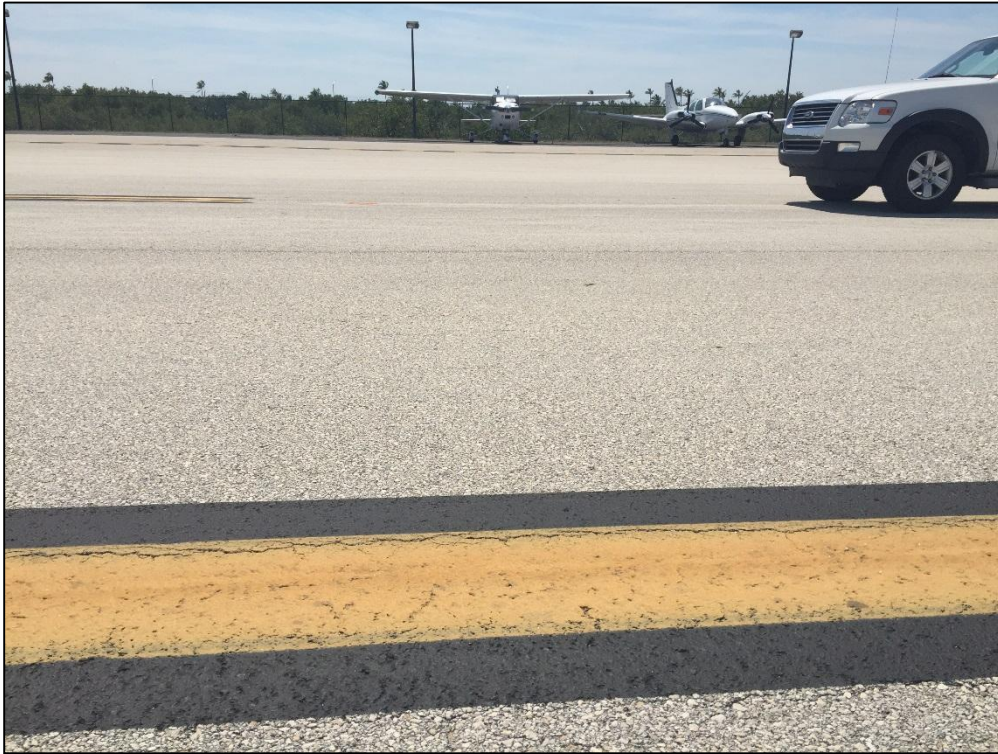
Taxiway Alpha, Section 105, Sample Unit 117 – Low Severity (48) Longitudinal and Transverse Cracking, Low Severity (53) Rutting, Low Severity (57) Weathering

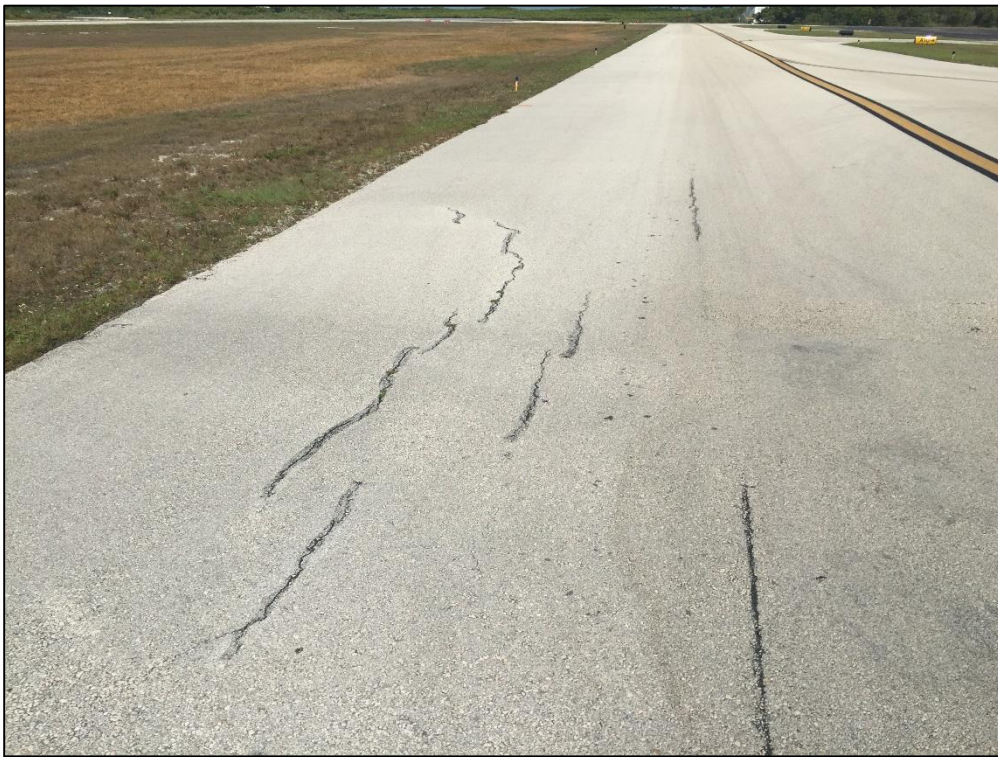
Taxiway Alpha, Section 110, Sample Unit 137 – Low Severity (48) Longitudinal and Transverse Cracking, Low Severity (52) Raveling, Low Severity (53) Rutting, Low Severity (57) Weathering

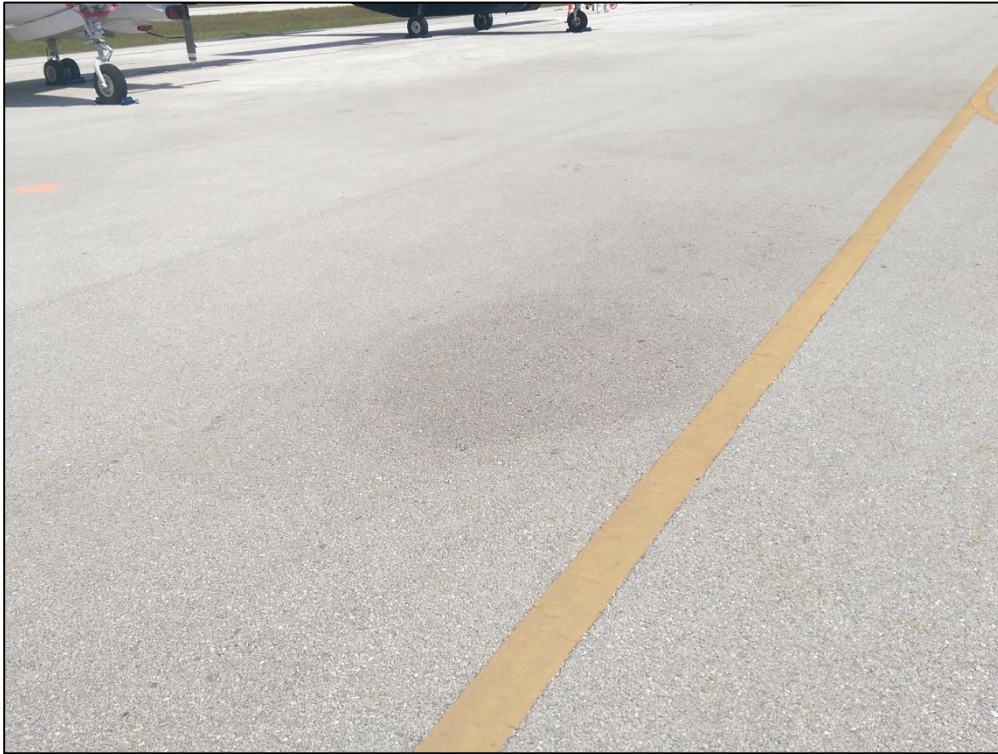
Apron West, Section 4215, Sample Unit 603 – Low Severity (45) Depression, Low Severity (52) Raveling

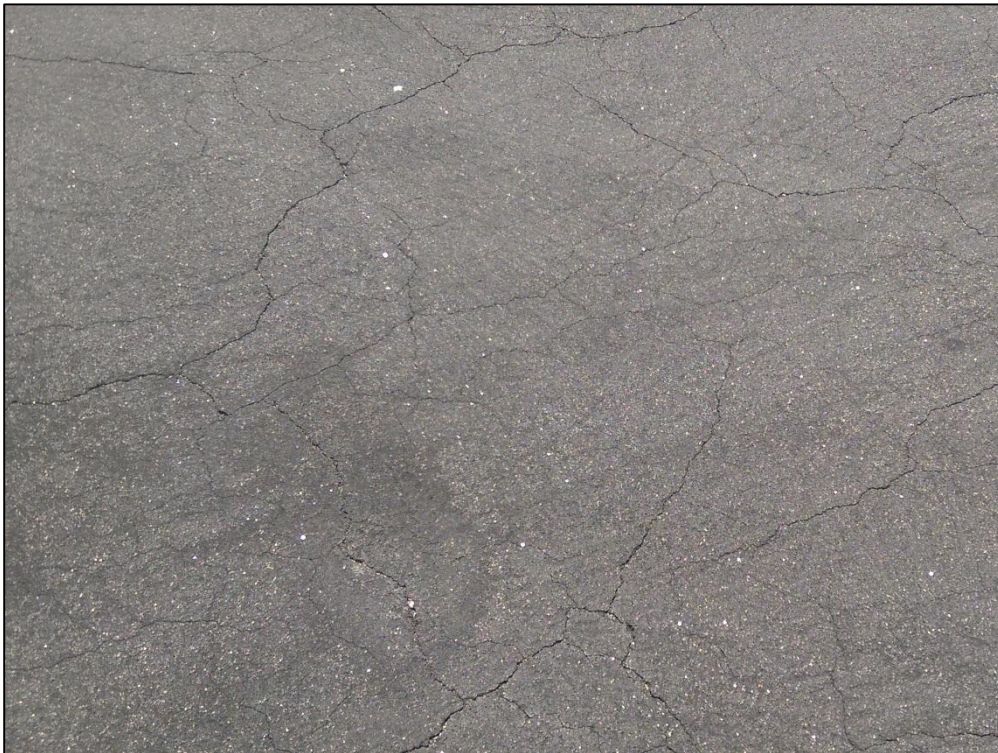
Apron East, Section 4150, Sample Unit 912 – Low Severity (43) Block Cracking, Low Severity (52) Raveling

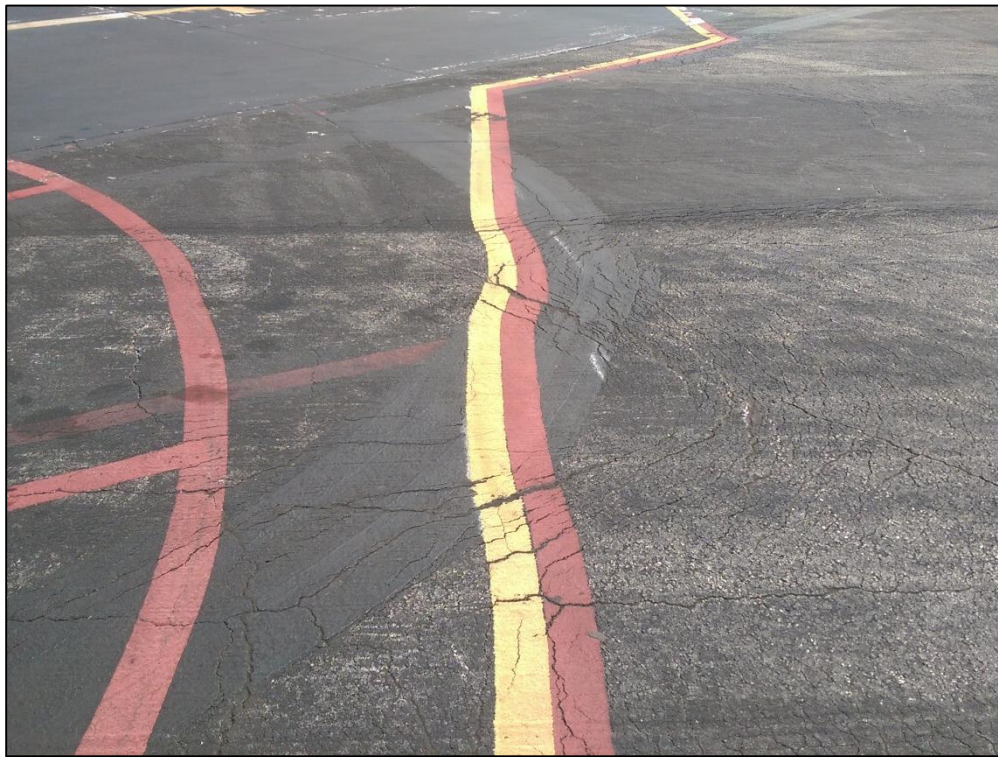
Apron East, Section 4120, Sample Unit 703 – Low Severity (50) Patching, (55) Slippage Cracking, Low Severity (41) Alligator Cracking

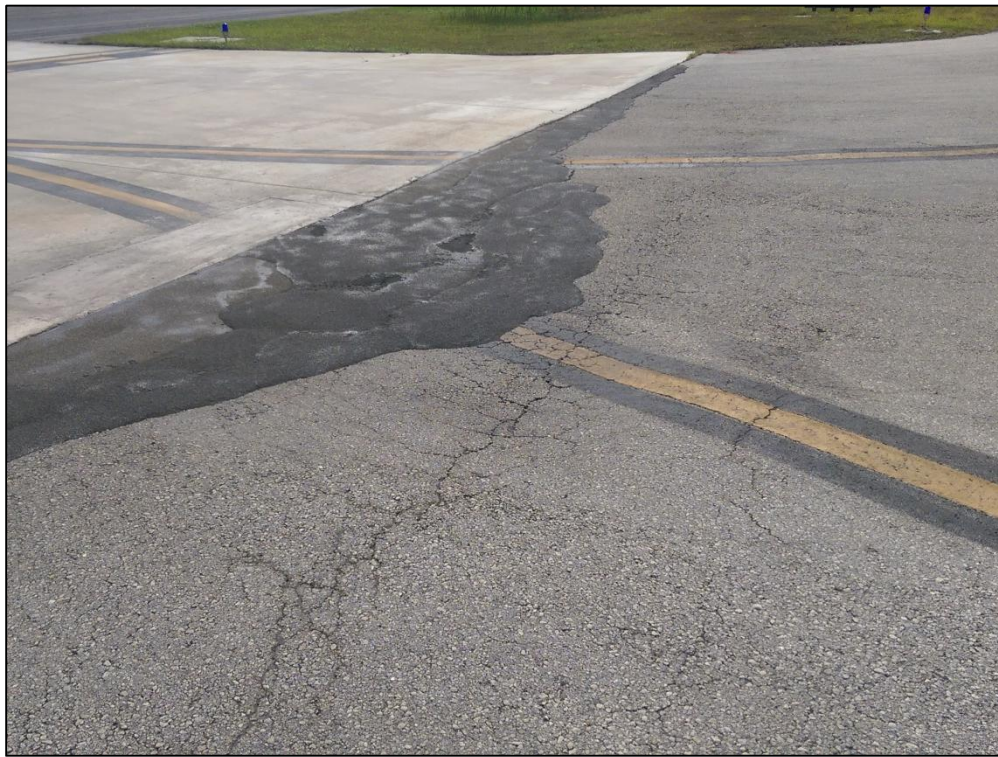
Apron East, Section 4150, Sample Unit 300 – Low Severity (41) Alligator Cracking, Low Severity (45) Depression, Medium Severity (50) Patching, Low and Medium Severity (48) Longitudinal and Transverse Cracking
