**NORTH
PALM BEACH
COUNTY GENERAL
AVIATION
AIRPORT (F45)**

DISTRICT 4
REGIONAL RELIEVER
AIRPORT
JUNE 2015

STATEWIDE
**Airfield
Pavement
Management**
PROGRAM

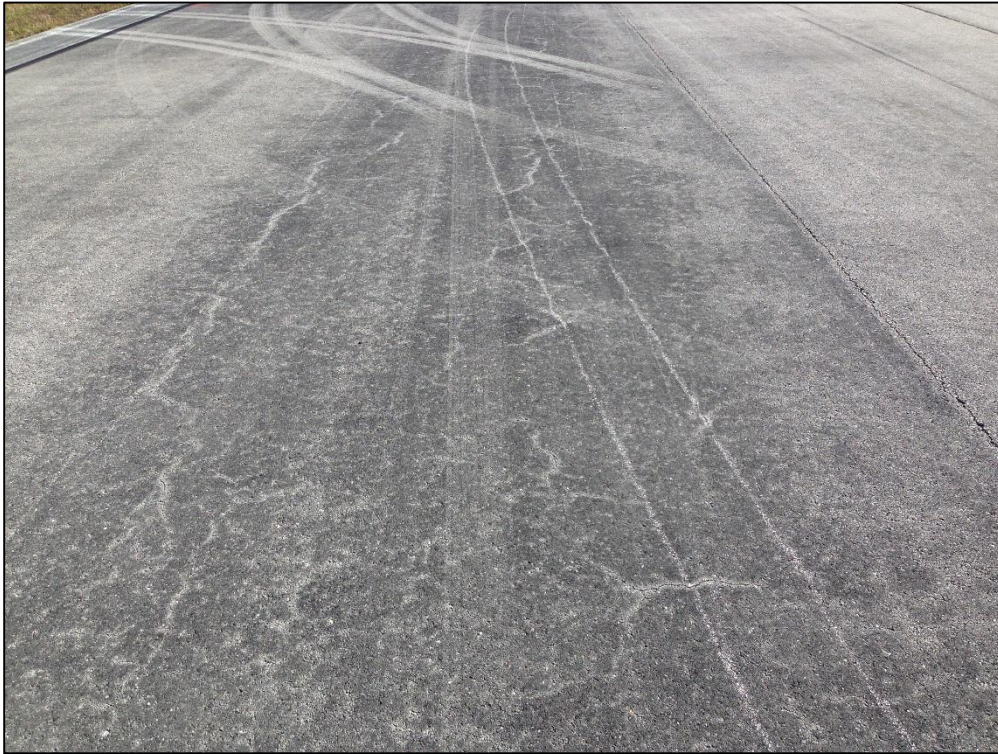
Runway 8R-26L, Section 6105, Sample Unit 134 – Low Severity (48) Longitudinal and Transverse Cracking, Low Severity (56) Swelling, Low Severity (57) Weathering

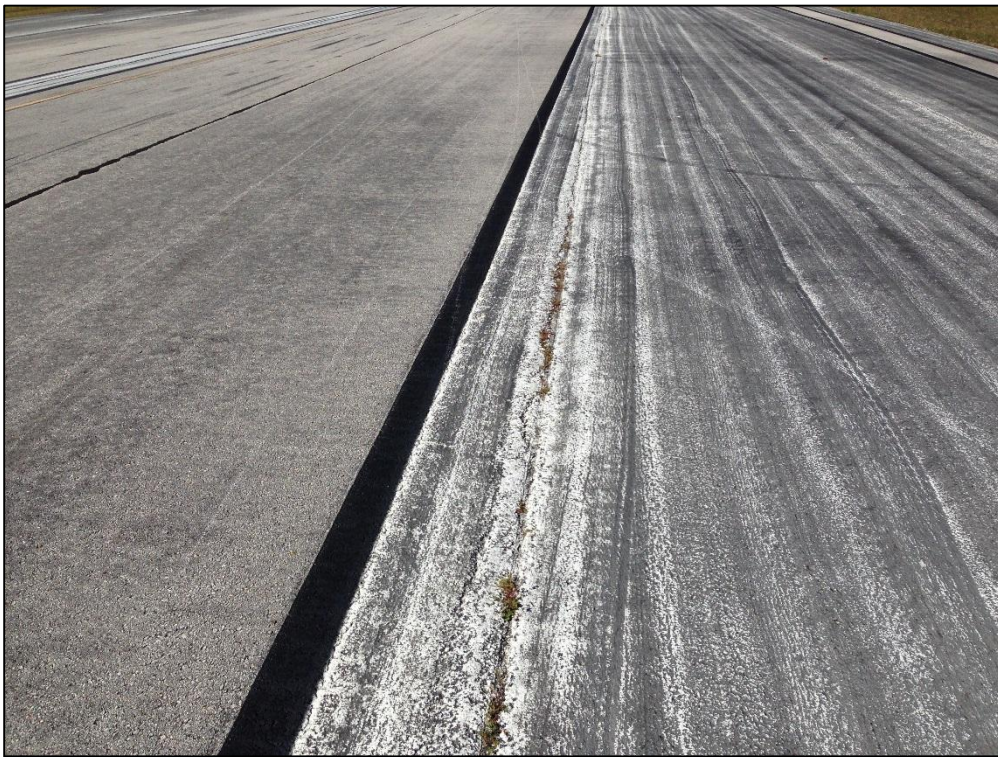
Runway 8R-26L, Section 6105, Sample Unit 122 – Low and Medium Severity (48) Longitudinal and Transverse Cracking, Low Severity (41) Alligator Cracking, Low Severity (52) Raveling, Low Severity (57) Weathering

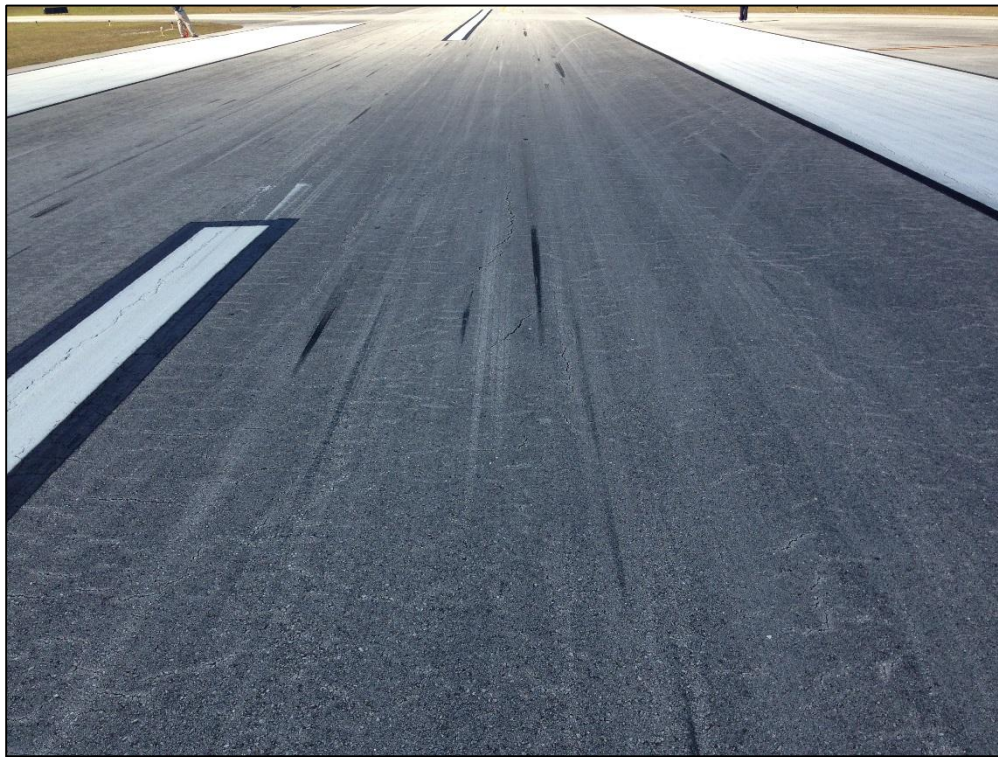
Runway 13-31, Section 6205, Sample Unit 120 – Low Severity (41) Alligator Cracking, Low Severity (52) Raveling, Low Severity (57) Weathering

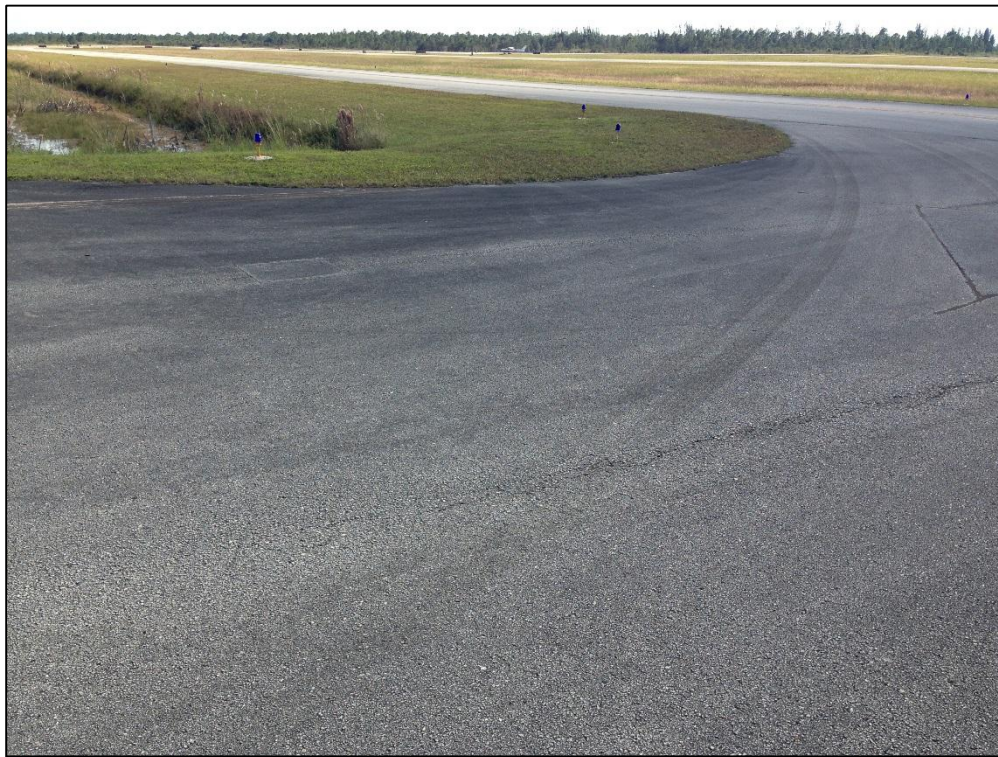
Taxiway Juliet, Section 1010, Sample Unit 100 – Low Severity (48) Longitudinal and Transverse Cracking, Low Severity (50) Patching, Low Severity (52) Raveling, Low Severity (57) Weathering

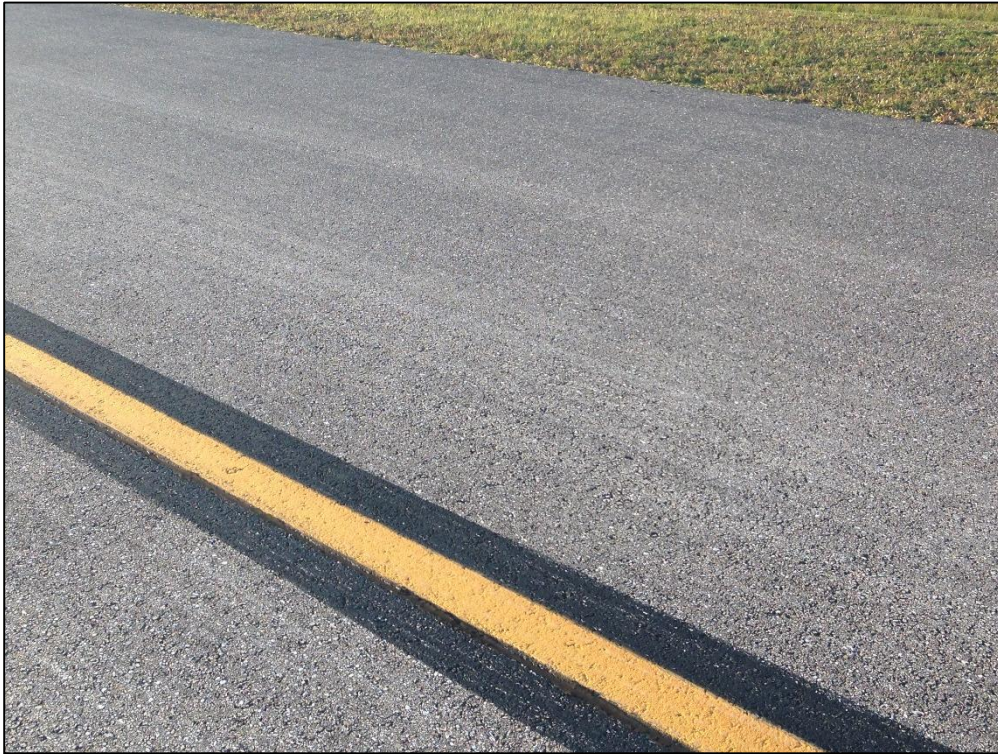
Taxiway Charlie, Section 305, Sample Unit 105 – Low Severity (57) Weathering

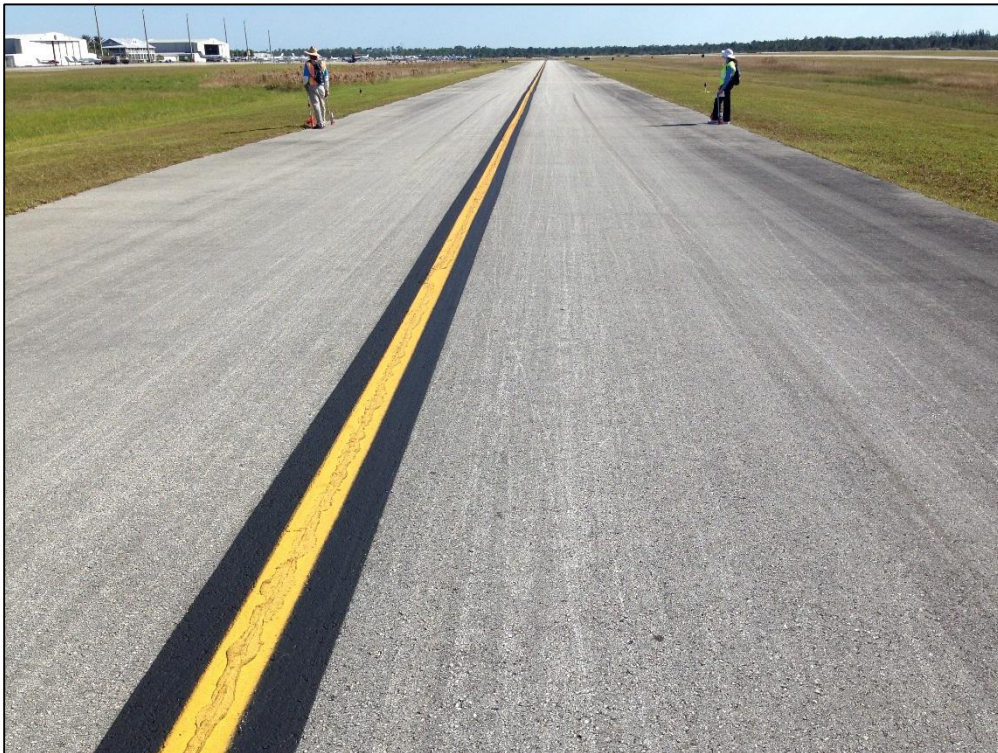
Taxiway Foxtrot, Section 605, Sample Unit 134 – Low Severity (48) Longitudinal and Transverse Cracking, Low Severity (57) Weathering

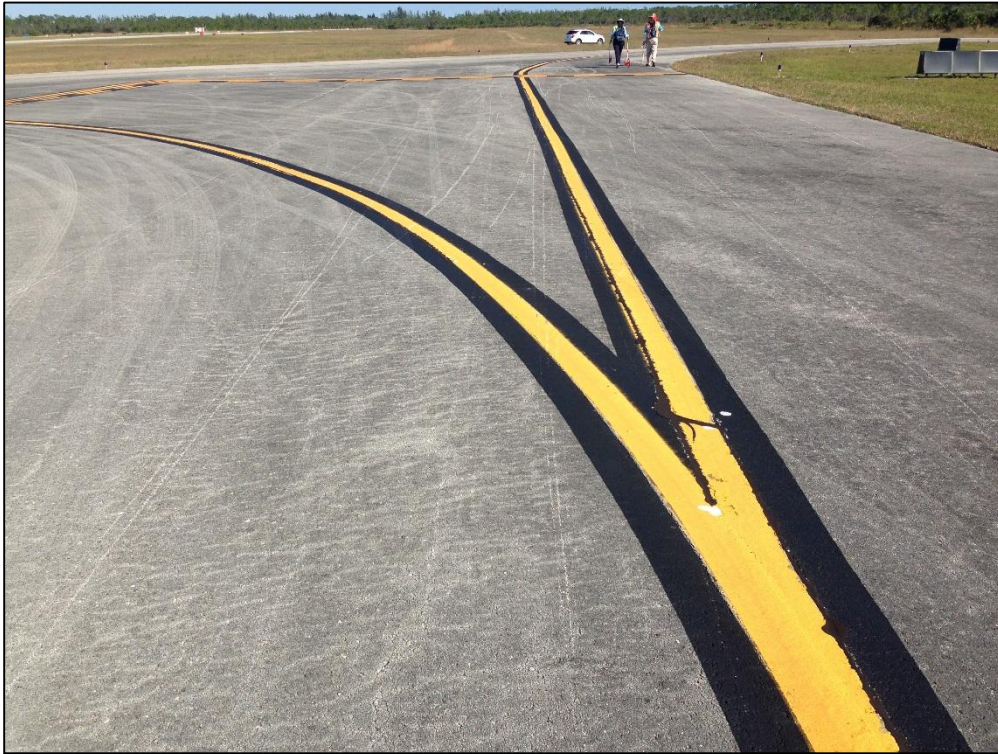
Taxiway Romeo, Section 1805, Sample Unit 101 – Low Severity (48) Longitudinal and Transverse Cracking, Low Severity (52) Raveling, Low Severity (57) Weathering

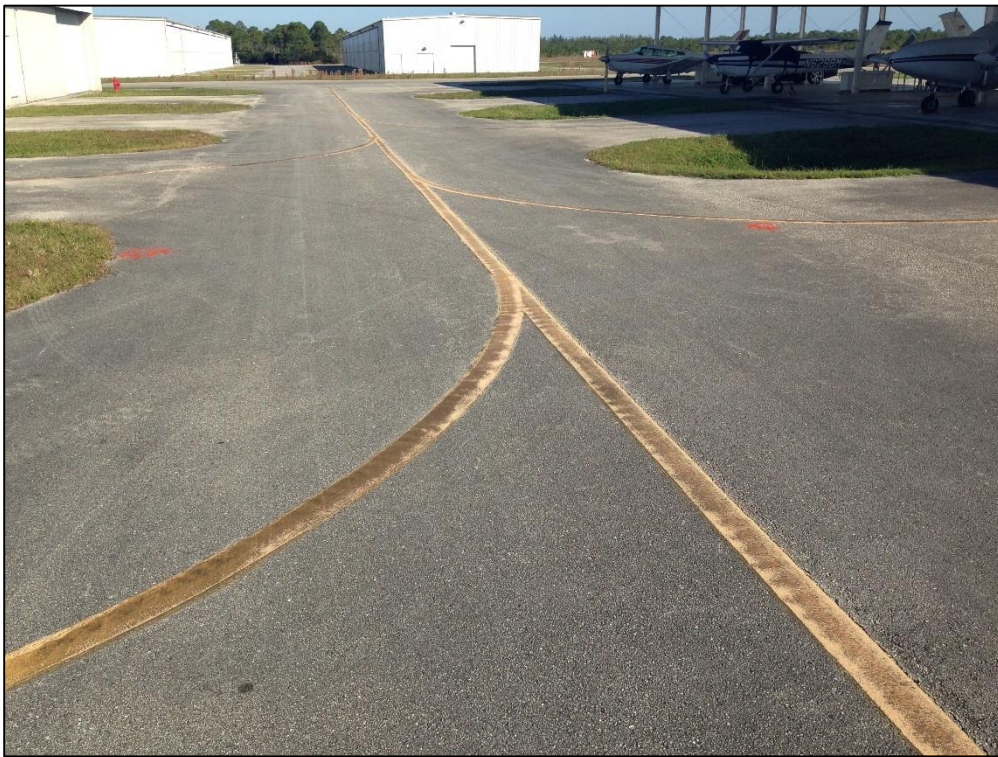
Apron T-Hangar, Section 4205, Sample Unit 302 – Low Severity (48) Longitudinal and Transverse Cracking, Low Severity (52) Raveling, Low Severity (57) Weathering

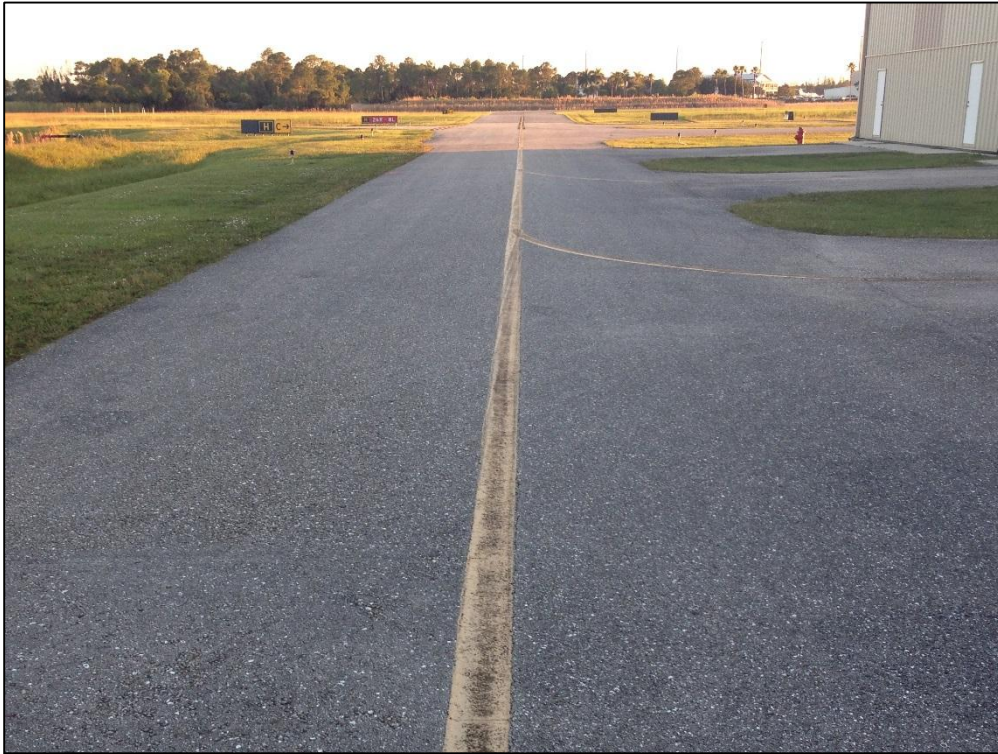
Apron T-Hangar, Section 4305, Sample Unit 801 – Low Severity (57) Weathering

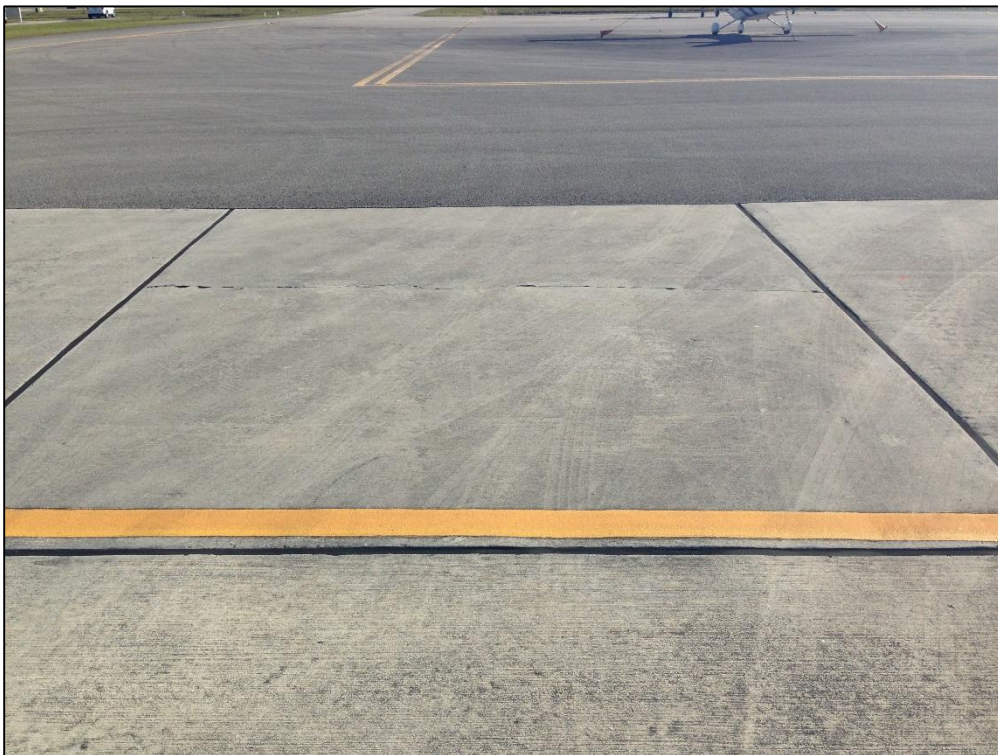
Apron North, Section 4115, Sample Unit 751 – Medium Severity (63) Longitudinal, Transverse, and Diagonal Cracking

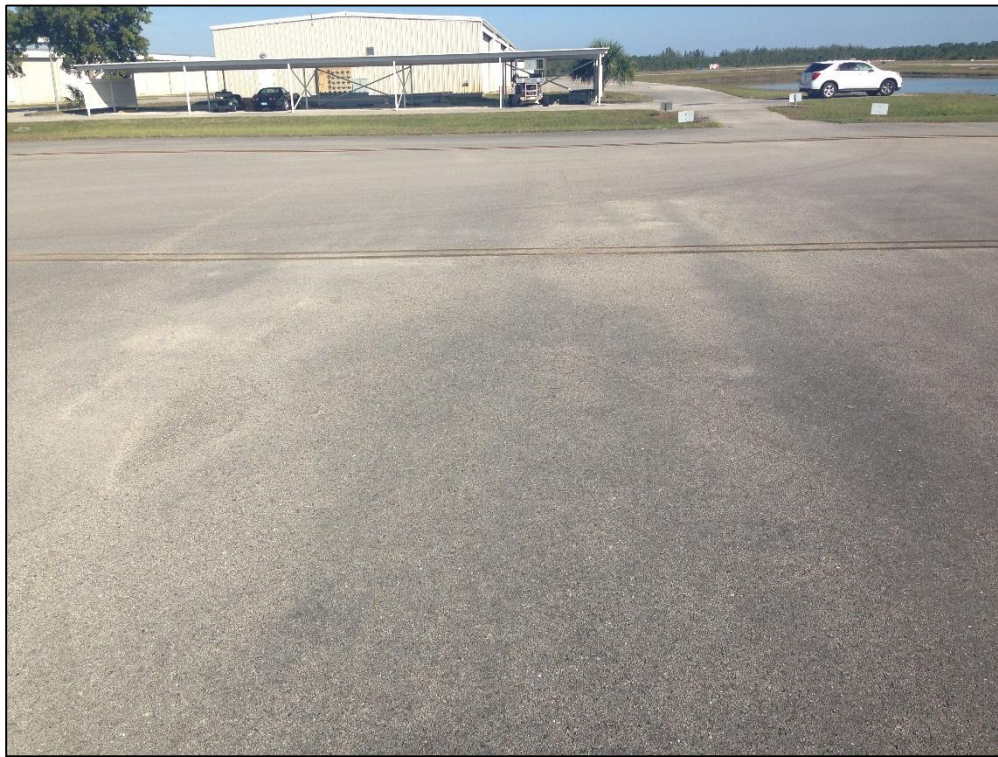
Apron North, Section 4105, Sample Unit 117 – Low Severity (48) Longitudinal and Transverse Cracking, Low Severity (52) Raveling, Low Severity (57) Weathering
