FLORIDA DEPARTMENT OF TRANSPORTATION
AVIATION AND SPACEPORT OFFICE

**CALHOUN COUNTY
AIRPORT (F95)**

JUNE 2015

STATEWIDE
**Airfield
Pavement
Management**
PROGRAM

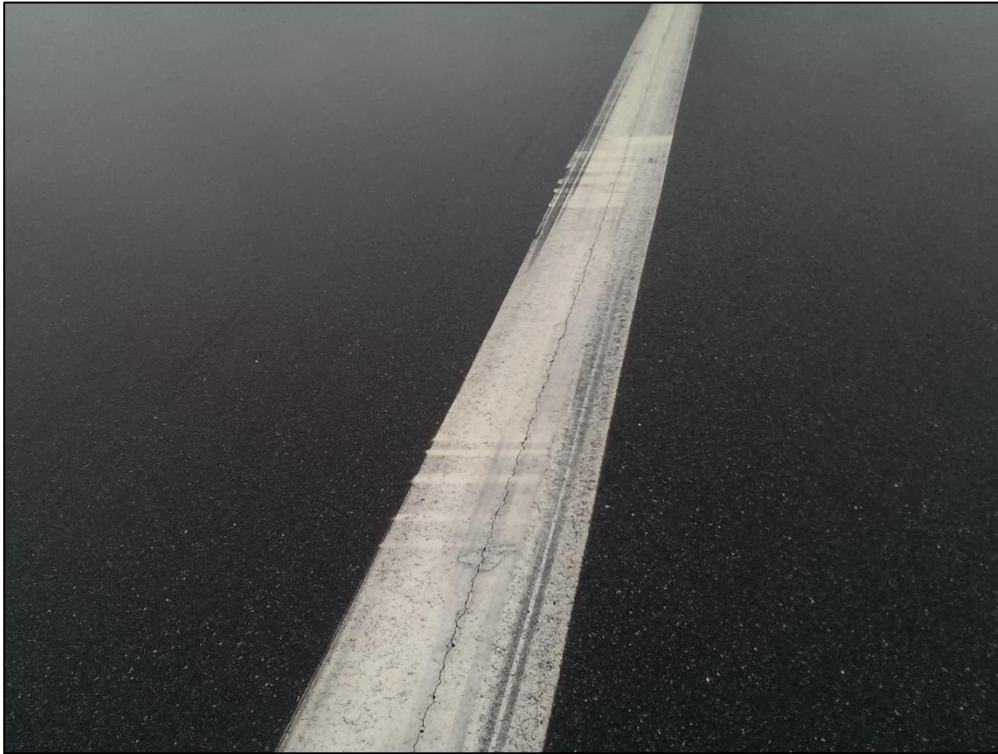
Runway 18-36, Section 6105, Sample Unit 160 – Low Severity (48) Longitudinal and Transverse Cracking, Low Severity (57) Weathering

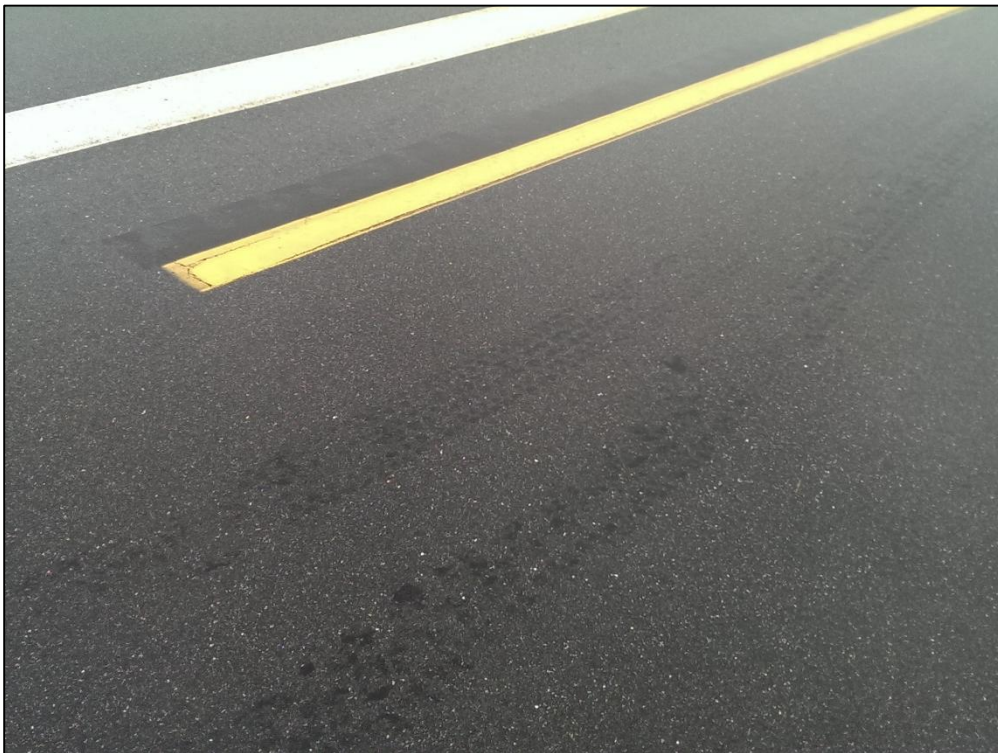
Runway 18-36, Section 6105, Sample Unit 134 – (42) Bleeding, Low Severity (57) Weathering

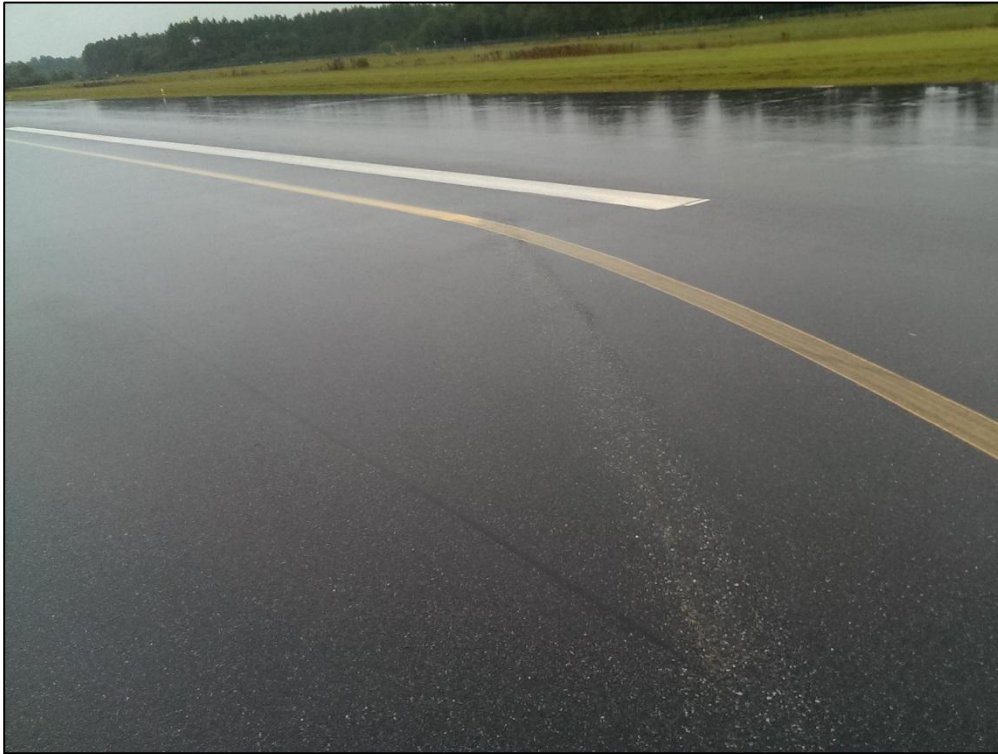
Runway 18-36, Section 6105, Sample Unit 138 – Low Severity (52) Raveling, Low Severity (57) Weathering

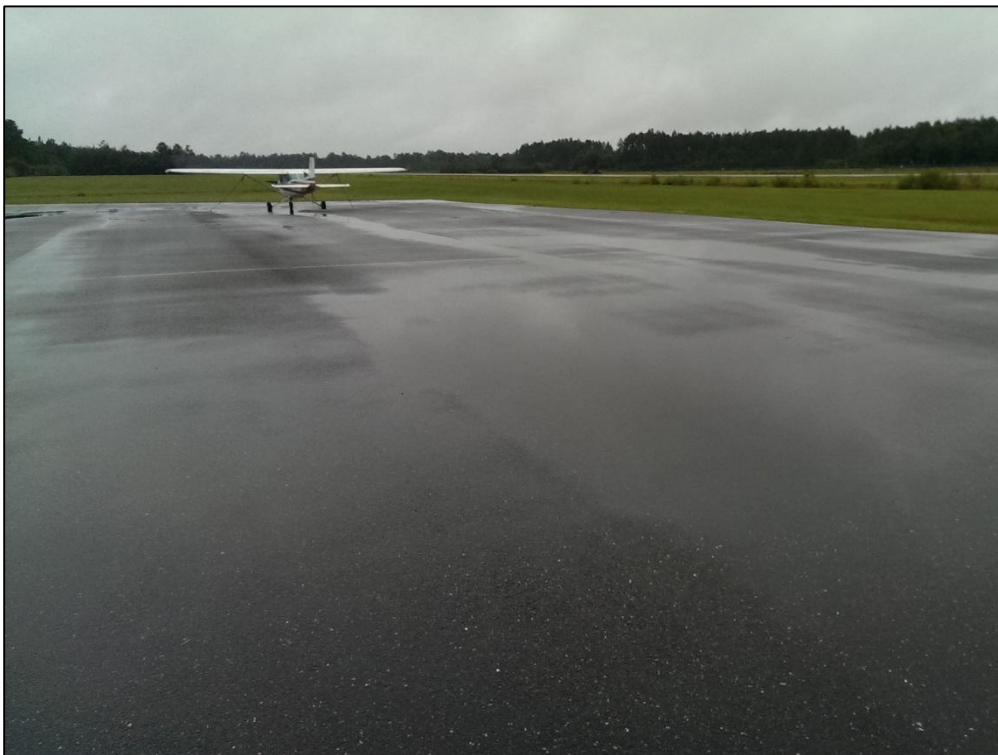
Apron GA, Section 4115, Sample Unit 103 – Low Severity (45) Depression, Low Severity (57) Weathering

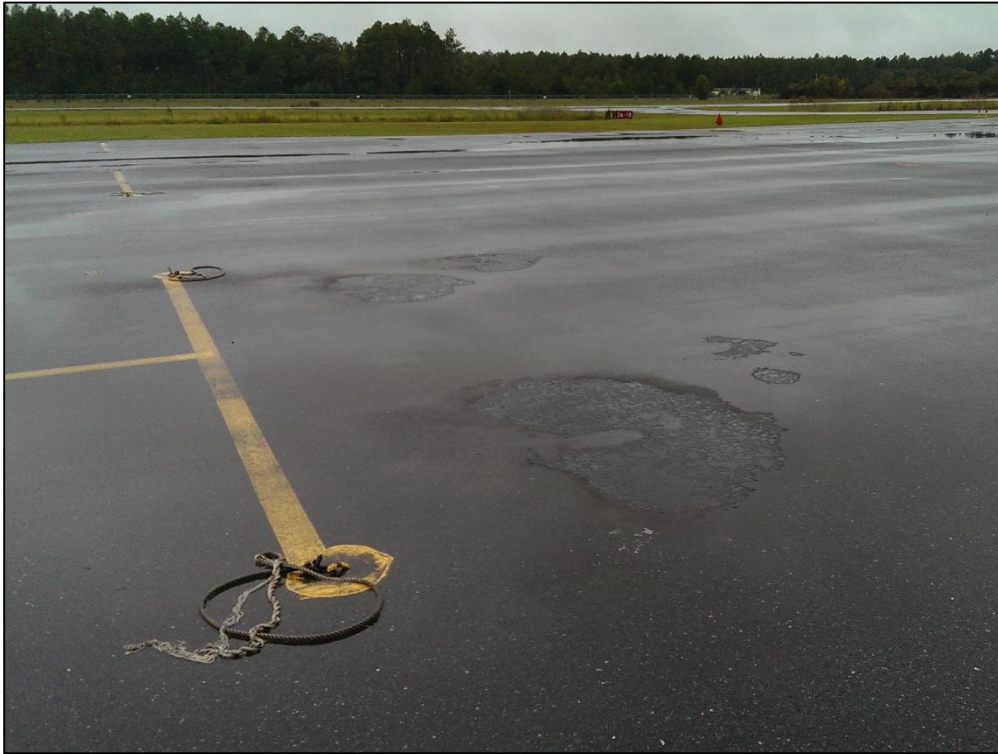
Apron GA, Section 4115, Sample Unit 202 – (49) Oil Spillage, Low Severity (57) Weathering

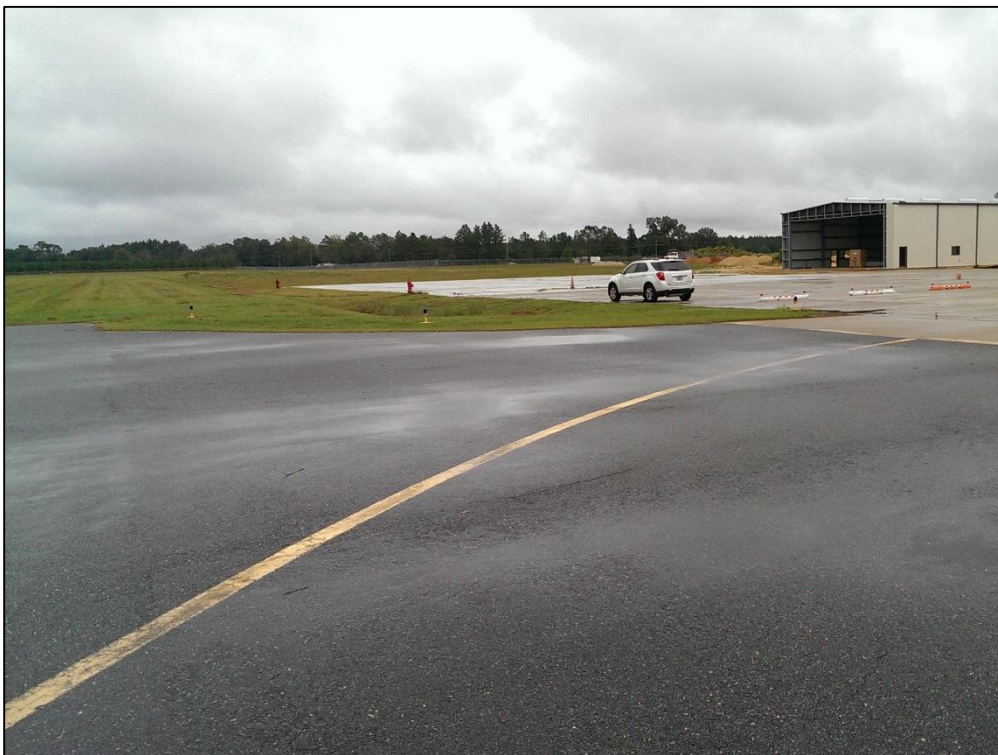
Apron GA, Section 4150, Sample Unit 200 – Low Severity (45) Depression, Low Severity (52) Raveling, Low Severity (57) Weathering

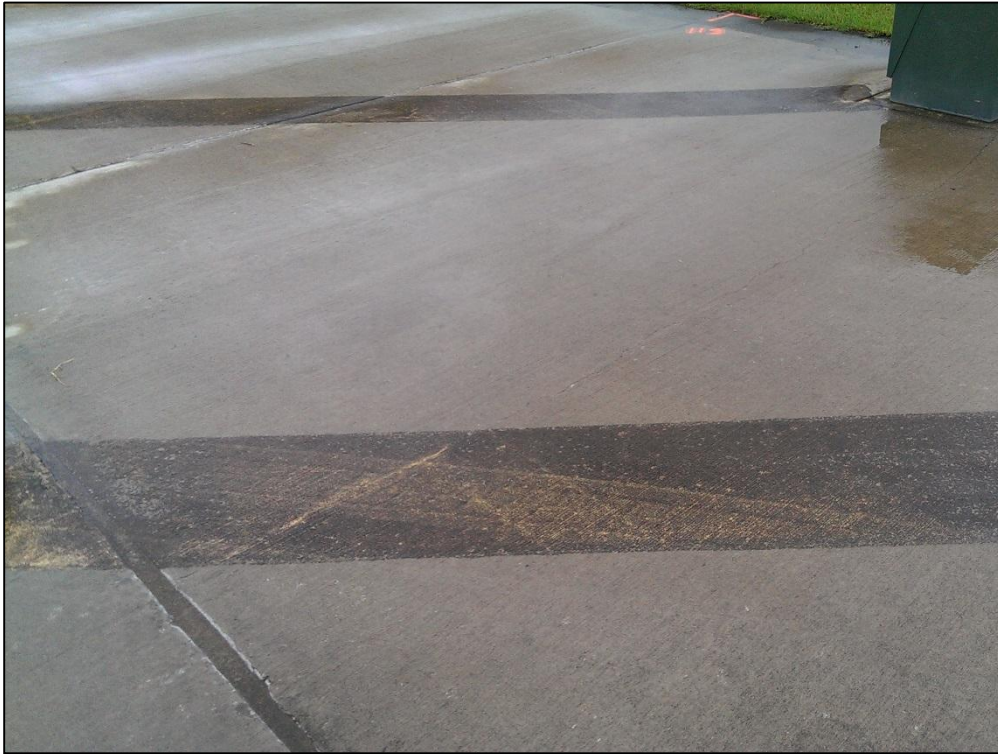
Apron GA, Section 4105, Sample Unit 113 – Low Severity (63) Longitudinal, Transverse, and Diagonal Cracking

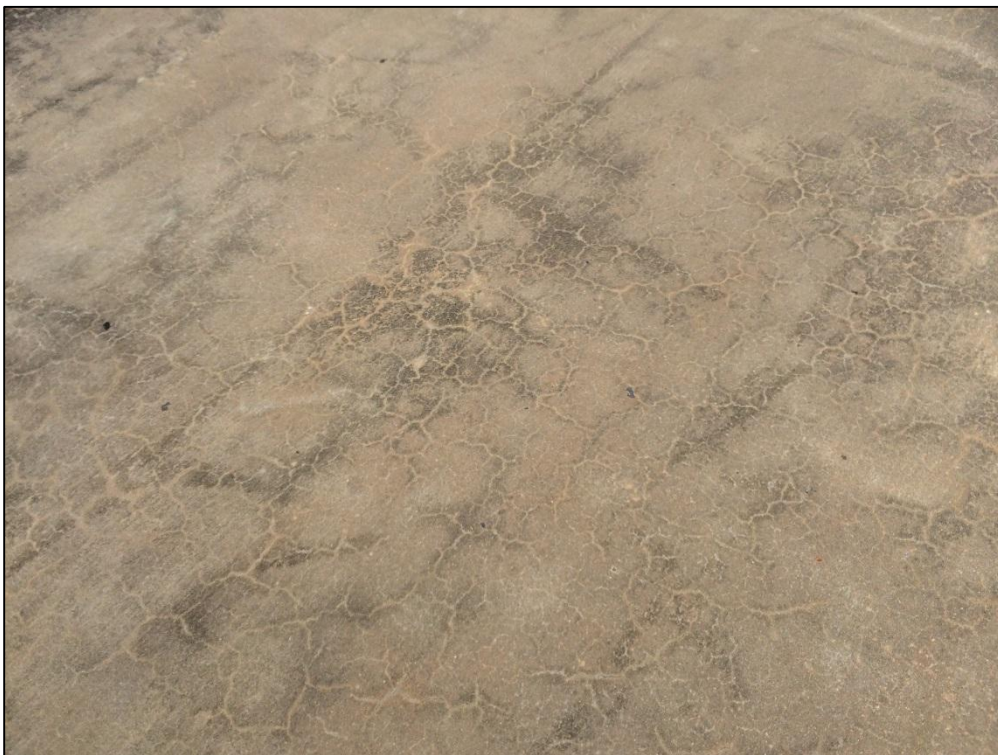
Apron GA, Section 4205, Sample Unit 209 – Low Severity (70) Scaling, Map Cracking, Crazing
