**FERNANDINA BEACH
MUNICIPAL AIRPORT
(FHB)**

JUNE 2015

STATEWIDE
**Airfield
Pavement
Management**
PROGRAM

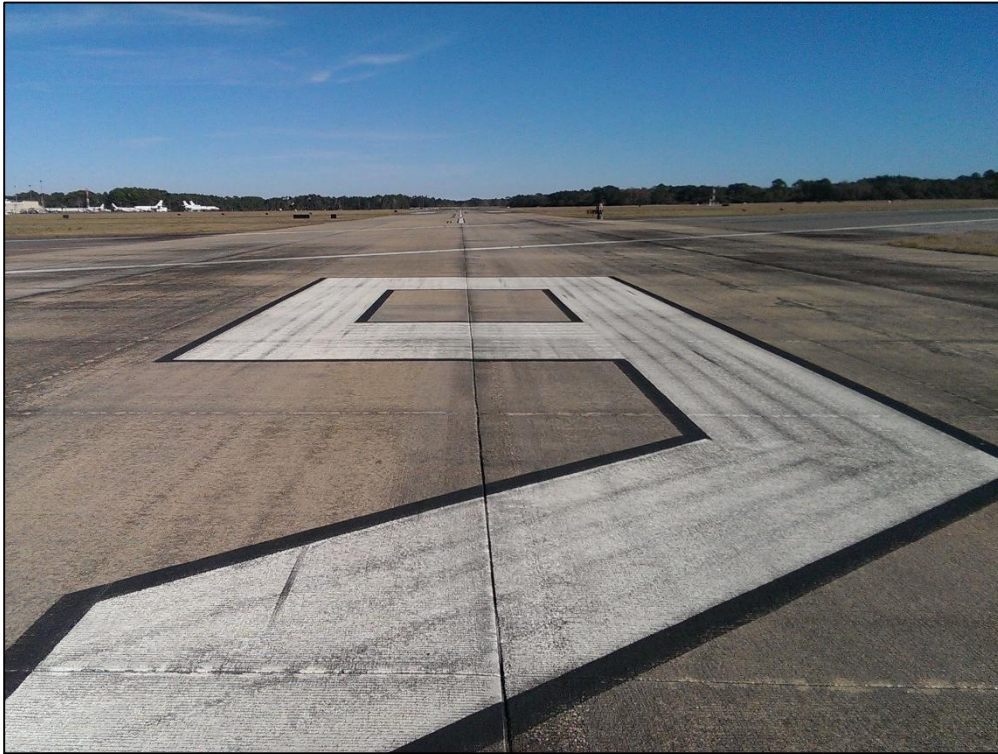
Runway 9-27, Section 6305, Sample Unit 301 – Low Severity (65) Joint Seal Damage

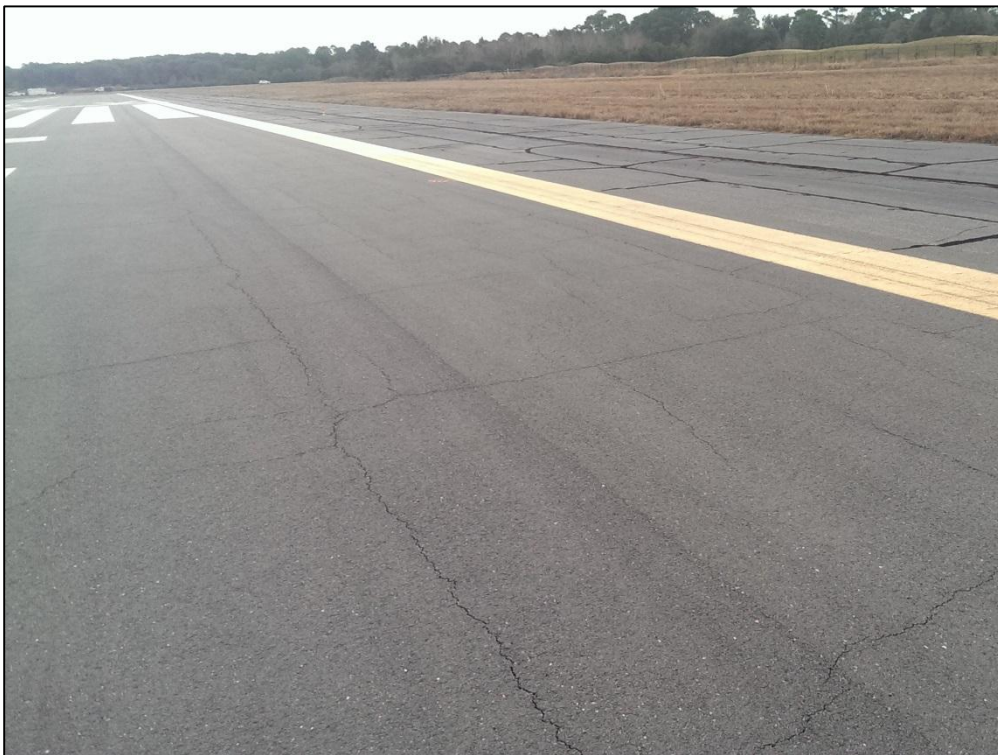
Runway 4-22, Section 6105, Sample Unit 312 – Low Severity (43) Block Cracking, Low Severity (48) Longitudinal and Transverse Cracking, Low Severity (57) Weathering

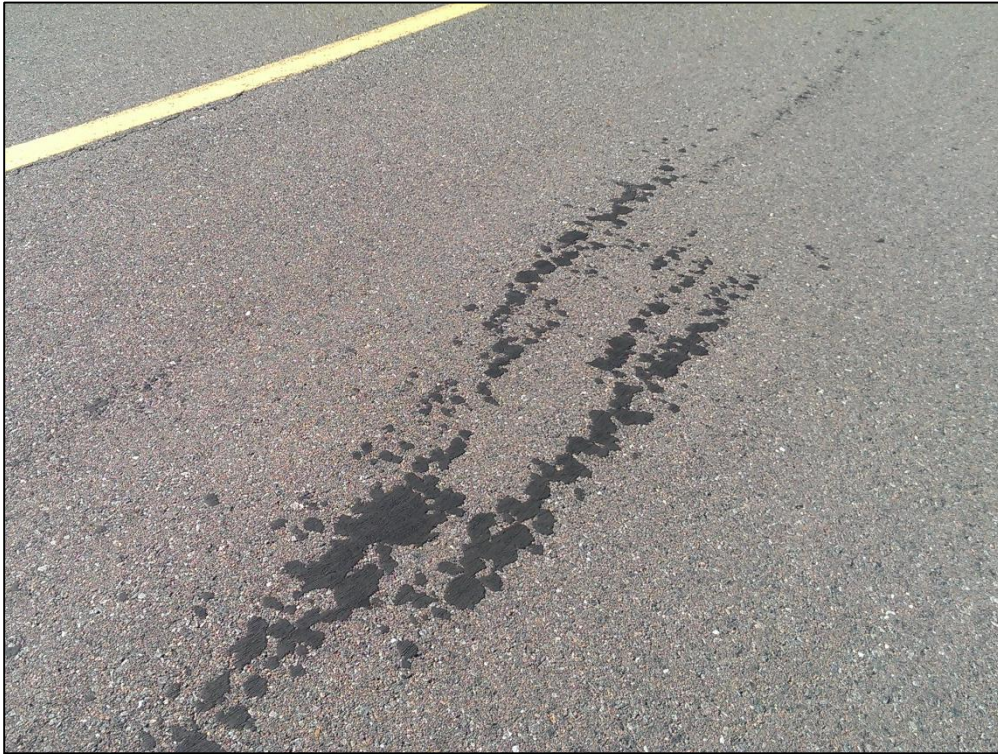
Taxiway Alpha, Section 325, Sample Unit 125 – (42) Bleeding, Low Severity (48) Longitudinal and Transverse Cracking, Low Severity (57) Weathering

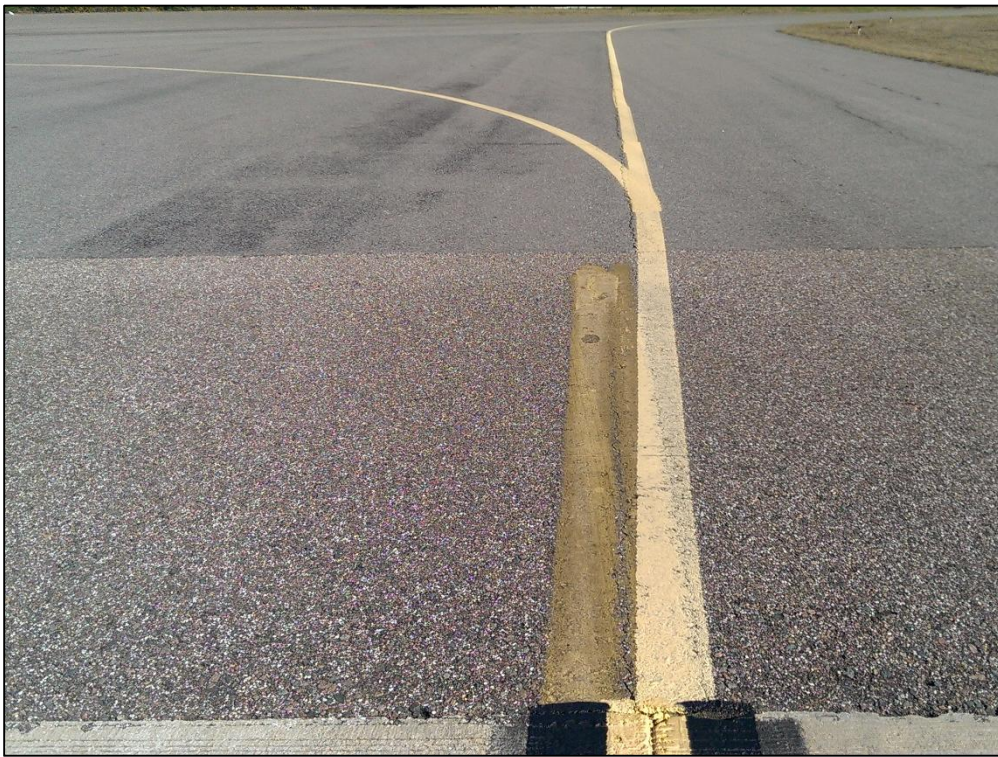
Taxiway Charlie, Section 145, Sample Unit 138 – (42) Bleeding, Low Severity (48) Longitudinal and Transverse Cracking, Low Severity (50) Patching, Low Severity (57) Weathering

SECTION: 145 FY 2015 TW C: 145 RECONSTRUCTION \$0.17M	SECTION: 220 FY 2015 TW B: 220 MILL AND OVERLAY \$0.18M	SECTION: 505 FY 2015 TW NW AP: 505 MILL AND OVERLAY \$0.03M	SECTION: 4105 FY 2015 AP NW: 4105 MILL AND OVERLAY \$0.16M
SECTION: 4110 FY 2015 AP NW: 4110 MILL AND OVERLAY \$0.15M	SECTION: 4220 FY 2015 AP N: 4220 RECONSTRUCTION \$0.36M	SECTION: 6225 FY 2018 RW 13-31: 6225 MILL AND OVERLAY \$0.13M	SECTION: 215 FY 2019 TW B: 215 MILL AND OVERLAY \$0.08M
SECTION: 225 FY 2020 TW B: 225 MILL AND OVERLAY \$0.08M	SECTION: 230 FY 2021 TW B: 230 MILL AND OVERLAY \$0.44M	SECTION: 235 FY 2022 TW B: 235 MILL AND OVERLAY \$0.35M

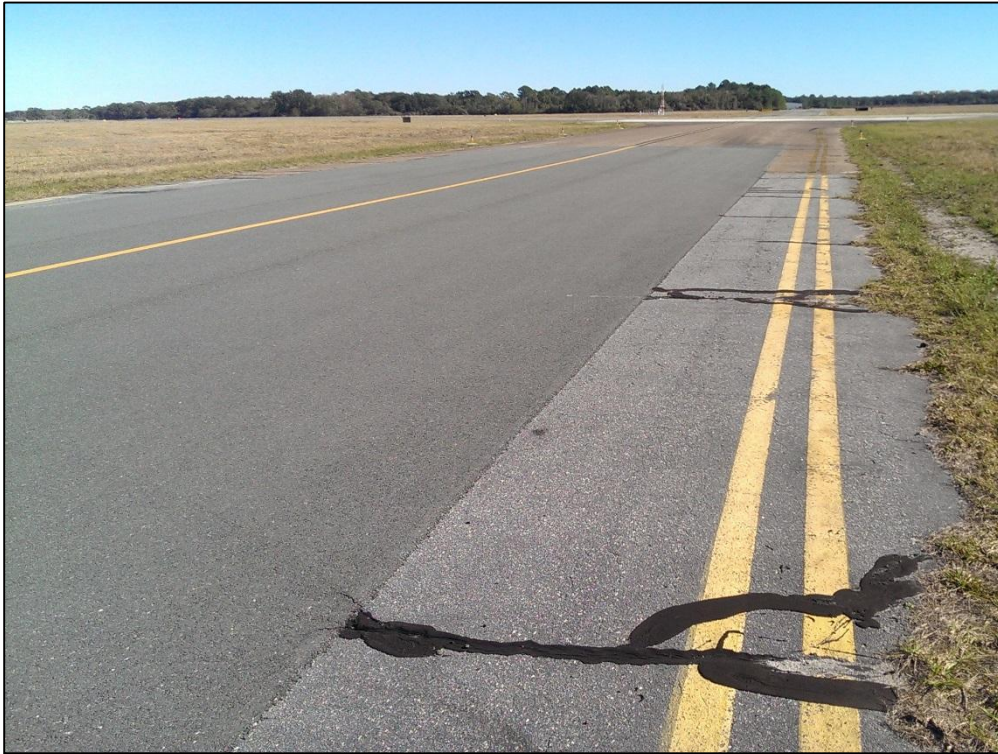
Taxiway Bravo, Section 235, Sample Unit 147 – Low Severity (48) Longitudinal and Transverse Cracking, Low Severity (52) Raveling, Low Severity (57) Weathering

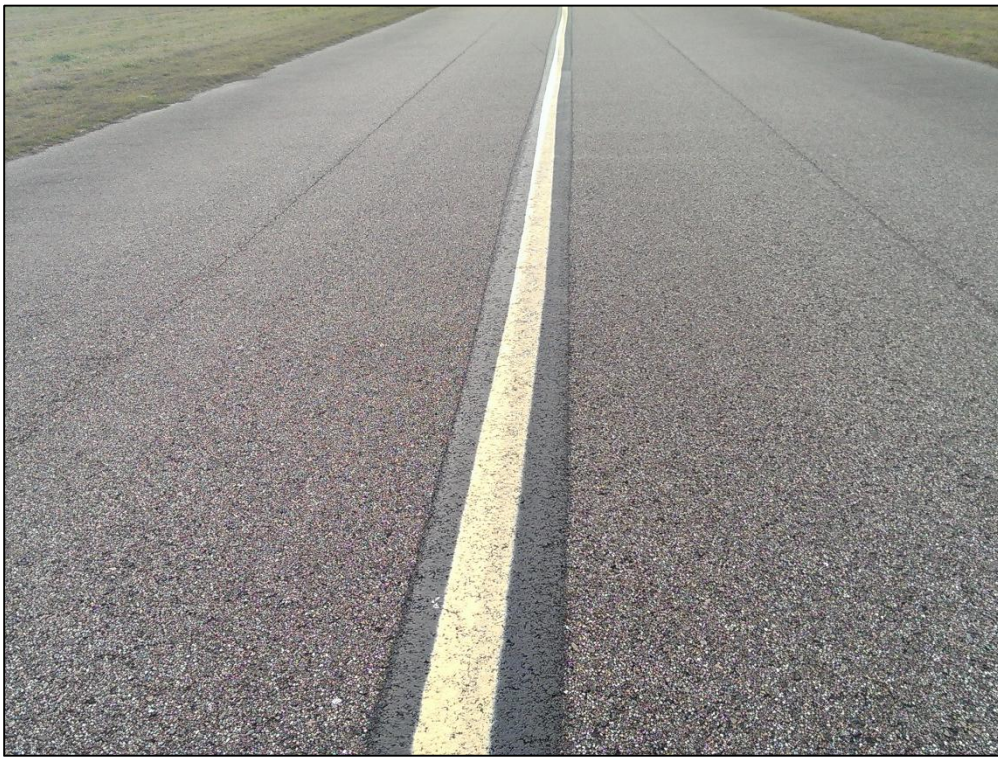
Taxiway Delta, Section 420, Sample Unit 119 – Low Severity (48) Longitudinal and Transverse Cracking, Low Severity (52) Raveling, Low Severity (57) Weathering

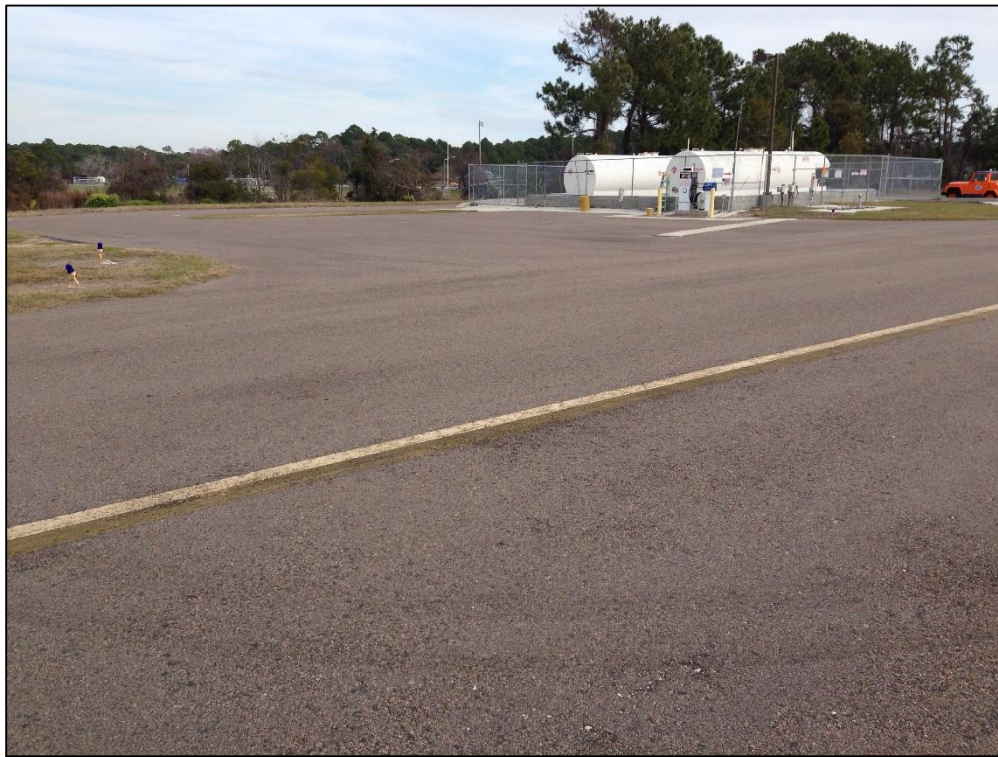
Taxiway Delta, Section 405, Sample Unit 101 – Low Severity (57) Weathering

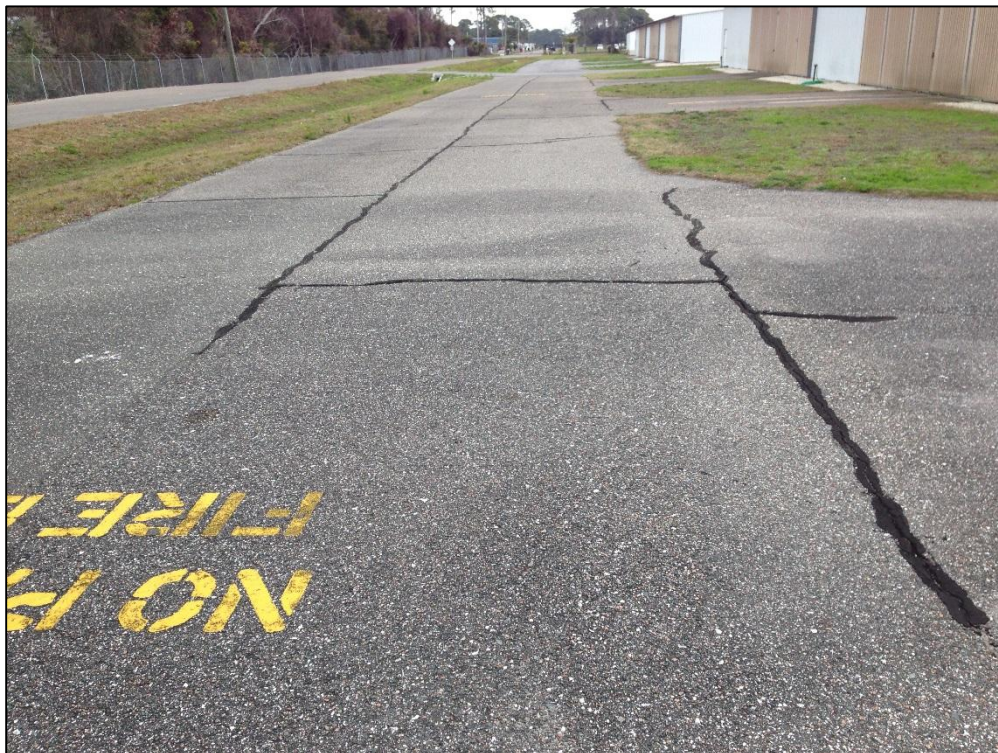
Apron T-Hangar, Section 4310, Sample Unit 106 – Low Severity (48) Longitudinal and Transverse Cracking, Low Severity (57) Weathering
