FLORIDA DEPARTMENT OF TRANSPORTATION
AVIATION AND SPACEPORT OFFICE

**GAINESVILLE
REGIONAL AIRPORT
(GNV)**

JUNE 2015

STATEWIDE
**Airfield
Pavement
Management**
PROGRAM

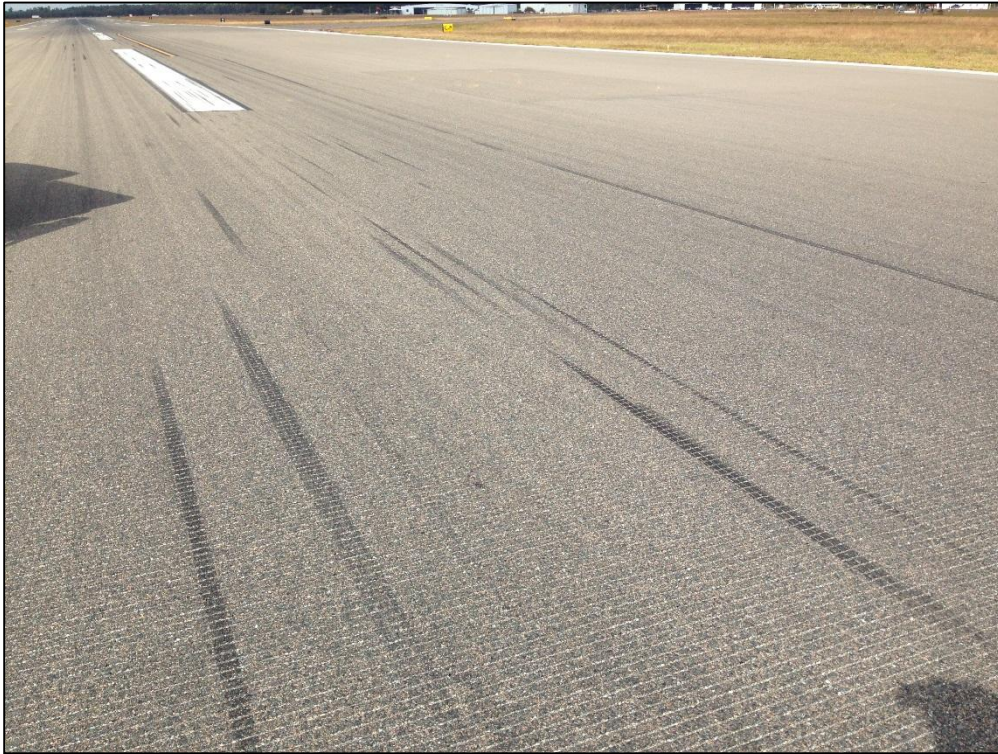
Runway 11-29, Section 6205, Sample Unit 365 – Low Severity (52) Raveling, Low Severity (57) Weathering

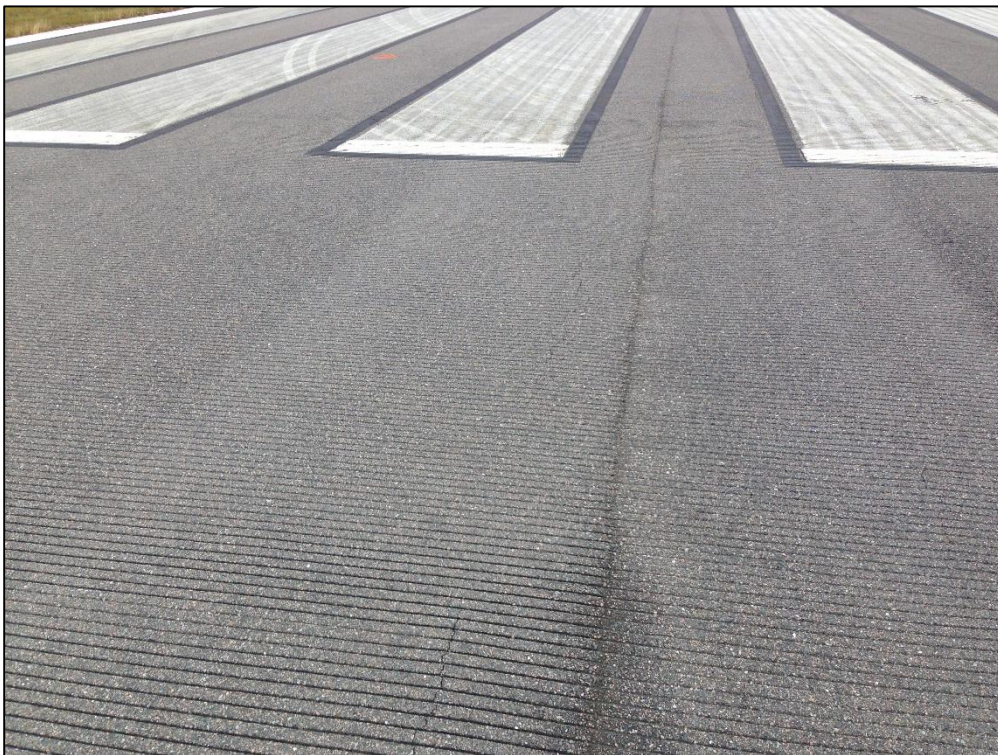
Runway 11-29, Section 6202, Sample Unit 300 – Low Severity (48) Longitudinal and Transverse Cracking, Medium Severity (52) Raveling, Low Severity (56) Swelling

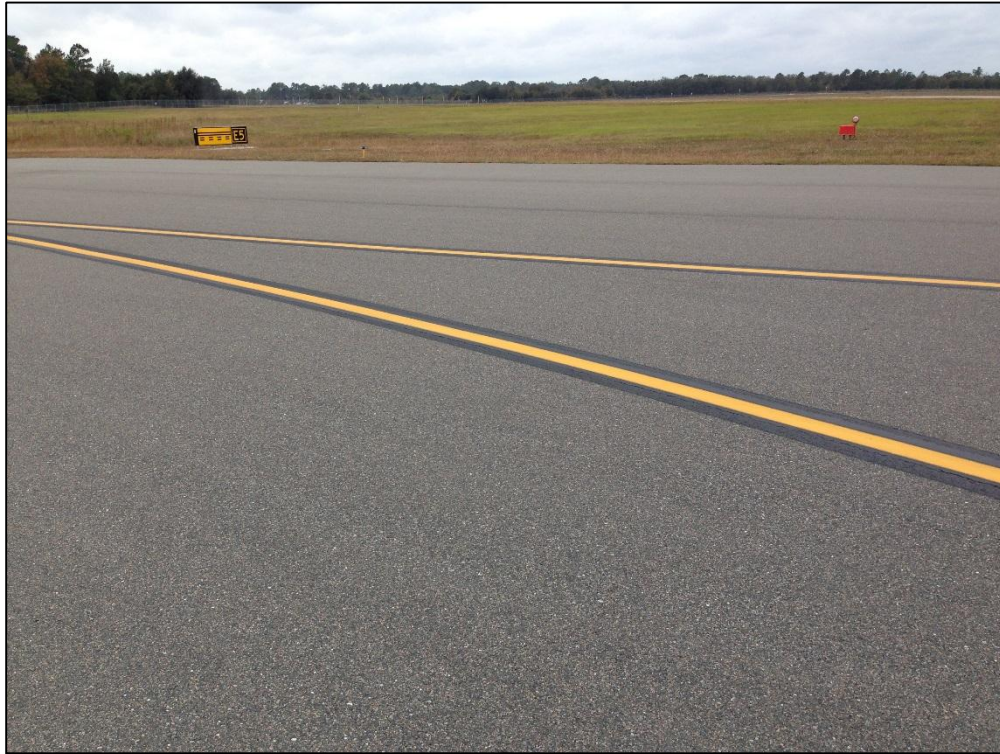
Taxiway E5, Section 550, Sample Unit 501 – Low Severity (48) Longitudinal and Transverse Cracking, Low Severity (57) Weathering

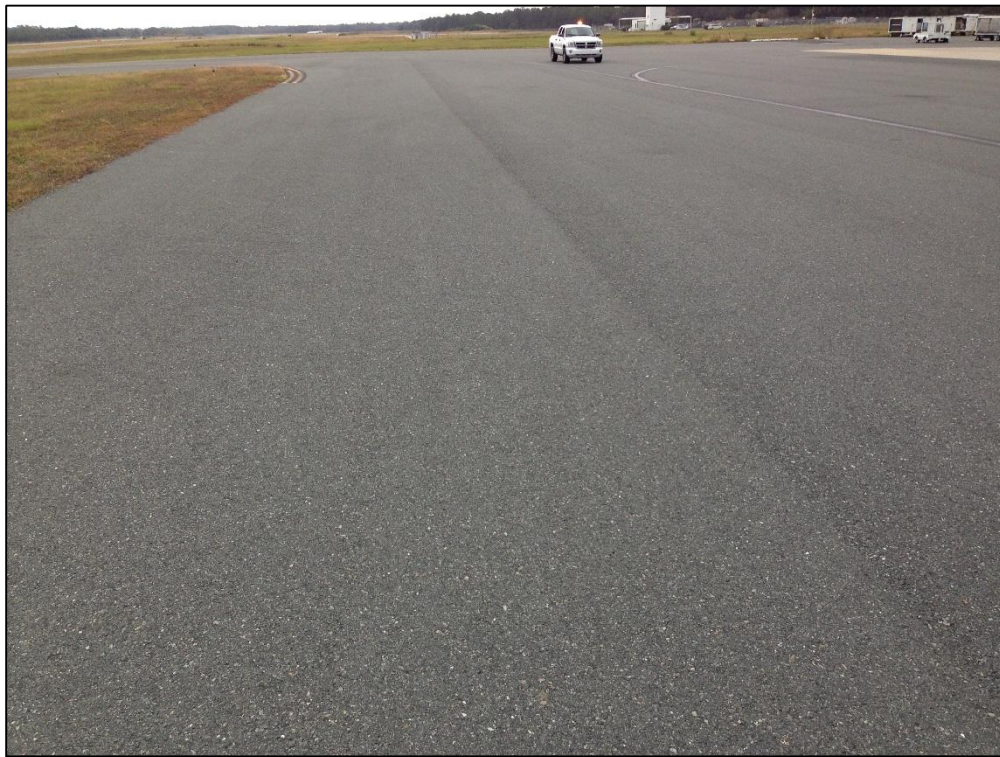
Apron 4105, Section 4105, Sample Unit 105 – Low Severity (57) Weathering

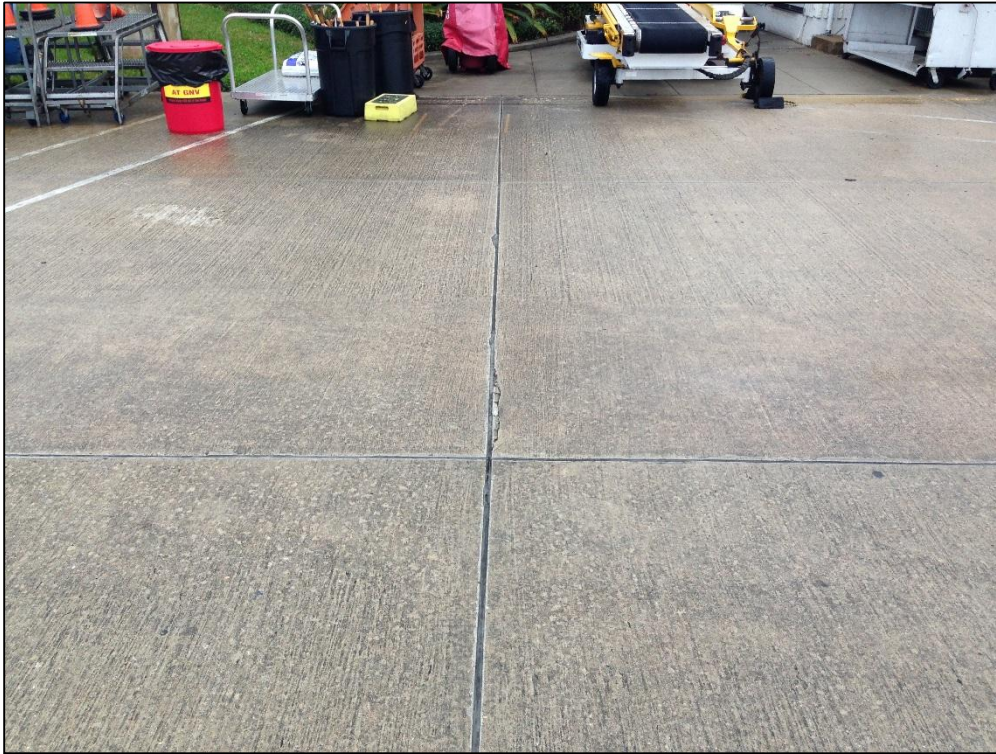
Apron South, Section 4115, Sample Unit 352 – Low Severity (70) Scaling, Map Cracking, Crazeing, Medium Severity (74) Joint Spalling

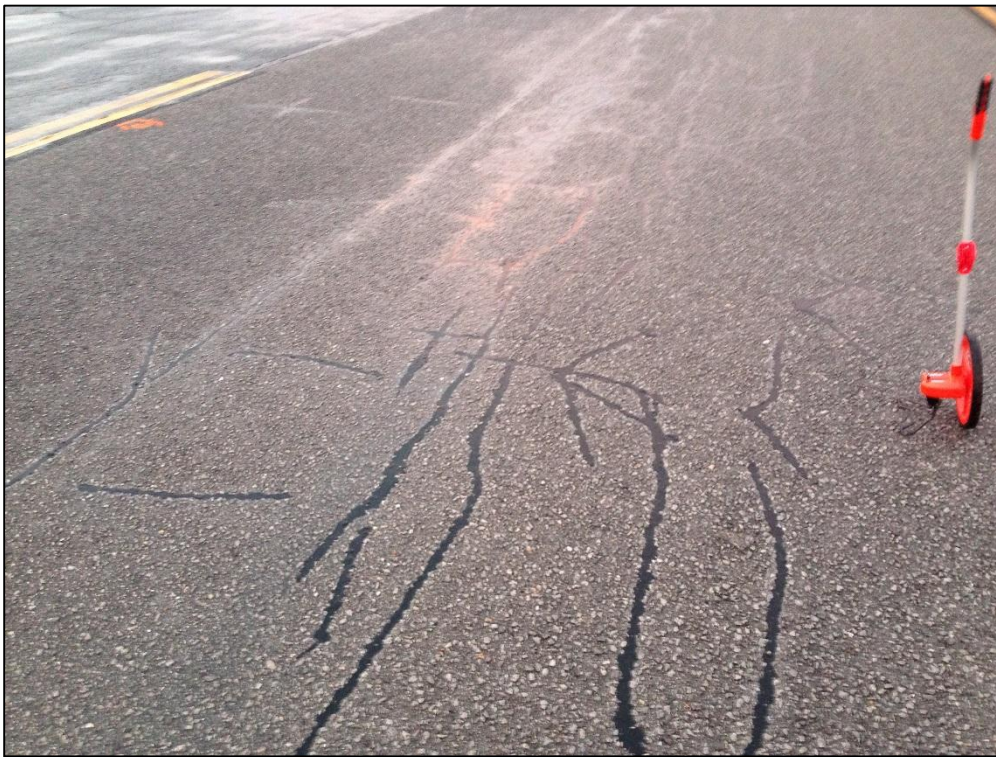
Taxiway Alpha, Section 105, Sample Unit 109 – Low Severity (48) Longitudinal and Transverse Cracking, Low Severity (43) Block Cracking, Medium Severity (52) Raveling

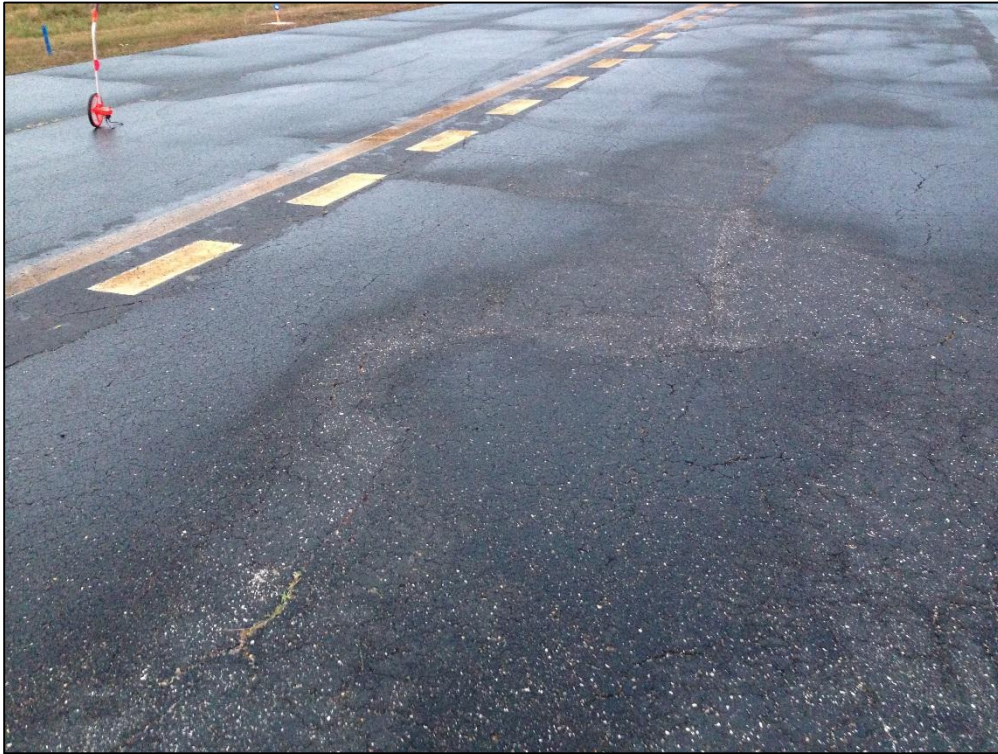
Apron Run-Up RW 7, Section 5205, Sample Unit 100 – Low Severity (43) Block Cracking, Low Severity (52) Raveling

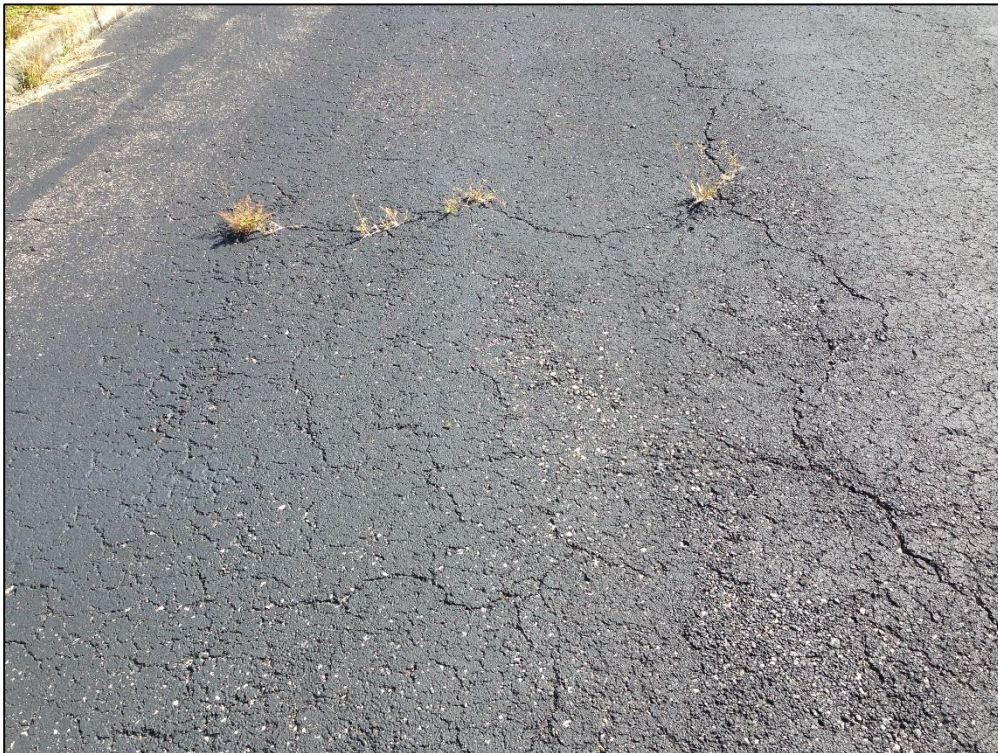
Apron SW, Section 4310, Sample Unit 102 – Low Severity (43) Block Cracking, Medium Severity (52) Raveling

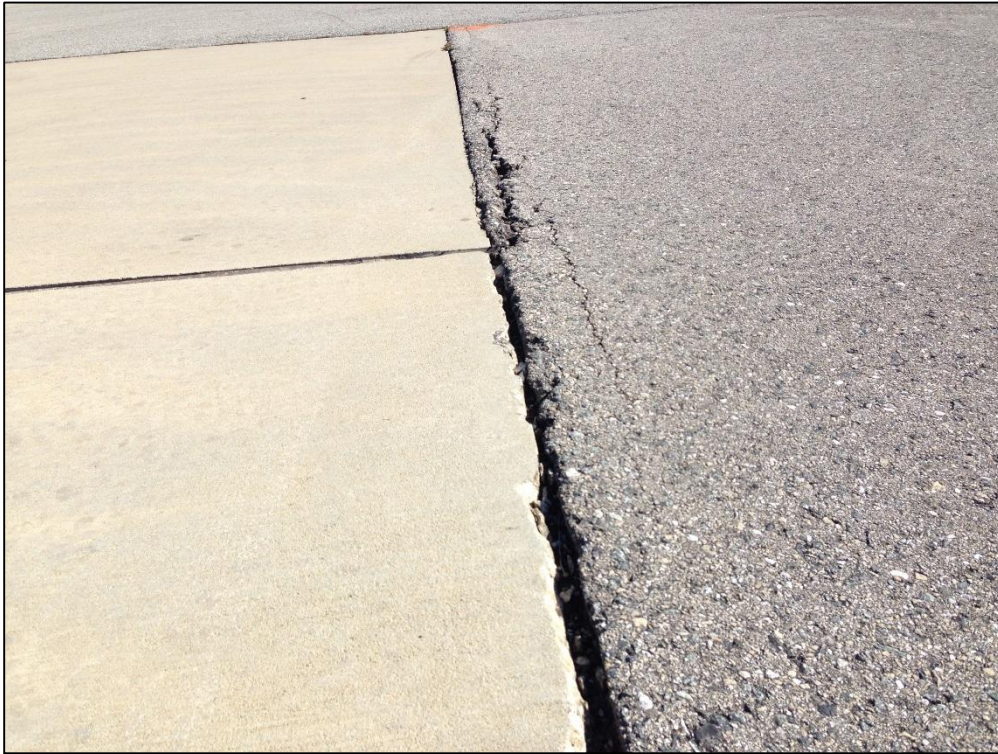
Apron SW, Section 4325, Sample Unit 204 – Low Severity (48) Longitudinal and Transverse Cracking, Low Severity (54) Shoving, Medium Severity (57) Weathering

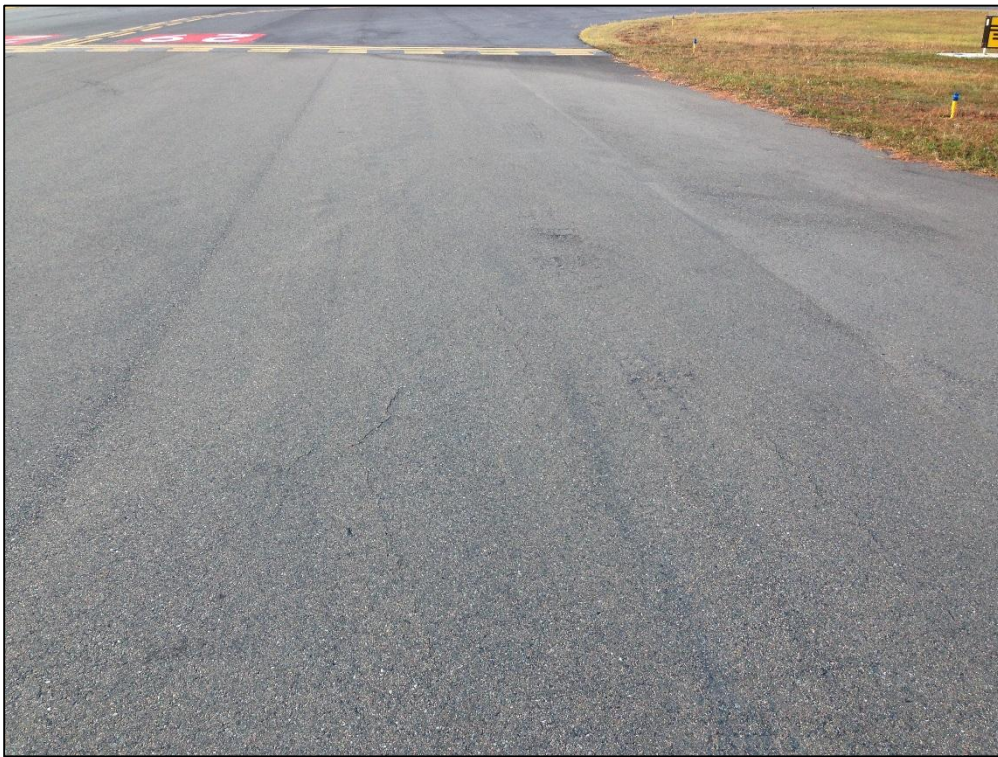
Taxiway E1, Section 515, Sample Unit 102 – Low Severity (48) Longitudinal and Transverse Cracking, Low Severity (57) Weathering

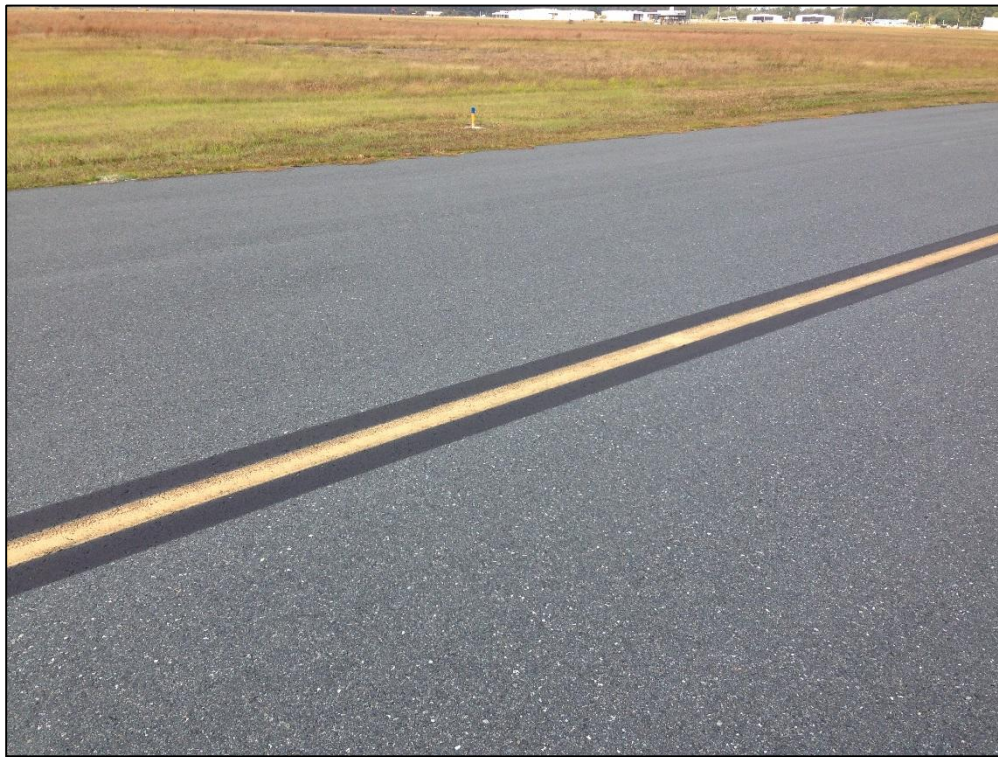
Taxiway Bravo, Section 210, Sample Unit 206 – Low Severity (57) Weathering

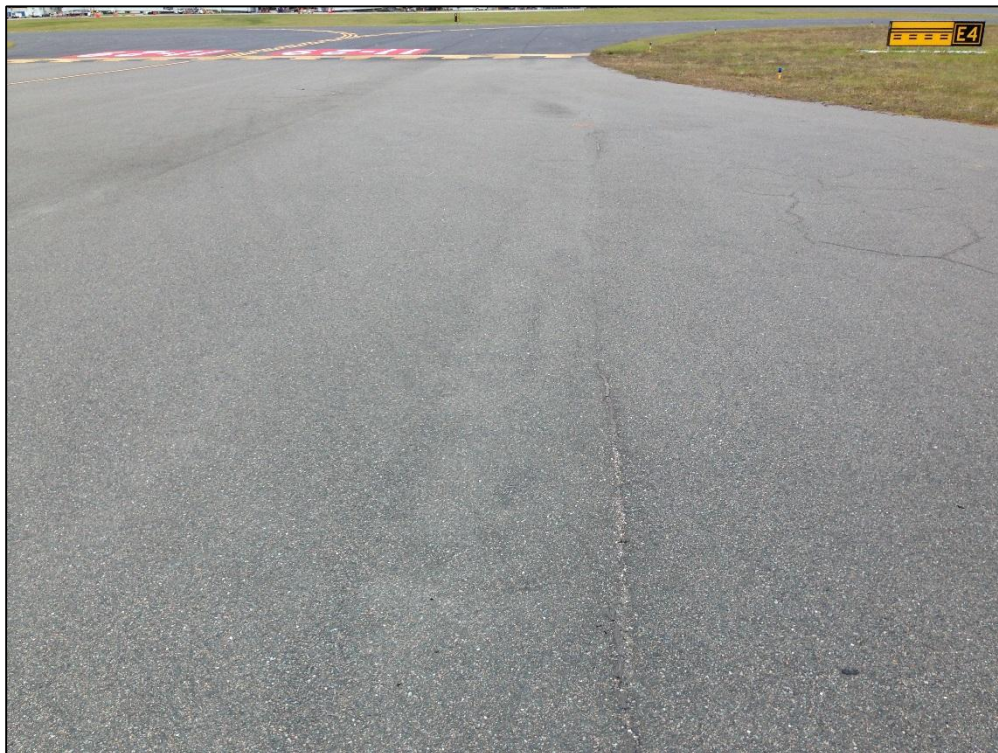
Taxiway E4, Section 540, Sample Unit 401 – Low Severity (48) Longitudinal and Transverse Cracking, Low Severity (57) Weathering
