FLORIDA DEPARTMENT OF TRANSPORTATION
AVIATION AND SPACEPORT OFFICE

**HERLONG
RECREATIONAL
AIRPORT (HEG)**

DISTRICT 2
REGIONAL RELIEVER
AIRPORT
JUNE 2015

STATEWIDE
**Airfield
Pavement
Management**
PROGRAM

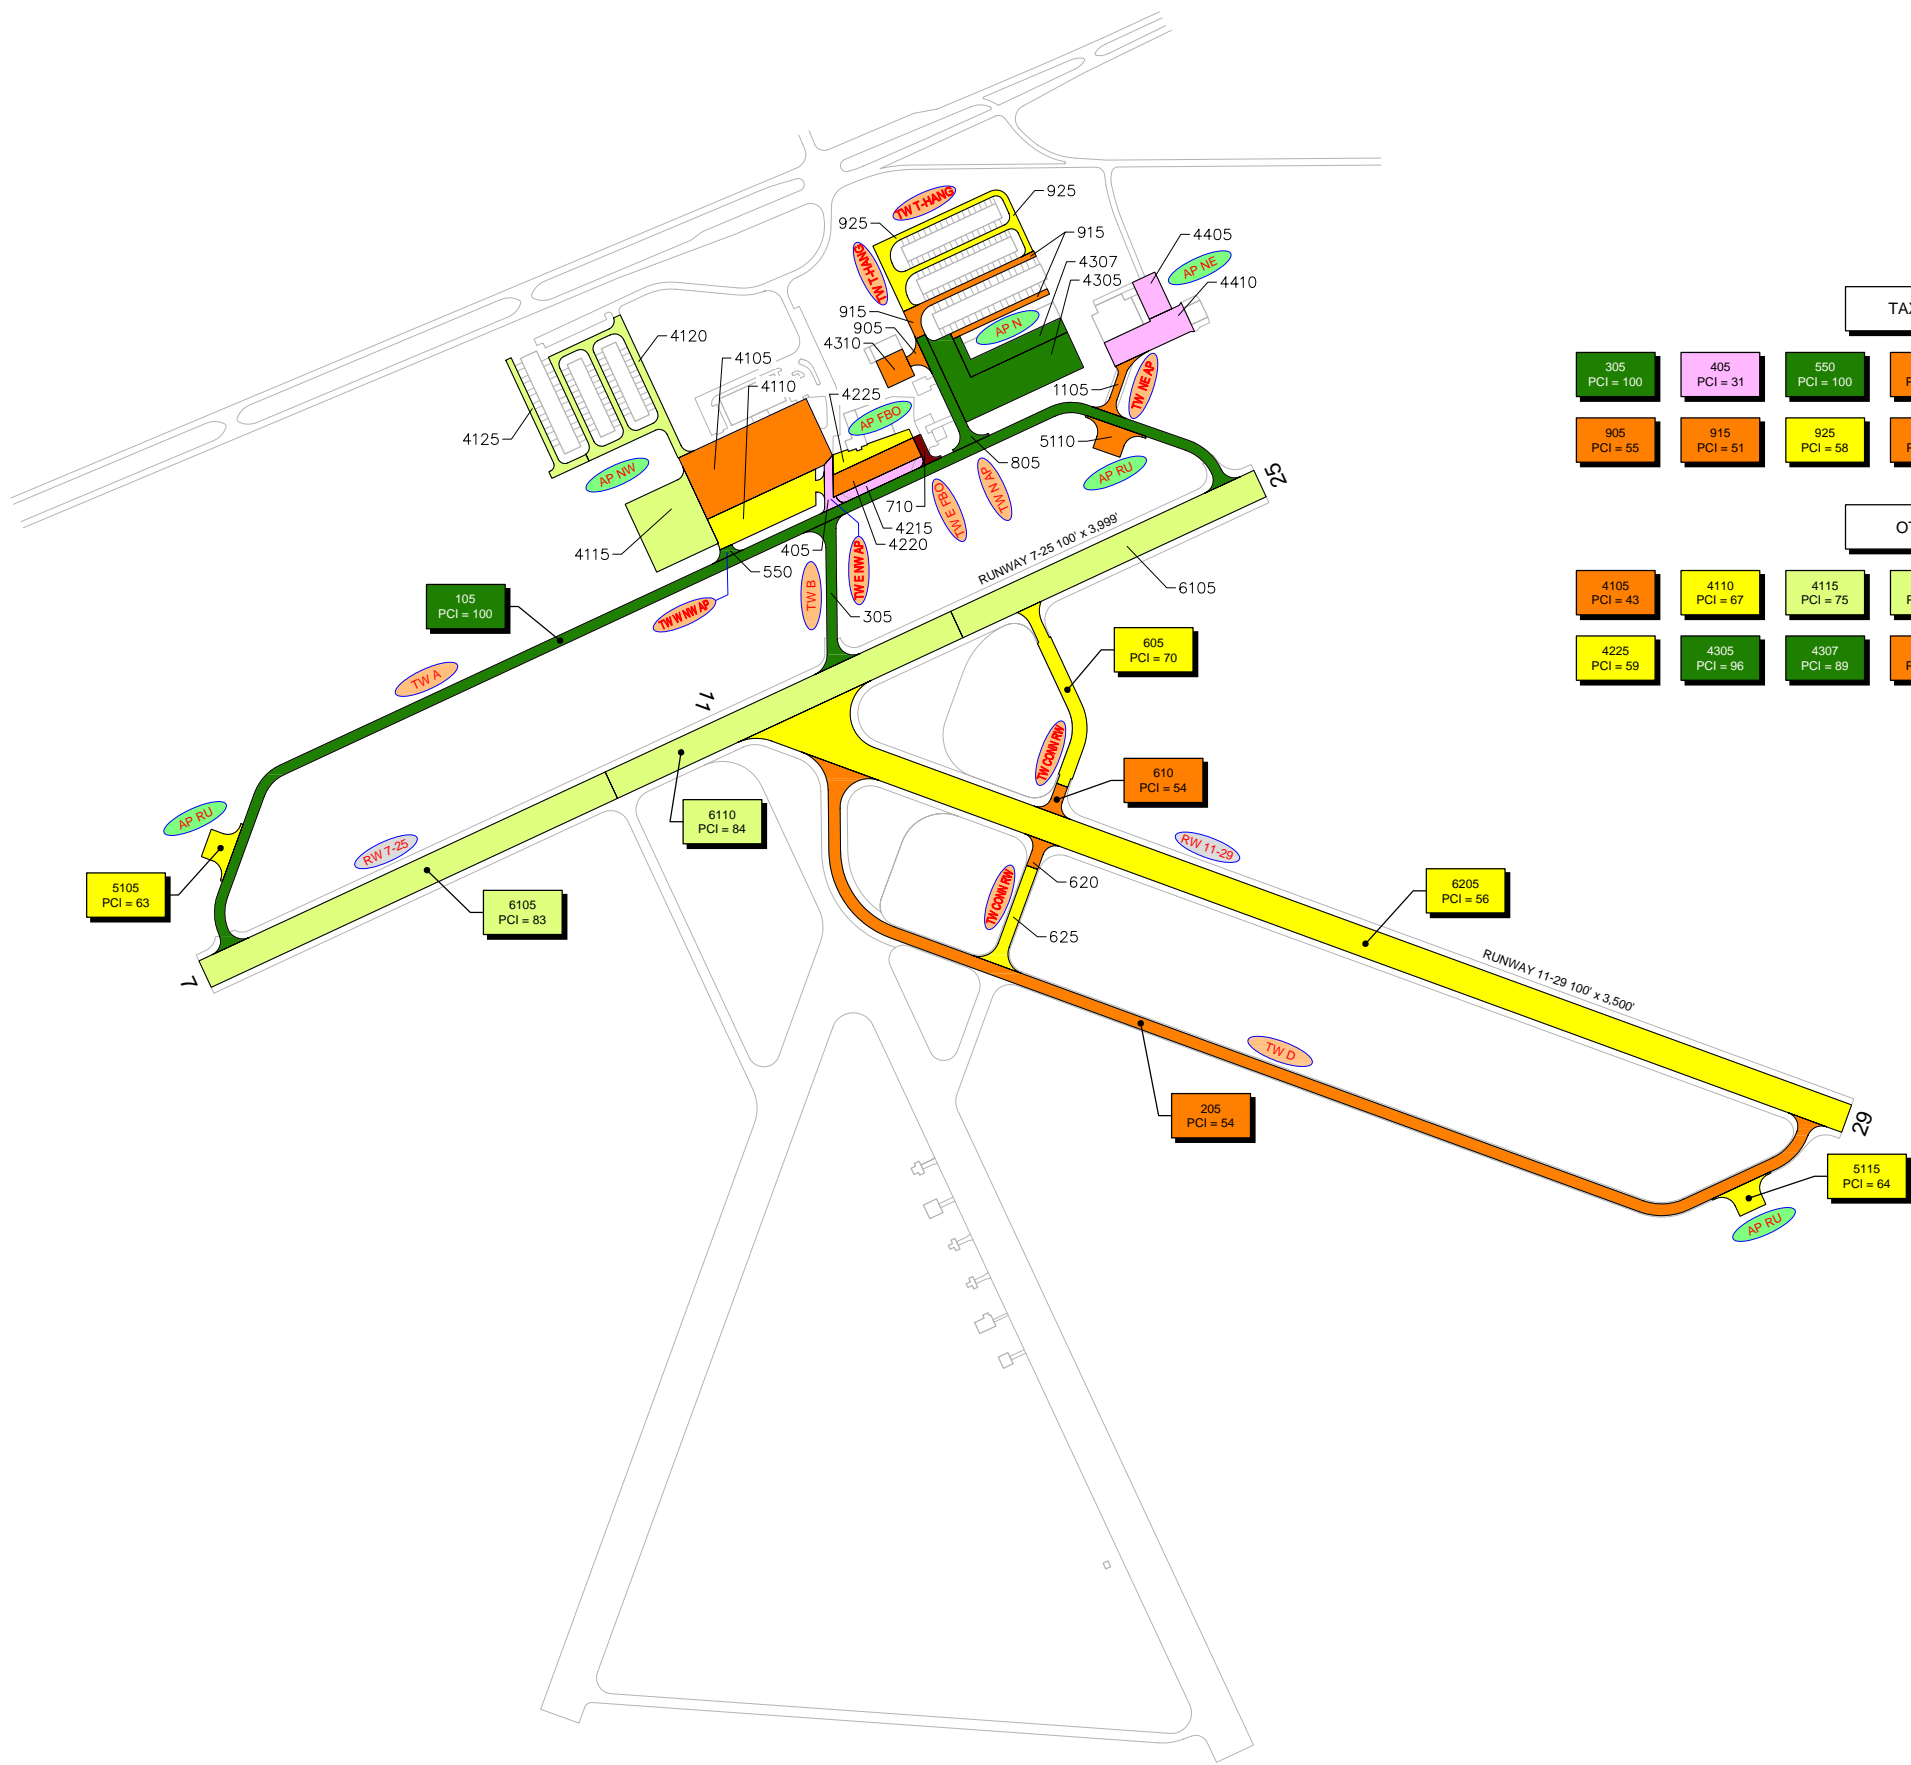
TAXIWAYS							
305 PCI = 100	405 PCI = 31	550 PCI = 100	620 PCI = 53	625 PCI = 70	710 PCI = 16	805 PCI = 95	
905 PCI = 55	915 PCI = 51	925 PCI = 58	1105 PCI = 41

OTHERS							
4105 PCI = 43	4110 PCI = 67	4115 PCI = 75	4120 PCI = 71	4125 PCI = 79	4215 PCI = 39	4220 PCI = 48	
4225 PCI = 59	4305 PCI = 96	4307 PCI = 89	4310 PCI = 52	4405 PCI = 35	4410 PCI = 31	5110 PCI = 44

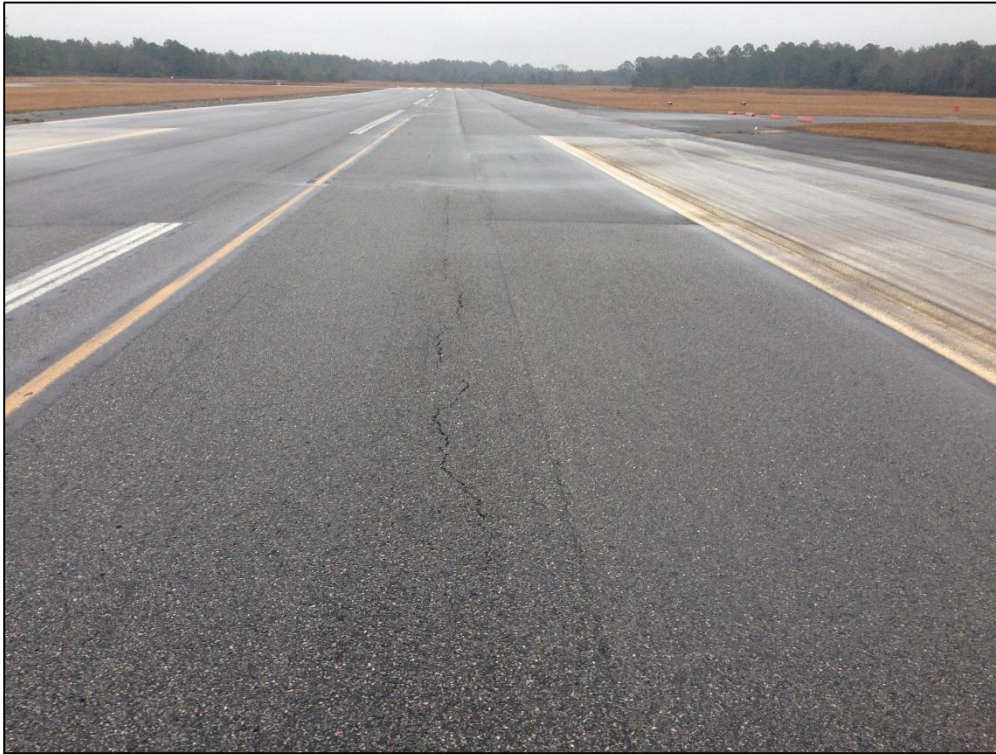
Runway 7-25, Section 6105, Sample Unit 157 – Low Severity (48) Longitudinal and Transverse Cracking, Low Severity (57) Weathering

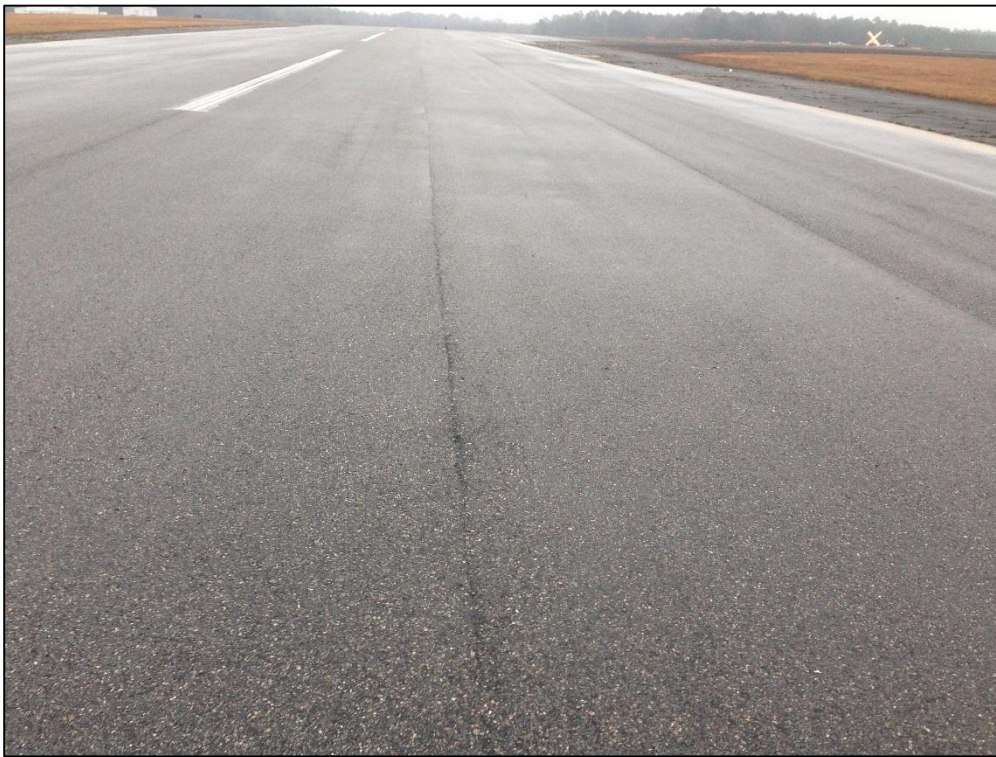
Runway 7-25, Section 6110, Sample Unit 133 – Low Severity (57) Weathering

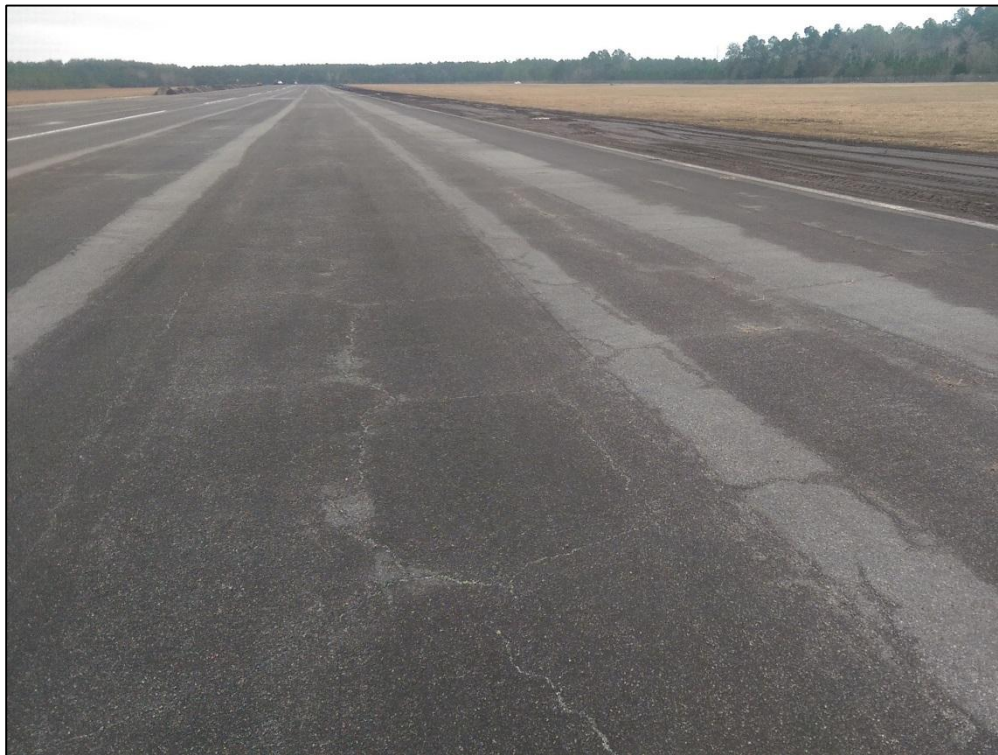
Runway 11-29, Section 6205, Sample Unit 149 – Low Severity (41) Alligator Cracking

- ⦿ Runway 11-29 – Section 6205
 - Mill and Overlay attributed to climate and age of pavement.
- ⦿ Run Up Apron – Sections 5105, 5110, and 5115
 - Mill and Overlay attributed to climate and age of pavement.
- ⦿ Northeast Apron – Section 4405
 - Reconstruction attributed to load, climate, and age of pavement.
- ⦿ Northeast Apron – Section 4410
 - Reconstruction attributed to load, climate, and age of pavement.
- ⦿ North Apron – Section 4310
 - Mill and Overlay attributed to climate and age of pavement.
- ⦿ FBO Apron – Sections 4215, 4220, and 4225
 - Reconstruction and Mill and Overlay attributed to load, climate, and age of pavement.
- ⦿ Northwest Apron – Section 4105
 - Mill and Overlay attributed to climate and age of pavement.

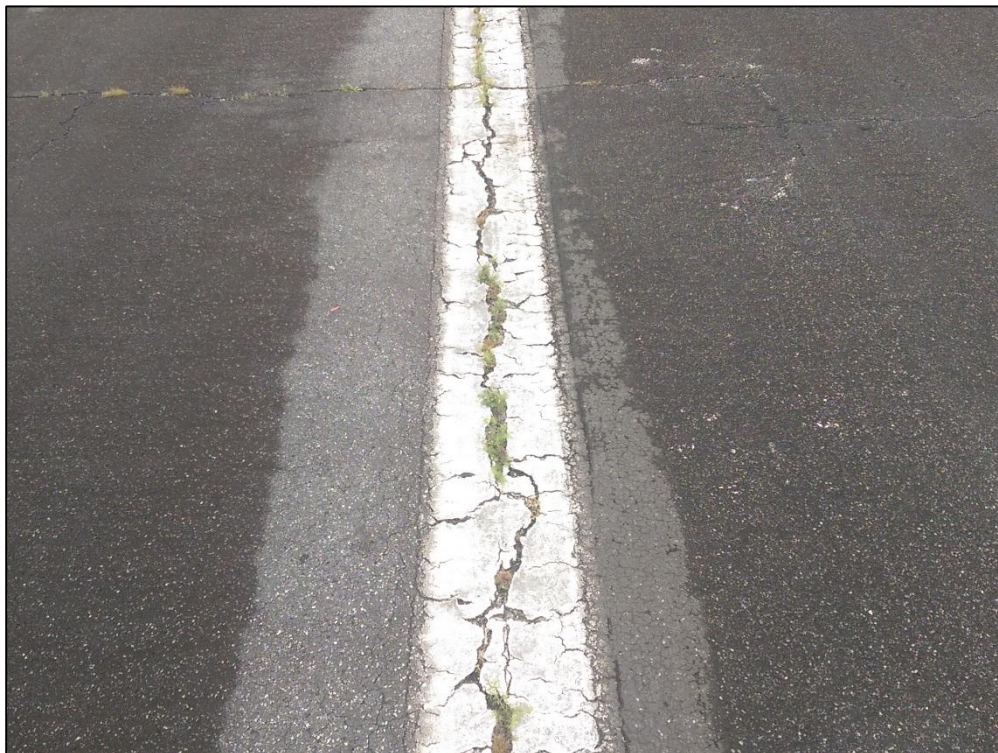
Runway 11-29, Section 6205, Sample Unit 167 – Low and Medium Severity (48) Longitudinal and Transverse Cracking, Low Severity (52) Raveling

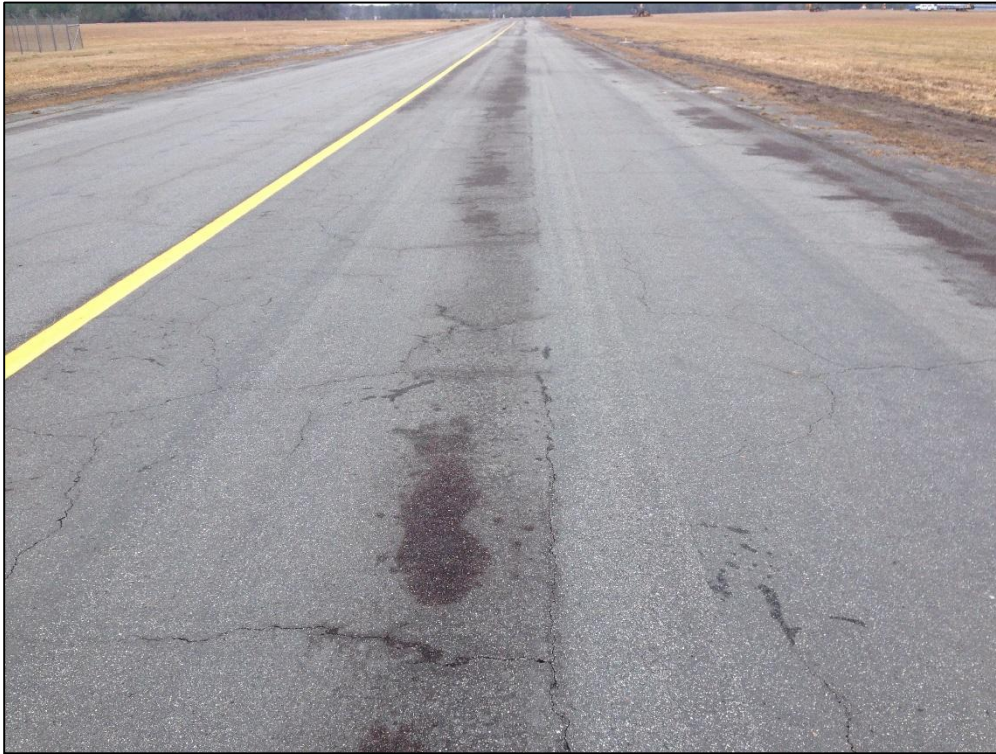
Taxiway Delta, Section 205, Sample Unit 120 – Low Severity (43) Block Cracking, Low Severity (48) Longitudinal and Transverse Cracking, Low Severity (52) Raveling

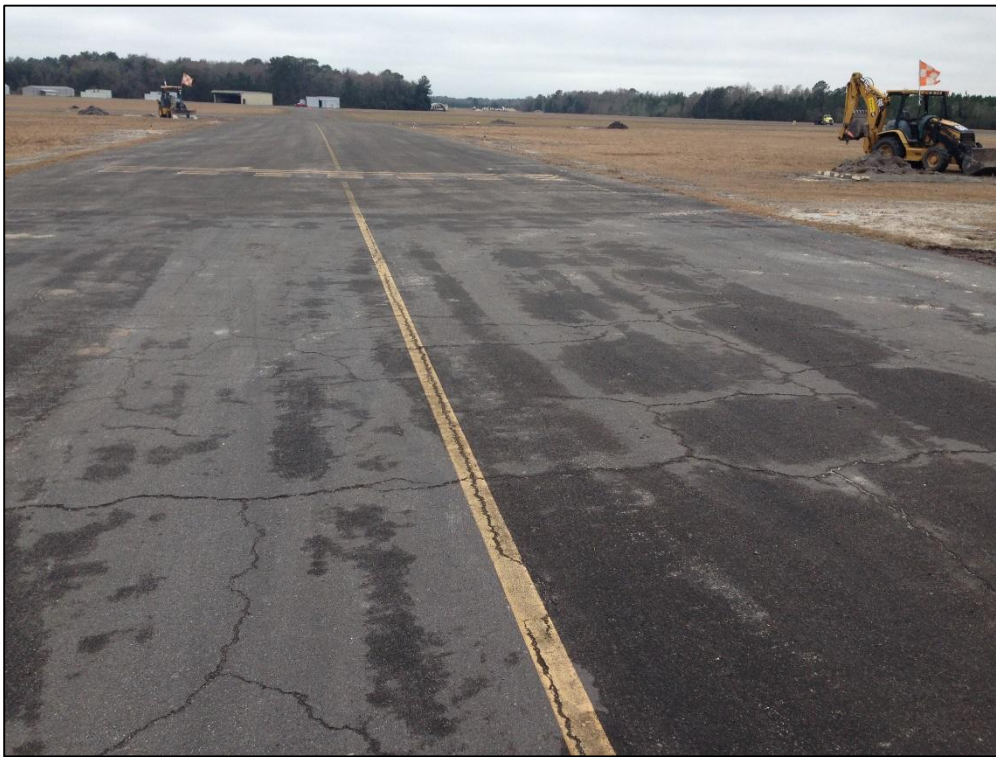
Taxiway Connector to Runway, Section 620, Sample Unit 100 – Low Severity (43) Block Cracking, Low Severity (52) Raveling

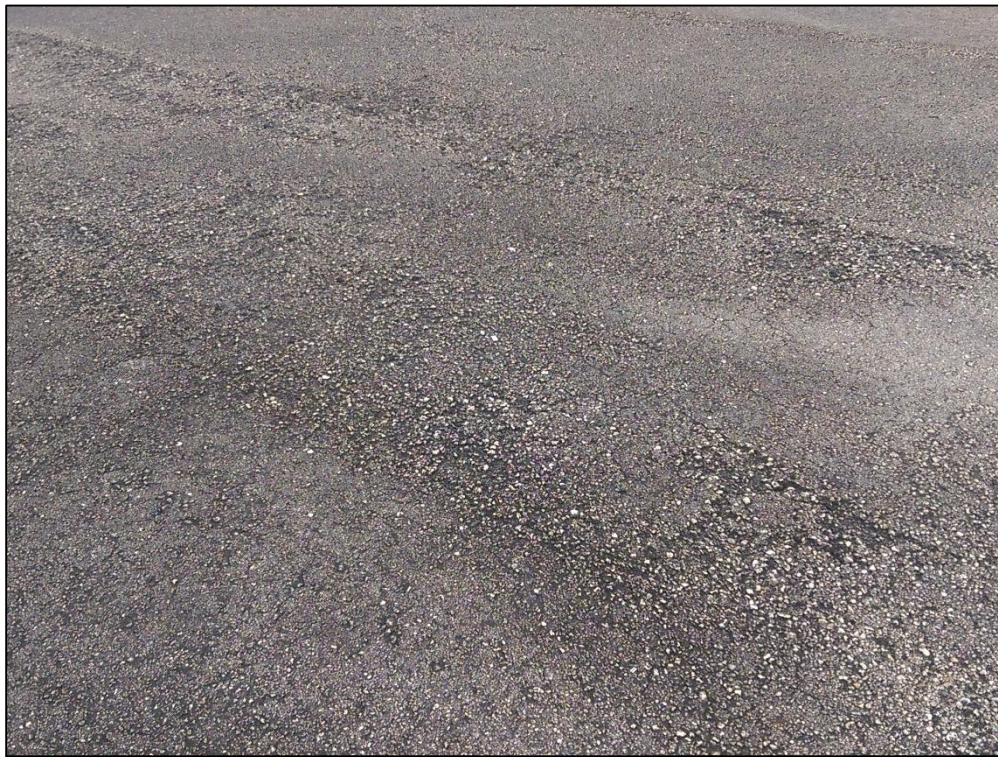
Apron Run-Up, Section 5105, Sample Unit 100 – Low Severity (48) Longitudinal and Transverse Cracking, Low Severity (52) Raveling, Medium Severity (52) Raveling

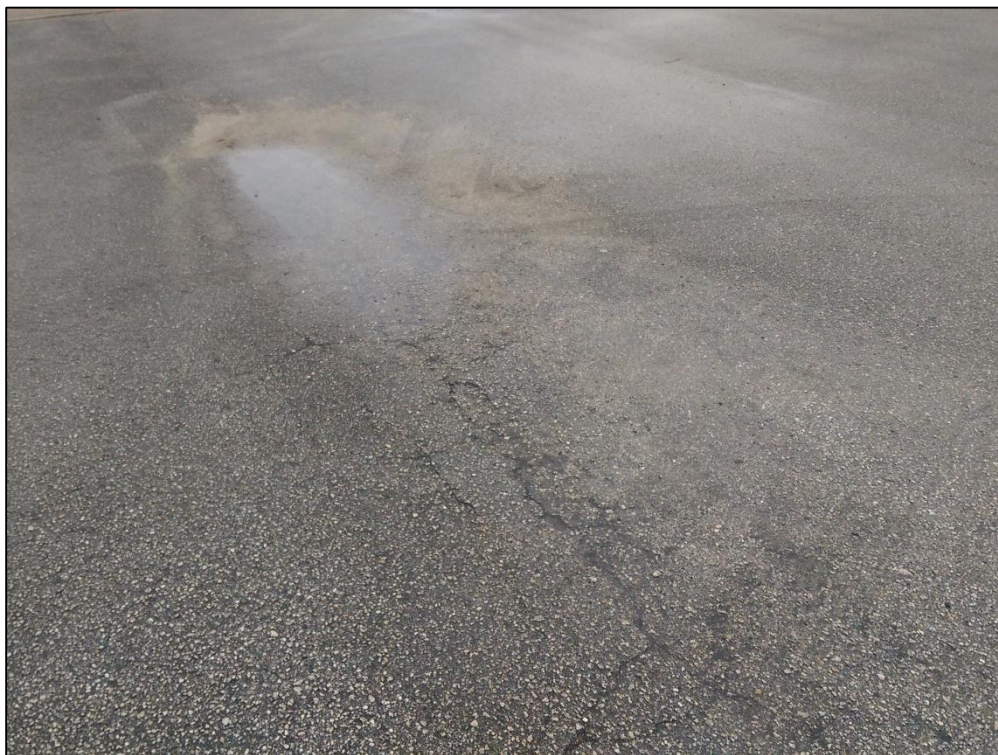
Apron Northeast, Section 4405, Sample Unit 401 – Low Severity (41) Alligator Cracking, Low Severity (53) Rutting, Low Severity (52) Raveling

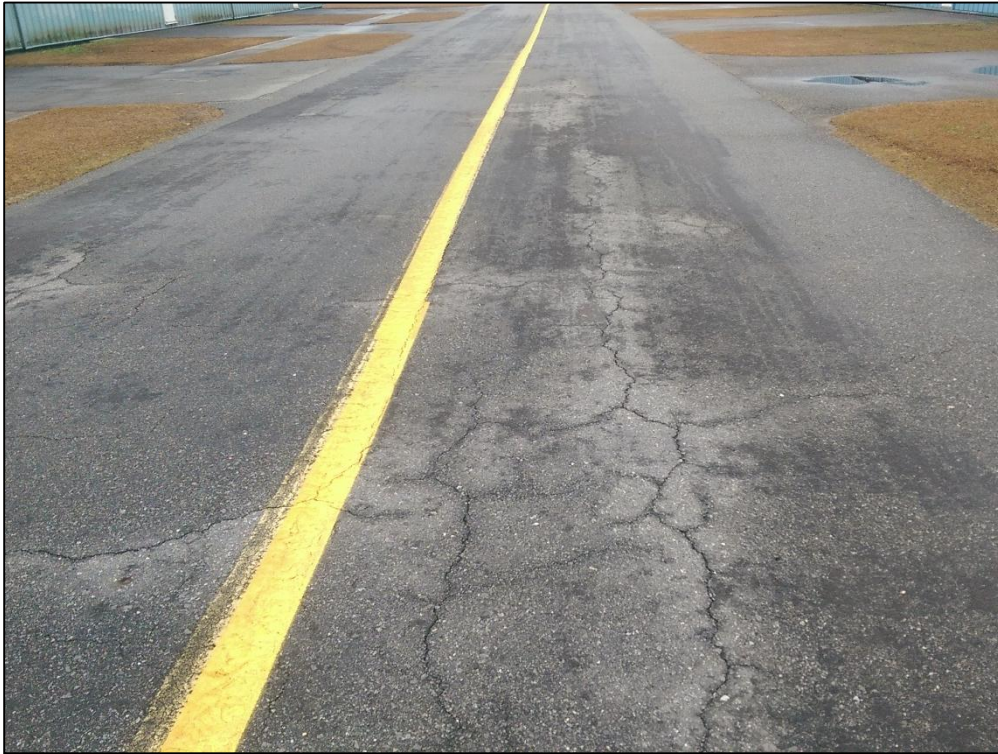
Taxiway T-Hangar, Section 915, Sample Unit 300 – Low Severity (43) Block Cracking, Low Severity (48) Longitudinal and Transverse Cracking, Low Severity (52) Raveling, Low Severity (57) Weathering

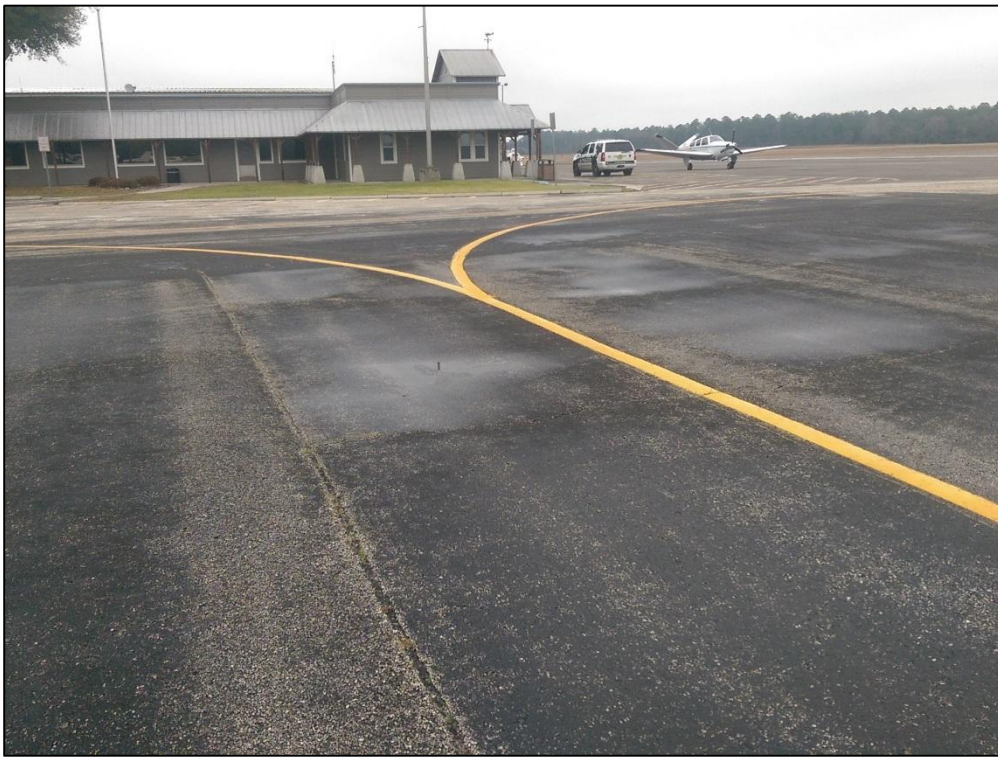
Apron Northwest, Section 4105, Sample Unit 254 – Low and Medium Severity (48) Longitudinal and Transverse Cracking, Low Severity (52) Raveling

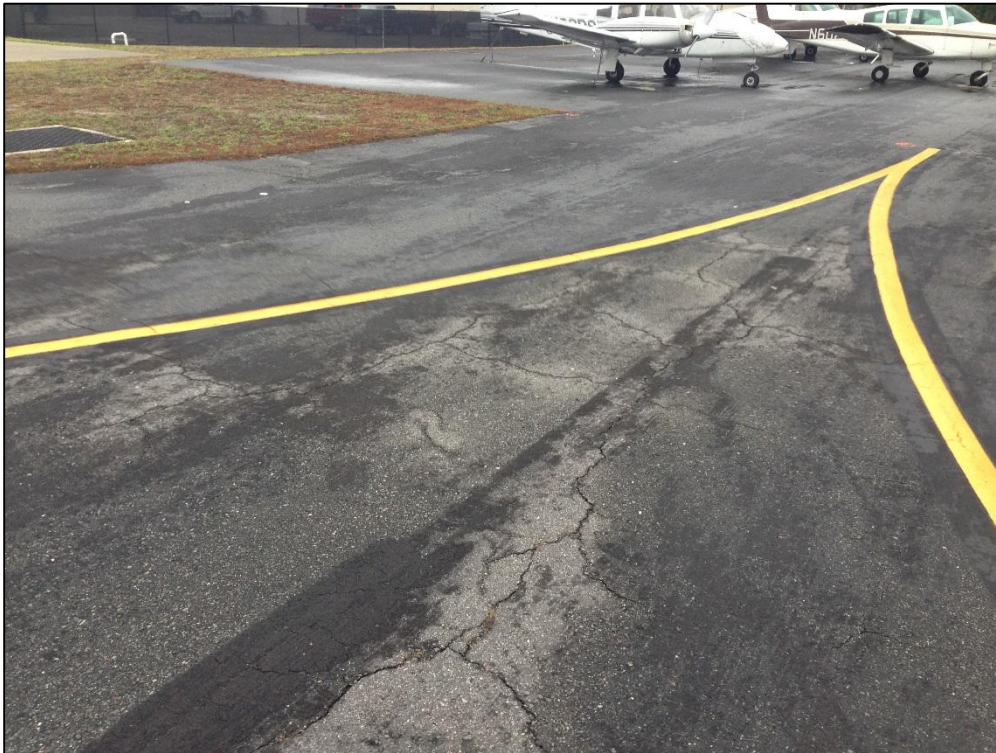
Taxiway T-Hangar, Section 905, Sample Unit 100 – Low Severity (43) Block Cracking, Low Severity (52) Raveling

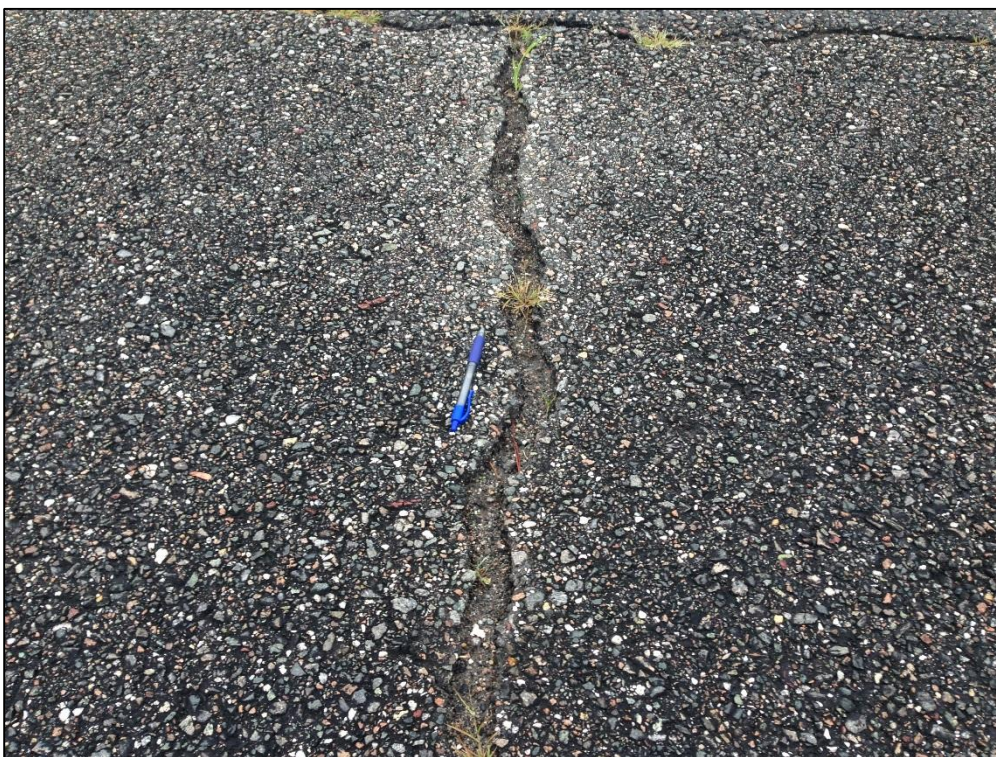
Apron FBO, Section 4220, Sample Unit 250 – Medium Severity (48) Longitudinal and Transverse Cracking, High Severity (48) Longitudinal and Transverse Cracking, Low Severity (52) Raveling

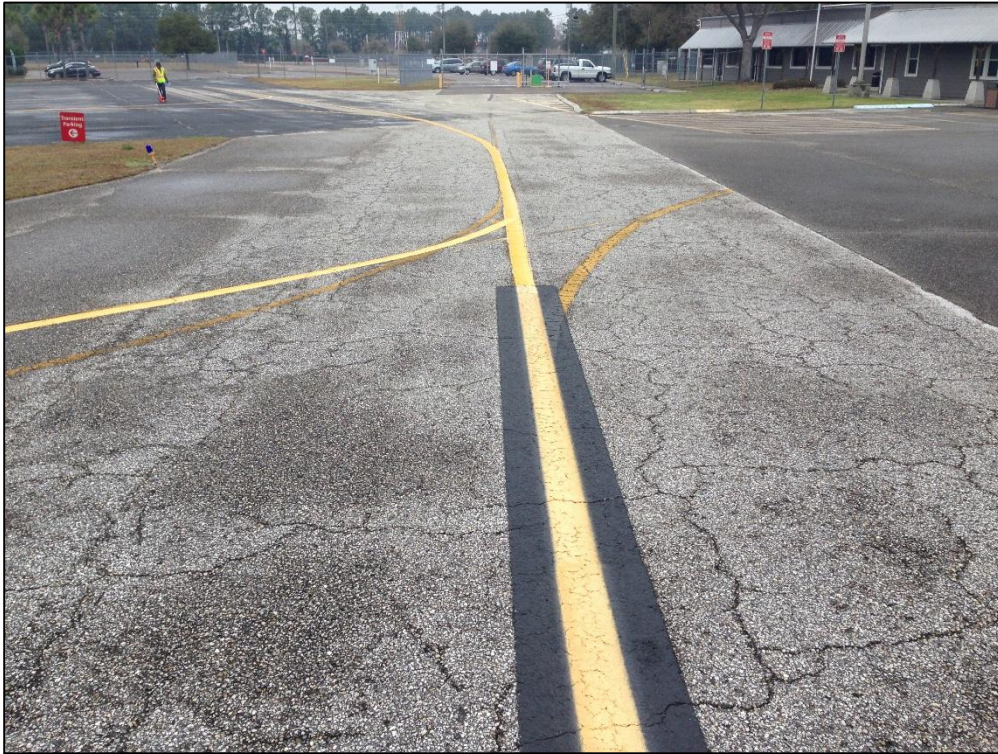
Taxiway East Connector to NW Apron, Section 405, Sample Unit 100 – Low Severity (43) Block Cracking, Low Severity (52) Raveling, Medium Severity (52) Raveling
